# **LADY ANNIE OPERATIONS**

**30<sup>TH</sup> OF JANUARY 2009**

**DISCHARGE EVENT REPORT**

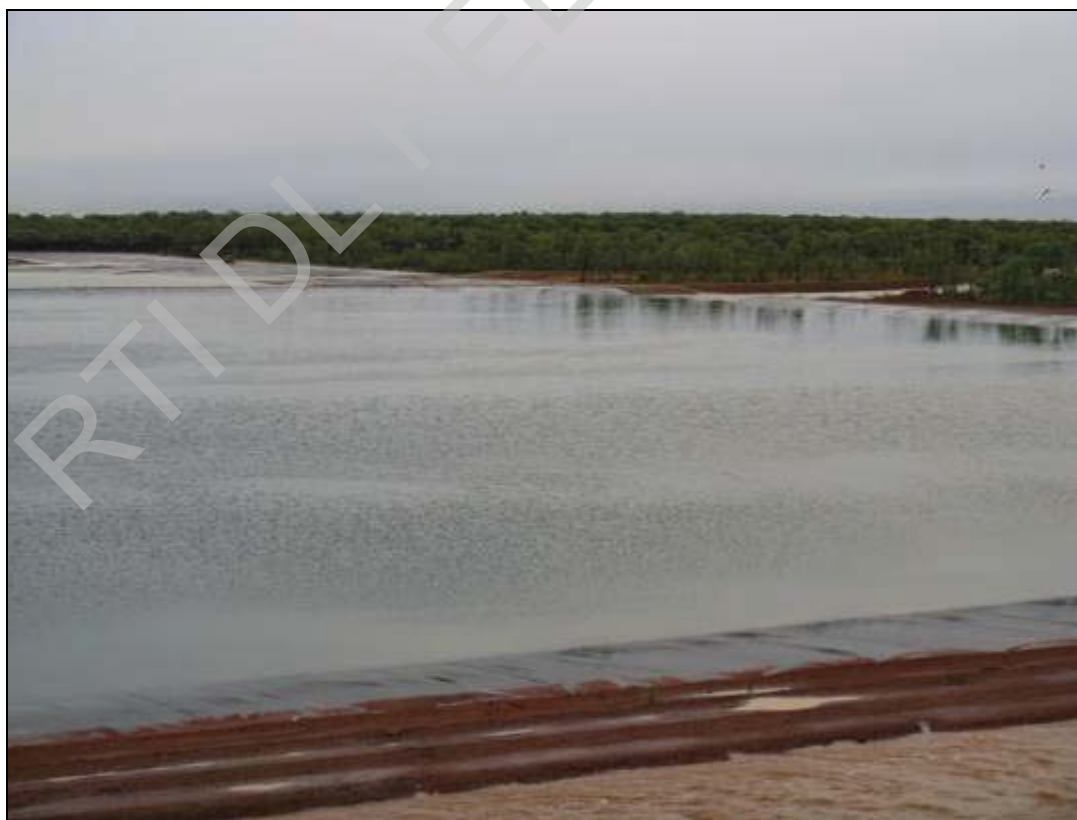
*Figure 2: Photo of both Storm Water Pond spillways (Taken 29JAN09).*

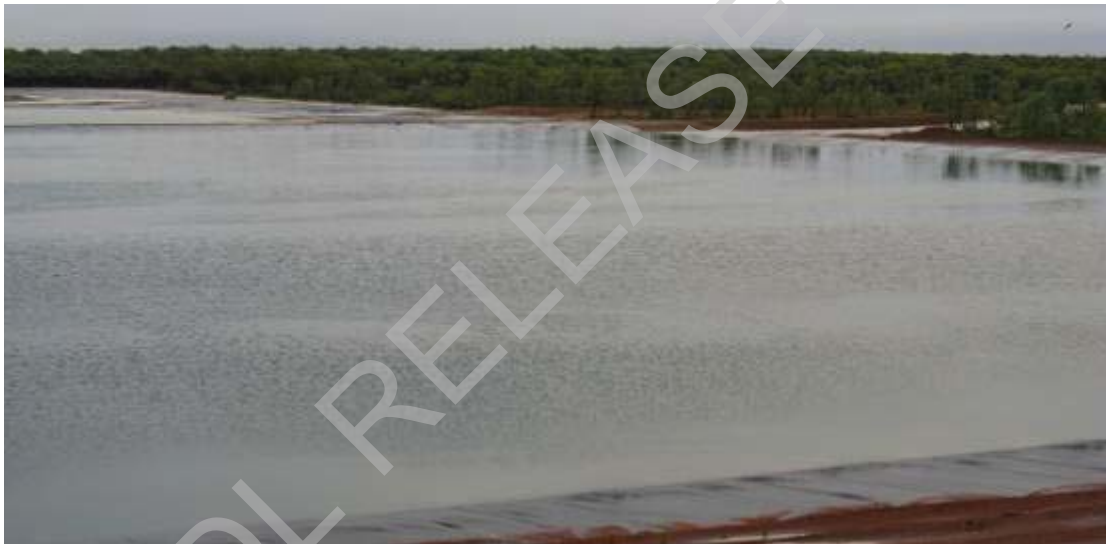
- a. In the interval between 1730 30<sup>th</sup> January and 0700 31<sup>st</sup> January, the spillway at SW Pond #1 scoured out beneath the liner. (Figure 4 & 5). The scour depth is estimated to be 500mm deep.
- b. The water level in SW Pond #1 dropped by approximately 1.5m overnight (Figure 6).
- c. The cause may be contributable to water above the liner forcing the water beneath the liner out under pressure. More investigation is required.

*Figure 4: SW Pond #1 Spillway (Taken 1000 30JAN09).*

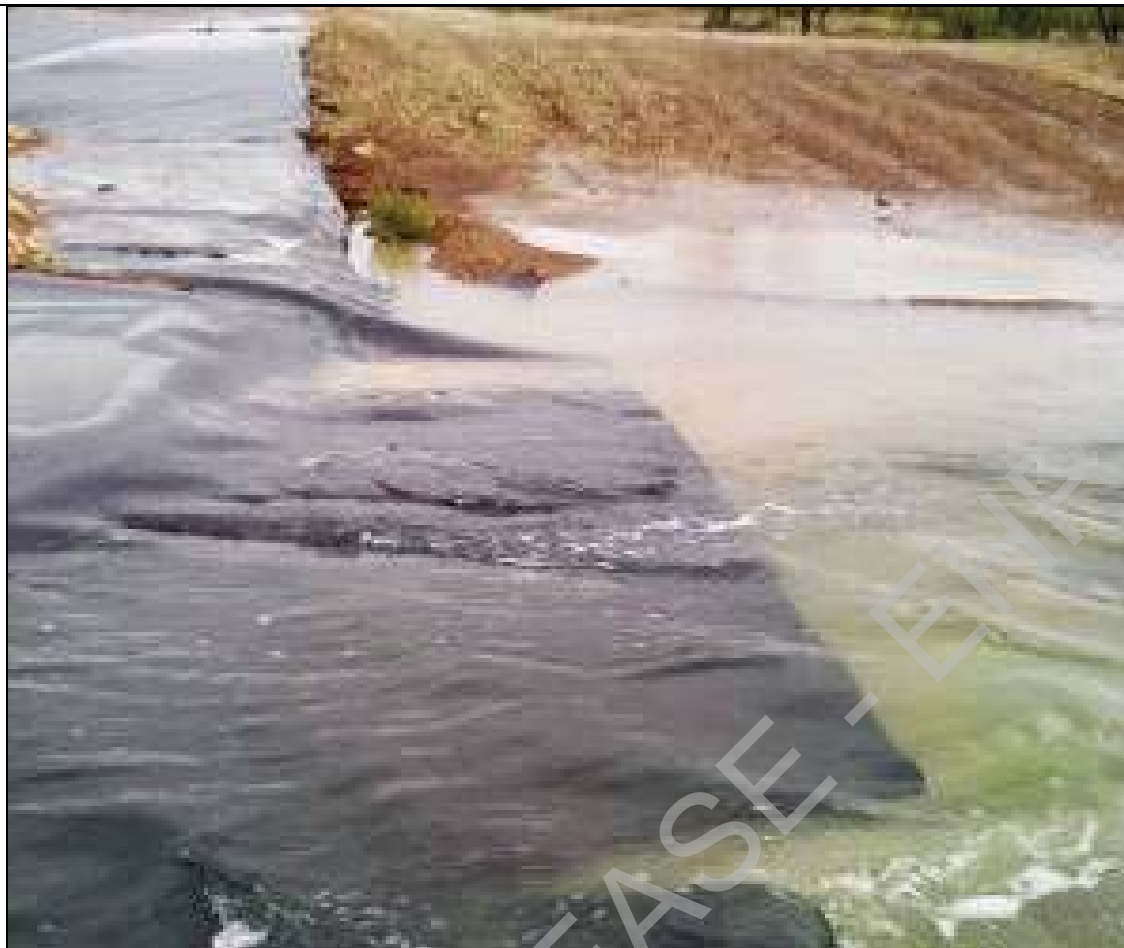
Figure 5: Water flowing over and under pond liner SW Pond #1 Spillway (Taken 0650 on

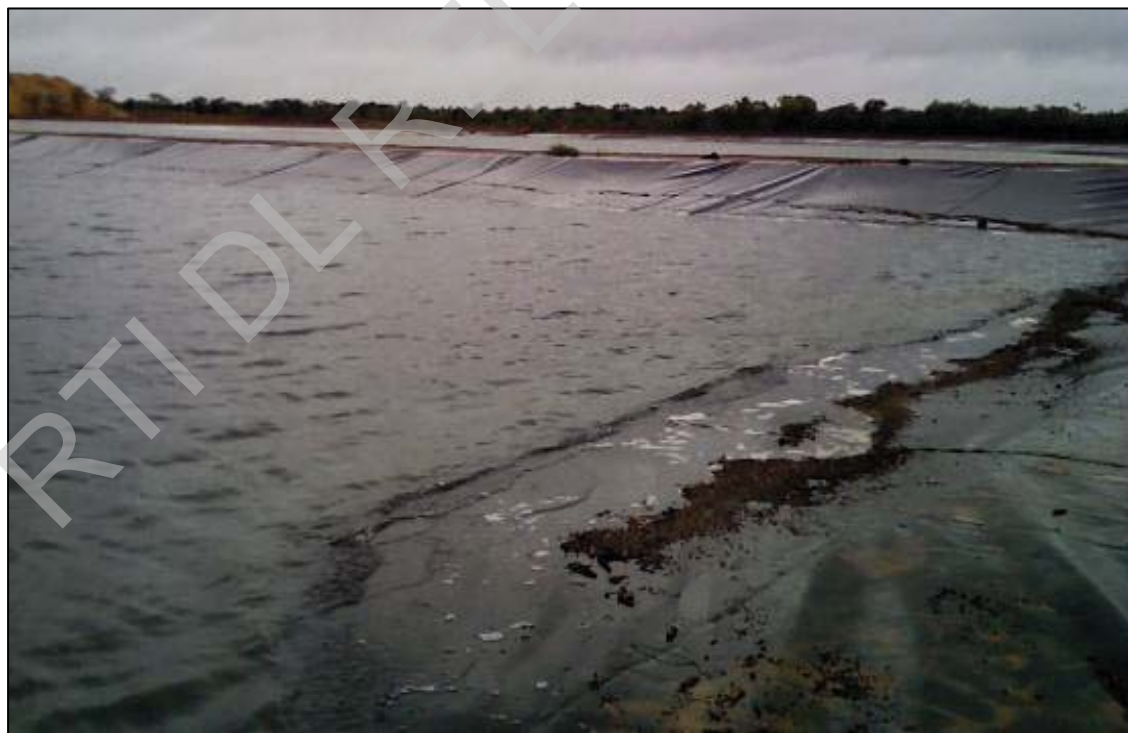
Figure 6: SW Pond #1 showing drop in water level of ~1.5m (Taken 0700 31JAN09).

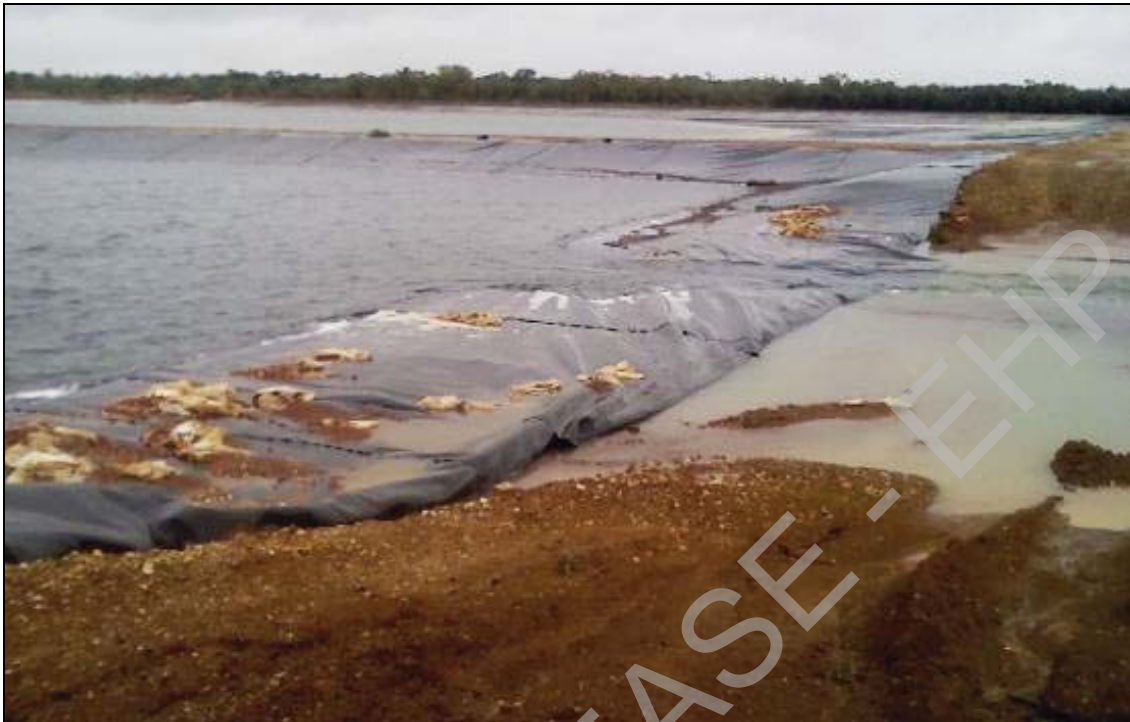
*Figure 7: Scour beneath SW Pond#1 Spillway (Taken 0700 on 31JAN09).*

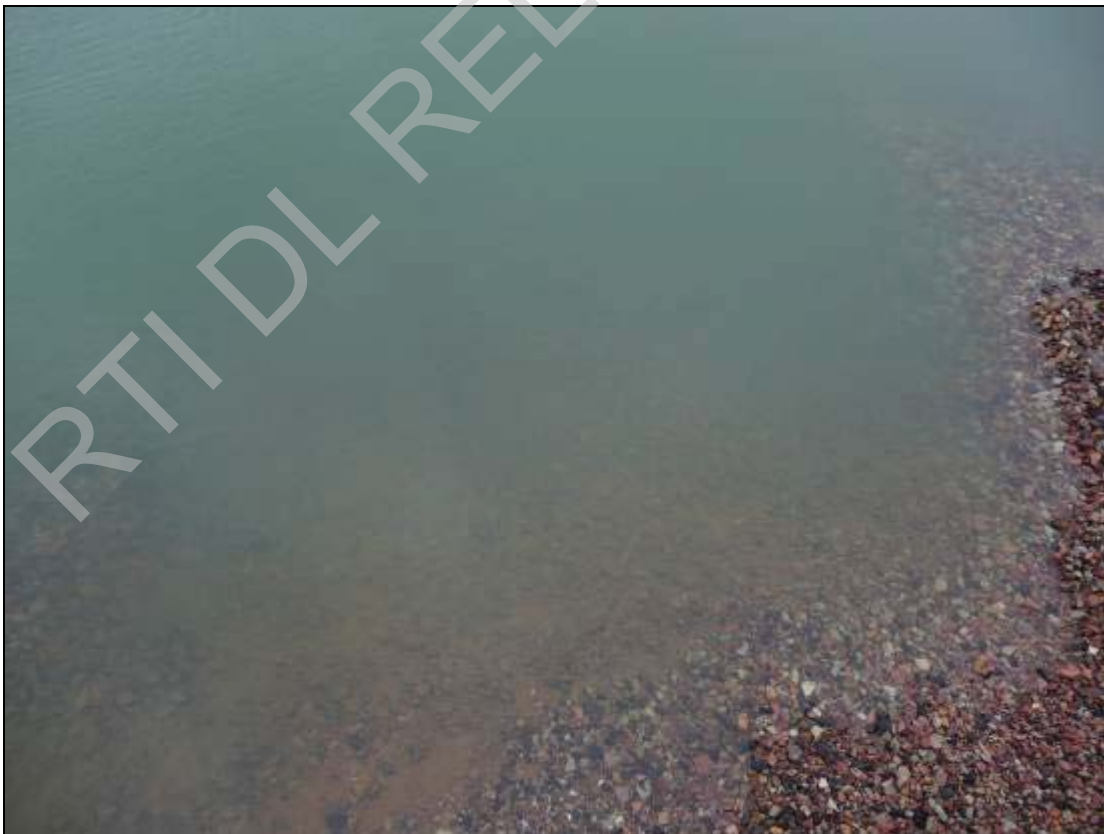
*Figure 8: Water colour of SW Pond #1 (Taken 0745 on 30JAN09).*

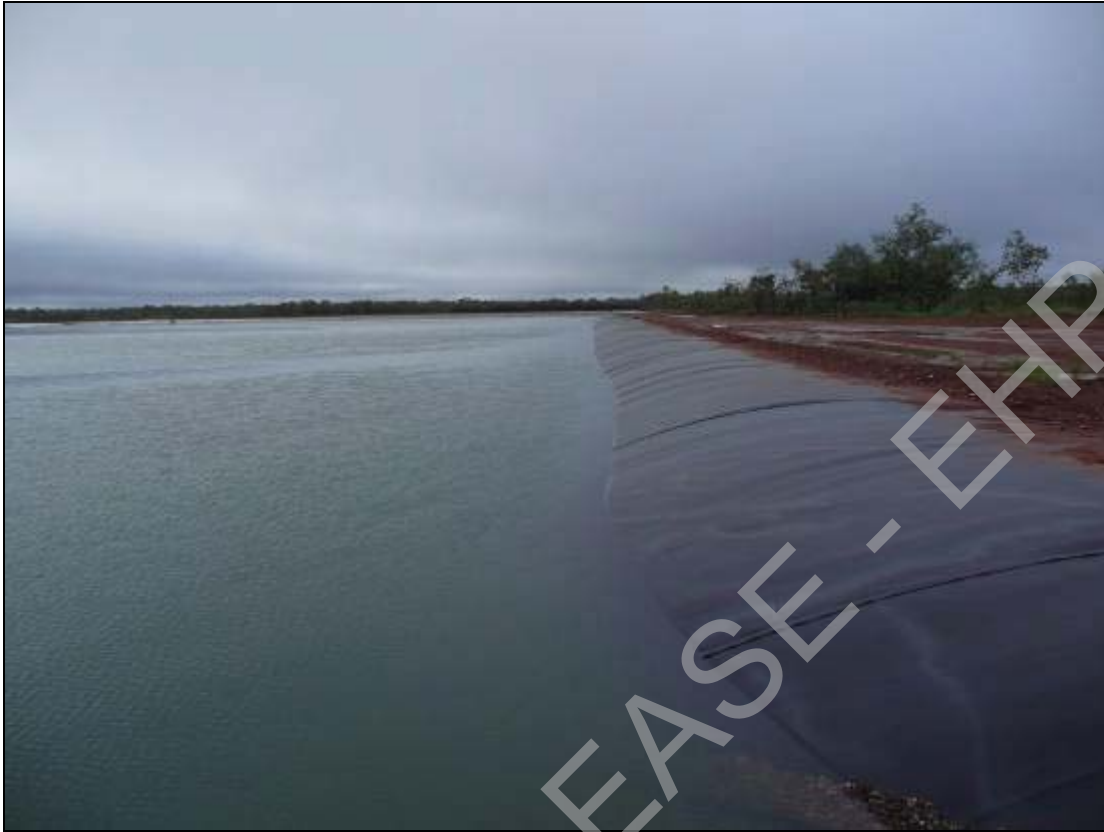
*Figure 9: SW Pond #1 looking south towards spillway (Taken 0745 on 30JAN09).*

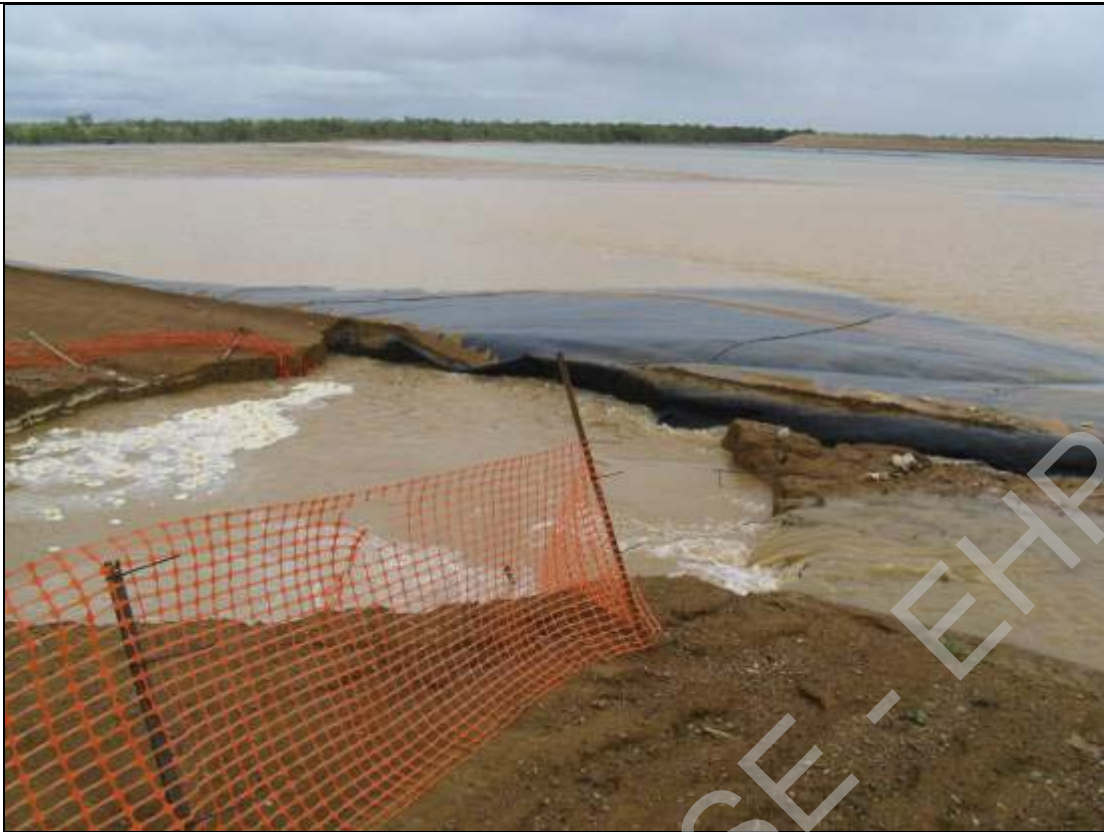
*Figure 10: SW Pond #2 at point of wall failure (Taken 1000 on 30JAN09).*

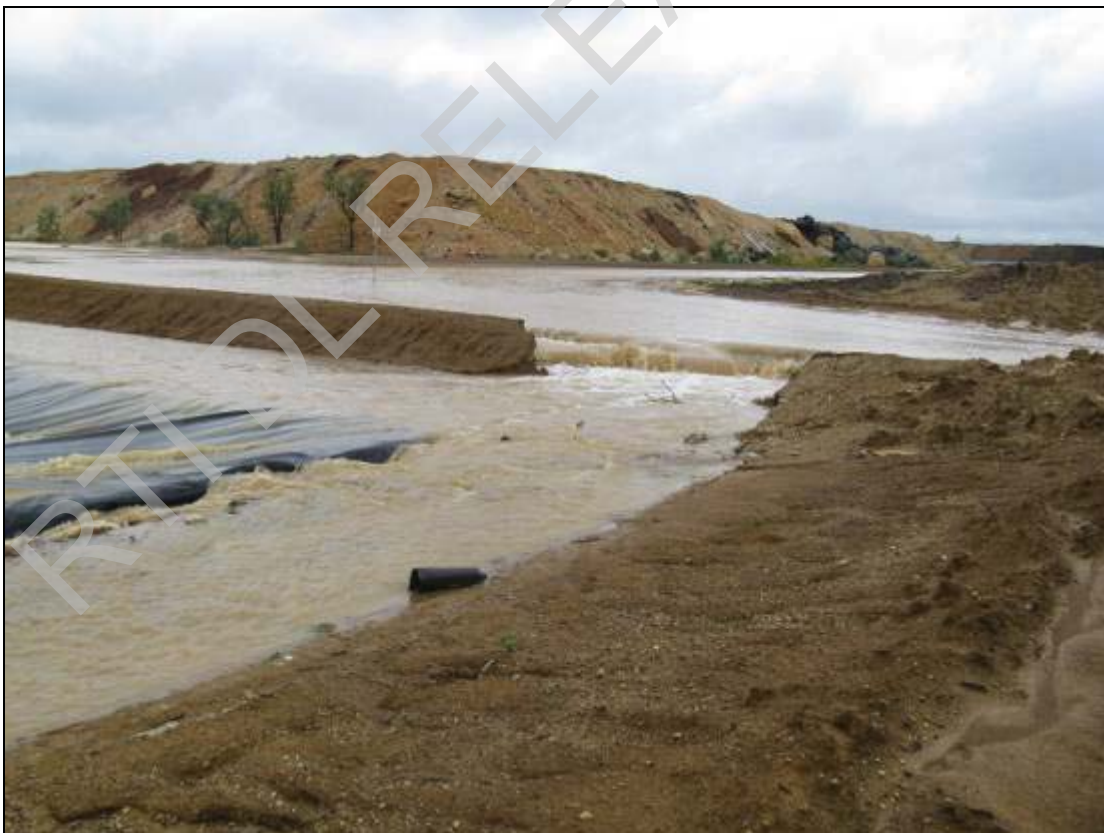
*Figure 11: Breach in bund wall on east side of SW Pond #2(Taken 1000 on 30JAN09).*

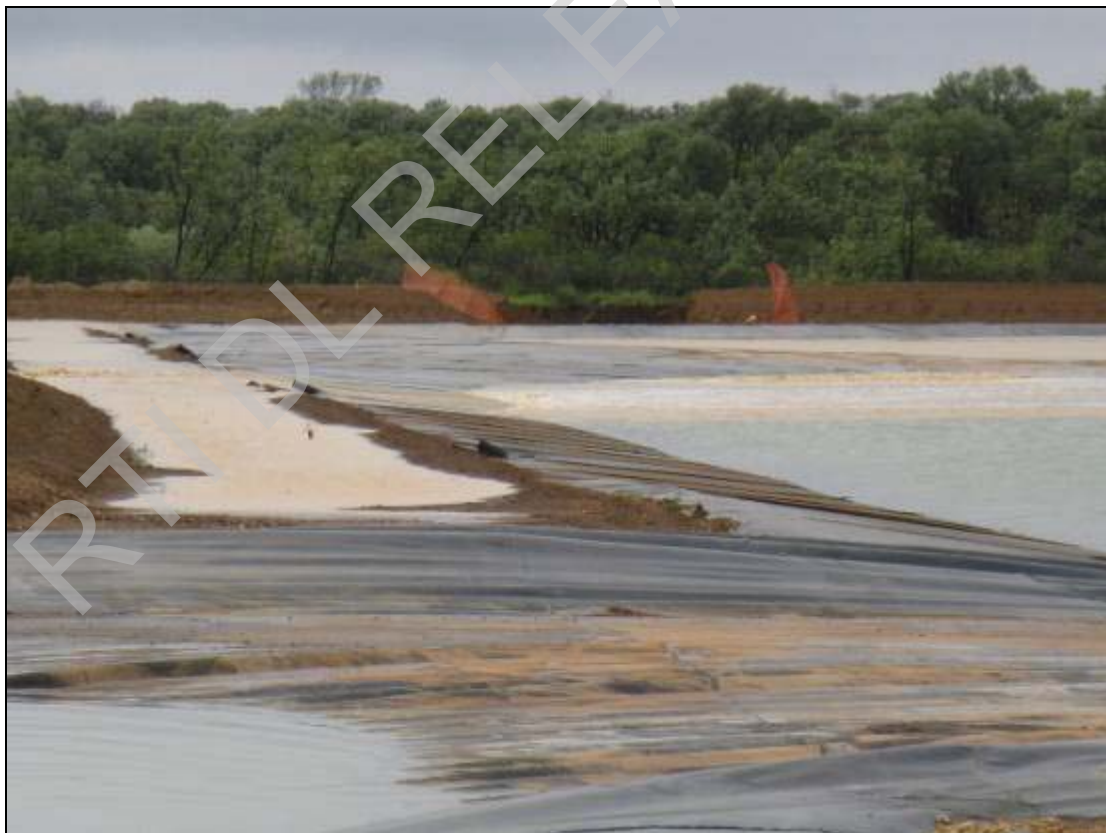
*Figure 13: SW Pond #2 looking south towards wall failure (Taken 1000 on 30JAN09).*

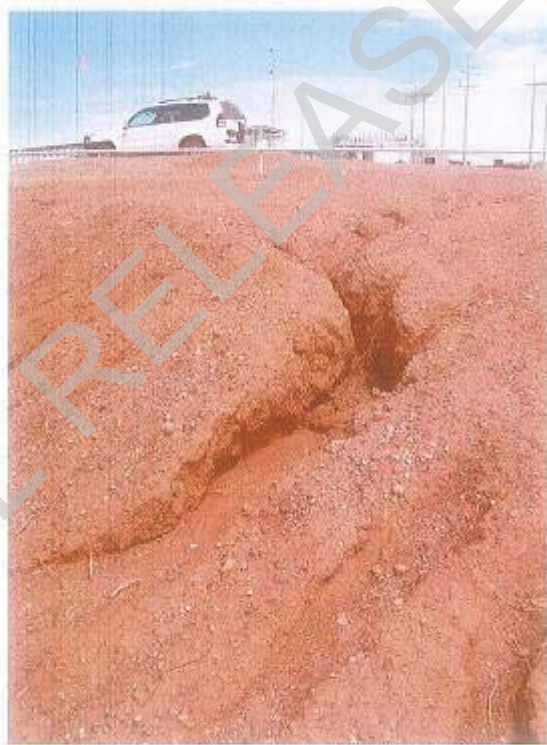
The process ponds all appeared to be in good condition. Some scour was evident in the soil bund at the top of the collection drains and above the process ponds and some of the soil had been washed into the ponds.

Figure 4: Scour above northern side of Process Ponds

Repair methods should follow the original construction methods to prevent or minimise further degradation.
