# Criterion Hotel, Warwick: Site Inspection Report

Queensland Heritage Register place ID 600962

On the 23 August 2019 heritage officers from the Department of Environment and Science (DES) undertook a site inspection of the Criterion Hotel at the request of the owners to inspect recent damage to the place. The Criterion Hotel is located at 84 Palmerin Street, Warwick and is entered in the Queensland Heritage Register (QHR) as a State heritage place (QHR place ID 600962). The owners and their representatives have identified that the building is showing large cracks in the front section of the building, which they state is being caused by ground shrinkage. While there is a severe drought affecting the district, the owners and their representatives allege that the ground shrinkage is being caused or exacerbated by trees planted by Southern Downs Regional Council (SDRC) in the road reserve along Palmerin Street, including in front of the Criterion Hotel. The purpose of the site visit was not to investigate the cause of the damage, but rather gather background information, assess the extent of the damage to the heritage place and provide preliminary advice on repairs.

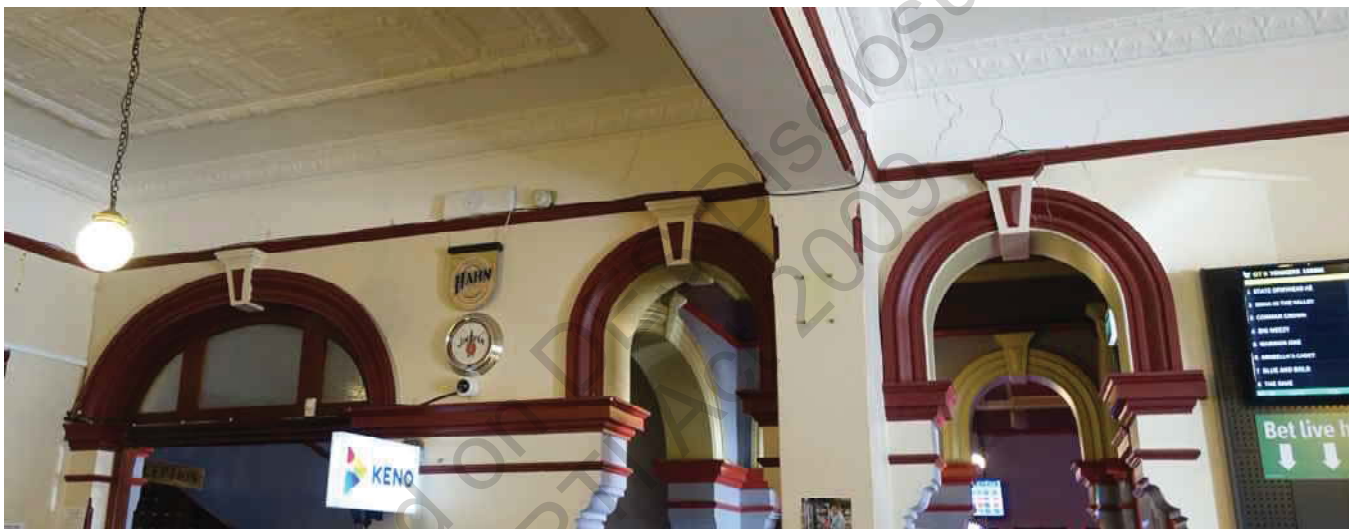
The Ground Floor was examined first. The cracks were clearly evident at or around the keystone of the archways and associated walls. The three archways between the public bar and the lobby all exhibited cracking above and around the keystones, extending towards the pressed metal cornices. The cracks appeared to be progressively larger from the lobby room on the western side of the main beam toward Palmerin Street (refer Image 4 below). The crack in the archway on the opposite side of the public bar leading into the billiard room appeared more pronounced because of the render delaminating from the substrate (refer Images 5a & 5b below). A fine crack was noted along the entrance wall, of the public bar above the decorative stain glass window (refer Image 6a below). An obvious and pronounced crack was evident in the front corner of the billiard room running diagonally from the front wall cornice towards the skirting (refer image 6b below). The render here had failed in sections exposing the brickwork underneath and showing delamination of the render from the bricks in at least two areas.

Image 4: Cracks above the archways leading from the public bar to the lobby (DES, 23 August 2019).

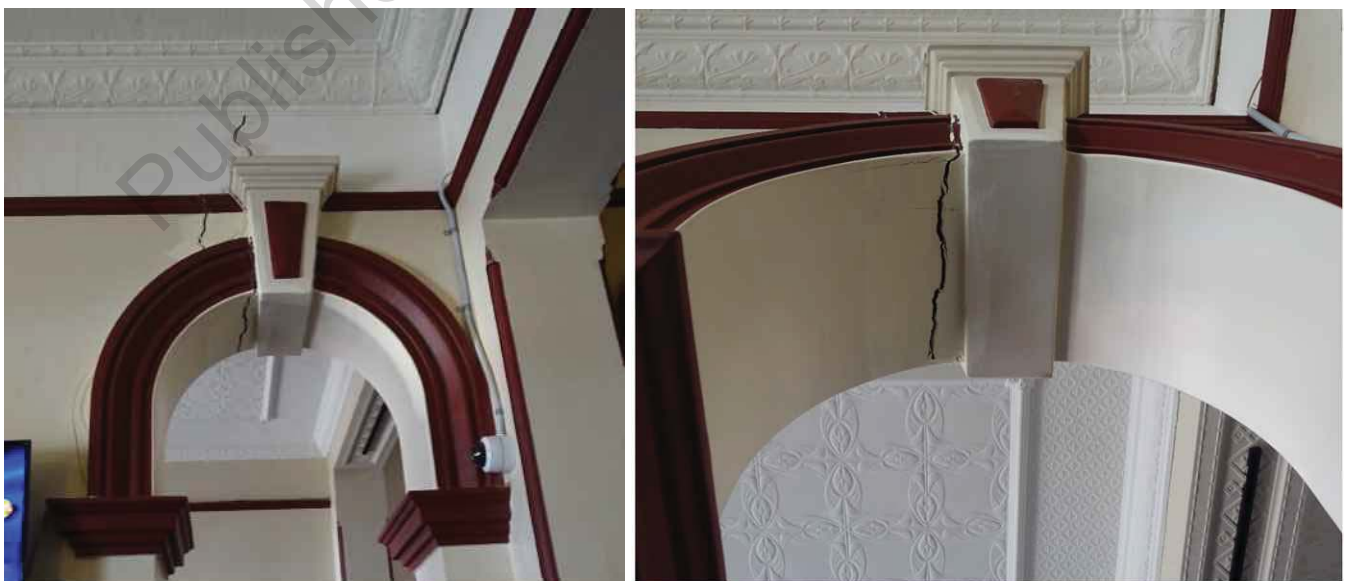
Images 5a (left) and 5b (right): A pronounced crack around the keystone of the archway heading north out of the public bar into the billiard room. (DES, 23 August 2019.)

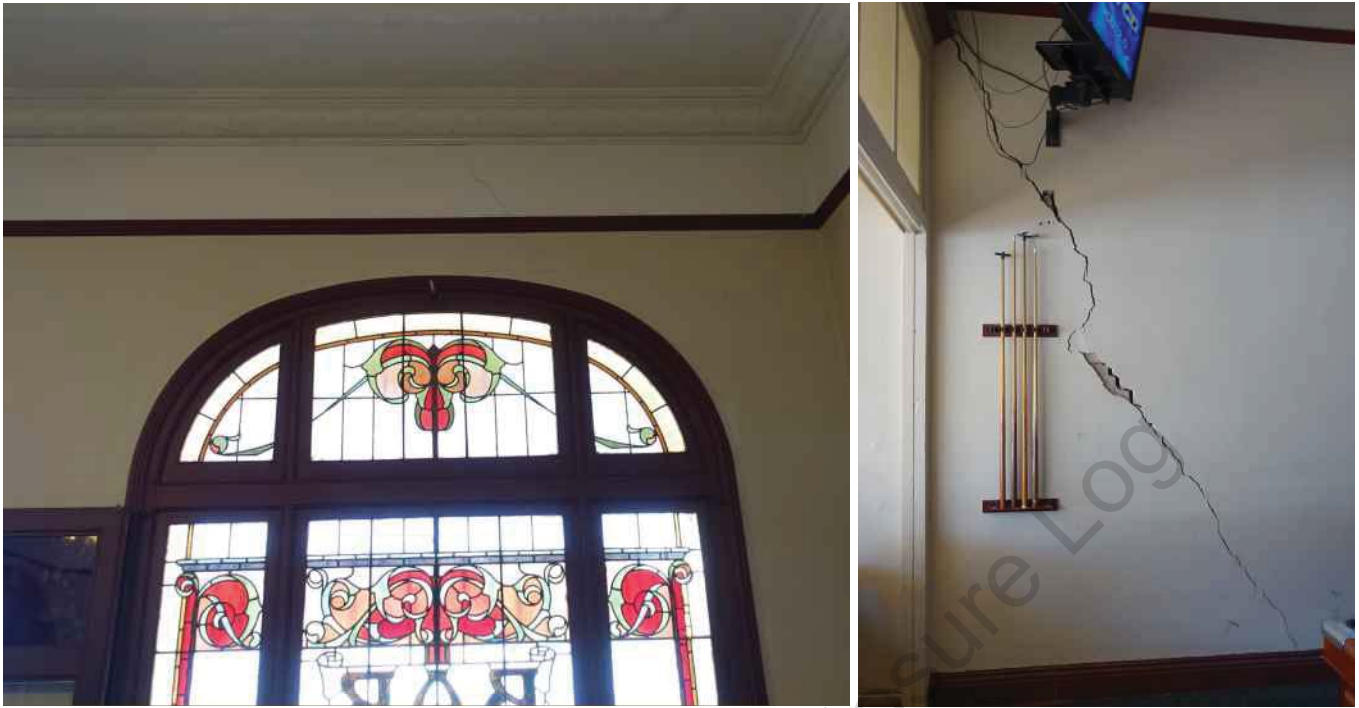
Image 6a (left): A fine crack above the stain glass window of the public bar facing Palmerin Street (DES, 23 August 2019).

Image 6b (right): A pronounced crack extending diagonally on the inter-tenancy wall of the billiard room (DES, 23 August 2019).

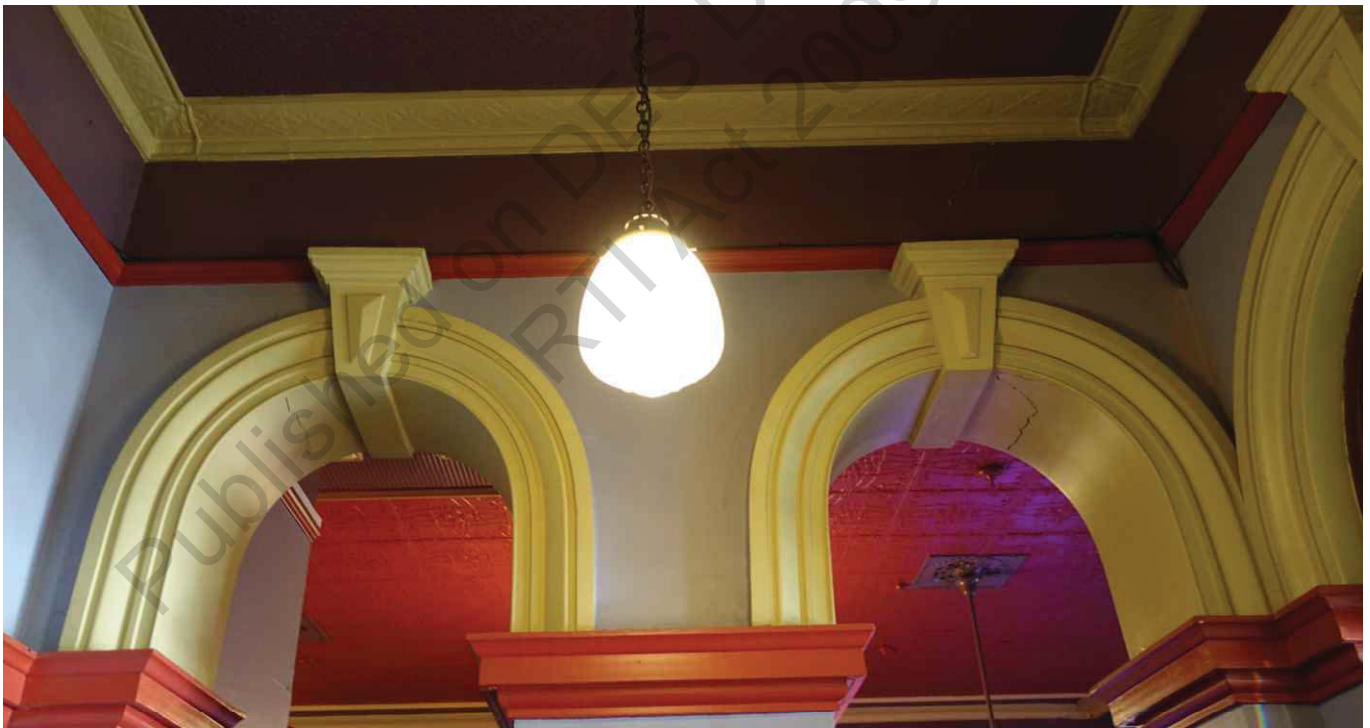
Image 7: Cracks in the underside of both archways leading from the lobby through to the gaming lounge (DES, 23 August 2019).

Further cracks were evident in the archways leading from the lobby through to the current gaming lounge. These cracks extended up the walls above the keystones and terminated at the junction of the wall and ceiling cornice. Again there was a visual pattern of the cracks appearing more pronounced toward the west or Palmerin Street (refer Images 7 -9 above and below).

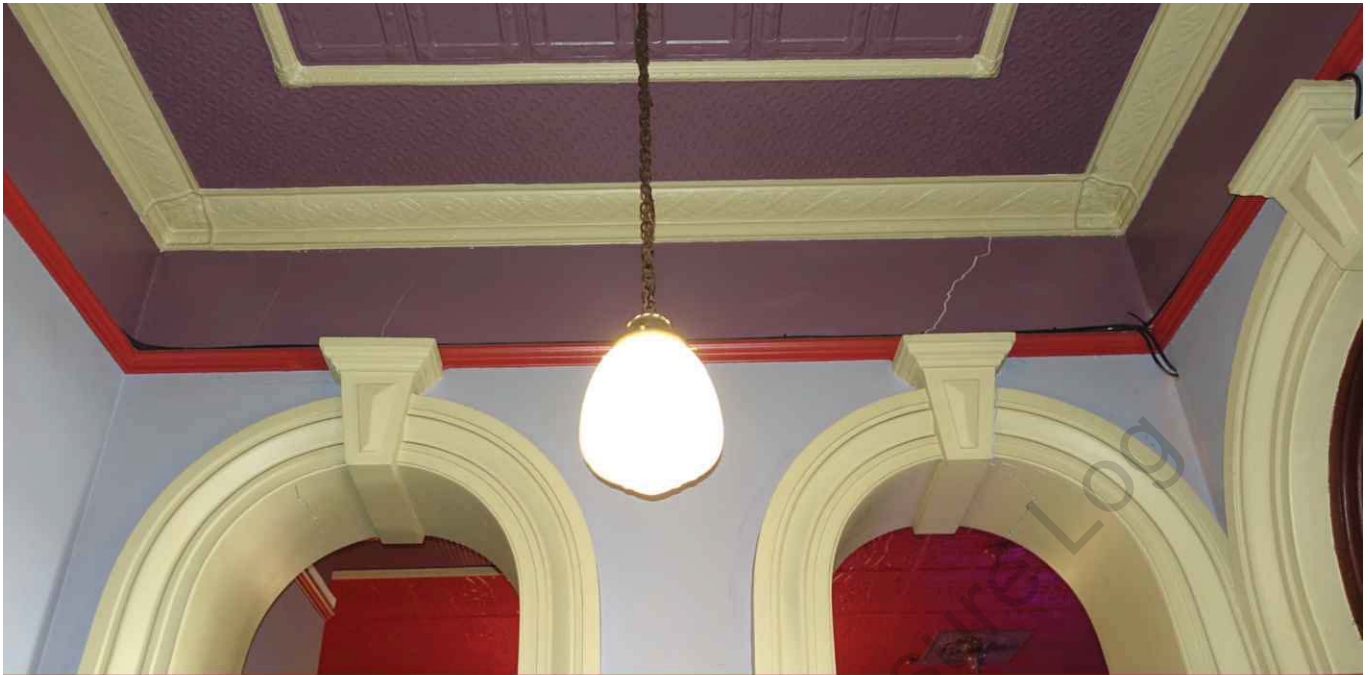
Image 8: Cracks in the underside of both archways and above the keystones in the walls leading from the lobby through to the gaming lounge (DES, 23 August 2019).

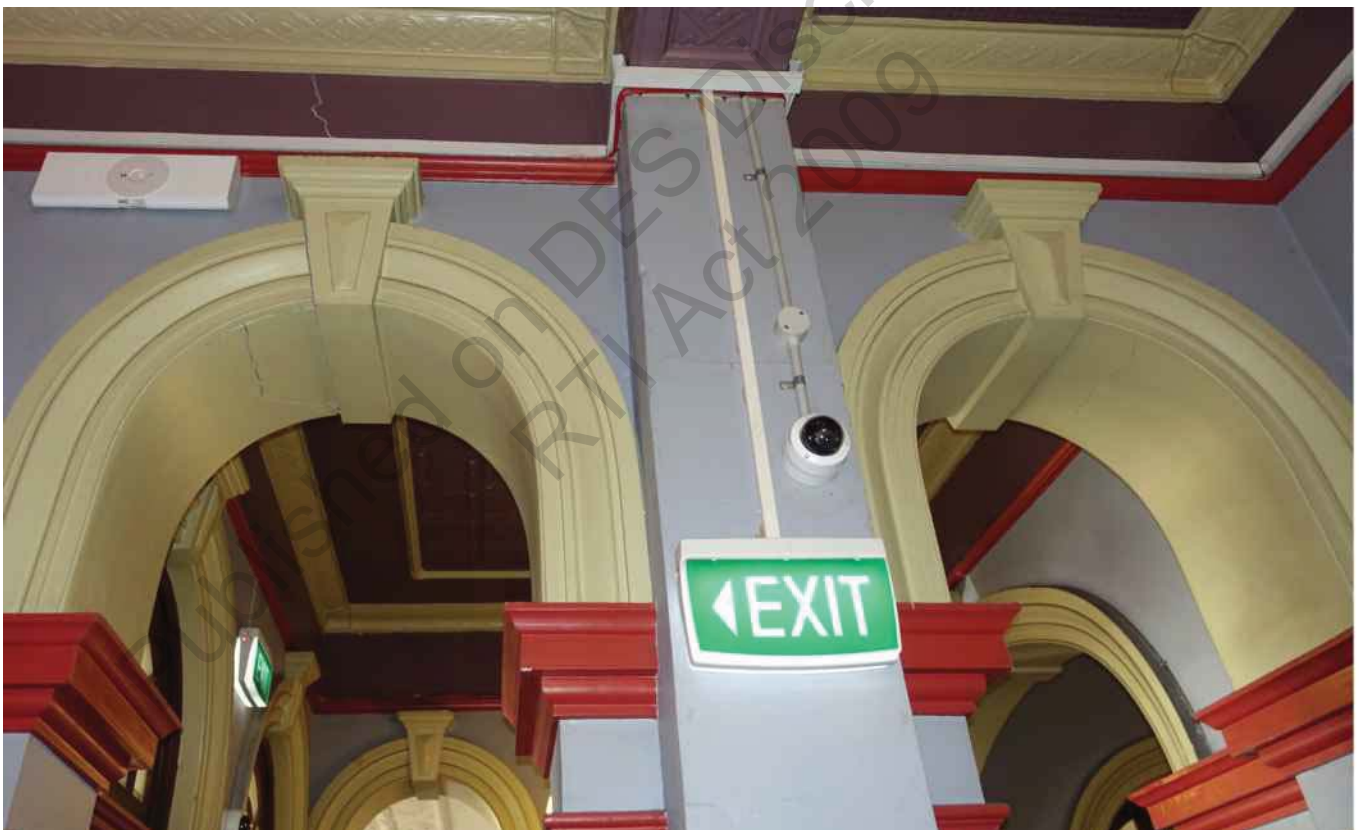
Image 9: Cracks in the underside of both archways and above the keystones in the walls leading from the gaming lounge back to lobby (DES, 23 August 2019).

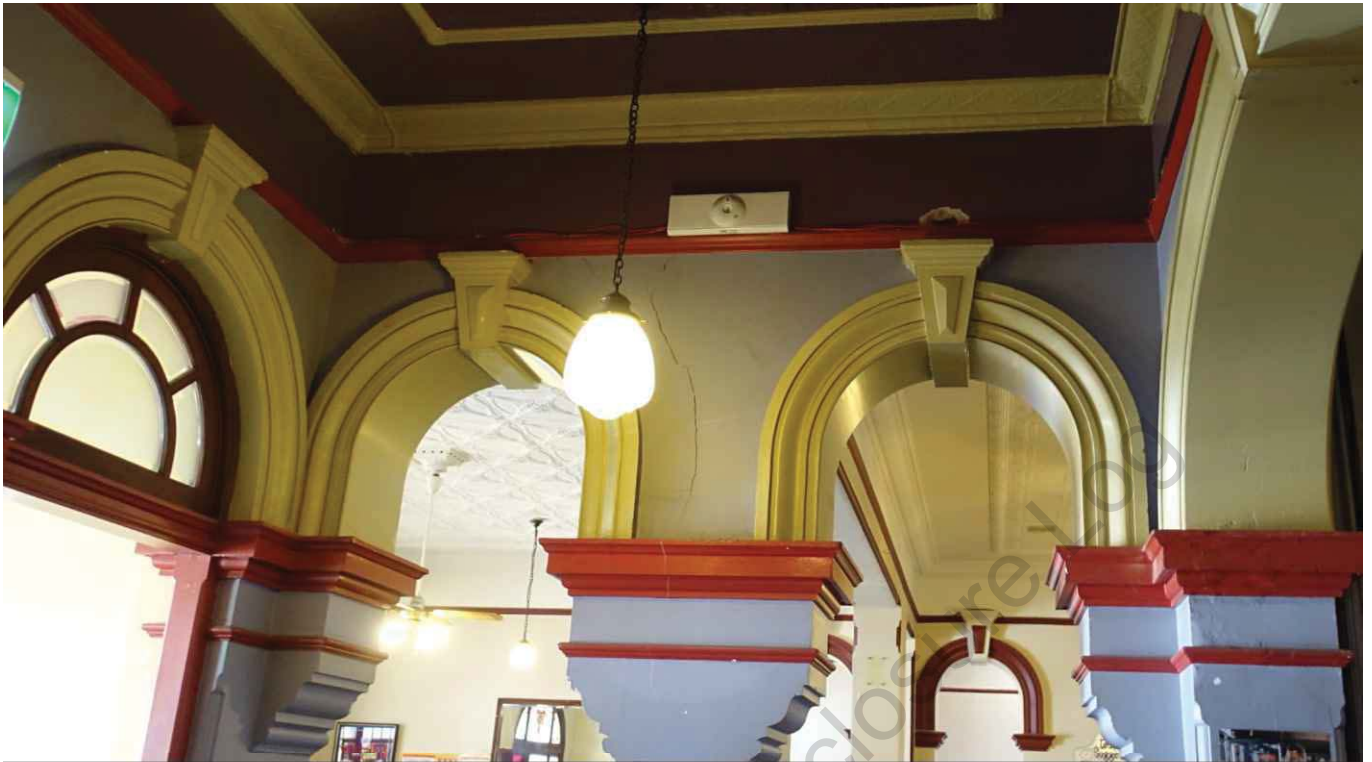
Large vertical; cracks are also present in the walls and supporting columns between the arches leading from the lobby and into the public bar (refer Image 10 below). Above one keystone and dado line, a section of render has delaminated and left a visible scar (refer Images 10 & 11 below). It should be noted that the missing render appears to be where a fixing point is located for fire services cabling.

Image 10: The lobby leading into the public bar. The supporting columns and associated walls have clear vertical cracking along the wall and into the column (DES, 23 August 2019).

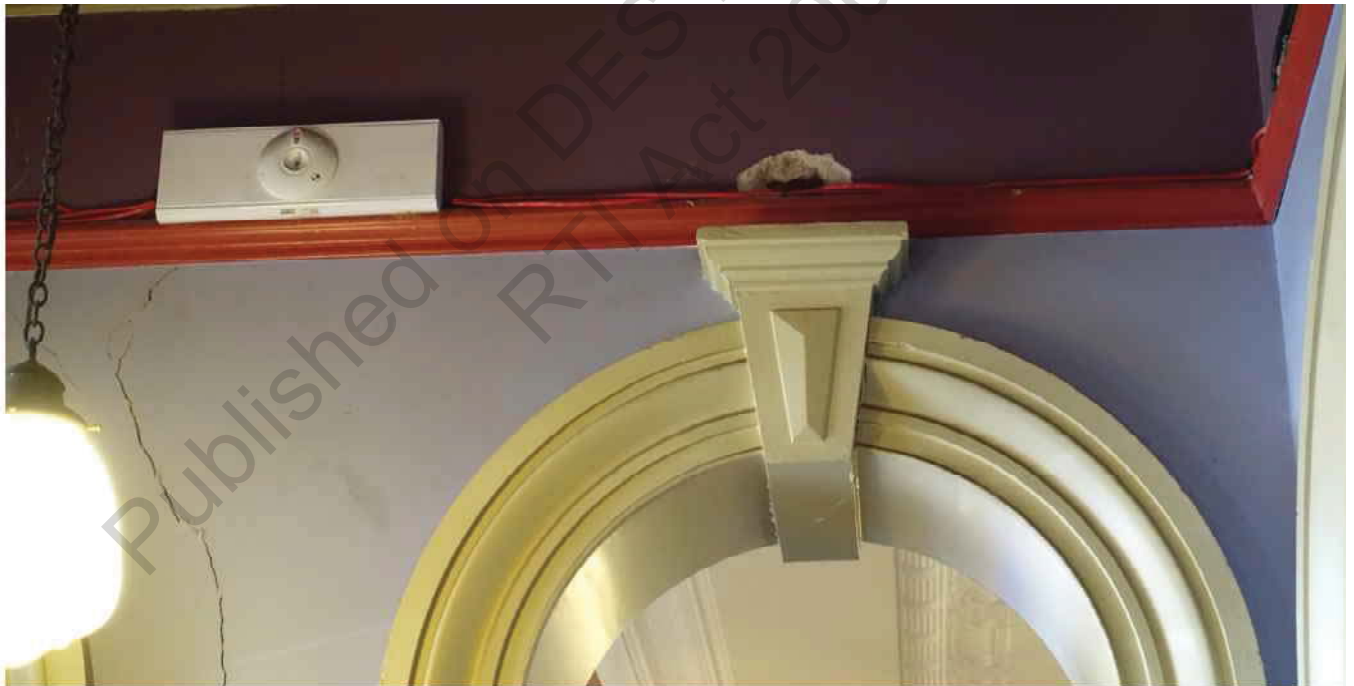
Image 11: A close-up of the crack in the column and the missing render above the keystone leading from the lobby to the public bar (DES, 23 August 2019).

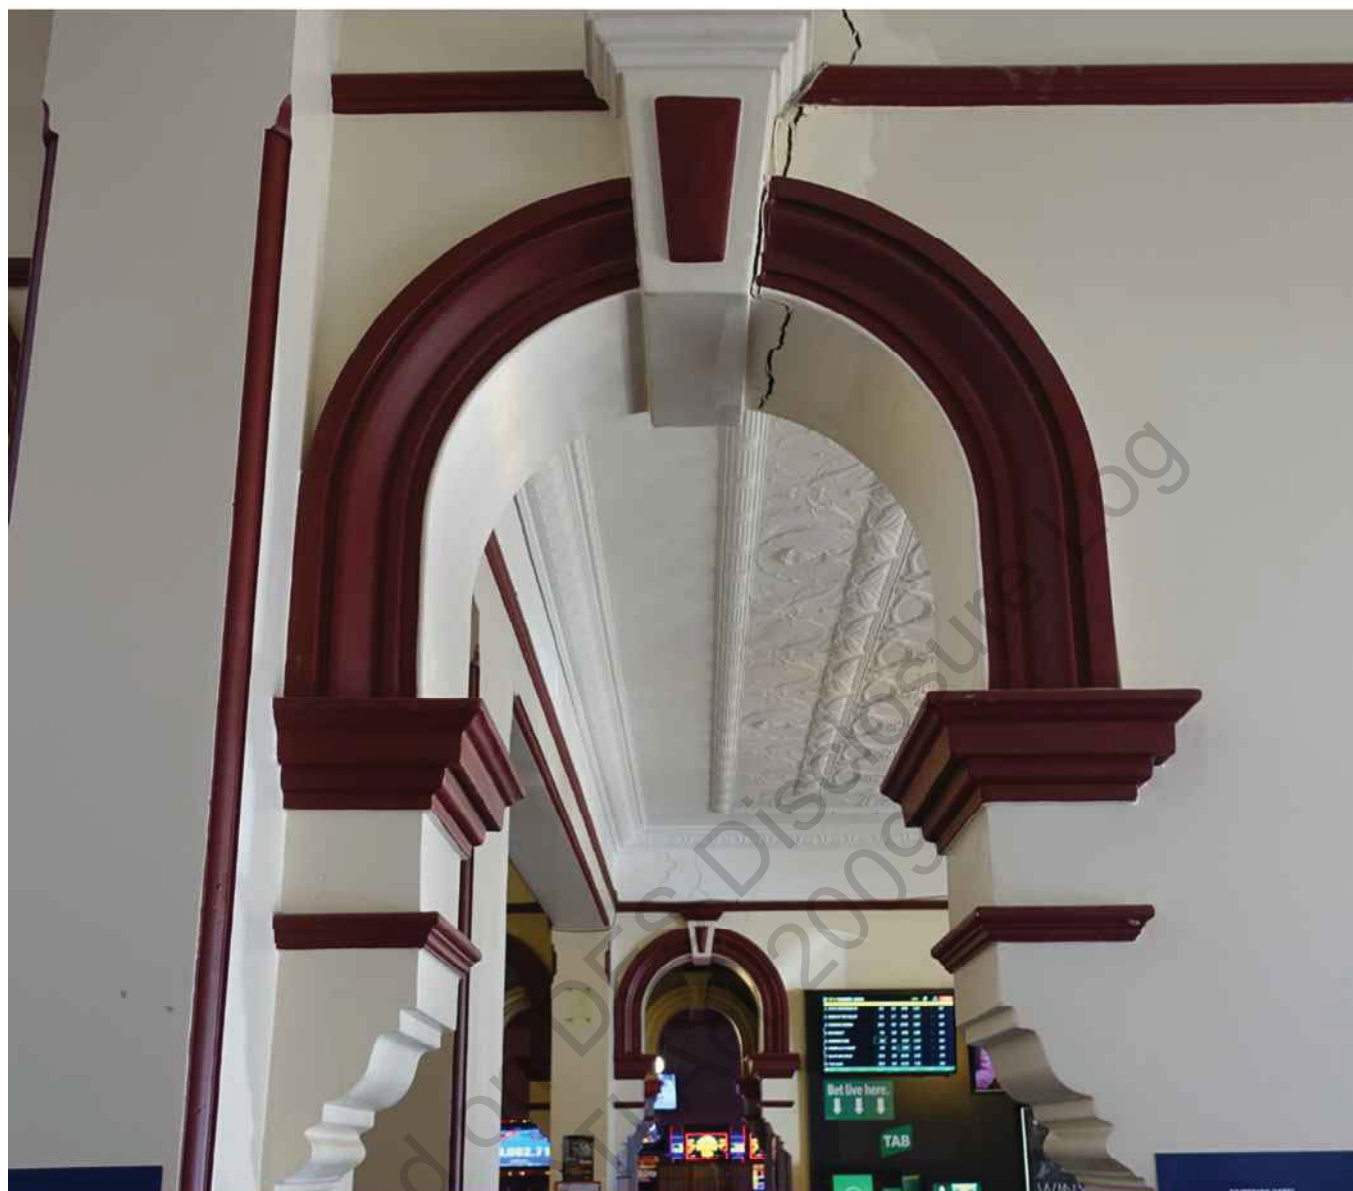
Image 12: An image showing the alignment of cracks in the archways from the billiard room to the public bar to the lobby located in the front section of the Criterion Hotel to the west of the main structural beam (DES, 23 August 2019).

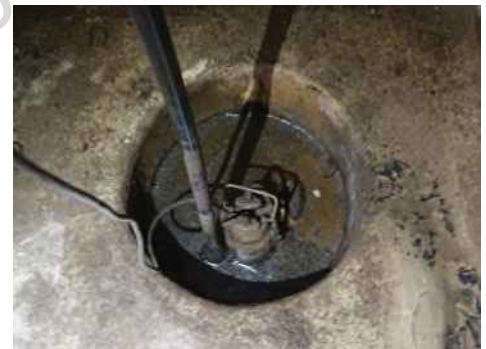
There is clear evidence of water staining and efflorescence in the lower portions of the rendered wall immediately above the spoon drain. It is understood from discussions with the owner that there has been previous flooding in the basement, up to 300mm above the basement floor level, due to the pump not working. This height appears to align with the water staining and efflorescence migrating to the surface. The flooding had been rectified within the last 6 months. It should be noted that application of a moisture barrier or acrylic paint on the walls is not recommended as the problem may result in irreversible damage to the substrate and may allow the salts to become trapped under non-permeable coatings. The sump and pump needs to be routinely checked to ensure rising ground water (presumably from a bore) does not exacerbate long term issues within the basement.

Image 14b (right): The sump with automated pump with water sitting just below surface (DES, 23 August 2019).

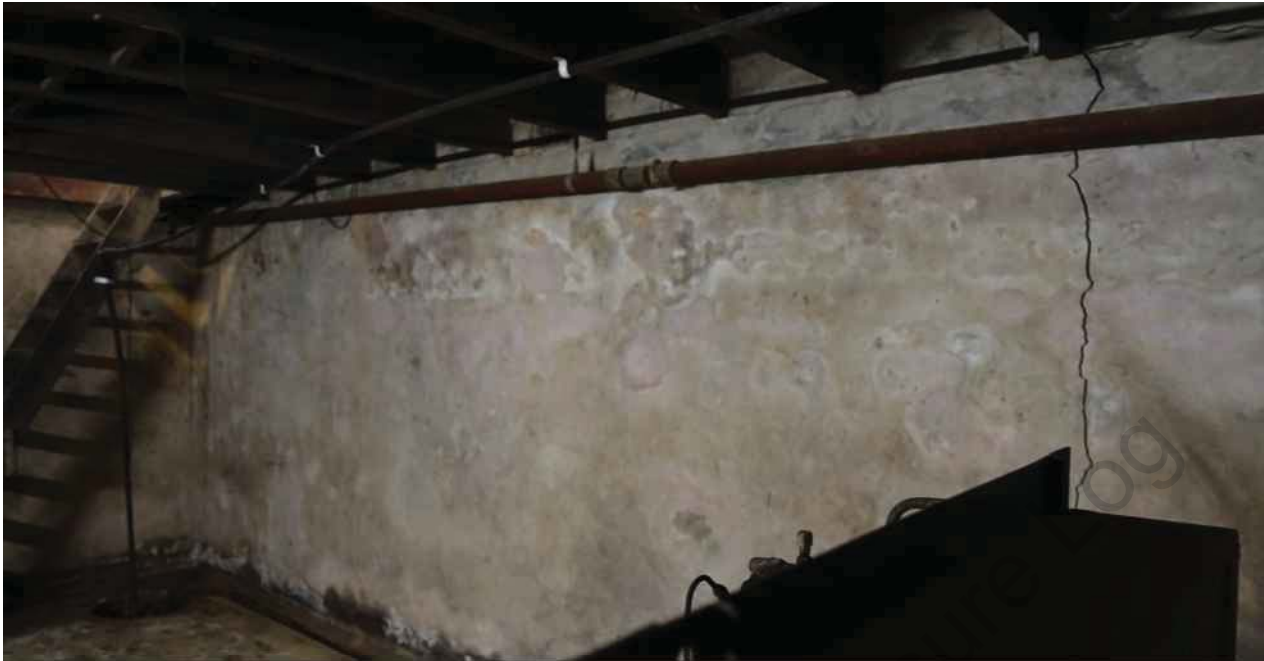
Cracks were evident on both sides of the southern and northern walls of the beer store of the basement (i.e. the room closest to Palmerin Street). The cracks extend from the ground floor joists, diagonally tapering, halfway down the walls toward the spoon drain (refer Images 15-17 below). This is consistent with movement as the cracking appears to increase in width with height i.e. are wider at the top. Neither crack extends to the floor of the basement, but the crack on the southern wall extends further than that on the northern side, which reaches approximately halfway. Despite the cracks appearing to terminate before reaching the floor slab, the slab also has a crack that appears to run across the width of the floor and roughly aligns with the cracks in the adjacent walls (refer Image 18 below). The position of the basement cracks is hard to determine accurately, but appear to roughly align with the position of the cracks in the ground floor above i.e. within the front section of the public bar. This is reinforced by damage to the timber floorboards under the bar where wet rot is evident, potentially caused by post mix, beer and associated refrigeration (refer Image 19 below). The damaged floor boards are located inside the wine and spirits store to the rear of the basement, which is on the other side of the structural dividing wall, where the cracks are located.

Image 15: The northern wall of the basement showing the proximity of the crack relative to the cellar access hatch and sump. Note the clear evidence of water staining and efflorescence, especially in the lower portions of the wall immediately above the spoon drain (DES, 23 August 2019).

It is noted some repair works have been undertaken to the walls with a high cement content in the render mix. It is suggested these repairs be removed and rendered with a compatible mix that matches the original render. It would be expected that a render dating to 1917 would have a high lime content and may contain little or no cement within the mix. These repair works are recommended to be undertaken by a contractor who is familiar with lime renders and buildings of this period.

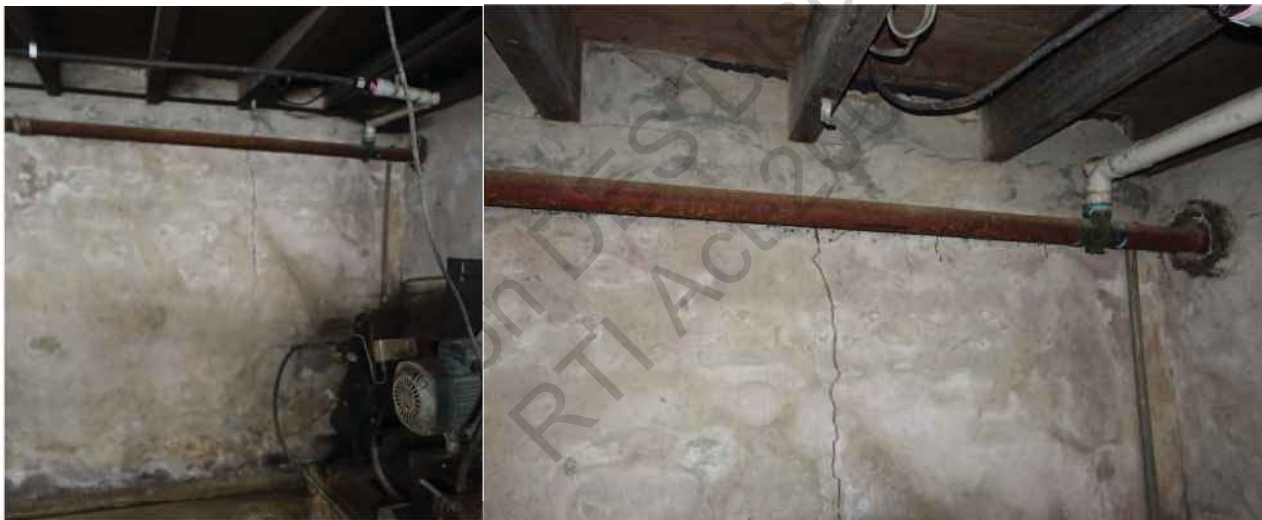
Images 16a (left) and 16b (right): showing the crack on the northern wall (DES, 23 August 2019).

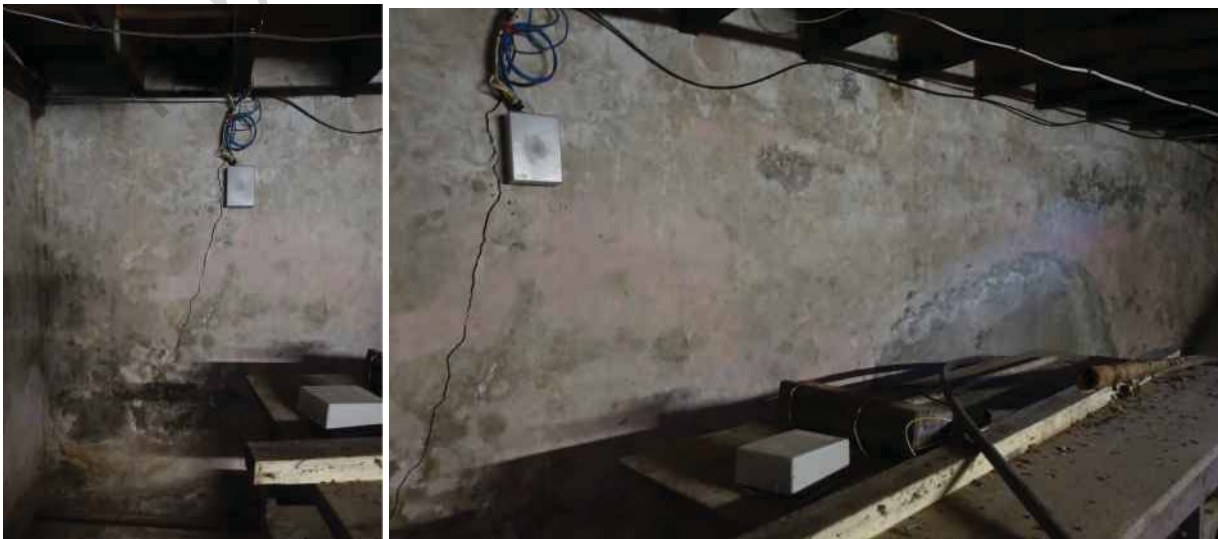
Images 17a (left) and 17b (right): showing the crack on the southern wall (DES, 23 August 2019).

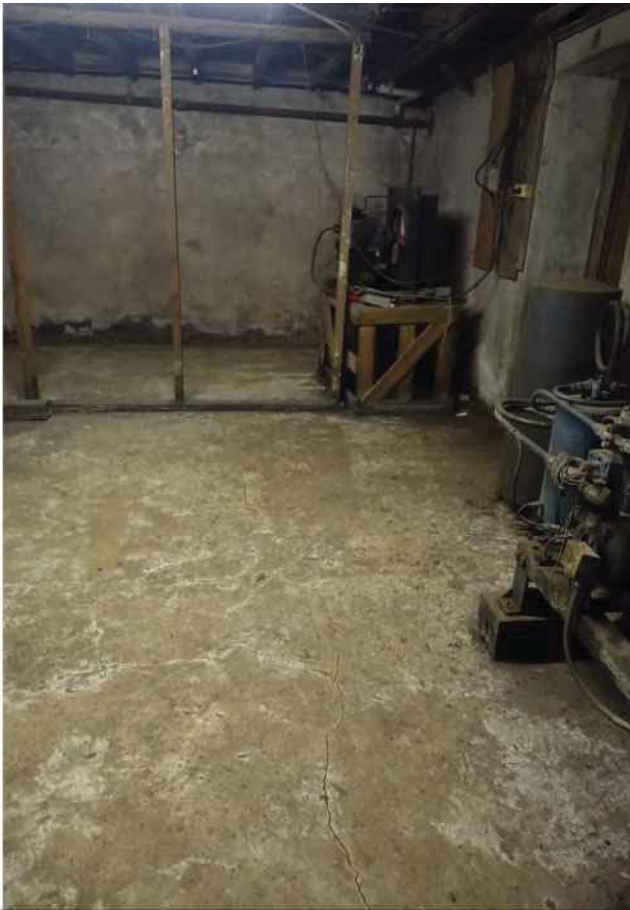
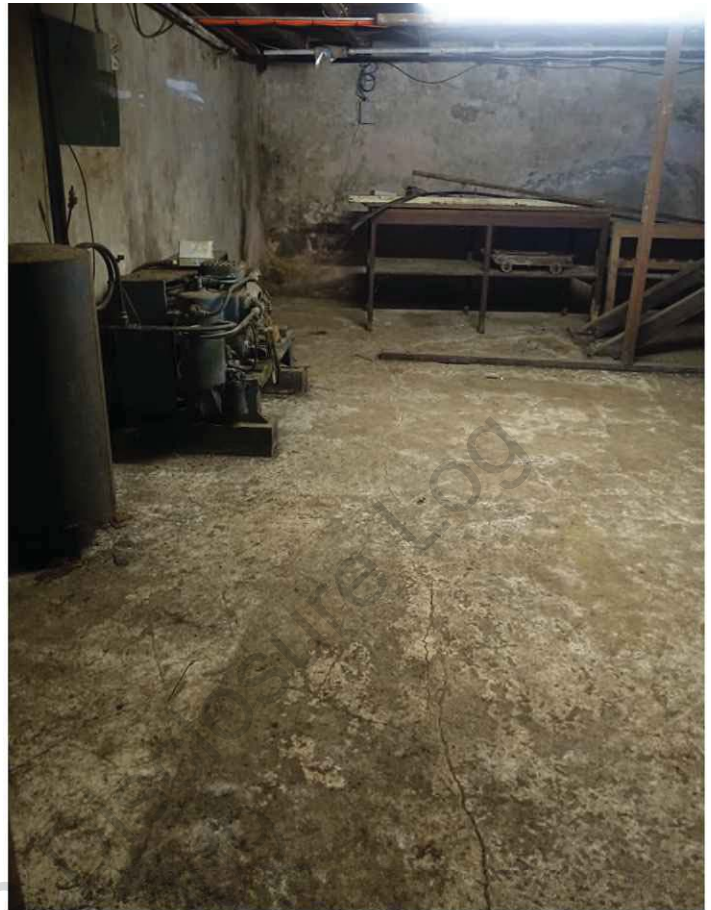
Images 18a (left): Looking across the basement to the northern wall (DES, 23 August 2019). 18b (right) Looking across the basement to the northern wall. Note the alignment of the slab crack relative to the wall cracks. (DES, 23 August 2019.)

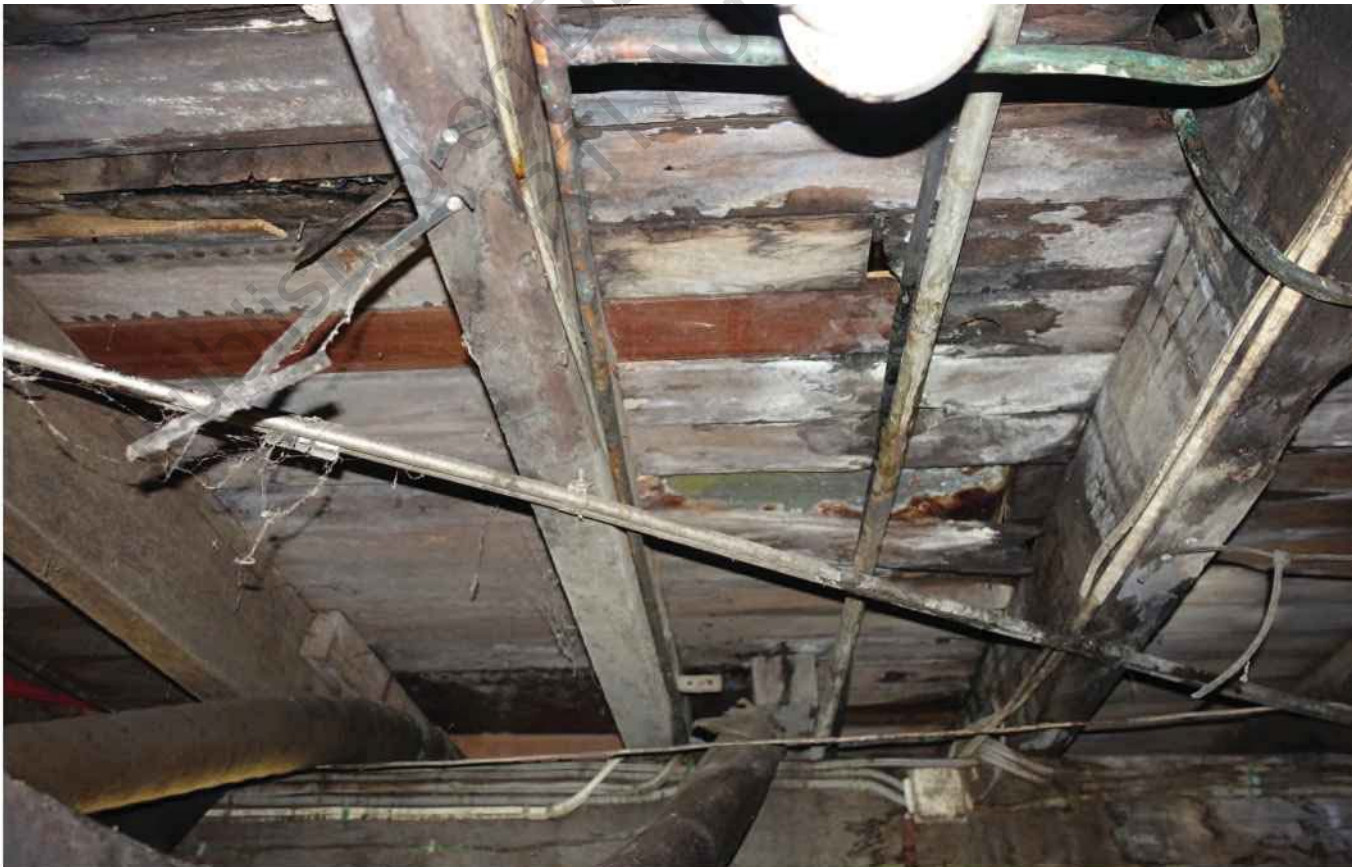
Image 19: The rotten and damaged floor boards in the wine and spirit store located directly under the bar (DES, 23 August 2019).

The rot in the bar floor needs to be properly assessed and suitable repairs made. The extent of the necessary works is unclear and may require replacement of structural timbers such as joists. The cause of the rot should be investigated and measures taken to reduce the potential for future damage. Like for like repairs could be undertaken under an exemption certificate and an application could be made once the scope of works is known.

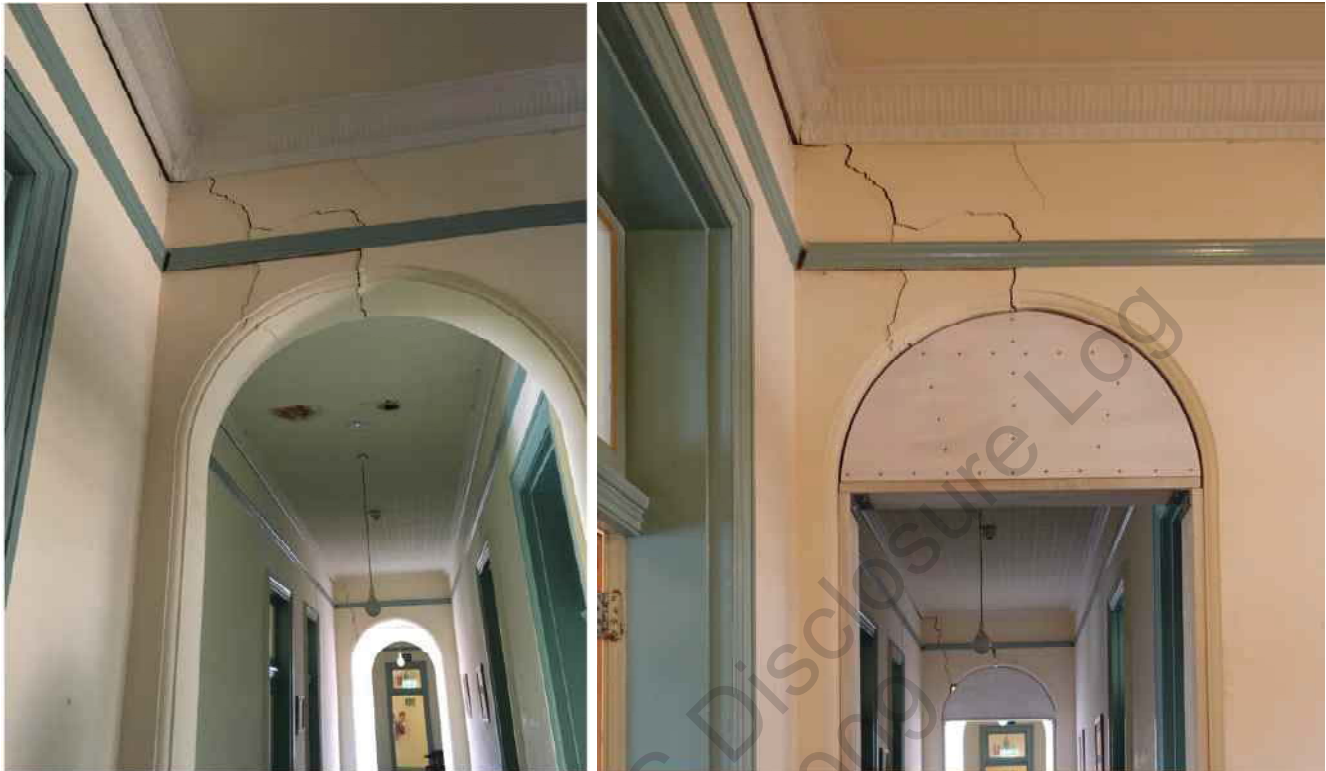
Images 20a (left) an image from the engineers report and 20b the same location with stabilisation works. Note the rust on the pressed metal ceiling in 20a. (DES, 23 August 2019.)

Like the ground floor, the damage was concentrated around archways along the corridor and the immediately adjacent rooms (refer images 20-22 above and below). Note the architrave has pulled away from the corner junction in the worst affected areas, which may suggest rotation of the structure along the main structural wall.

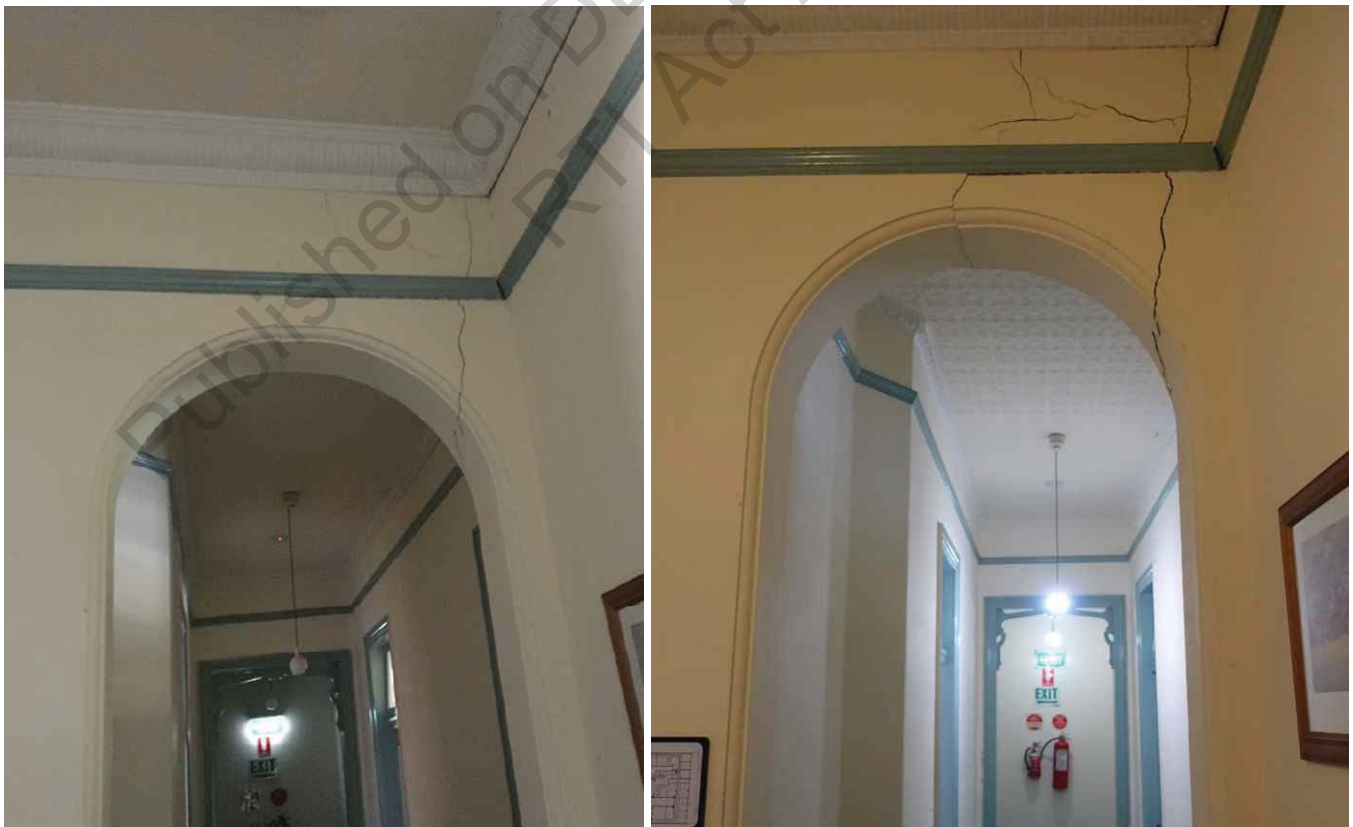
Images 21a (left) an image from the engineers report and 21b (right) the same location during the site visit. The cracks do visually appear to be more pronounced in the later images. (DES, 23 August 2019.)

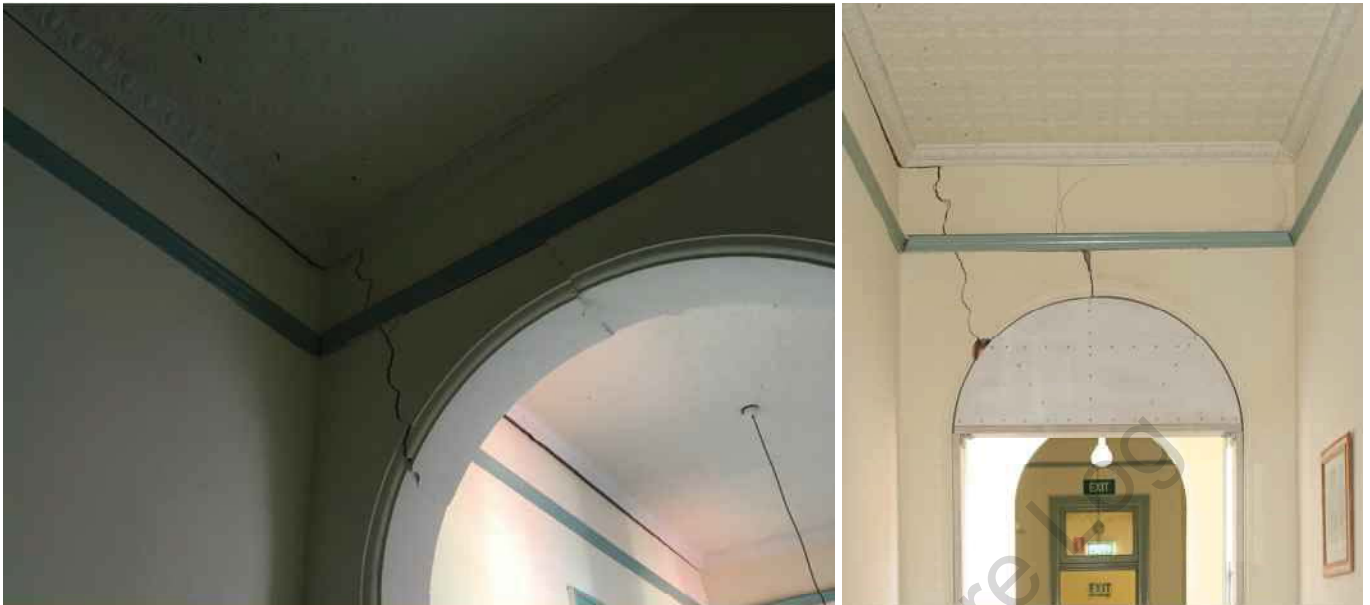
Images 22a (left) an image from the engineers report and 22b (right) the same location with stabilisation works (DES, 23 August 2019).

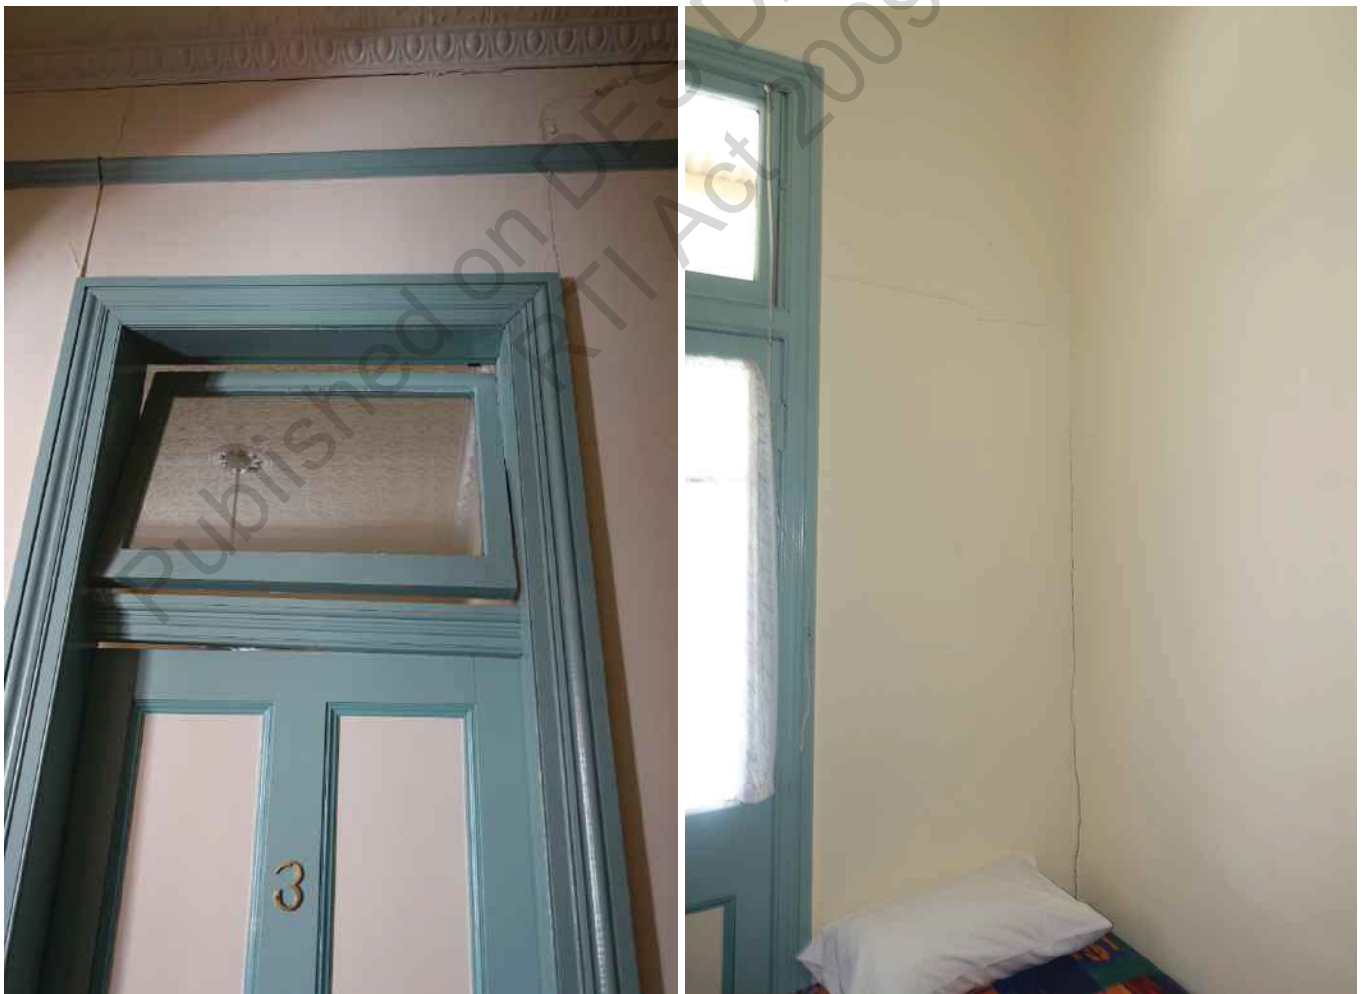
Image 23a (left) an image of the door to room 3 with racks and misalignment Image 23b (right) The interior of a room showing a vertical crack in the corner and horizontal crack between the window and corner. (DES, 23 August 2019.)

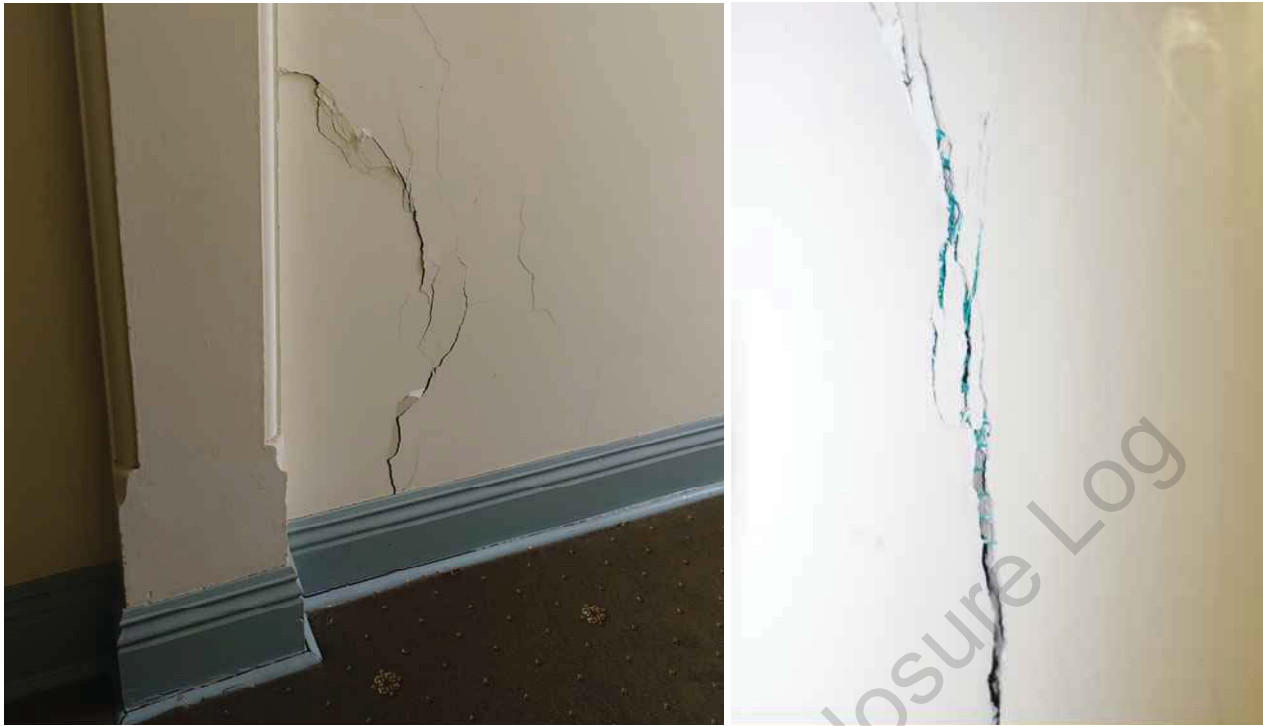
Image 24a (left) cracking in the northern end of the upstairs wall and Image 24b (right) a close-up image of the cracks showing metal mesh in the plasterwork and render underneath (DES, 23 August 2019).

Some of the room doors in the northwest corner of the building were out of alignment and the doors no longer shut properly. There were clear vertical cracks in the masonry in proximity to the door frames and extending up to the architrave. Within the rooms themselves additional cracking was evident both vertically and laterally near windows and the corners towards the verandah (refer Images 23a and 23b above). Further evidence of movement was evident in the far northern wall where a large diagonal crack had opened up, exposing green plastic mesh in the plaster work (refer Images 24 above). The plastic mesh suggests this crack may have been previously repaired as this modern material was not common when this building was constructed in 1917. These areas would align with the tenancy below and their extent should be considered and investigated on both levels to determine the full scope of cracking (refer images 24a, 24b and 25 above).
