# Criterion Hotel, Warwick: Site Inspection Report

Queensland Heritage Register place ID 600962

On the 23 August 2019 heritage officers from the Department of Environment and Science (DES) undertook a site inspection of the Criterion Hotel at the request of the owners to inspect recent damage to the place. The Criterion Hotel is located at 84 Palmerin Street, Warwick and is entered in the Queensland Heritage Register (QHR) as a State heritage place (QHR place ID 600962). The owners and their representatives have identified that the building is showing large cracks in the front section of the building, which they state is being caused by ground shrinkage. While there is a severe drought affecting the district, the owners and their representatives allege that the ground shrinkage is being caused or exacerbated by trees planted by Southern Downs Regional Council (SDRC) in the road reserve along Palmerin Street, including in front of the Criterion Hotel. The purpose of the site visit was not to investigate the cause of the damage, but rather gather background information, assess the extent of the damage to the heritage place and provide preliminary advice on repairs.

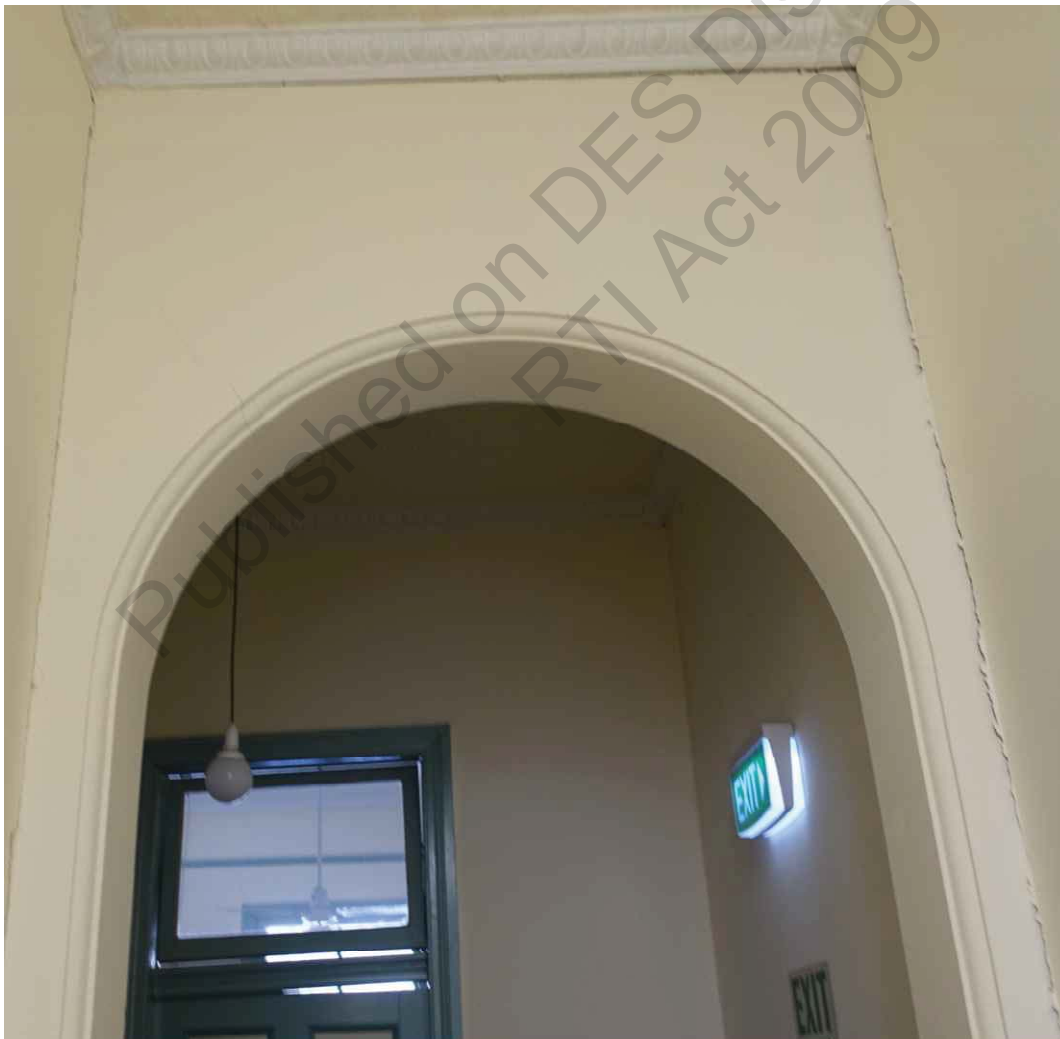
Image 25. Looking west toward room 1 on the first floor - note the cracking above the arch, along the wall joints and delaminating of the architrave. The door and fan light to room one behind are also misaligned. (DES, 23 August 2019.)

Some of the room doors in the northwest corner of the building were out of alignment and the doors no longer shut properly. There were clear vertical cracks in the masonry in proximity to the door frames and extending up to the architrave. Within the rooms themselves additional cracking was evident both vertically and laterally near windows and the corners towards the verandah (refer Images 23a and 23b above). Further evidence of movement was evident in the far northern wall where a large diagonal crack had opened up, exposing green plastic mesh in the plaster work (refer Images 24 above). The plastic mesh suggests this crack may have been previously repaired as this modern material was not common when this building was constructed in 1917. These areas would align with the tenancy below and their extent should be considered and investigated on both levels to determine the full scope of cracking (refer images 24a, 24b and 25 above).

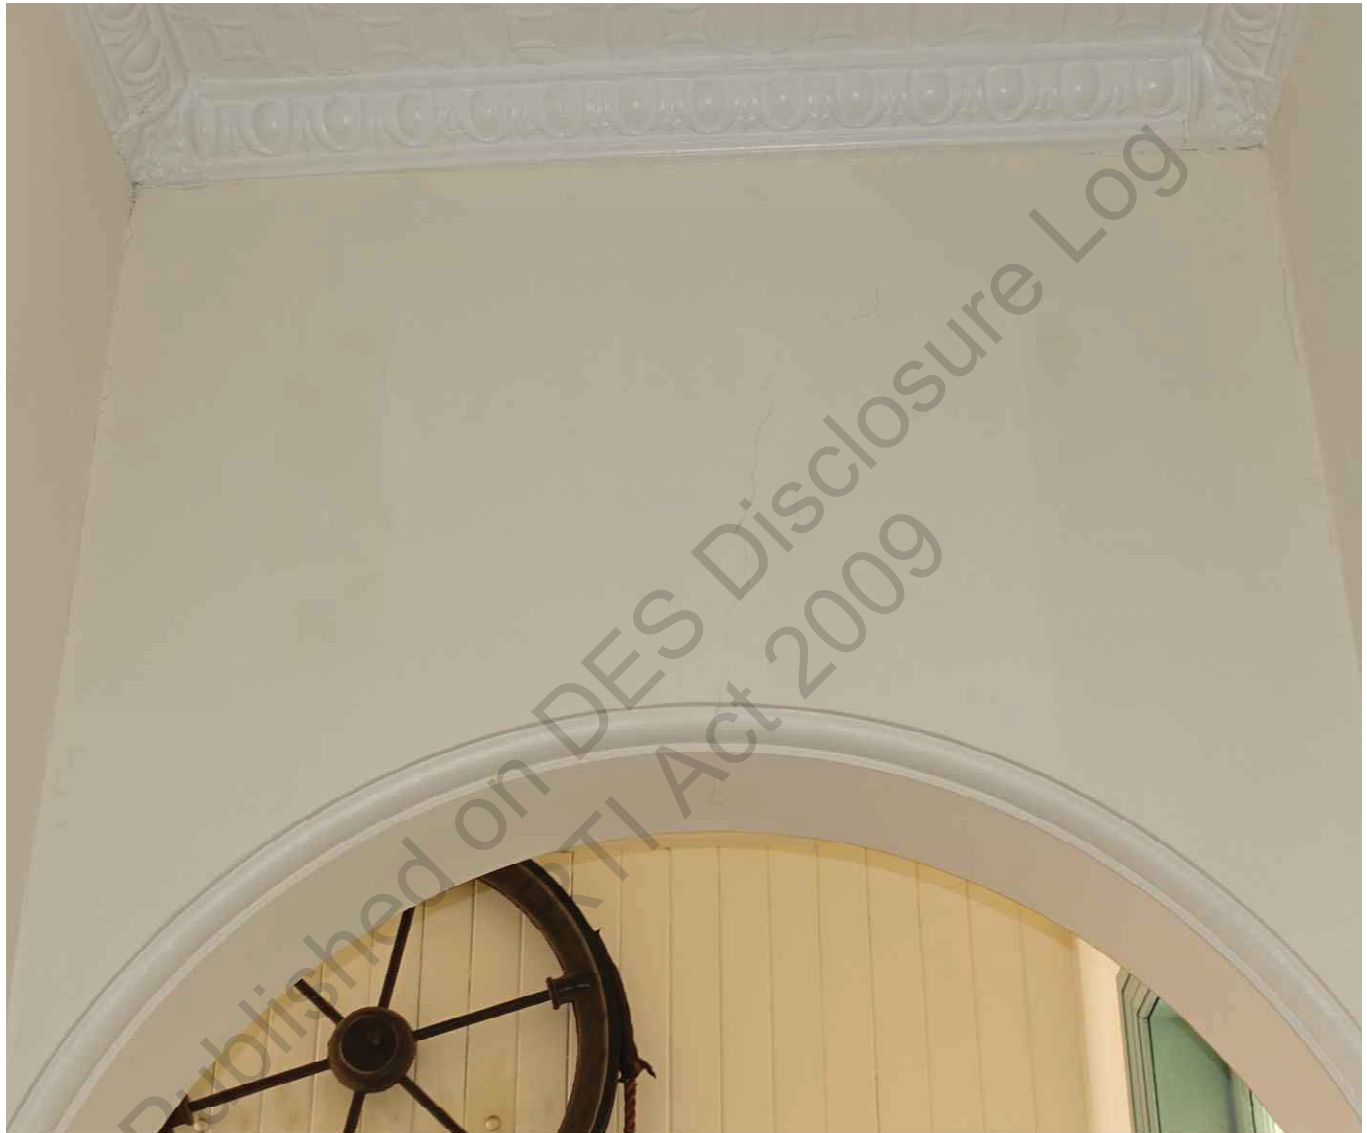
Image 26: A fine crack mid archway behind the upstairs coffee room - the pulley and rope mechanism for the food lift was part of the original design and is visible and intact (DES, 23 August 2019).

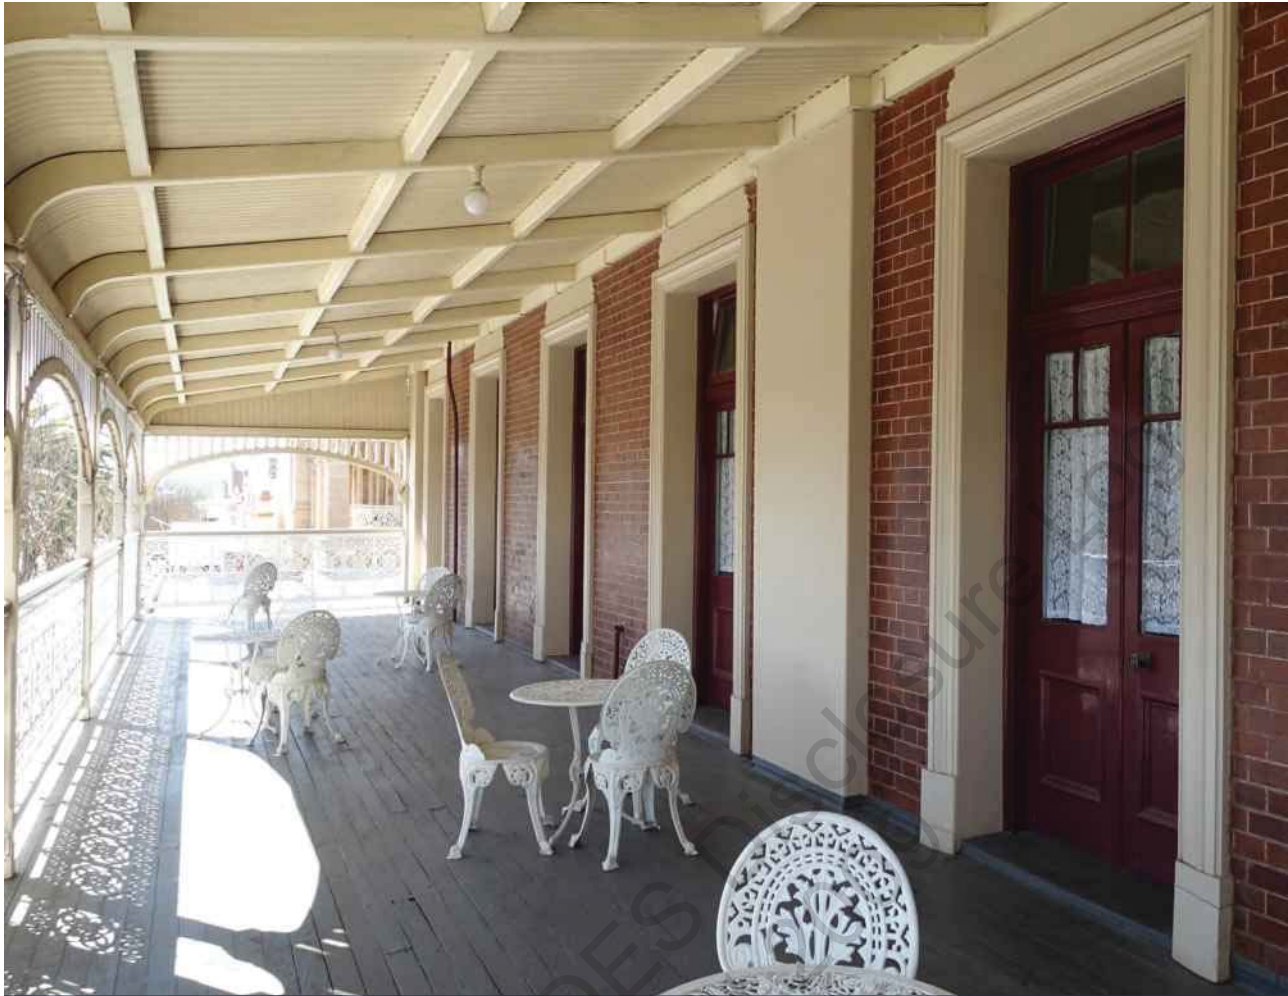
The first floor verandah is generally in good condition but a small series of issues were identified. Some lateral cracks were visible in the bases of some of the door frames, with associated vertical cracks in the thresholds of the doors and sills of the windows. Some cracks were seen in the exposed timber frame of the verandah roof (refer Image 29 below). Some wood rot was noted in the roof framing with evidence of attempted repairs (refer Image 32 below).

Image 27: A view north along the verandah - some cracks are evident in the base of some door frames (DES, 23 August 2019).

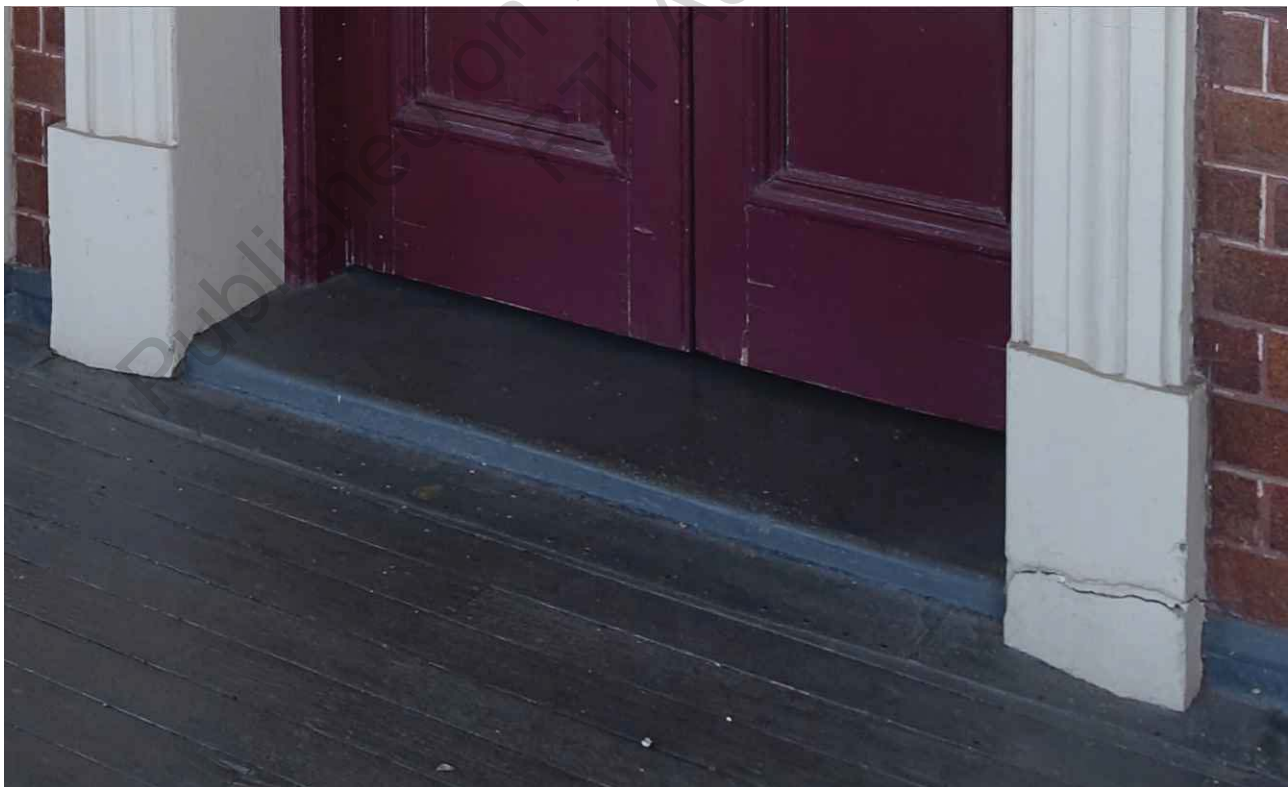
Image 28: The base of the verandah French doors to bed 3 - there is a horizontal crack in the right architrave plinth (DES, 23 August 2019).

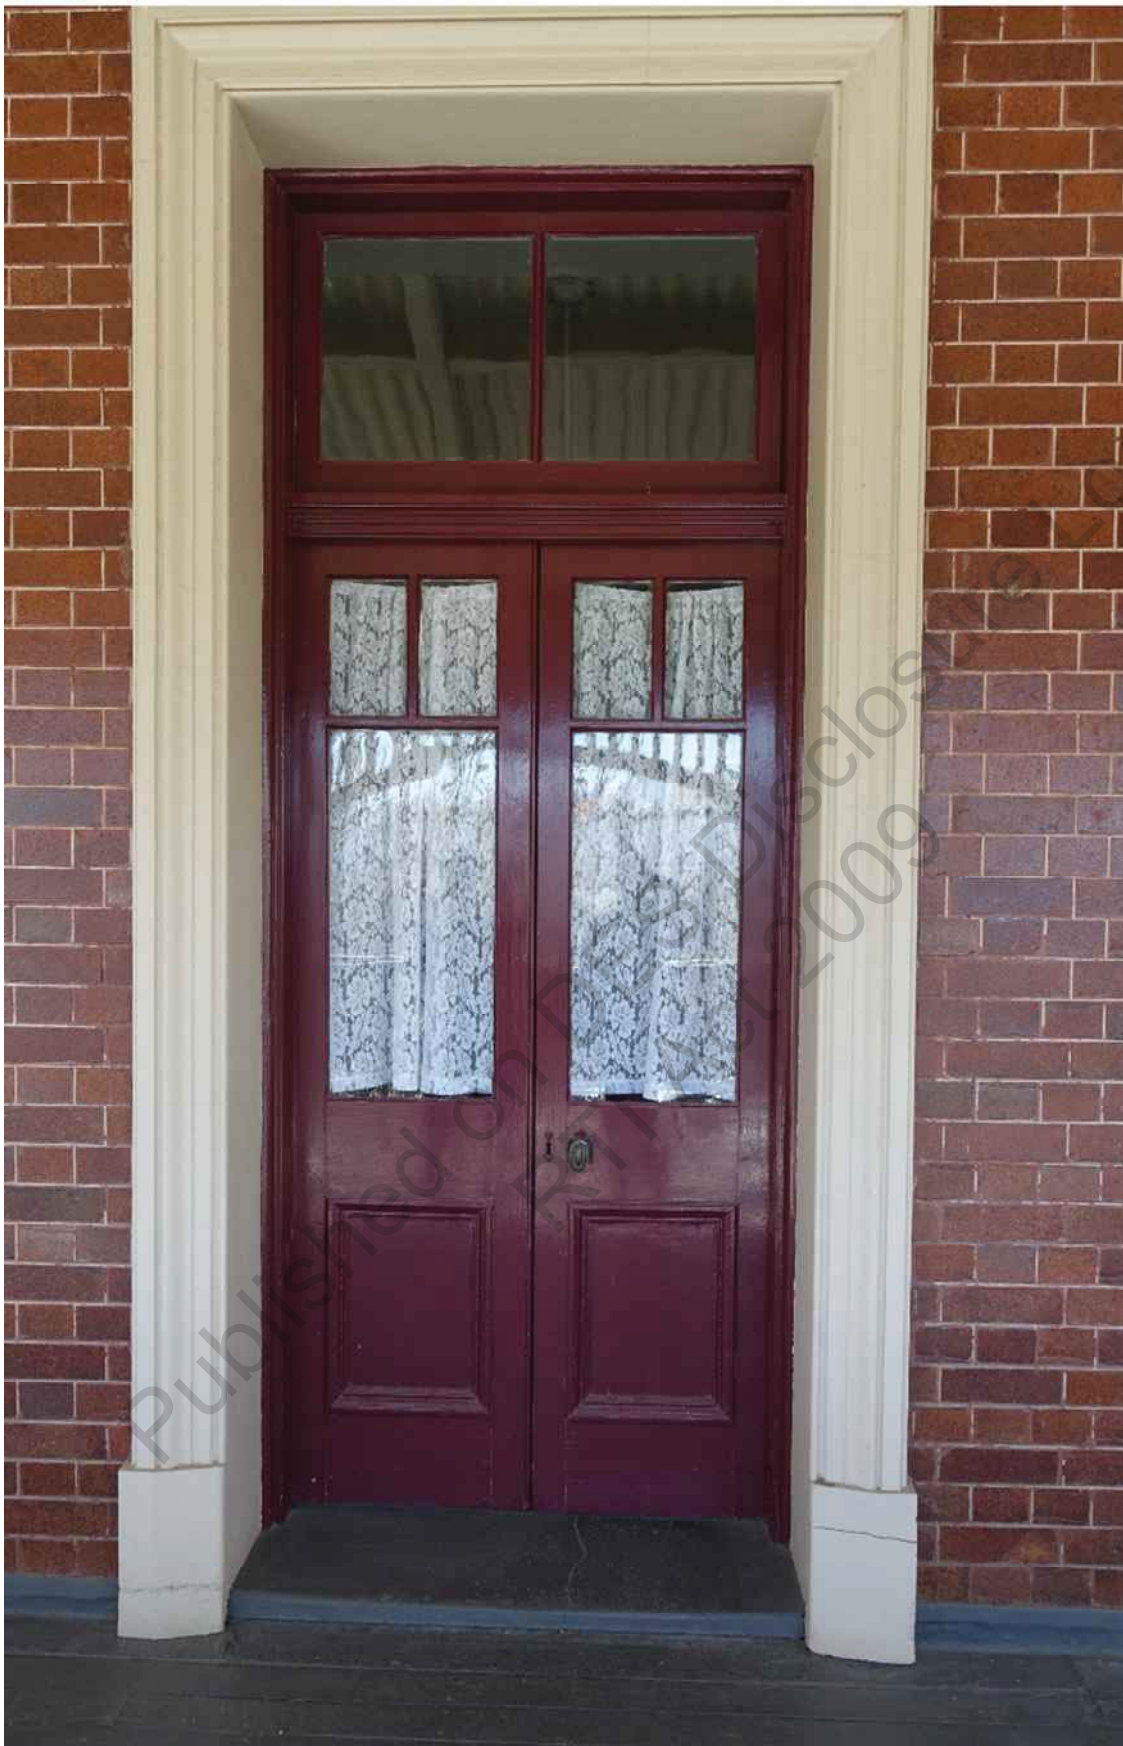
Image 29: Verandah French doors located in bed 5 showing horizontal cracks at the architrave plinth on both sides of the door frame - the left crack has paint applied, the right crack is open. The exterior moulded rendered door architrave otherwise appears to be sound condition. There is also a vertical crack through the tread between the frames but this does not appear to be recent. (DES, 23 August 2019.)

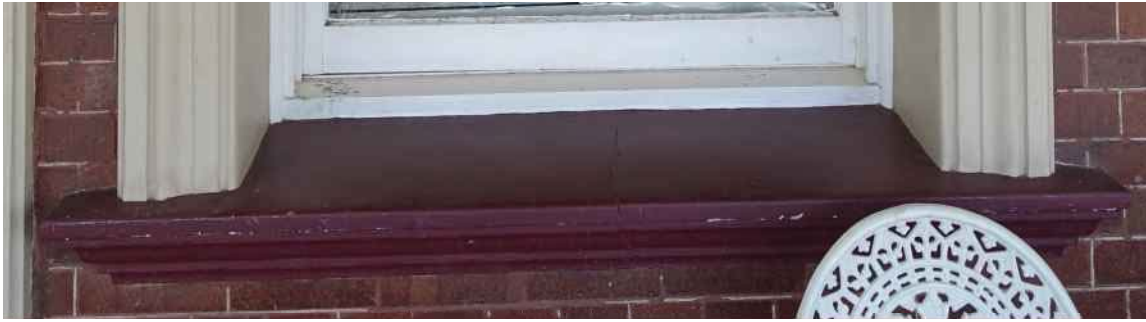
Image 30: A vertical crack in the sill of the verandah window to bed 8 (DES, 23 August 2019).

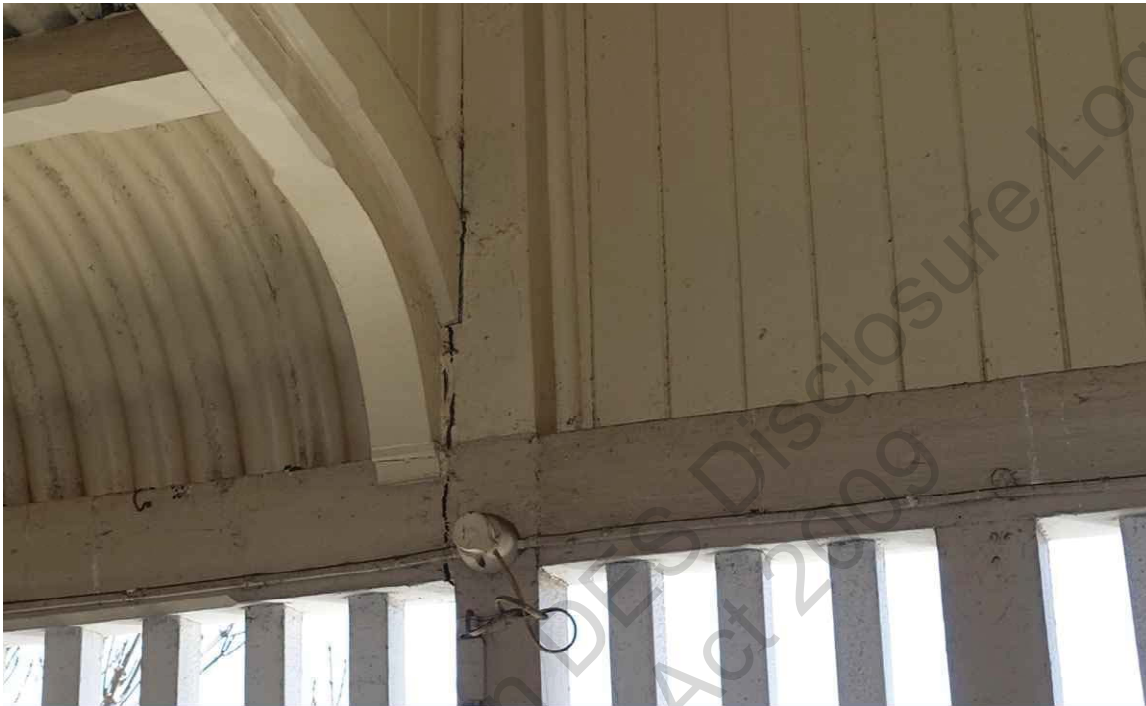
Image 31: A vertical crack in the timber frame located in the centre section of the verandah roof - located directly outside the sitting room (DES, 23 August 2019).

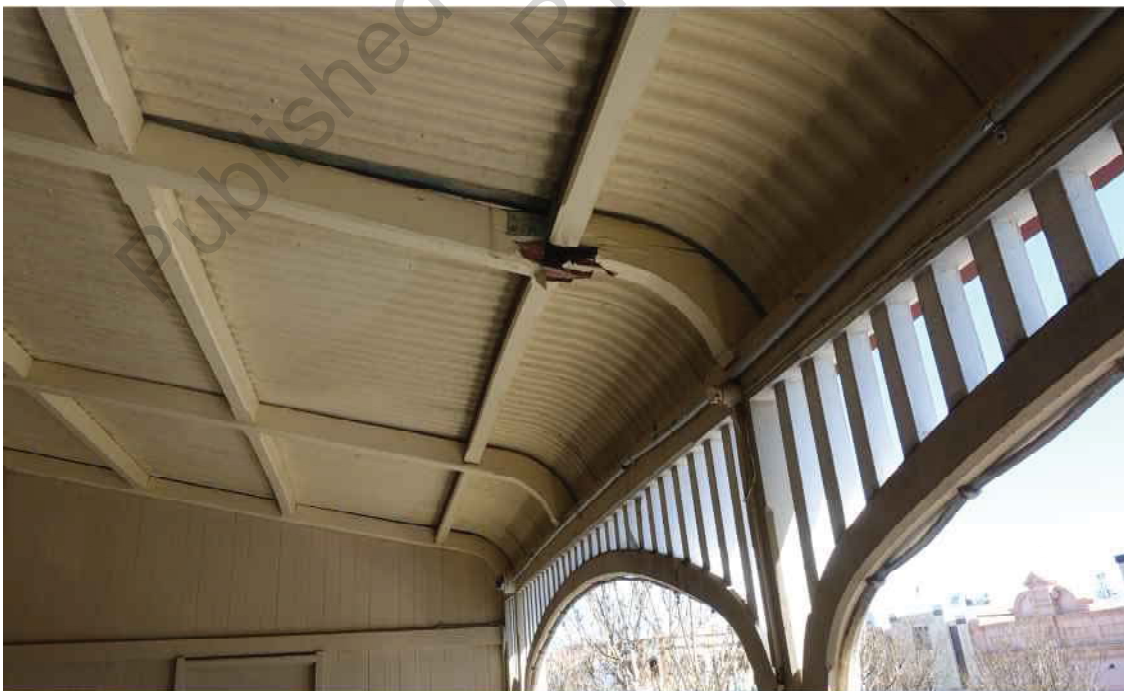
Image 32. Wood rot in a structural beam of the verandah roof located to the southern end of the hotel. A metal bracket has been inserted for support. (DES, 23 August 2019.)

There are some areas of rot in the verandah timbers. The extent of the affected areas appears to be quite small and like for like repairs of up to 10% of the verandah timbers could be undertaken under the terms of the General Exemption Certificate (GEC) without the need for further application. A copy of the GEC is attached but further information and a copy of the GEC can also be found at:

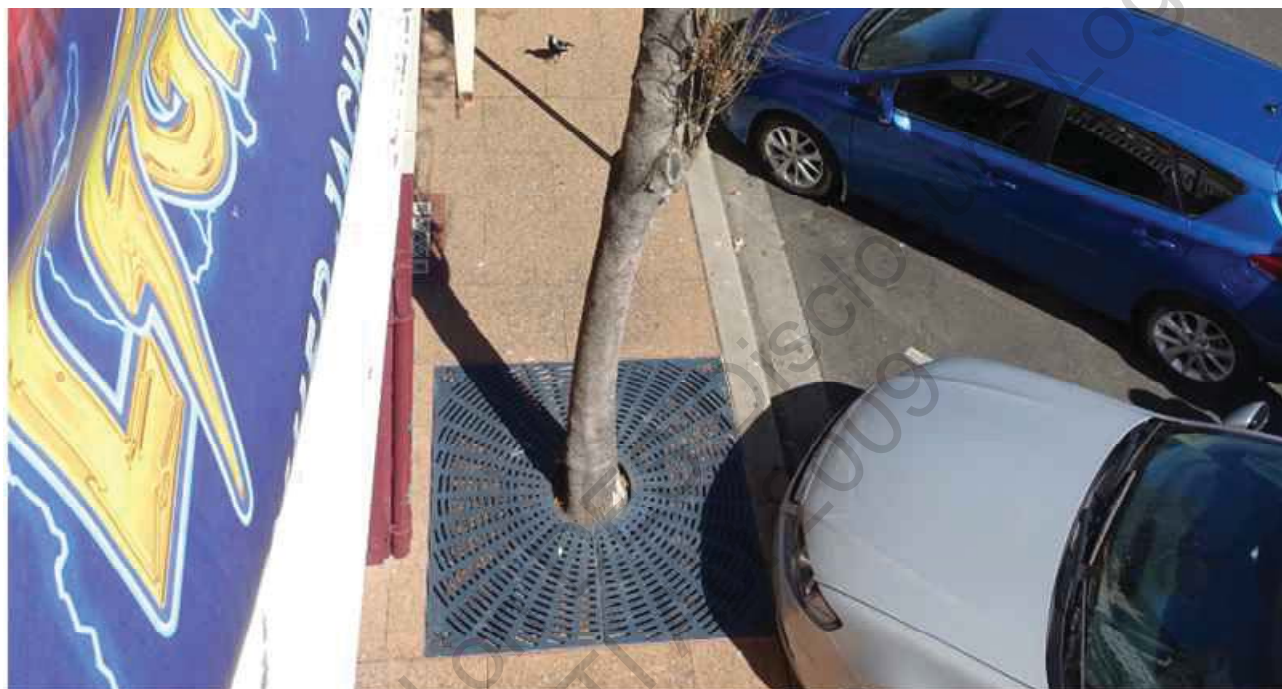
Image 33. An image from the verandah illustrating the proximity of the trees to the verandah posts and associated downpipes (DES, 23 August 2019).

The ongoing physical relationship of the street trees in relation to the building will need to be monitored to ensure they do not cause direct or indirect damage to the verandah, its structural supports, associated guttering/downpipes or paintwork.

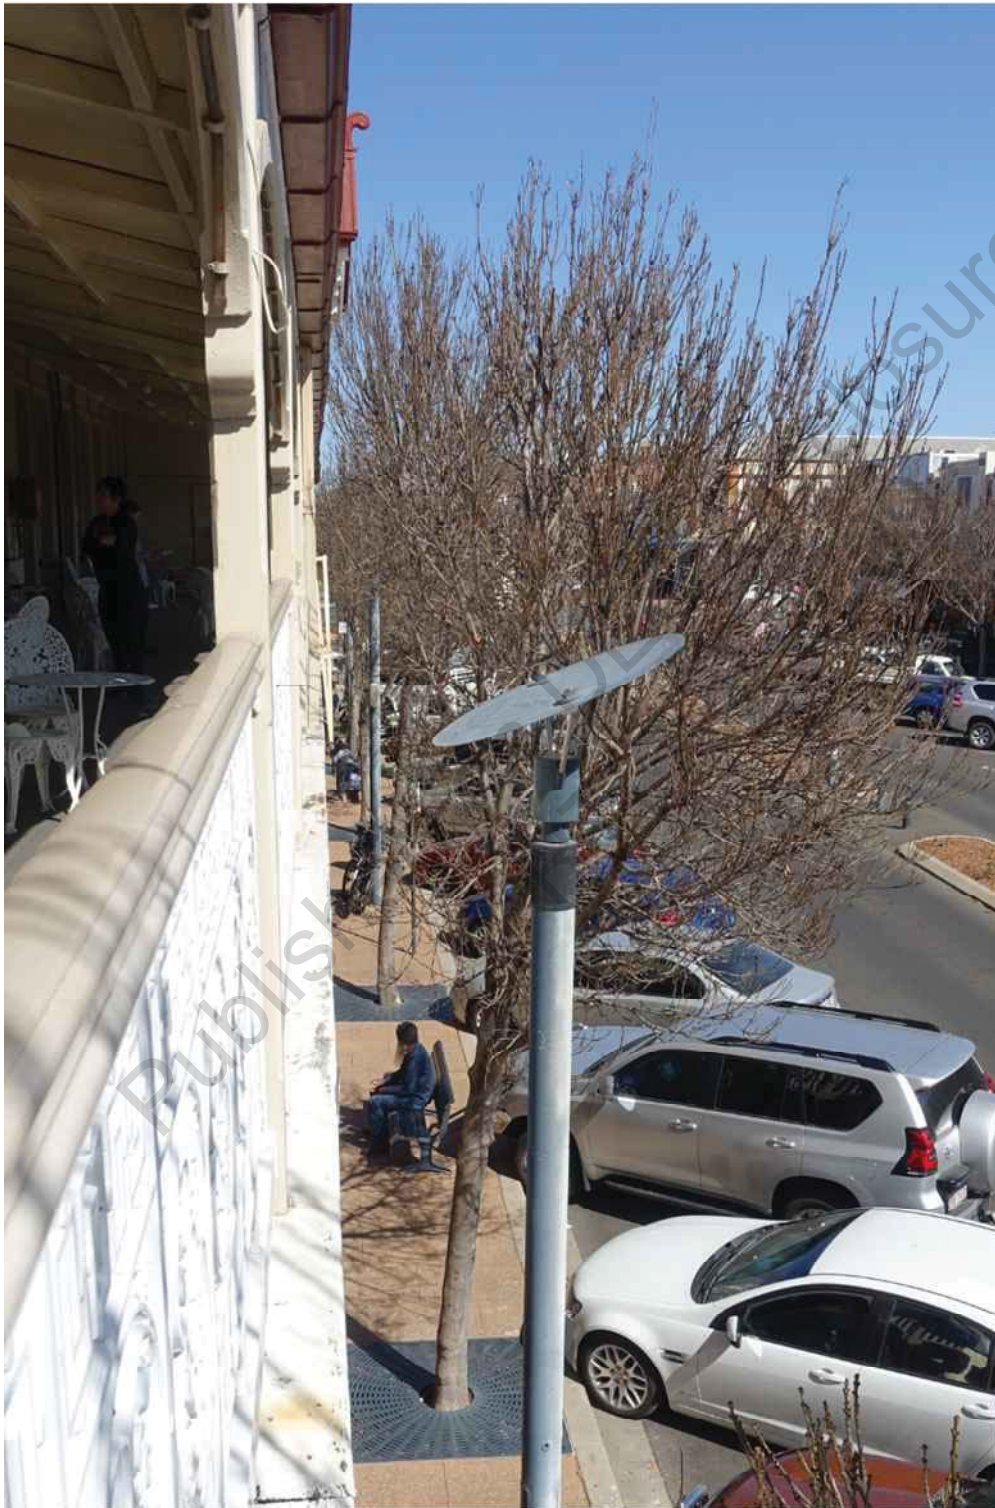
Image 34: Looking south along Palmerin Street - note the proximity of the trees to the verandah guttering and balustrade posts and associated downpipes (DES, 23 August 2019).

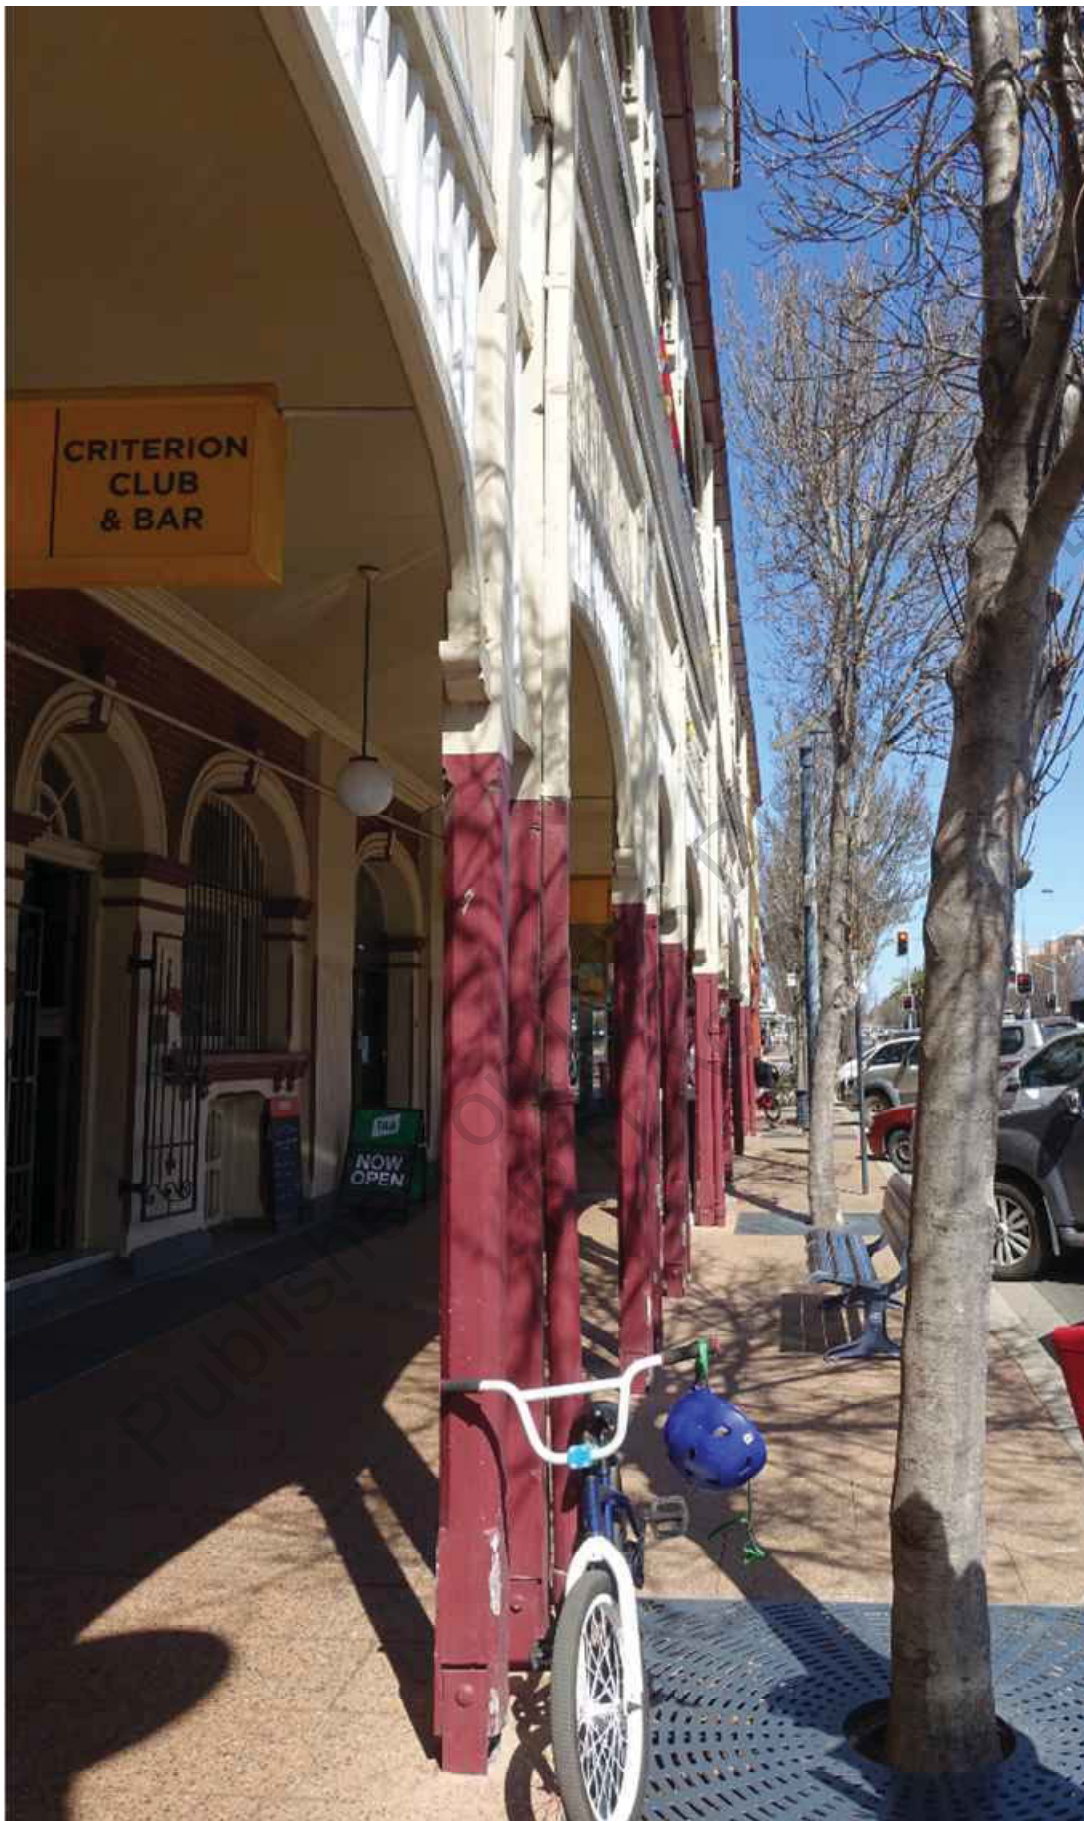
Image 35. The façade of the Criterion Hotel showing the relationship of the four trees to the verandah and downpipes (DES, 23 August 2019).
