**RE: Follow-up report on Jackson 15 flowline leak**

**Photographs of Incident: Jackson #38 oil release**

Photographs of Remediation Progress: Jackson #38 oil release

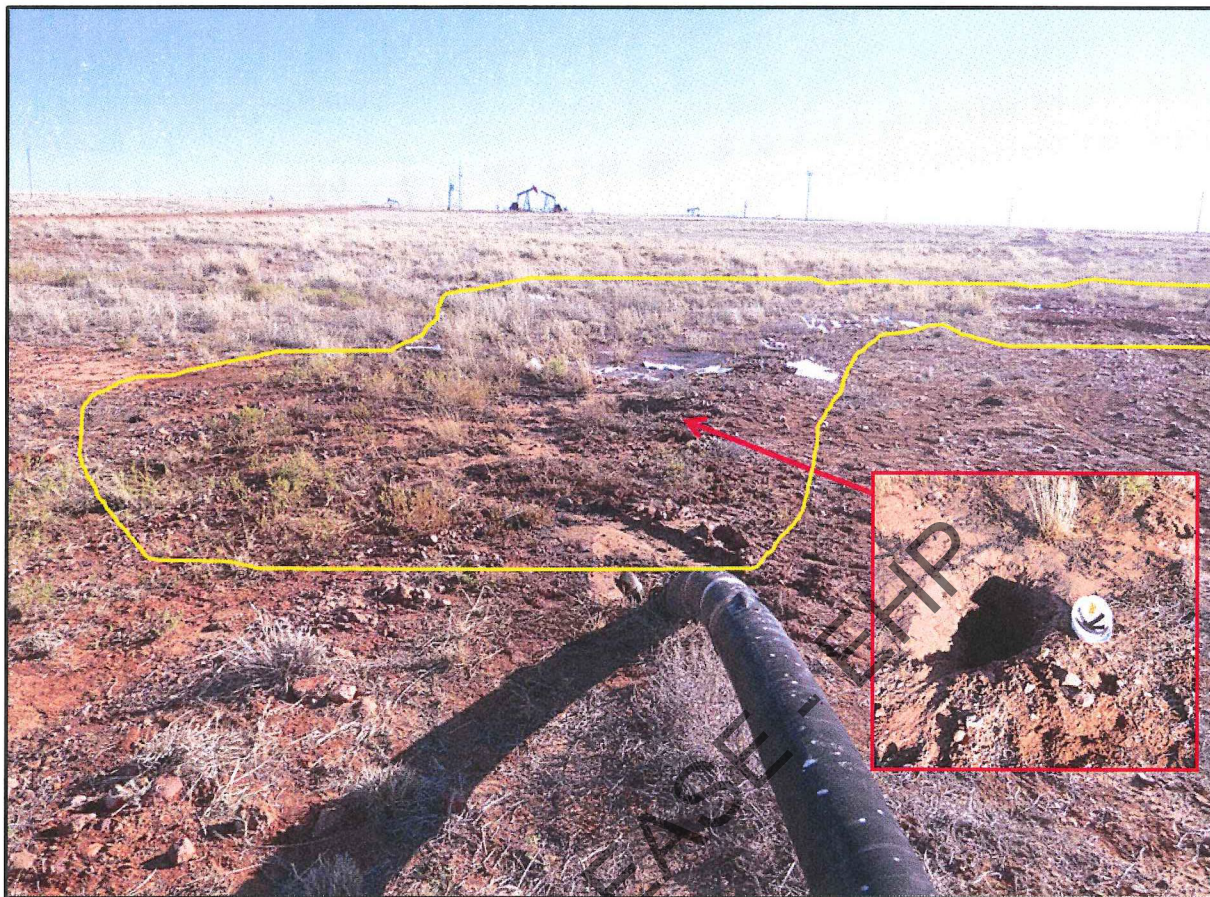
On 2 October 2012 the site was sufficiently dry to enable backhoe access for commencement of delineation and clean-up. The source of the leak was identified as a pinhole caused by external corrosion underneath the 'yellow jacket' shroud around the steel flowline. The potential for corrosion of 'yellow jacket' shrouded steel pipelines was assessed as part of the environmental evaluation conducted for PEN100046407 – refer to implementation action 5.3.4 which is in progress. Approximately 200 m<sup>3</sup> of soil has been removed from the spill zone and relocated to the Jackson landfarm for treatment.

**Figure 1:** Jackson 15 flowline leak – source location and immediate vicinity shortly after following removal of oil on surface by vacuum truck and absorbent pads

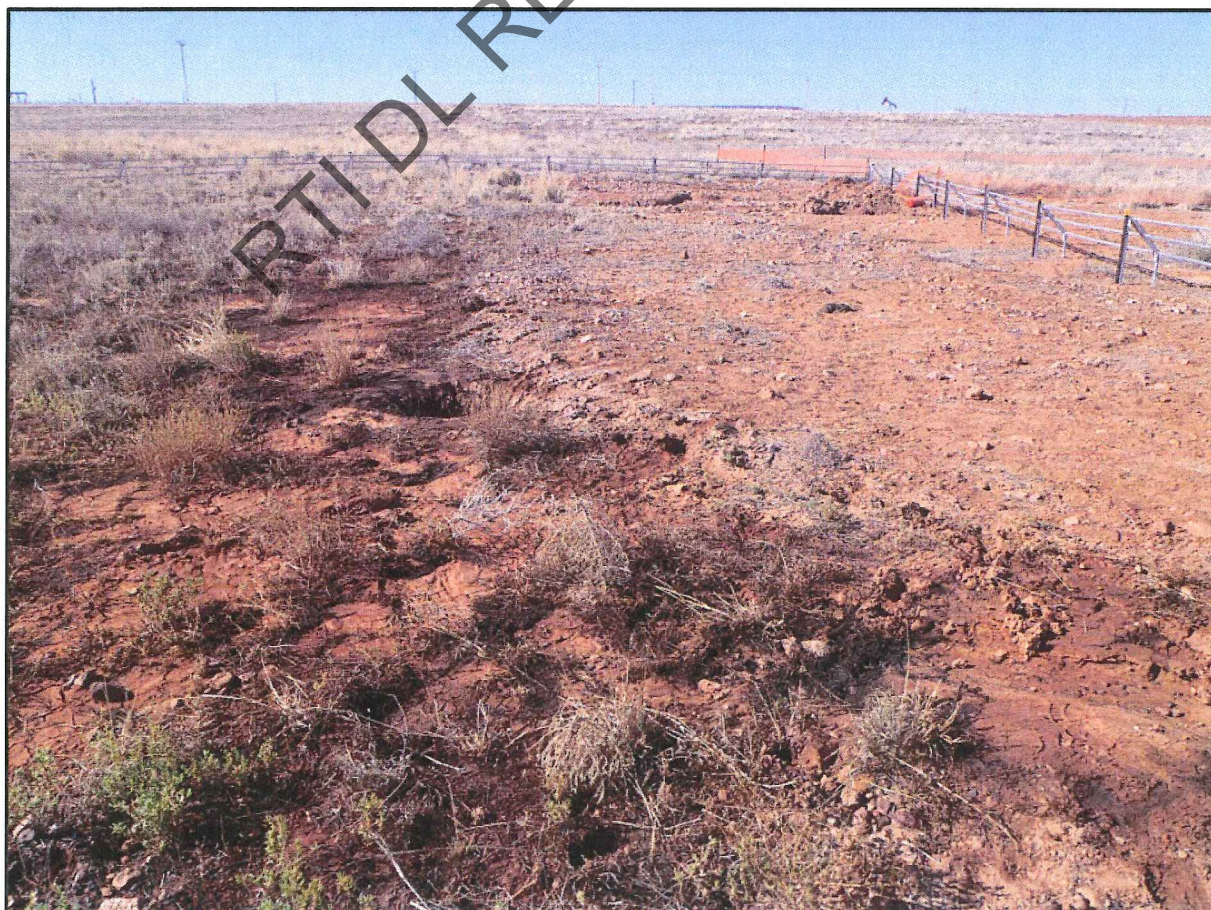
**Immediately downstream of the source (samples 2, 3, 8):** Some pockets of visible surface hydrocarbon contamination, and low to moderate TPH in soil samples (except for sample 8 which was characterised by pronounced surface staining and elevated TPH). Delineation revealed vertical migration to approximately 1 metre. Removal of soil in this area is continuing as of 4 October 2012 with further soil removal pending availability of machinery. Contaminated soil to be taken to Jackson landfarm for processing.

**Remaining impacted area (samples 4-7, 10, 11):** Minimal observed hydrocarbon impact on the surface, and low to slightly elevated TPH in soil samples. All contaminated soil was removed from this area and trucked to Jackson landfarm for processing.

**Figure 2:** Jackson 15 flowline leak – indicative of surface impact

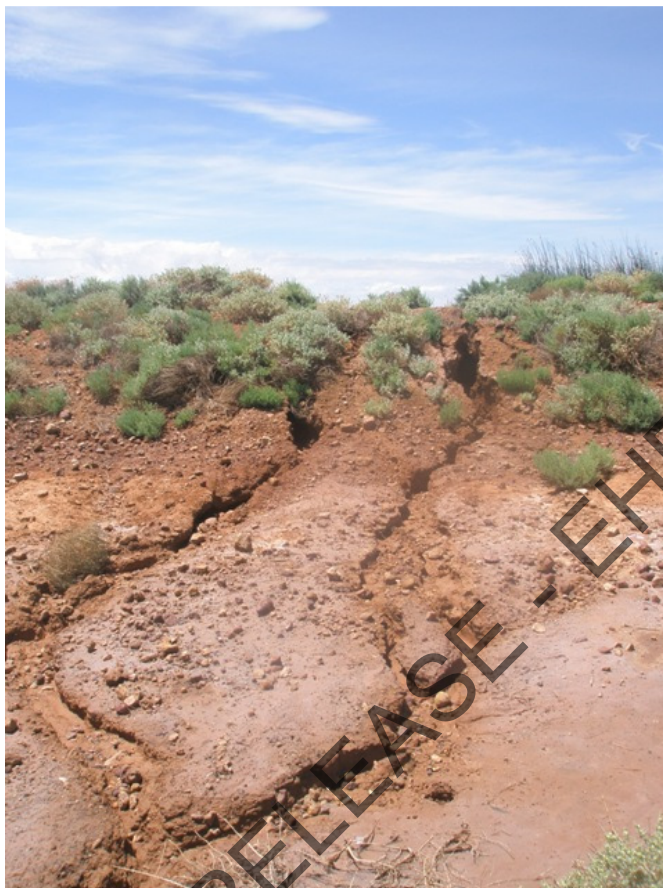
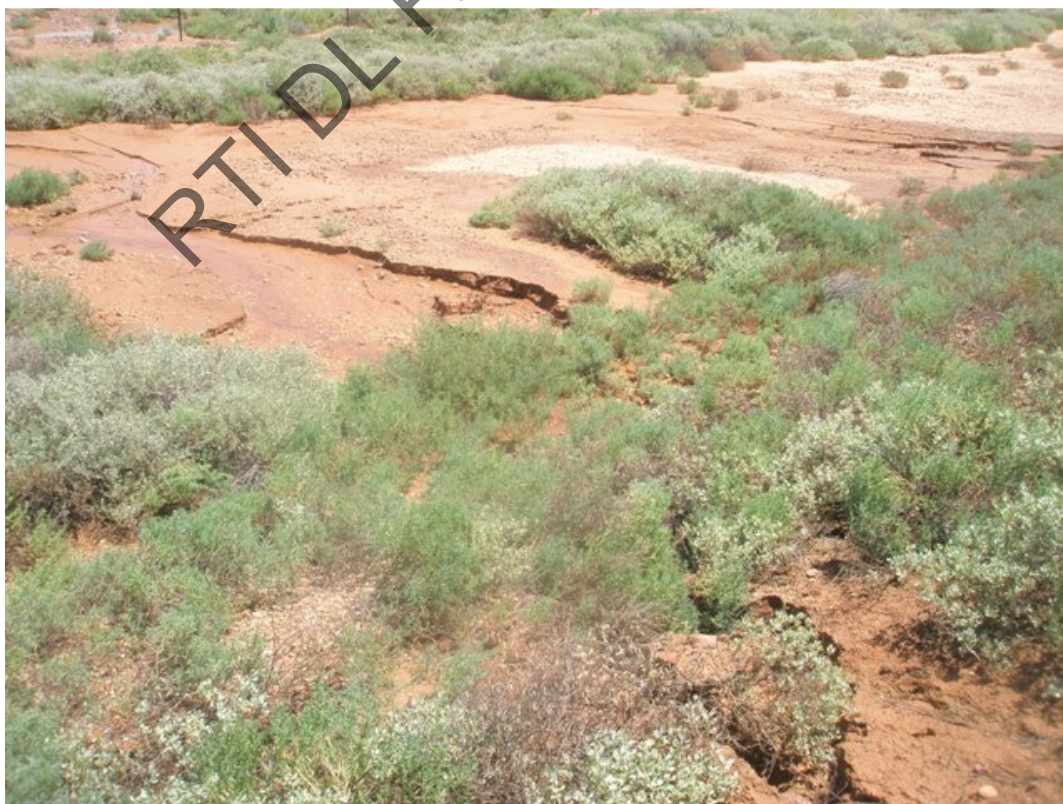
Examples of minor erosion channels where water has flowed over the pond wall

8. Repair erosion damage to dam bund wall caused by the breach. Will be conducted after conditions are dry enough for equipment access (has been delayed by further rain fall events).

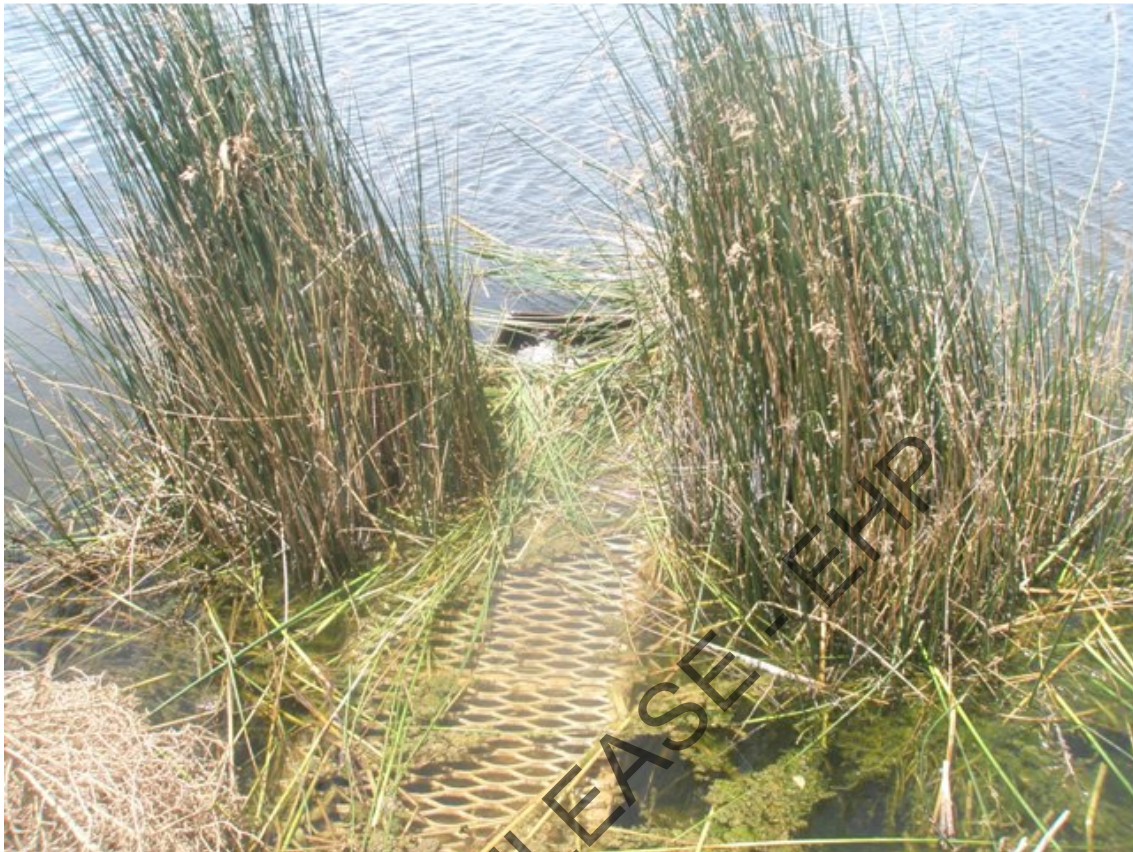
The 3 monthly Workplace EHS Inspection Checklist for the facility includes pond wall inspections, but doesn't include an item to check for, and arrange removal of, reeds or other vegetation inside the ponds in the vicinity of outlet lines (i.e. the hazard may not be recognised during inspections).

The operational surveillance work instruction for this facility specifies checks at the discharge point of the pond, but does not specify checking the pond level or checking the pond weir box for potential restrictions. This was based on the pond discharge being a gravity fed weir arrangement (i.e. no mechanical equipment, such as a pump shutting down, could cause a level increase), and a blockage due to tumbleweed and reeds had not been anticipated.

Reeds growing in the vicinity of the weir box

7. Remove all remaining reeds from the vicinity of inlet point for the weir box (reeds in immediate vicinity that could be reached by hand have been removed). Will be conducted as soon as conditions are dry enough for equipment access (has been delayed by further rain fall events, but action 1 is in place to mitigate until then).

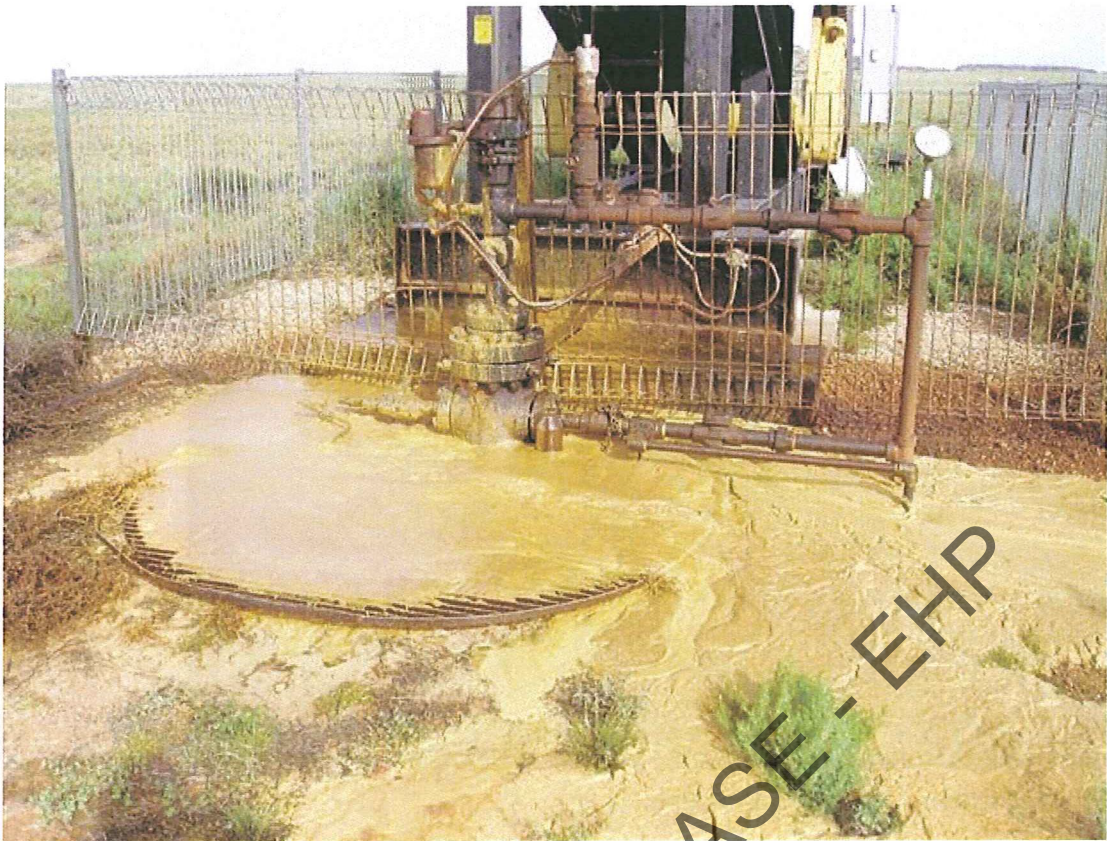
The release was discovered at Jackson #38 at 0830 hours on Thursday 16 September. Jackson #38 is a producing oil well with a beam pump. Currently, fluid from Jackson #38 is approximately 88% produced water. The pump has an environmental stuffing box (ESB) installed to minimise leaks from the pump shaft. The beam pump packers failed and released hydrocarbon to the ESB. As the ESB filled, as expected, it tripped the well closed, preventing a hydrocarbon release. The non-return valve (NRV) in the piping connecting Jackson #38 to the local manifold was passing, allowing backflow from other wells connected to the same manifold. Consequently the well head cellar filled and overflowed.

Incident investigation has identified that a piece of rod guide material had become lodged in the NRV seat preventing the valve from closing. The NRV has been scheduled for replacement.

*Overflowed cellar at Jackson #38. All free hydrocarbon has been removed.*

- Non return valve replaced with a new valve – proactive
- Well rod packers replaced
- Environmental stuffing box inspected
- Well head cellar emptied

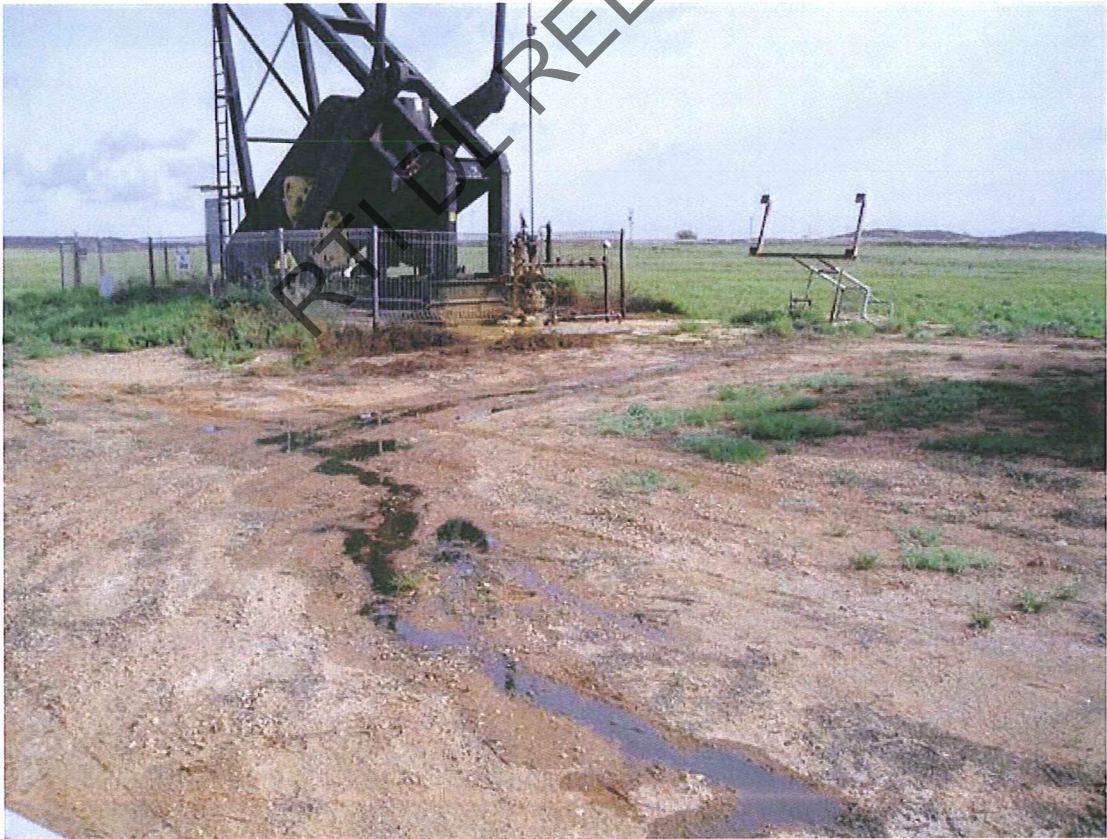
*Jackson #38 flow of hydrocarbon on lease area.*

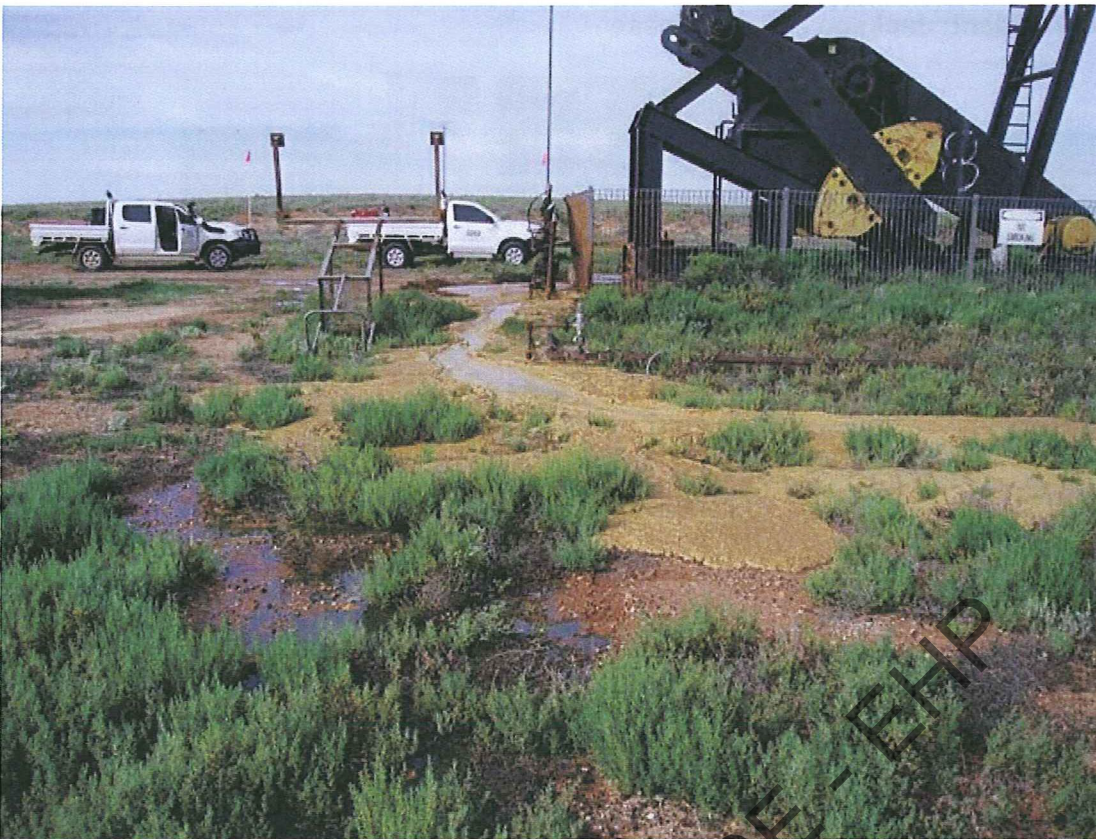
*Jackson #38. Showing extent of soil contamination.*
