**Environmental Site Assessment -  
Lot 2 on RP 210504, New Farm  
Power Station, Lamington Road,  
New Farm, Queensland**

**Brisbane City Council**

**PPK Environment &  
Infrastructure Pty Ltd**

May, 1998  
84K043A-PR001A/jf

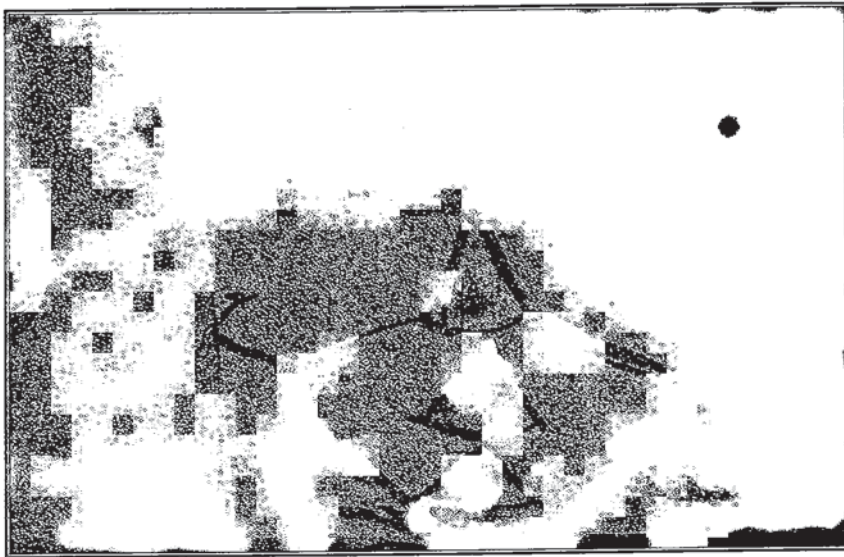
**Photo 1 : Asbestos insulation debris on top of concrete plinth, Ground Floor.**

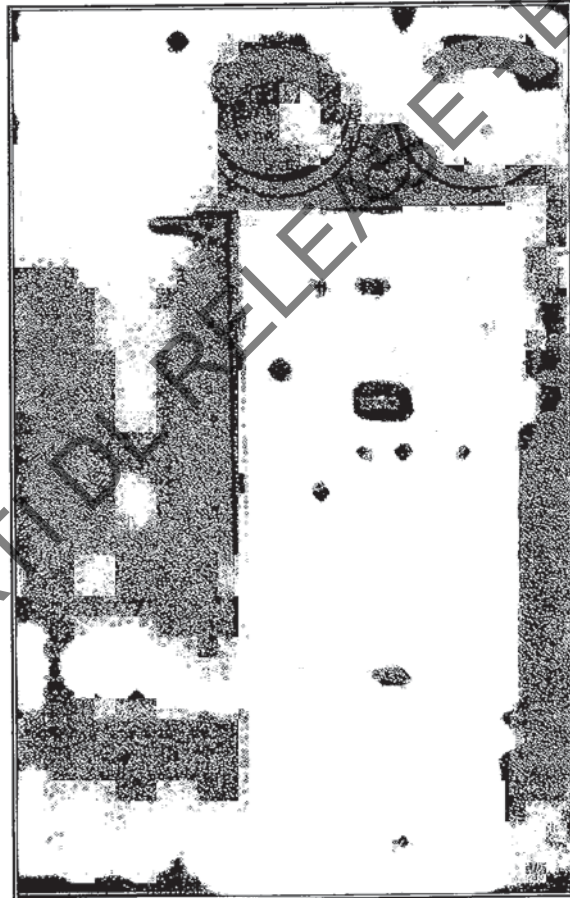
**Photo 2 :**

Asbestos millboard material containing chrysotile asbestos is located in switch room fuse covers and is present as thermal lining inside the electrical cabinet door on the east wall of the ground floor. Additional asbestos millboard in the form of castings are present in the switch rooms and appear to originate from within the switch gear. The millboard material is in a generally poor condition and scattered over the floor surface.

- a) Asbestos mounting board inside the electrical cabinet, Ground Floor**
- b) Asbestos millboard lining to the door of the electrical cabinet, Ground Floor**
- c) Asbestos cement arc shield inside the electrical cabinet, Ground Floor.**

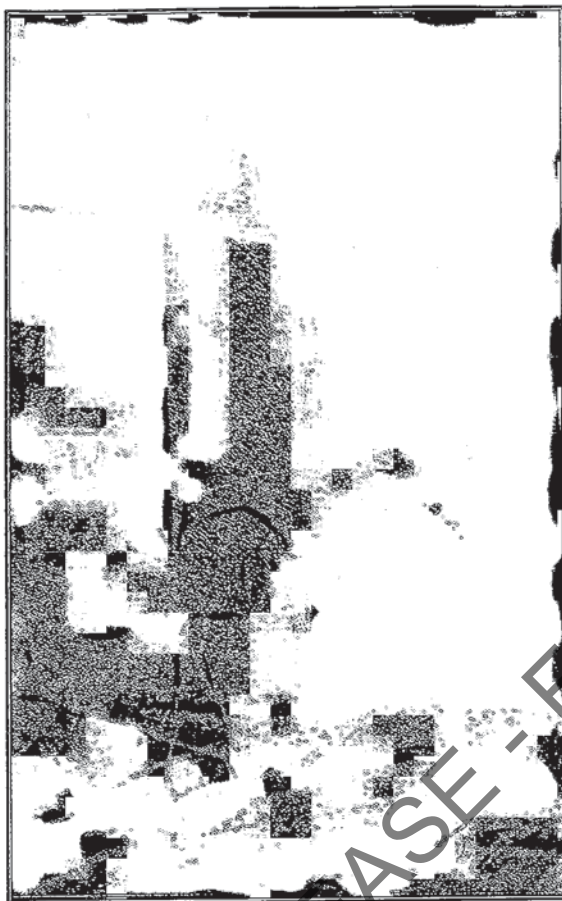
A small section of fibre cement pipework is located in the service tunnel at the far western end of the ground floor. This material is unsealed and generally in good condition.

**Photo 3 : Asbestos cement pipe in service tunnel, Ground Floor.**

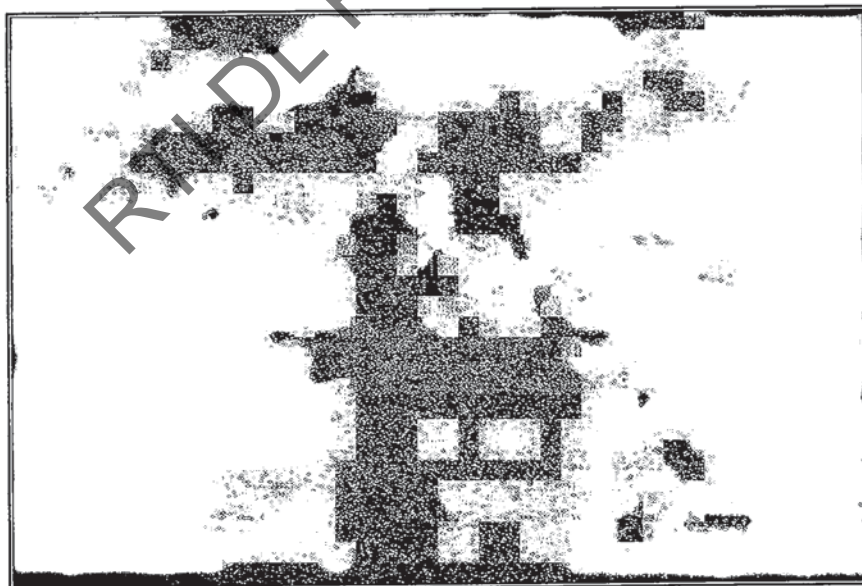
**Photo 4 : Asbestos insulation debris on floor against northern wall, Level 1.**

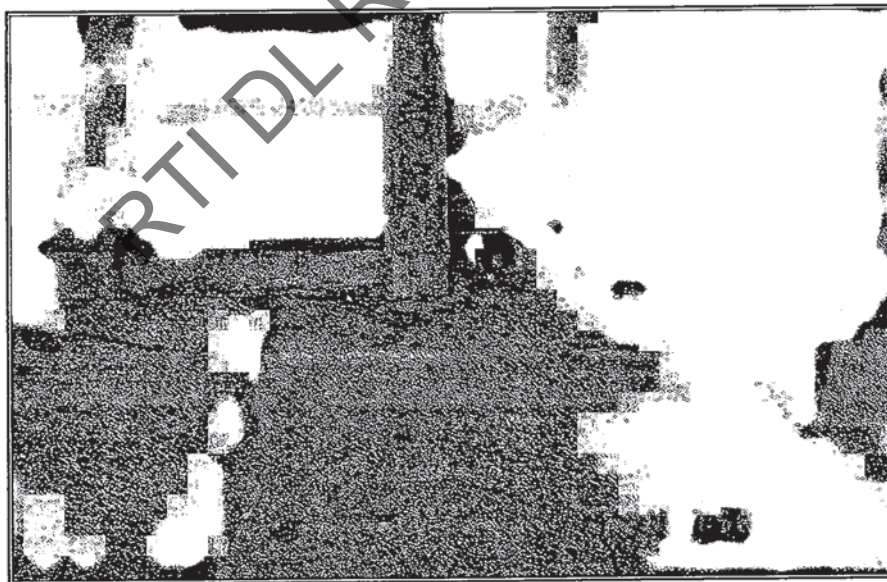
**Photo 8 : Asbestos cement debris scattered over floor of south / east and south / west decks, Second Floor.**

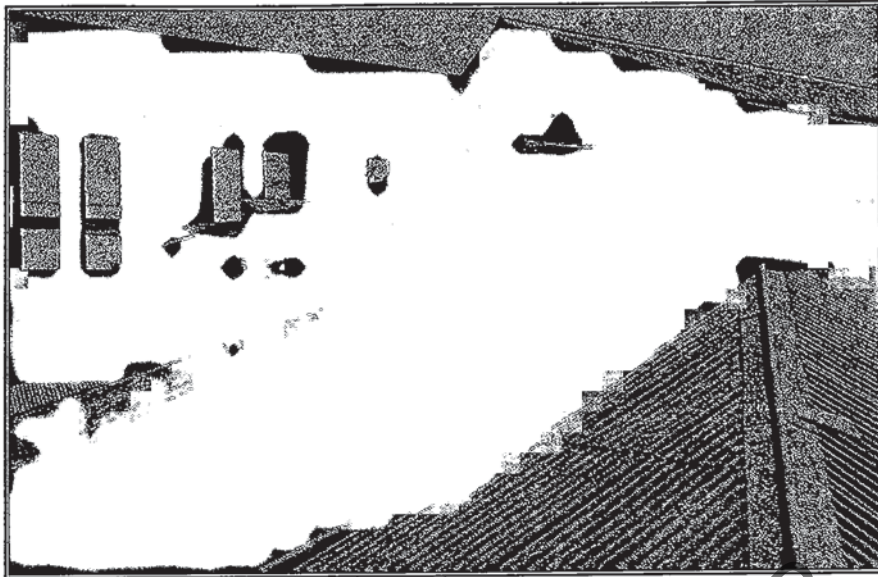
Photo 9 : Asbestos gable end, Roof.

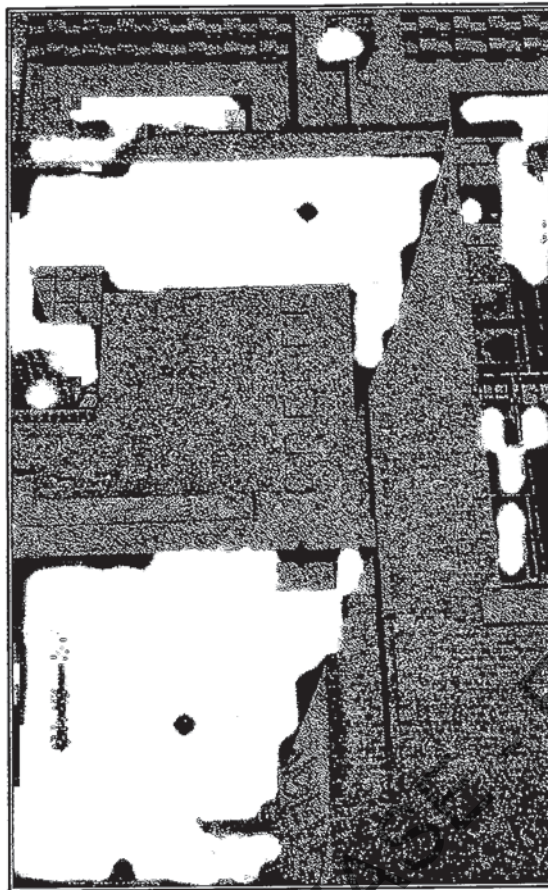
**Photo 11 : Asbestos cement eaves lining on east side of power station, Level 1 Mezzanine.**

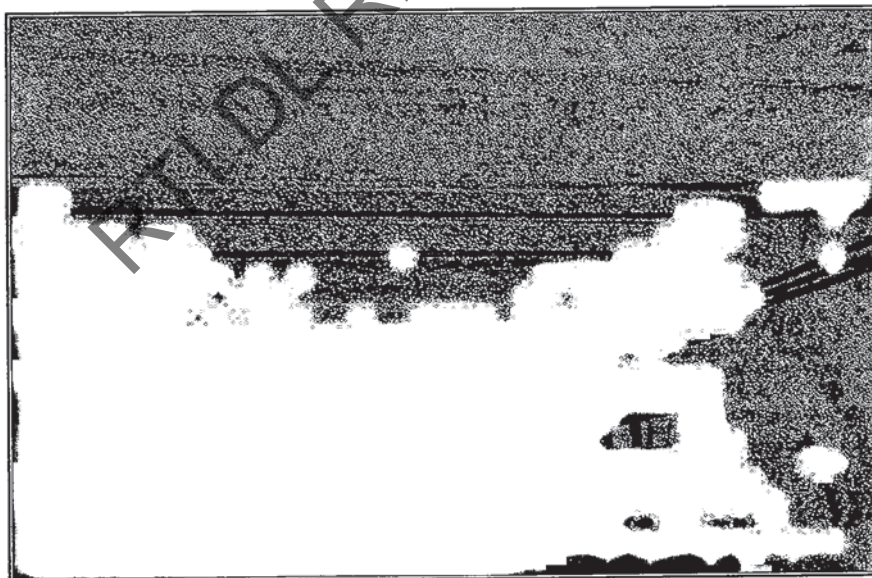
Structures painted with lead-based paint have deteriorated considerably over the years. Much of the paint has peeled away from the substrate and has fallen on lower surfaces. Elevated lead concentrations in excess of the occupational exposure guidelines of 0.25 % were detected in six of the seven samples submitted for laboratory analysis. A maximum lead content of 46 % was detected sample P3, corresponding to a light blue/grey paint on structural steel RSJ beams.

**Photo 12 : Silver lead based paint on horizontal structural steel beams, Level 2.**

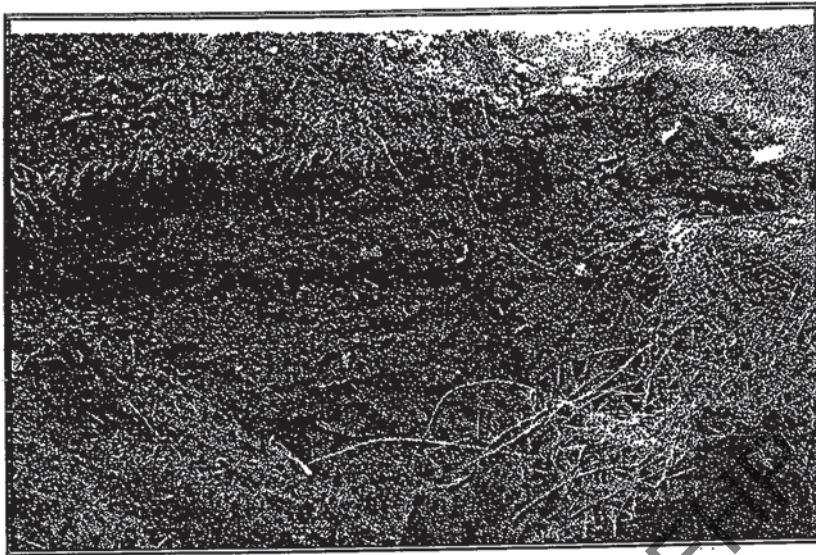
- Asbestos was present on site in a condition that presents a health risk to workers removing the material.
- Asbestos was present in a soil sample obtained from test pit 10, excavated in the area of fill in the demolished boilerhouse.
- Lead was found in 6 of 7 paint samples submitted for laboratory analysis in concentrations exceeding National Health and Medical Research Council (NH&MRC) guidelines.
- Polychlorinated biphenyls (PCBs) were not reported above detection limits in the samples submitted for laboratory analysis, however, it is likely that PCBs would be present in capacitors in fluorescent light fittings based on the light fittings' age.

**Photo 13: Test Pit 10 (Demolished Boilerhouse)**

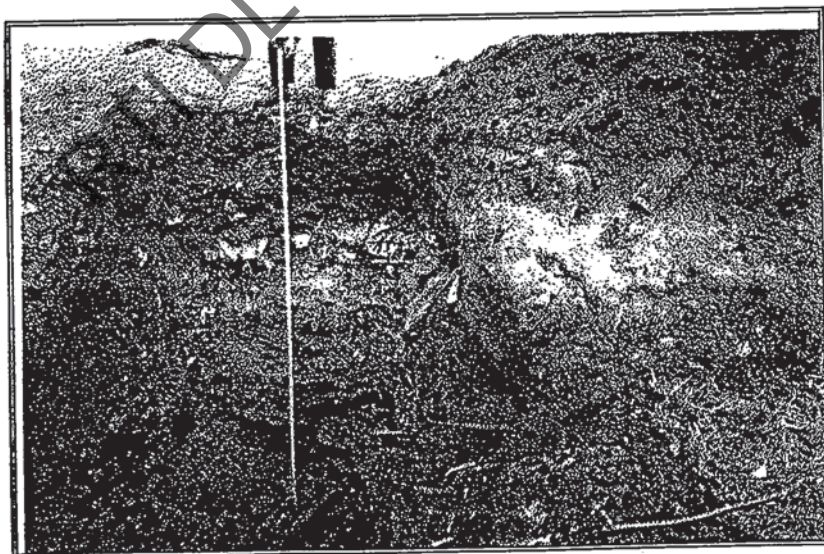
**Photo 14: Test Pit 9 (Demolished Boilerhouse)**
