DEVINE BELMONT ESTATES PTY LIMITED

DECONTAMINATION

HO10070  
MAY 1990

HOLLINGSWORTH DAMES & MOORE

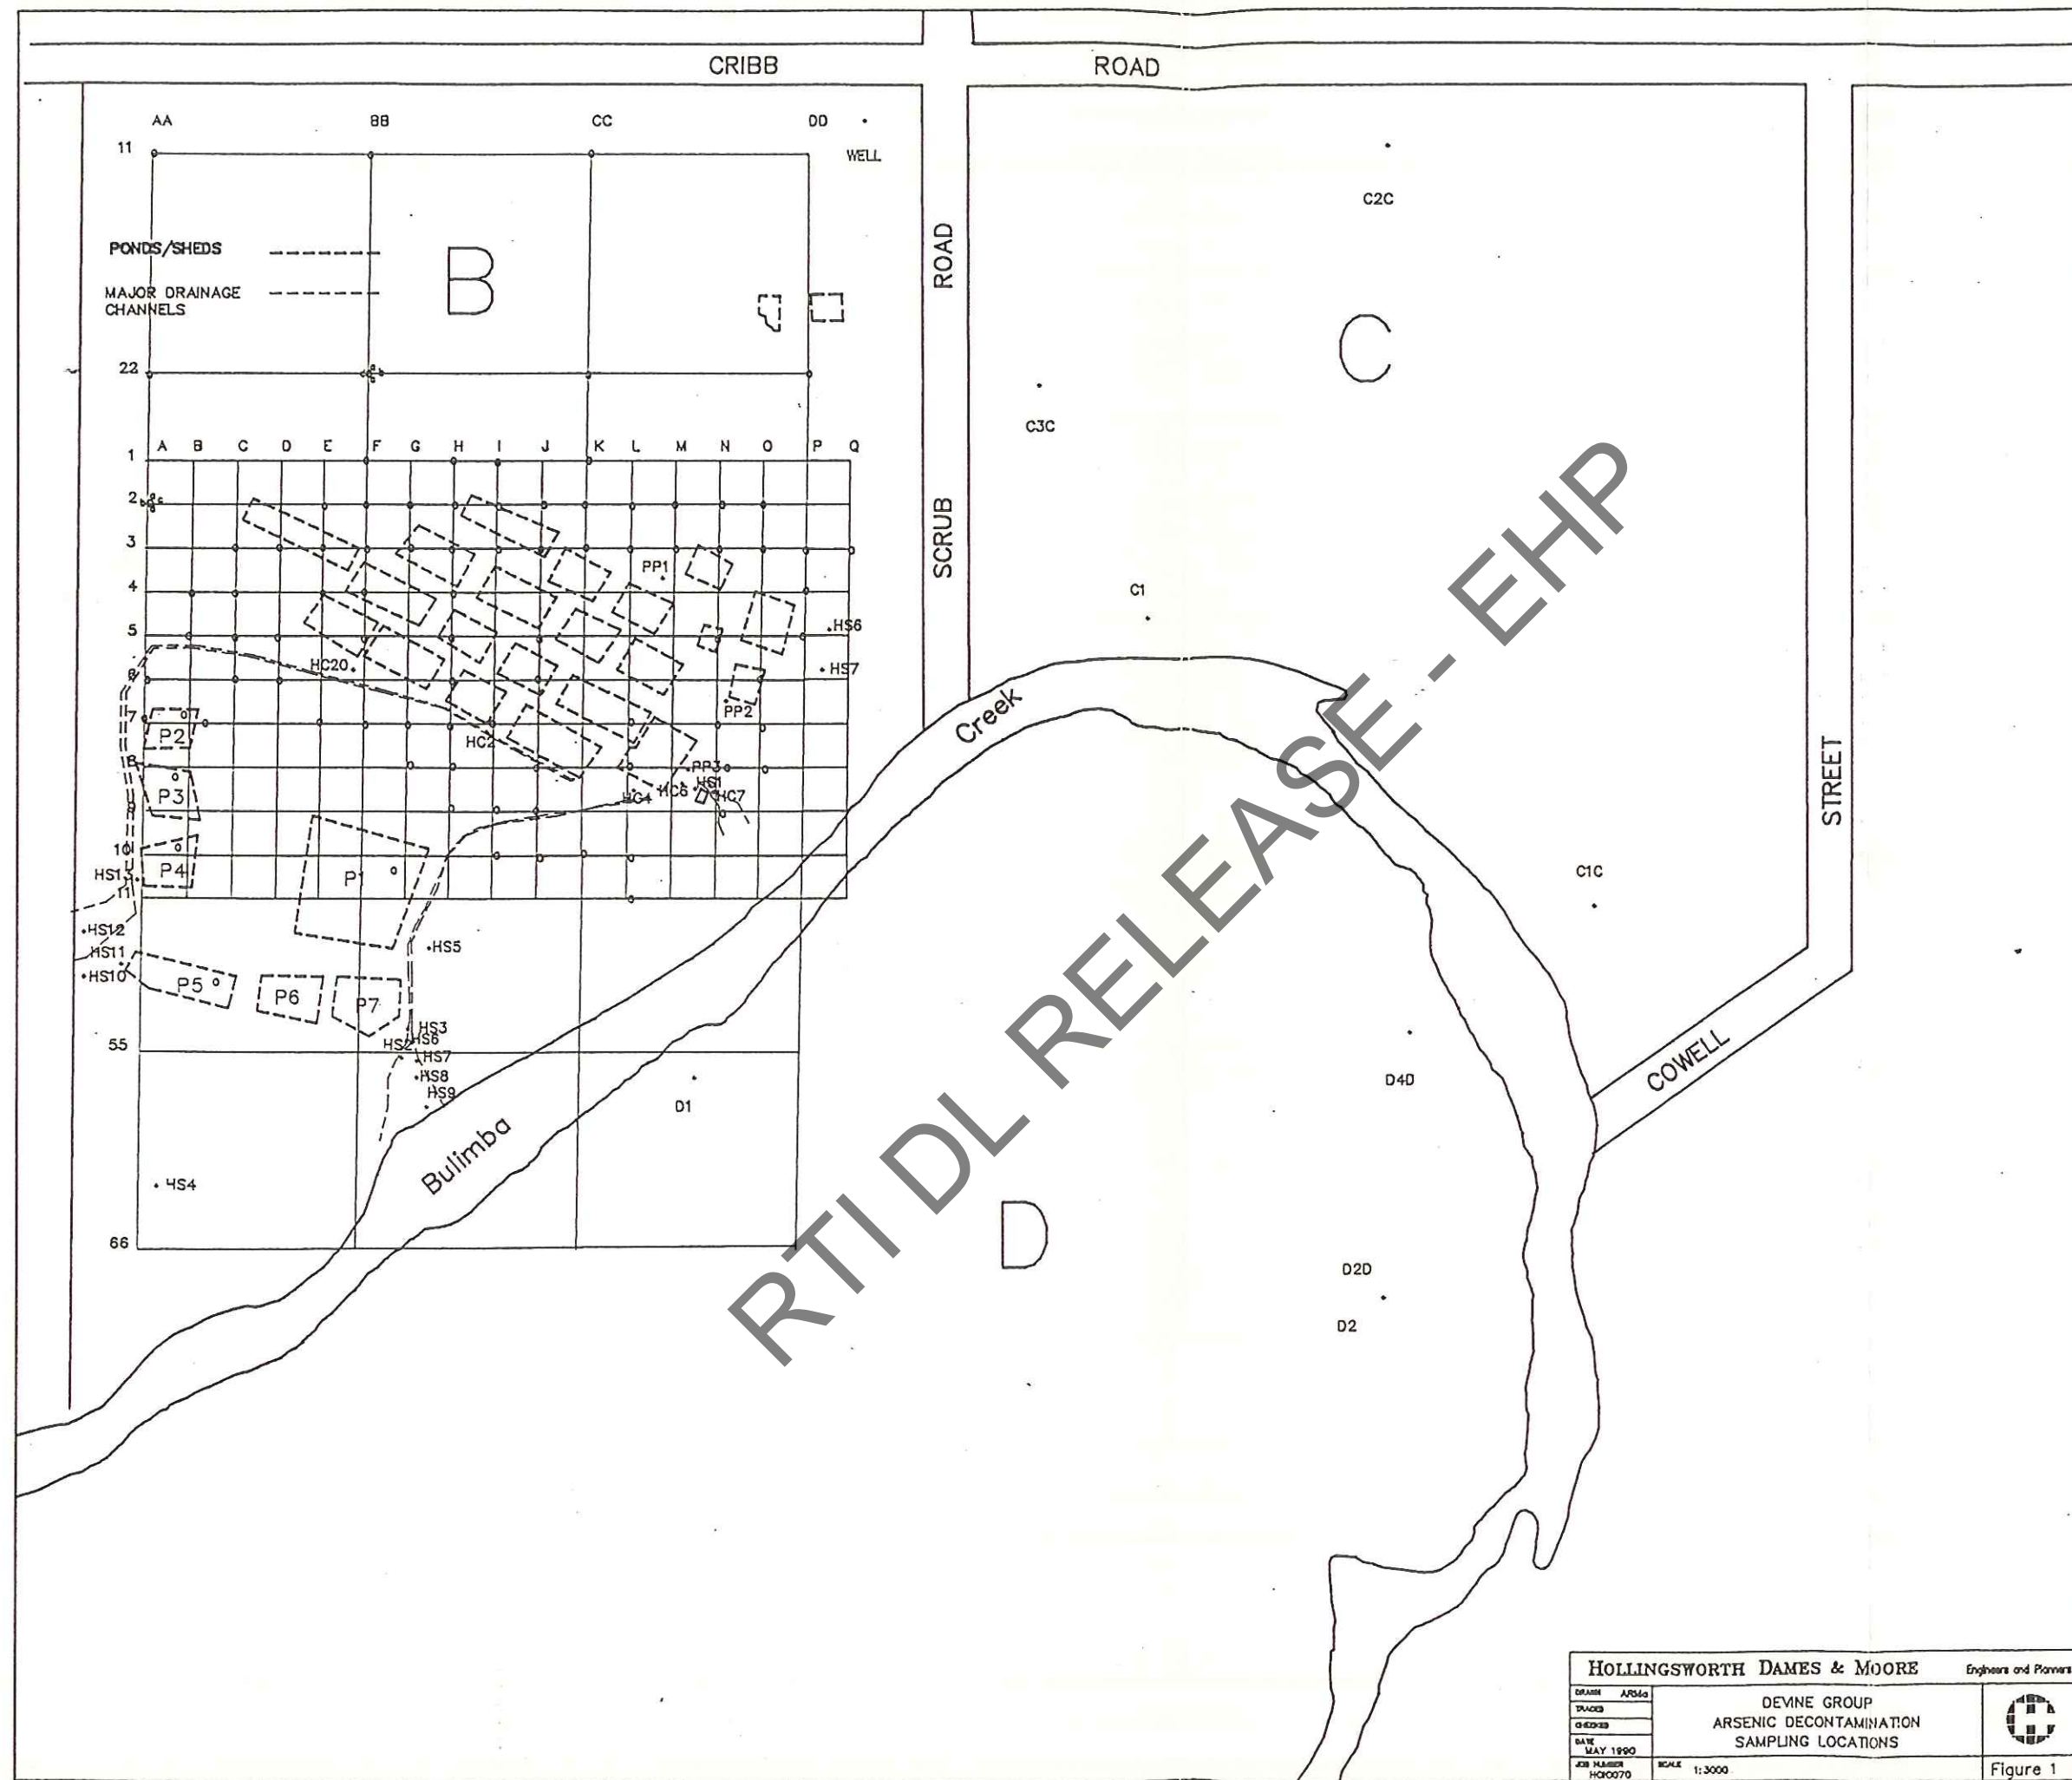
- Samples of soil were taken from grid nodes and additional locations for arsenic analysis (see Figure 1).
- From areas which were found in the preliminary survey to be contaminated with arsenic, a further set of samples was taken for leachability testing. These samples represented "worst case" contamination and moderate contamination in the Western, Central, and Eastern segments of the contaminated area.

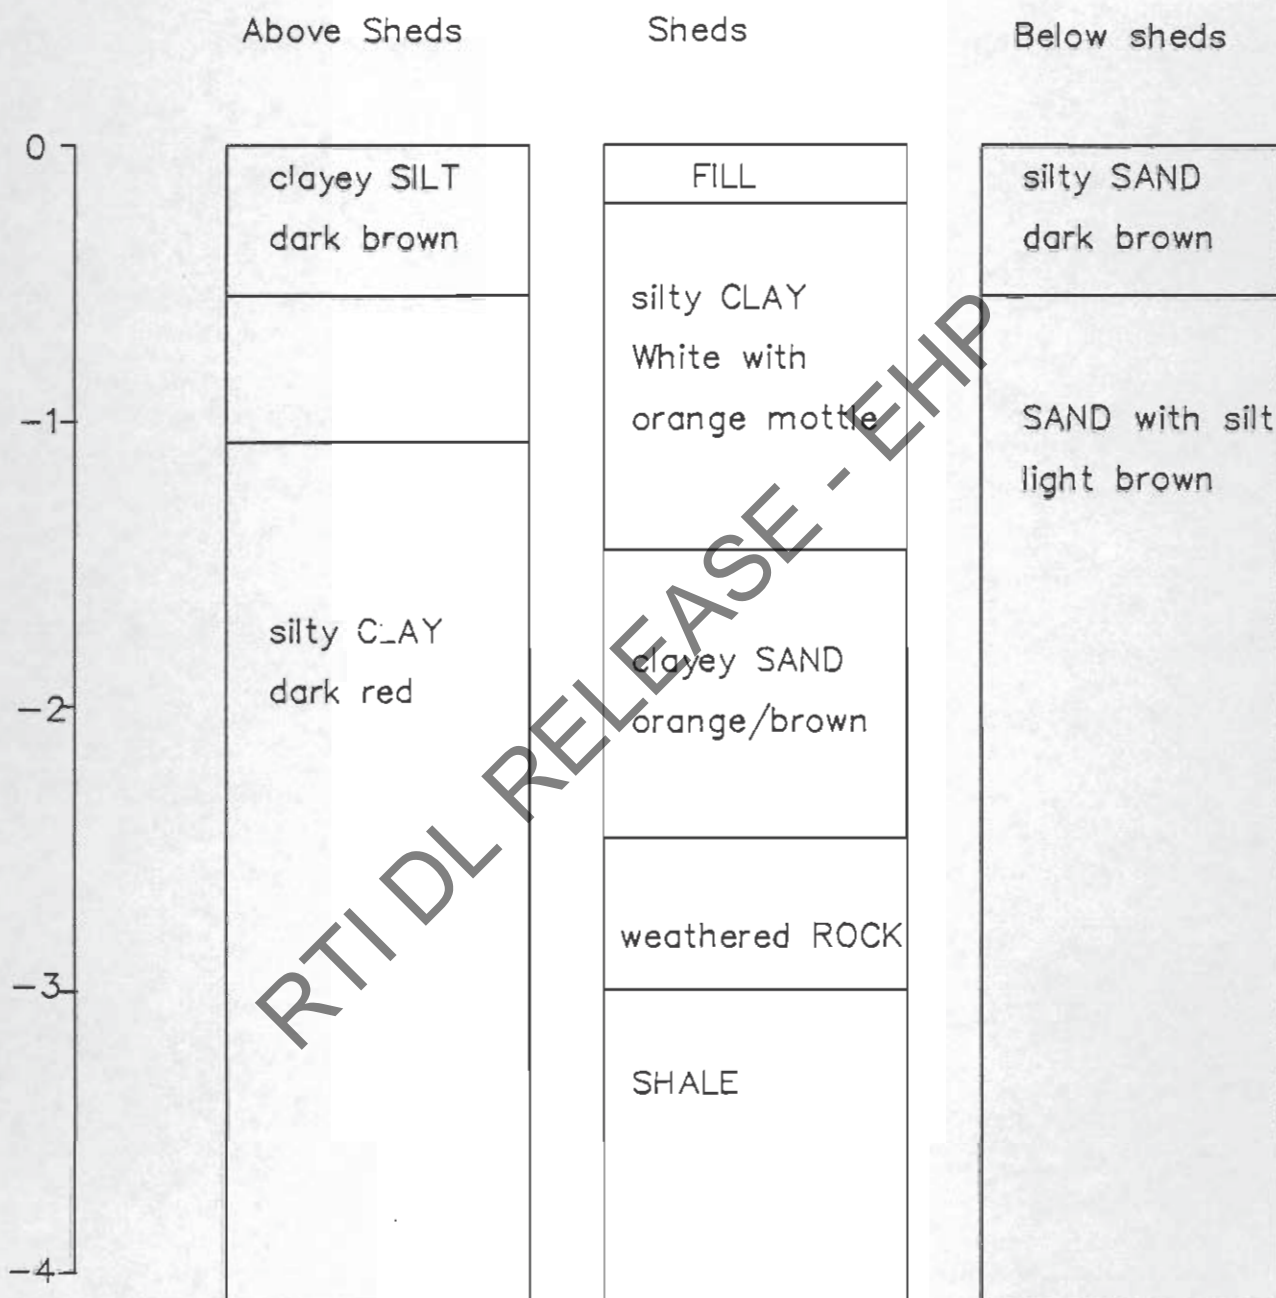
# Typical Subsurface Profiles for Section B

From the investigations, arsenic contamination was located over some 4 hectares. Samples taken over varying depths revealed that arsenic contamination tended to be confined to the top 100 mm to 200 mm of the soil profile. Areas where there was surface runoff tended to be contaminated to a greater depth indicating that the arsenic may have been deposited with eroded and deposited sediment. In these runoff areas it will be necessary to treat/remove the top 500 mm of soil.
