JOB NO. DE16/234    AUGUST, 2016  
QUEENSLAND DEPARTMENT OF NATURAL  
RESOURCES AND MINES  
PRELIMINARY ASSESSMENT  
OF SINKHOLES  
53 17 MILE ROCKS ROAD AND  
113 CLIVEDEN AVENUE  
OXLEY

Job No: DE16/234  
Ref No: 21154-rev 1  
Author: Russell Howchin

**RE: PRELIMINARY ASSESSMENT OF SINKHOLES, 53 17 MILE ROCKS ROAD AND 113 CLIVEDEN AVENUE, OXLEY**

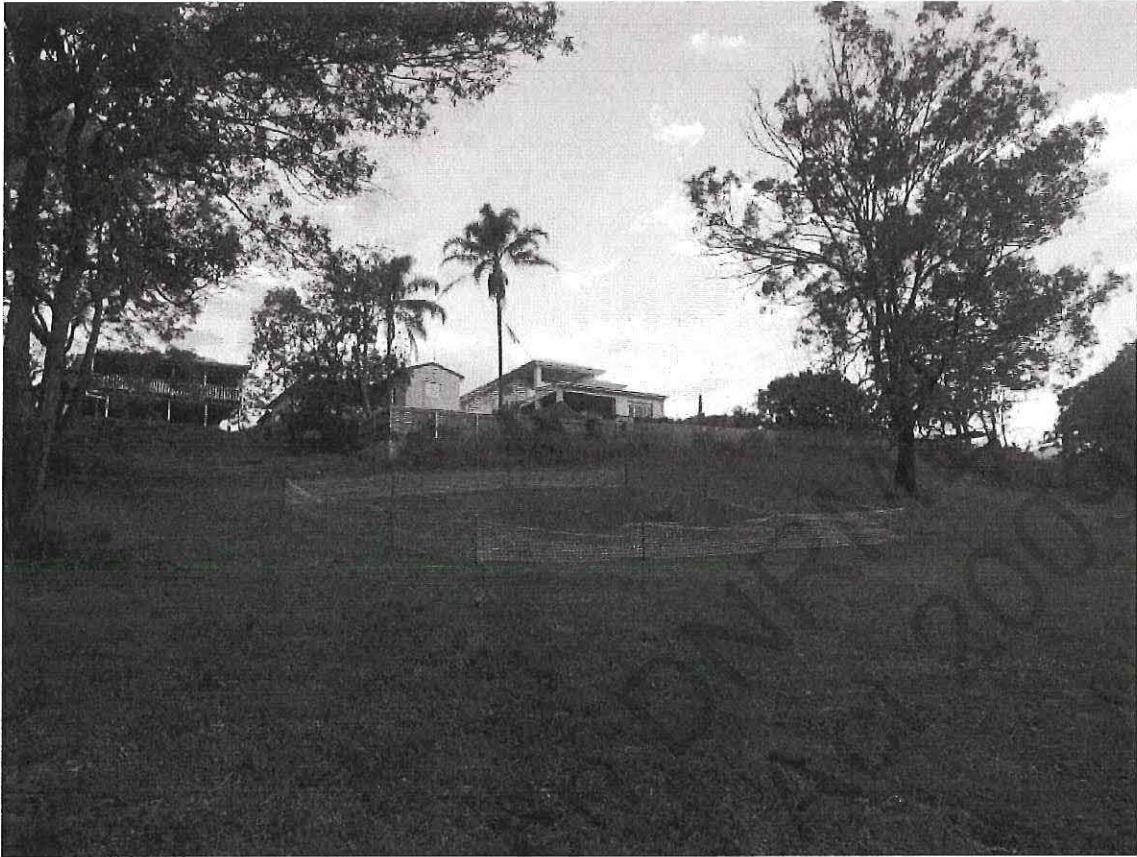
Four sinkholes between approximately 0.5m to 1m in diameter and between 500mm to 800mm in depth are present on a hillslope within a drainage line adjacent to the boundary of No 38 Blackheath Street and 53 17 Mile Rocks Road. These sinkholes have appeared "in the last month or two" according to anecdotal information from nearby residents. Another smaller sinkhole approximately 0.5m in diameter and 300mm to 400mm deep is located downslope of Nos 12 to 14 Blackheath Street. Site photos are attached as Appendix A.

**Site Photo 1 – Looking Upslope to Sinkhole Area inside Orange Safety Barrier**

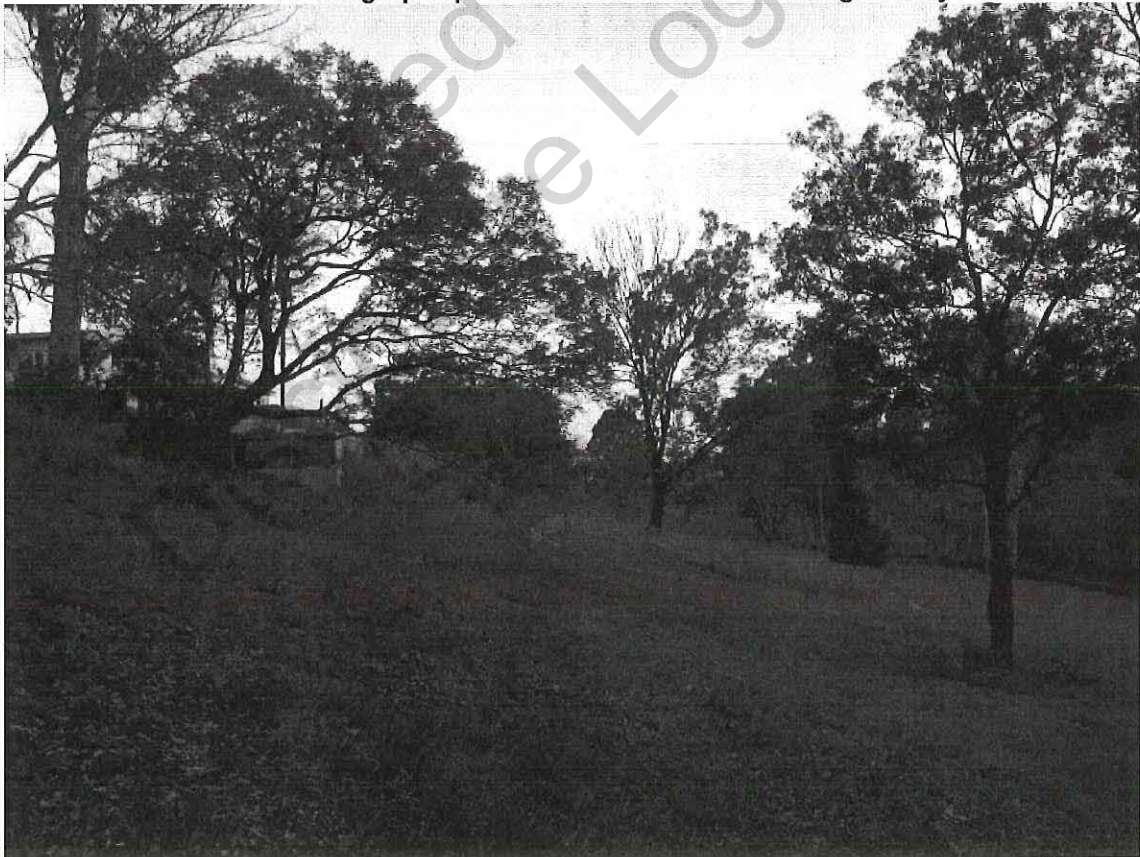
**Site Photo 2 – Looking Across Slope to Sinkhole Area inside Orange Safety Barrier**

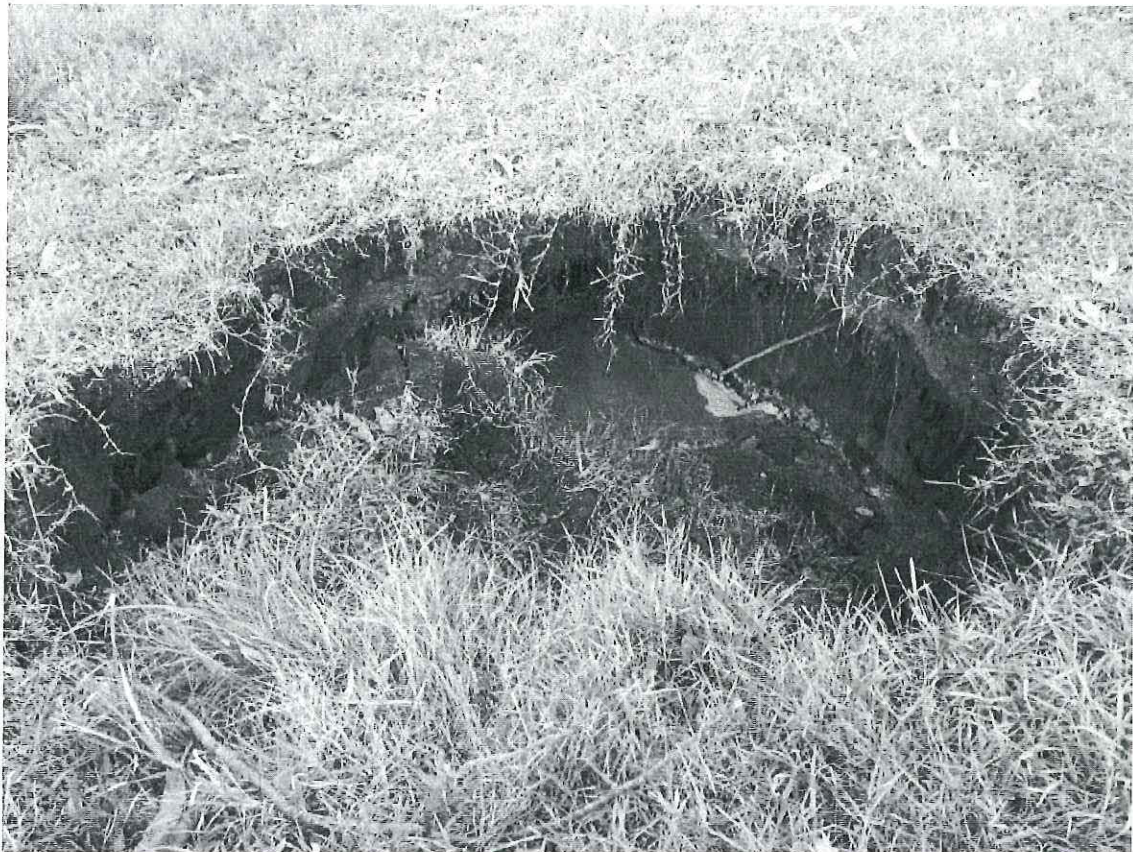
The sinkholes have most likely been initiated by the accumulation of groundwater along the basalt/siltstone interface, the subsequent erosion of the soft siltstone creating voids beneath the basalt cap, and the collapse of the basalt and surface soils into the voids. Further rainfall can exacerbate and increase the size of the sinkhole areas.

**Site Photo 3 – Close Up of One of the Sinkholes**

Removal of the soil and rock in the sinkhole area, and reinstatement using the in-situ materials is recommended. The basalt must be broken down so that the rock structure is destroyed and the material has soil like properties upon replacement. The subsurface materials must be removed so as to expose the siltstone rock layer (where not too deep beneath the ground surface), thoroughly blended and reinstated in small, "hit and miss" sections along the hillslope, to reduce the potential for further instability and activation of landslips which may affect the upslope and downslope properties. It is noted that the height of any future landslide escarpments would not necessarily be limited to the thickness of the basalt cap over the siltstone, and would typically include in addition at least the thickness of siltstone below which is washed away by groundwater flows. It is noted that the lower portions of the hillslope and the area surrounding the Child Care Centre may also be adversely affected by floodwaters, as these areas were covered by floodwater during the Brisbane 2011 flood event.

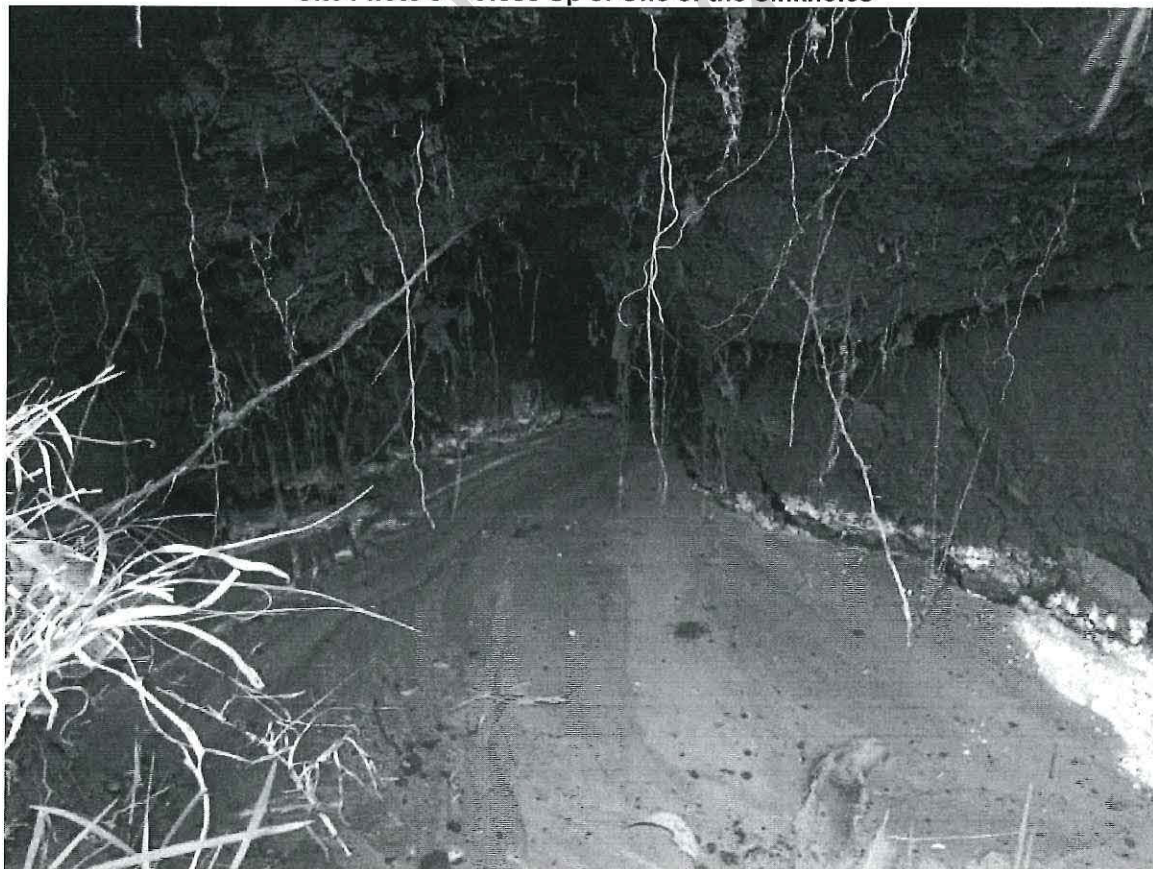
However, sandy silt debris material was observed at the base of the slope adjacent to the sinkhole area. This indicates the possible presence of groundwater springs originating between the basalt and underlying siltstone, and associated erosion and "washout" of the soft siltstone rock.

**Site Photo 4 – Inside One of the Sinkholes (“Sandy Silt” Sediment at Base of Void)**

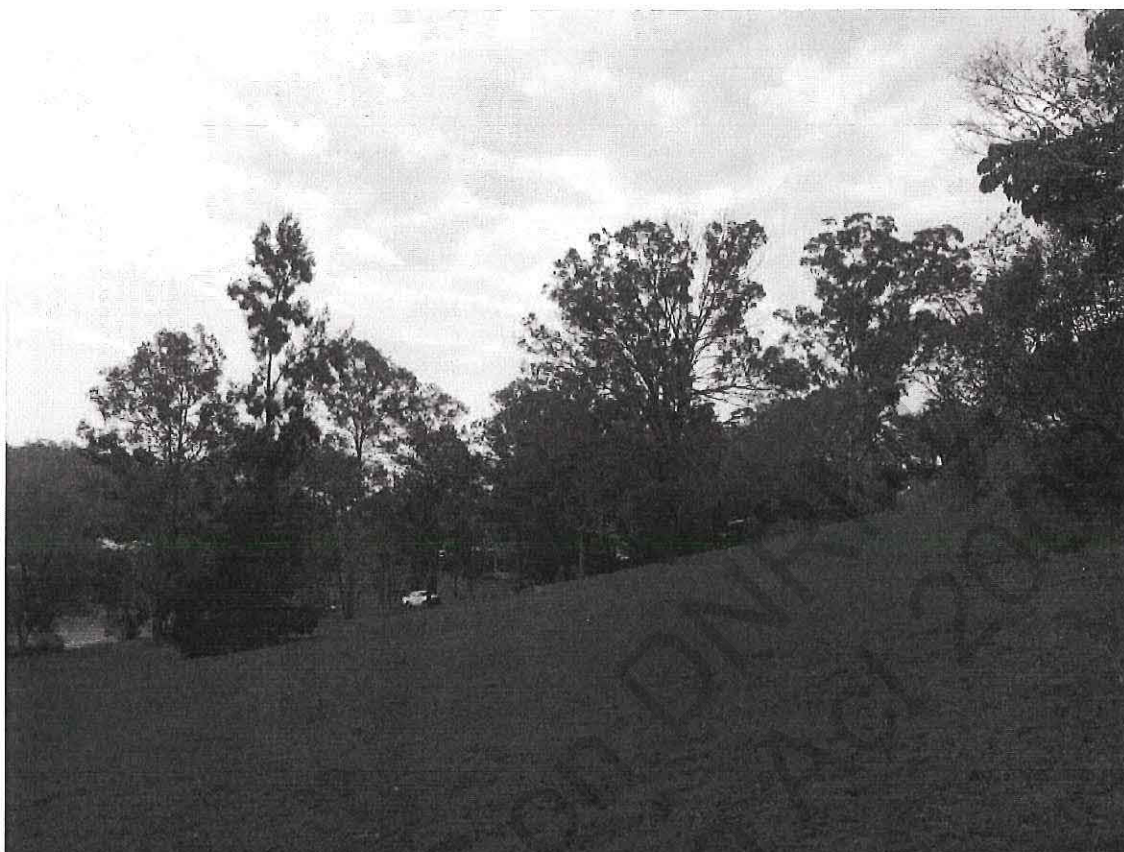
**Site Photo 5 – Looking North Over Hillslope (Sinkholes Inside Orange Barrier in Background)**

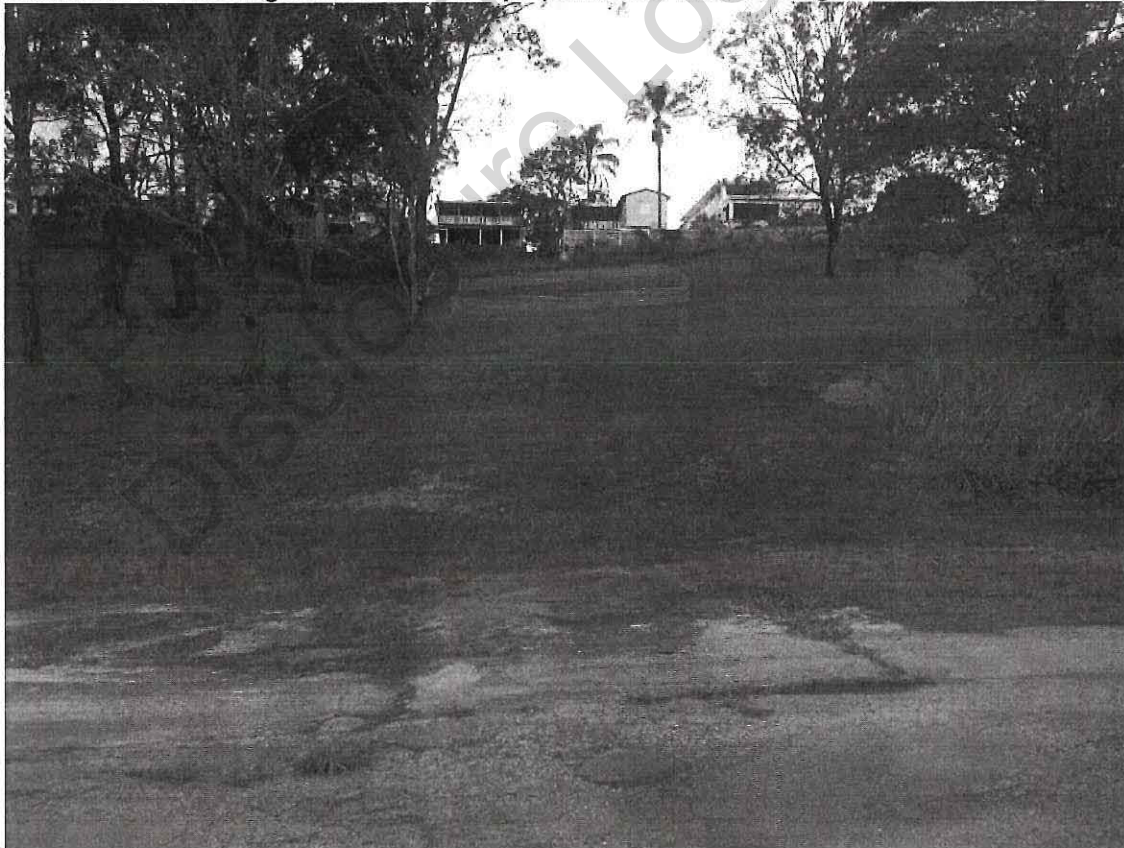
Sand and silt materials were observed as debris in scattered areas over the hillslope. The accumulation of the debris materials in these areas is also possibly related to sedimentary rock washouts beneath the ground surface. It is noted that the greatest accumulation of sand and silt materials was observed at the base of the slope directly beneath the sinkhole area.

**Site Photo 6 – Looking Upslope towards Sinkhole Area – Note Sandy Silt At Base of Hillslope**

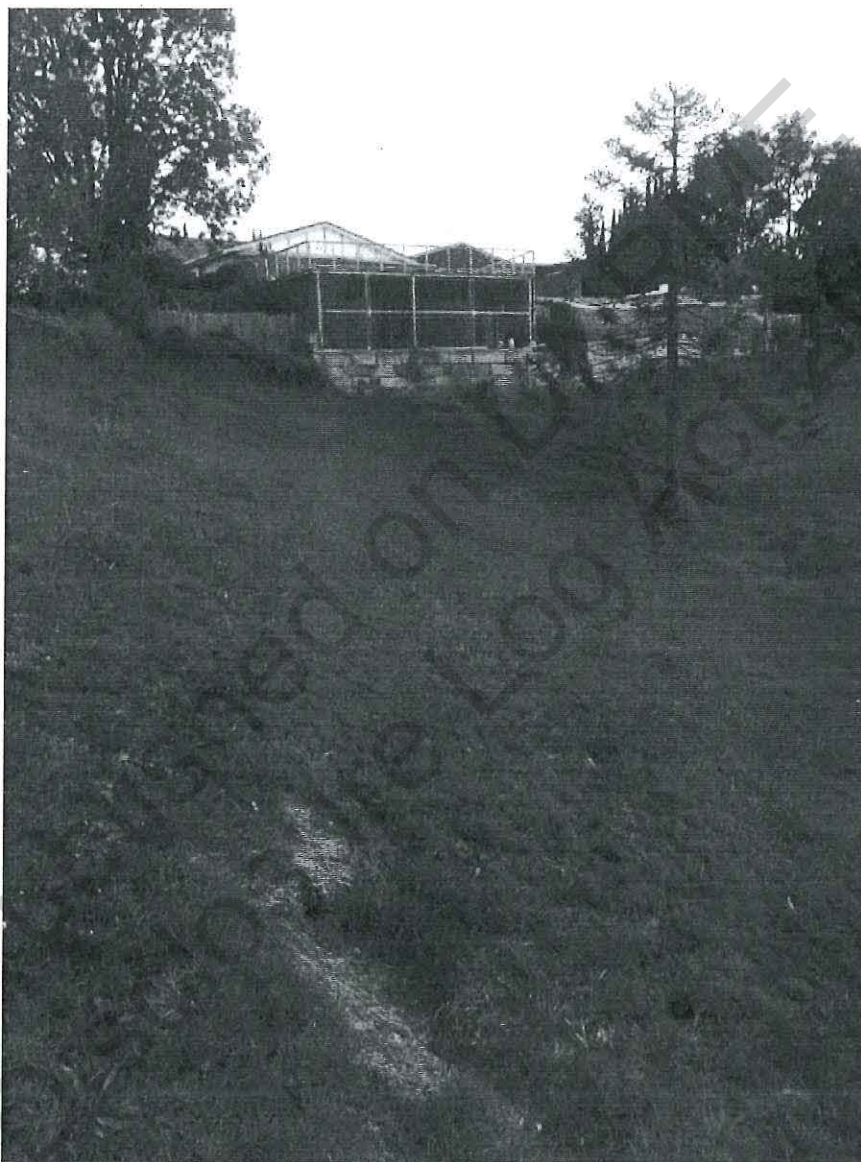
**Site Photo 7 – Looking South Over Hillslope (Sinkhole Adjacent Nos 12-14 Blackheath Street)**
