## SONOMA MINE MANAGEMENT PTY LTD

### Two Mile Creek Diversion Operations Monitoring 2019

Sonoma Coal Mine

June 2019

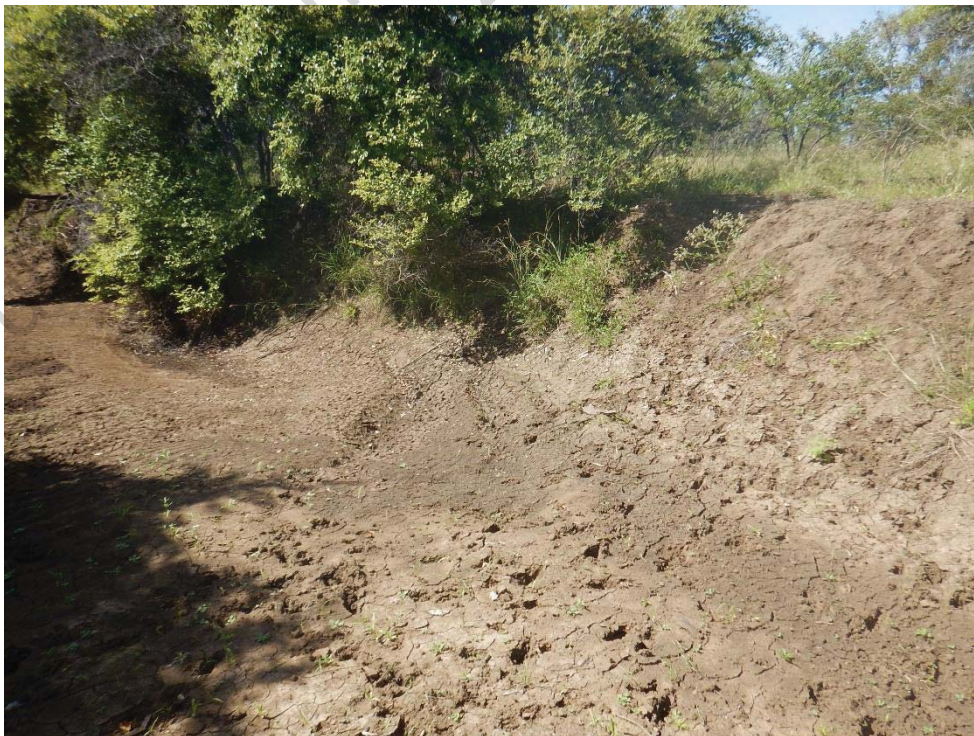
Figure 6.1 Bank Erosion and Undercutting Downstream Of TMC-US1

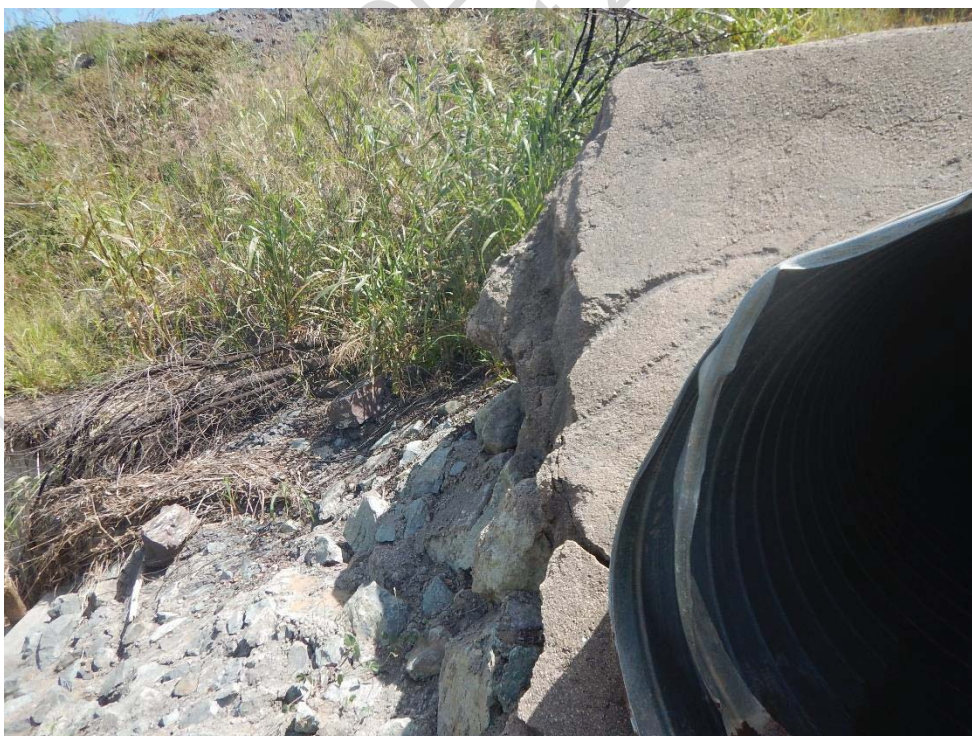
Figure 6.10 Damaged Headwall of High Level Culverts at Upstream Side of Haul Road

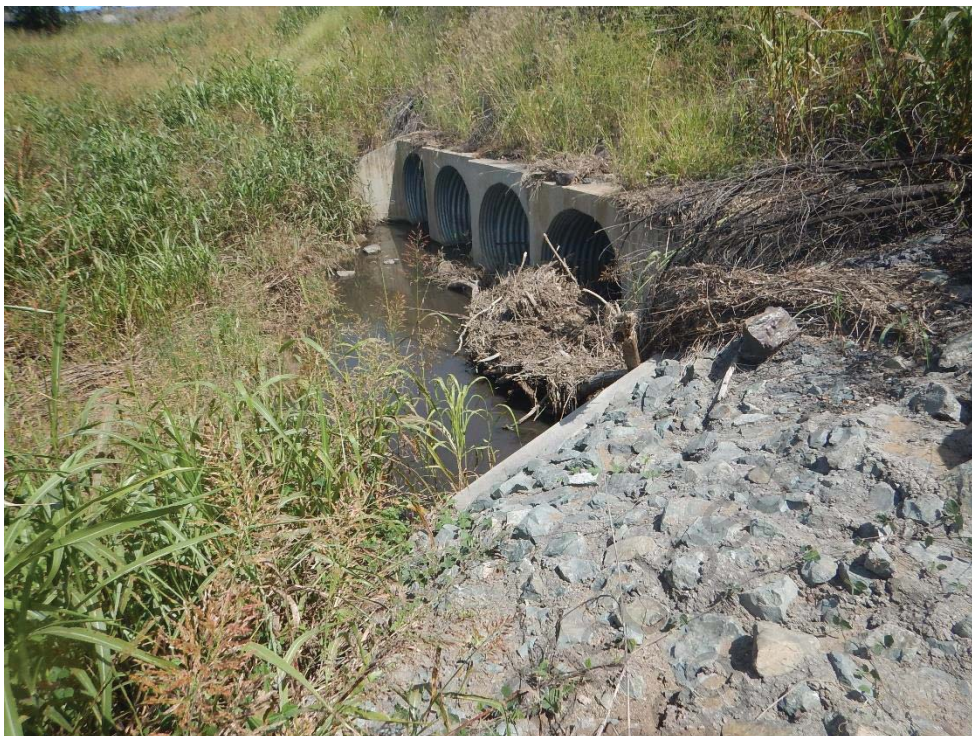
Figure 6.11 Low Flow Culverts at Upstream Side of Haul Road

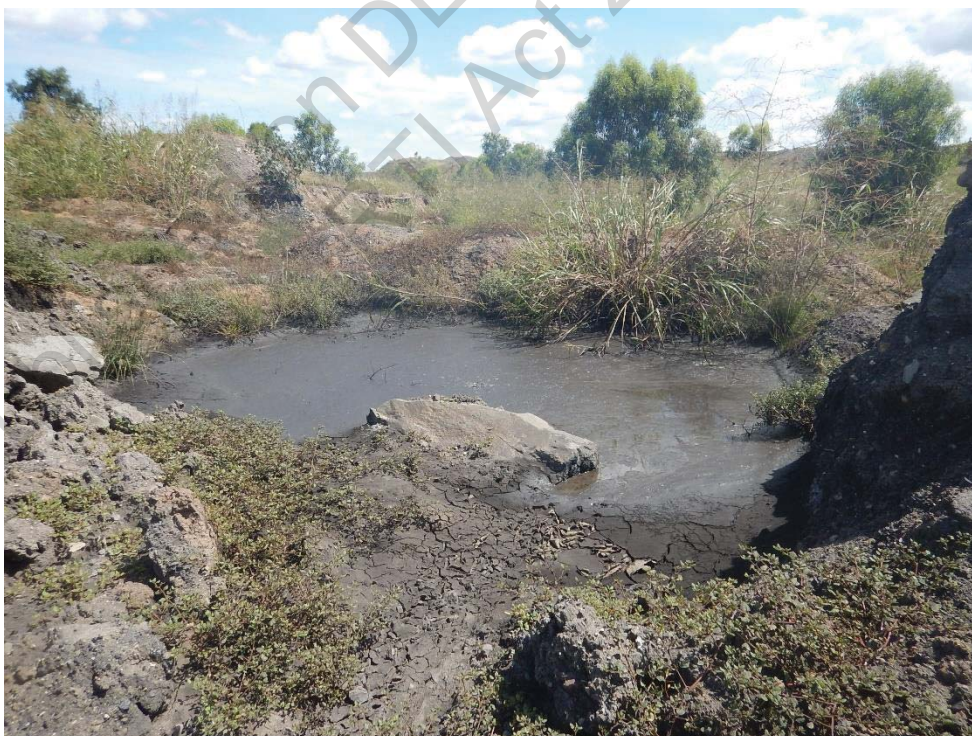
Figure 6.12 Scour Hole Downstream of Haul Road Causeway

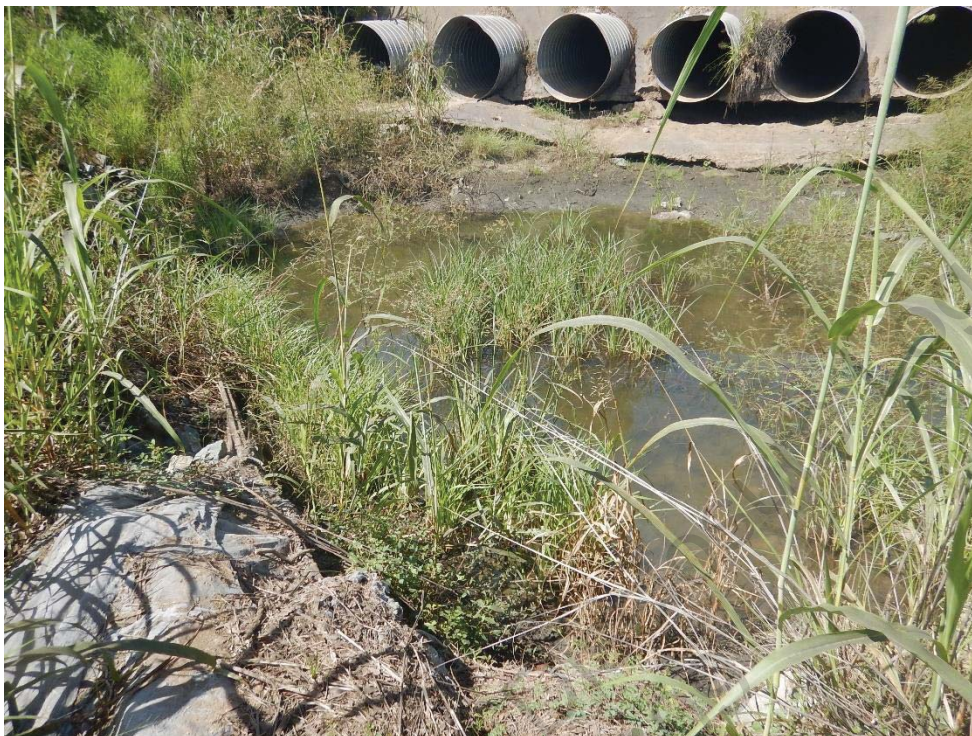
Figure 6.13 Scour Hole and Damaged Apron at Downstream Headwall of High Level Haul Road Culverts

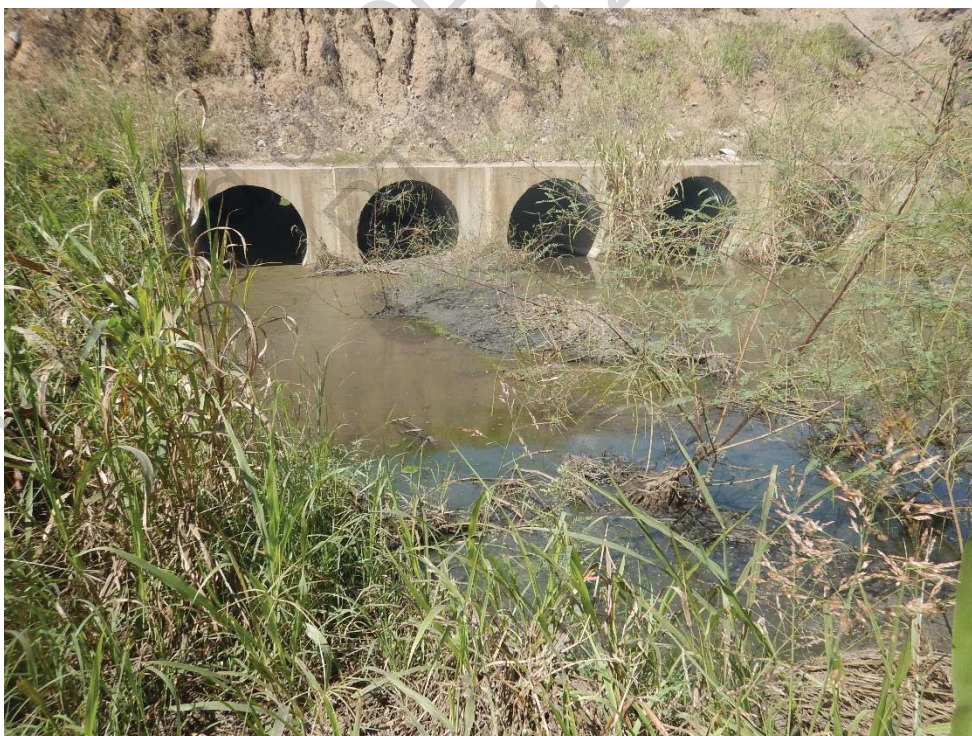
Figure 6.14 Downstream Headwall of Low Level Haul Road Culverts

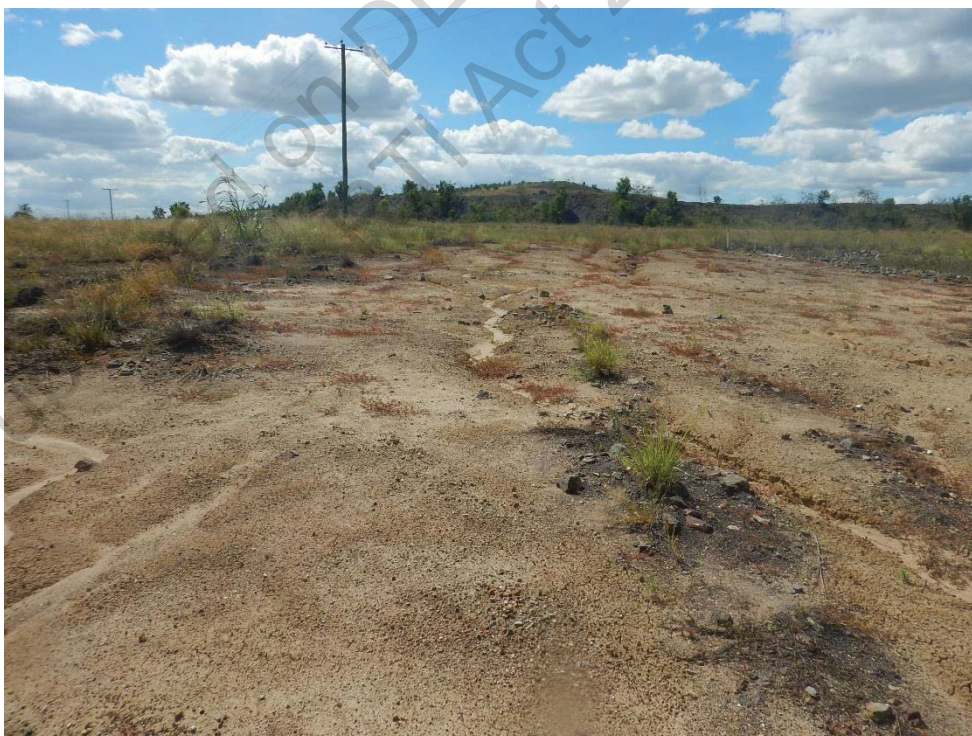
Figure 6.22 View to North-West Across Light Vehicle Road Causeway Crossing

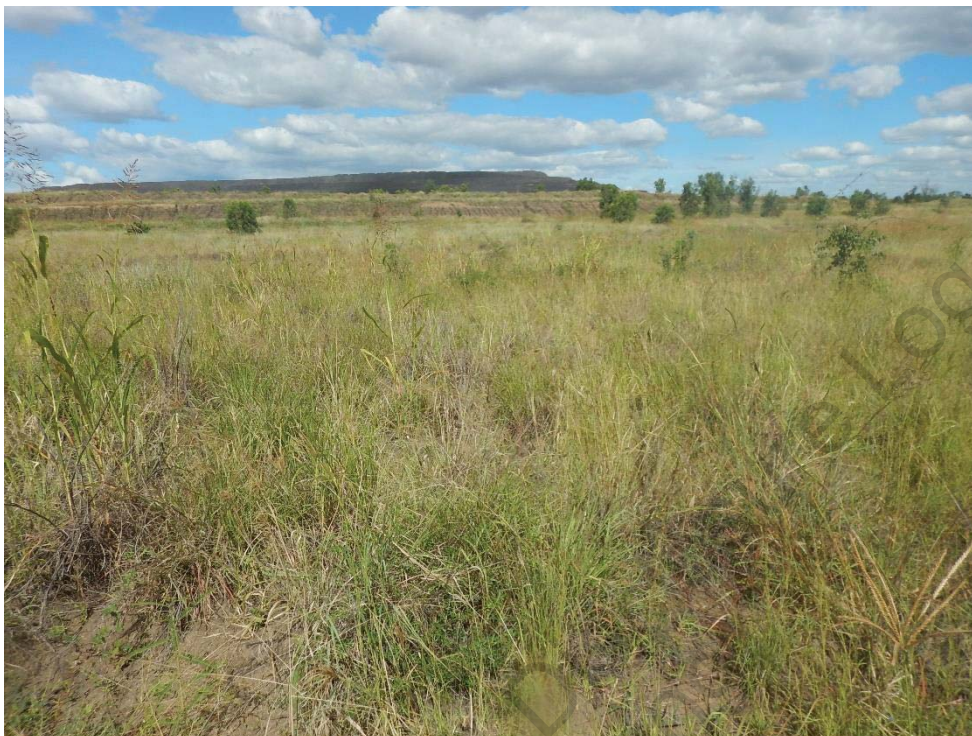
Figure 6.23 Vegetation Establishment on Right Bank Downstream Of TMC-Div3

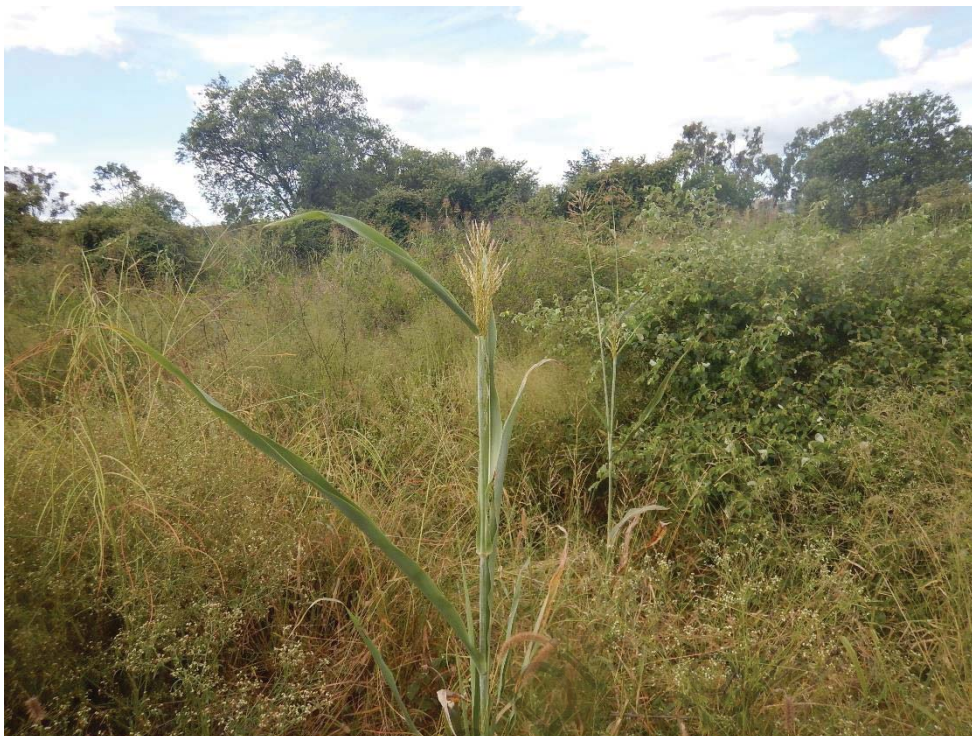
Figure 6.26 Dense Ground Cover At TMC-DS1

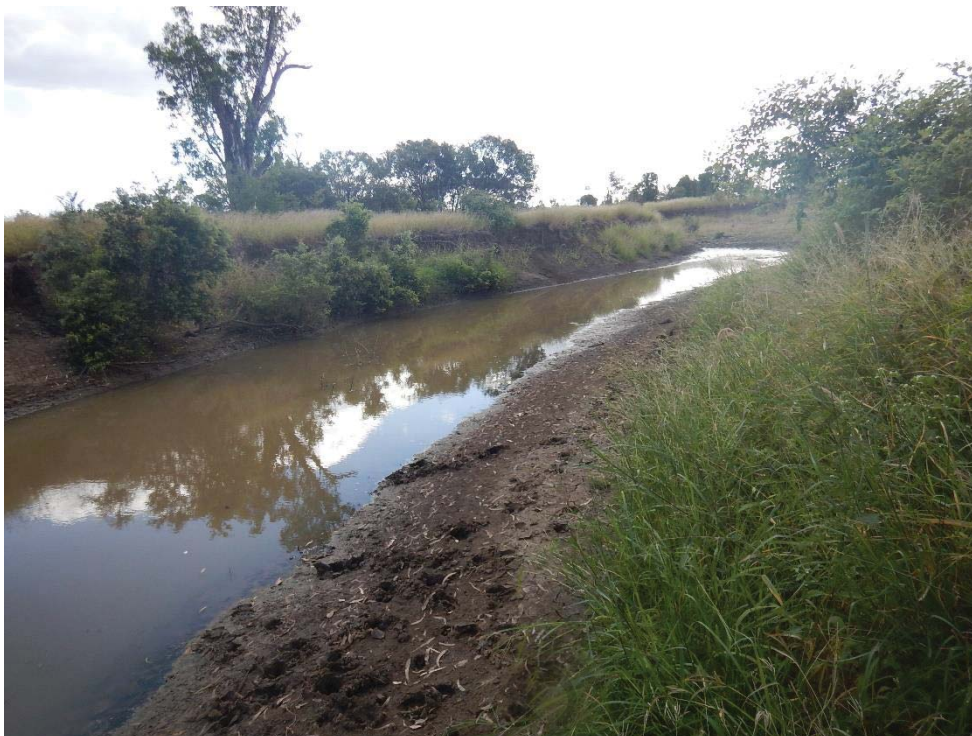
Figure 6.30 Ponding and Bank Steepening At TMC-DS4

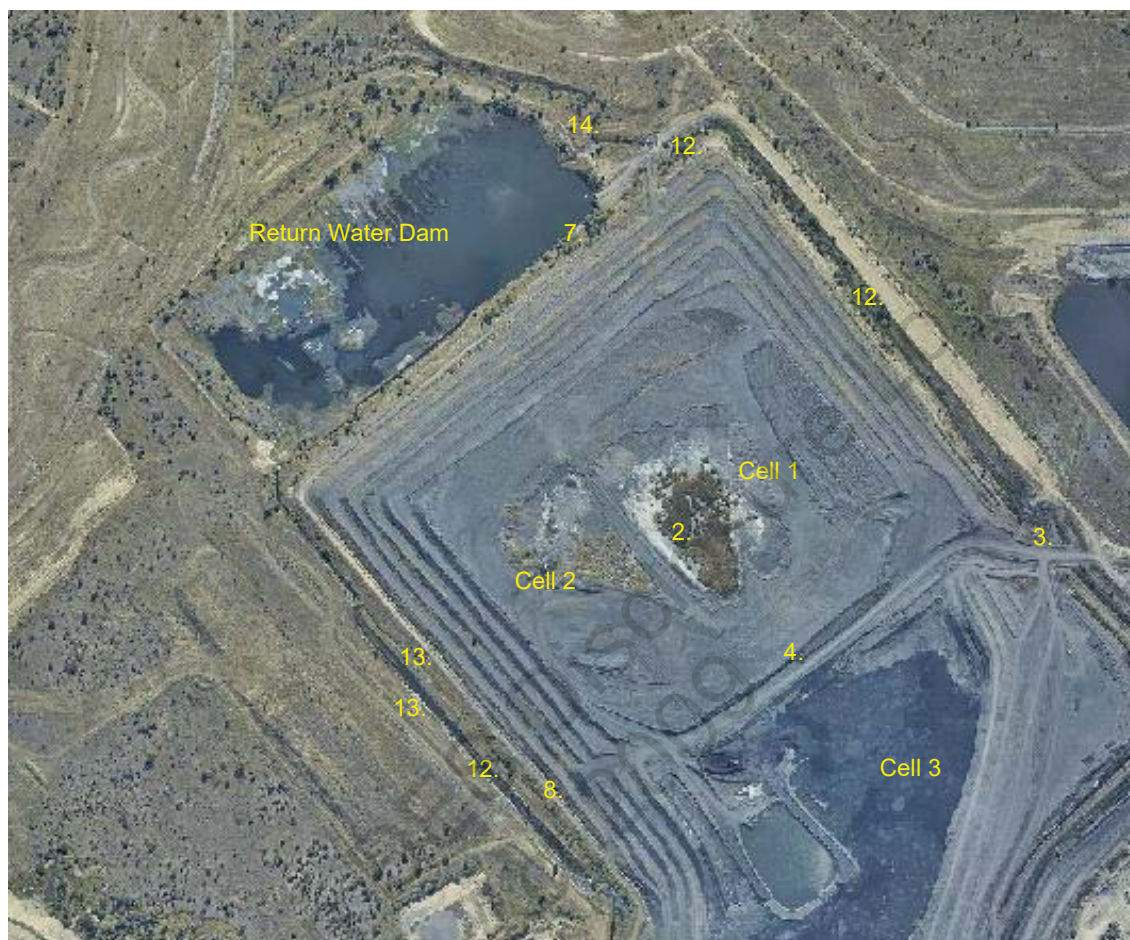
Figure 2.2 Location of Observations for CDA1/2

14. The rock entry chute into the Return Water Dam at the downstream end of the eastern solution trench experienced some damage (movement of rock and erosion of channel banks) during the Cyclone Debbie rainfall event in late March 2017 but is still functional.

15. There are currently no piezometers installed in the CDA 1/2 starter walls or coarse rejects external walls. Piezometers are typically installed to validate the design assumptions regarding water table (phreatic surface) levels and associated landform stability. The need for installation of piezometers in the CDA1/2 external walls should be re-assessed following a review of the original stability analyses given that CDA1/2 has reached the end of its operational life.

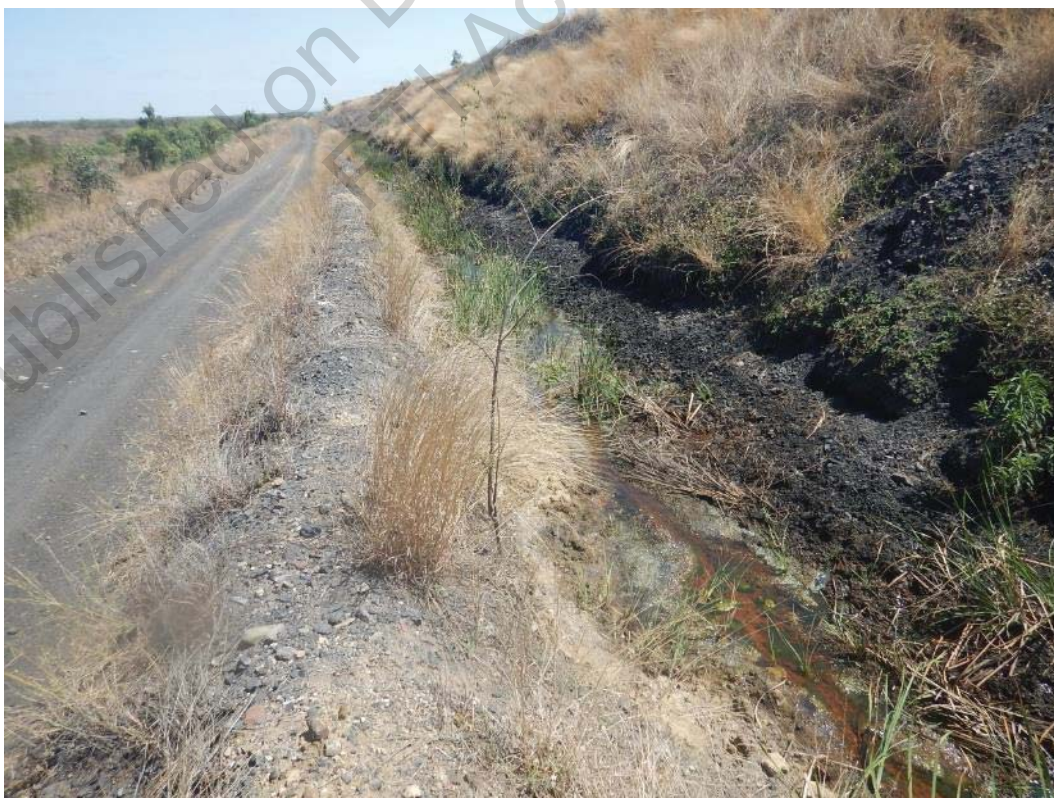
Photo 8 Western Wall of Cell 2 and Seepage Flows in Drain above Starter Bund (View to north)

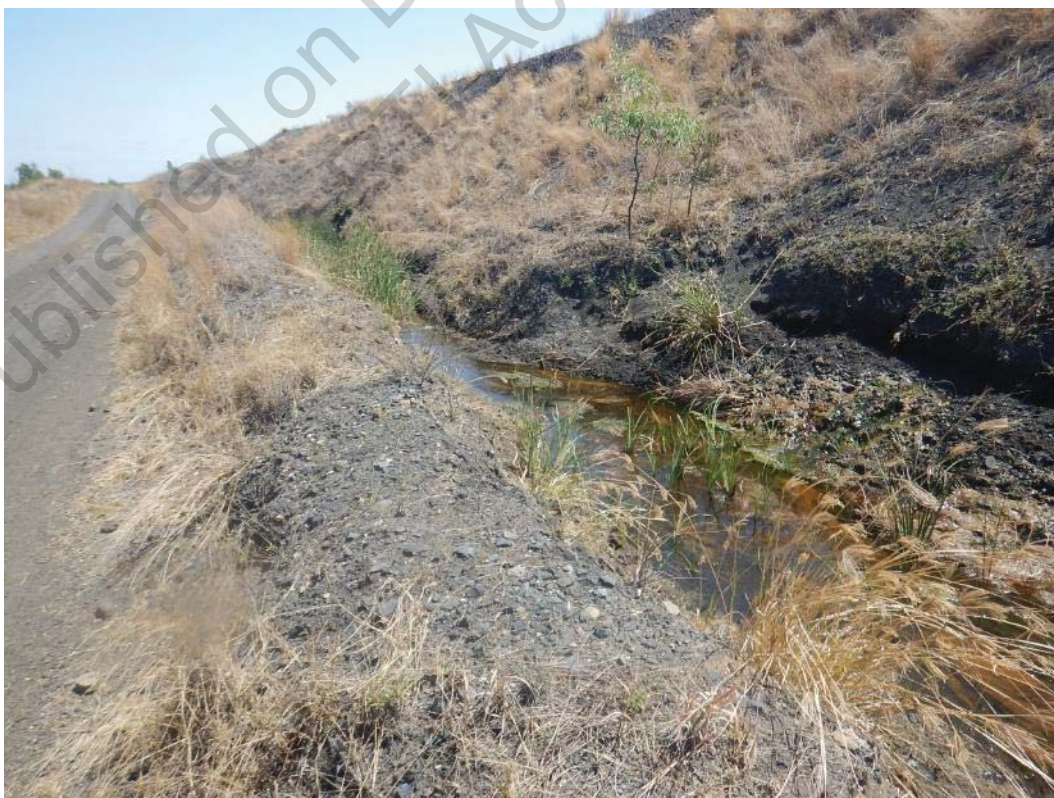
Photo 10 Seepage at toe of First Rejects Wall Lift above Starter Bund - Western Side of Cell 2 Near with Cell 3

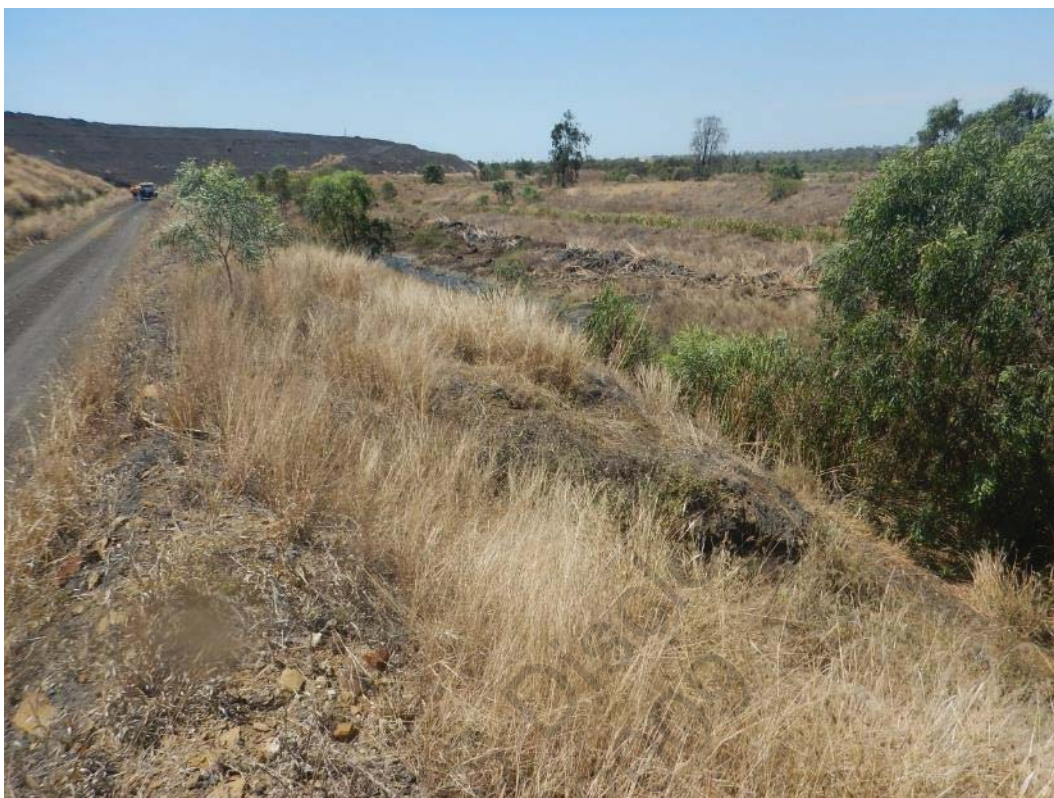
Photo 13 Trees On Starter Bund – Western Side of Cell 1

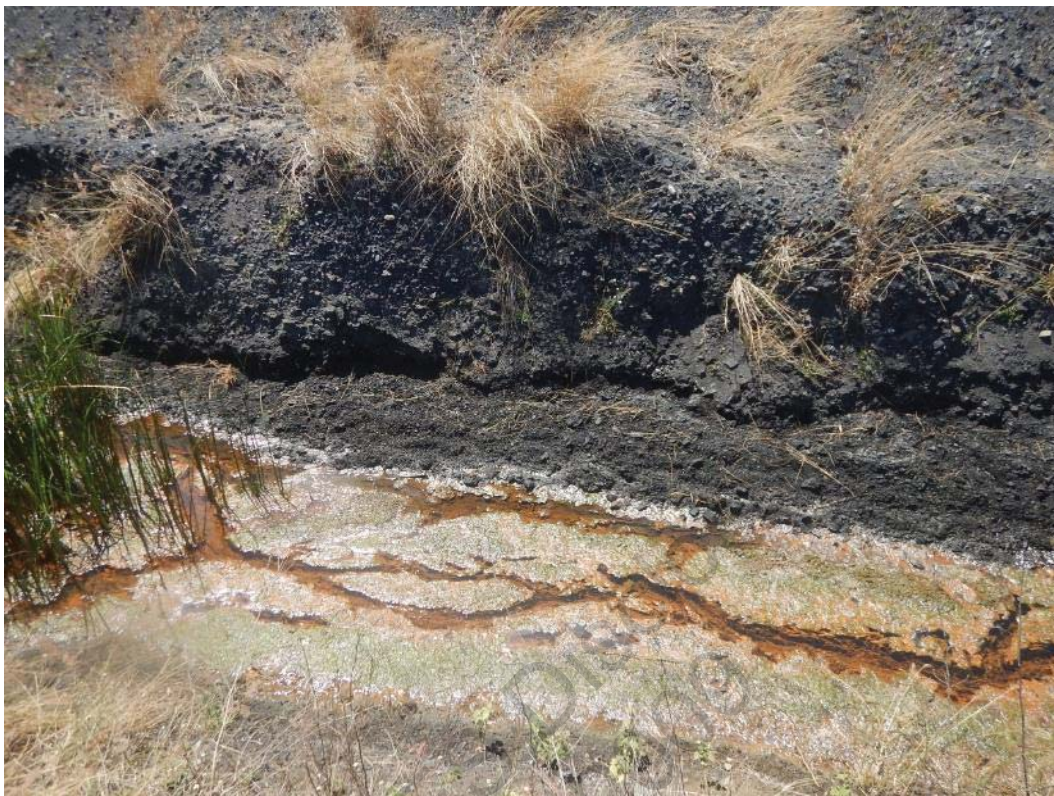
Photo 13 Seepage Expression Above Starter Bund – Western Side of Cell 3

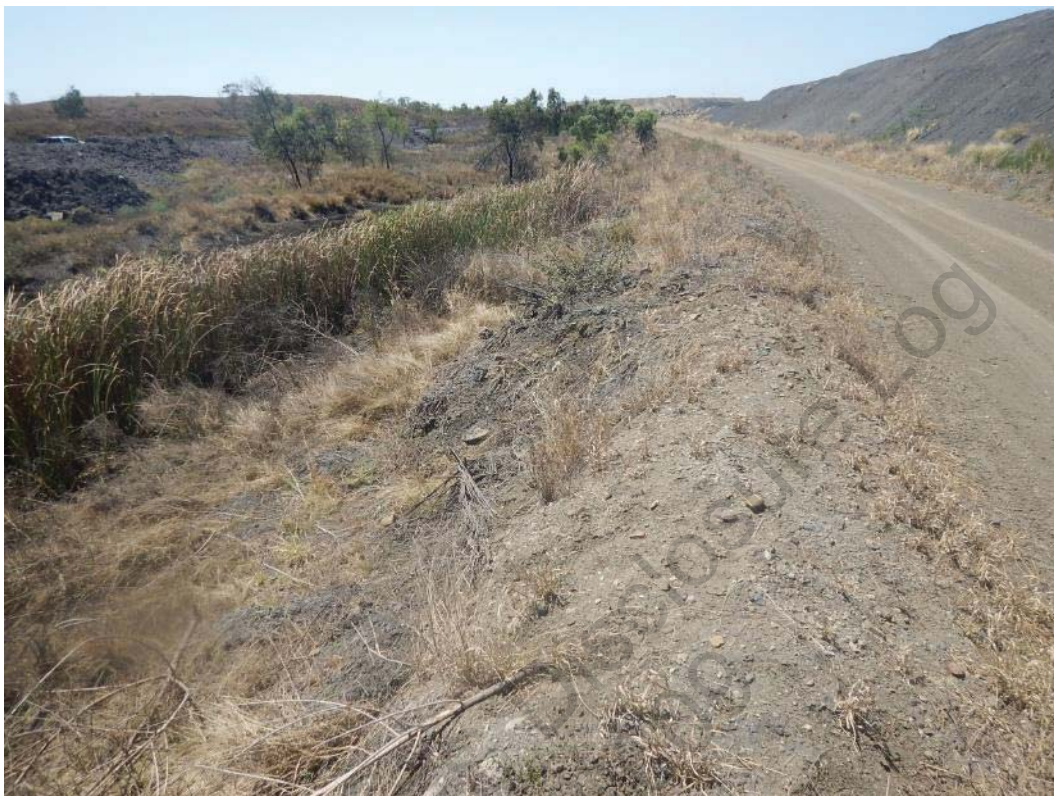
Photo 17 Trees Growing on Outside Face of Starter Bund - Eastern Side of Cell 4

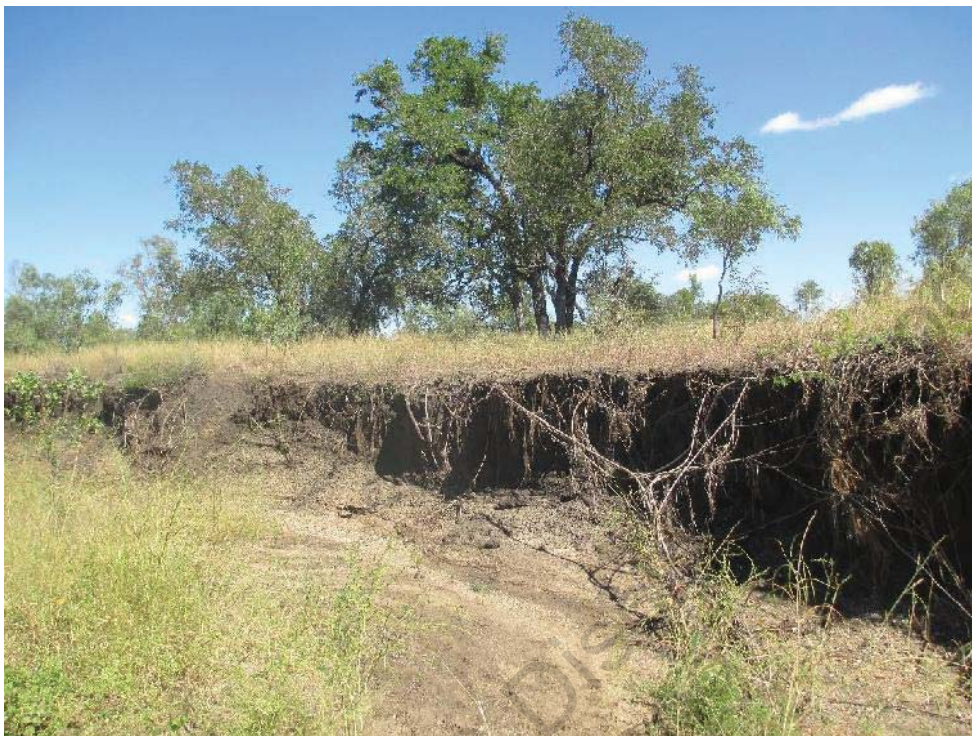
Figure 6.1 Bank Erosion And Undercutting Downstream Of TMC-US1

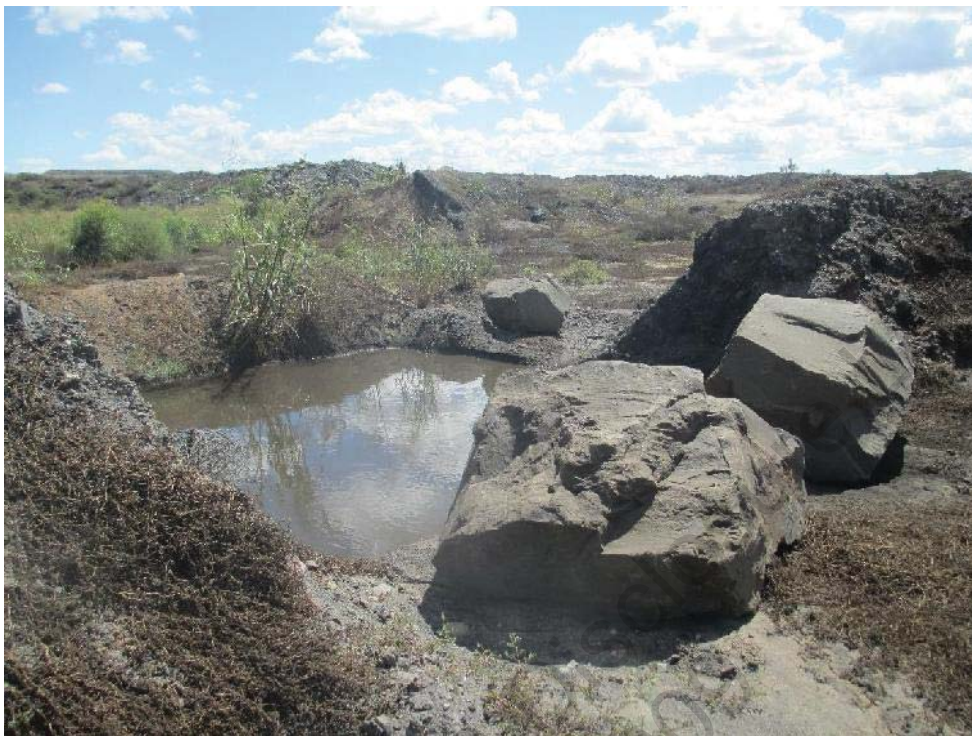
Figure 6.11 Scour Hole Downstream Of Haul Road Causeway

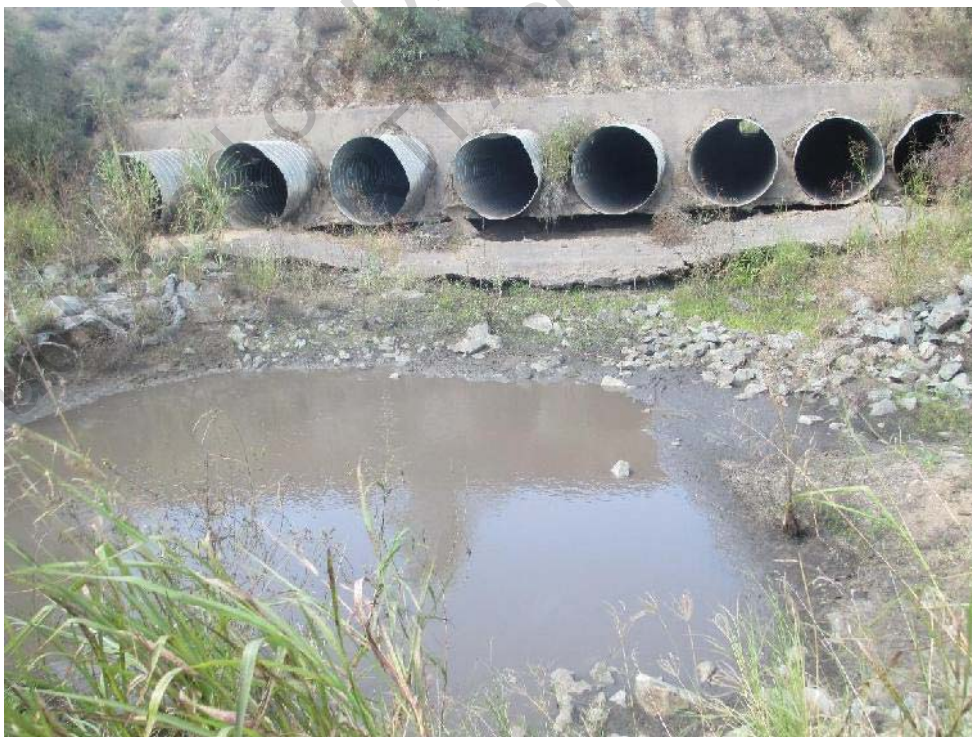
Figure 6.12 Scour Hole And Damaged Apron At Downstream Headwall Of High Level Haul Road Culverts

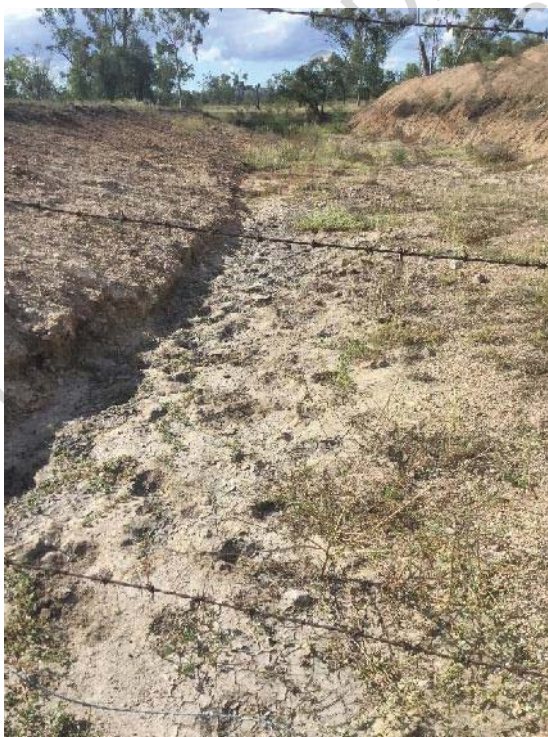
Figure 6.33 Erosion At Toe Of Left Bank Of Drain Downstream Of Drake 1 Pit And Drake 2 Pit
