Department of  
**Environment and  
Heritage Protection**

**Re: Compliance Inspection of ACI Operations Pty Ltd for ERA 44 Glass or glass fibre manufacturing**

I refer to the inspection of ACI Operations Pty Ltd at 137 Montague Road, South Brisbane on 19 February 2014, conducted by officers of the department.

## O-I Australia Ltd (ACI) Level C compliance inspection – Schedule B Air

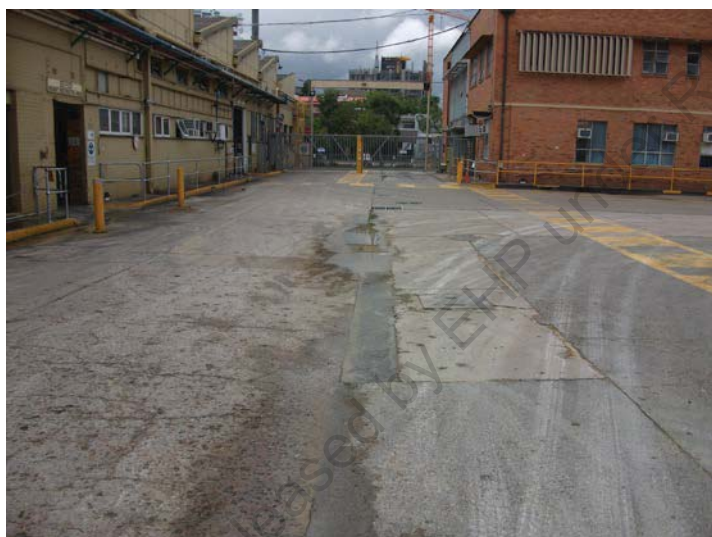
**Photo 2.** Stormwater drain with 'drain warden', photo captured looking at the entry driveway near Montague Road/Brereton Street.

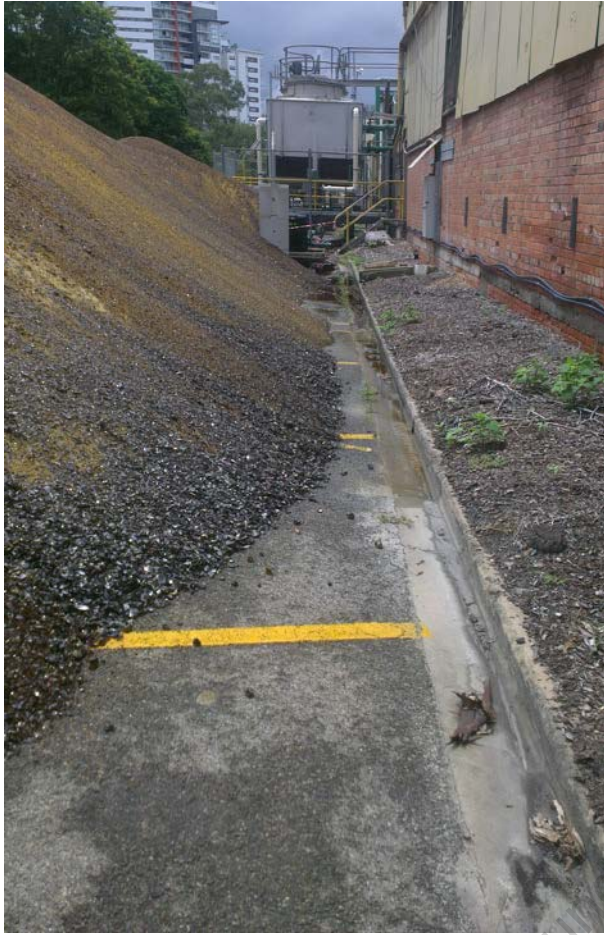
**Photo 3.** Surplus stockpile management of recycled glass.

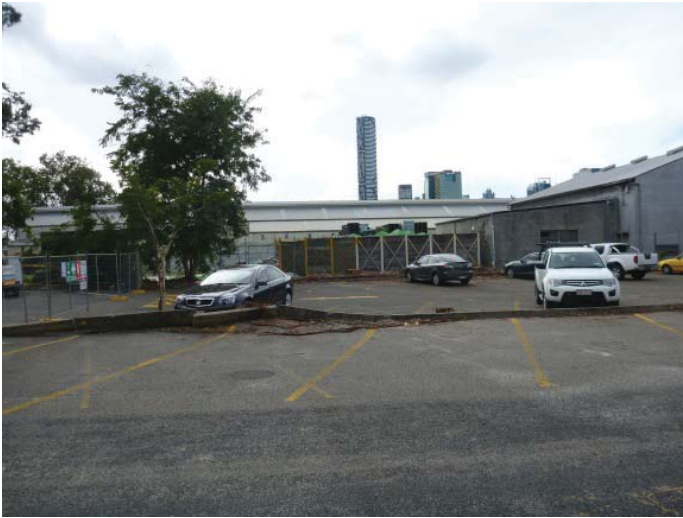
Photo 10 – Carpark where overflow glass material was stored during previous inspection

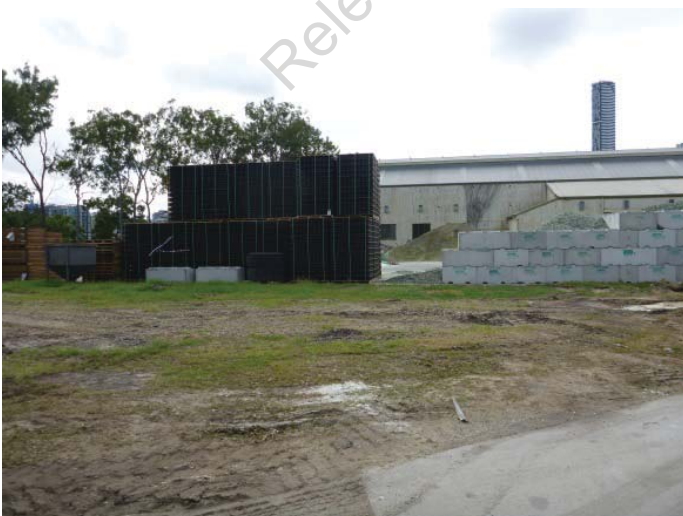
Photo 12 – Grass area that was covered with stockpiled glass shards during last inspection

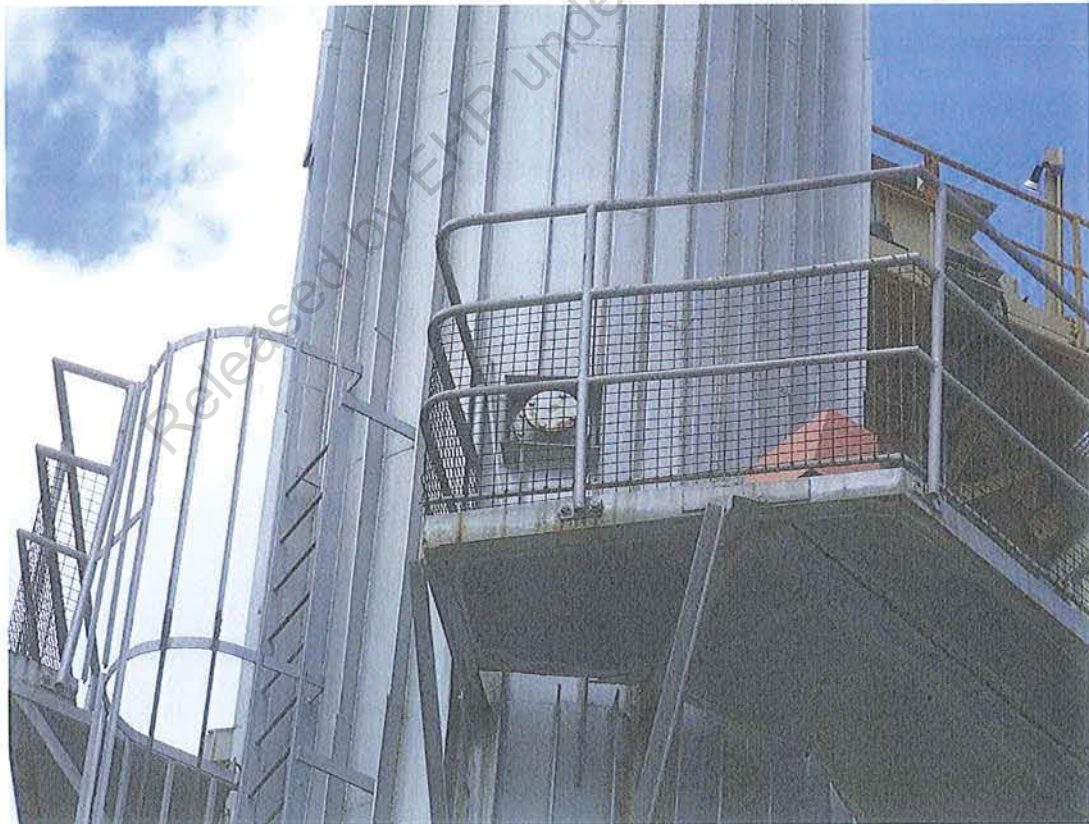
View of the RP1 sampling port and associated sampling platforms. Condition B11 requires that release points be conspicuously marked with the release point number referred to in Table 1 of the Air Schedule. Condition B12 requires that the labelling be readily visible from the ground and at the sampling point. RP1 did not comply with the labelling requirements of conditions B11 and B12.

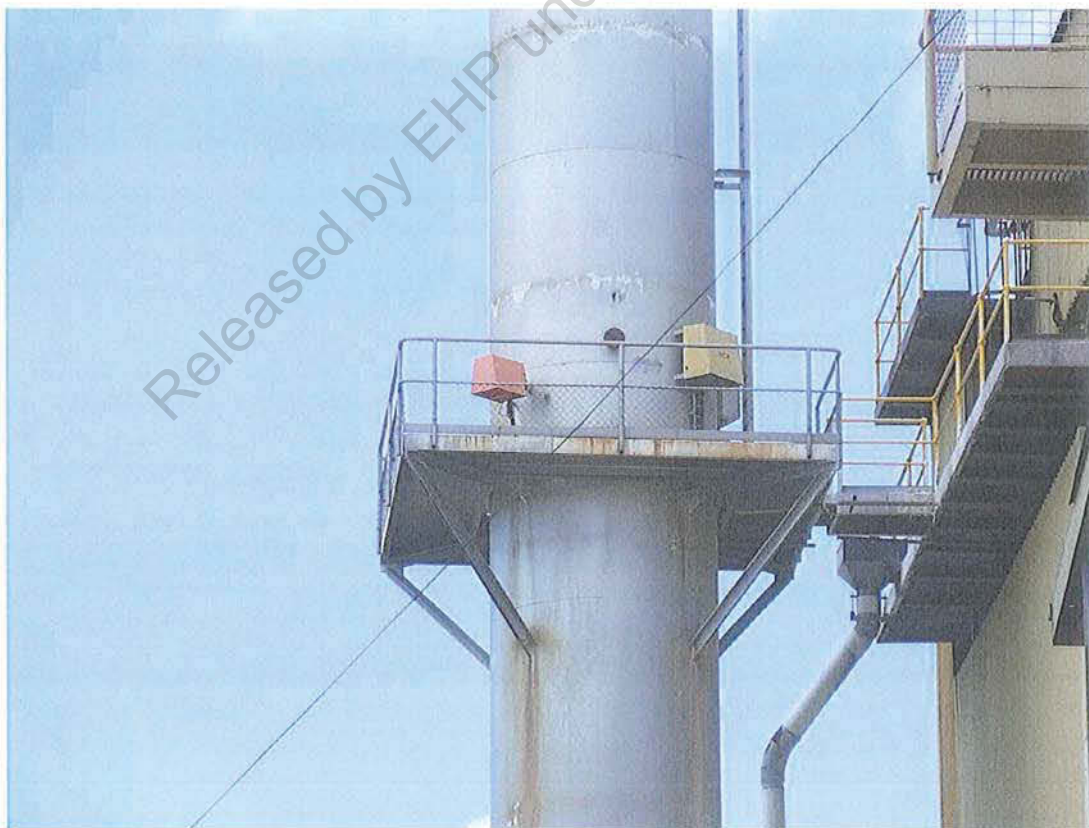
View of the RP2 sampling port and associated sampling platforms. Condition B11 requires that release points be conspicuously marked with the release point referred to in Table 1 of the Air Schedule. Condition B12 requires that the labelling be readily visible from the ground and at the sampling point. RP2 did not comply with the labelling requirements of conditions B11 and B12.

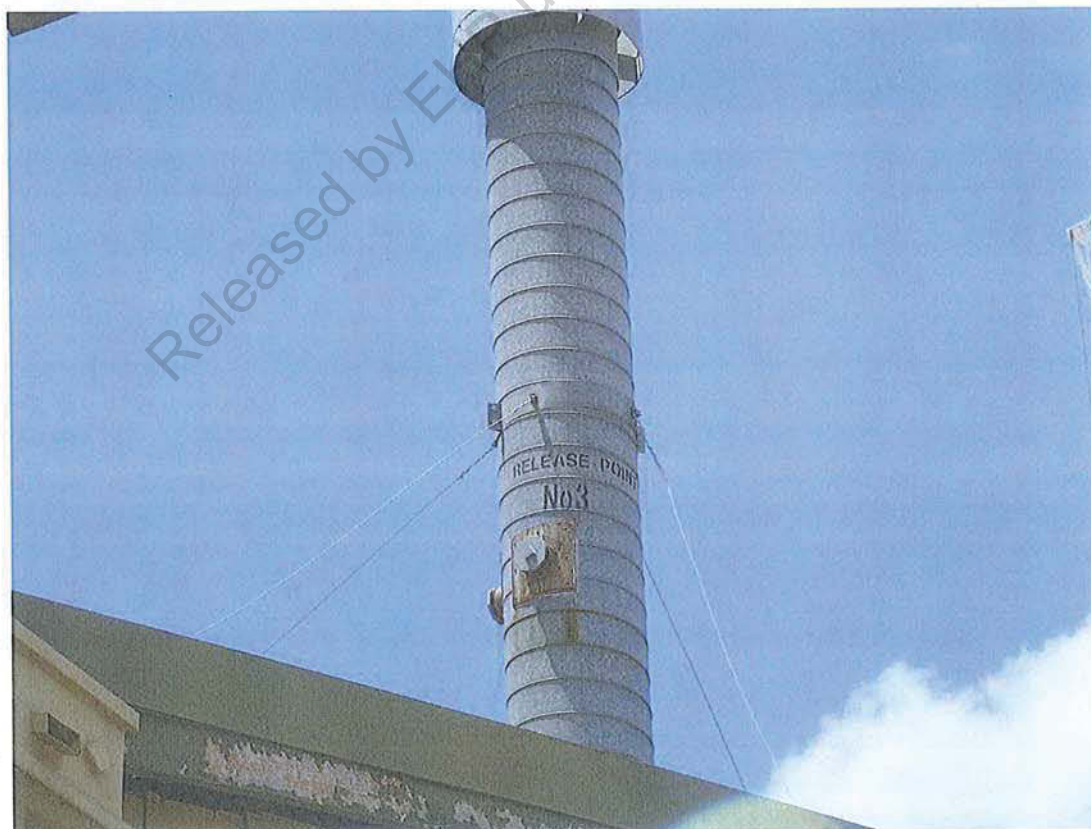
View of the RP3 sampling port. RP3 complied with conditions B11 and B12 as it was conspicuously labelled, and the labelling was clearly visible from ground level and at the sampling point. Direct access to the sampling ports looked to be via the roof. This situation should be checked for compliance with the requirements of *Australian Standard AS 4323.1-1995 Stationary source emissions- Selection of sampling positions*.

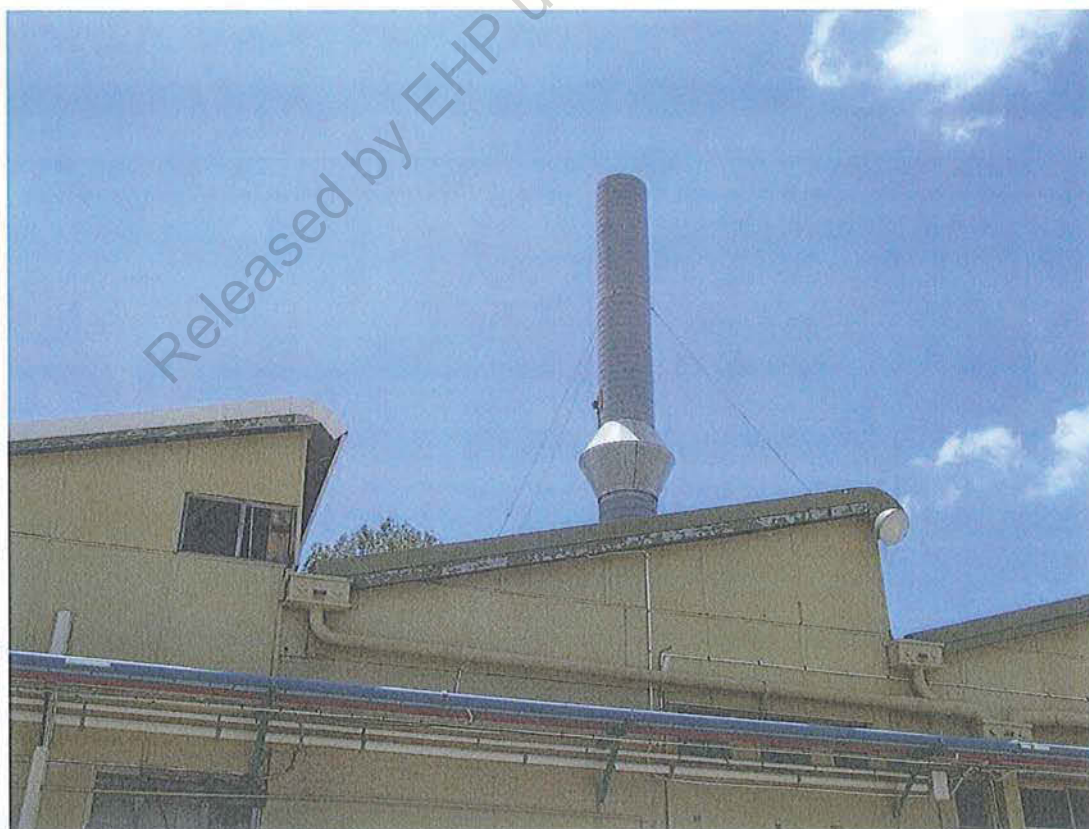
View of the RP4 sampling port. RP4 was not compliant with the labelling requirements of requirements of conditions B11 and B12. Direct access to the sampling ports looked to be via the roof. This situation should be checked for compliance with the requirements of *Australian Standard AS 4323.1-1995 Stationary source emissions- Selection of sampling positions*.

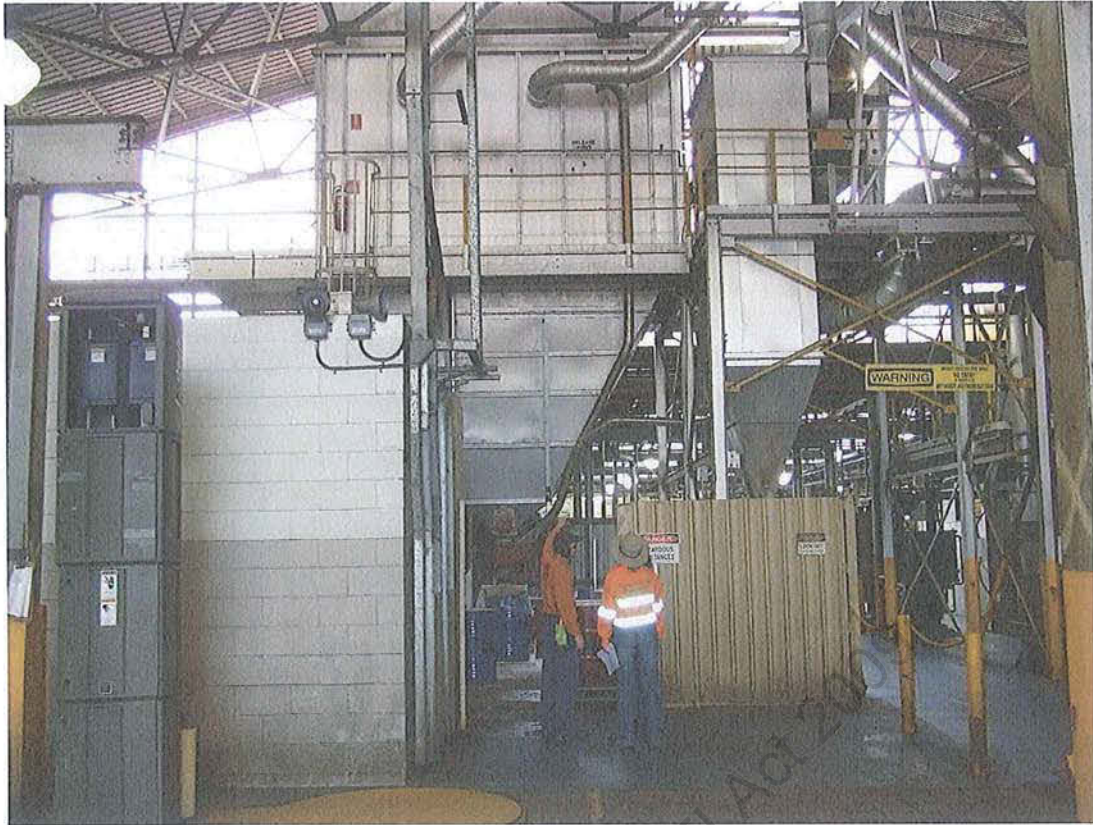
View of the stannic chloride fabric filter dust collector (baghouse). Condition B16 requires that the collector is operated at an efficiency of no less than 99.7 percent for stannic chloride and ammonia chloride particulate matter. O-I was not able to describe how the collection efficiency for the collector was determined or maintained.

**Recommended action 3:** that O-I determines how the stannic chloride fabric filter dust collector removal efficiency required by condition B16 is determined and maintained.

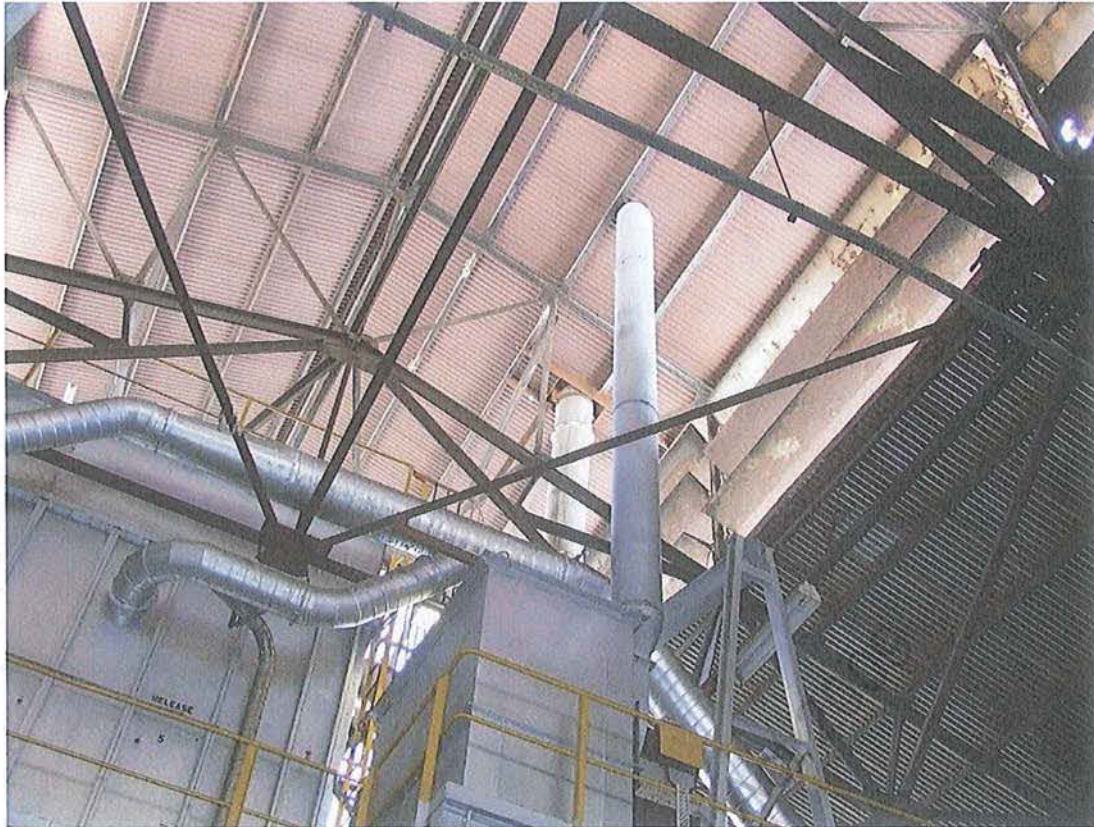
View of Release Point 5 – stannic chloride fabric filter dust collector (baghouse). RP5 was not compliant with the labelling requirements of conditions B11 and B12. Direct access to the sampling ports looked to be via the roof. This situation should be checked for compliance with the requirements of *Australian Standard AS 4323.1-1995 Stationary source emissions- Selection of sampling positions*.

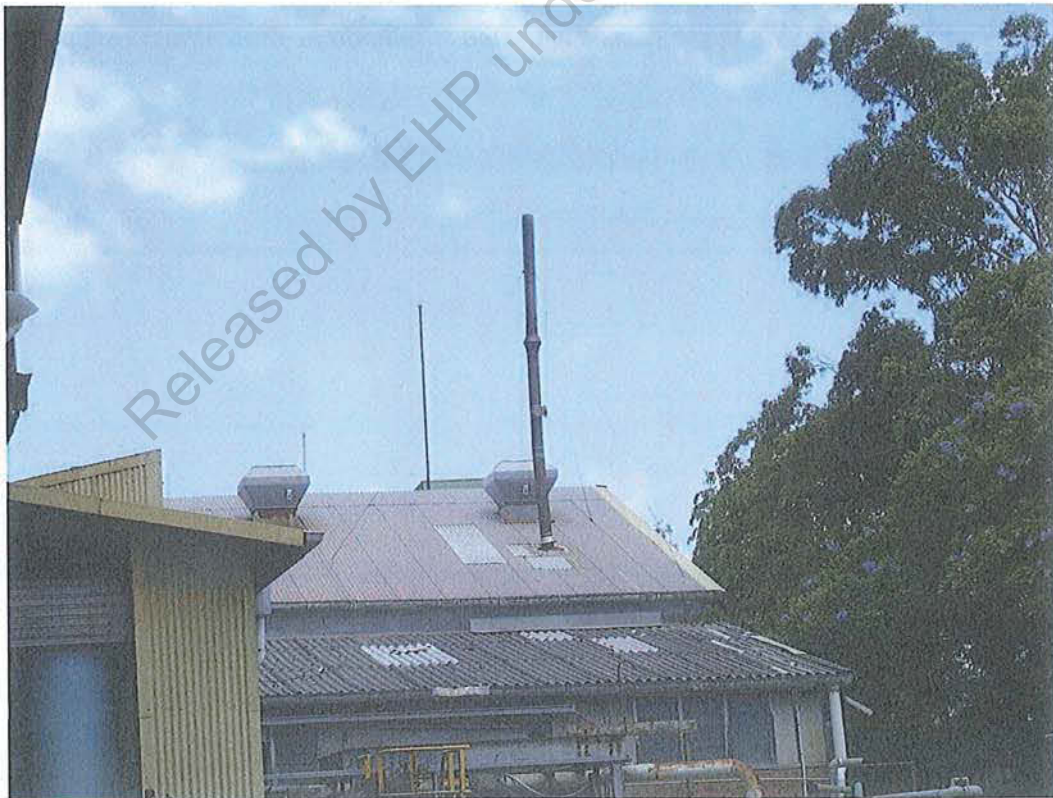
View of the RP6 sampling port. RP6 was not compliant with the labelling requirements of conditions B11 and B12. Direct access to the sampling ports looked to be via the roof. This situation should be checked for compliance with the requirements of *Australian Standard AS 4323.1-1995 Stationary source emissions- Selection of sampling positions*.

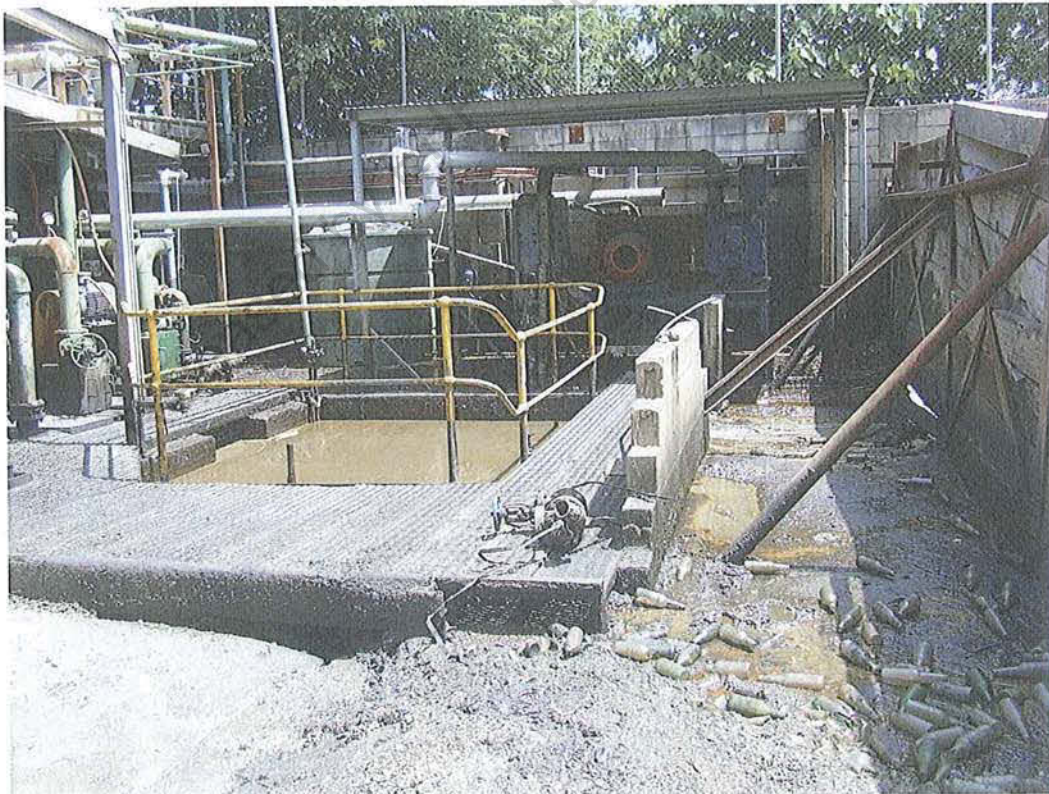
View if the site "sump". Localised odours of an unpleasant nature were readily detectable in the vicinity of the sump.

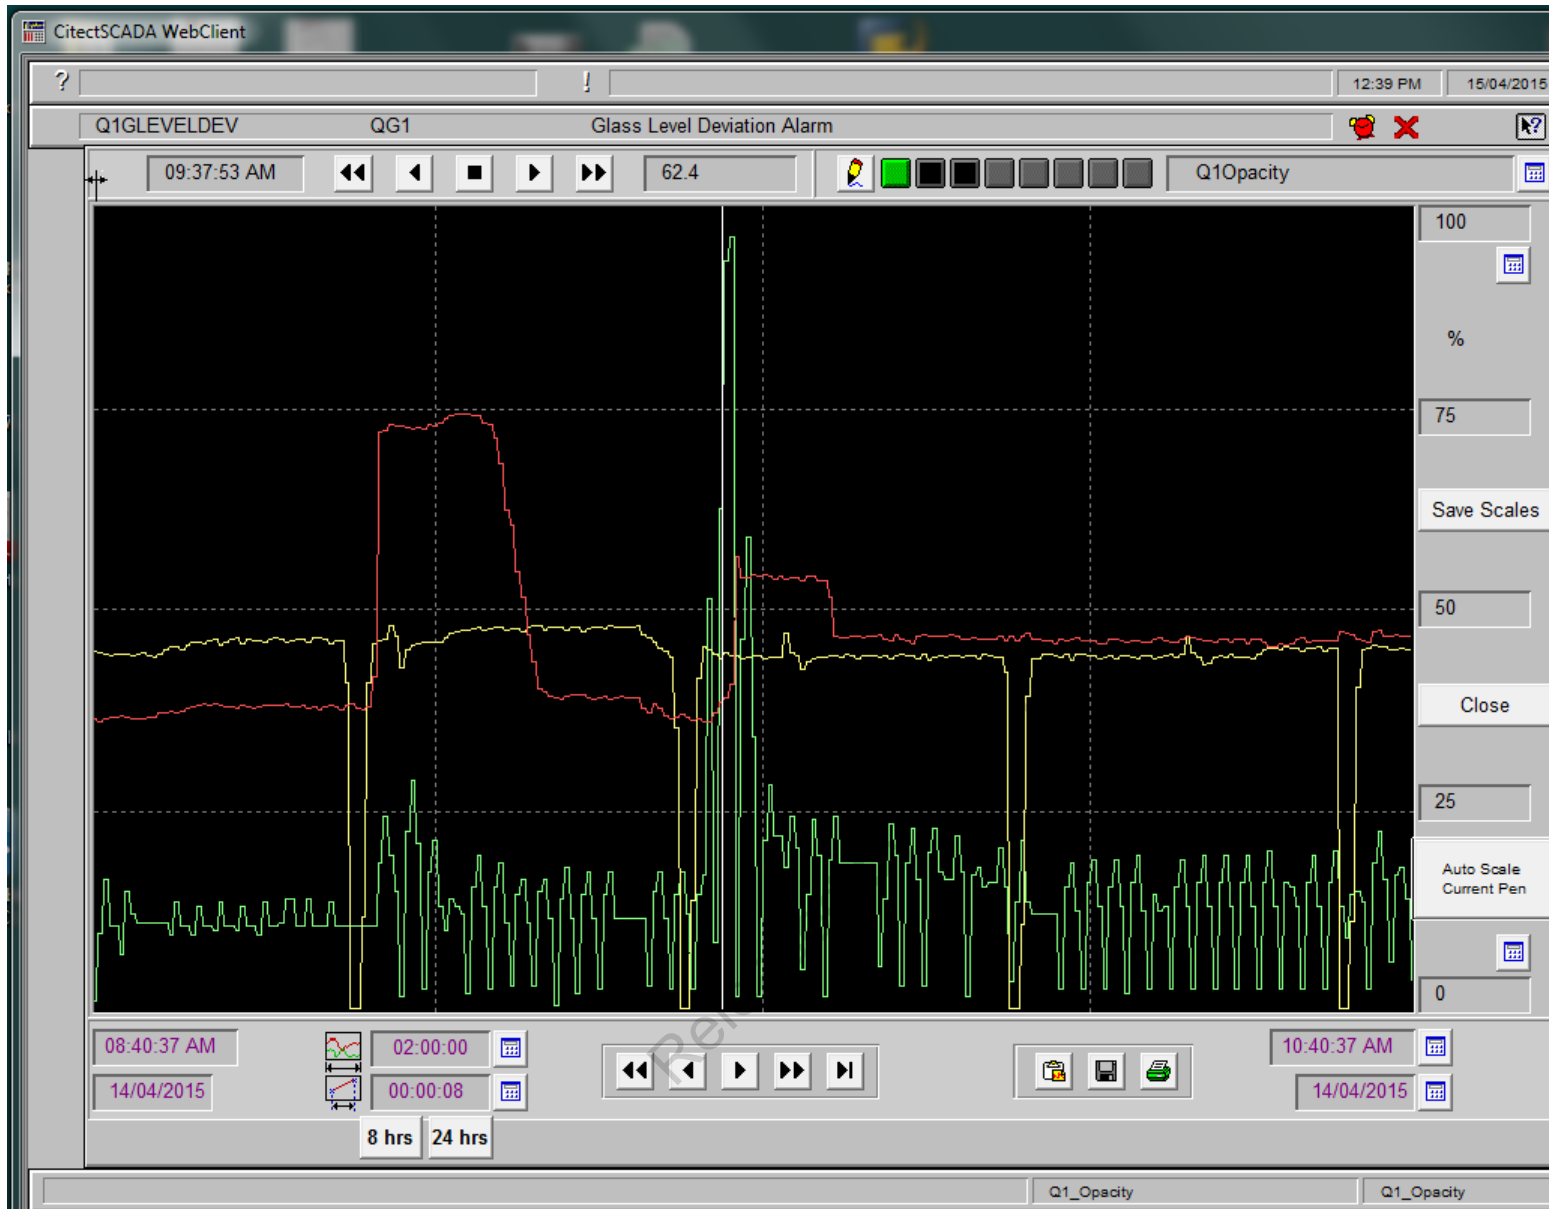
Original opacity event on QG1 was at 9:37 AM, and lasted 3 min. Driven by high pressure upon opening up regenerators for raking.  
Once NPL were aware of issues around pressure, they minimised their work to 1 opening at a time.

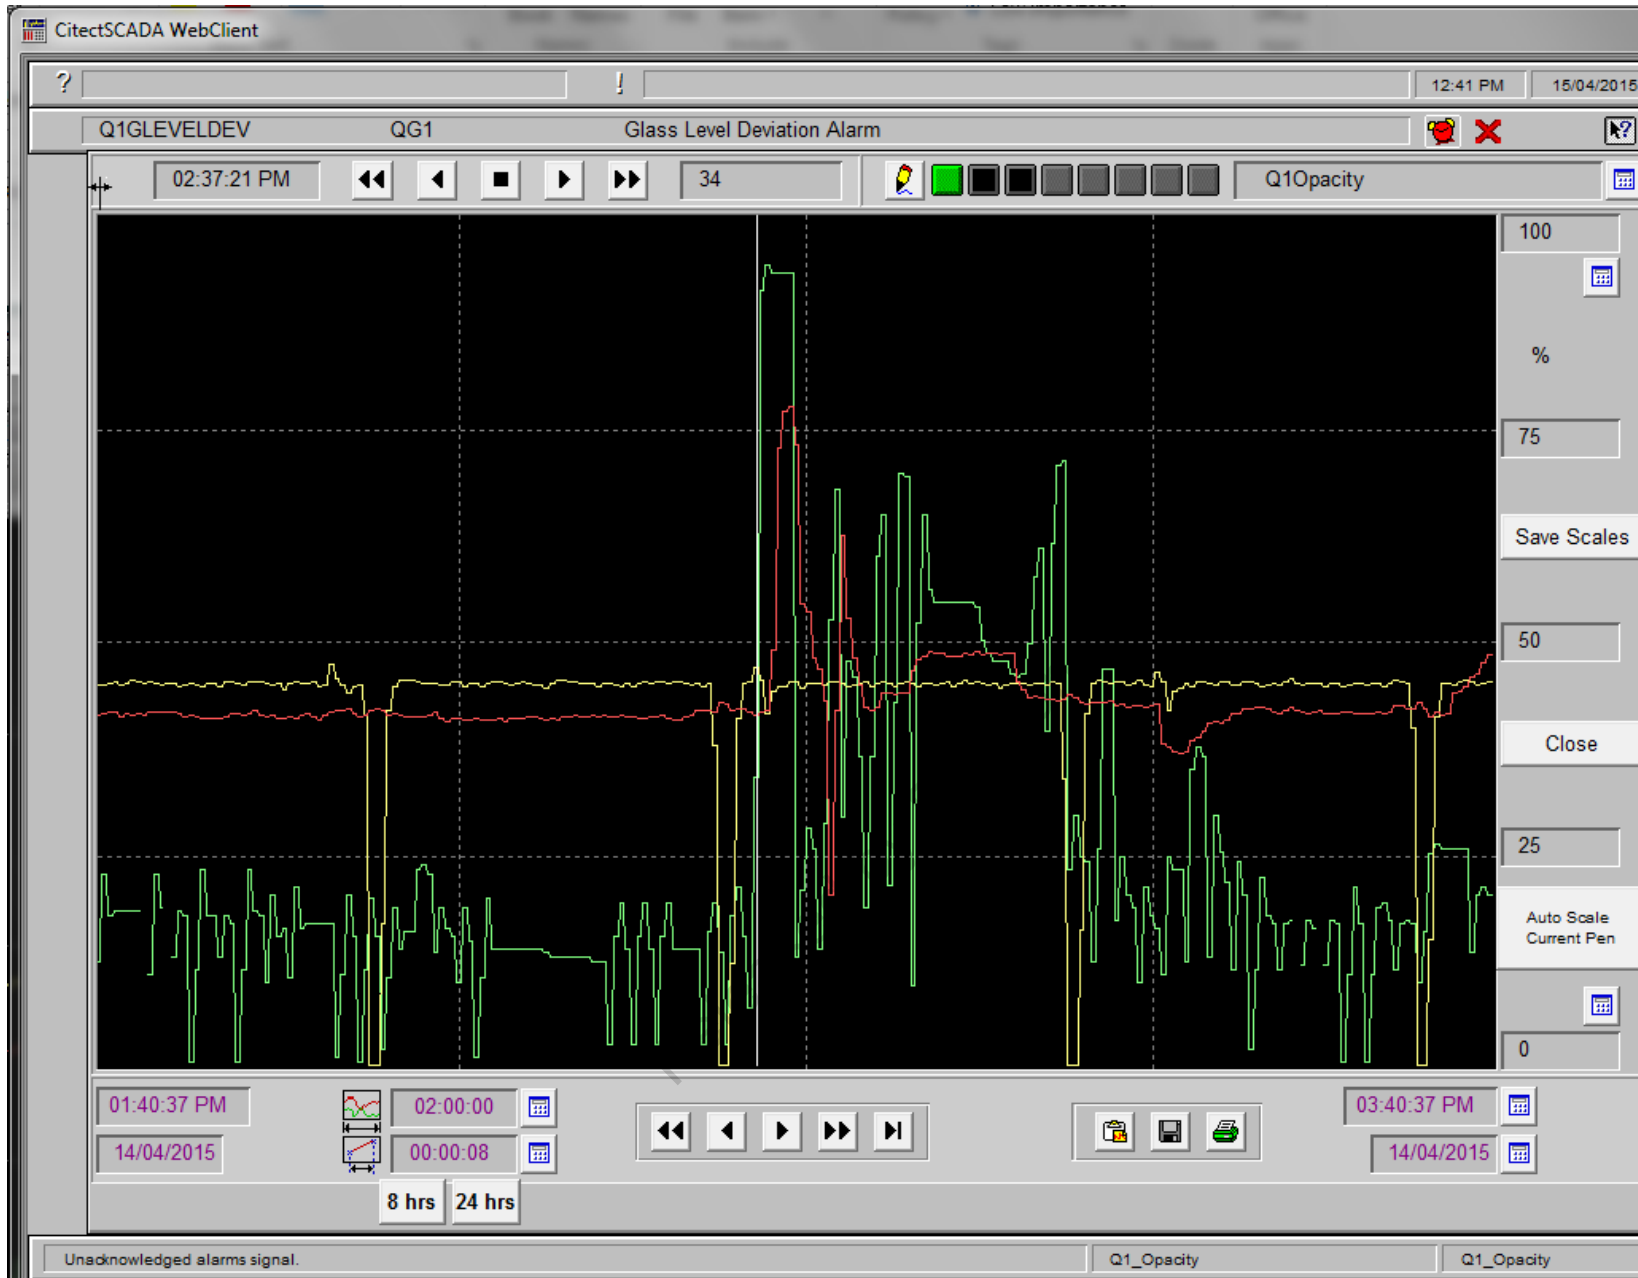
Second event was more extended (below), and started at 14:37 and was at an elevated level (generally above 45 % opacity) until 15:08. This happened upon closing up regenerators post-work. Unclear why exactly this one happened, however I believe that the sulphates and brick-dust within the regenerators was disturbed during raking which took a while to clear.
