### STAGE 1 ENVIRONMENTAL SITE ASSESSMENT 188 – 192 UPPER DAWSON ROAD ROCKHAMPTON, QLD (Lots 1 and 2 on RP608391)

Prepared for:

**AUSTRALIAN CHILDCARE DEVELOPMENTS PTY LTD**

October 2003  
Ref N<sup>o</sup>: 6034/7

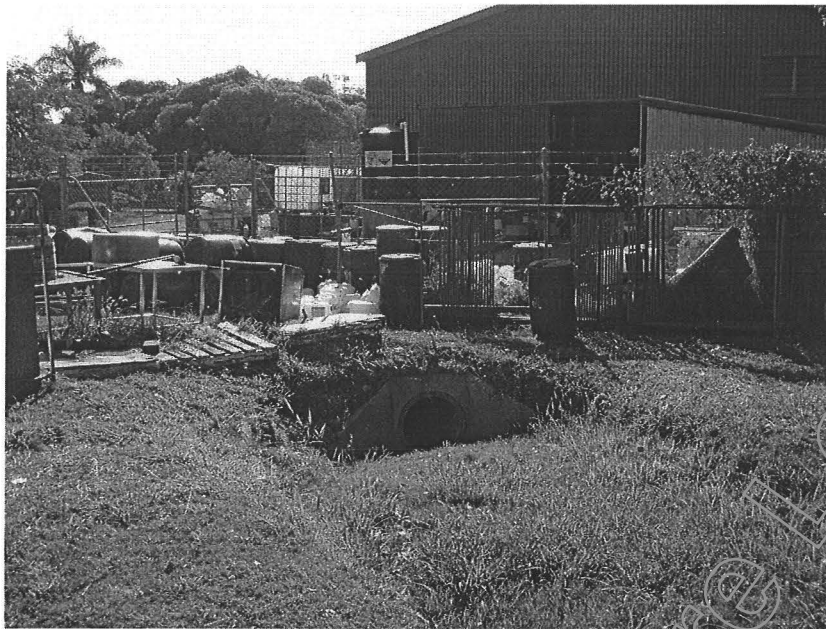
**Photograph 3**

View northeast from the rear of the site showing stormwater drain inlet and open storage behind.

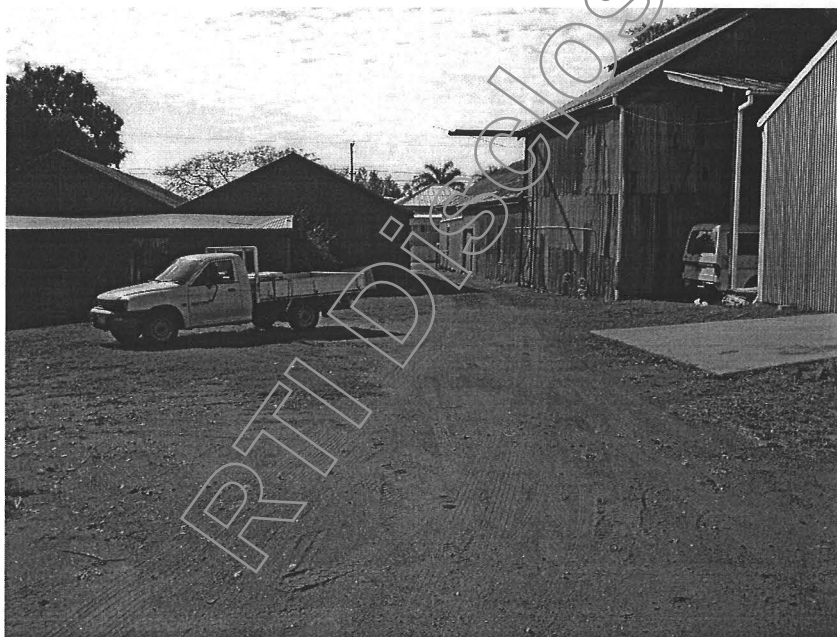
**Photograph 4**

View east across center of the site showing shed layout.

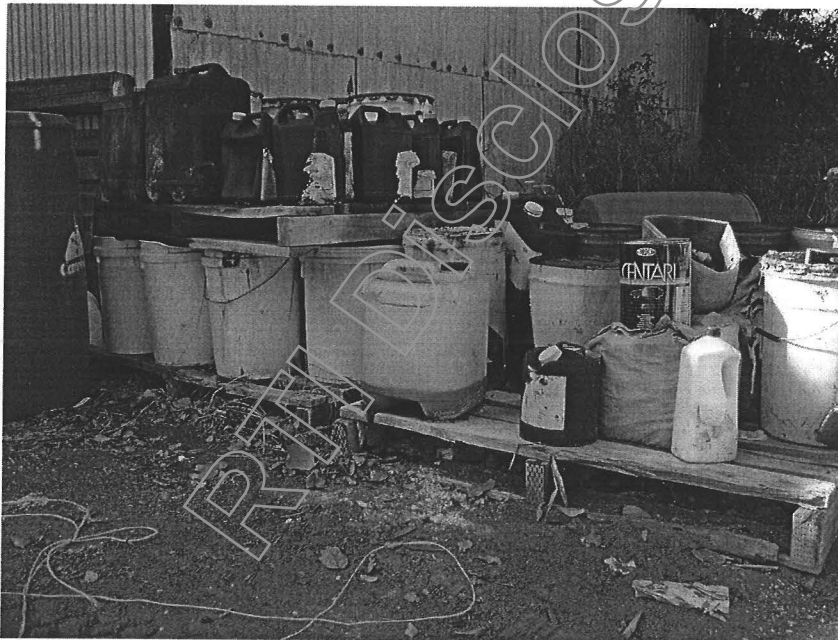
**Photograph 6** View of chemical storage in the rear fenced compound beside AH4

| Hand Auger Borehole No. | Depth (m) | Brief Description of Soils Penetrated | Sample No. 6034/7/ | Sample Depth (m) |
|---|---|---|---|---|
| AH4 | 0.00-0.20 | Beside containers stored in open fenced area at rear of sheds.<br><b>SILT, SAND and GRAVEL - FILL:</b> loose once disturbed, chemical staining and odour. | AH4.1 | 0.00-0.10 |

GeoEnvironmental Consultants recommend that the RAP include remediation of the site by selectively excavating all old fill and visibly impacted surface soil up to the order of 0.30m deep. Excavated soil should be removed under EPA permit to an off-site landfill location. Further leaching tests are proposed in the RAP prior to proceeding with the recommended remedial action at this site.

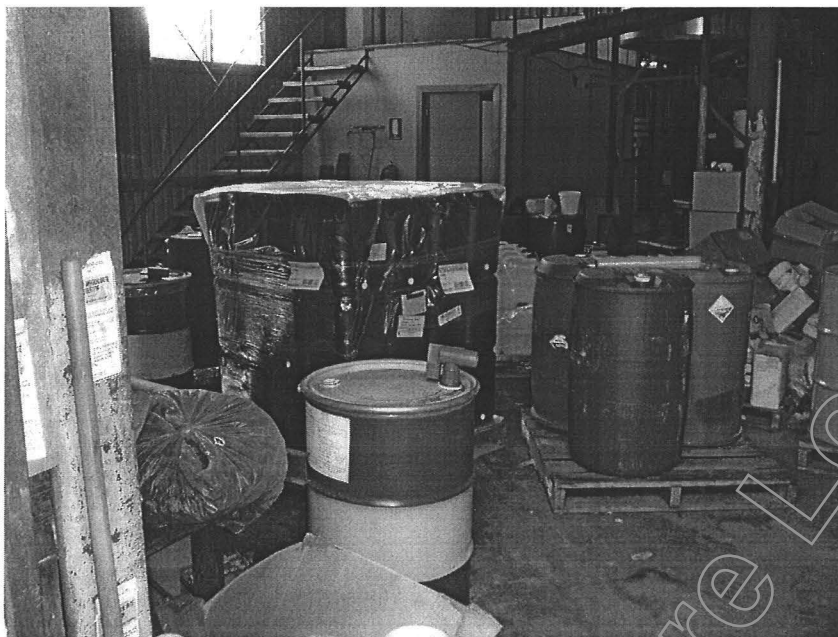
Inspection of the shed located at the southwest corner of the site revealed this shed was currently being used for blending and storage of cleaning products. A bunded aboveground tank used for storage of sodium hypochlorite was noted at the northwest corner of this building. Numerous empty or near empty containers of cleaning products were stored outside the southwest corner of this shed. One drum of paint was noted in this area also.

**Photograph 7** View of typical chemical storage in the rear shed.

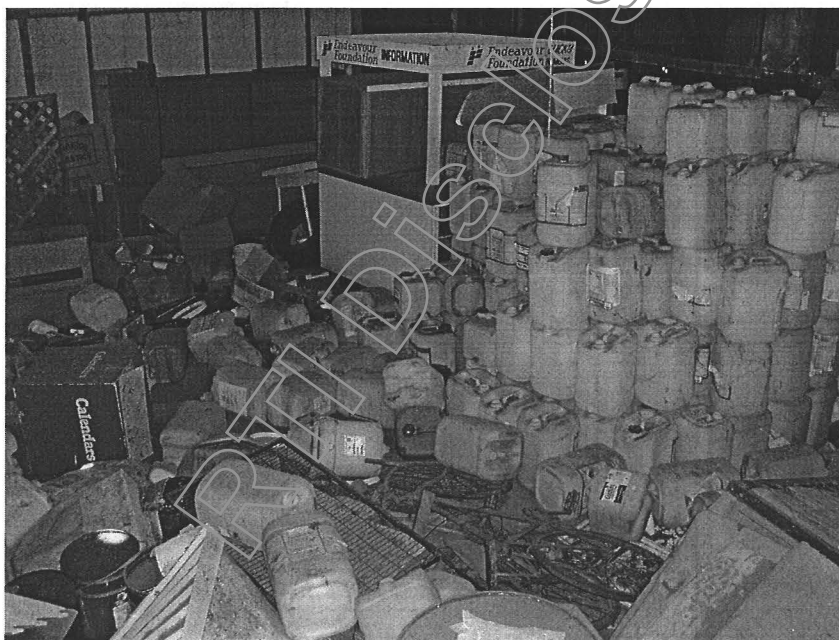
**Photograph 8** View of empty chemical containers in the south-east shed
