**Project:** Contaminated Land Site Investigation  
50-52 Parramatta Road, Underwood,  
Queensland.

**Project No.:** 404

## Contaminated Land Site Investigation for 50-52 Parramatta Road, Underwood, Queensland.

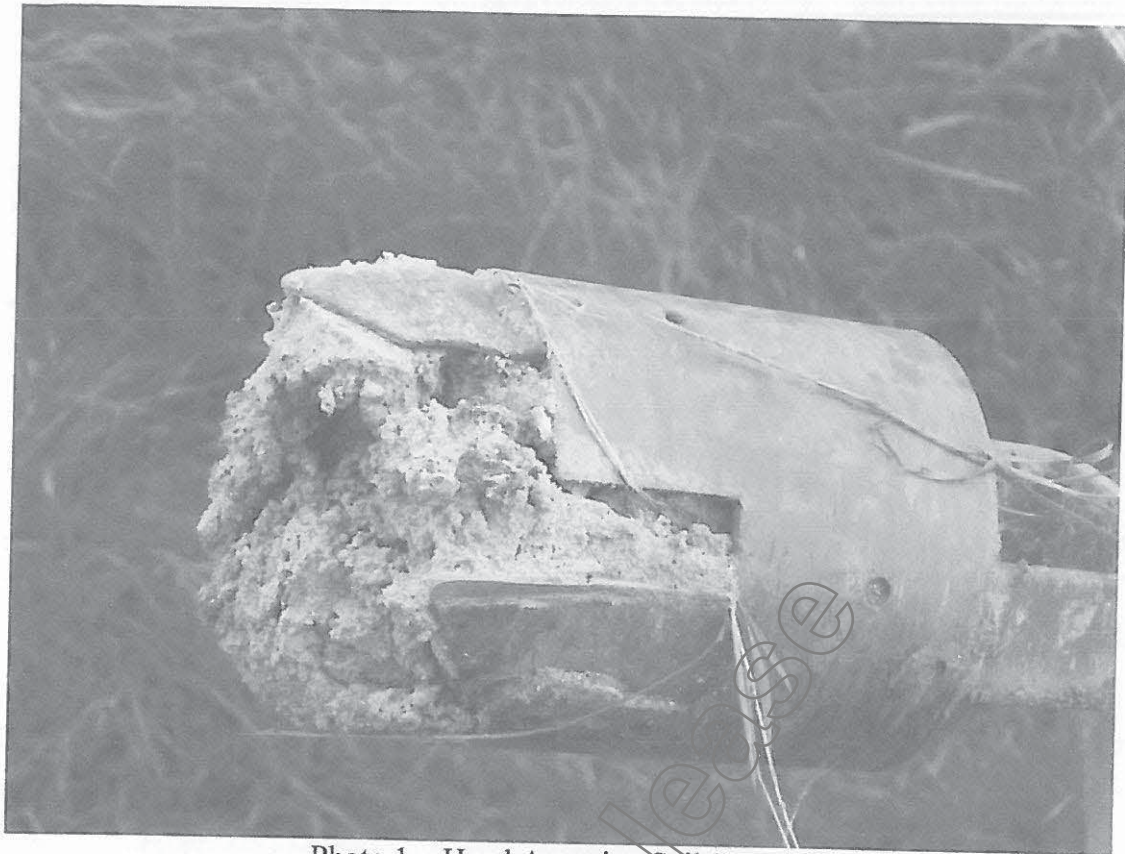
Photo 1 – Hand Auguring Soil Sample

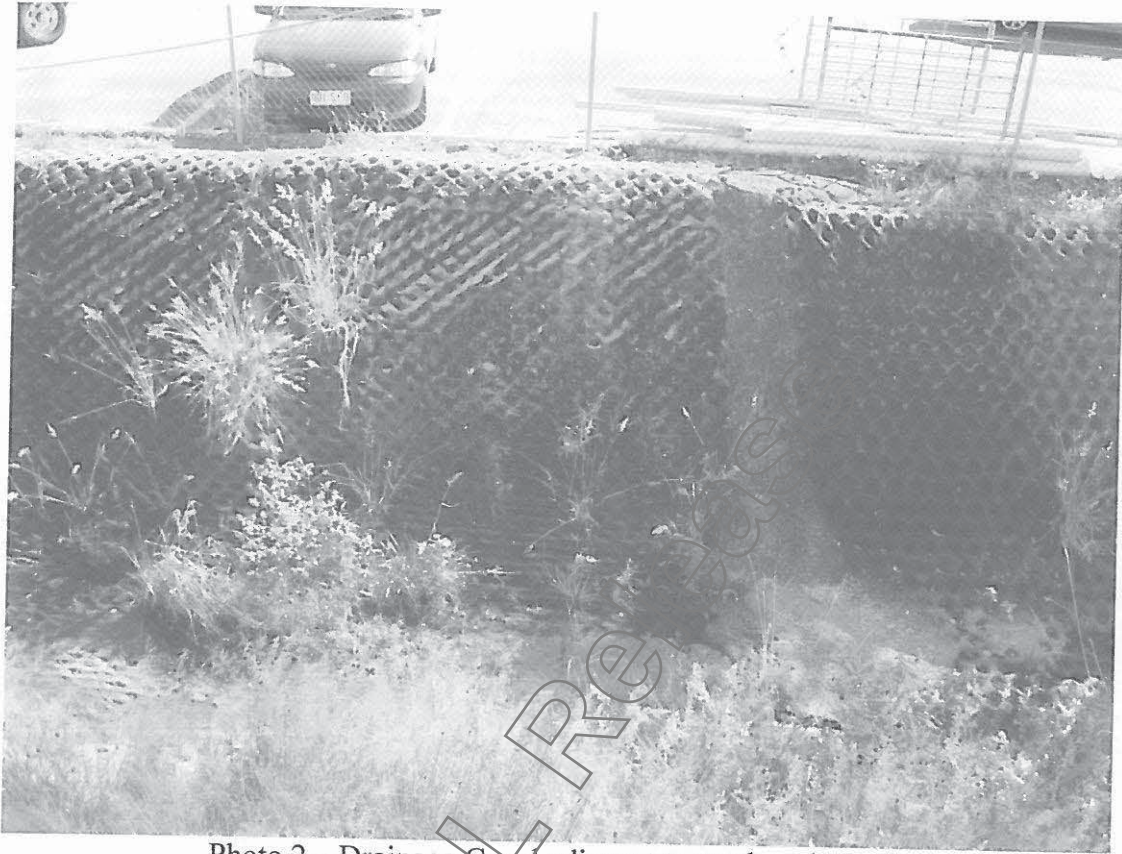
Photo 2 – Drainage Canal adjacent to north end of site

The site drains across concrete into the Canal to the north. No groundwater was observed in the boreholes during the sampling process.

The site walkover revealed no evidence of spills or contamination. It is anticipated that historically any spills near the shed would have been rapidly washed into the drainage channel just to the north if not properly contained. If there were any spills or seepages into the ground it may have been detected in our testing. However, nothing was detected. It is recommended that once the site is clear of all chemicals in containers, which is probably the case now, it be taken off the list of possible contaminated sites.

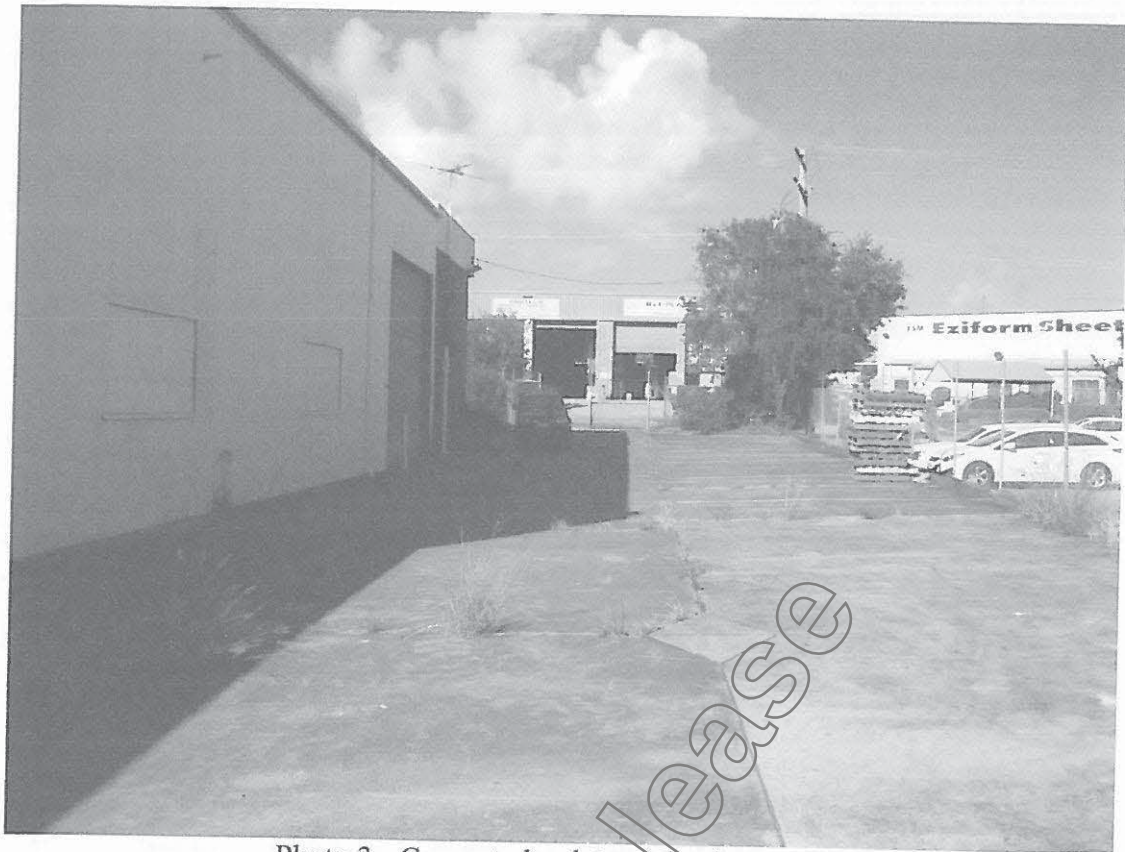
Photo 3 - Concrete hardstand dipping to east

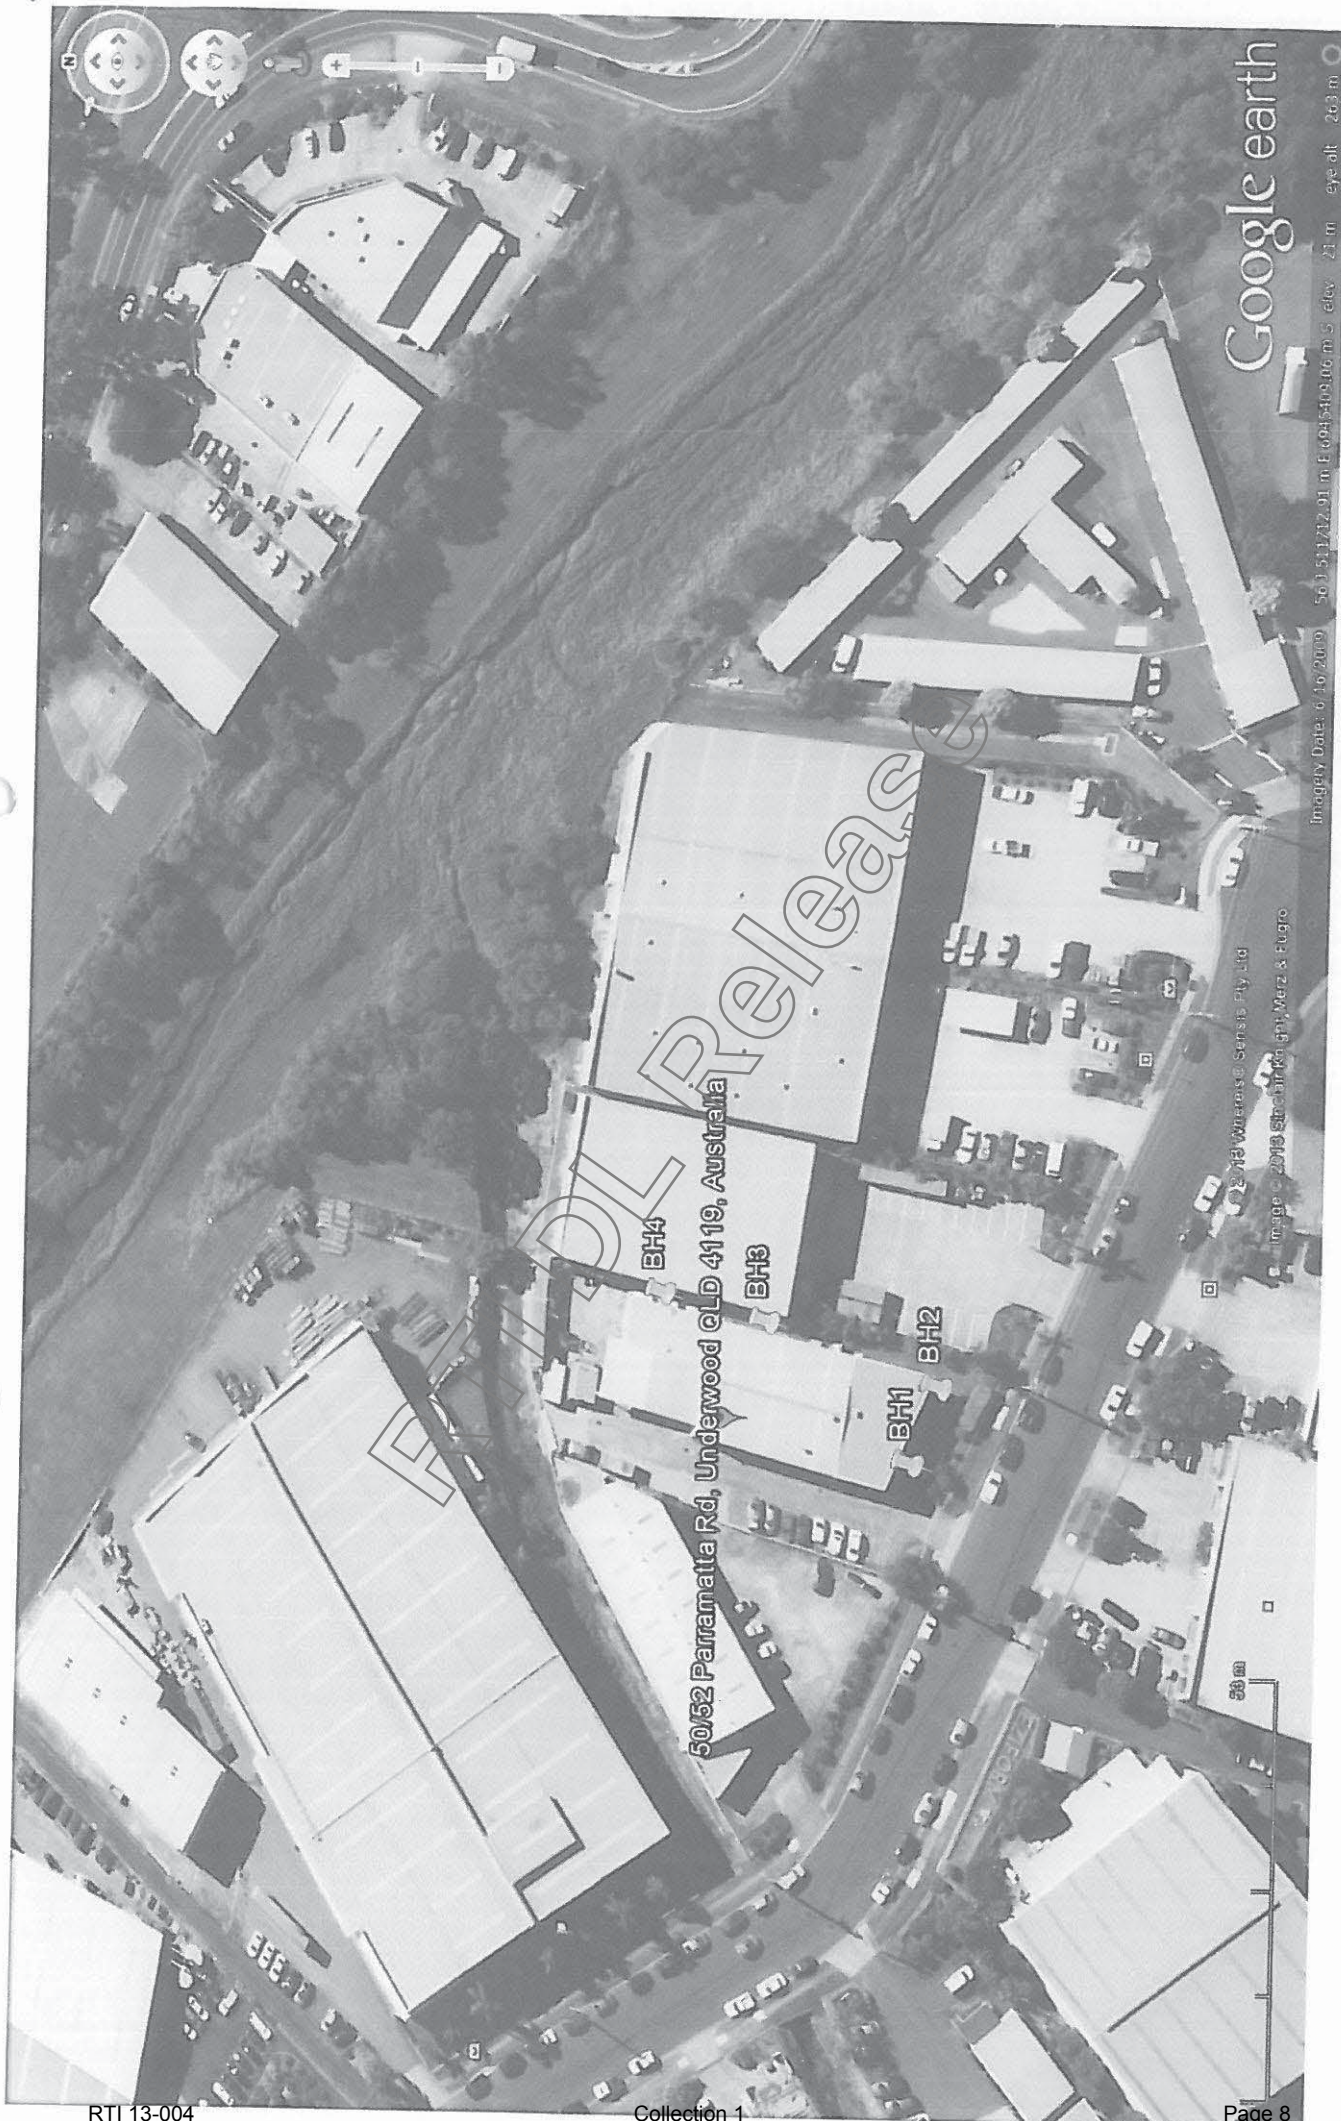
ANNEX A – PLAN

The locations of the boreholes and are shown approximately in Annex A-Site Plan attached to this report and were obtained by pace measurements from surface features shown on supplied drawings. The engineering logs of the boreholes are presented in Annex B.

BH4

BH3

BH2

BH1
