## **CENTURY MINE SEDIMENT QUALITY MONITORING PROGRAM (SQMP) REVIEW 2017**

**A Report for New Century Resources**

**Report No. 18/07 Vol 1**

**March 2018**

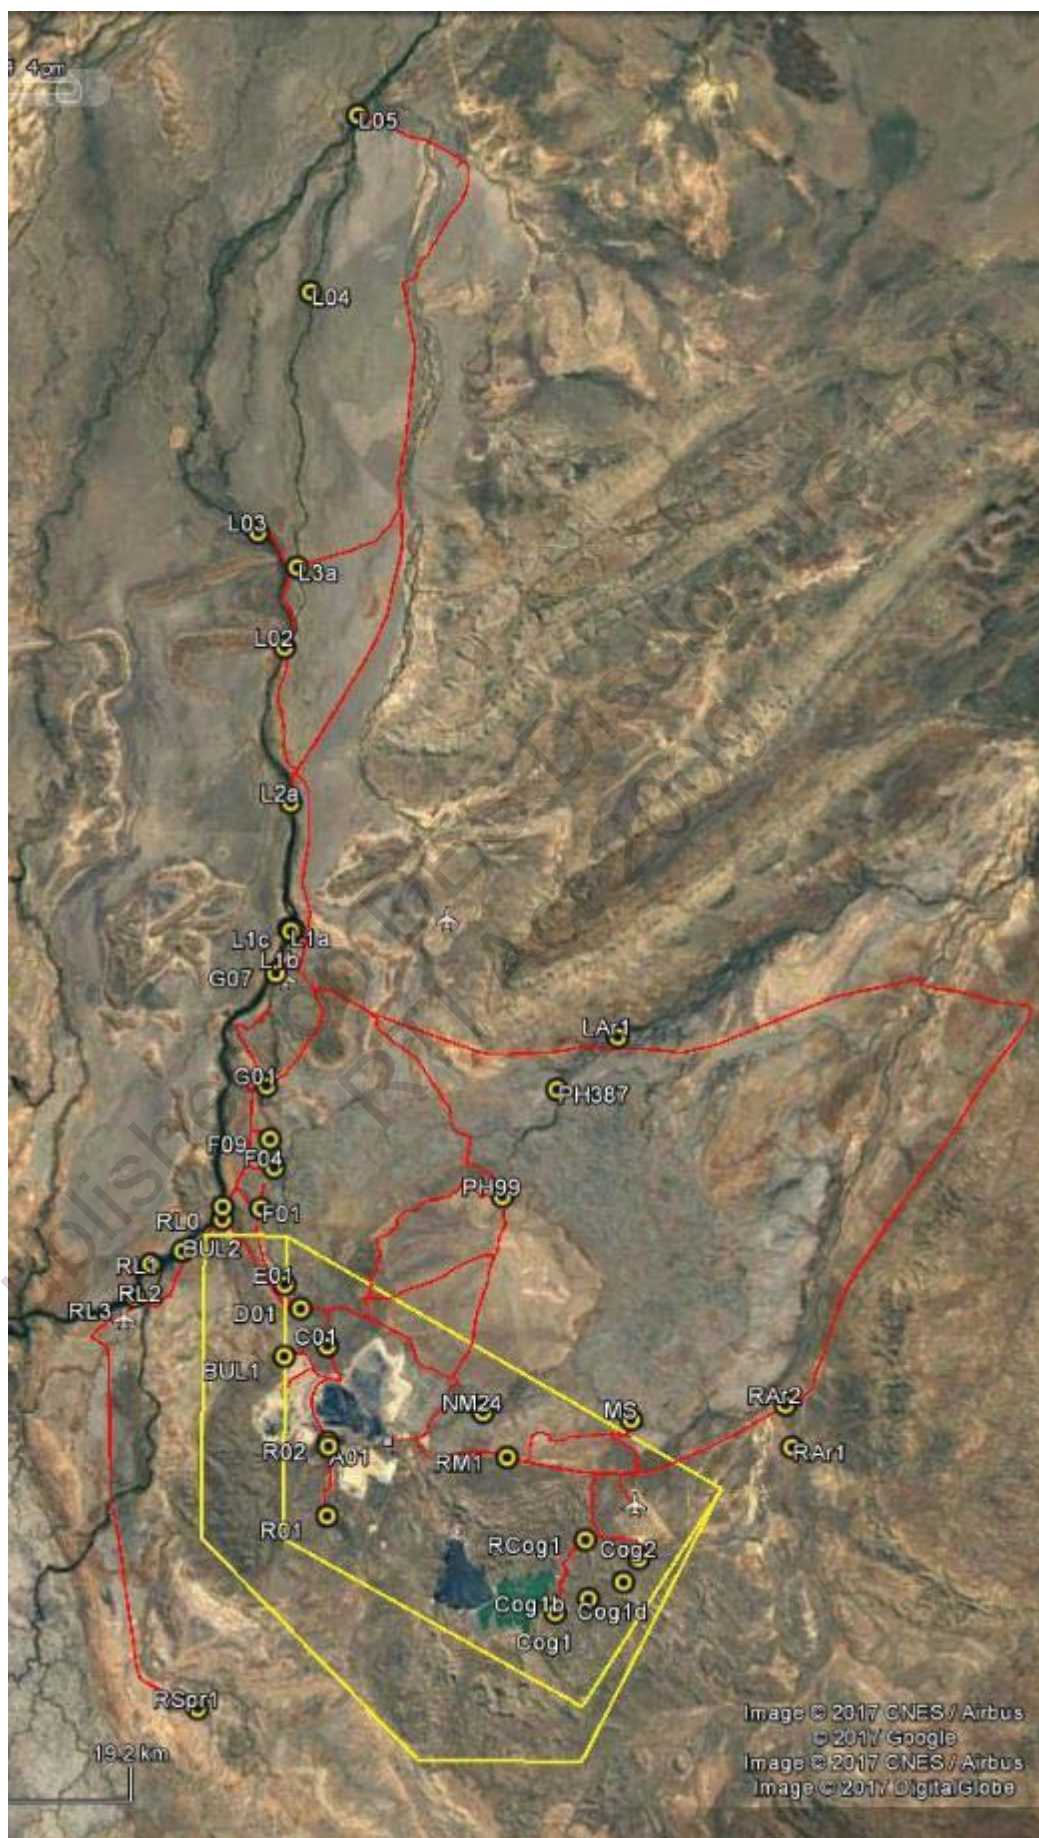
**Figure 3.1.1.** Location of Century Mine REMP Sites. Control sites are shown in green and potential impact sites in red. The Century Mining Limited leases are outlined in yellow with access road in red.

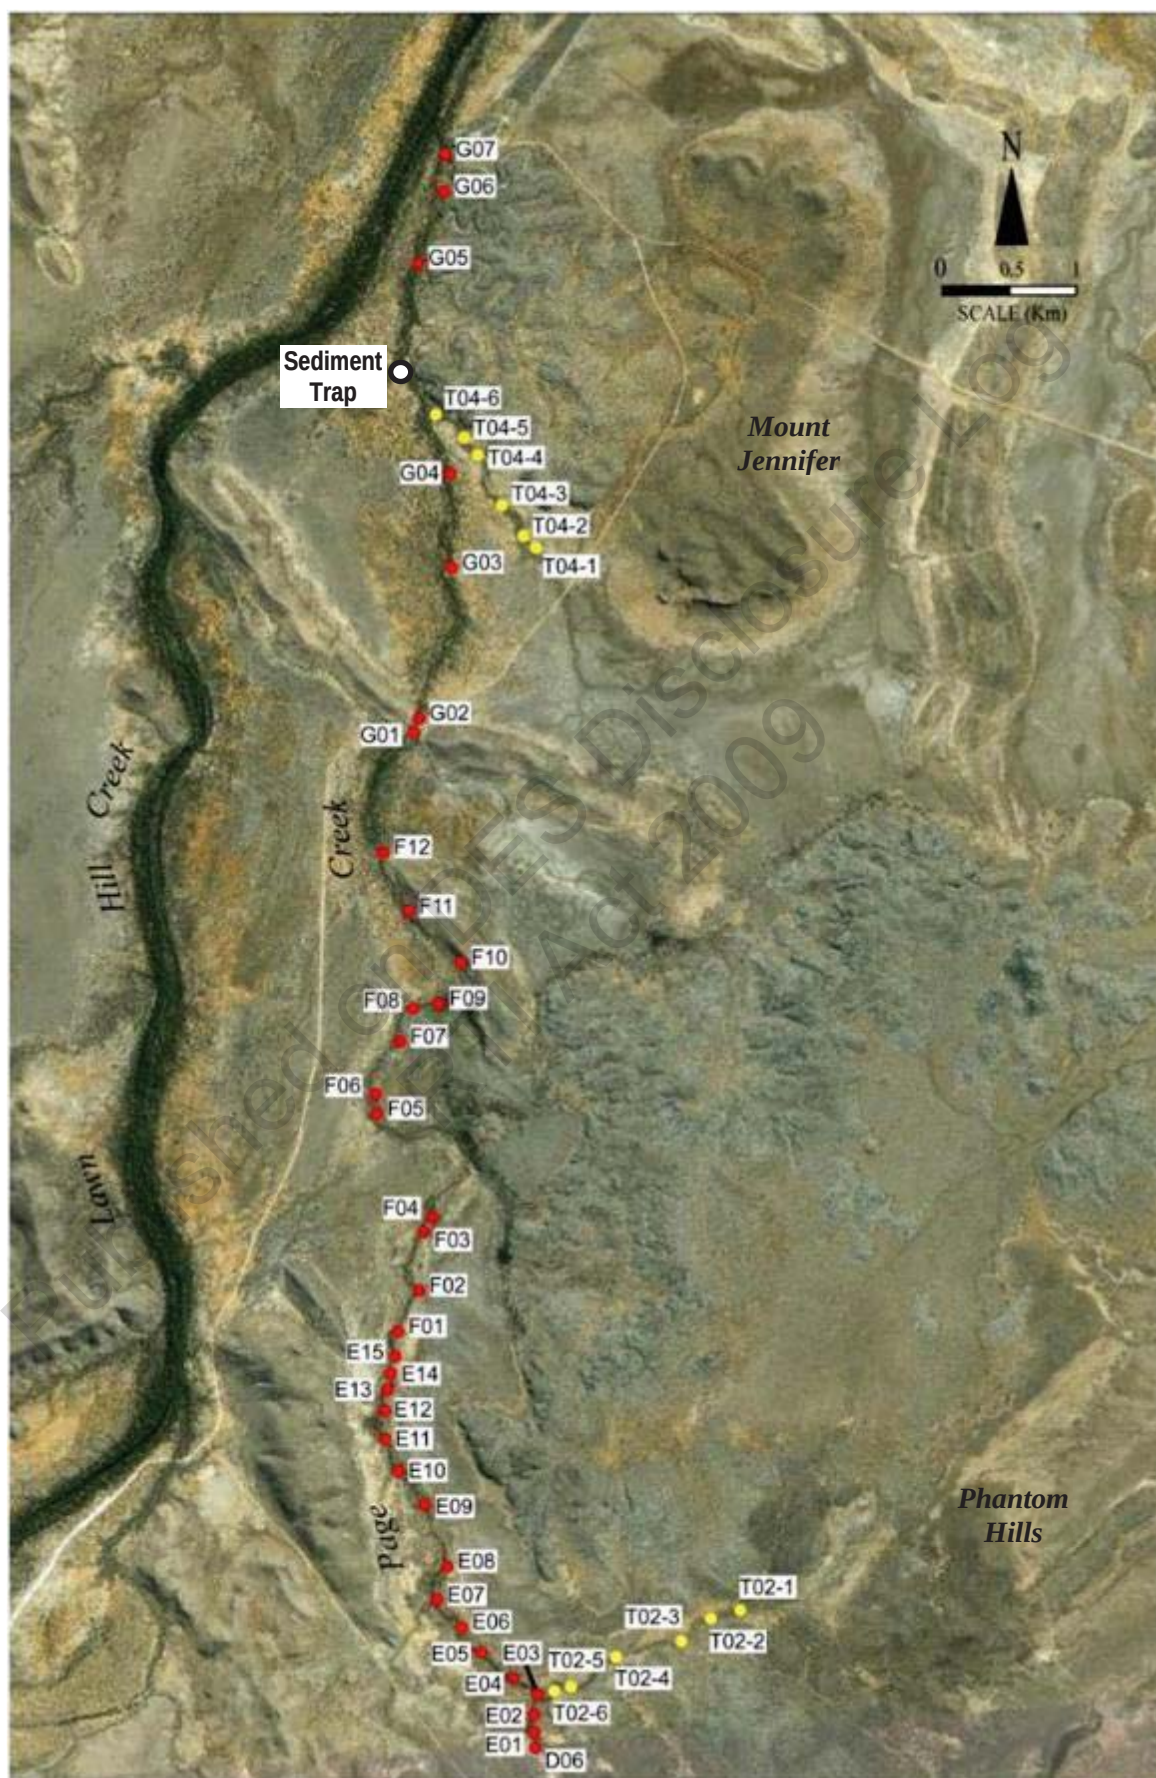
**Figure 2.1.2** Page Creek sites located in stream reaches E to G. [Google Earth]. Tributary sites (prefixed T) were sampled in 2010 but have not been sampled since.

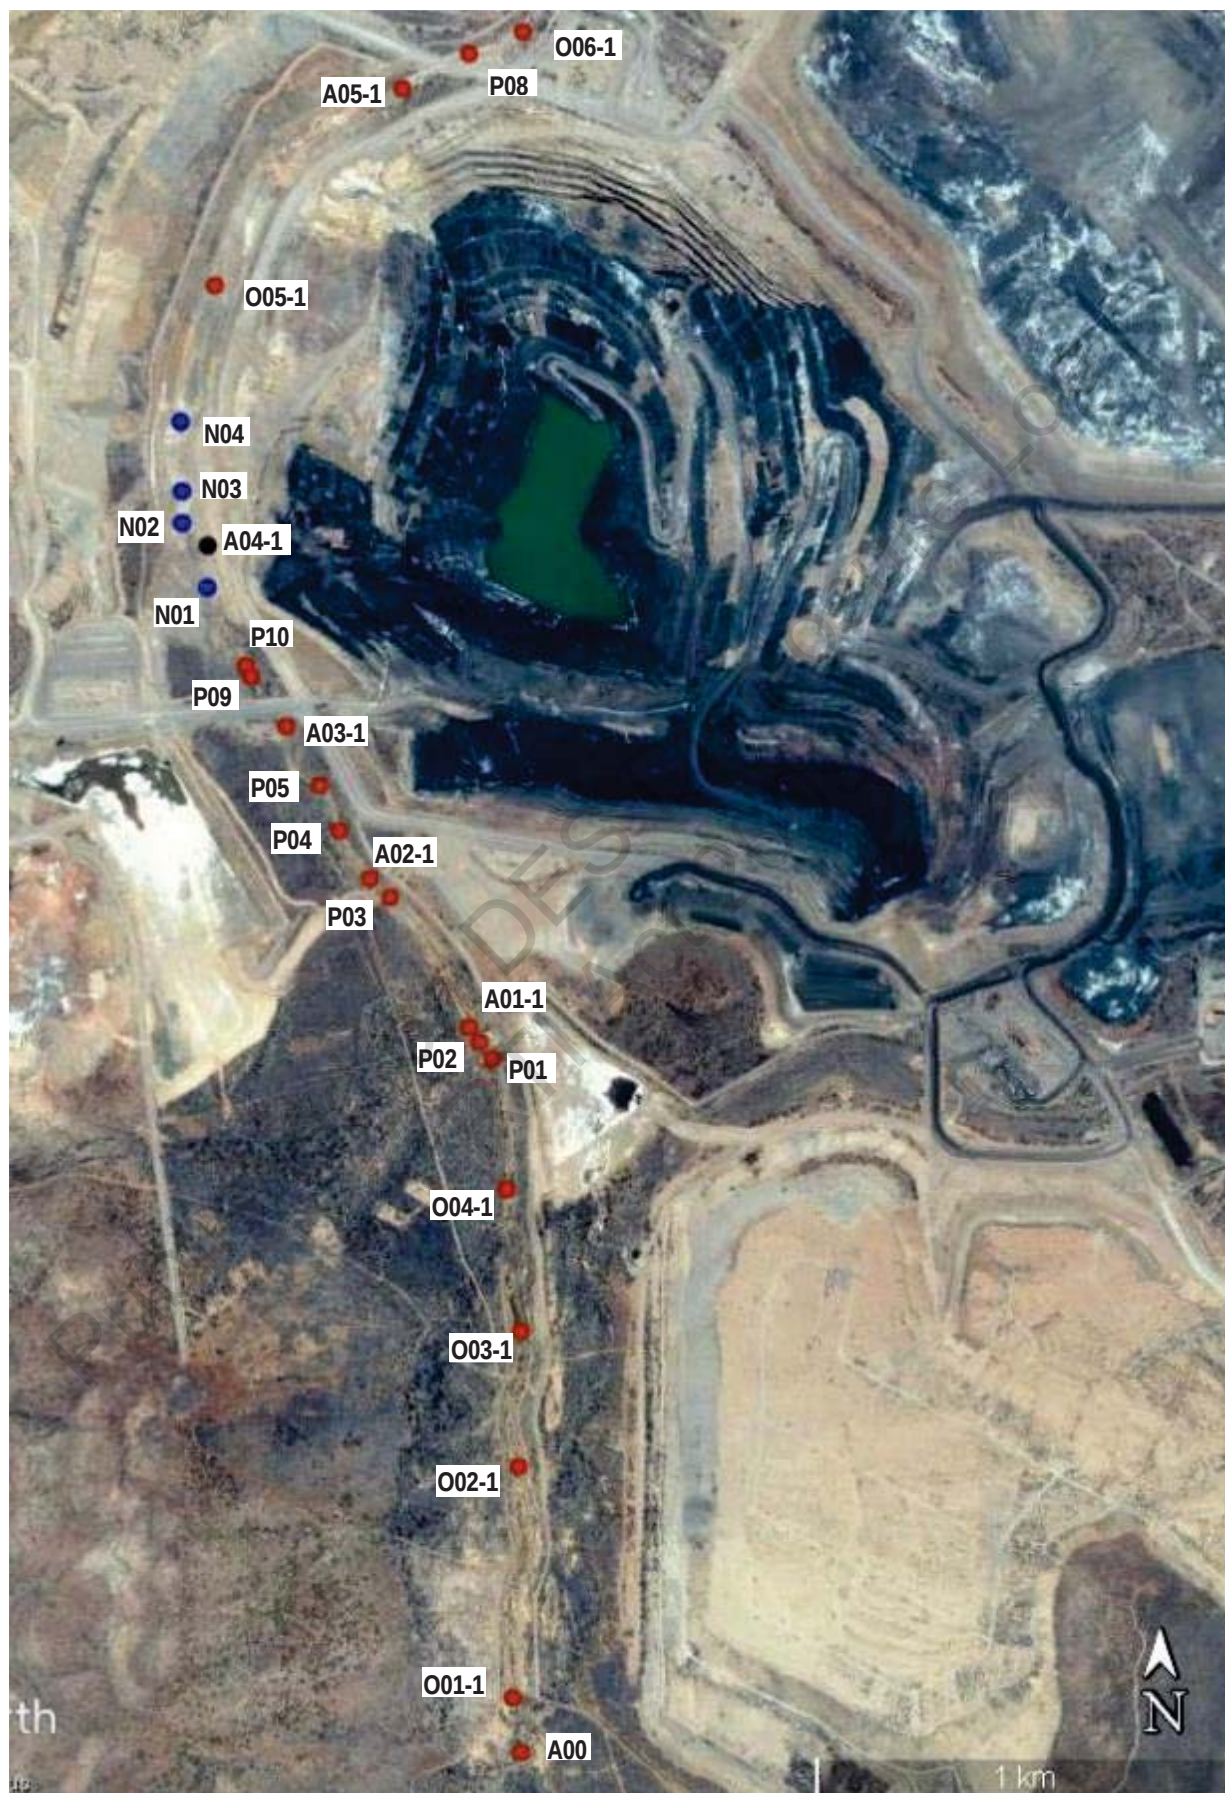
**Figure 2.1.3** Page Creek Diversion channel sites sampled in 2014. [Google Earth 2017].

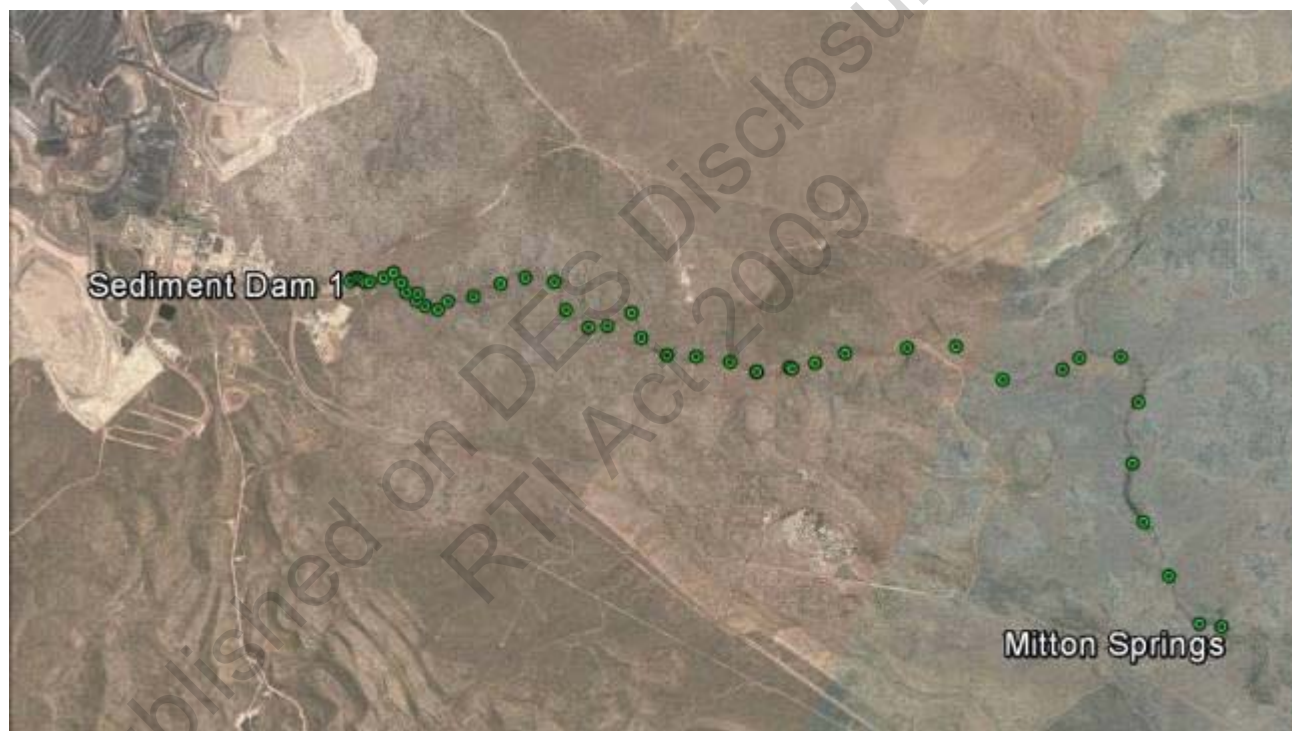
**Figure 4.1.1:** Map showing the location of sites sampled during the initial survey of North Mitton Creek in 2014.

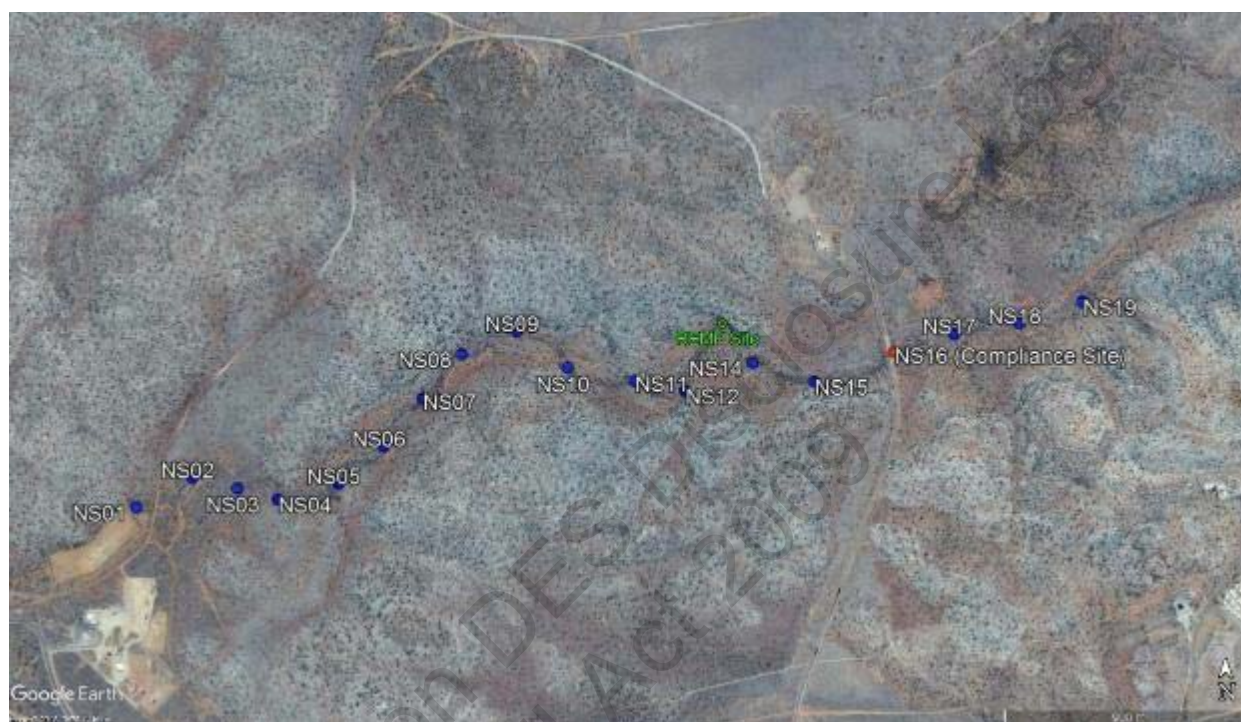
**Figure 4.1.5** North Mitton Creek SQMP stream reaches sampled in 2016 and 2017. Points mark the beginning of each reach (except for NS19 which marks the end of Reach NS18). The REMP and compliance sites are discrete sampling locations.

required works. However, the process of evaluating the sediment volume in every part of every reach is excessively laborious for ongoing routine monitoring purposes. More significantly, the bottom sediments in many key sections of the creek are now so sparse (1 to 6 cm deep) that it is no longer feasible to obtain sediment load estimates that are sufficiently accurate to be used for trend assessment purposes. For example a sediment depth estimation error of only  $\pm 2$  cm (which is not easy to achieve) may now equate to an uncertainty level of  $\pm 100\%$  or more.

Accordingly, in 2017 an attempt was made to rationalise the program by establishing fixed site locations that could be resampled each year in order to assess temporal trends without undermining our capacity to identify sediment removal opportunities. The 2017 pilot trial entailed collecting composite samples representative of reaches nominally 250 to 500 m in length (actual reach lengths are recorded in the results tables). This procedure requires sampling personnel to traverse the entire length of each reach taking regular subsamples along the way in order to accumulate a representative composite sample.

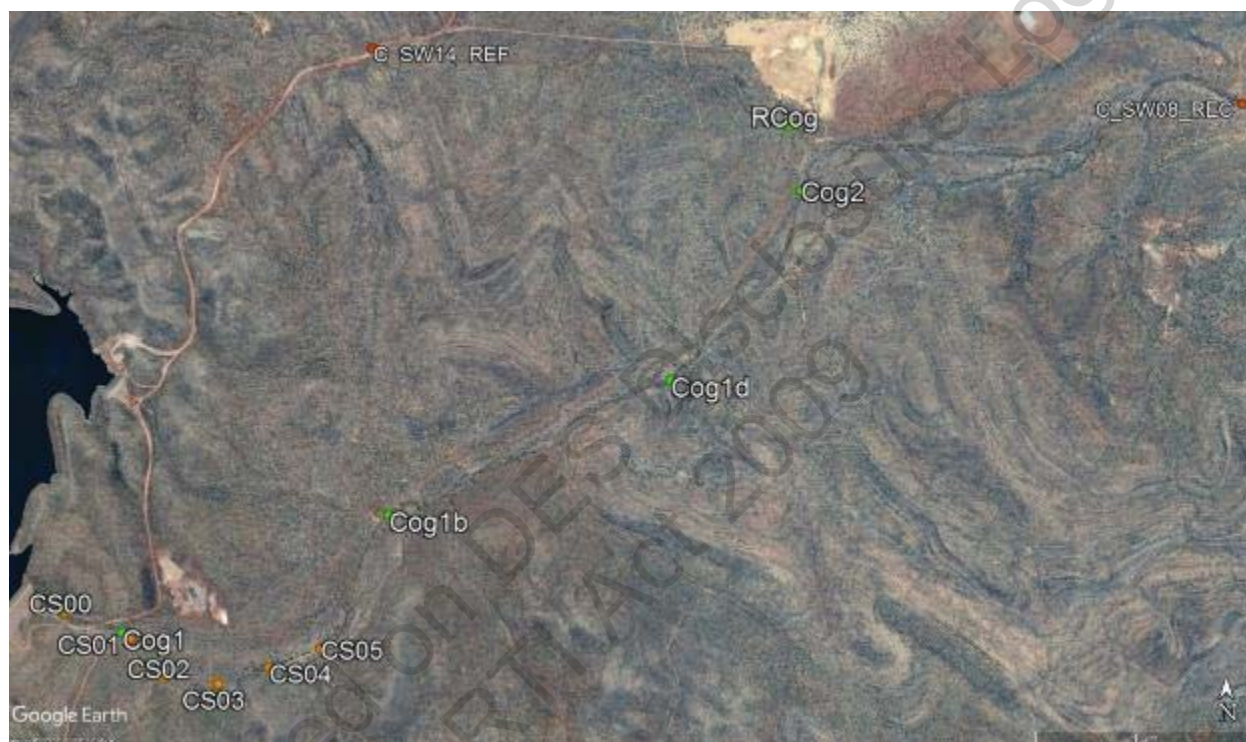
**Figure 5.1.1** Current monitoring sites on Cogan Creek. Red markers denote compliance sites, green denote REMP sites and orange markers are SQMP sites.

The monitoring sites network for Cogan Creek is shown in Figure 5.1.1. REMP site Cog1, a small pool formed by seepage water situated immediately downstream of the evaporation dam saddle wall, has been monitored annually in post-wet season REMP surveys for more than a decade. The site was originally located closer to the dam but it was necessary to gradually move it further downstream because it developed into a *Typha* (bulrush) wetland with vegetation so dense that the water column could no longer be accessed by sampling personnel.

Given existing uncertainties regarding the ongoing functionality of the Cog1 wetland, the routine SQMP monitoring site network (listed in Table 5.3.1 and shown on Figure 5.1.1) extra sites immediately upstream and downstream of Cog1 were added to the network in 2018 in order to increase early detection capacity in the event that the wetland fails and the contaminated sediments become mobile. Sampling and analysis methods will be the same as those used in North Mitton Creek.

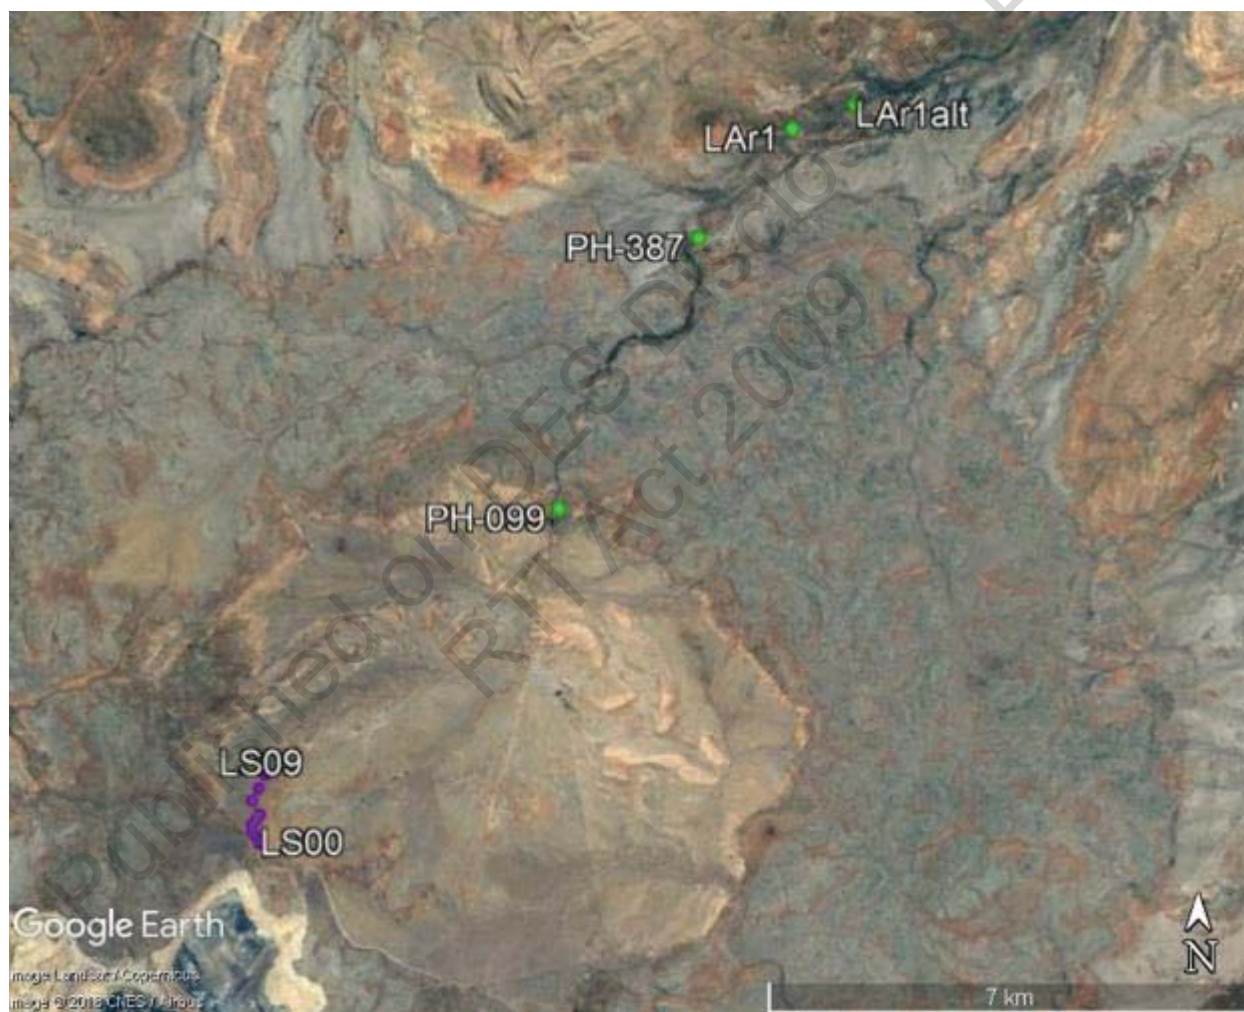
**Figure 6.1.1** Current monitoring sites on Little Archie Creek. Green markers denote REMP sites and purple markers are SQMP sites. SQMP sites are numbered consecutively in downstream order from LS00 to LS09.

During the 2015 REMP survey an attempt was made to locate additional REMP monitoring sites that were closer to the mine. This resulted in the establishment of two additional sites (PH387 and PH099, see Figure 6.1.1) which appeared to be capable of periodically holding water long enough to be sampled for aquatic biota and which could be sampled for sediment every year. The 2015 and 2016 REMP reports provided no indication of metal enrichment in the sediments at those sites, suggesting that Zn contamination was confined to the very small, highly ephemeral stream reach immediately proximal to the mine site. To determine the full extent of the contamination, ten SQMP reach sampling sites (LS00 to LS09) were established to encompass the uppermost 1.6 km of the creek.

The REMP sites shown in Figure 6.1.1 will be sampled annually during the postwet REMP surveys.

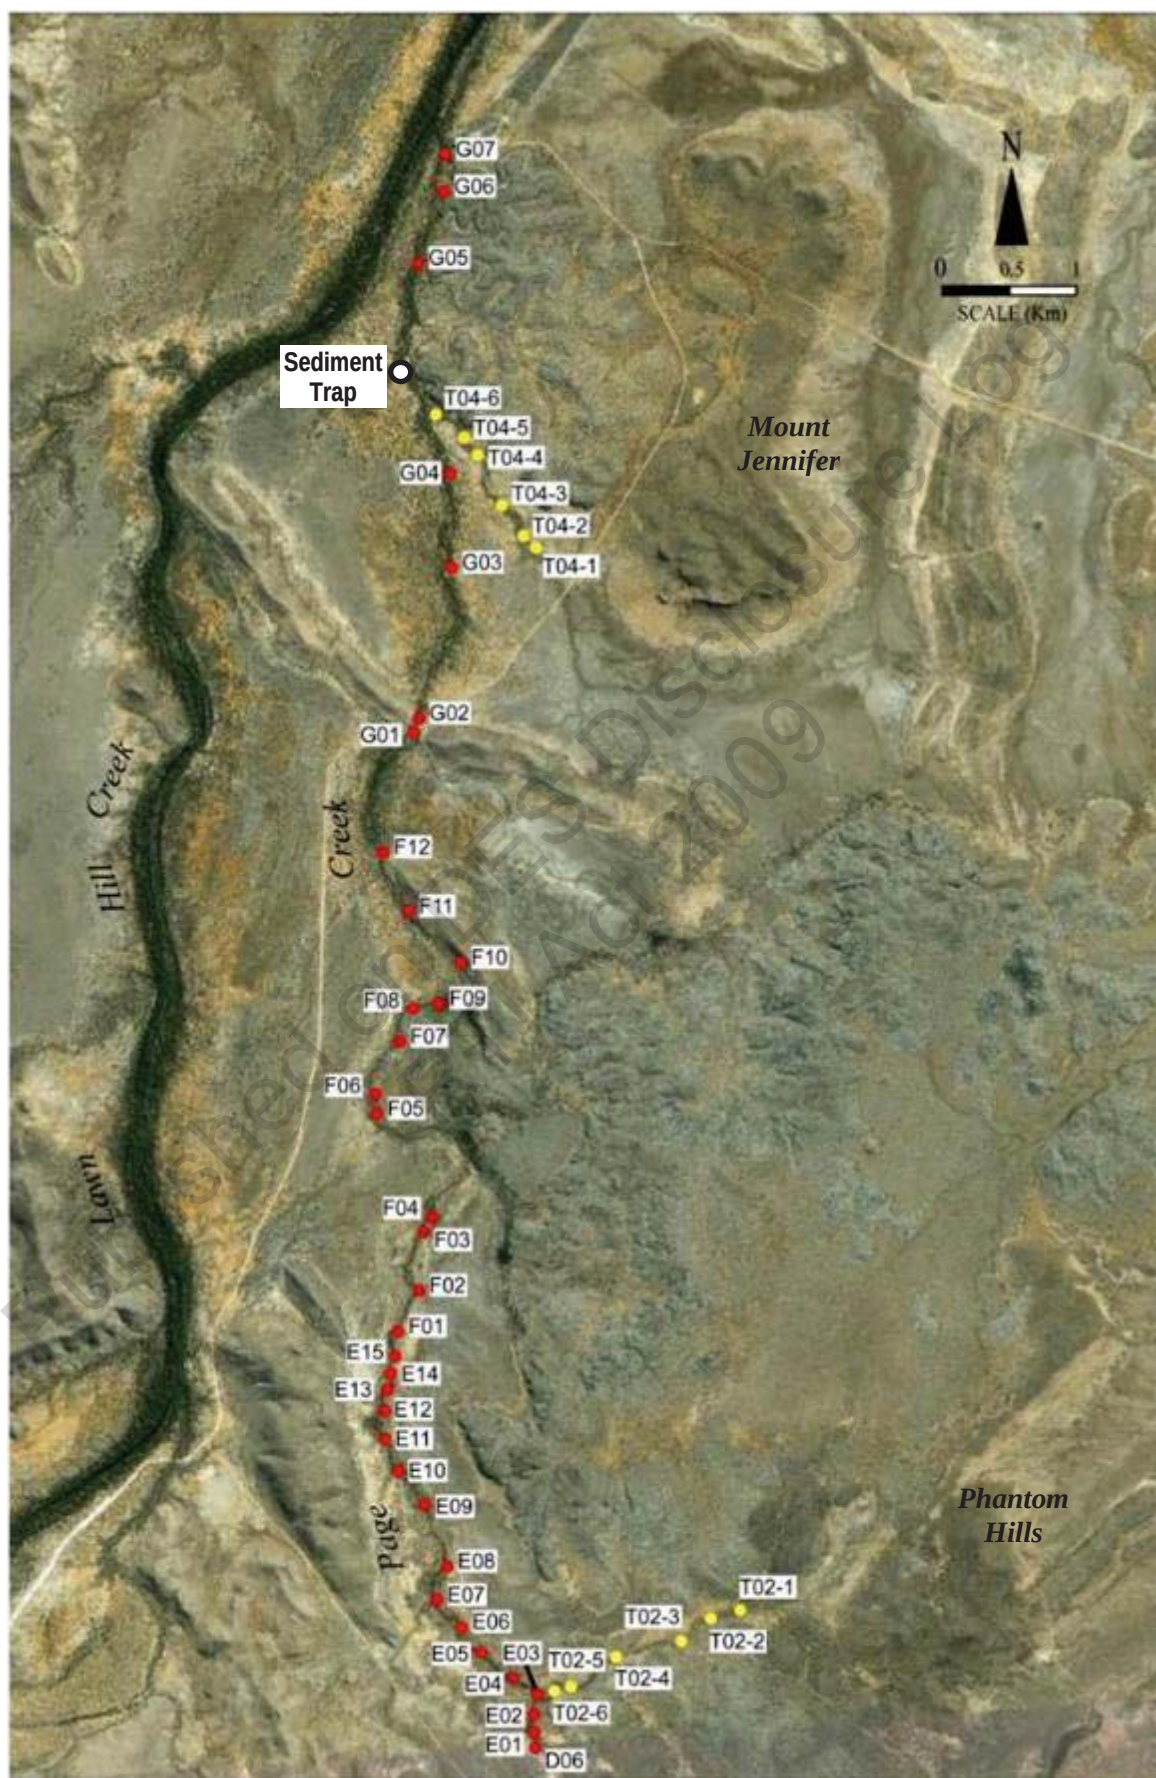
**Figure 2.1.2** Page Creek sites located in stream reaches E to G. [Google Earth]. Tributary sites (prefixed T) were sampled in 2010 but have not been sampled since.

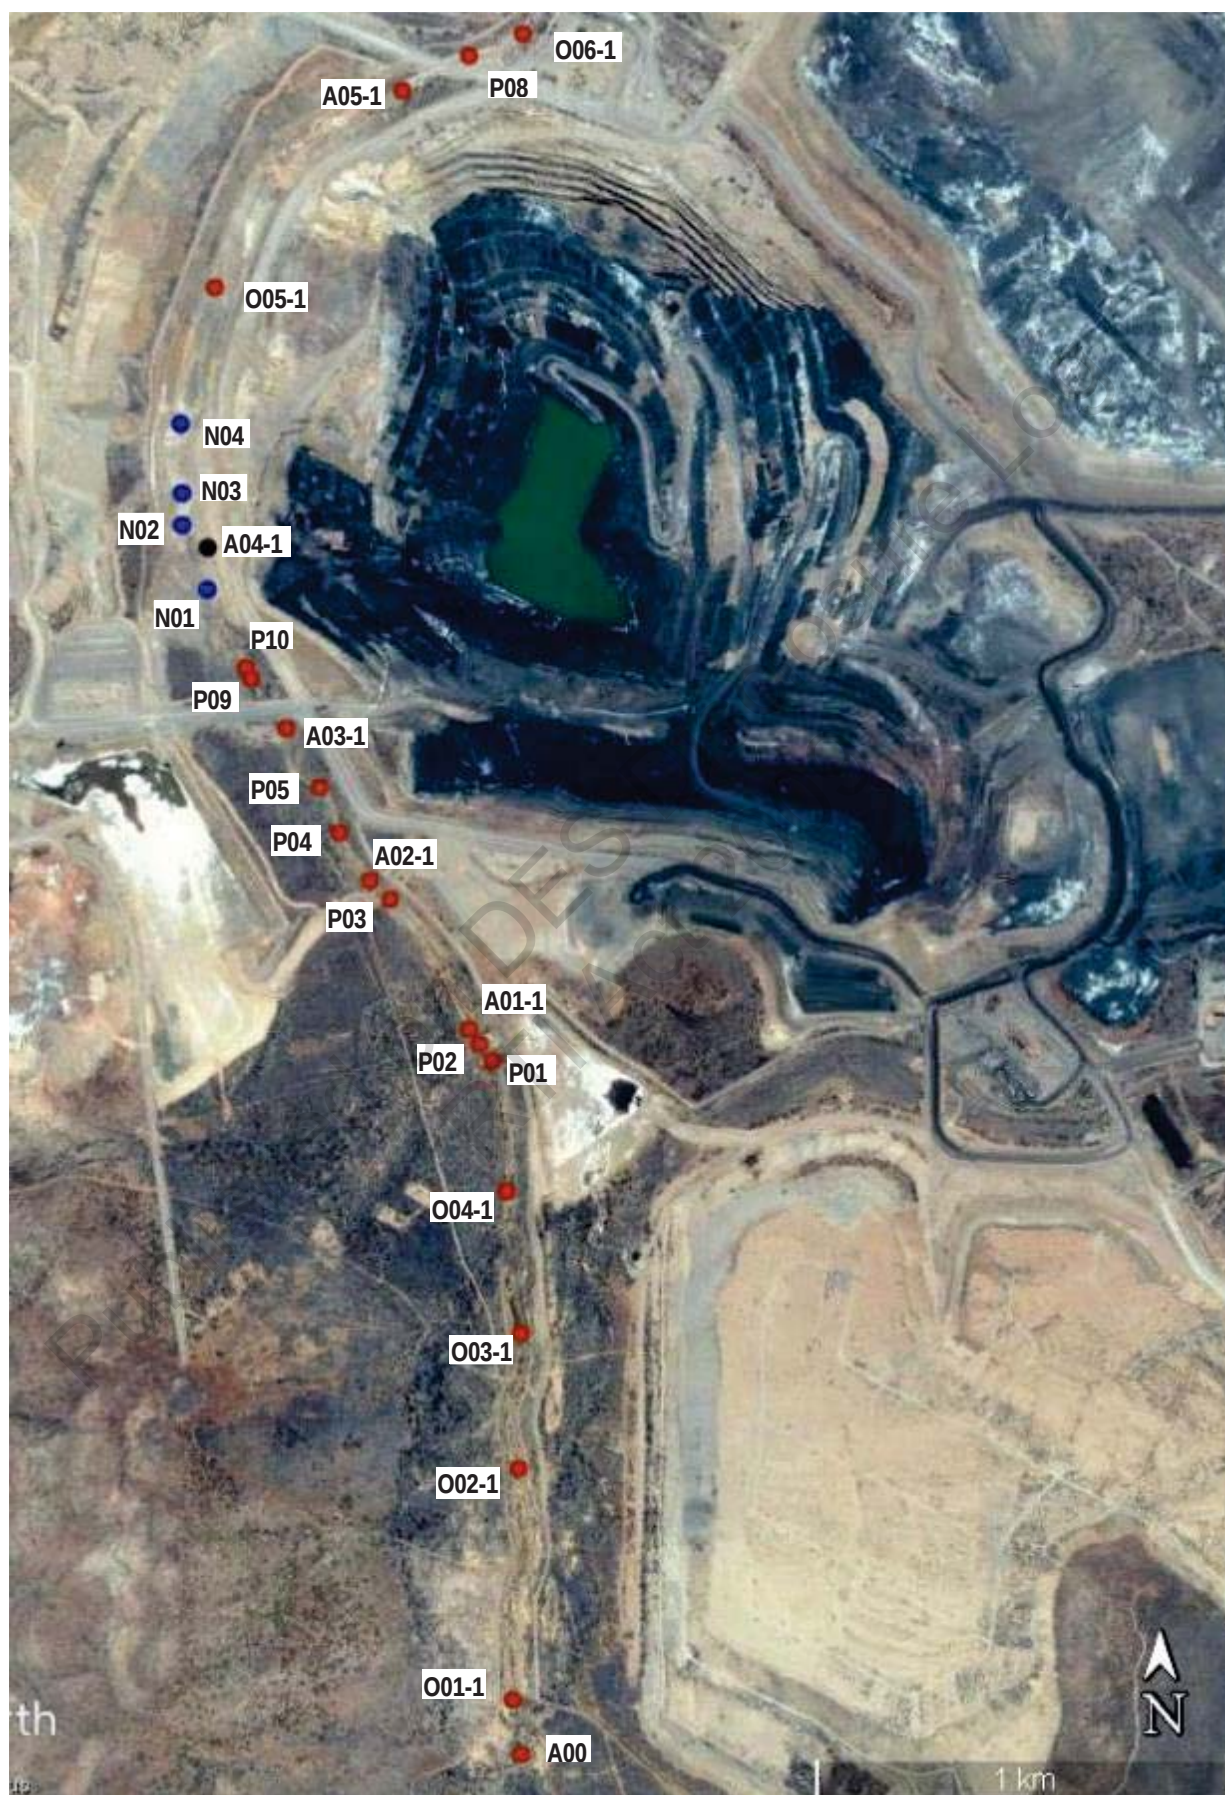
**Figure 2.1.3** Page Creek Diversion channel sites sampled in 2014. [Google Earth 2017].

The new sites established in the diversion included control sites located upstream of site A01. That upper section of the diversion has been designated as “Reach 1A”. In 2014 a minor realignment of the diversion resulted in site A04 being bypassed and four new sites were established in order to obtain baseline data for the new section of channel. The current diversion site network, which has not changed since 2014, is shown in Figure 2.1.3.

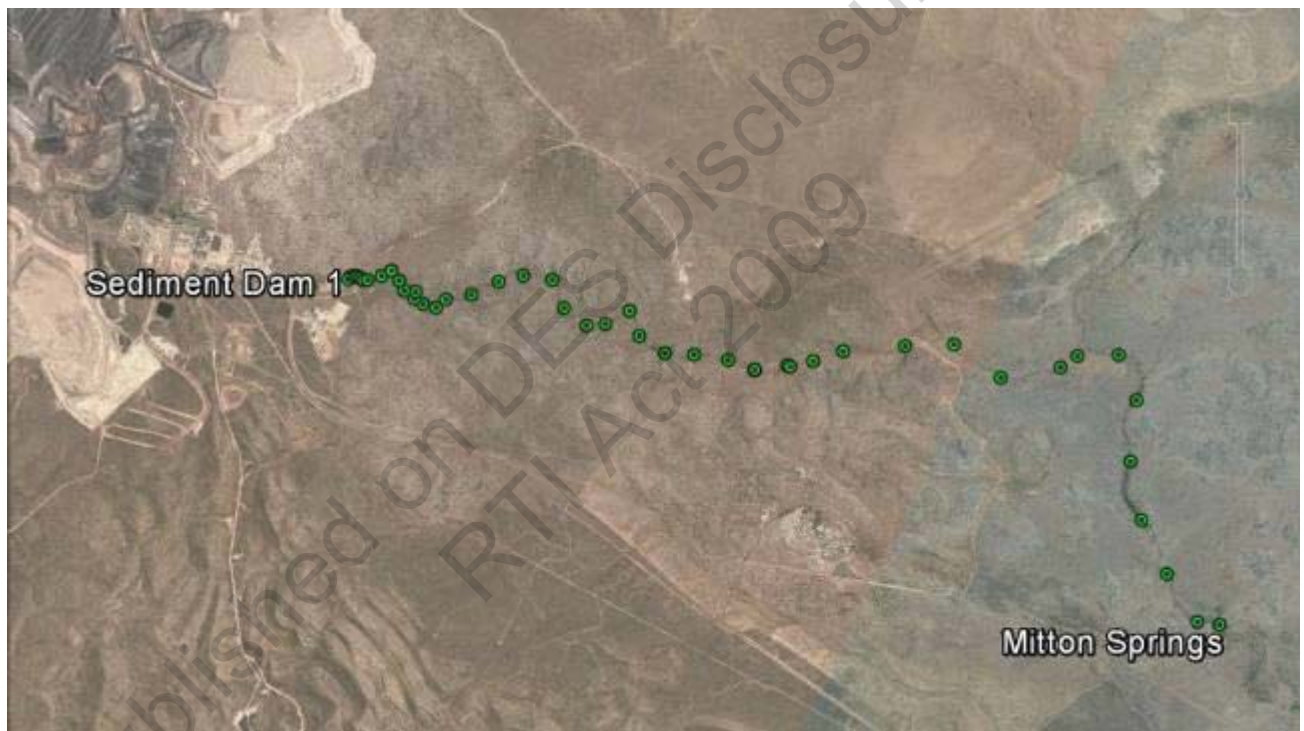
**Figure 4.1.1:** Map showing the location of sites sampled during the initial survey of North Mitton Creek in 2014.

The upper reaches of North Mitton Creek were first surveyed by TropWATER in August 2014 as part of a broad one-off study to characterise waterways in the vicinity of the mine site as an aid to closure planning. That survey indicated that North Mitton creek and its associated vegetation communities were in reasonably intact condition, but bottom sediments in the creek were found to be enriched with mine-related metals, especially zinc. In response to that initial finding Century immediately contracted TropWATER to conduct a detailed study to quantify the source, nature and extent of the sedimentary contaminant residues, assess ecological risks, recommend remedial measures and target locations for potential sediment removal. Sampling was conducted at 42 locations established at gradually increasing intervals between the Sediment Dam One spillway and Mitton Springs site MS1 (which was already known to contain low metal concentrations based on REMP sampling results); a thread distance of approximately 10 km from the Sediment Dam Spillway (Figure 4.1.1).

The results of that sediment sampling survey, completed in October 2014, indicated that sediments within a 7.4 km section of North Mitton Creek, between Sediment Dam One and the entry point of Gum Hole Plains tributary, contained elevated concentrations of mine-sourced zinc (plus minor quantities of cadmium and lead). Zinc concentrations within that stream-reach attenuated significantly with distance downstream (see Figure 4.1.2), but only three of the 42 sites sampled reported results that did not exceed the ANZECC 2000 ISQG-High, indicating that immediate remedial action was warranted. Zinc loads in the contaminated section of the creek totalled approximately 1400 kg, 540 kg of which was contained within a 1.32 km length of stream situated within 2 km of the sediment dam.

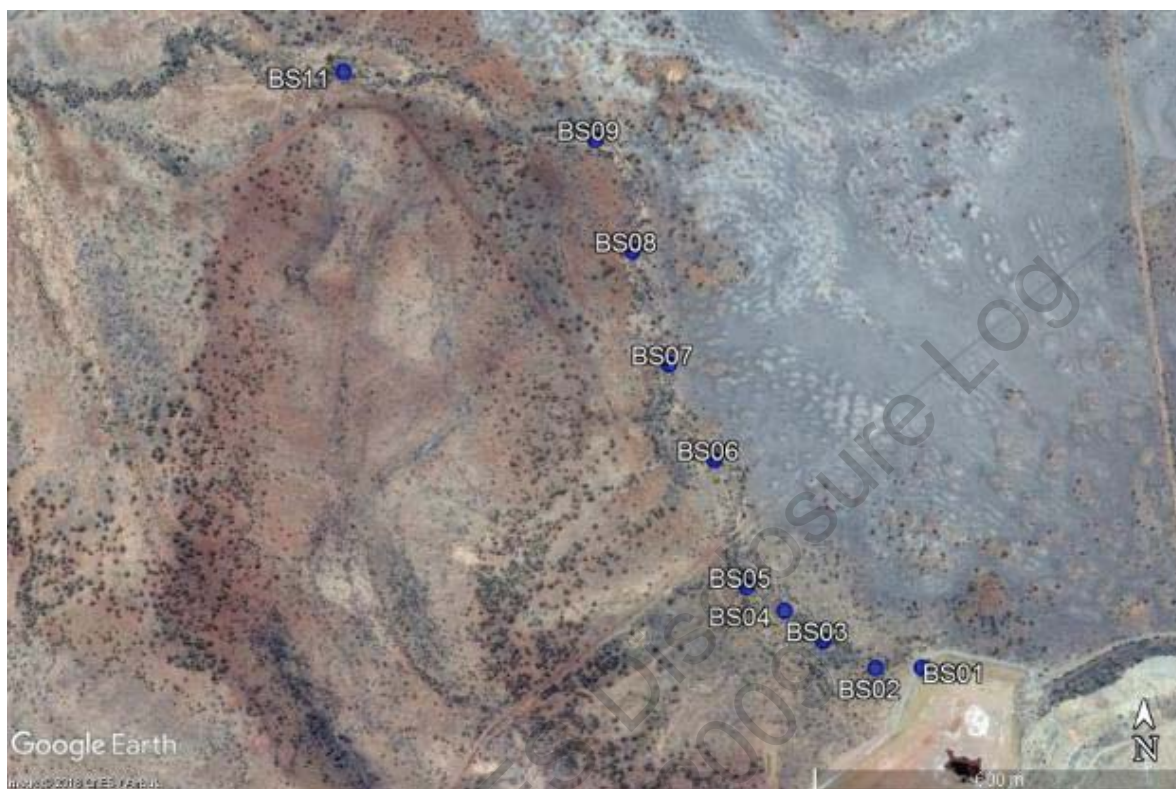
**Figure 7.3.1** Location of routine SQMP reach sampling sites in the upper reaches of Bullridge Creek. Sites in the lower reaches of the creek are shown in Figure 7.1.1.

In 2018, to increase our capacity to detect sediment movements and discriminate between random variations and emerging trends, the spatial scope of the sampling sites in the upper reaches was extended 750 m further downstream by adding sites BS09 (a 250 m reach) and BS11 (500 m). Due to the consistently low results reported to date at SQMP sites in the lower reaches of the creek, sites BS31 and BS33 were discontinued and the length of reaches BS30 and BS32 have been increased to cover those sections of the stream. The 2018 site network (see Figure 7.3.1 and Table 7.3.1) will be retained for future routine annual SQMP surveys.
