**SUNROCK WOOL PTY LTD**

**PRELIMINARY SITE INVESTIGATION  
(STAGE 1) OF LAND AT  
17 RIVER ROAD, REDBANK**

**24262-001-362  
MARCH 1992**

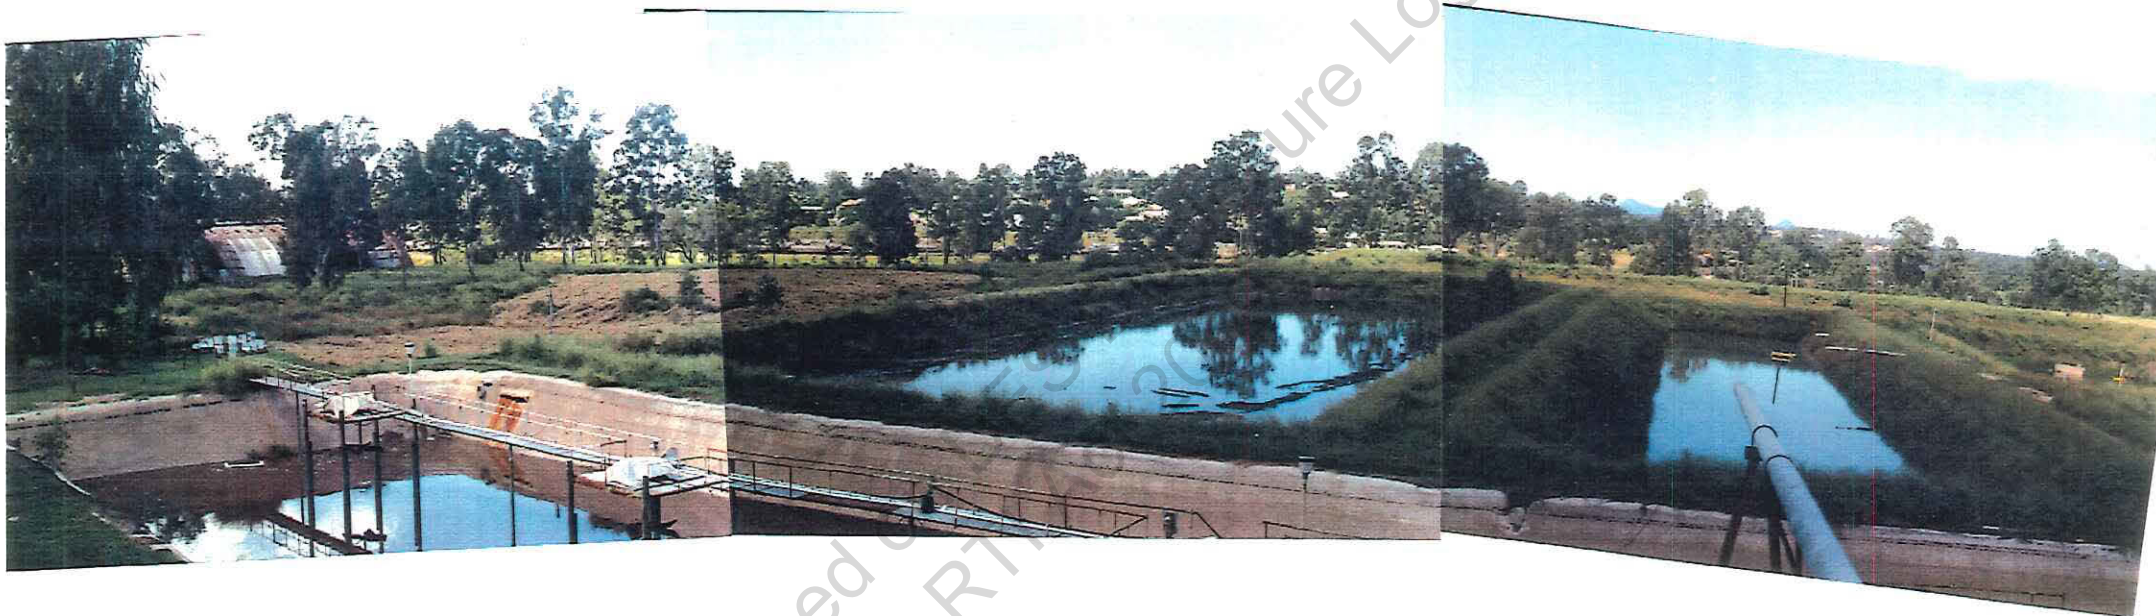
**Photograph 1** View of the south showing the five settling ponds and to the east, an igloo (No. 1) used by Redbank Steel. Note sludge mound to east of settling pond (mown area).

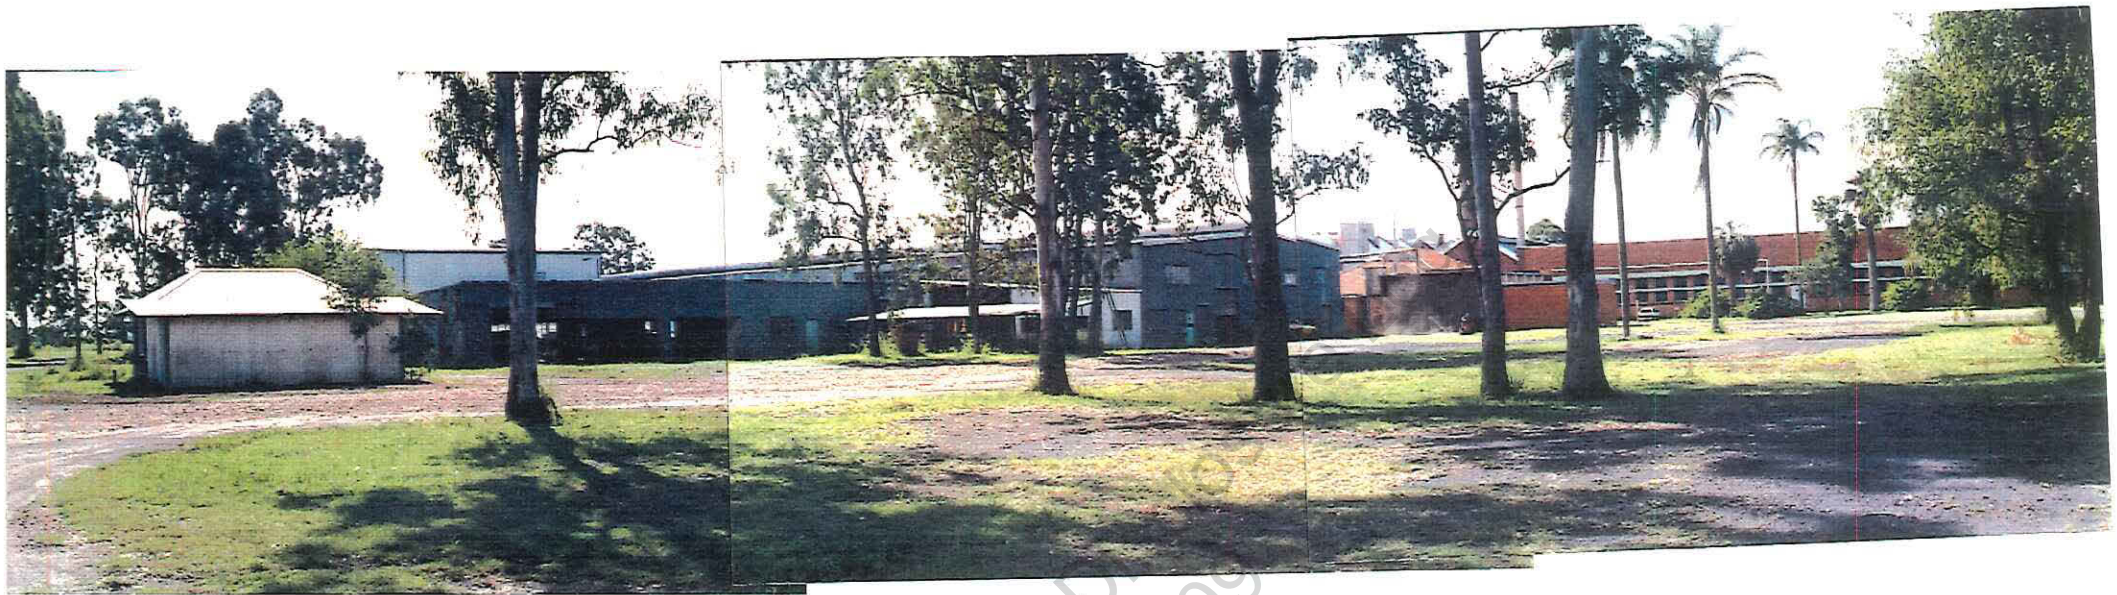
Photograph 2

View to west showing the eastern side of the factory, including the workshop on the LHS to middle and the shed housing the scouring lines on the RHS.

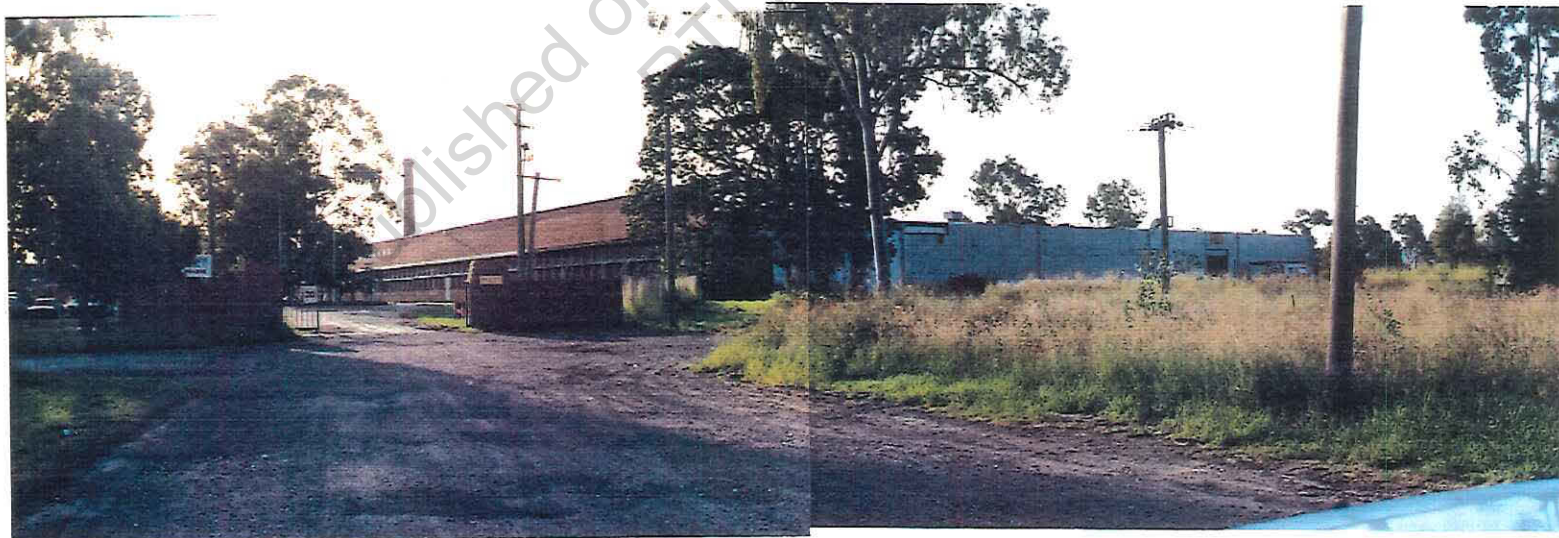
Photograph 3

View to west showing the front entrance on River Road with a track off to the right going to the engineering shop (tenant, on RHS) and to the dwellings on the north of the site. File A

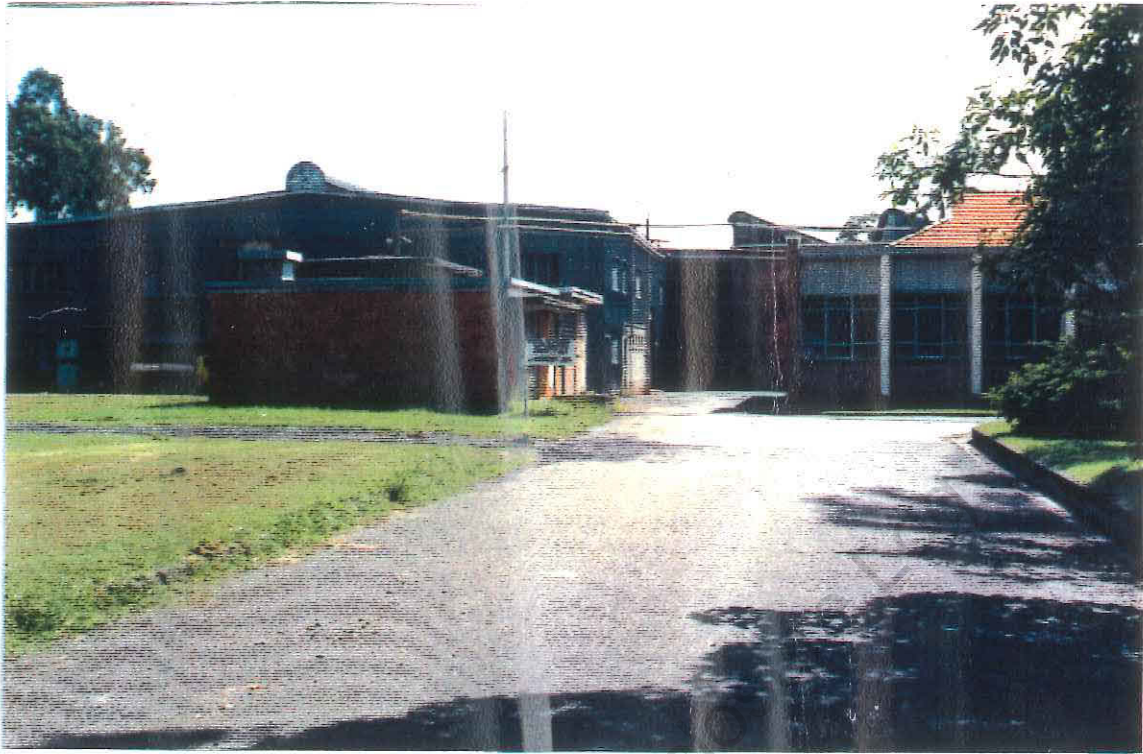
**Photograph 4** View to west showing substation in foreground, office on RHS, and workshop to rear.

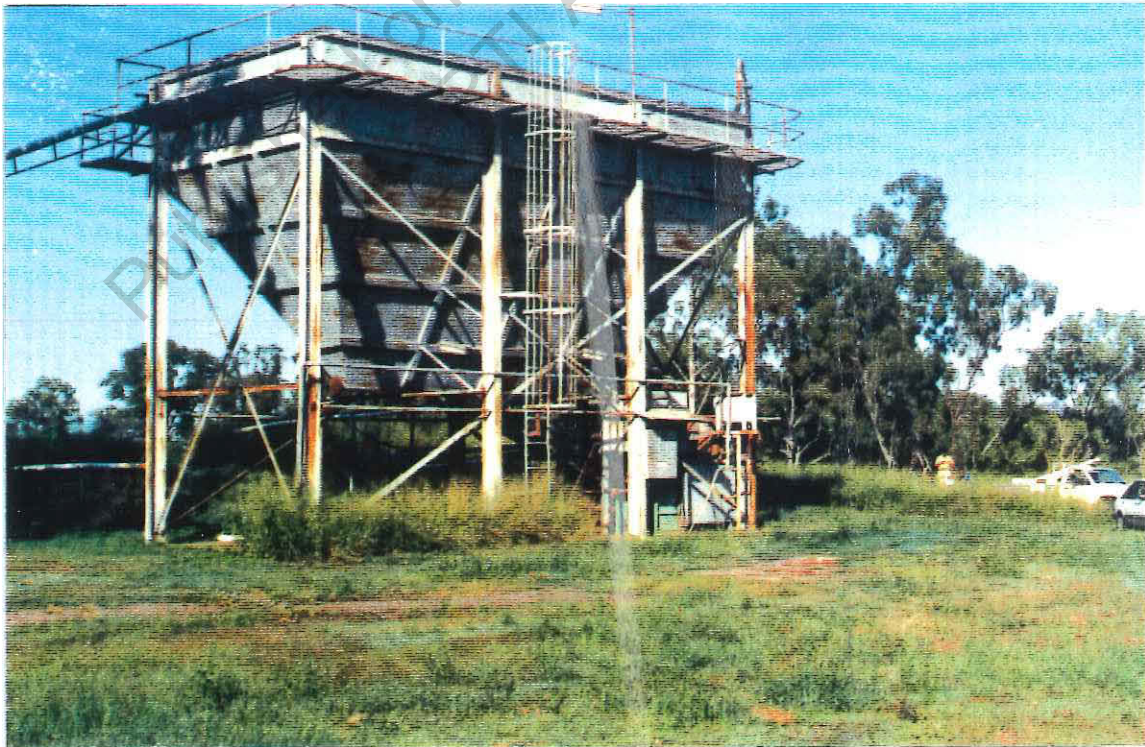
**Photograph 5** View to the southwest showing large clarifier at pond 1. (Figure 1). Borehole No. 1 being drilled on RHS.

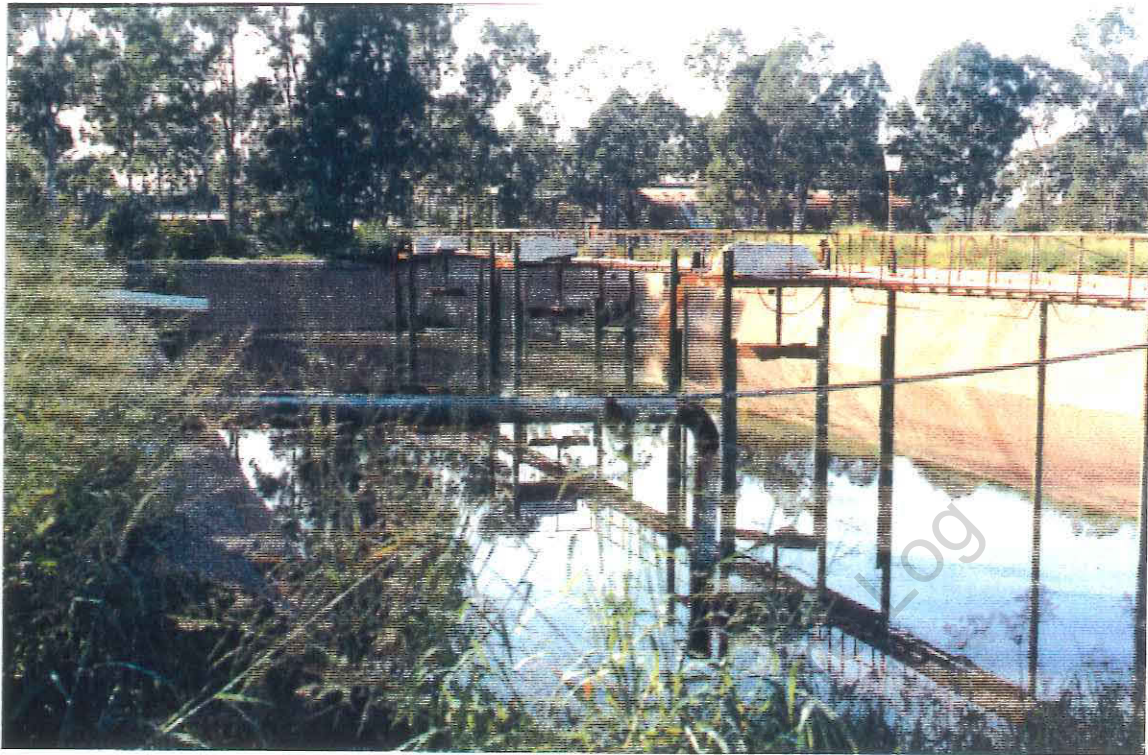
**Photograph 6**

View to east showing settling pond 1. (Figure 1) and igloo of Redbank Steel in background.

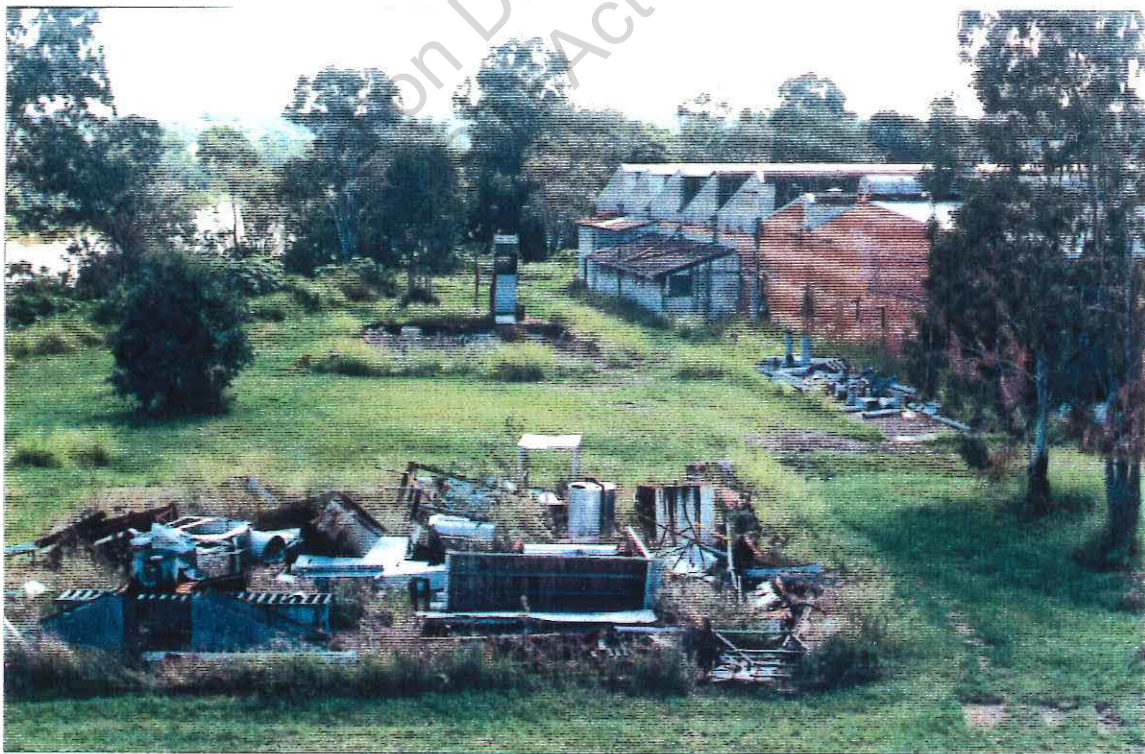
**Photograph 7**

At present there are two rubbish piles on the western side of the main factory building (Photo 7) which are predominantly old machinery parts, ducting etc. Three man-made lagoons on the northern side of the property (Lot 1 on RP No. 77197) also contain water, and are being used for the dumping of rubbish from the tenants on site. Odour from biological decay is noticeable in the area of these lagoons. Most of the ground around the site appears clean and any bare areas have arisen from water retention.

View to north showing western side of factory, with the smaller clarifier in centre, Brisbane River to LHS. The first shed (brick wall) is area where finished garments etc. were made.

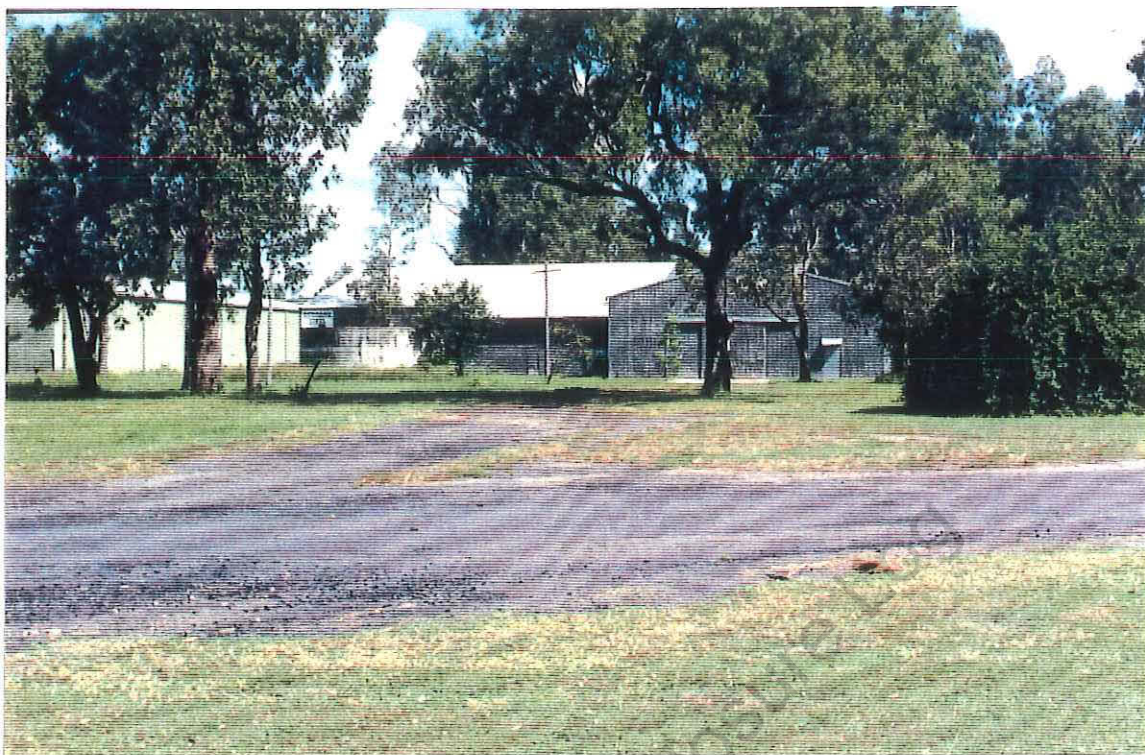
**Photograph 8** View to south showing another shed used by Redbank Steel. LHS shows shed used by Plastics recycling (tenant).

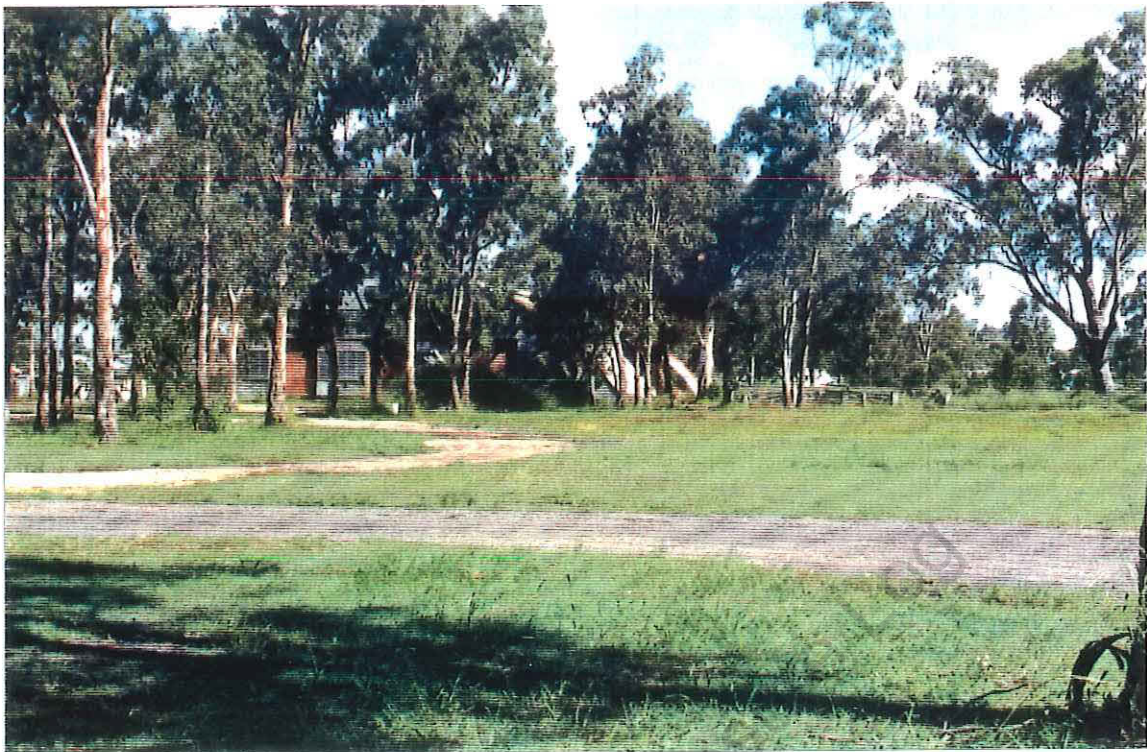
**Photograph 10** View to south showing "abandoned" igloo used by Redbank Steel.

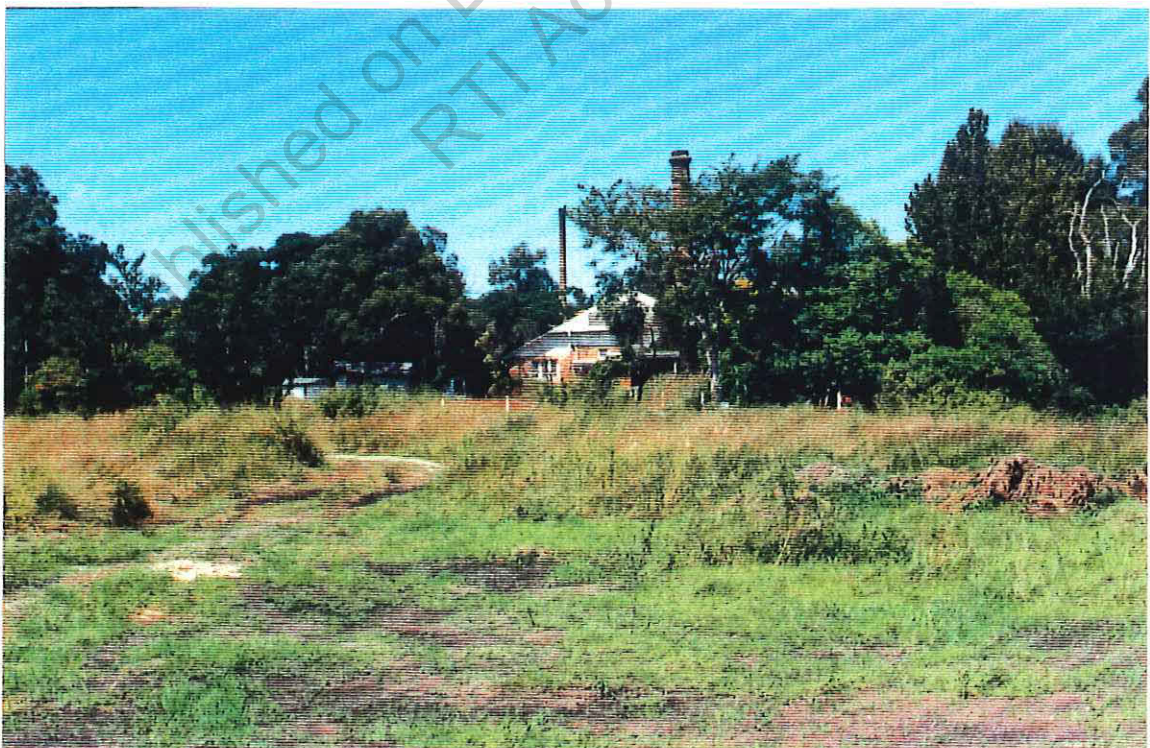
**Photograph 11** View to south showing northern aspect of sch4p4(6) Pers dwelling with the smoke stacks of the factory just visible.

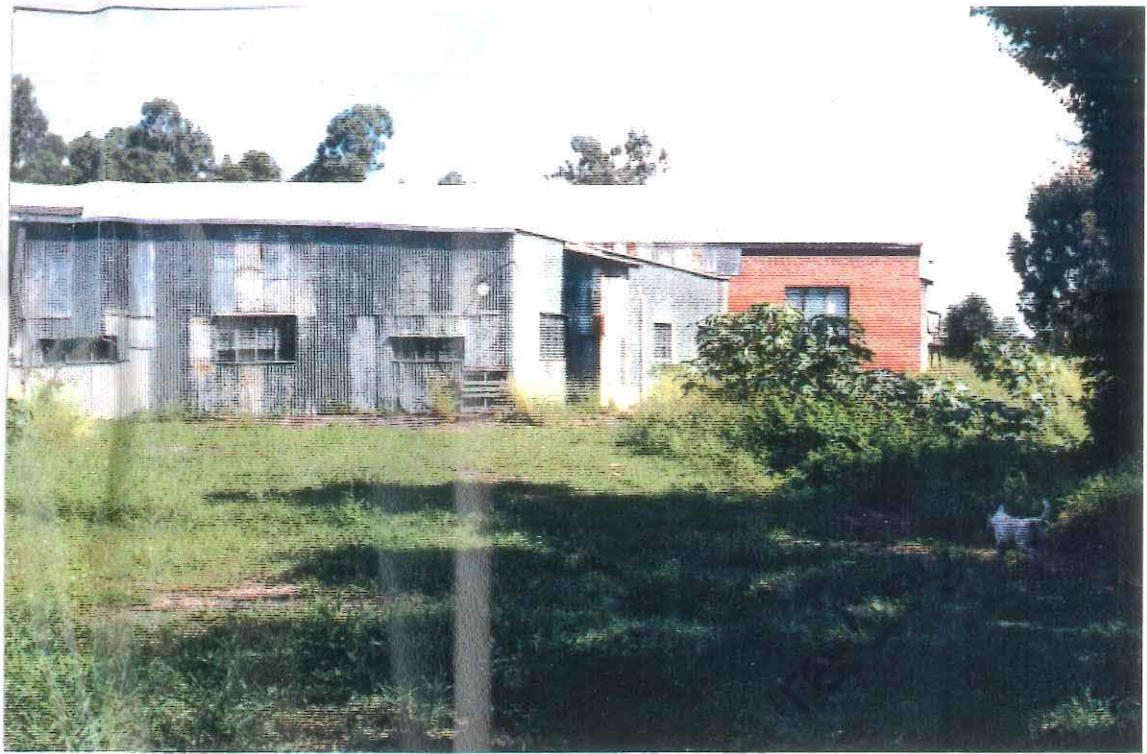
**Photograph 12** View to the south at northwest corner of factory, dropping off to the river on RHS. Shed in picture used to be area for chemical storage.

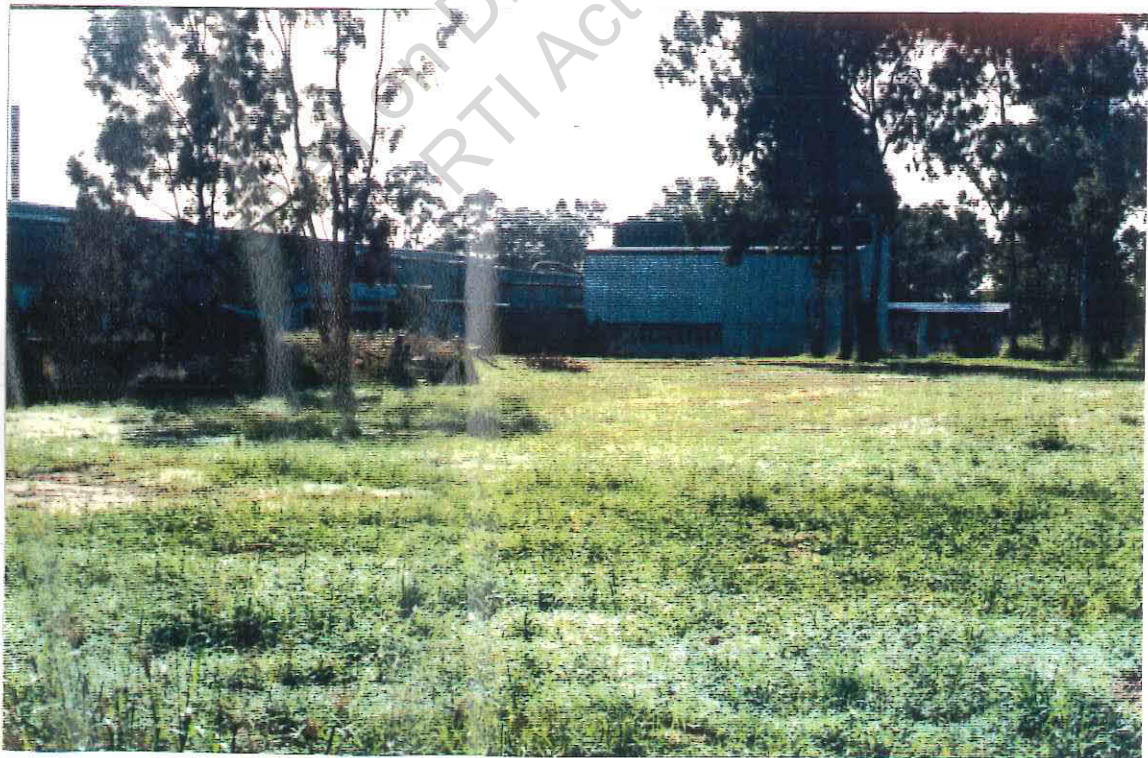
**Photograph 13** View to northeast showing southern aspect of factory, with shed at centre containing empty chemical drums.

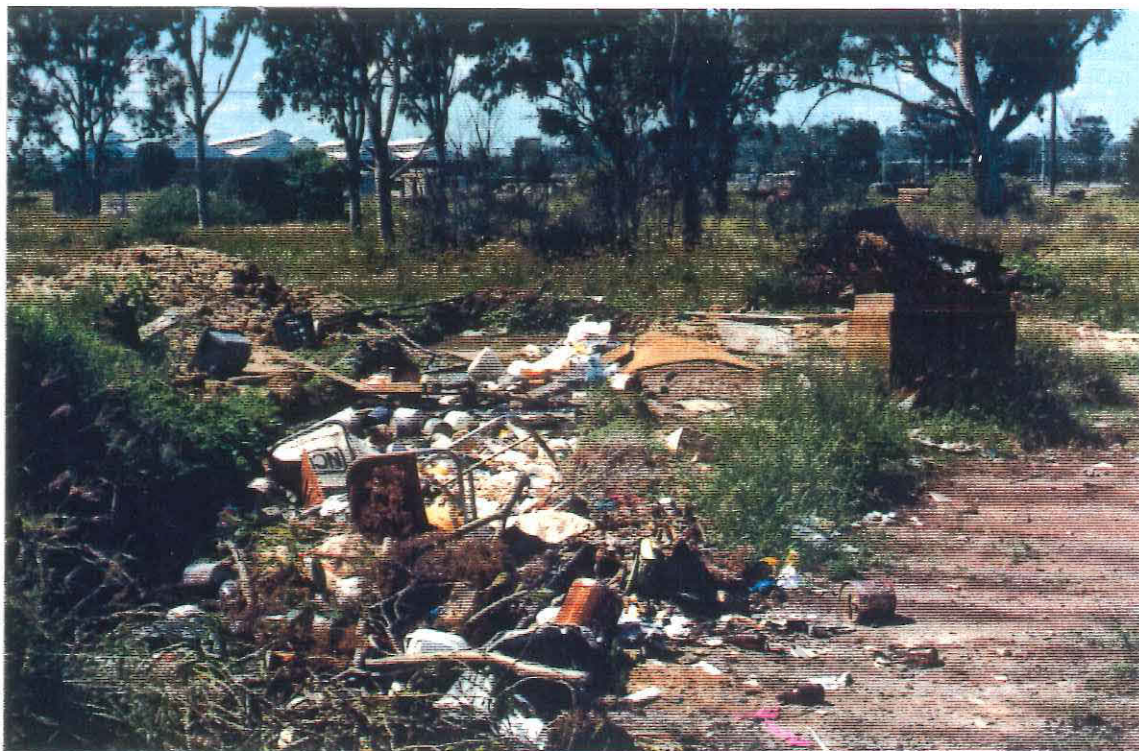
**Photograph 14** View to east showing a pond at northern end of site used for dumping.

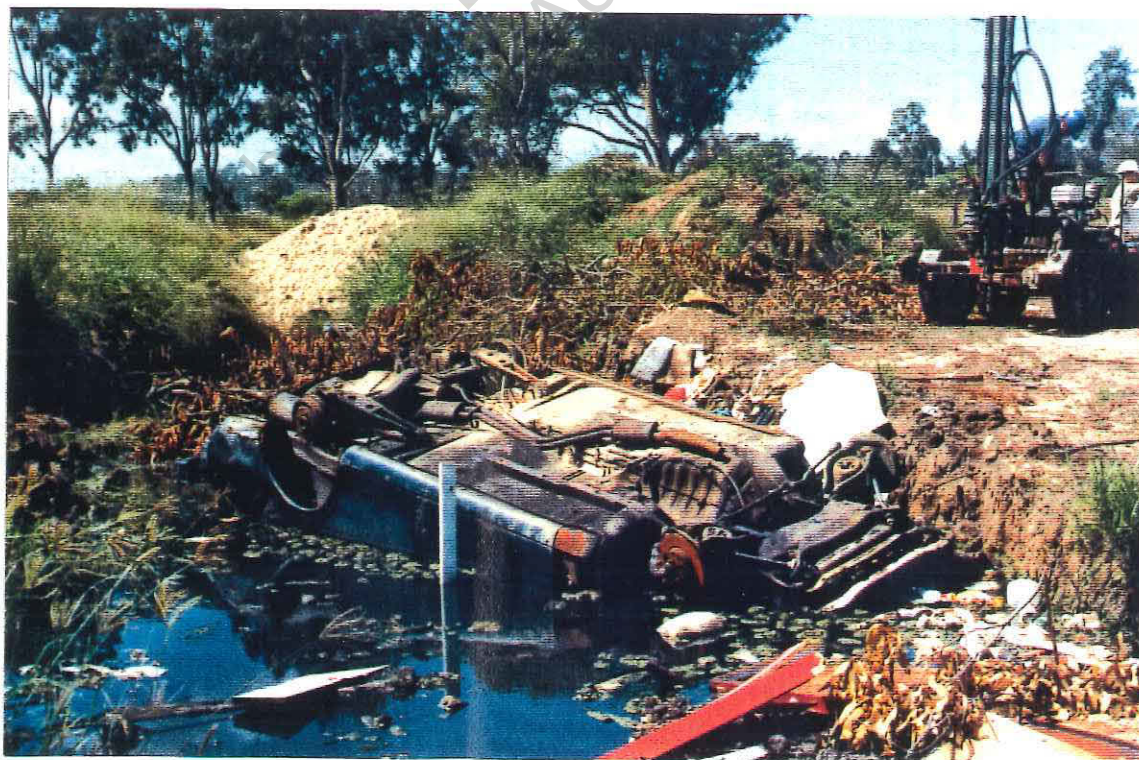
**Photograph 15** View to southeast showing another pond at northern end of site used for dumping. Drilling rig for borehole No. 2 on RHS.
