Department of Environment and Heritage Protection  
MINISTERIAL BRIEFING NOTE

SUBJECT: Northern Bribie Island erosion and risk of an ocean breakthrough to Pumicestone  
Passage

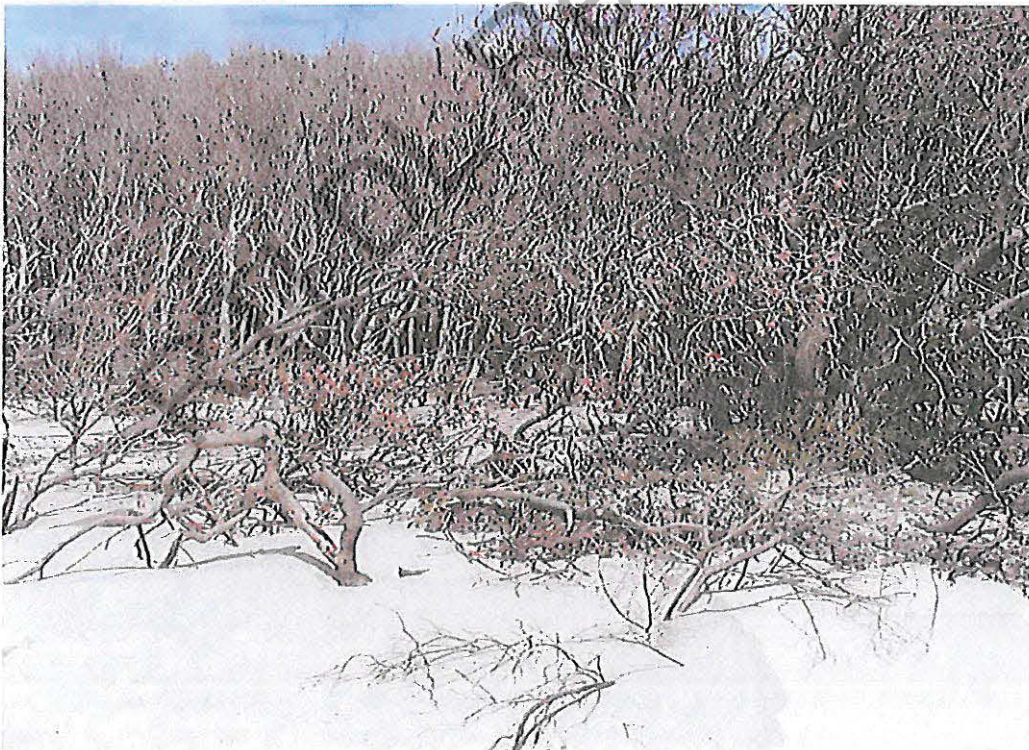
**Photo 1: Typical wave over-wash and death of tea-tree forest from salt and sand burial on low dunes at Bribie Island.**

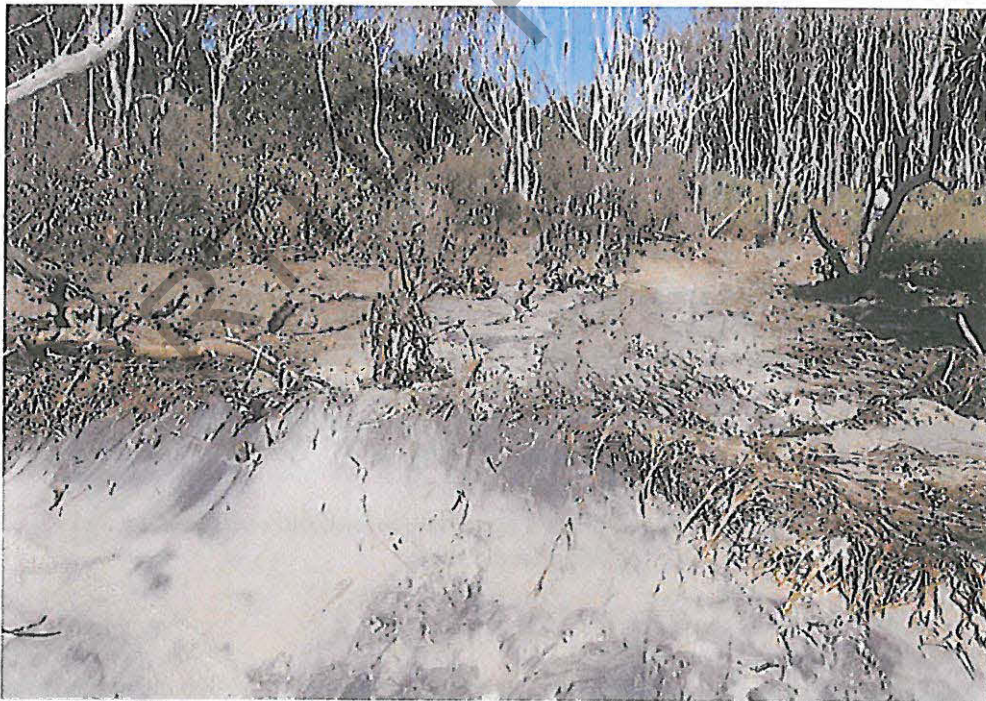
Photo 3A: Wave overwash area at Site 2. Dune width here is 35m back to mangrove. Note wave foam up to 1m deep.

Erosion and wave over-wash at a site opposite Bells Creek has lowered and narrowed the dunes to the extent that now has the potential to break-through and form a new entrance.

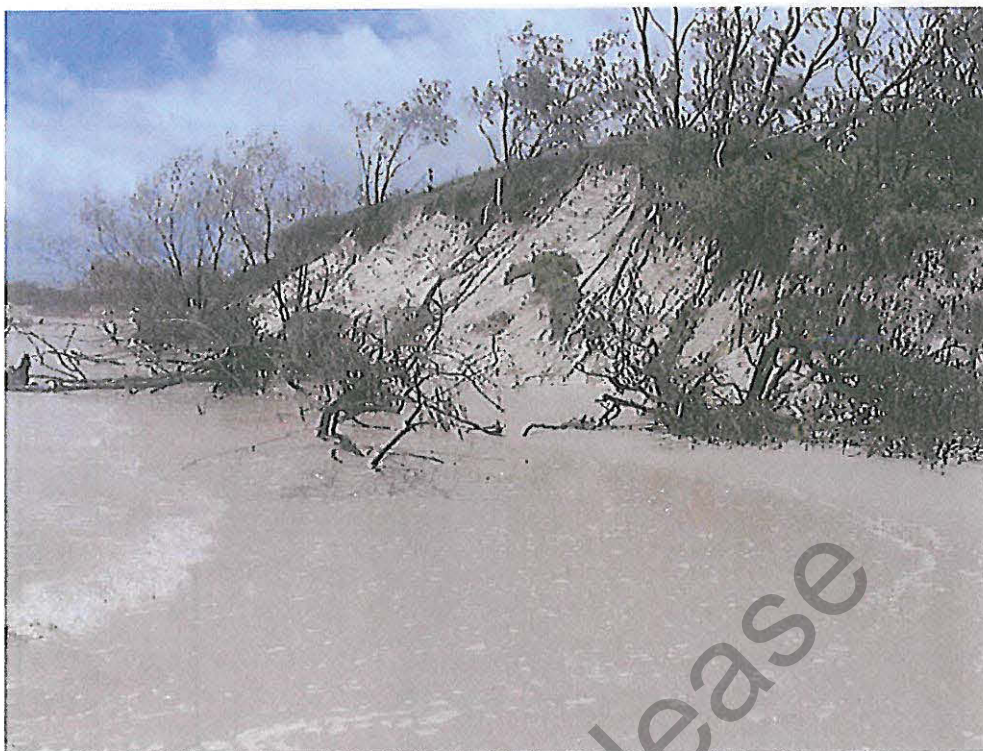
Photo 5: Sand borrow area to the immediate south of wash-over.

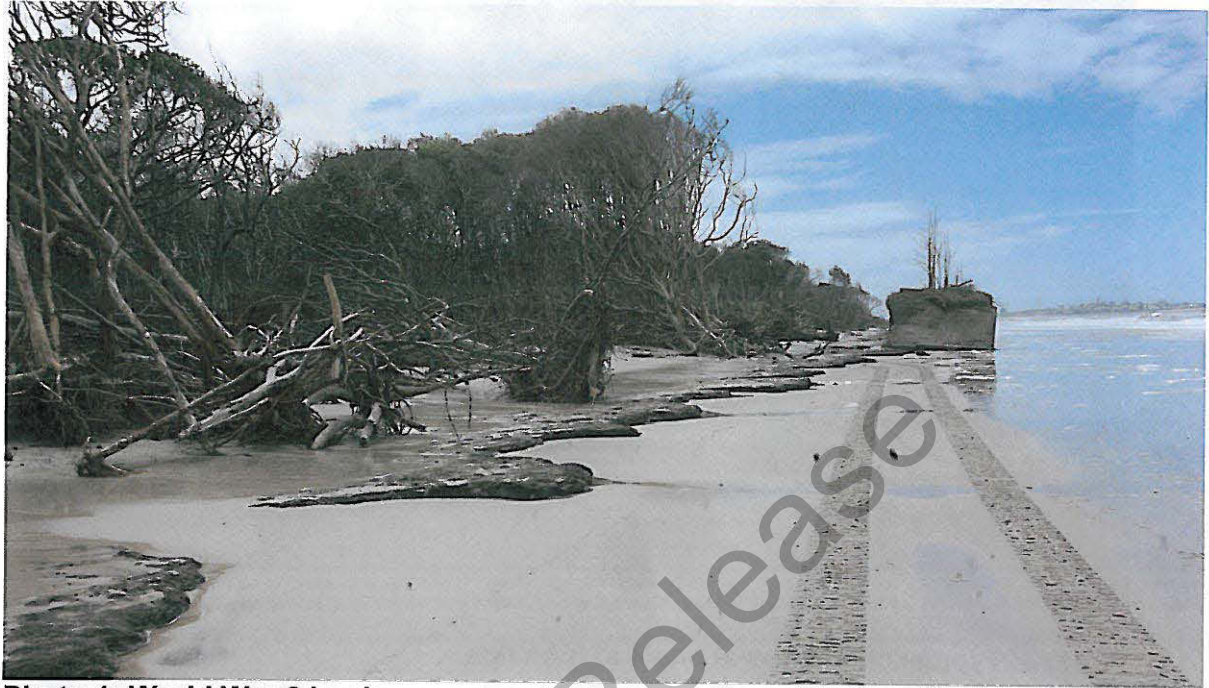
**Photo 1: World War 2 bunkers exposed by sea erosion with shoreline retreat into tea-tree swamps.**

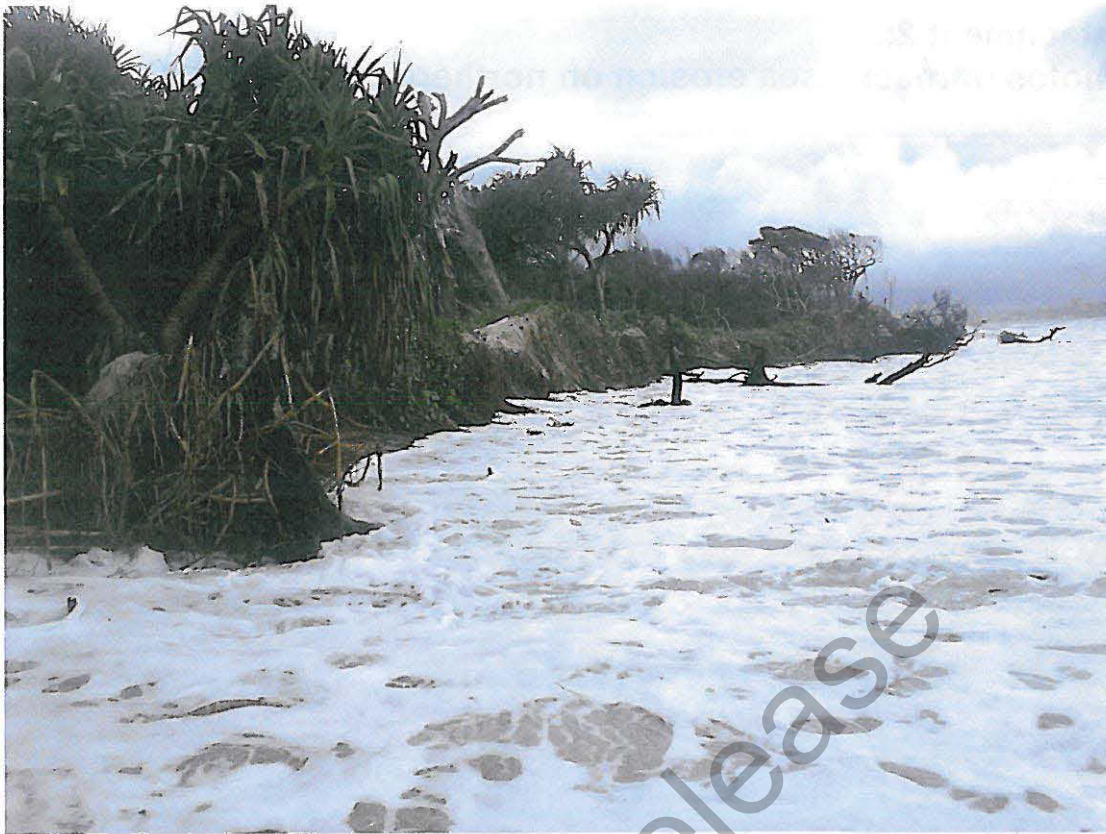
Photo 3: Typical conditions at site 4 at high tide.

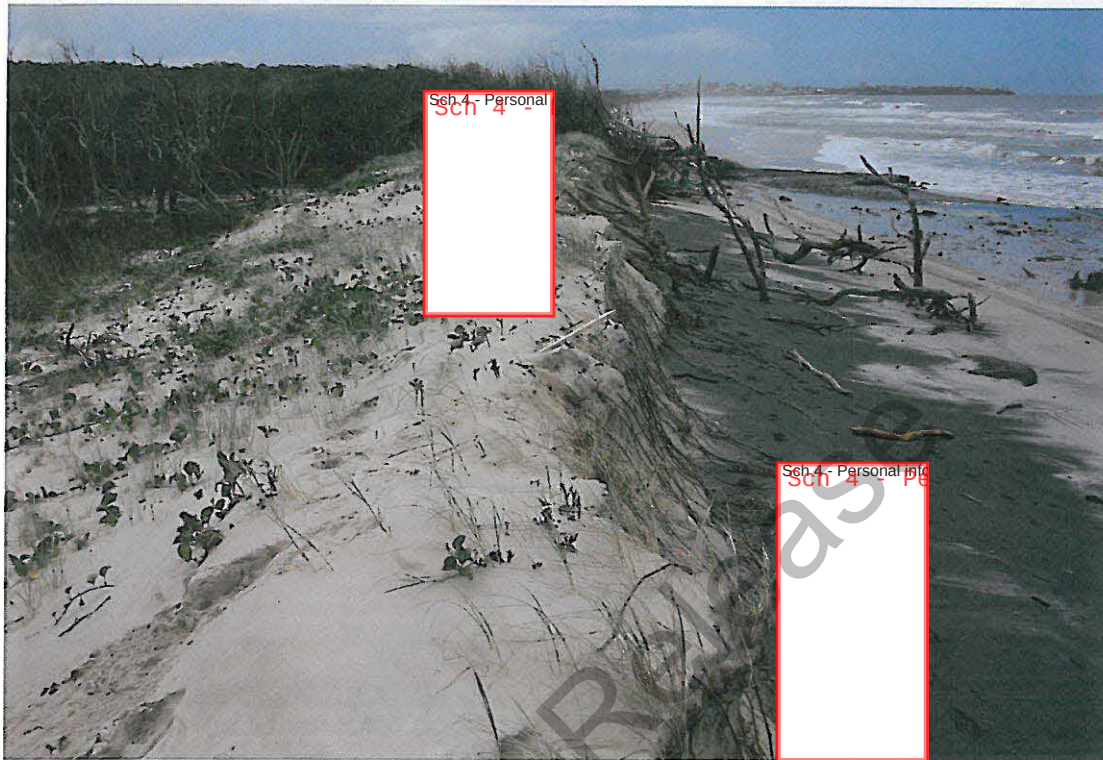
**Photo1: Bribie Island at its narrowest point at site 2 following erosion by cyclone Oswald in February 2013– dune some 30m wide**

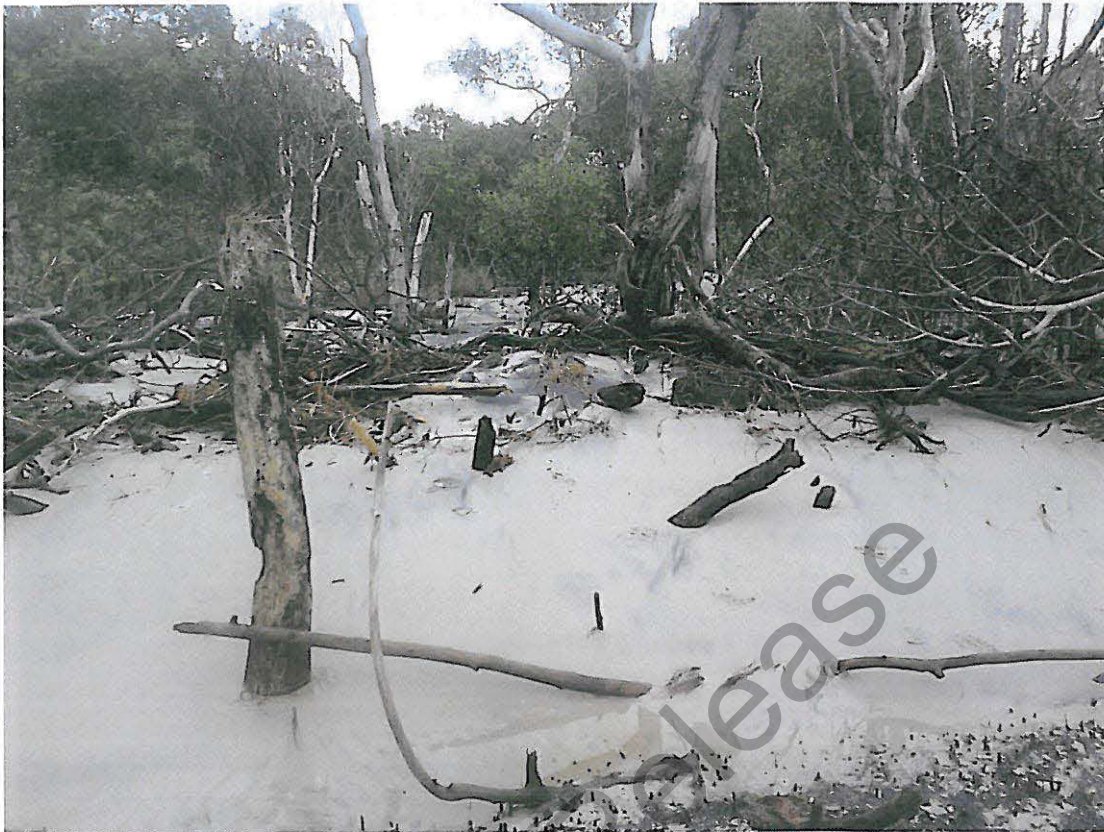
**Photo 3: View of site 2 from the high water mark on the eastern beach looking into mangrove in Pumicestone Passage.**

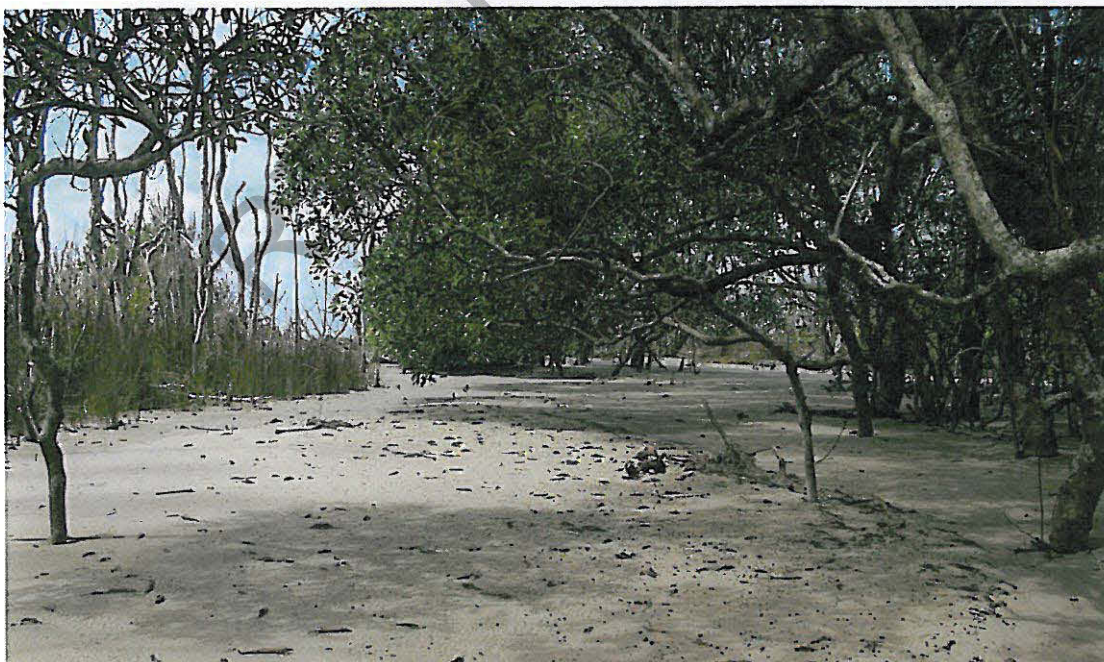
**Photo 4: Wave over-wash deposits of sand from the ocean beach into mangrove on the western side of the island**

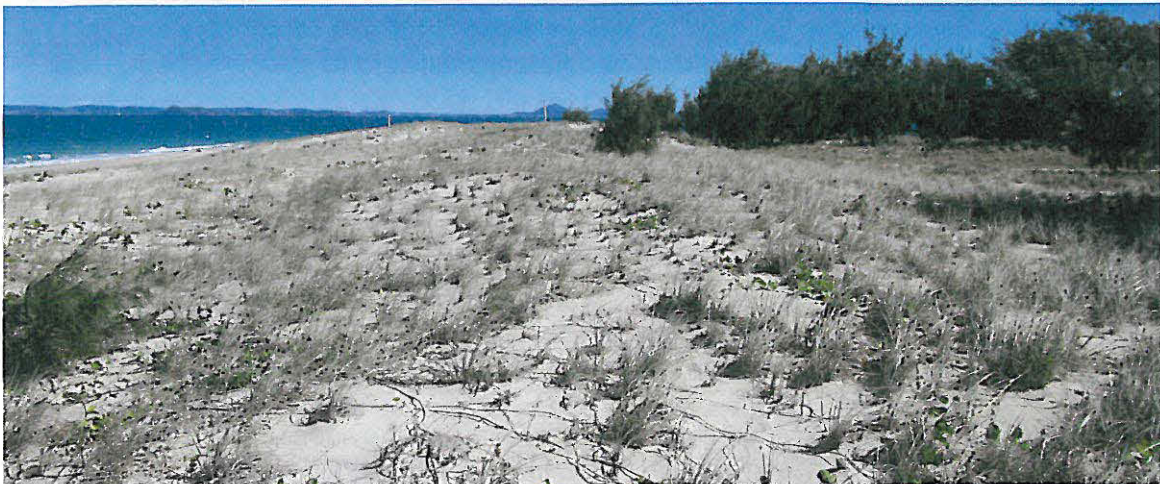
Photo 2: Broad zone of dune accretion backing Fishermans Beach. Note the horsetail she-oak trees colonising the older parts of the dune.

Fisherman's Beach is characterised by a wide zone of windblown sand accumulation colonised by herbaceous pioneer dune species (Photo 2). Young horsetail she-oak (*Casuarina equisetifolia* var *incana*) estimated at up to 4 years old occur at the back of this zone (Photo 1). Moving inland successive dunes are colonised by progressively older horsetail she-oak are observed, the oldest and most landward being estimated at 50-100 years old (Photo 3). Horsetail she-oak are an important indicator of dune age and coastal processes as they are the first pioneer tree species to colonise dunes stabilised by pioneer grasses and usually do not regenerate in old dune area, but die out and are replaced by tertiary species such as eucalypts, tea

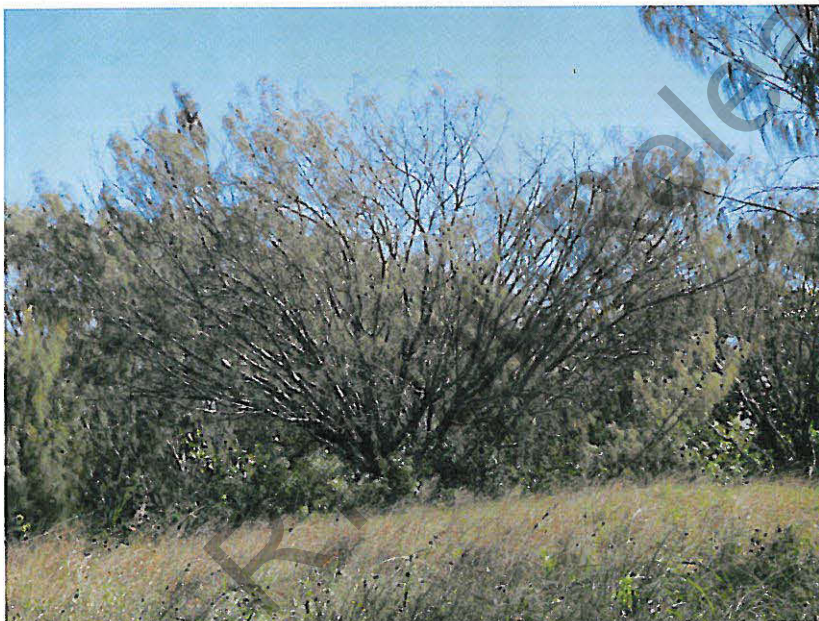
Photo 3: Very old horsetail she-oak on the most landward dune ridges running parallel to Fishermans Beach.

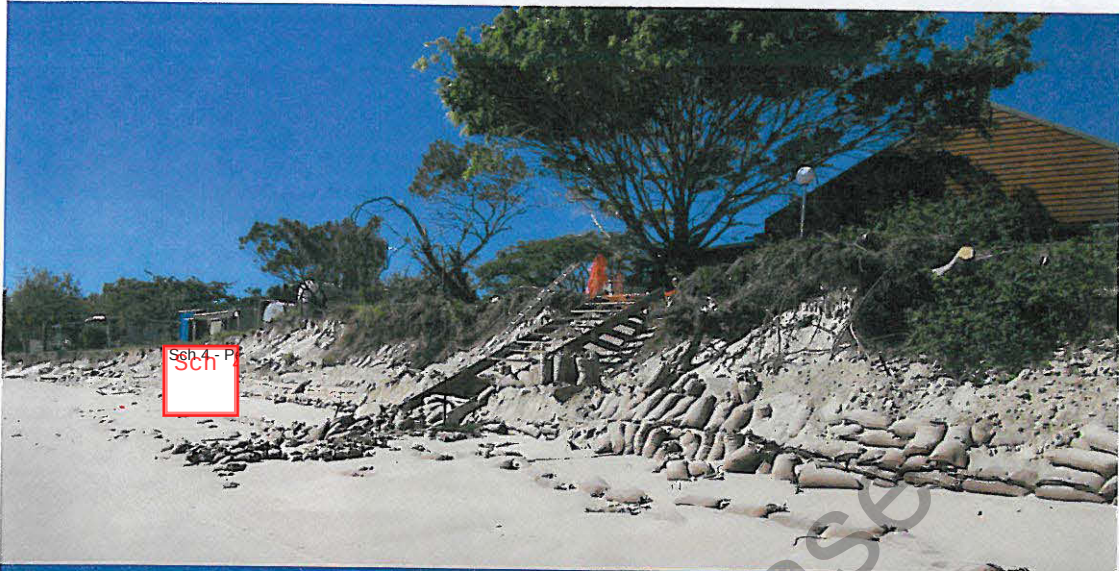
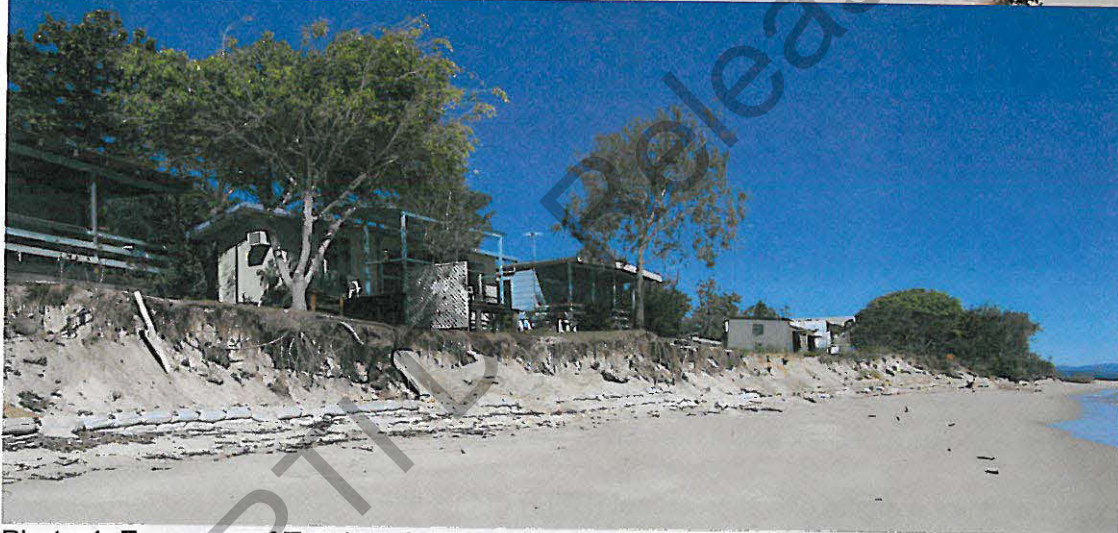
Photo 4: Exposure of Tourism Centre buildings on the edge of the erosion scarp. Note the extensive sand bagging.

Putney Beach is characterised by high steep erosion scarps progressively reducing in height eastward towards the base of the spit. The tourist facility is a collection of buildings and infrastructure now located on the dune crest now only metres from the scarp face (Photo 4). Buildings along 180 of beachfront are considered as being under imminent threat and building along a further 80m of beachfront, but setback further from the scarp face is under a moderate threat of loss from erosion. Vegetation on the scarp edge is characterised by eucalypts, tea-tree and beach scrub species typical of older areas with little exposure to marine conditions. At the central section of this coast a tea-tree swamp consisting of many large and very tall trees is now exposed on the beach by long-term erosion (Photo 5). The age of these trees and the expectation that a large, well vegetated dunal barrier would have existed seaward of this swamp strongly points to a long-term trend of shoreline recession. Old soil profiles are observed in the modern scarp face and the depth of the organic rich A-horizon (Photo 6) indicates a relatively old soil. No shell material was observed in the soil profile. Shell dissolves out over time from organic acids and

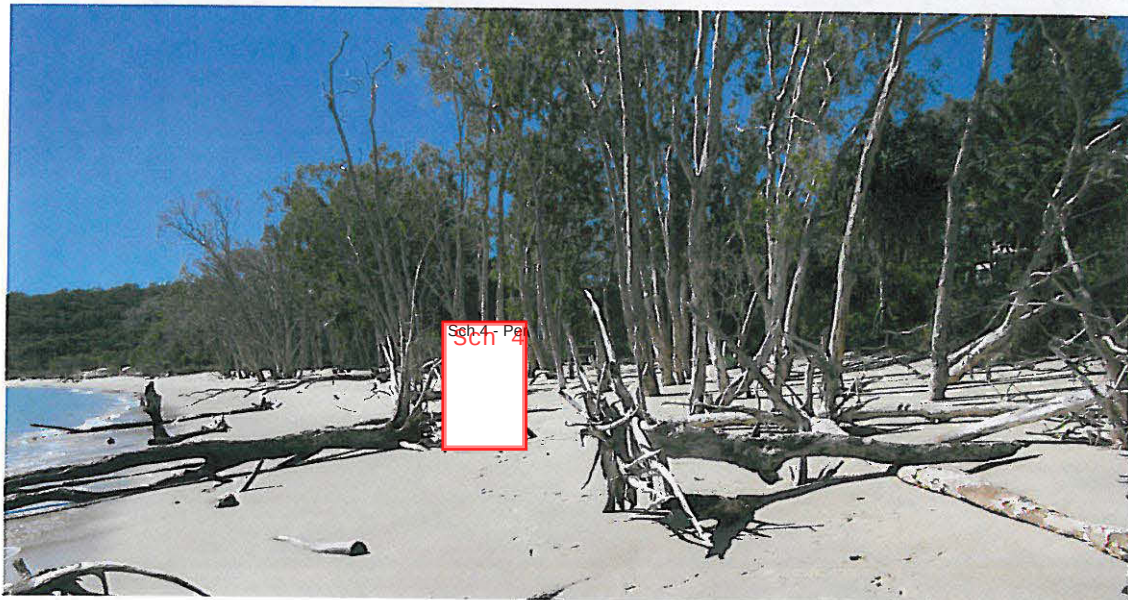
Photo 5: Tea-tree forest exposed on the beach by erosion of the seaward dune (looking east towards the base of the spit).

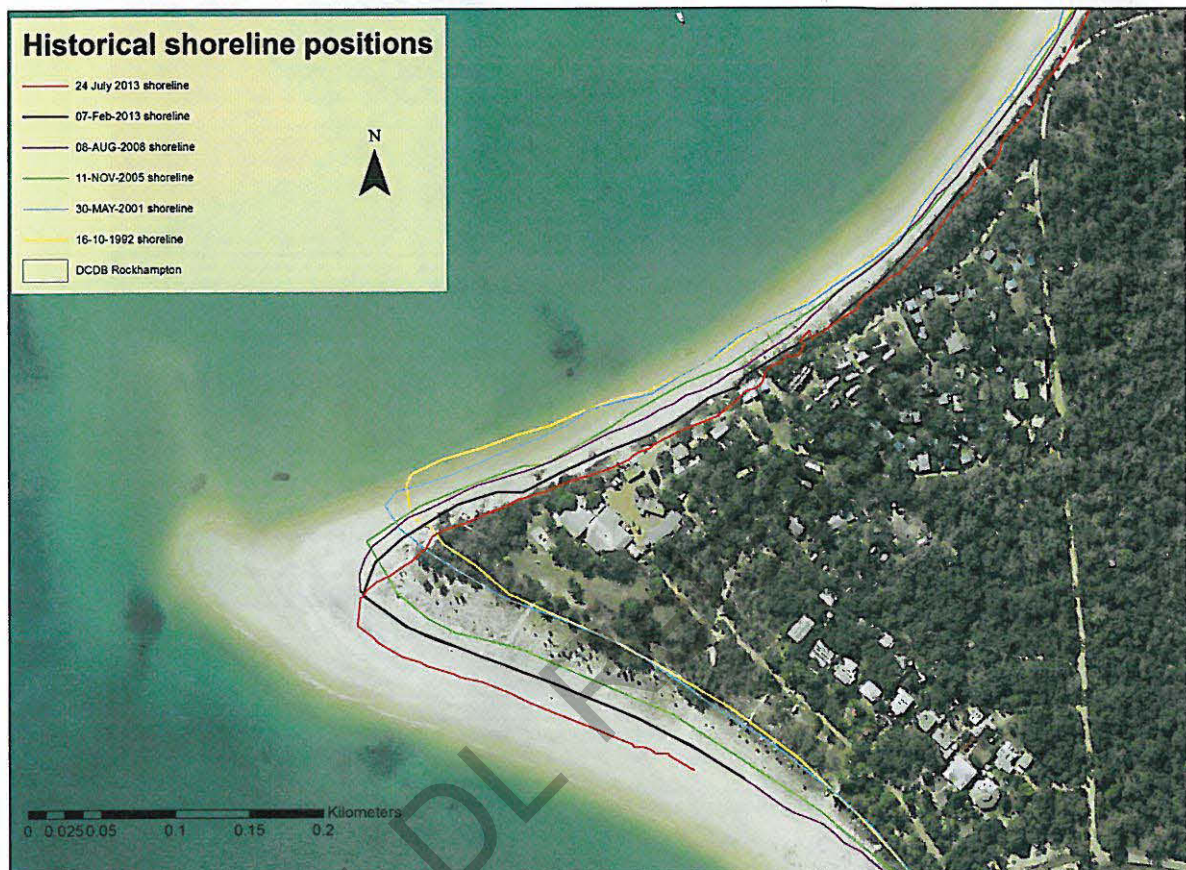
Figure 3: Historical shoreline positions on Great Keppel Island since 1992

Observation of historical shoreline positions over the last 30 years (Figure 3) confirm a consistent trend of shoreline erosion at Putney Beach and accretion at Fishermans Beach over the last 21 years. This trend in the vicinity of the tourist facility **main building** indicates a shoreline recession of 42m since 1992 giving a long term rate of shoreline recession of 2m per year. 180m to the east the erosion is slower at 27m since 1992, giving a long term rate of recession of 1.3m per year. Over the last 5 years the respective rates of recession for the western and eastern ends were both 3.4m per year which indicated acceleration. A shoreline recession of about 6m was recorded for the site in the first 7 months of 2013. There is certainly no evidence of a slowing or reversal of the erosion trend.

Fishermans Beach has experienced strong accretion since 1992 of up to 80m, or almost 4m per year.

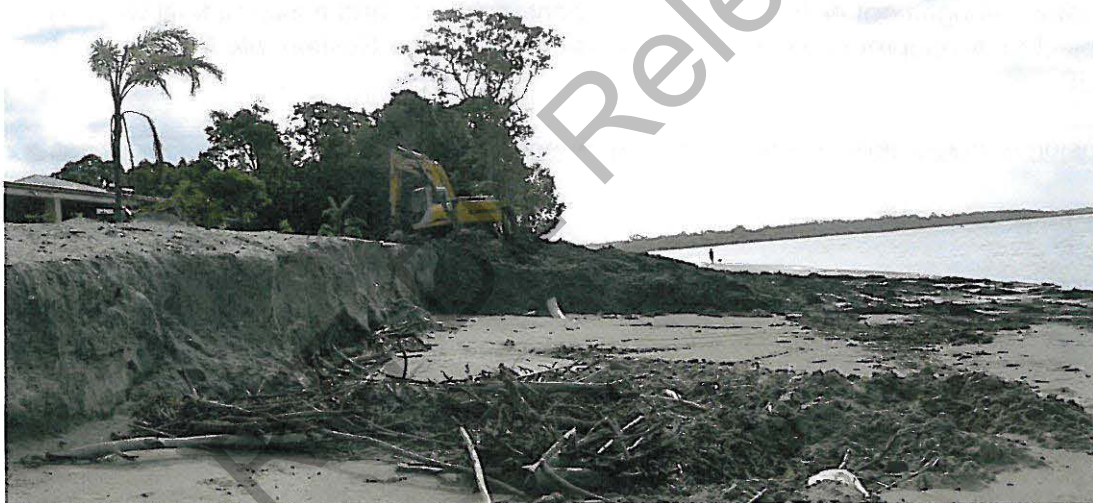
Photo 7: Scraping sand from the intertidal zone at Toogum to reinforce the eroded dune. The sand only persisted for a few weeks and was moved back down the beach slope by a storm event.

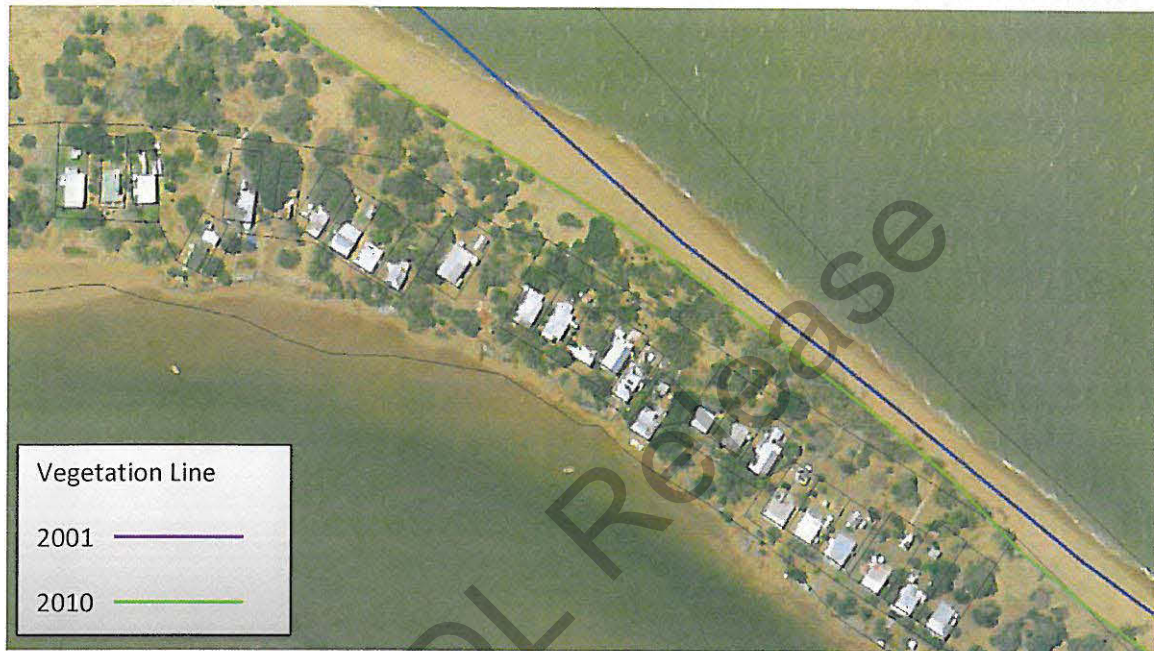
**Figure 2: Vegetation lines overlayed on 2010 aerial photography**

The shoreline position adjacent to Skyringville Passage has remained relatively stable over the 10 year period assessed. This is expected as the erosion issues are associated with the reduced supply of sediment from the Burnett River which should impact on the oceanside beach.
