# **CROYDON GOLD MINE**

**1996 (AMENDED)  
DECOMMISSIONING PLAN FOR ML5248**

Prepared by Woodward-Clyde  
May 1997

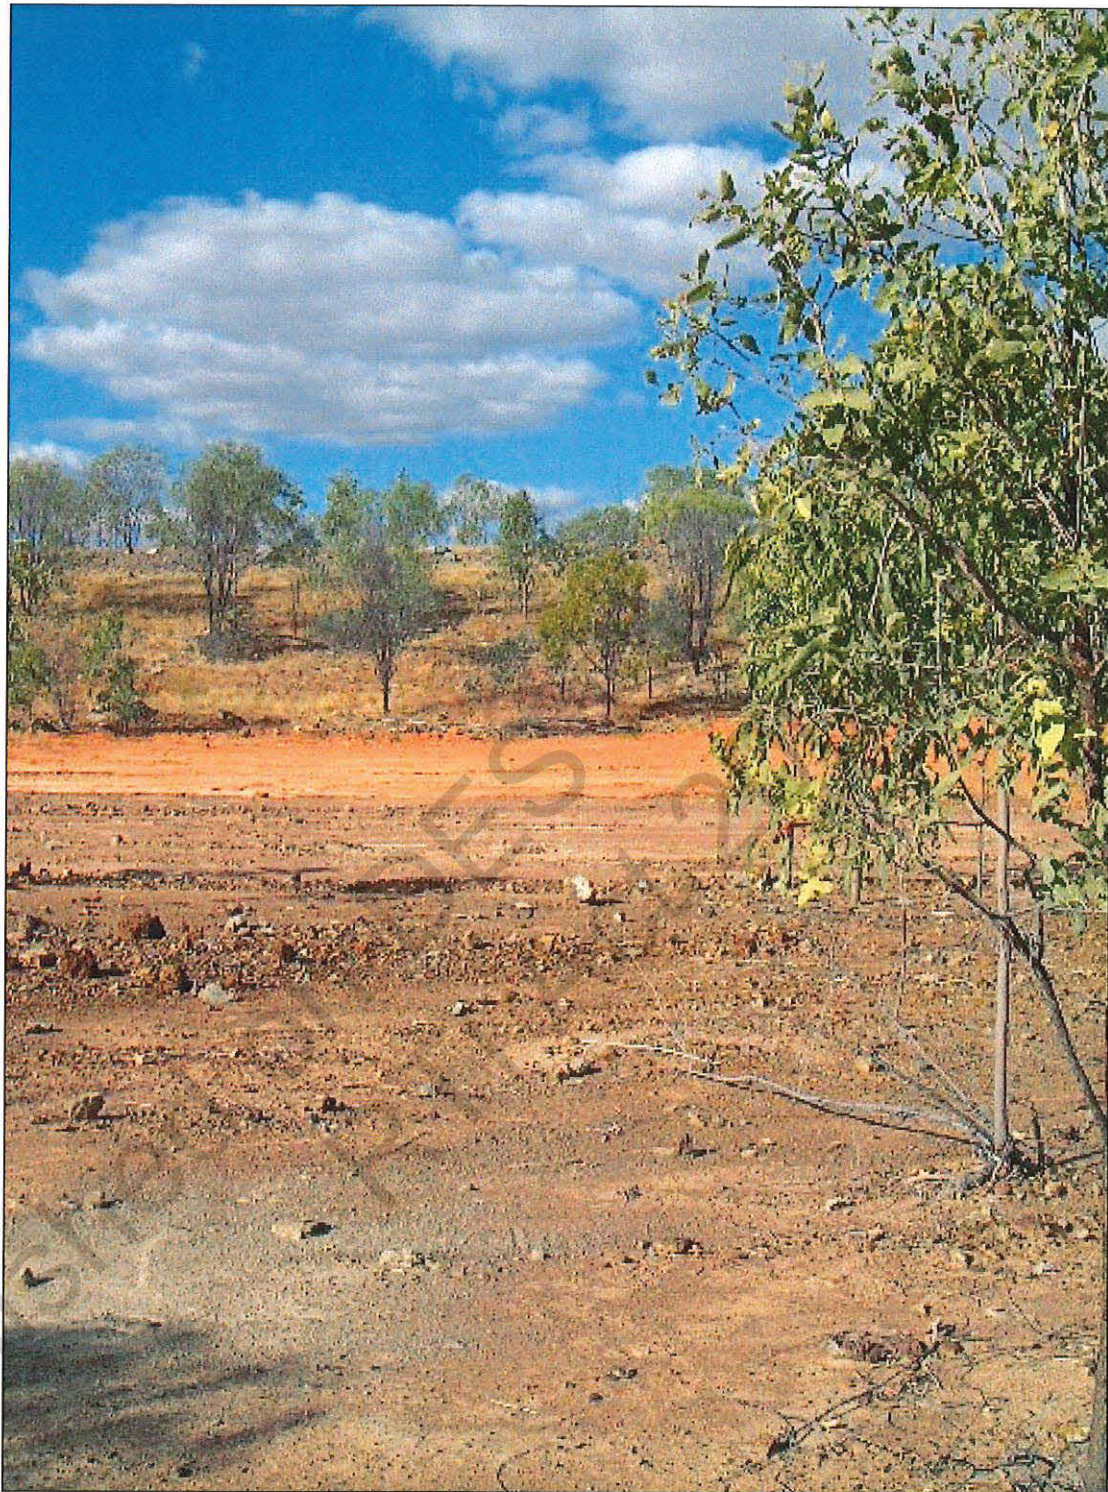
**Content Waste Dump (Transect 1)**

The vegetation on the rehabilitation areas on the Golden Butterfly and the Content waste dumps show a good cover. However, the vegetation has low vigour and biomass (140-275 kg/ha) and appears to be in decline, with trees and shrubs dying (38% mortality on the Golden Butterfly waste dump). Low soil fertility is considered to be the cause of the poor vegetation vigour, associated with recent drought years.
