**STAGE 1 ENVIRONMENTAL SITE ASSESSMENT  
COMMERCIAL/RETAIL DEVELOPMENT  
CNR KEATING STREET AND MOGGILL ROAD  
INDOOROOPIILLY**

**Prepared for**  
Property Solutions (Australia) Pty Ltd

Project No. 06253A  
March 2007

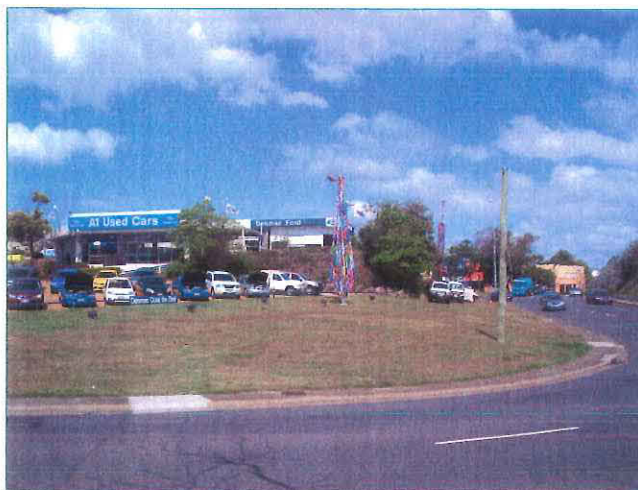
At the time of the investigation, the site was leased for a vehicle viewing and sales yard with associated office space (refer to Photographs 1 and 2).

Photograph 1: View from the south-western corner of the site looking east

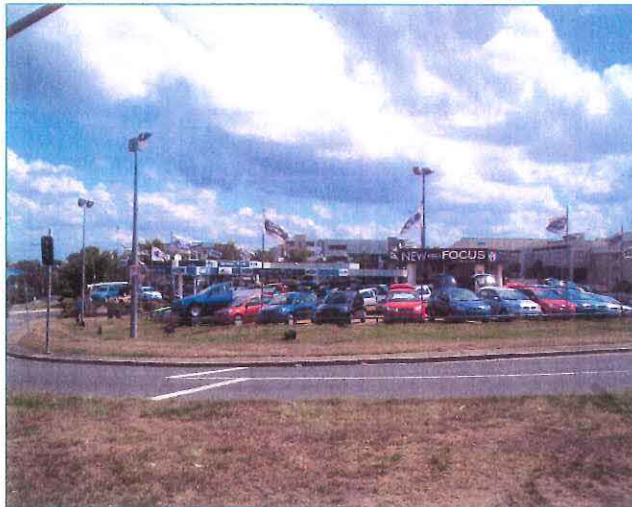
Photograph 2: View from the northern corner of the site looking south

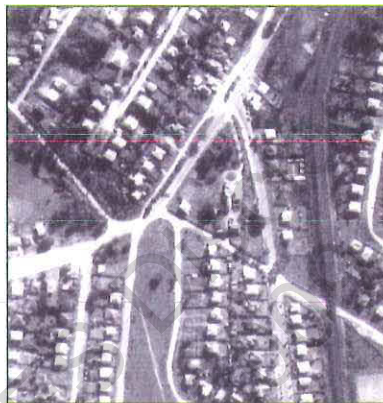
- 1946 The site is approximately triangular in shape and bound by Moggill Road, Coonan Street and Keating Street. A single structure is located in the south-west corner of the site while a cluster of larger structures is visible in approximately the centre of the site. The remainder of the site appears vacant with a few isolated trees. The surrounding area is occupied by residential properties.

Photograph 3: Extract from 1946 Aerial Photograph

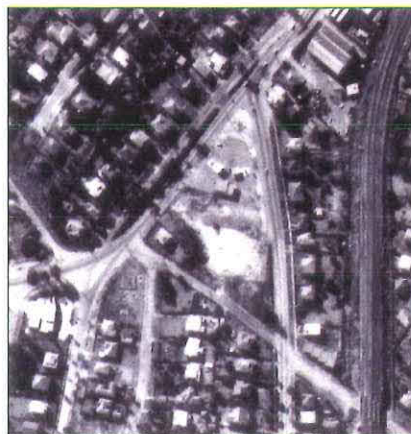
- 1964 The isolated structure located in the south-west corner is the only structure remaining from the photograph taken in 1946, with the buildings in the centre having been demolished. A cluster of three small buildings now occupies the northern portion of the site with the remainder of the site appearing vacant.

Photograph 4: Extract from 1964 Aerial Photograph

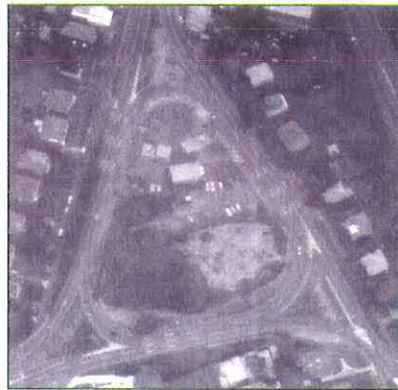
- 1974 The site is similar to that seen in the photograph taken in 1964 except the isolated building located in the south-west corner has been demolished. A number of cars are using the site for informal parking.

Photograph 5: Extract from 1974 Aerial Photograph

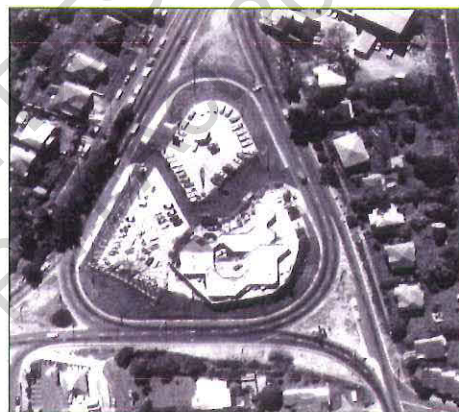
- 1981 A large split level building (show room observed today) occupies the southwest corner of the site with frontage on Coonan Street and Keating Street. The south-west and northern portions of the site are paved and used for the storage and display of additional motor vehicles. One of the three buildings that occupied the northern portion of the site in 1974 remains in the centre of the northern display yard. A retractable shade structure appears to be present over much of the south-west display yard.

Photograph 6: Extract from 1981 Aerial Photograph

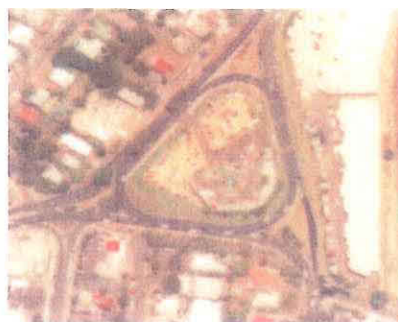
- 2002 The site appears similar to that seen in the photograph taken in 2002

Photograph 7: Extract from 2002 Aerial Photograph
