**Re: Complaints regarding ash storage dust and accelerated rusting of property**

**Executive Summary**

## **Ambient Climatic Monitoring Report**

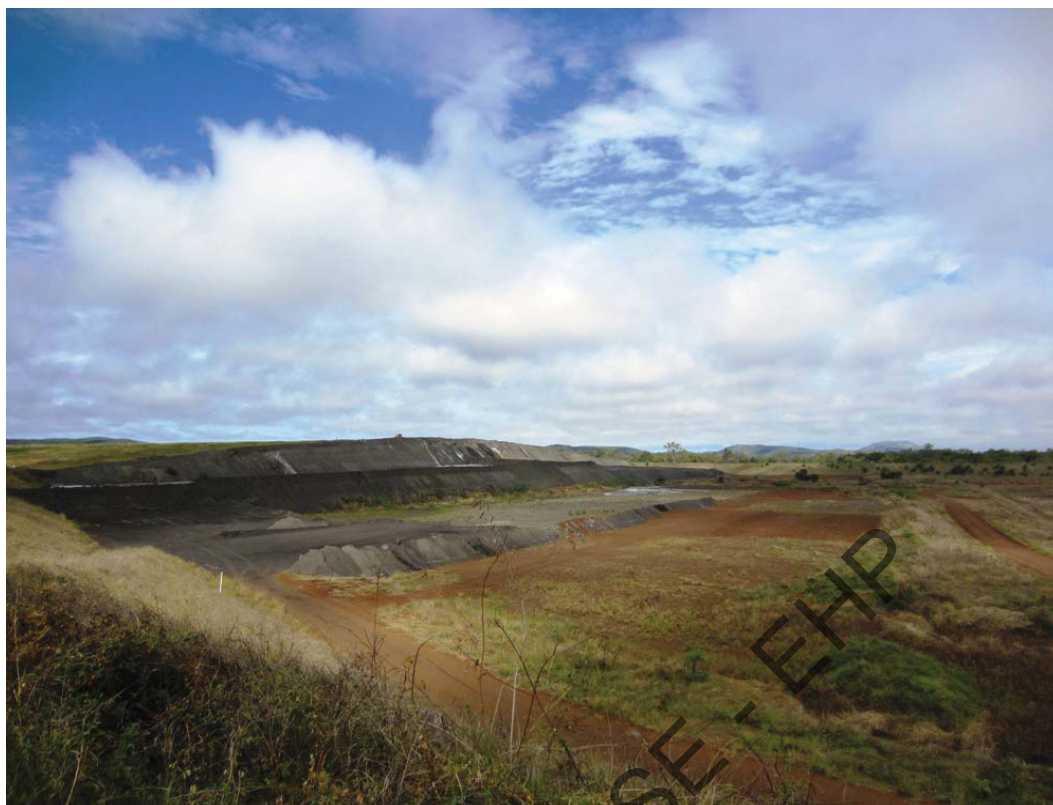
**Figure 61** Photo showing the active face of the ash storage area

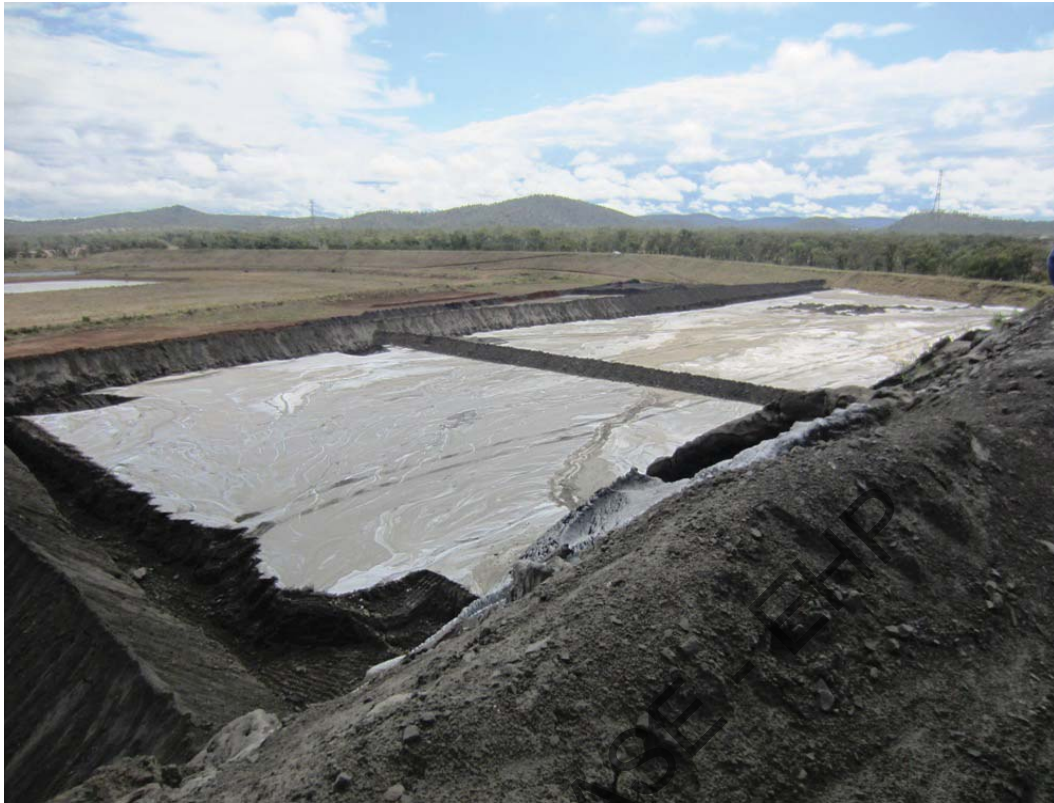
**Figure 62 Photo showing active cell (left) and dried out cell (right)**

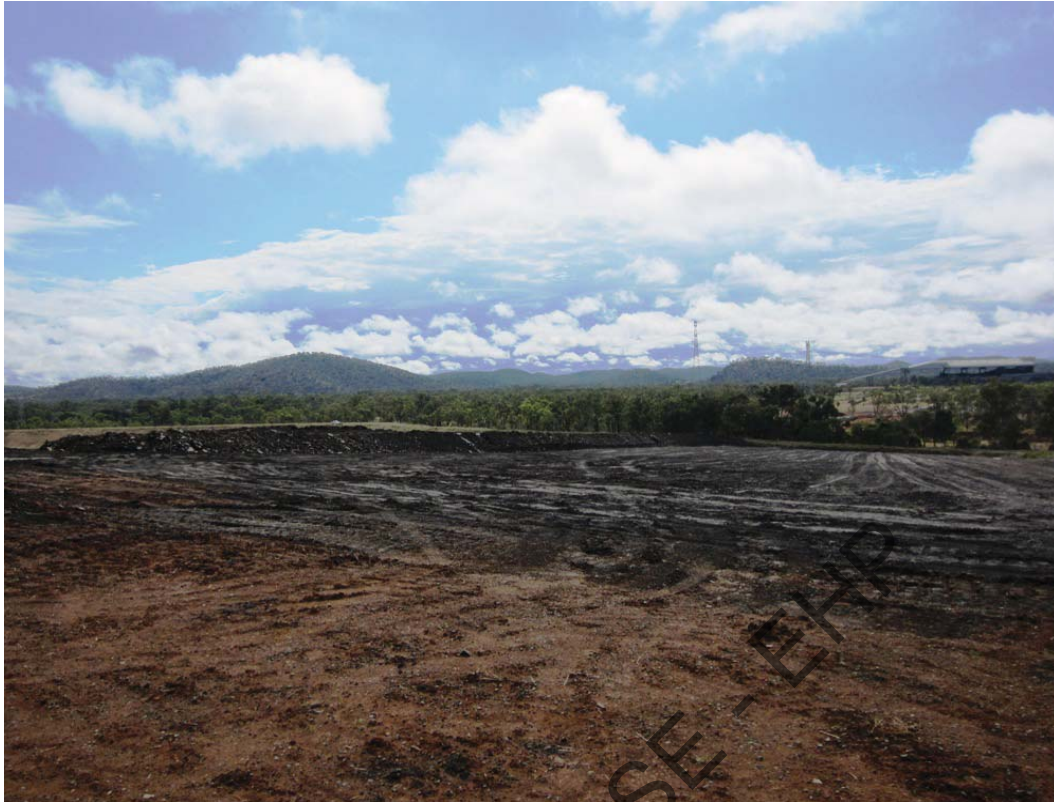
**Figure 63** Photo showing final contoured ash storage area ready for rehabilitation
