## **SITE REPORT HYDROCARBON CONTAMINATED SOIL**

**LOT 11, RP728865  
2 ELVIN STREET**

**PAGET INDUSTRIAL ESTATE  
MACKAY**

Prepared By: Simmonds and Bristow Pty Ltd  
Date: 28 November 1997

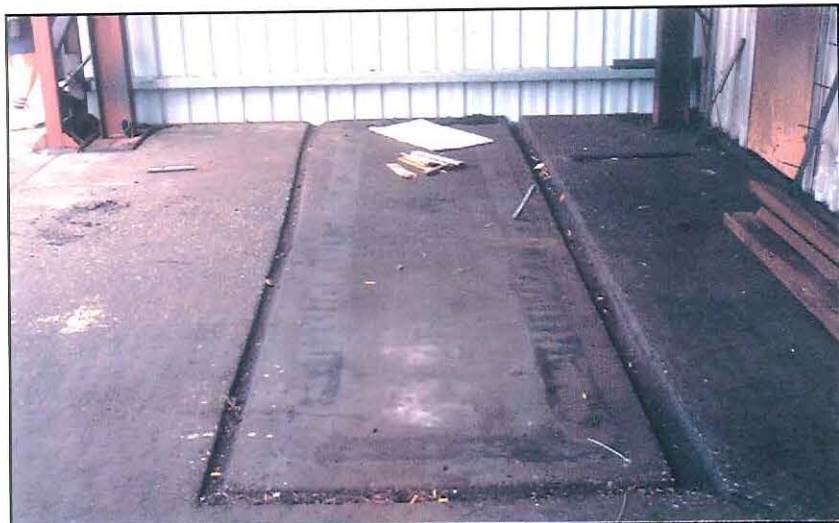
**Photo 1A-** Lubrication bay adjacent to BH-6

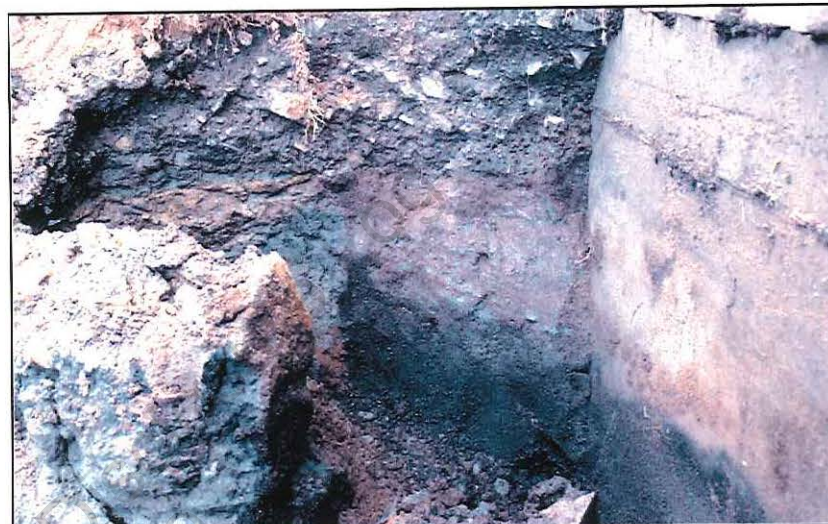
**Photo 2A-** Hydrocarbon contamination adjacent to rat wall BH-6

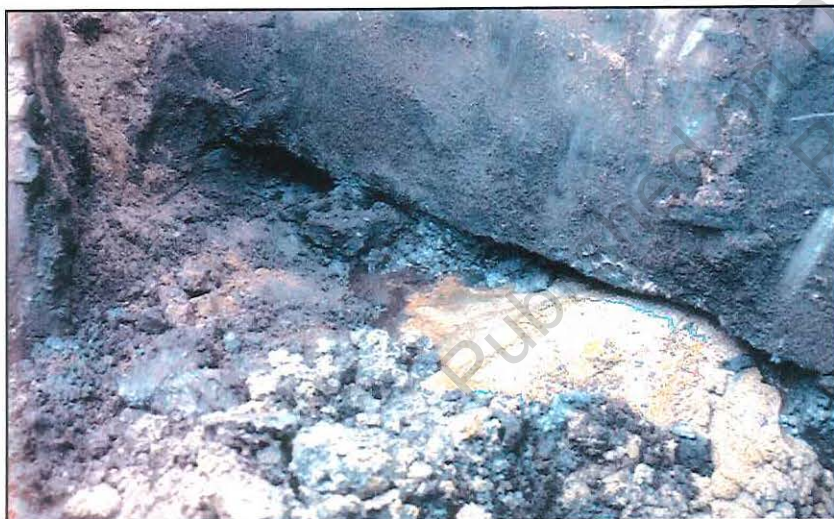
**Photo 3A-** Hydrocarbon contamination flowing from beneath rat wall BH-6

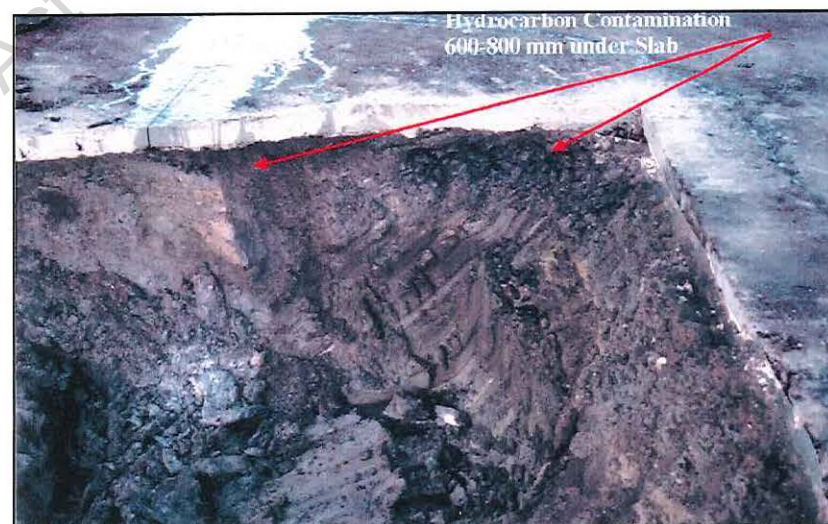
**Photo 4A-** Pit 1 excavation looking east

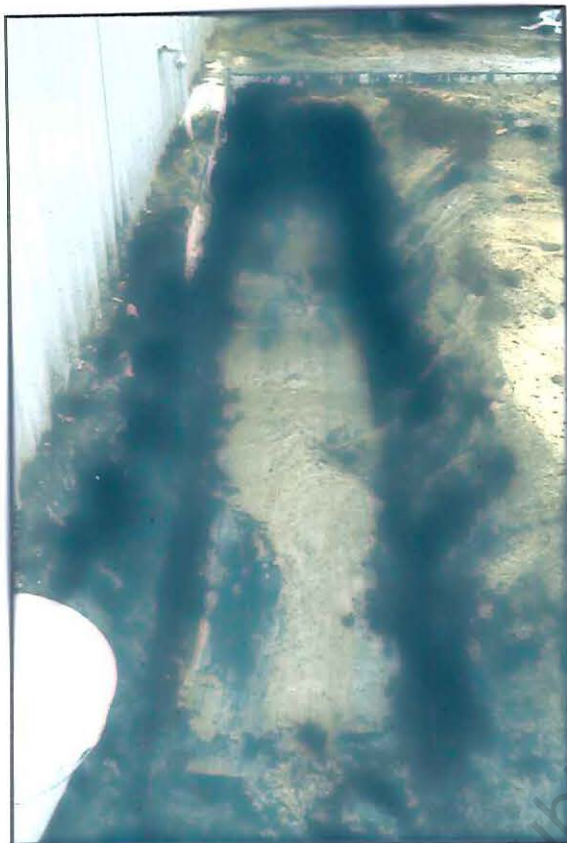
**Photo 1B-** Construction of clay barrier western side of shed.

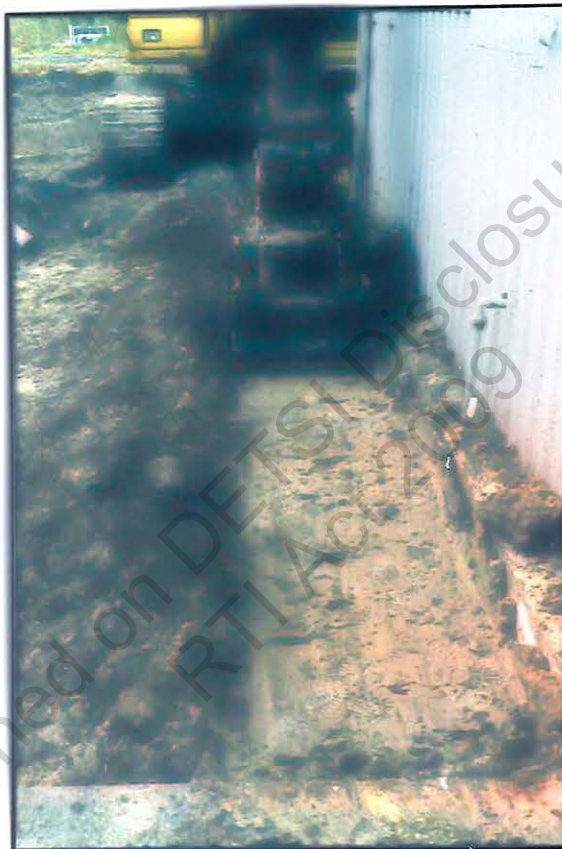
**Photo 2B-** Clay barrier compaction.

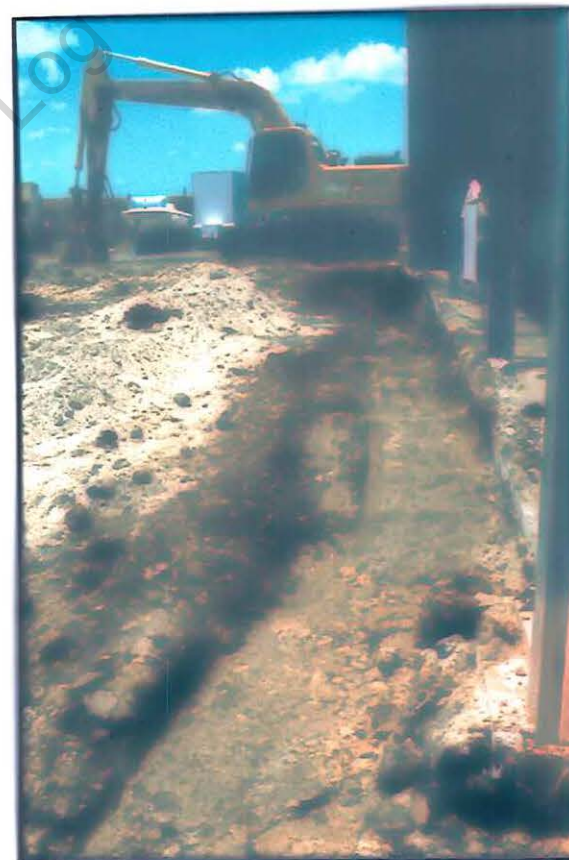
**Photo 3B-** Construction of clay barrier northern side of shed.

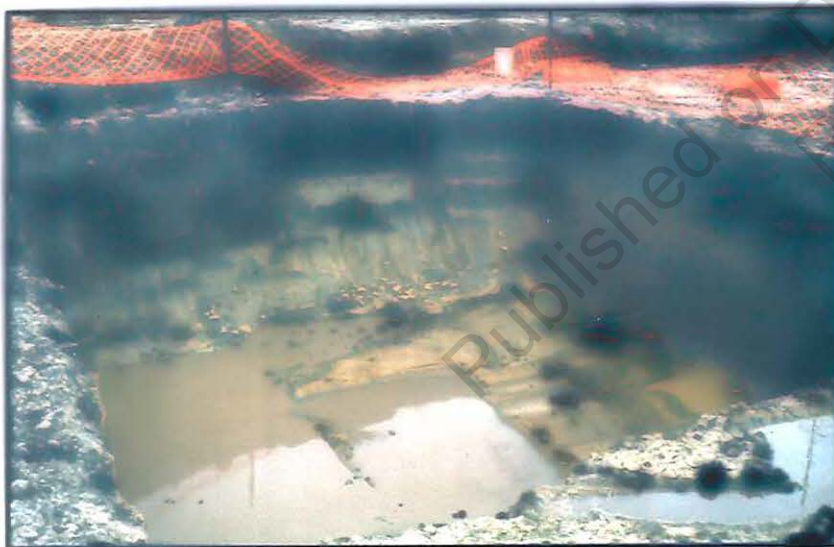
**Photo 10B-** Pit 1 excavation looking west
