## Logan Greyhound Facility

### CONTAMINATED SITE INVESTIGATION

- Final
- June 2010

## Logan Greyhound Facility Cronulla Park

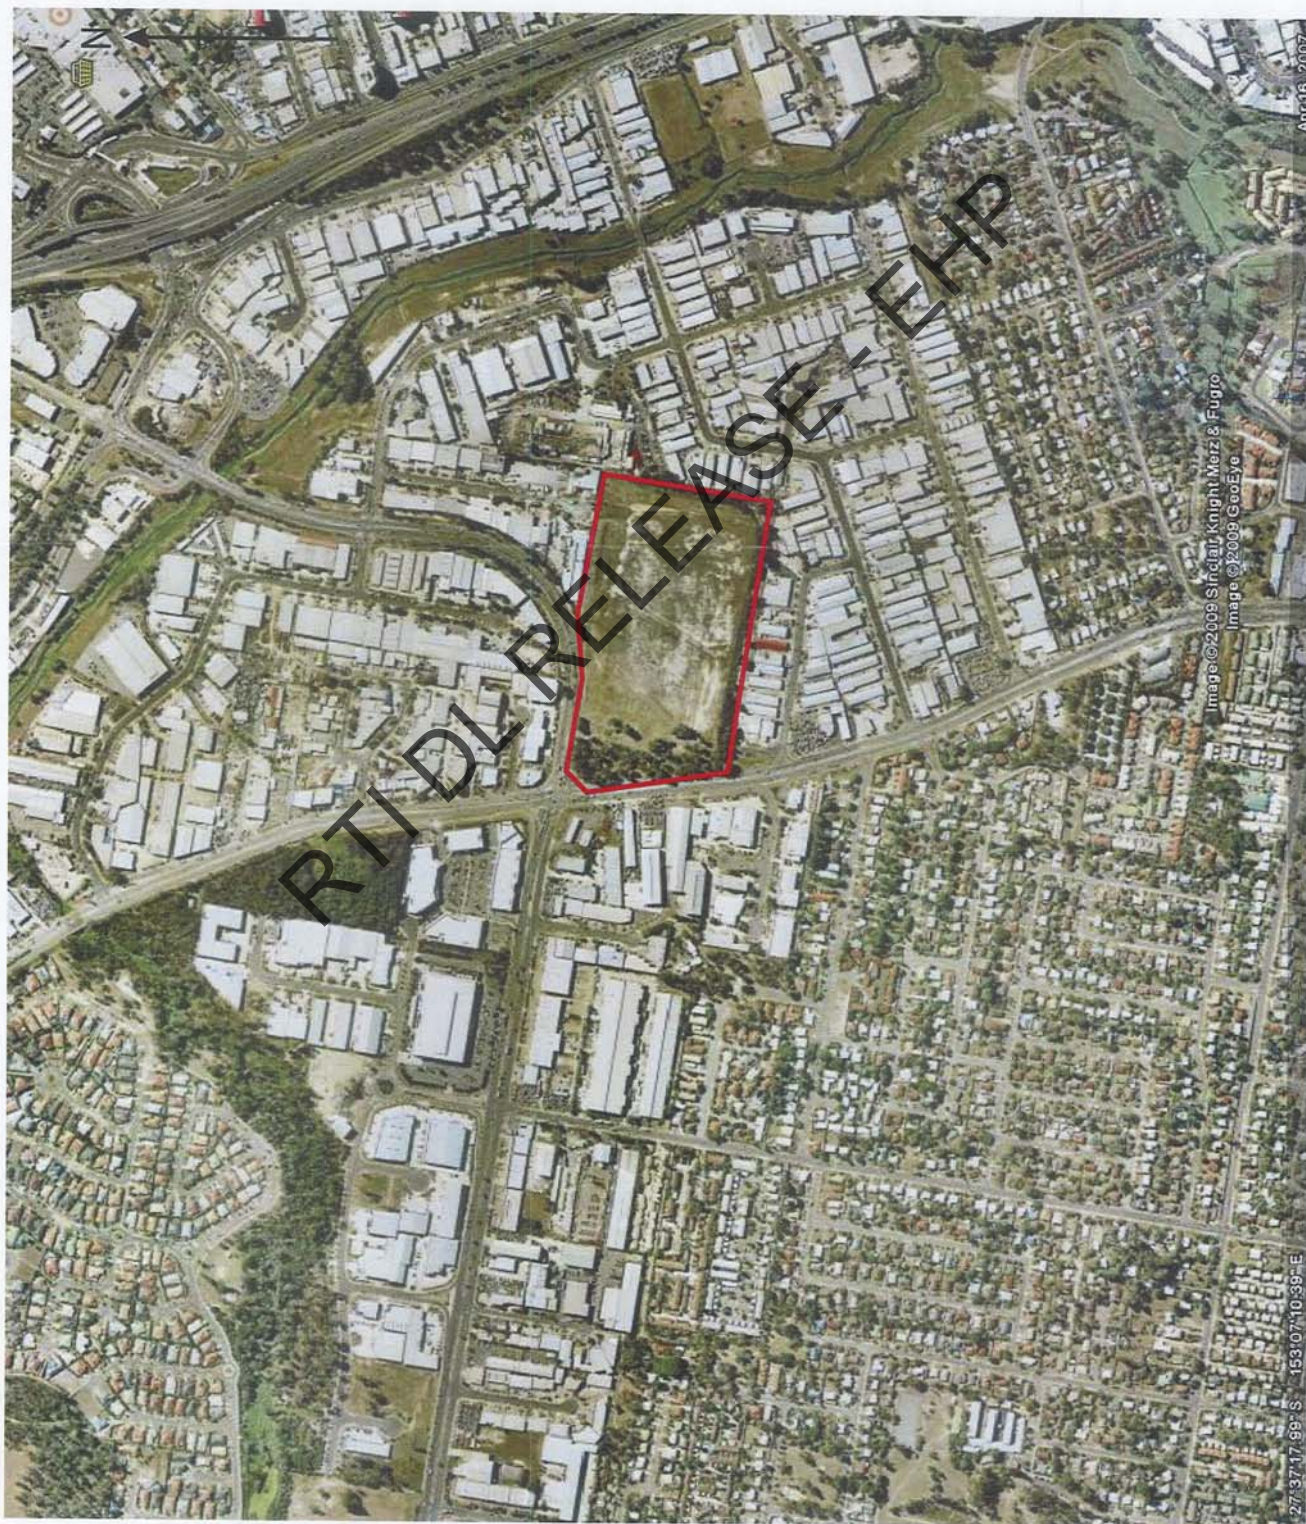
**Figure 1**  
**Site Location Plan**

1. Aerial Photograph - Google Earth Pro, 2008
2. Scale and features shown are approximate locations only

Greyhounds Queensland Limited (GQL) is planning the development of the Logan Greyhound Facility ("the Project") at Cronulla Park, Slacks Creek ("the site"). Cronulla Park was formerly used a landfill ("the Landfill") between the 1970s and 1980s. A plan showing the location of the site is provided in **Figure 1, Appendix A**.

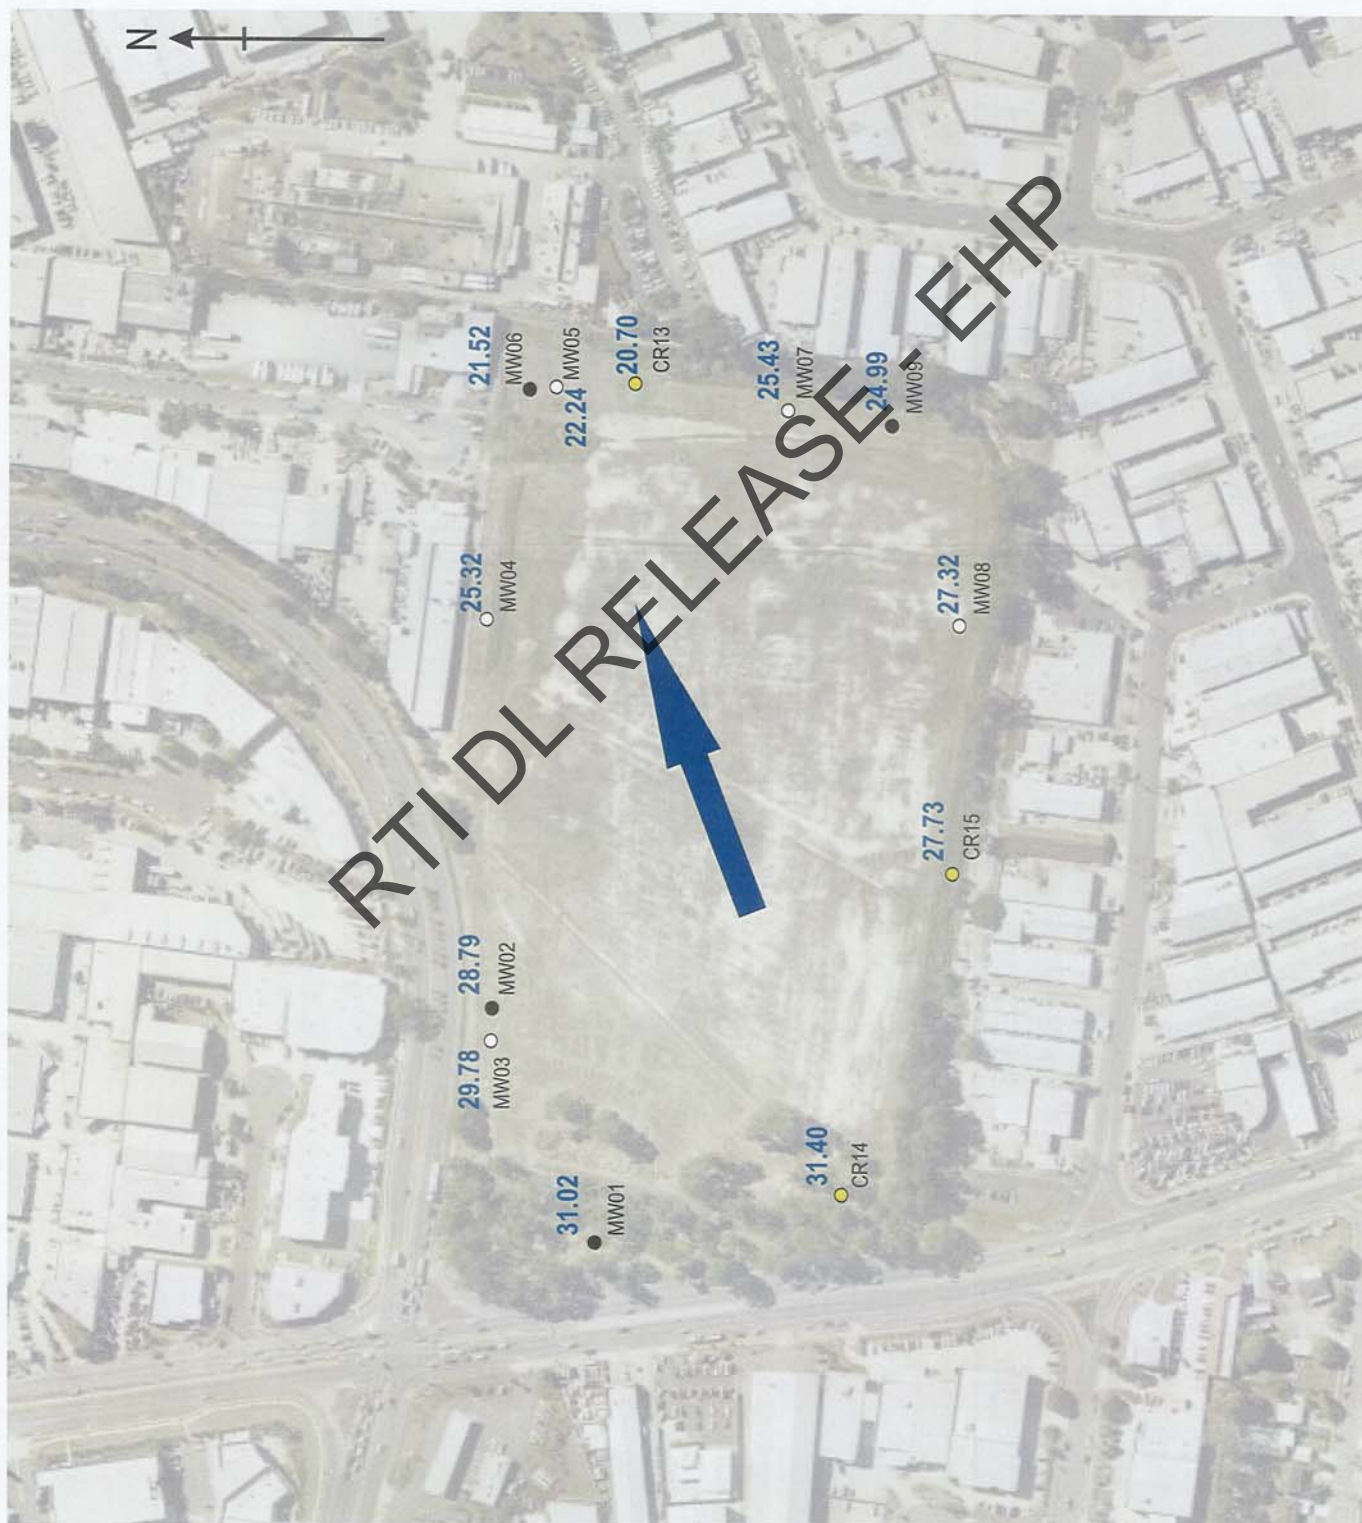
**Figure 6**  
**Average Groundwater Levels**

**Figure 6, Appendix A** provides a summary of the groundwater levels monitored during the investigation. Both the groundwater within the weathered sandstone and perched groundwater within the Landfill flow in a north easterly direction towards Slacks Creek. The perched groundwater within the Landfill is expected to combine with the groundwater in the weathered sandstone down gradient of the site. This is evident from ammonia and organic contaminants detected in CR13 which is a groundwater monitoring well installed by LCC down gradient of the Landfill.
