RE: POWERHOUSE CONTAMINATION LINING

As per our conversation I enclose the details of the proposed clay liner to be used for containing the on-site contamination materials.

In March of 1993, Scientific Services Branch of the Brisbane City Council was commissioned to undertake a stage 1, Preliminary Site Investigation to determine the extent of contamination at the site known as "The New Farm Powerhouse".

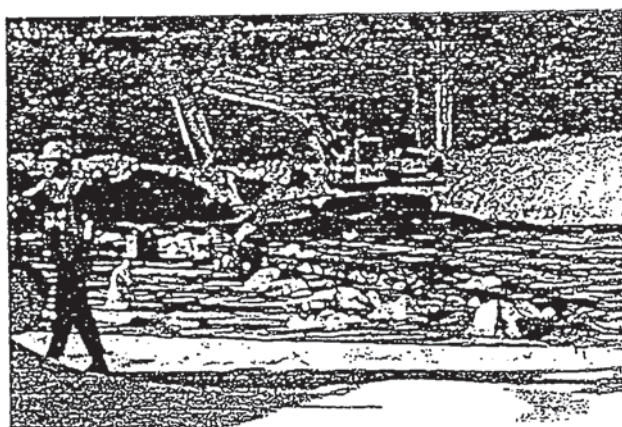
Figure 1: Construction Equipment on a HDPE Bentofix Composite Liner

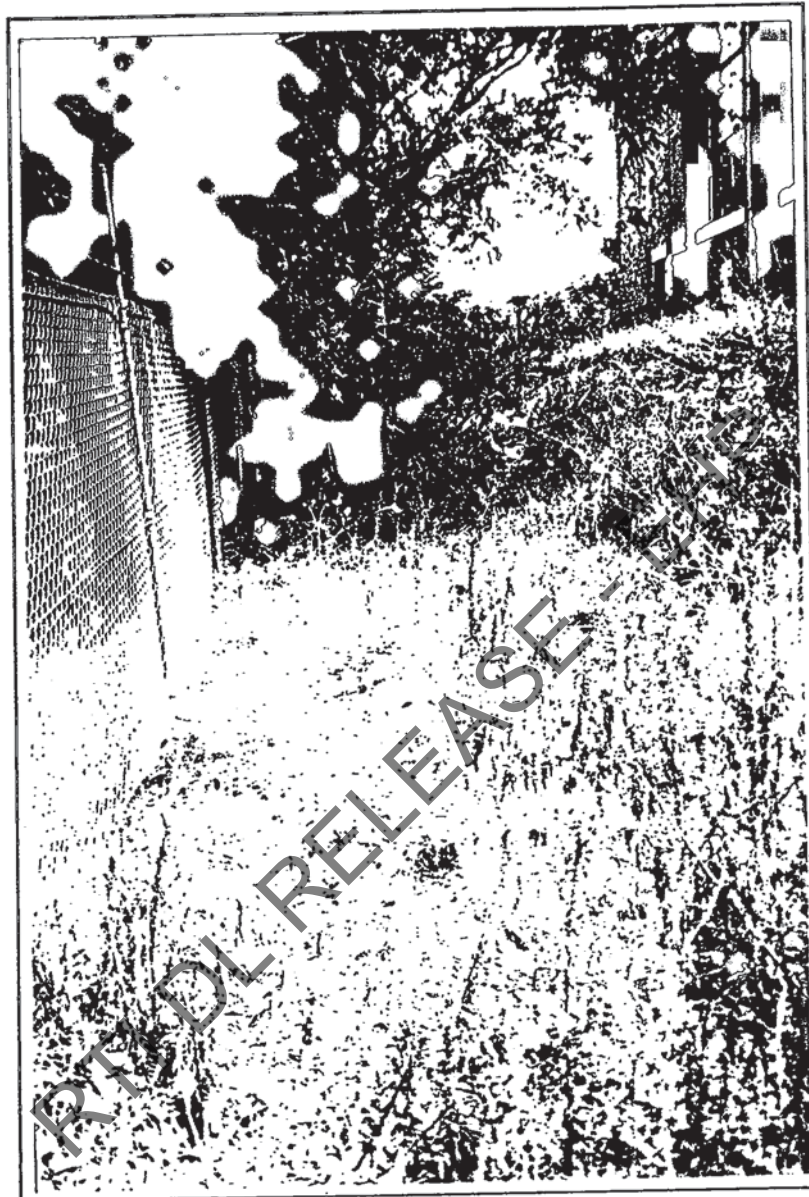
**FIGURE 11** *Embankment from the powerhouse to New Farm Park*

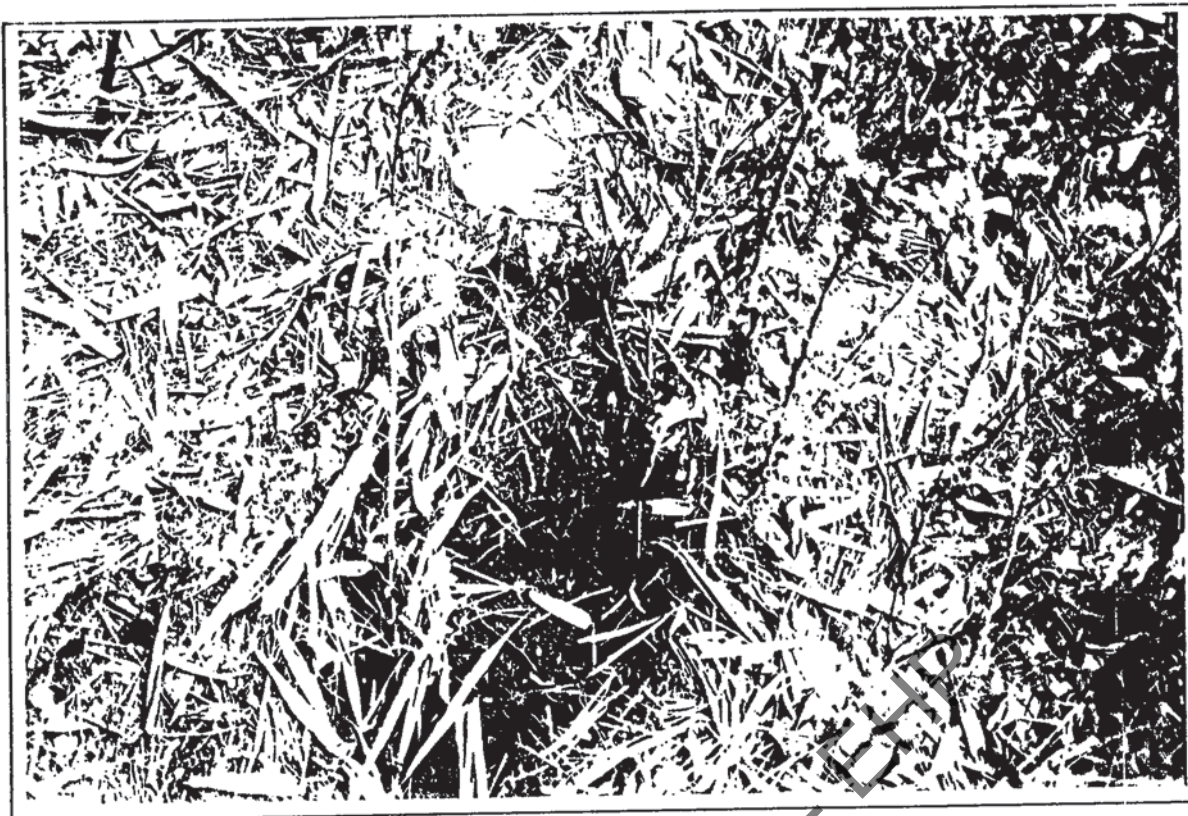
*FIGURE 12 Ash on the surface of the embankment*
