## Compliance Activity Details Report

Subject: Condamine Power Station initial post-comission compliance site inspection

Compliance Activity Ref: CA21295

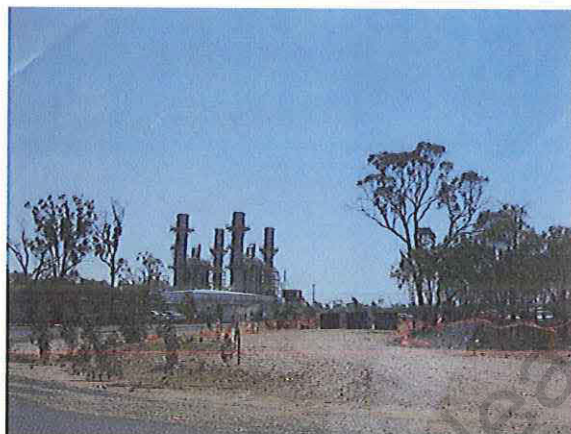
Photo 1

The total area of the land of Lot 48 is approximately 518 ha and is zoned "Rural" under the local government's planning scheme. Previous clearing has occurred on this site for the use of grazing in the area. Some more clearing was required in association with the MCU for the power station, however, the remnant vegetation in this regional ecosystem on site has been mapped "not of concern" and typically consists of mixed regrowth vegetation. Similarly, no fauna of conservation significance has been recorded at this site.

The footprint of the power station is approximately 3 ha, which includes all related permanent structures, e.g. reverse osmosis plant, storm water containment facilities, administration and workshop buildings, staff amenities, water treatment plant and water storage components).

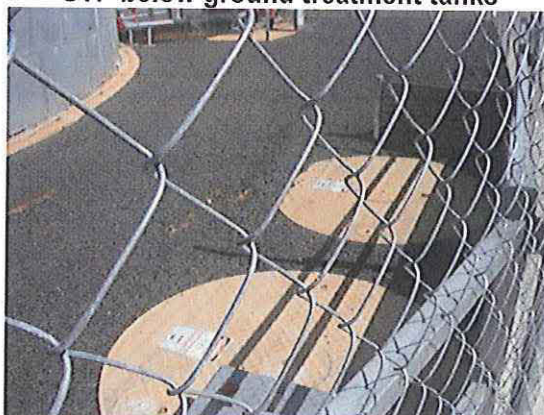
Photo 2

The first ERA inspected was **ERA 63 Threshold 2(a) – sewage treatment**. The on-site STP – the plant is designed for approximately 40 people (approximately 10 staff are on site at any one time). The effluent is treated in two below ground treatment tanks (using chlorine) (Photo 2) before the effluent is discharged onto a piece of land (approximately 25m x 25m), approximately 300m west of the power station in bushland (Photo 3). The volume of the daily discharge to land is unknown.

STP below ground treatment tanks

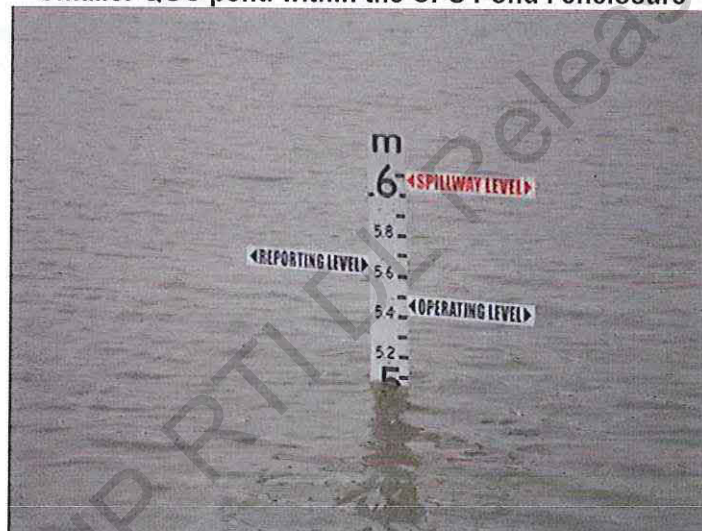
**Photo 5**

**Smaller QGC pond within the CPS Pond I enclosure**

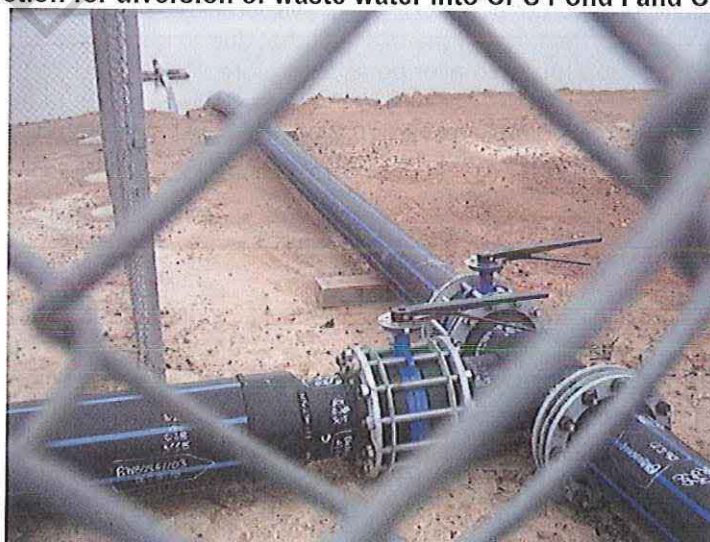
**Photo 6**

**ERA 60 Threshold 1(d) – regulated waste disposal** is carried out at Condamine Power Station Pond I (CPS Pond I). The pond is located on Lot 48 and has a capacity of approximately 280ML (Photo 4). In Schedule H – Table 2 – *Basic details of regulated dams* this high hazard category pond is authorised for a maximum volume of 2000ML for the purpose of storing and evaporating saline water from the Condamine Power Station. DERM staff was informed during the site visit that due to geological limitations on site, the dam construction proceeded but for a much smaller pond. Therefore, the DA should be amended accordingly by seeking an amendment application from the client. Spillway depth of this pond is 6 m whereas MRL (mandatory reporting level) is at 5.6 m (Photo 5). At the time of inspection there was no waste discharge into the pond, as any waste water from the power station was diverted at the T-section at CPS Pond I to go to CPS Pond II (Photo 6).

**T-intersection for diversion of waste water into CPS Pond I and CPS Pond II**

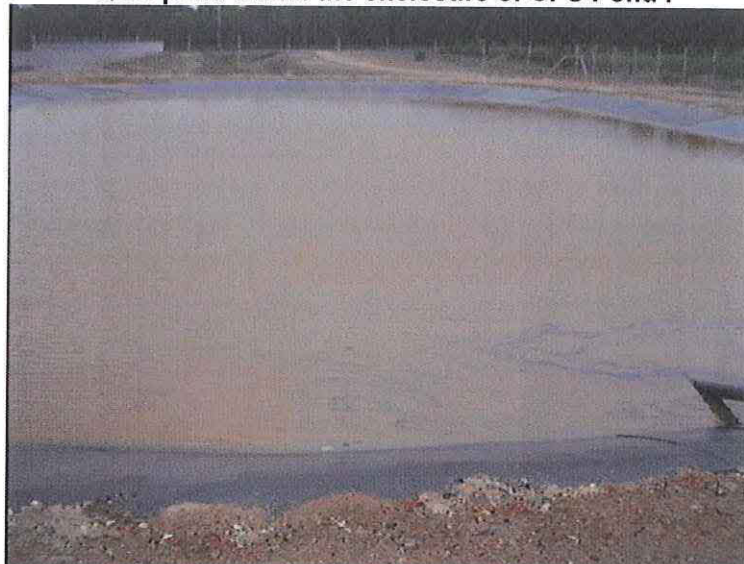
Photo 7

QGC pond within the enclosure of CPS Pond I

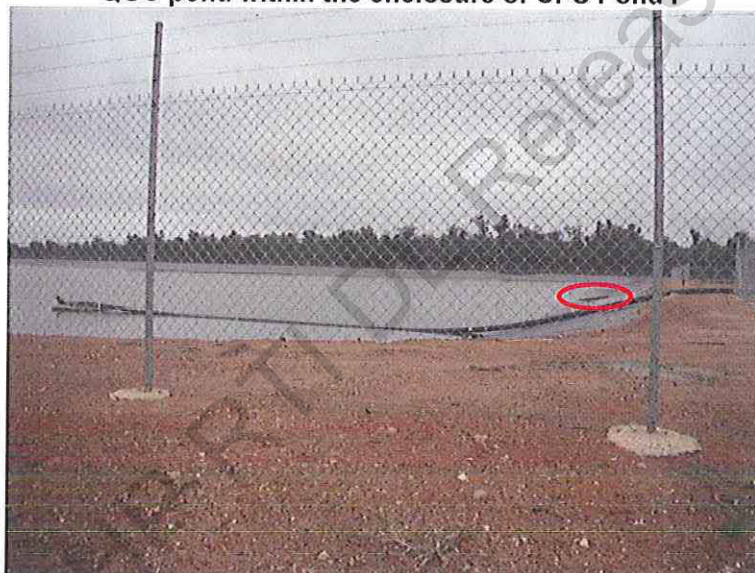
Photo 8

QGC pond within the enclosure of CPS Pond I

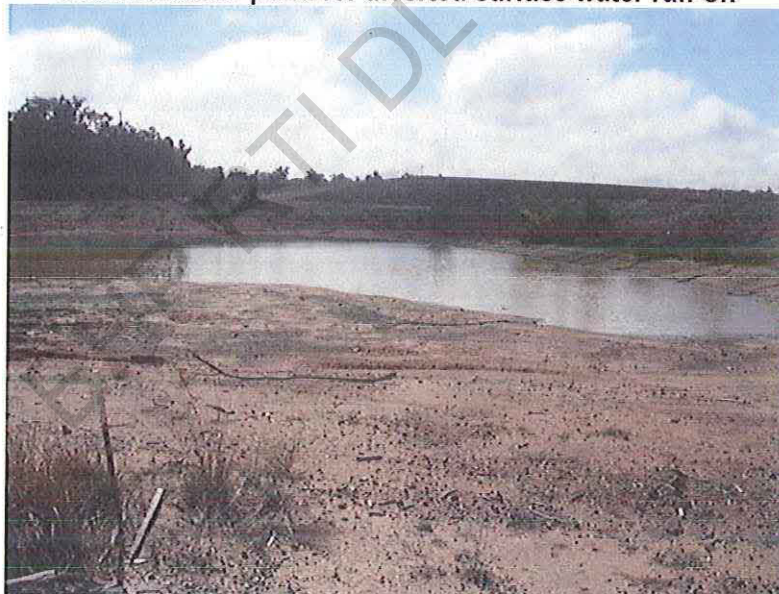
Photo 11

Sedimentation pond for diverted surface water run-off

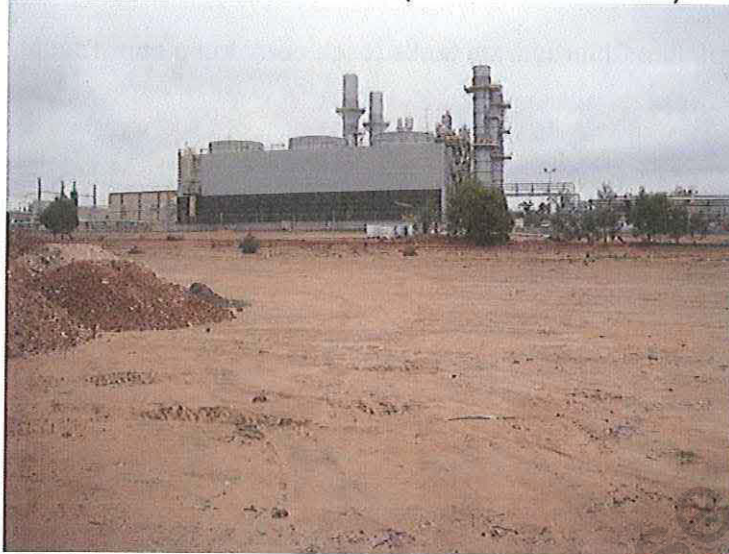
Photo 12

The Condamine Power Station (Photo 12), authorised as **ERA 14 Threshold 1 – power generation** was commissioned in August 2010. The construction company (Austrian Energy) submitted air emission testing (as required in accordance with conditions C4 and C12 of DA IPCE00549207A11. The emission testing was for NO<sub>x</sub> emissions from generator stacks A1 and A2 and was found to be in compliance with the emission limits (25ppmV at 15% O<sub>2</sub> reference). All trafficable areas on site of the power station are sealed (as per DA requirement). To date neither the department nor QGC have had any noise and/or dust nuisance complaints regarding this site. At the time of the site inspection, the power station was running continuously as a combined cycle plant, thus running gas turbines in combination with steam turbines (Photo 13).

Condamine Power Station (viewed from the east)

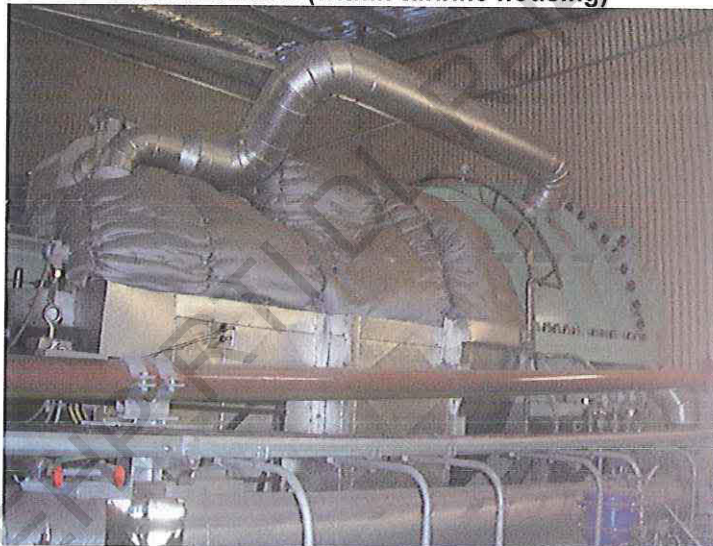
Photo 13

Steam turbine (within turbine housing)

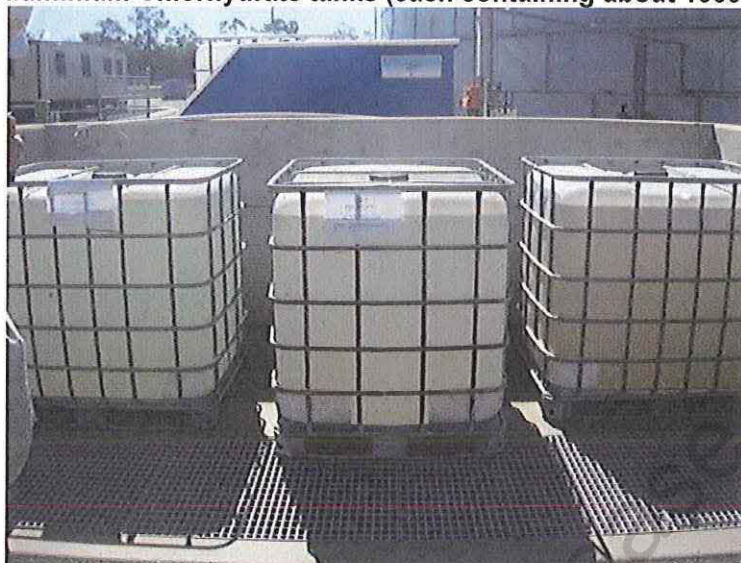
Photo 14

and many more chemicals. The department obtained a copy with all types of chemicals and volumes held on site. No non-compliance issues were found regarding the chemical storage on site. Chemicals were generally either stored in a self-bunded chemical storage shed (on a gravelled ground) or were stored in bunded hard-stand areas (some of these areas were also roofed).

Aluminium Chlorhydrate tanks (each containing about 1000L)

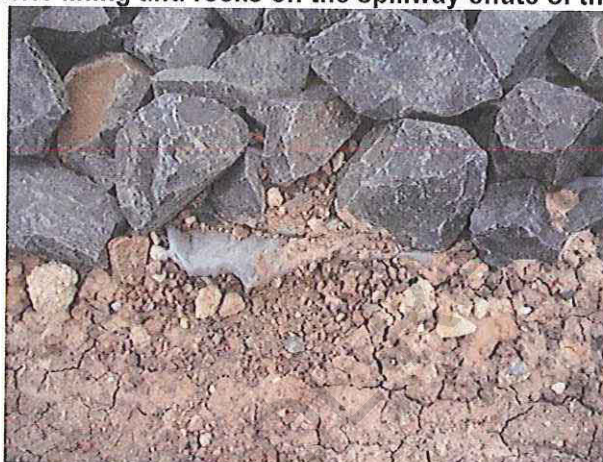
Photo 19

(Grey) Geofabric lining and rocks on the spillway chute of the CPS Pond II

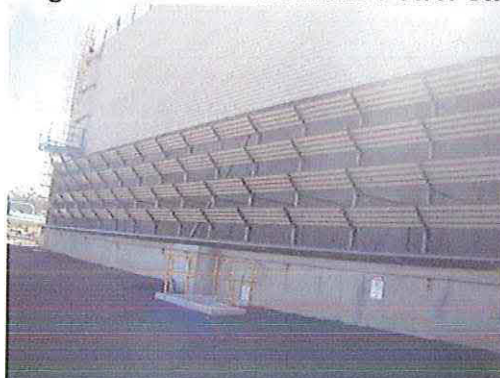
Photo 20

On 27 June 2010 cooling water from the cooling water tower (Photo 20) spilled to land on site of the power station. Due to the slope the water was flowing overland towards and into a bushland section carrying with it sediment from the sparsely vegetated area (Photo 21).

Cooling tower at the Condamine Power Station

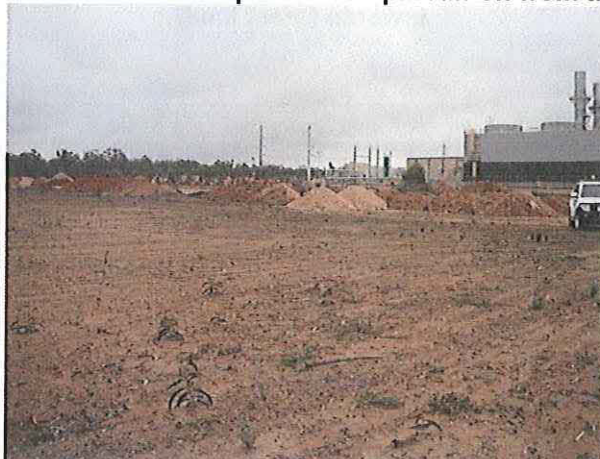
**Photo 21**

**Sparsely vegetated land which experienced spill run-off from the cooling tower**

It is recommended to include in the letter to be sent to the client that the land between the cooling tower and the adjacent bushland on site at Lot 48 BWR138 be contoured and revegetated to minimise erosion during rain events.

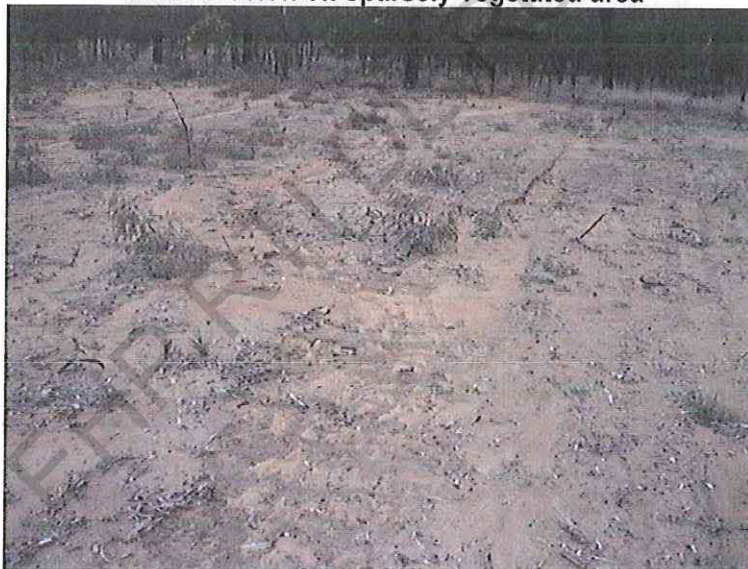
**Photo 21**

Outcome Description: An area of approximately 100m (length) x 60m (width) experienced sheet erosion due to the surface water run-off during the spill. The run-off also caused transport of fine sediment/ topsoil into the adjacent bushland. The sediment deposit is not considered to cause adverse effects on regrowth/vegetation in the area, however, the erosion issue on site (area between the cooling tower and the adjacent bushland) should be dealt with to avoid erosion from surface water run-off during rain events. A letter will be sent to the client, as part of the compliance site inspection follow-up on 19 August 2010 and the erosion issue on site will be raised in this letter. No other issues were noticed as a consequence of the water spill. Groundwater monitoring results should be checked on to see whether any unusual elevation of salinity can be detected, although that given recent rainfall events this may be unlikely.

As a result of a significant amount of water (approximately 22000L) flowing over the sparsely vegetated area, widespread sheet-erosion over an area of approximately 100m (length) x 60m (width) was caused on the land between the cooling tower and the adjacent bushland (Photo 22), dislocating fine sediment/topsoil in the process and transporting it into the adjacent bushland area (Photo 22).

**Sheet erosion on sparsely vegetated area**

accordance with condition (D4) erosion protection measures and sediment control measures must be implemented and maintained to minimise erosion and the release of sediment.

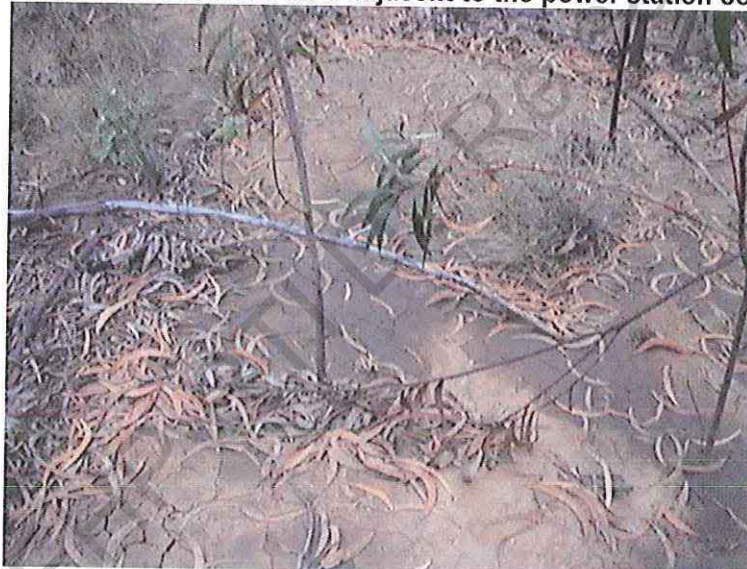
**Photo 23**

Most of the soil had dried up in the adjacent bushland area and only some small areas still had semi-moist soils, most likely a result of recent rainfall in the area (Photo 23).

**Semi-moist soil in the bushland area adjacent to the power station cooling tower**

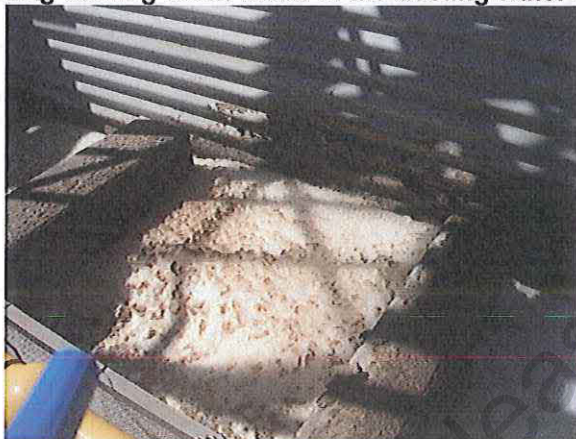
**Photo 24**

QGC confirmed that the cause of the spill of cooling tower water to land was caused by foaming of cooling tower water in the cooling tower basin (where the water is collected after the first cooling cycle). The cause of the foaming of the water is not know exactly, however QGC is now managing the water in the cooling tower basin by:

**Foaming cooling tower water in the cooling water basin**

- manual spray application (spray contains the anti-foaming agent Nalco 71D5) of scum build-up on and around the basin (Photo 24)
- dosing the cooling water with the anti-foaming agent (Photo 25)
- investigation into purchasing additional water level detector sensors which will be able to still detect the water level even in foamy conditions.

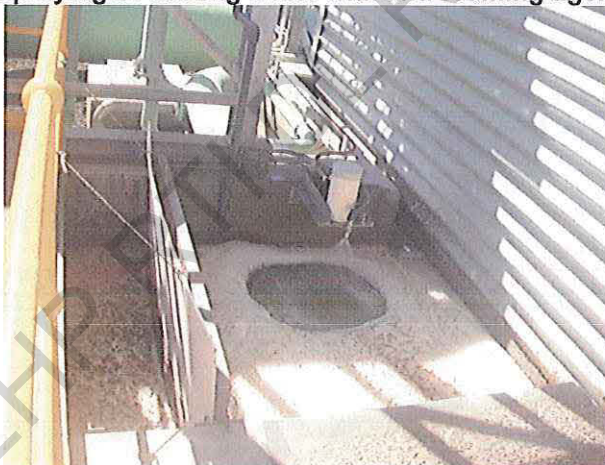
**Photo 25**

**Spraying of cooling water with anti-foaming agent**
