# Assessment report

## Clean-up notice

## Subject: Meeting with John White and Consultants Regarding the Adjacent State Owned Land

## Subject: Photos from Site Visit 28 March 2013

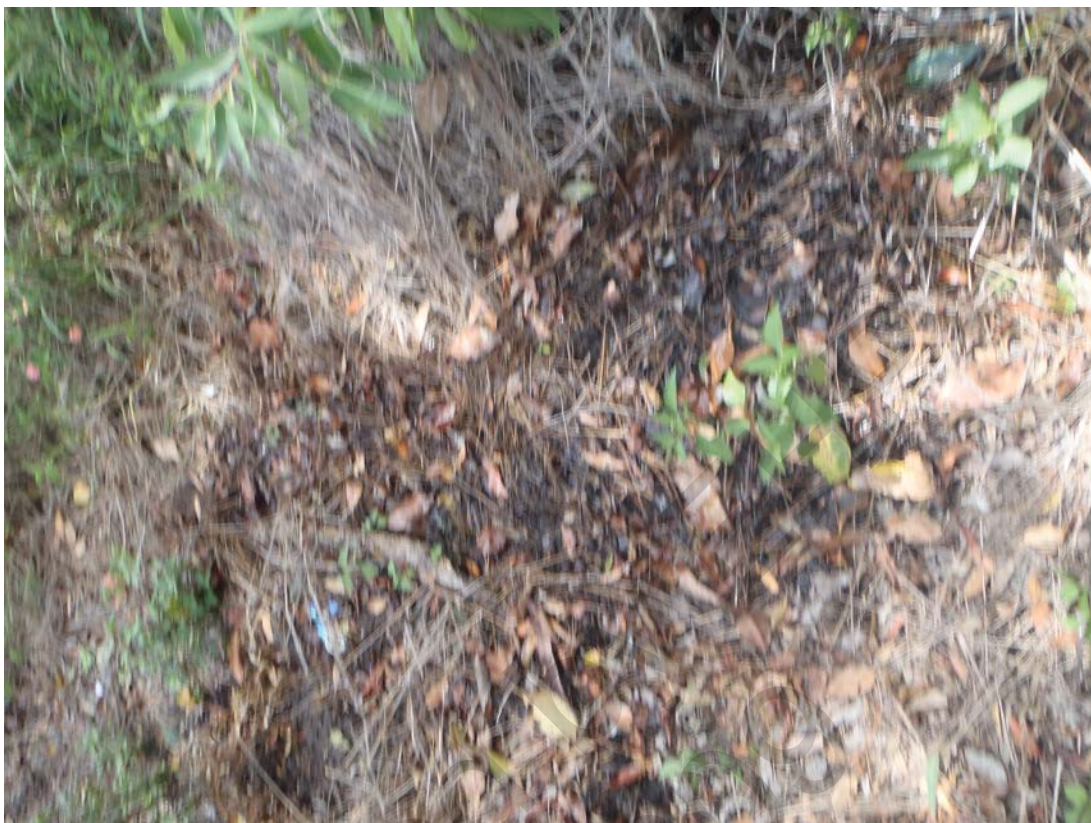
Some minor contamination from the incident has occurred on the state owned land (see photo 1 and 2 below). DS stated that any filling that was to occur in the former tannery ponds would require correct compaction rates that fit for purpose for the future use of the site.

Photo 1 – Minor contamination on state owned land. The contamination is found adjacent to the east boundary of 6 Potassium Street, Narangba.

- Pumping out the former tannery ponds and disposing of this water to an appropriate facility;
- Filling in the former tannery ponds once the pump out has occurred;
- Bunding all the boundaries of the property that connect to the incident site to prevent further contamination from entering the site
- Surveying and fencing all state owned property boundaries

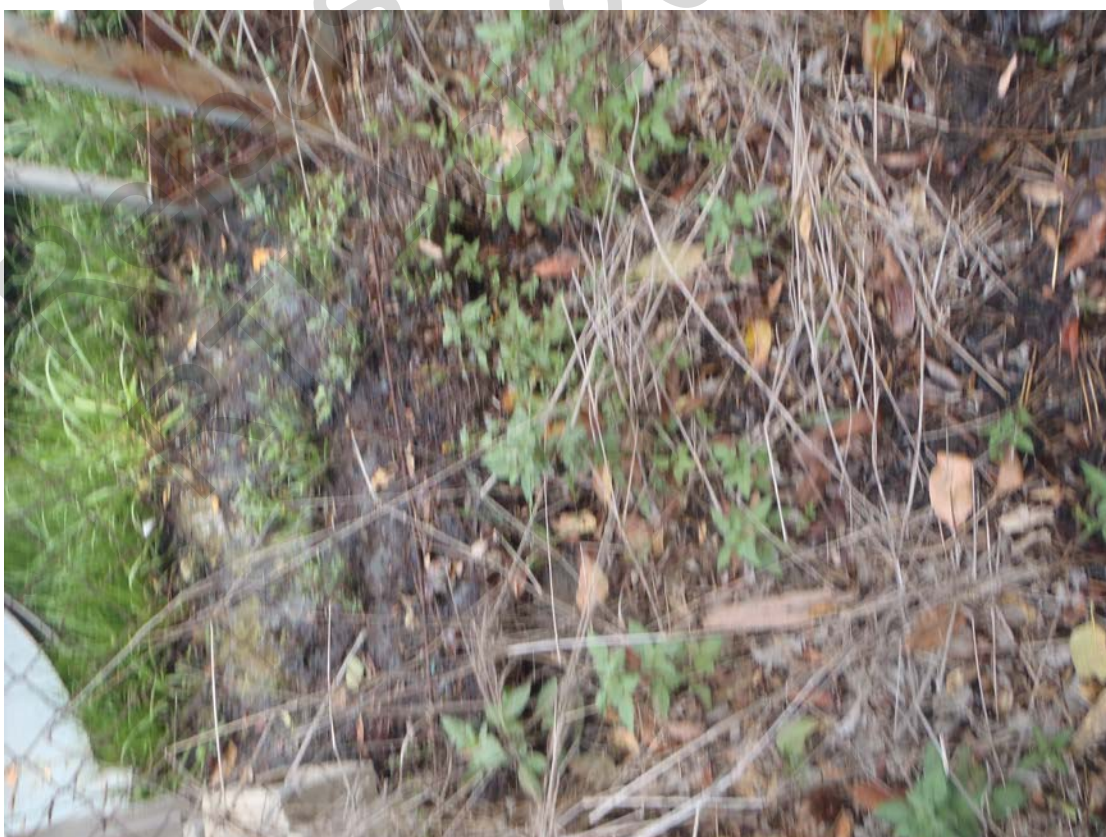
Photo 2 – Minor contamination on state owned land. The contamination is found adjacent to the east boundary of 6 Potassium Street, Narangba. Please note the fence in the image indicates the incident site boundary.

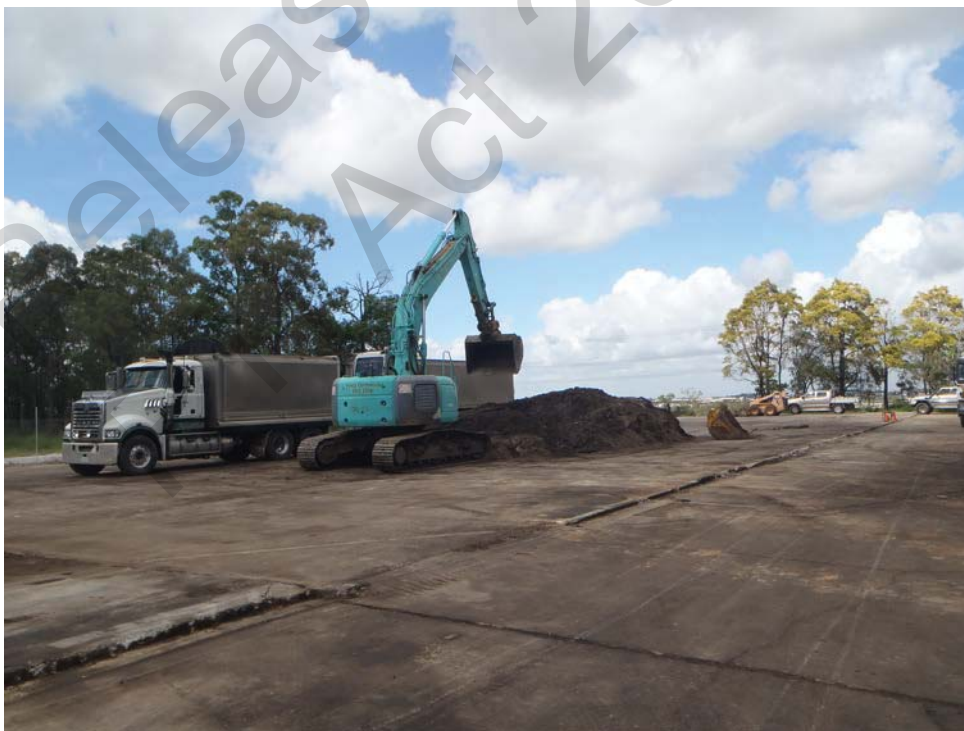
Photo 1 – Photo taken looking south-east from the potassium street entrance gate at the top of the property. Note that the stock piles of contaminated soil were being loaded into a truck for disposal.

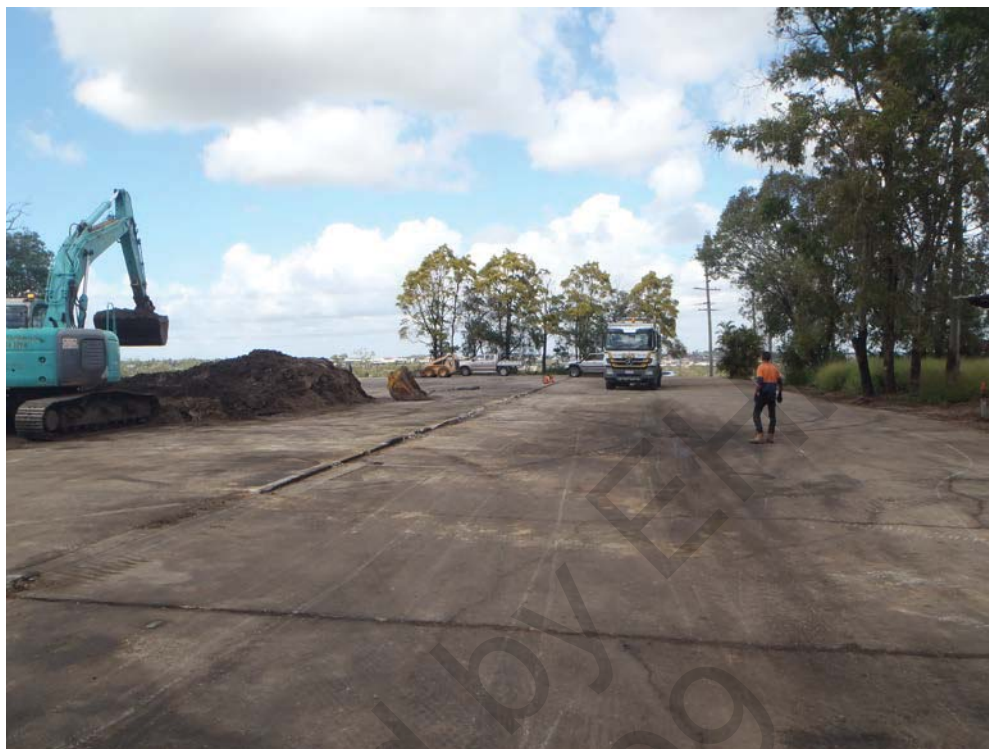
Photo 2 – Photo taken looking south from the potassium street entrance gate at the top of the property. Note The liquid waste truck at the rear of the photo. This truck was being used to clean the out the stormwater drainage systems in order for the system to be re-opened.

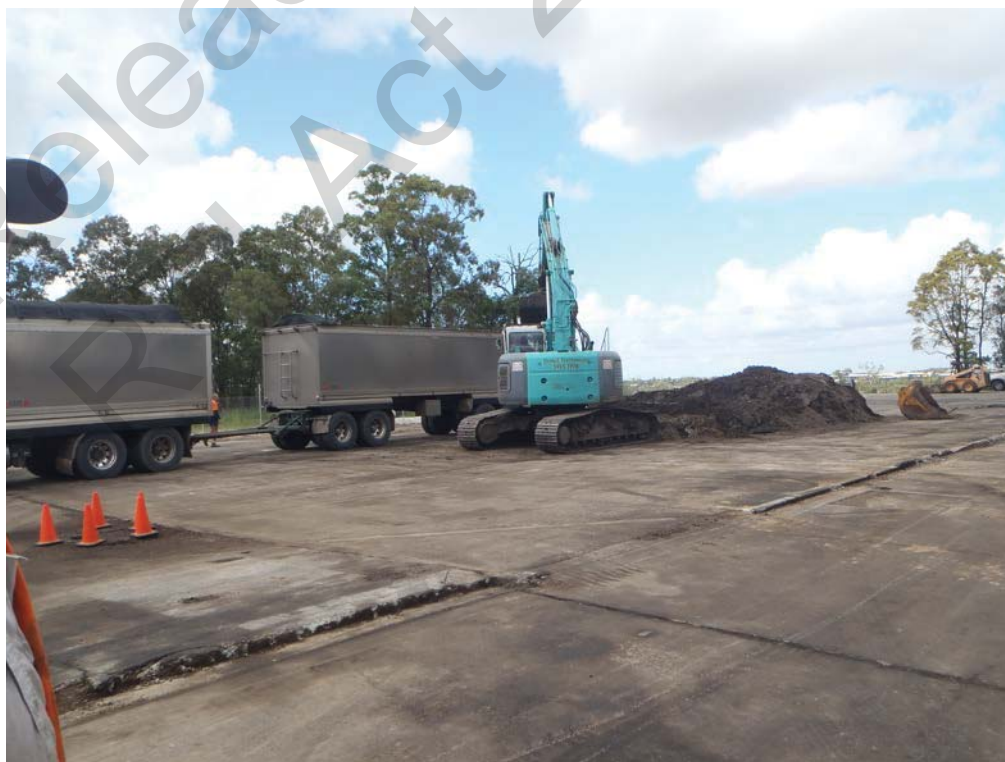
Photo 3 – Photo taken looking south-east from the potassium street entrance gate at the top of the property. Close up of the stock piles of contaminated soil were being loaded into a truck for disposal.

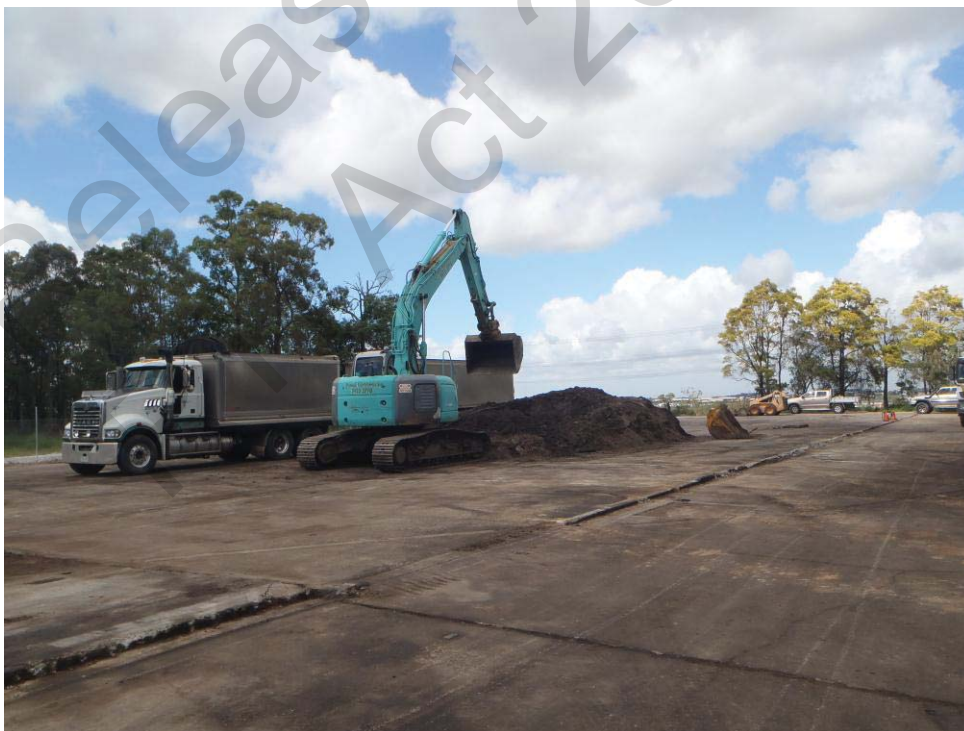
Photo 1 – Photo taken looking south-east from the potassium street entrance gate at the top of the property. Note that the stock piles of contaminated soil were being loaded into a truck for disposal.

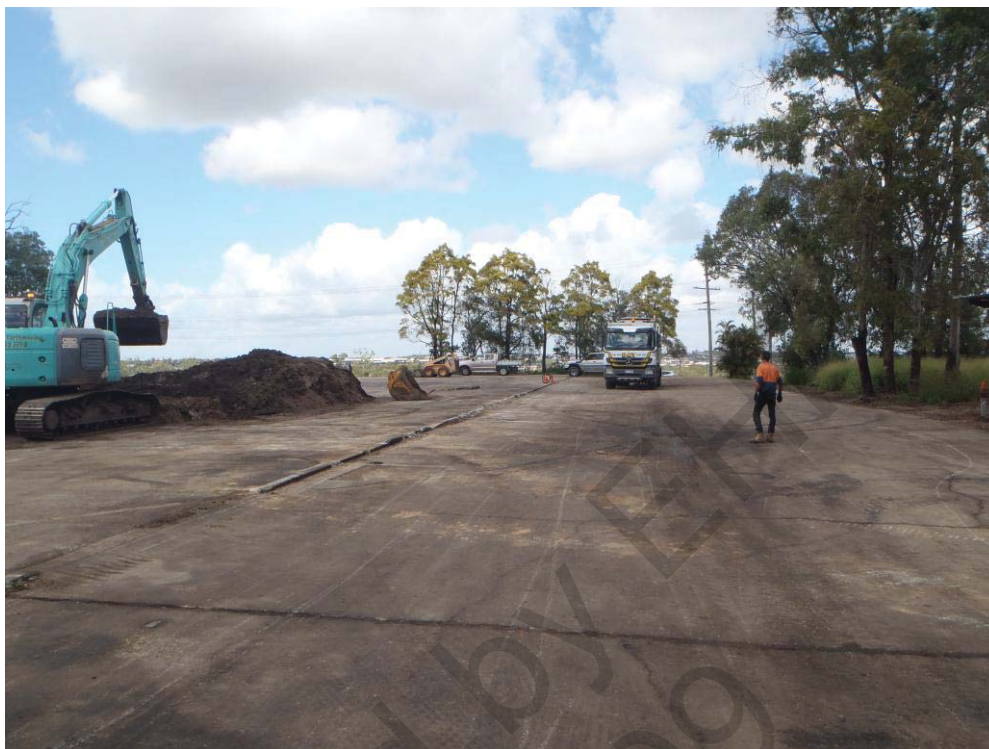
Photo 2 – Photo taken looking south from the potassium street entrance gate at the top of the property. Note The liquid waste truck at the rear of the photo. This truck was being used to clean the out the stormwater drainage systems in order for the system to be re-opened.

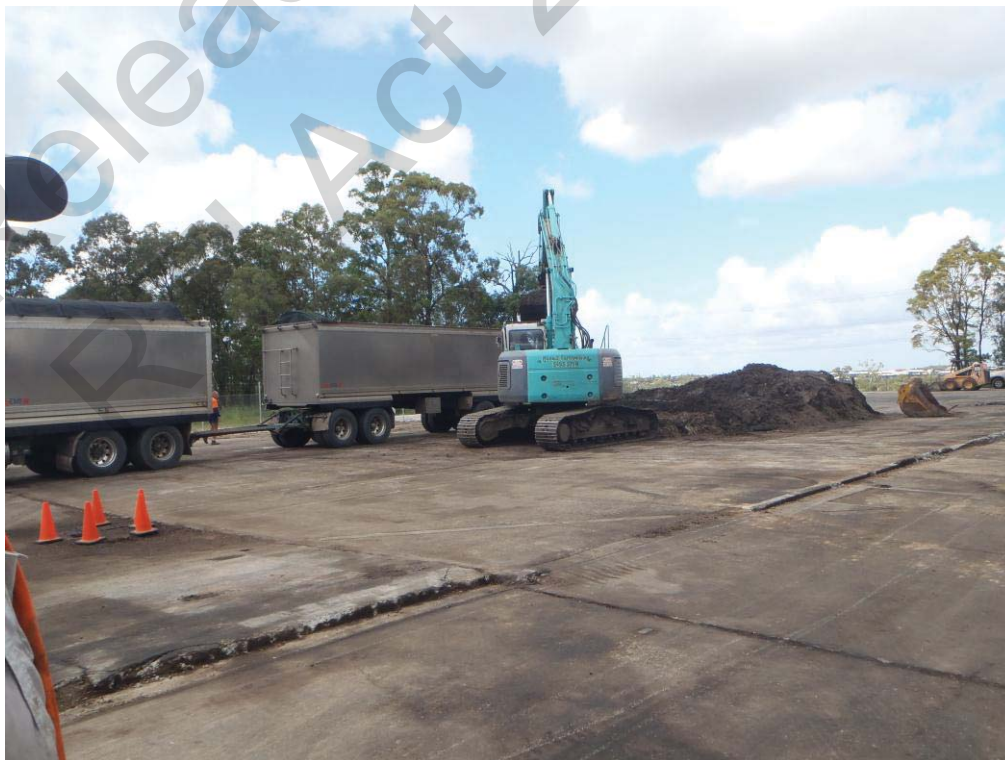
Photo 3 – Photo taken looking south-east from the potassium street entrance gate at the top of the property. Close up of the stock piles of contaminated soil were being loaded into a truck for disposal.
