## **BROOKVIEW LAUNDRY**

### **Site Contamination Investigation Report**

**DECEMBER 2001  
JOB NO. 7141-01/2**

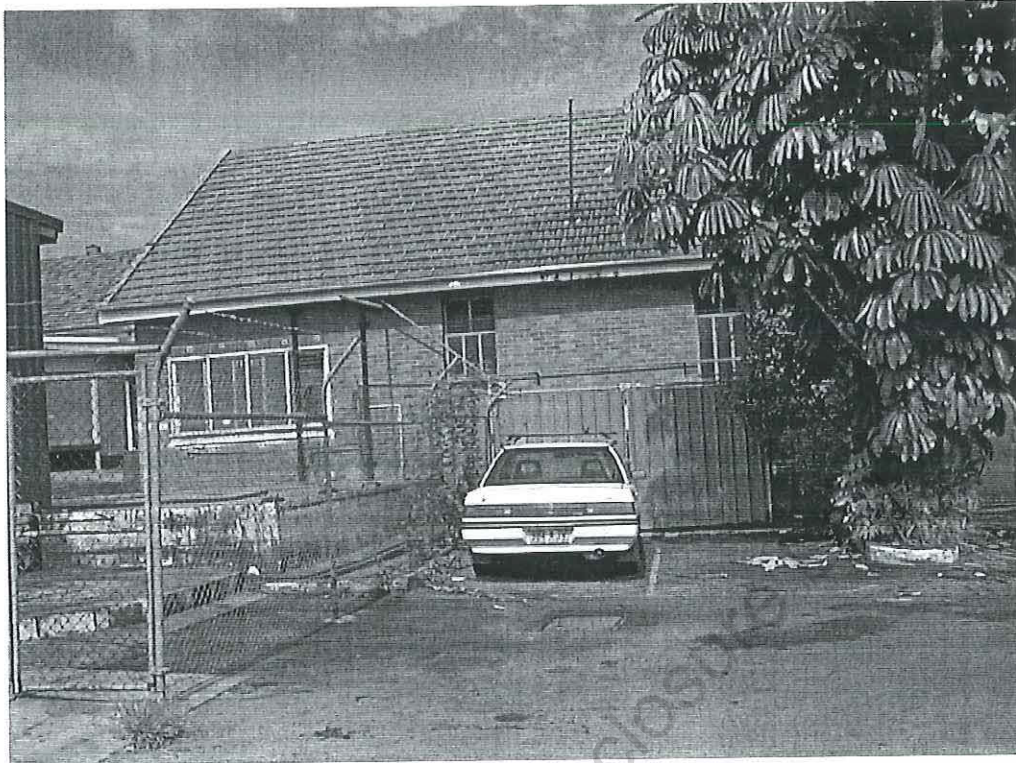
A site inspection revealed that the emergency generator and associated above ground fuel tank had been located on a thick concrete slab adjacent the former bulk fuel oil tank and the boiler house (Appendix F – Photo 1).

There was no evidence of any staining on the concrete slab and no cracking of the concrete slab was evident.

**Photo 1 : Laundry boiler room located in background. Bulk fuel oil tank formerly located on a thick concrete slab to the left. Stand-by diesel generator and above ground storage tank formerly located on the thick raised concrete slab to the left.**

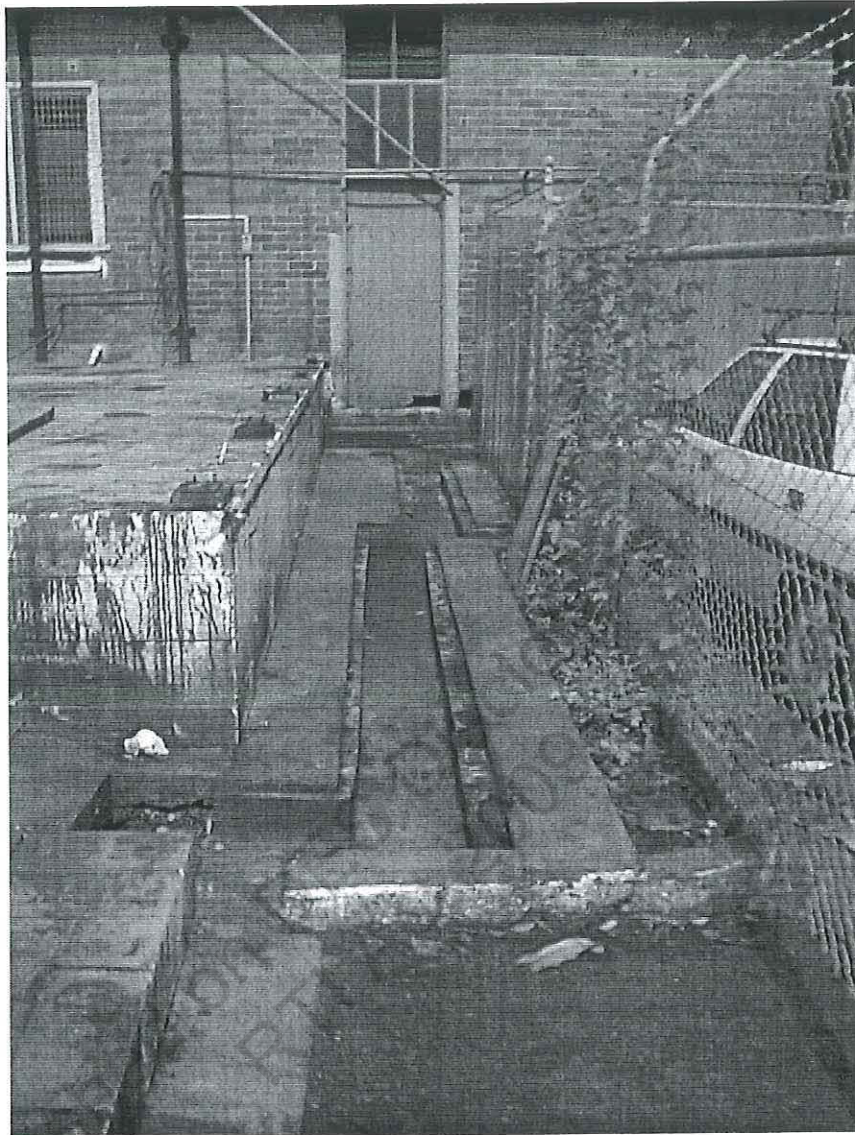
A concrete lined channel, housing the old fuel lines from the former bulk fuel oil tank to the boiler room, did contain residues of fuel oil. These residues of fuel oil were cleaned up by Nationwide Oil and the fuel lines removed from the site (Appendix F – Photo 4).

**Photo 4 : Concrete lined channel containing the former fuel lines  
from the bulk fuel oil container to the boiler room.**

The slab under the former bulk fuel oil storage stand-by diesel generator and associated above ground diesel tank was excavated. The slab comprised a 330mm thick base (refer Appendix F – Photos 6 and 7) with no staining or smell evident from the soil below the slab. Similarly the concrete pipe channel was also formed over a 330mm thick base (Appendix F – Photo 4).

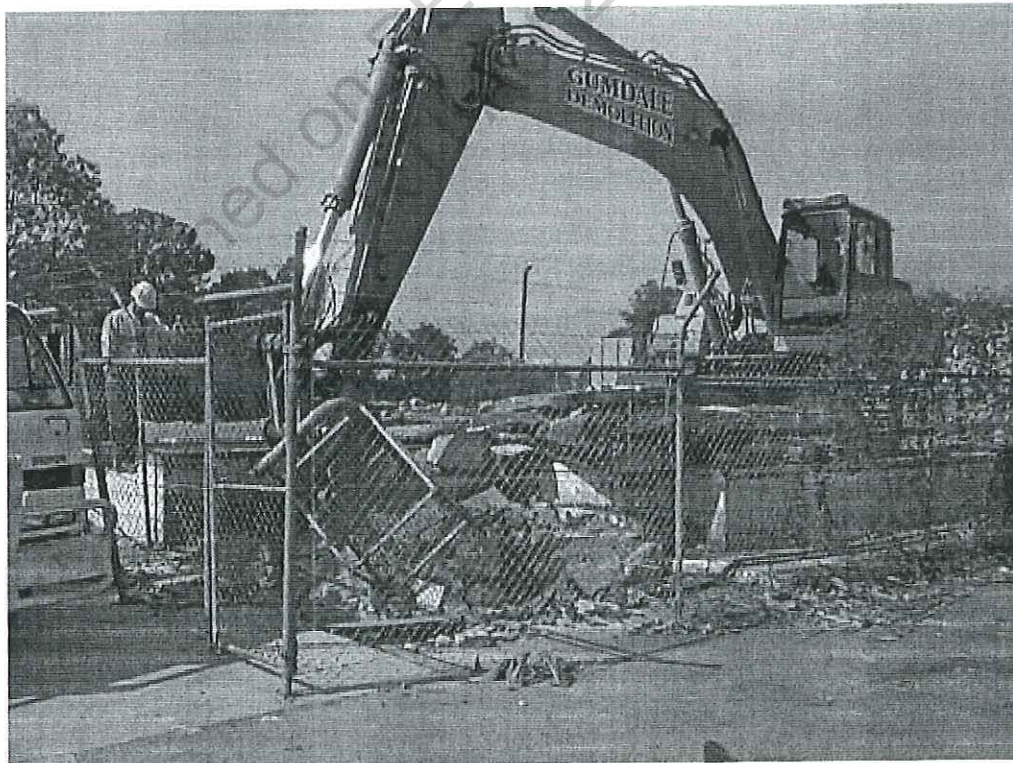
**Photo 6 : Demolition of the slab below the former bulk fuel oil vessel.**

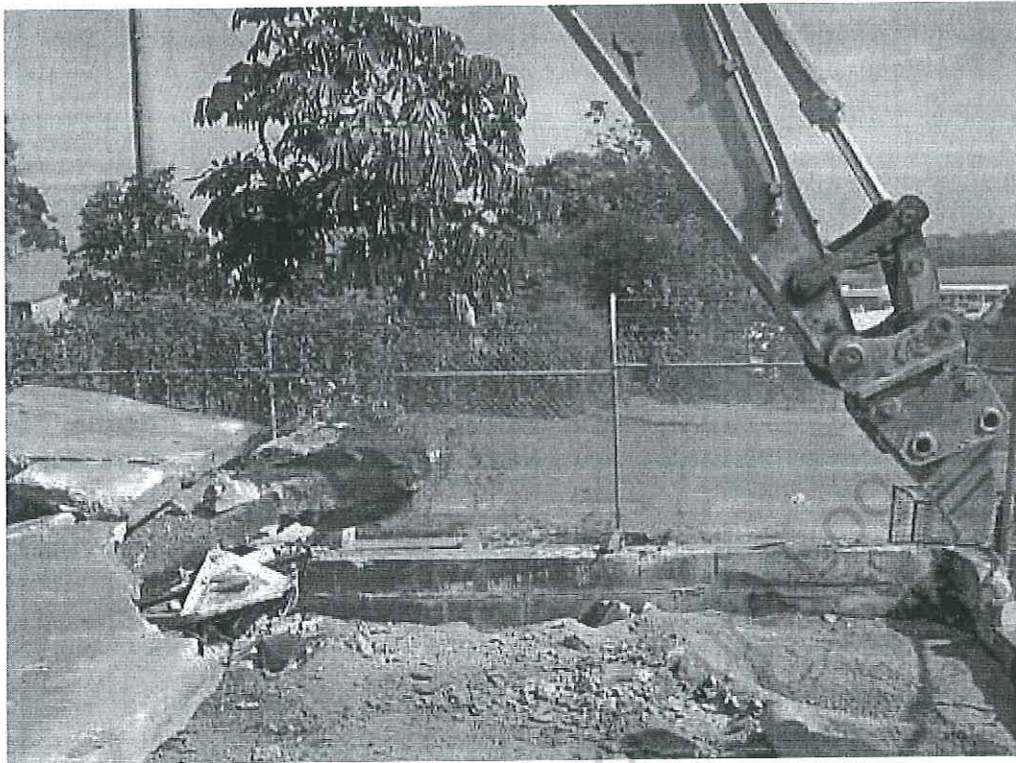
**Photo 7 : Exposed thick concrete slab and soil (showing no signs of staining) below the former bulk fuel oil storage area.**

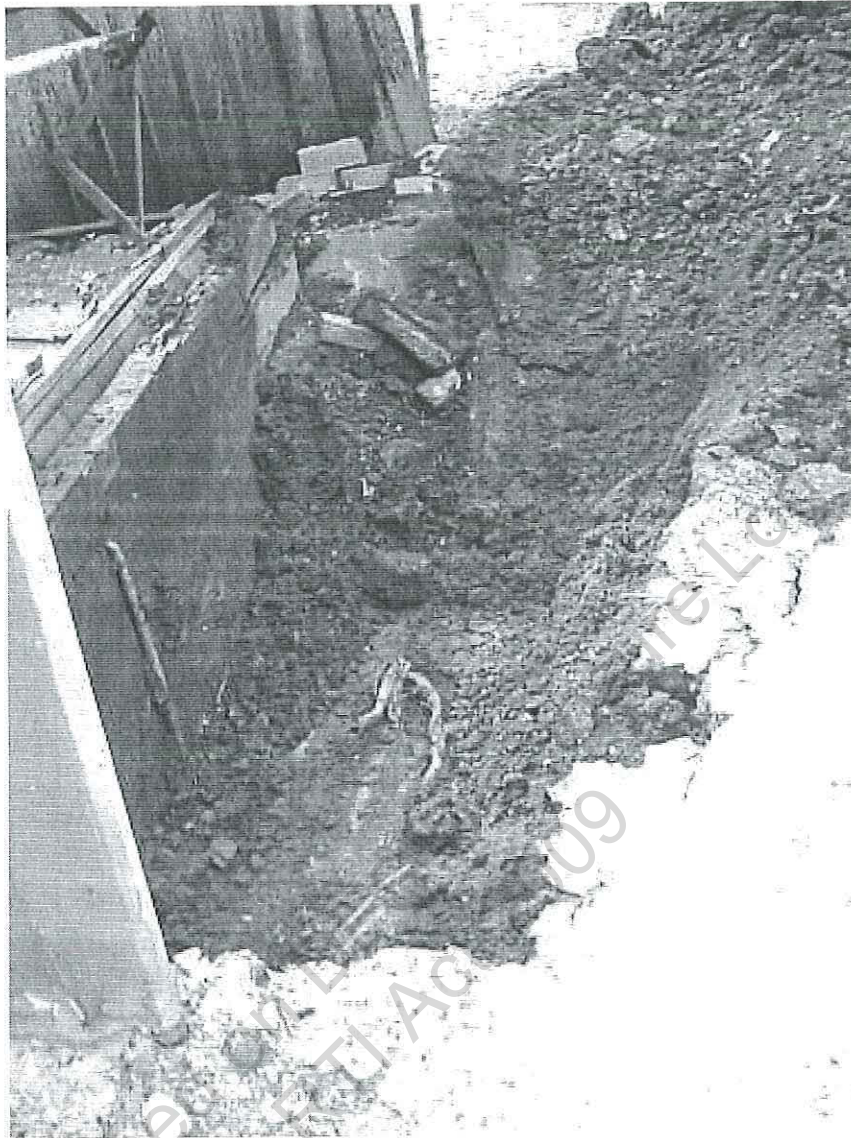
**Photo 9 : Excavation of soil adjacent old ENERGEX transformer.**

Following demolition of the former laundry, site sampling revealed no soil contamination apart from one small area (adjacent the Energex transformer) which showed minor contamination from transformer oil hydrocarbons. This contaminated hydrocarbon soil was remediated on-site by aerobic bioremediation.
