23 January 2015

Project No. 087673045-059-L-Rev1

**SITE INVESTIGATION SUBMISSION FOR LOT 20 ON SP262379, CAIRNS VILLA CARAVAN PARK**

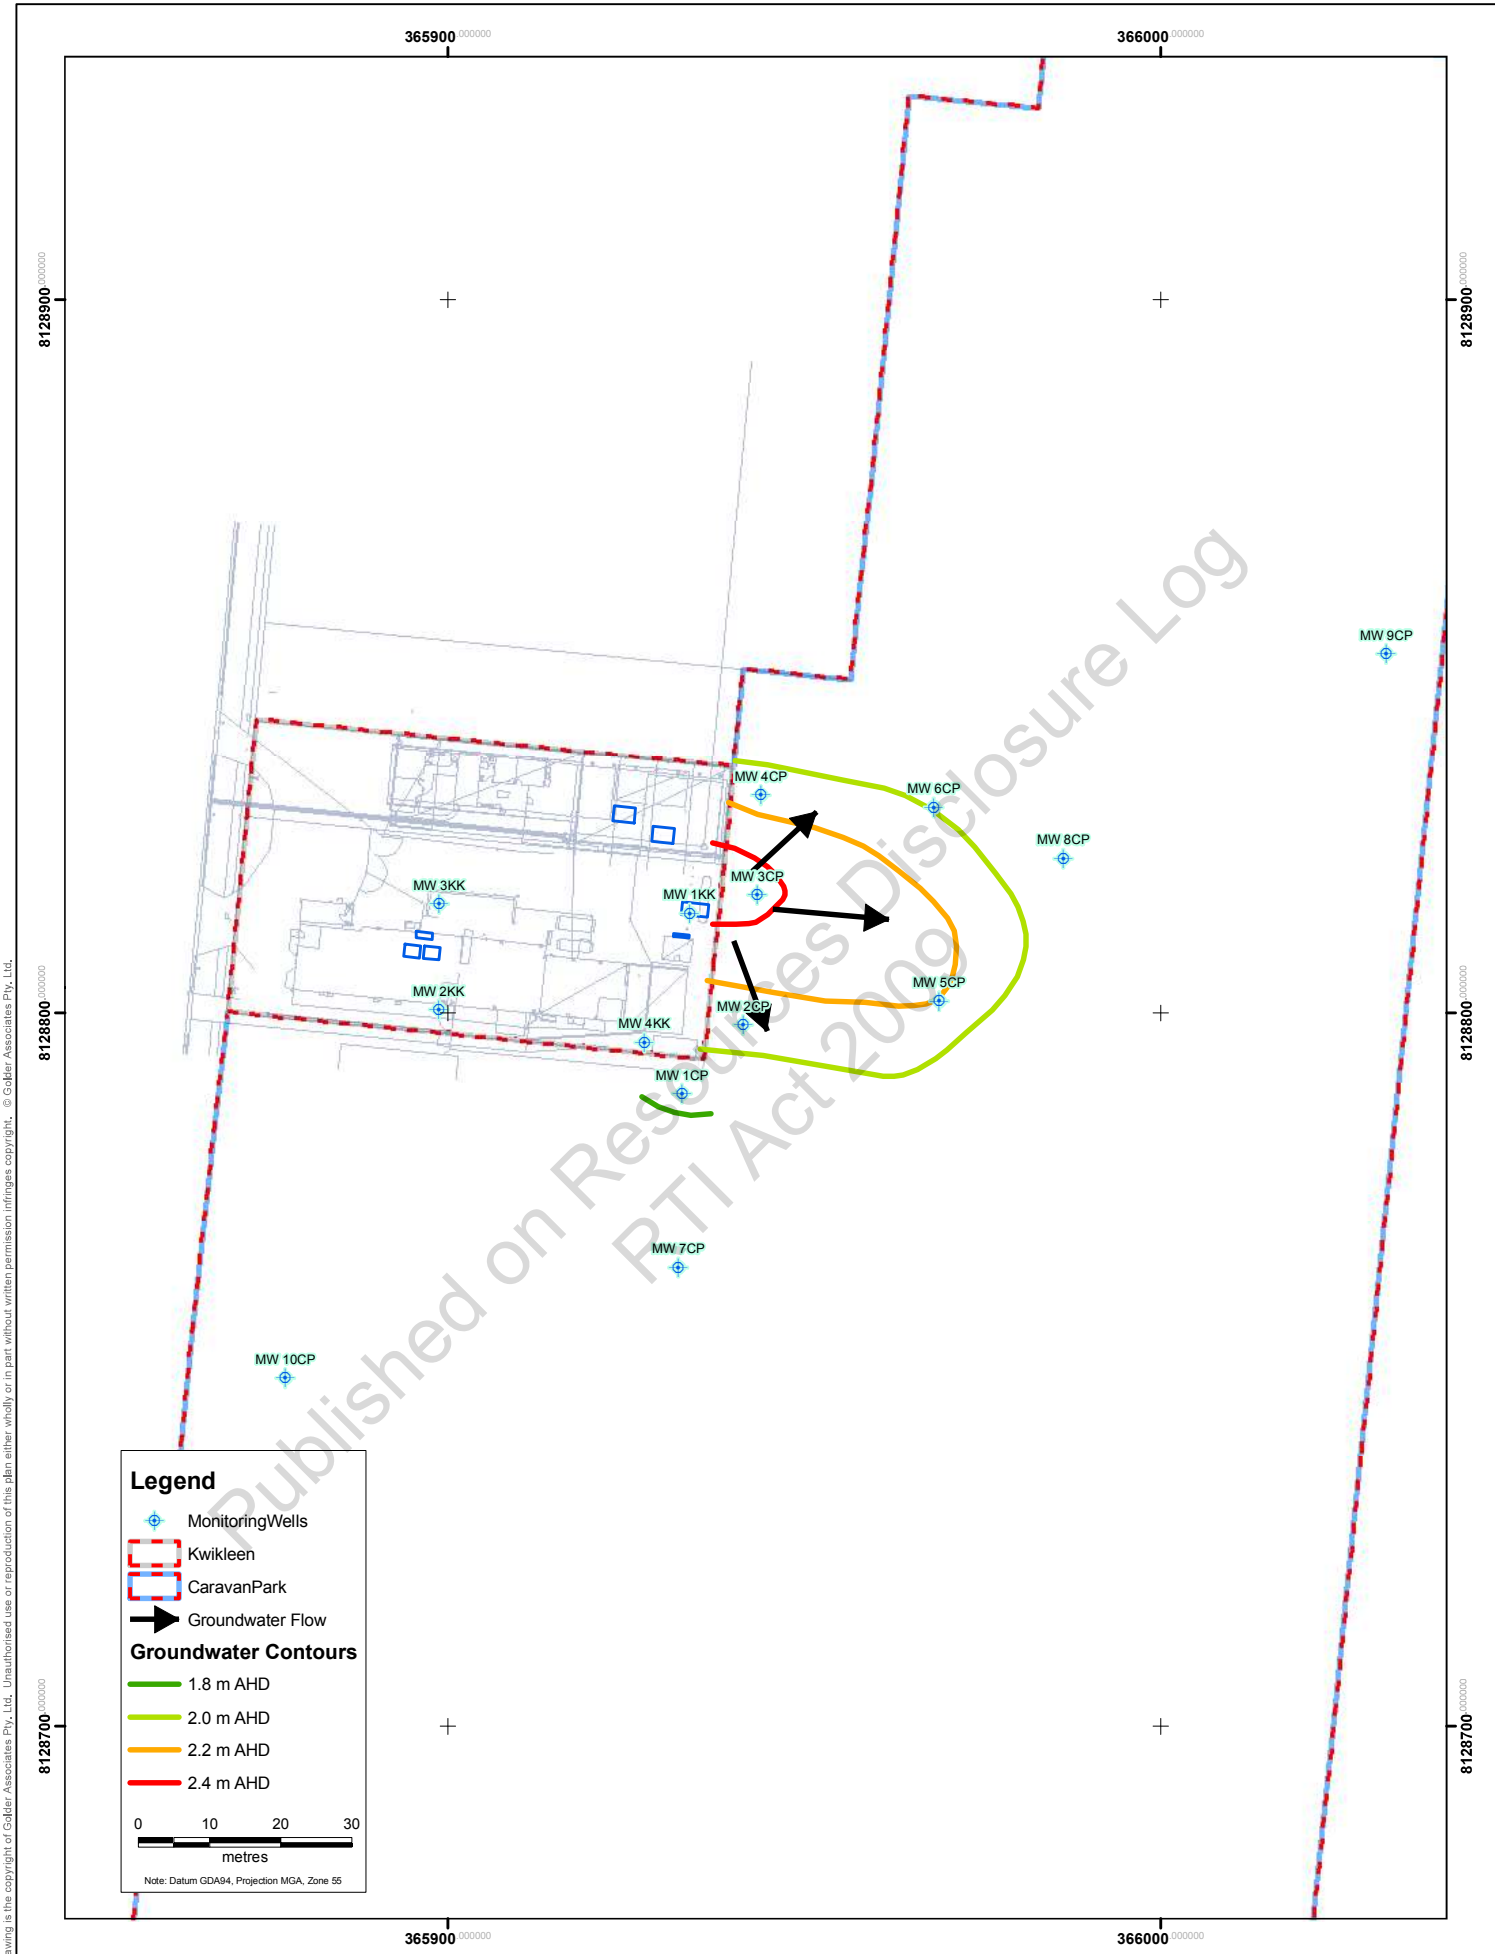
Groundwater levels indicated by Douglas Partners are summarised in Table 1. Interpreted groundwater contours based on these results are shown on Figures 3A and 3B. It should be noted that well depth measurements by Golder Associates in 2009 indicate that the well originally logged by Douglas Partners as MW5 has at some stage since been transposed with the location indicated by Douglas Partners for be MW6. As such, all Douglas Partners water level and laboratory results indicated to be MW5 and MW6 have been considered as results from MW6CP and MW5CP, respectively during this assessment.

| | | CHECKED PKS | DATE 26 JUNE 2009 | Interpreted Groundwater Contours - March 2007 | |

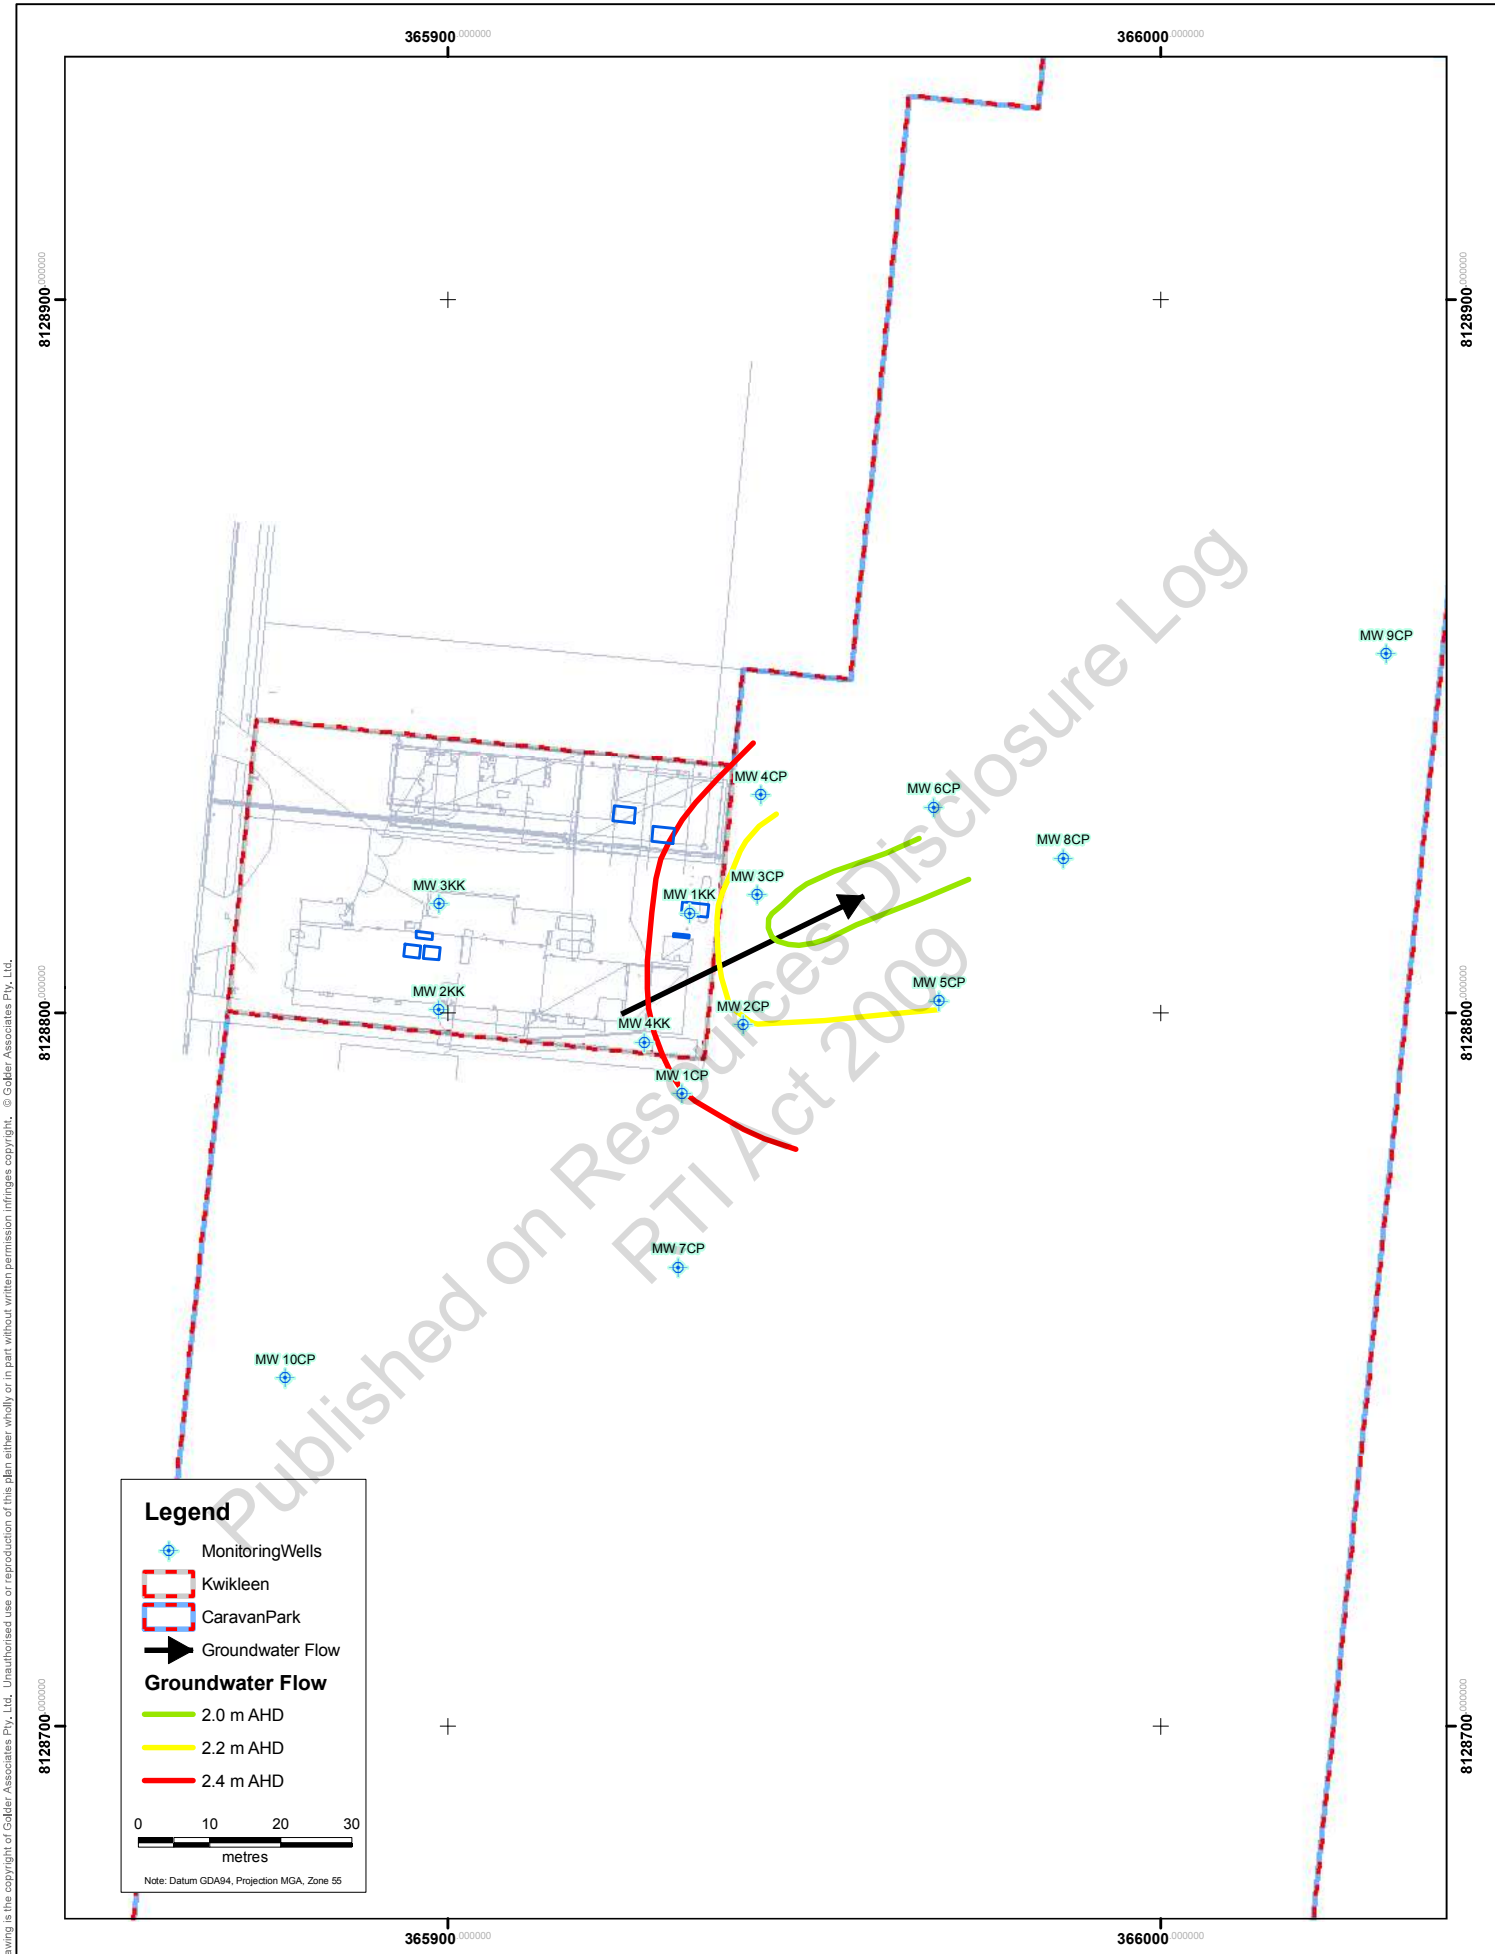
| | | CHECKED PKS | DATE 26 JUNE 2009 | Interpreted Groundwater Contours - April 2007 | |

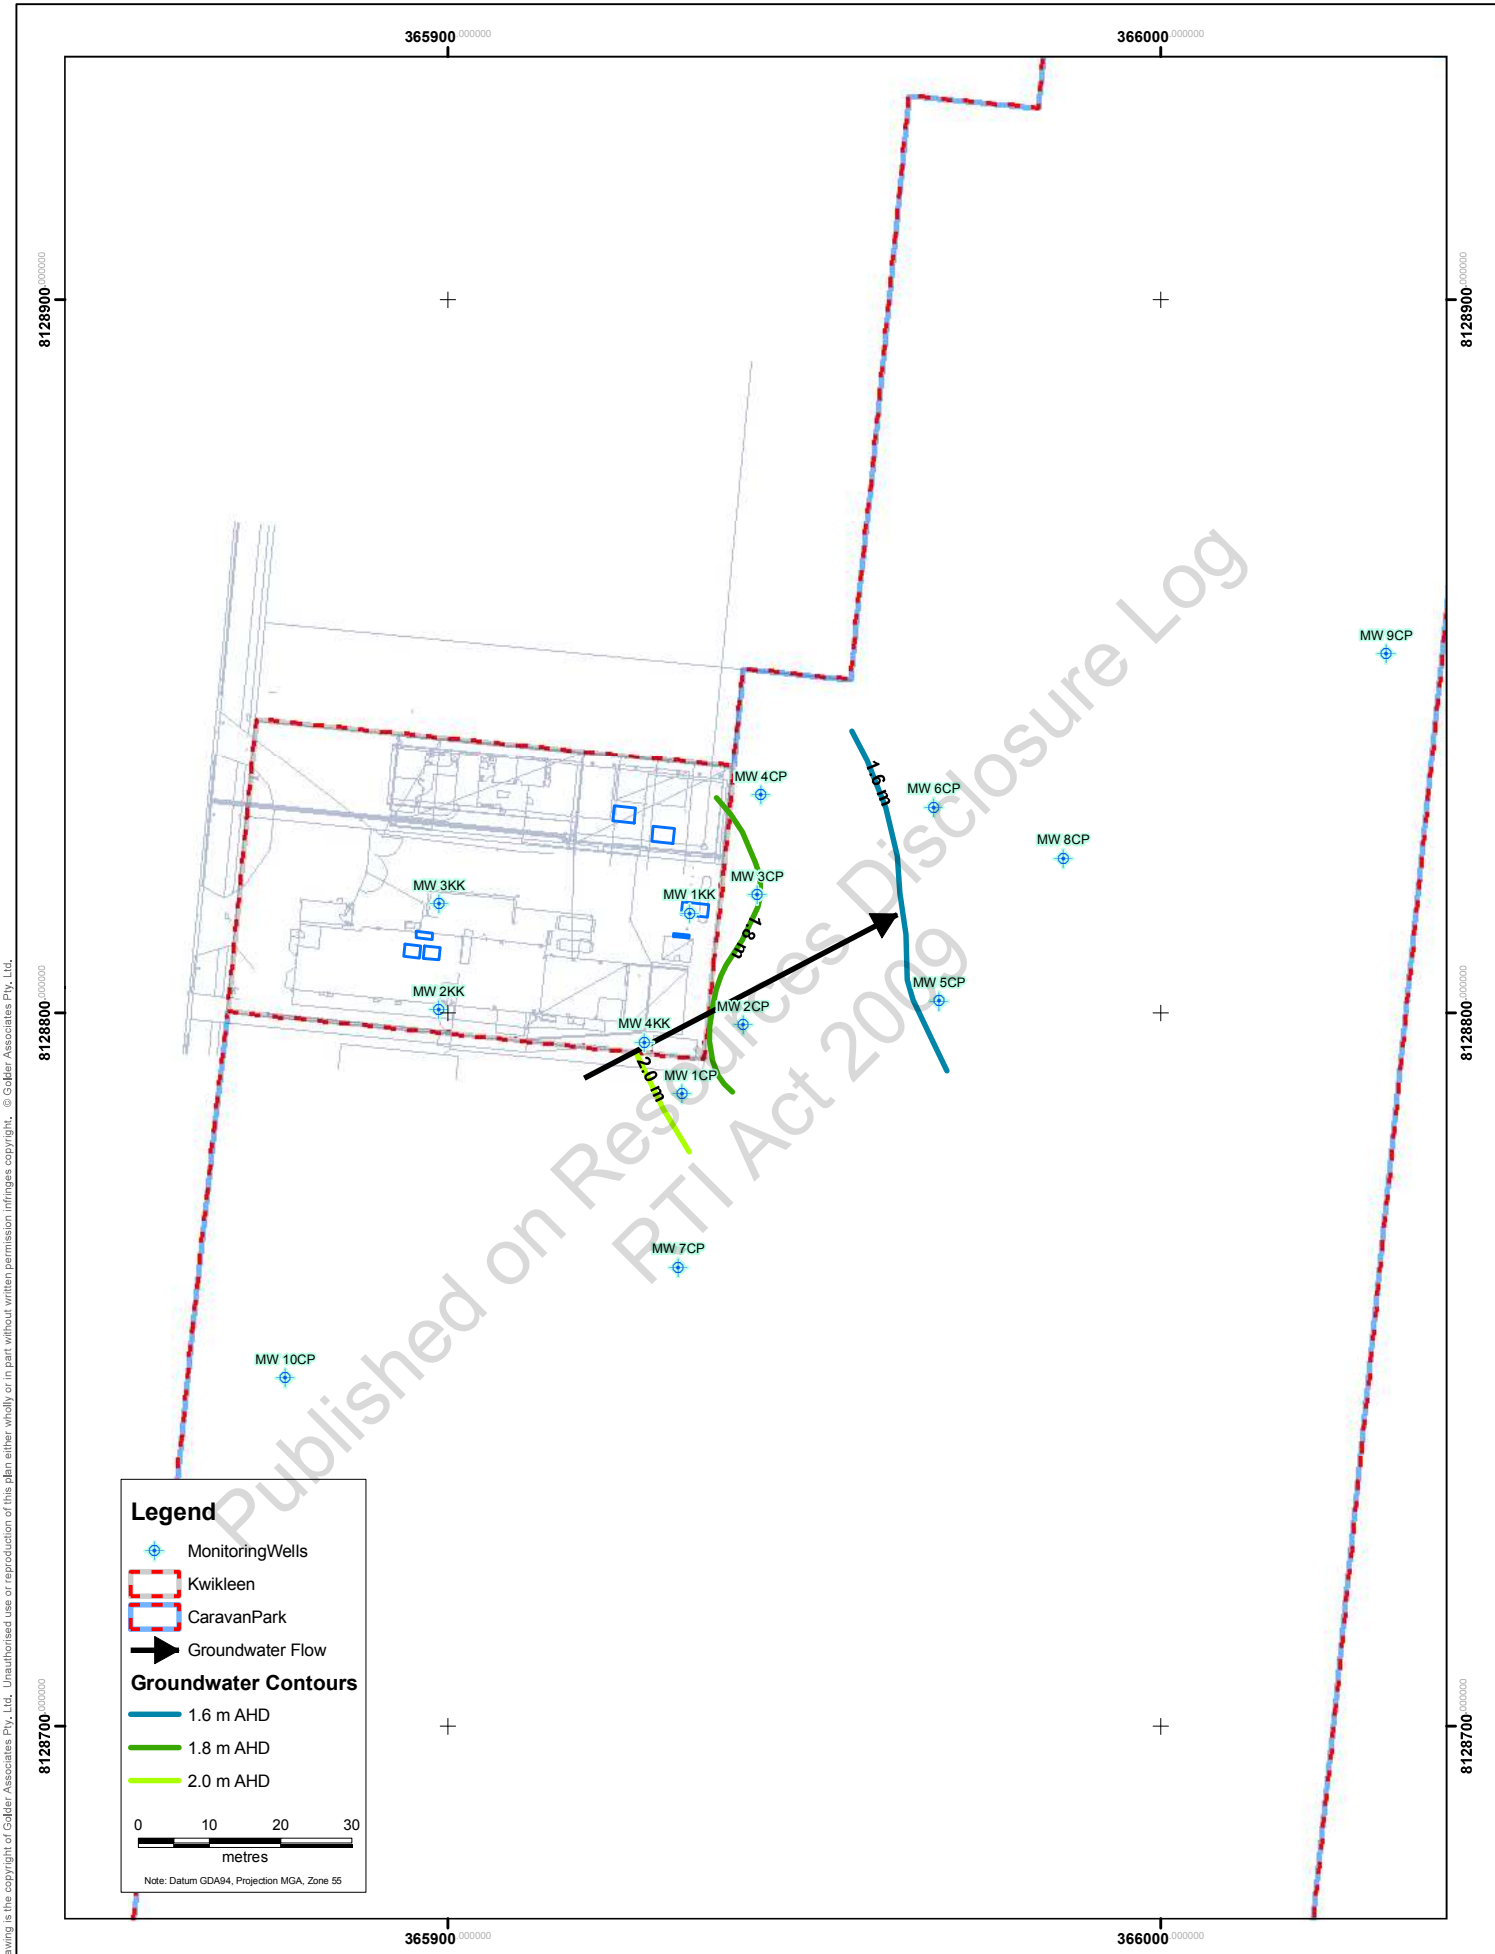
| | | CHECKED PKS | DATE 26 JUNE 2009 | Interpreted Groundwater Contours - July 2007 | |

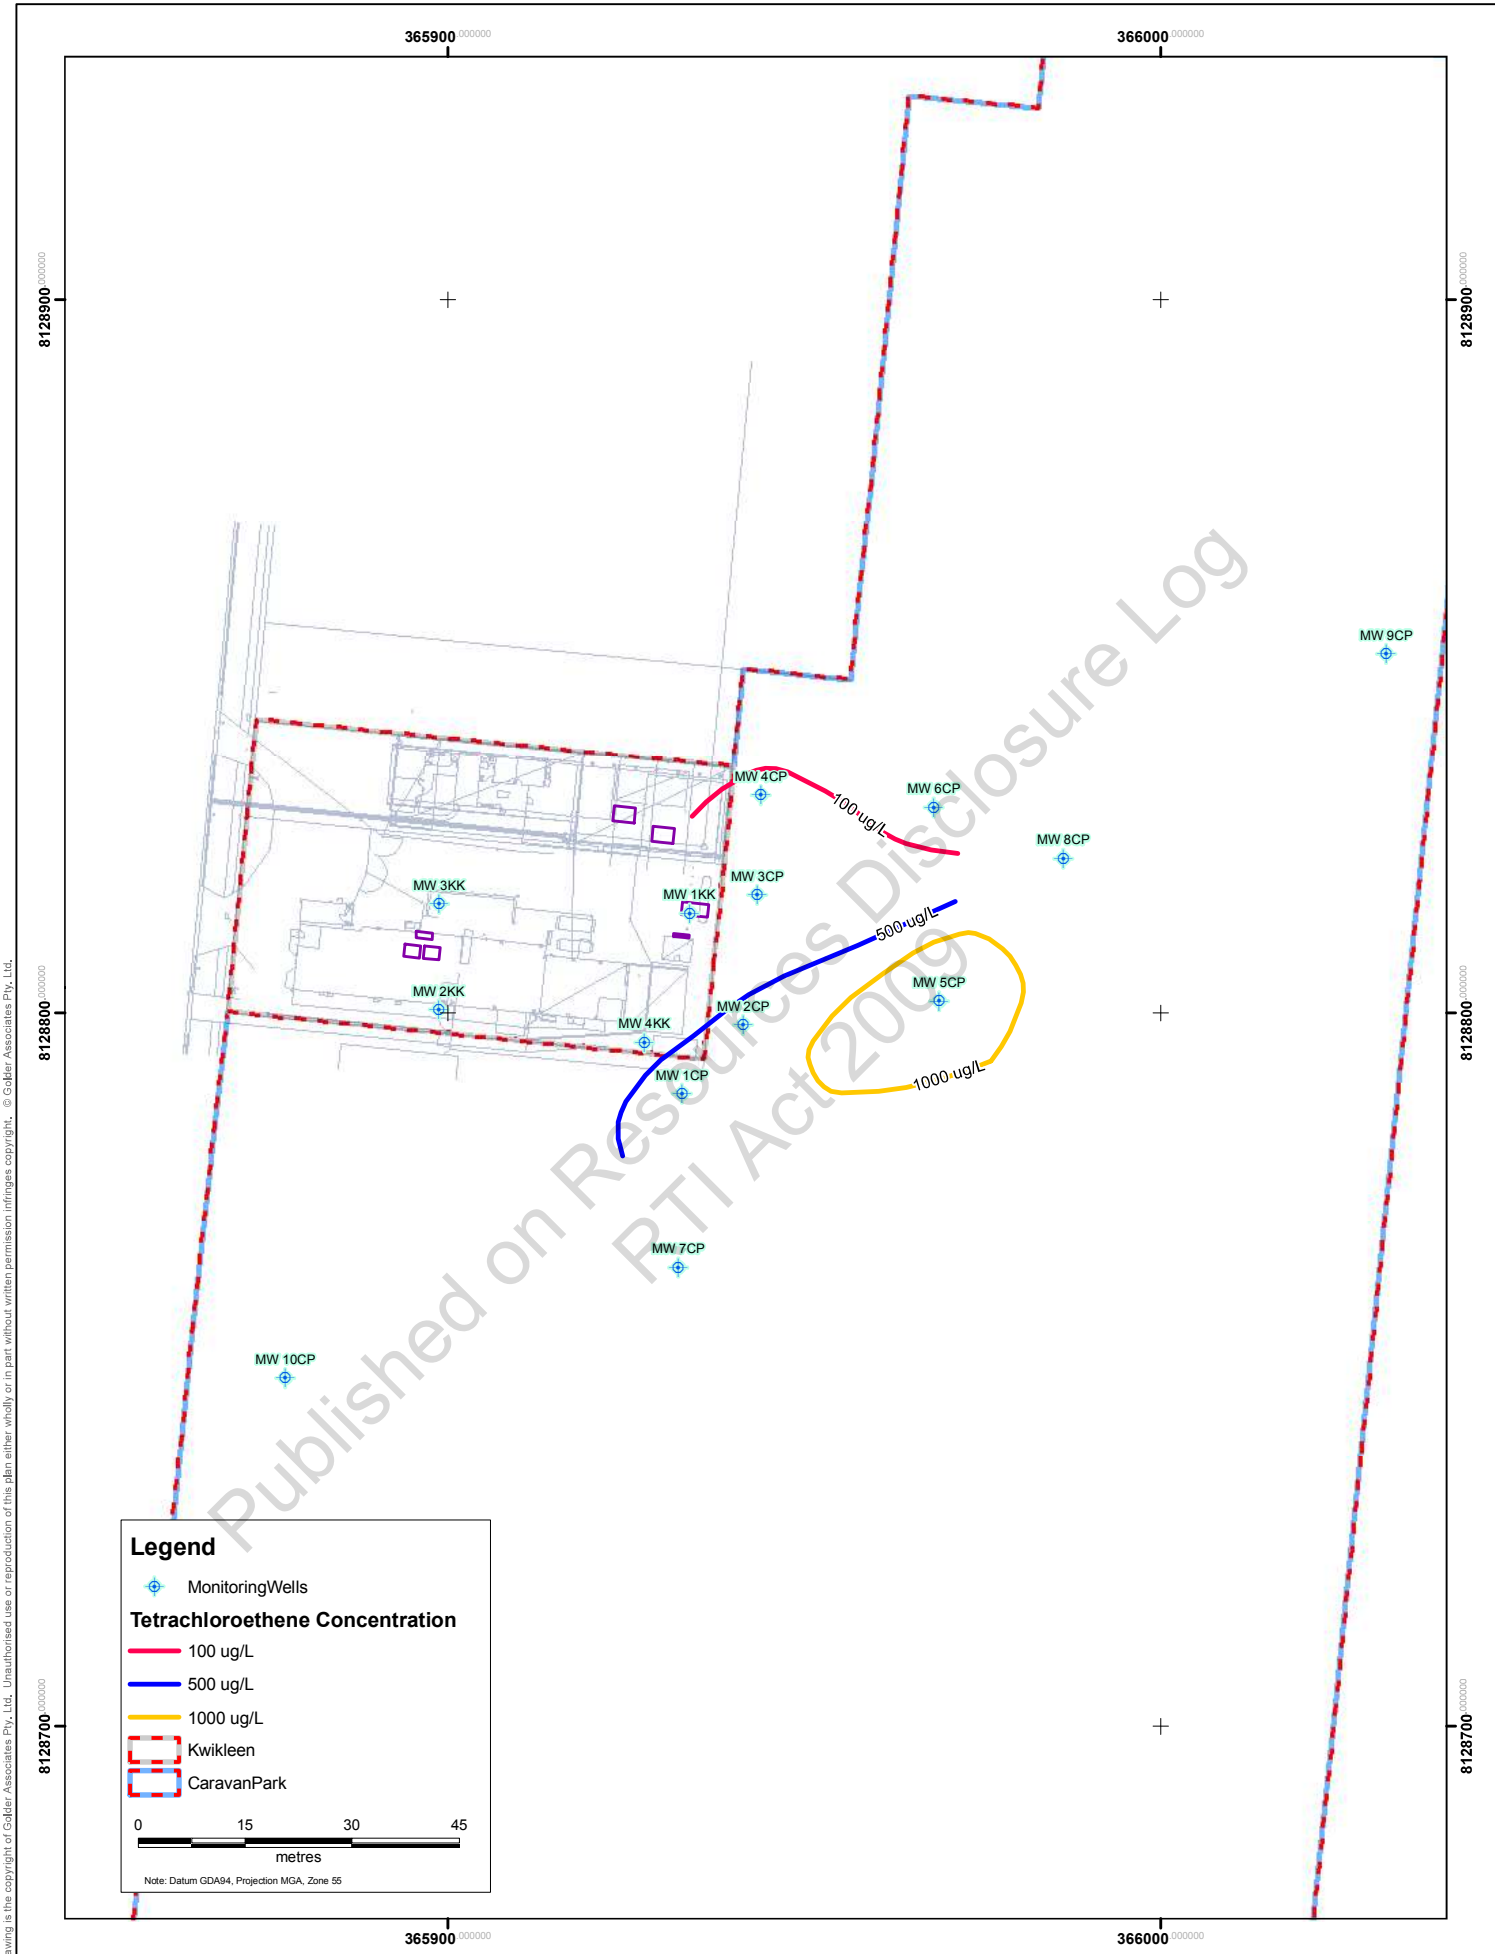
| | | CHECKED PKS | DATE 26 JUNE 2009 | Interpreted Tetrachloroethene Concentration Contours - July 2007 | |

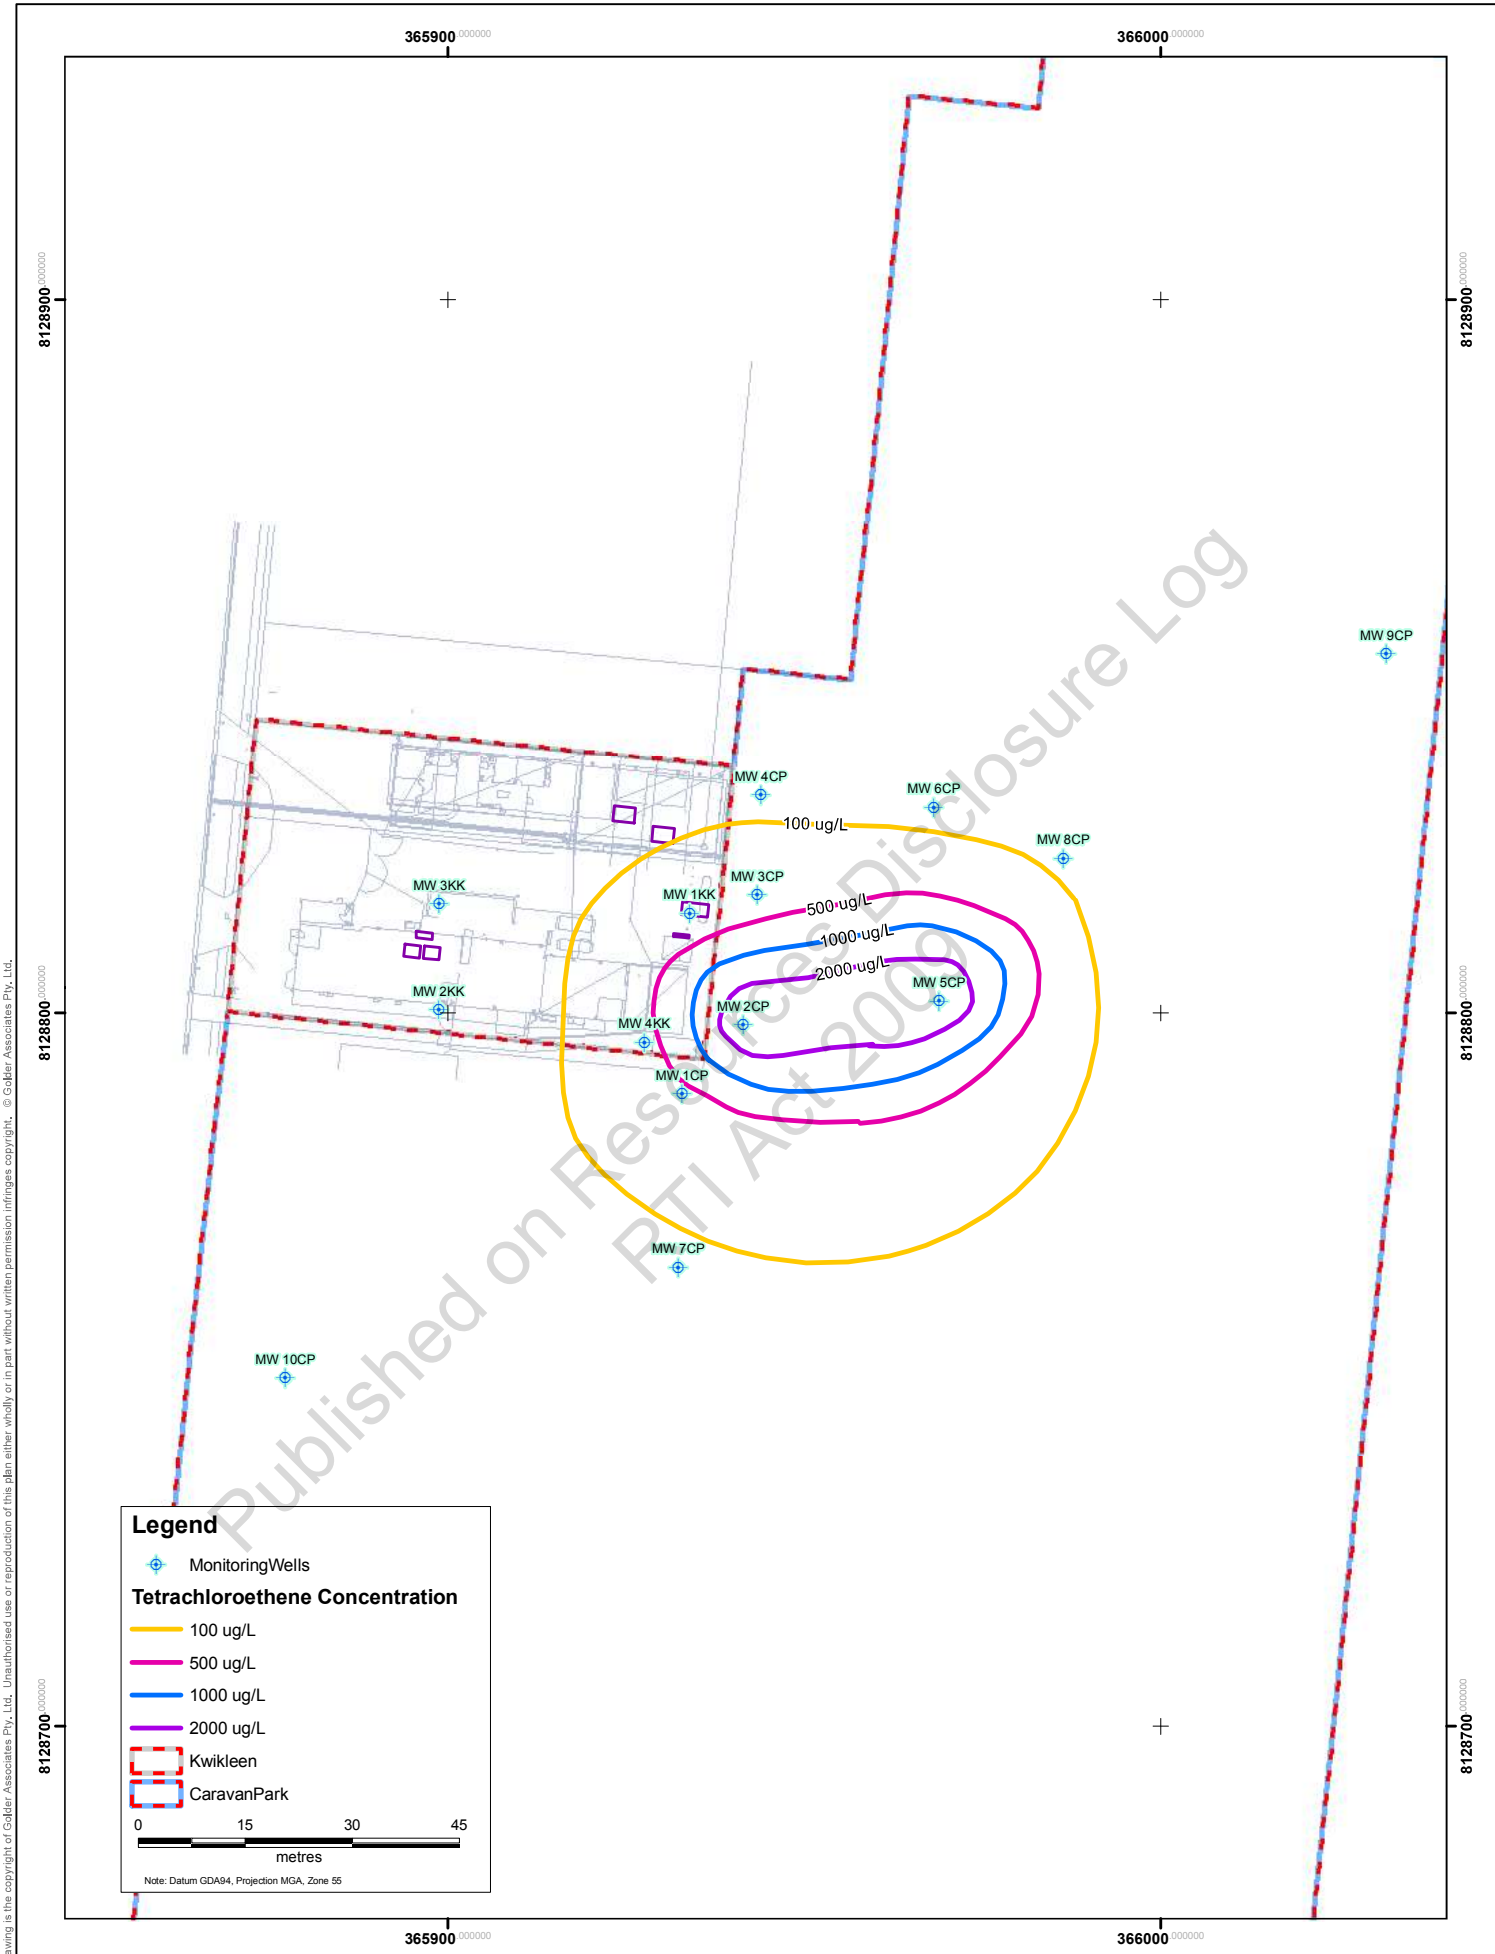
| | | CHECKED PKS | DATE 26 JUNE 2009 | Interpreted Tetrachloroethene Concentration Contours - October 2007 | |

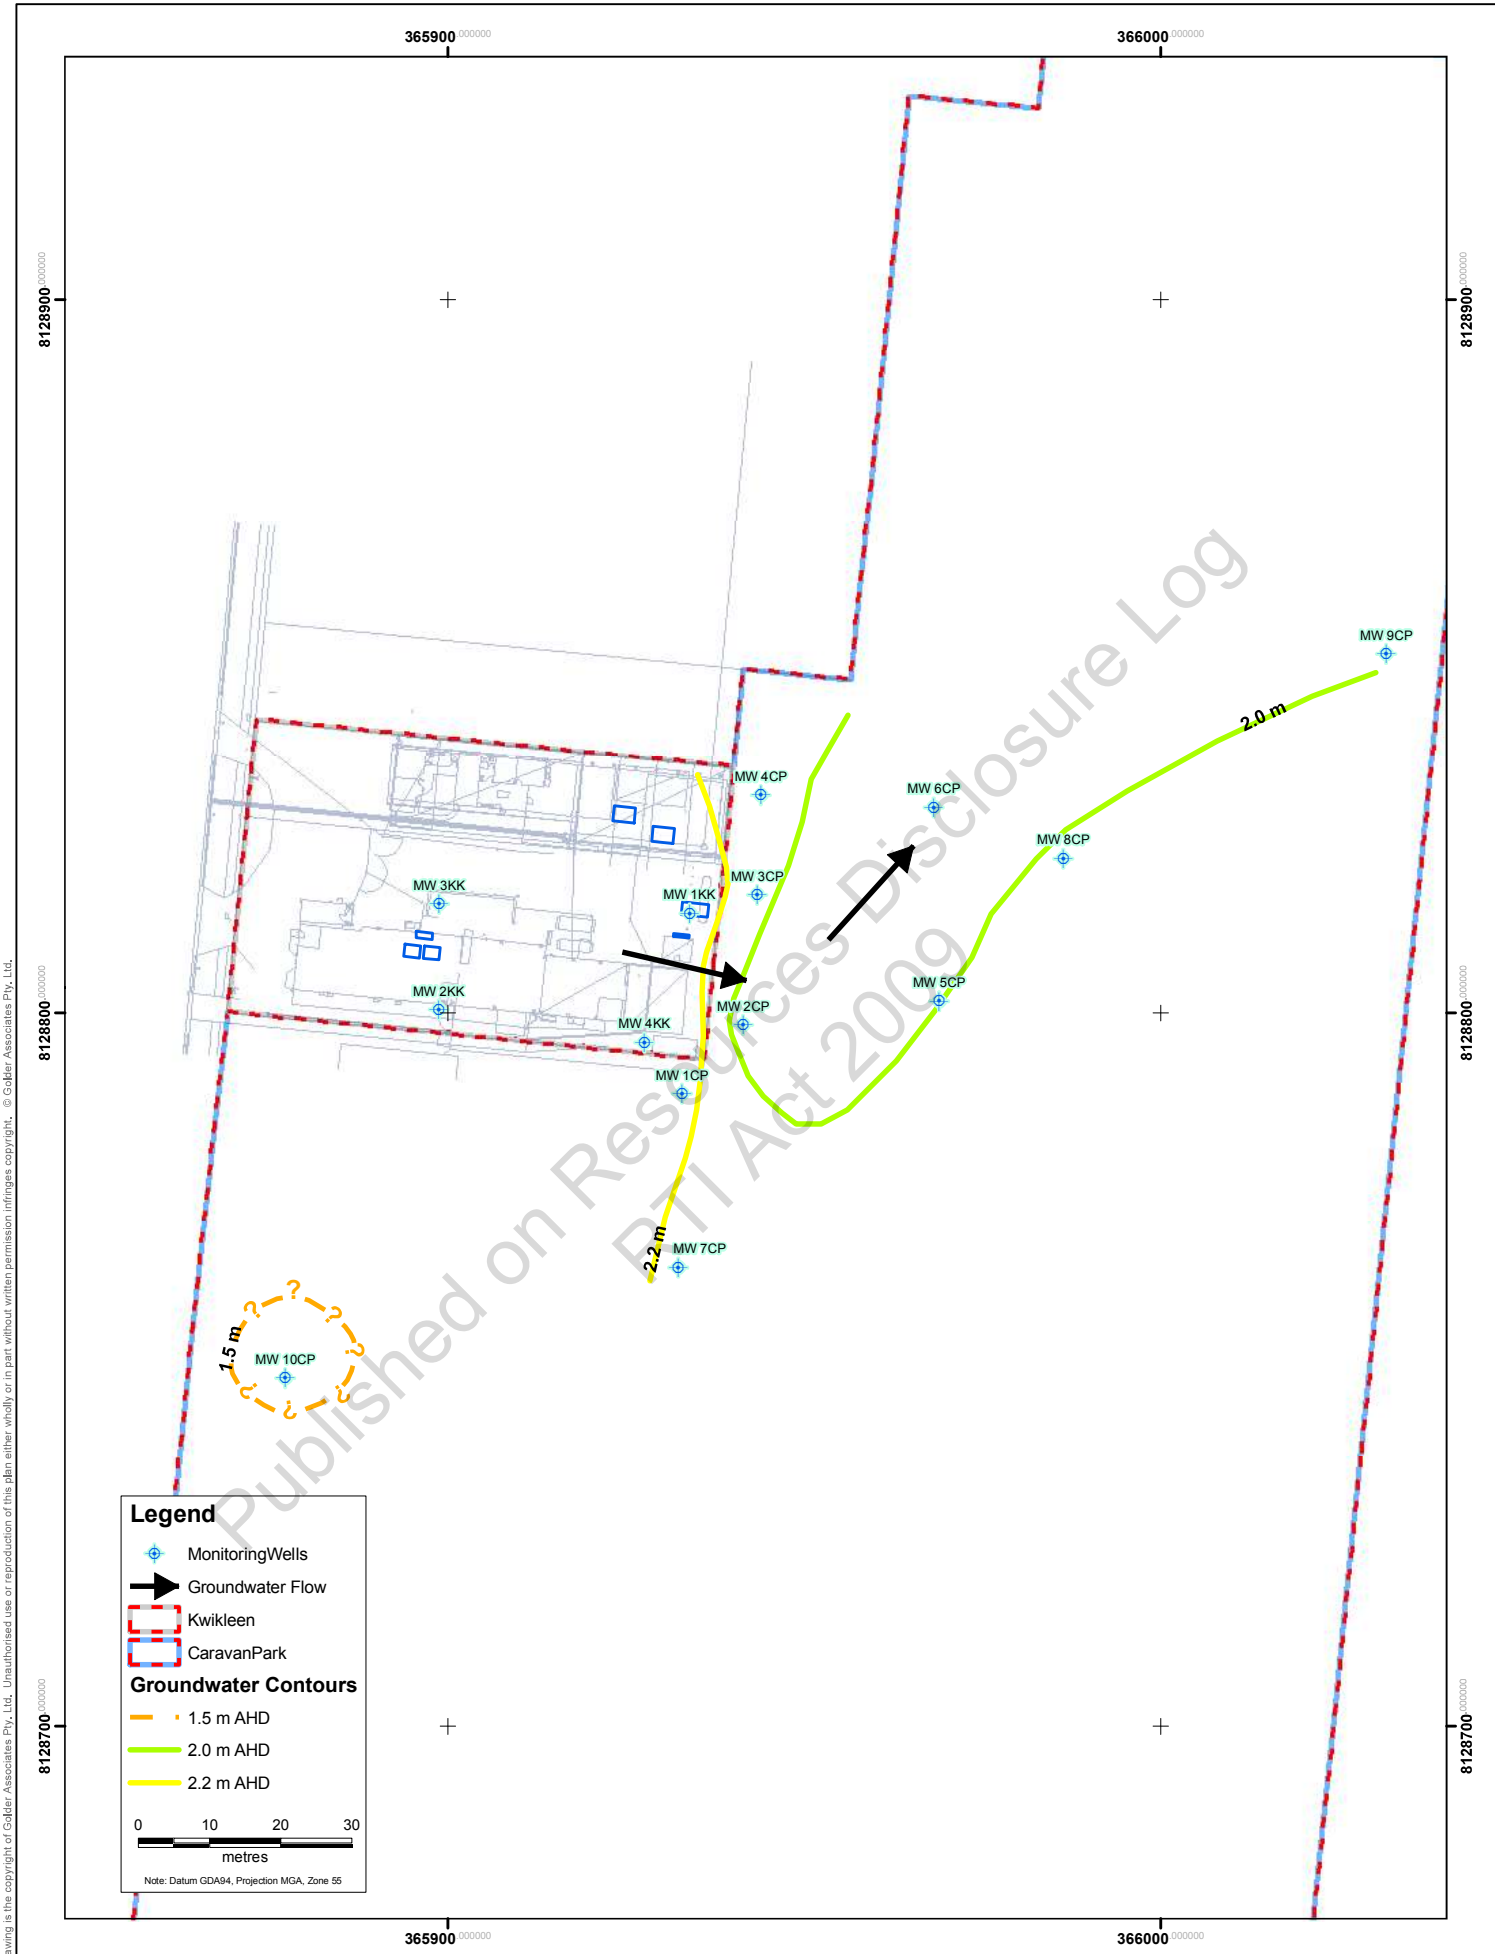
| | | CHECKED PKS | DATE 26 JUNE 2009 | Interpreted Groundwater Contours - March 2008 | |

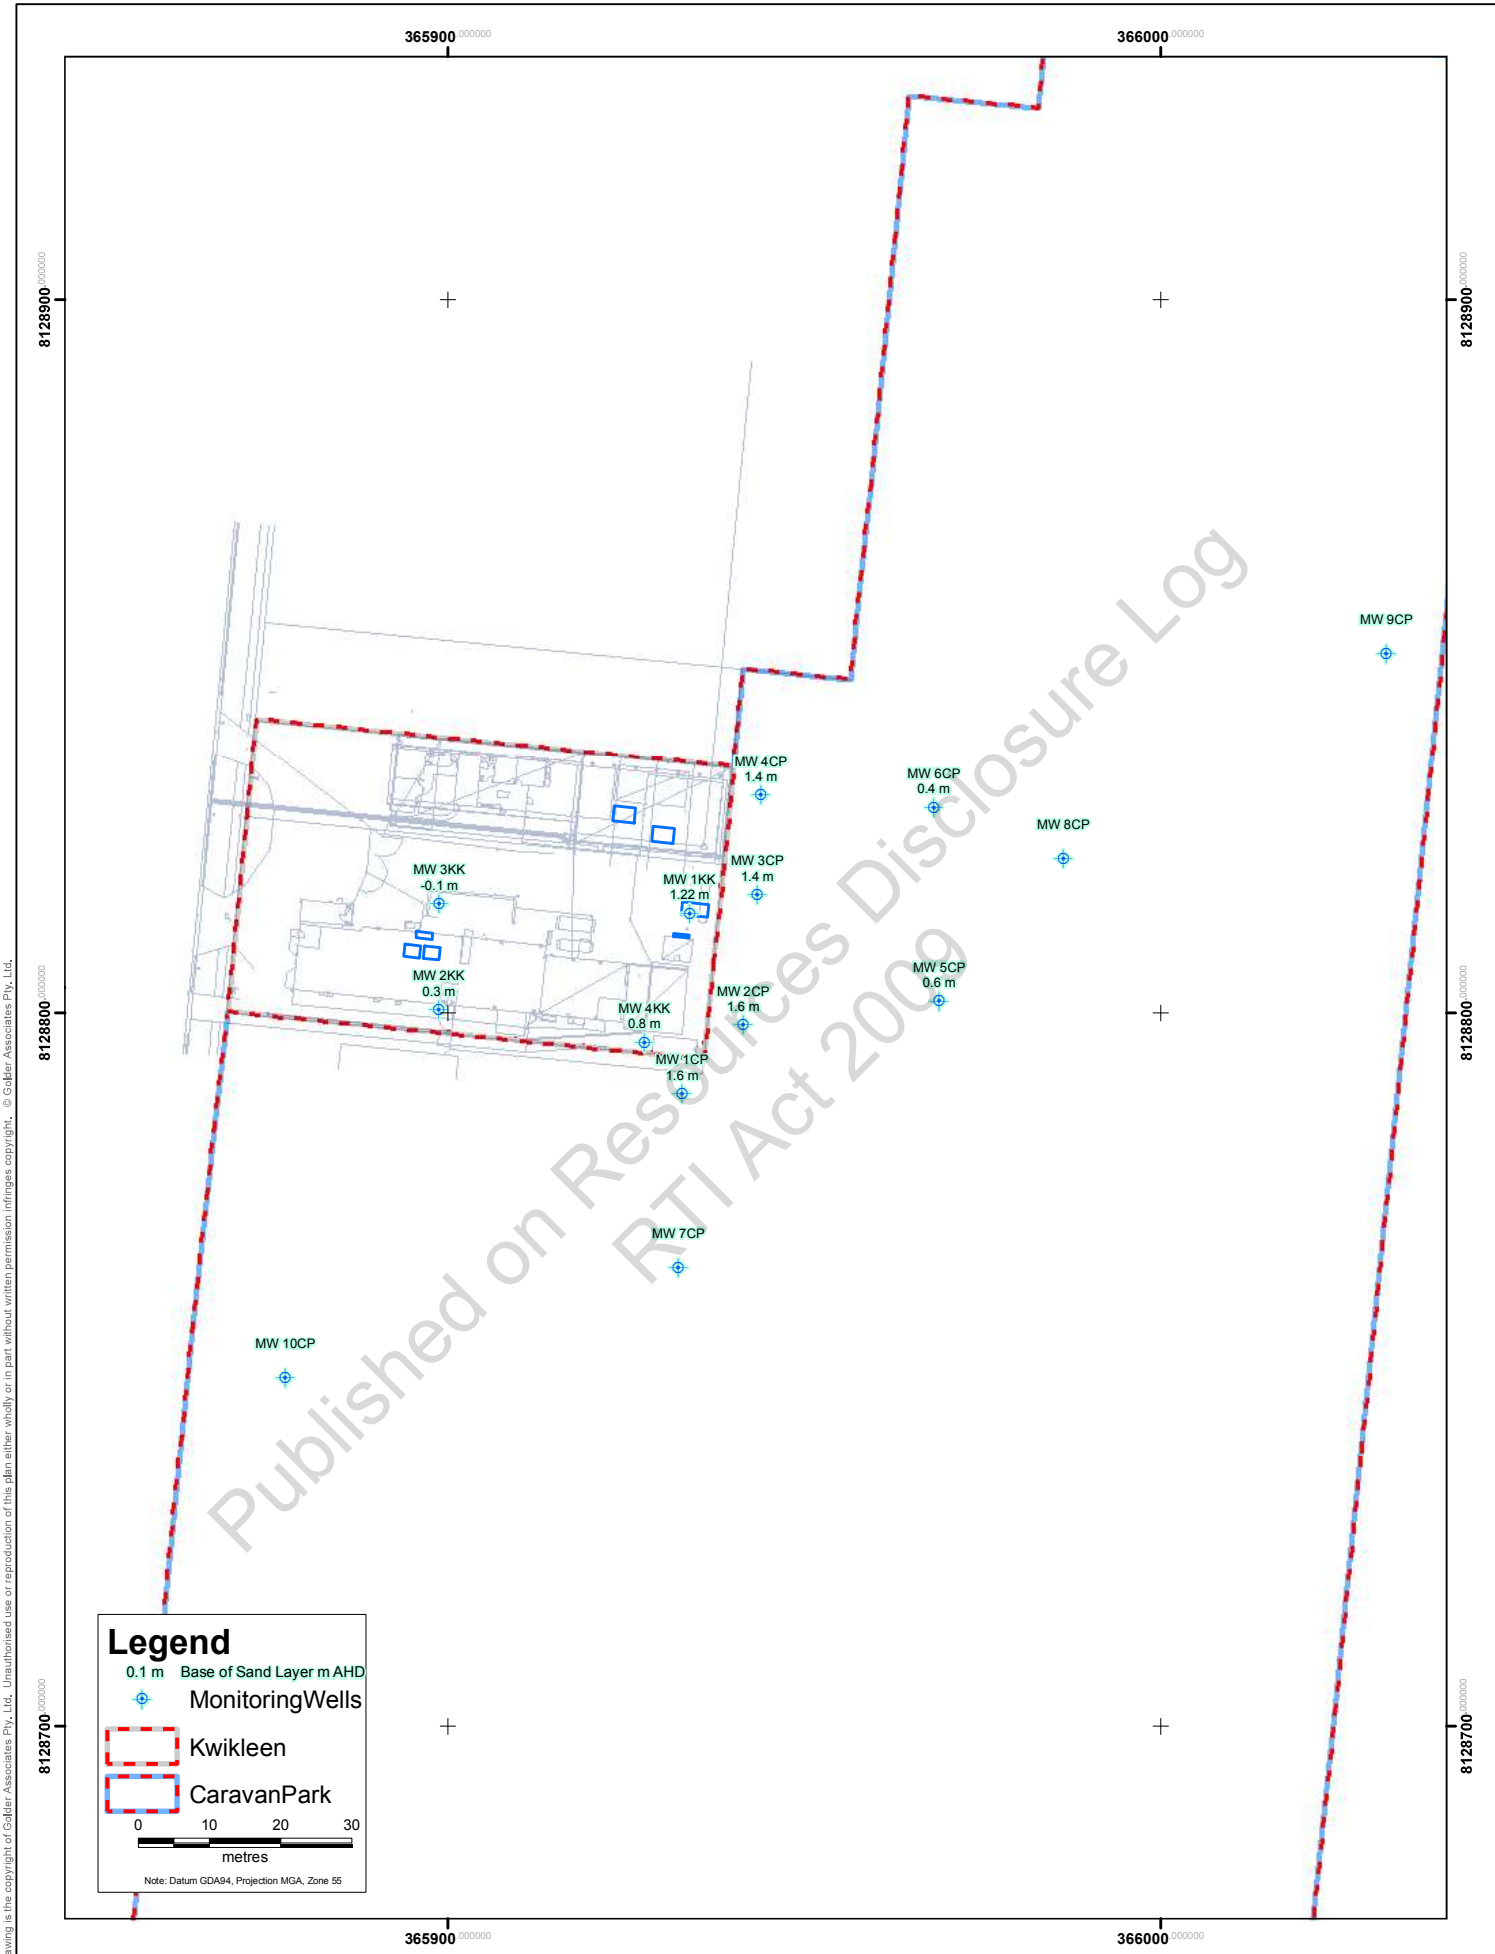
Based upon the results of the current and previous investigations, contours of the base of the saturated sand layer and the top of the dark grey clay layer have been developed as shown on Figures 11 and 12, respectively. Using this information it was assessed that significant spillage/leakage of dry cleaning fluid from onsite processes could lead to pooling (and therefore high soil and groundwater concentrations) in the following areas:

| | | DRAWN BAG | | DATE 23 JUNE 2009 | | TITLE Base of Sand Layer | | | | | | | |
