23 January 2015

Project No. 087673045-059-L-Rev1

**SITE INVESTIGATION SUBMISSION FOR LOT 20 ON SP262379, CAIRNS VILLA CARAVAN PARK**

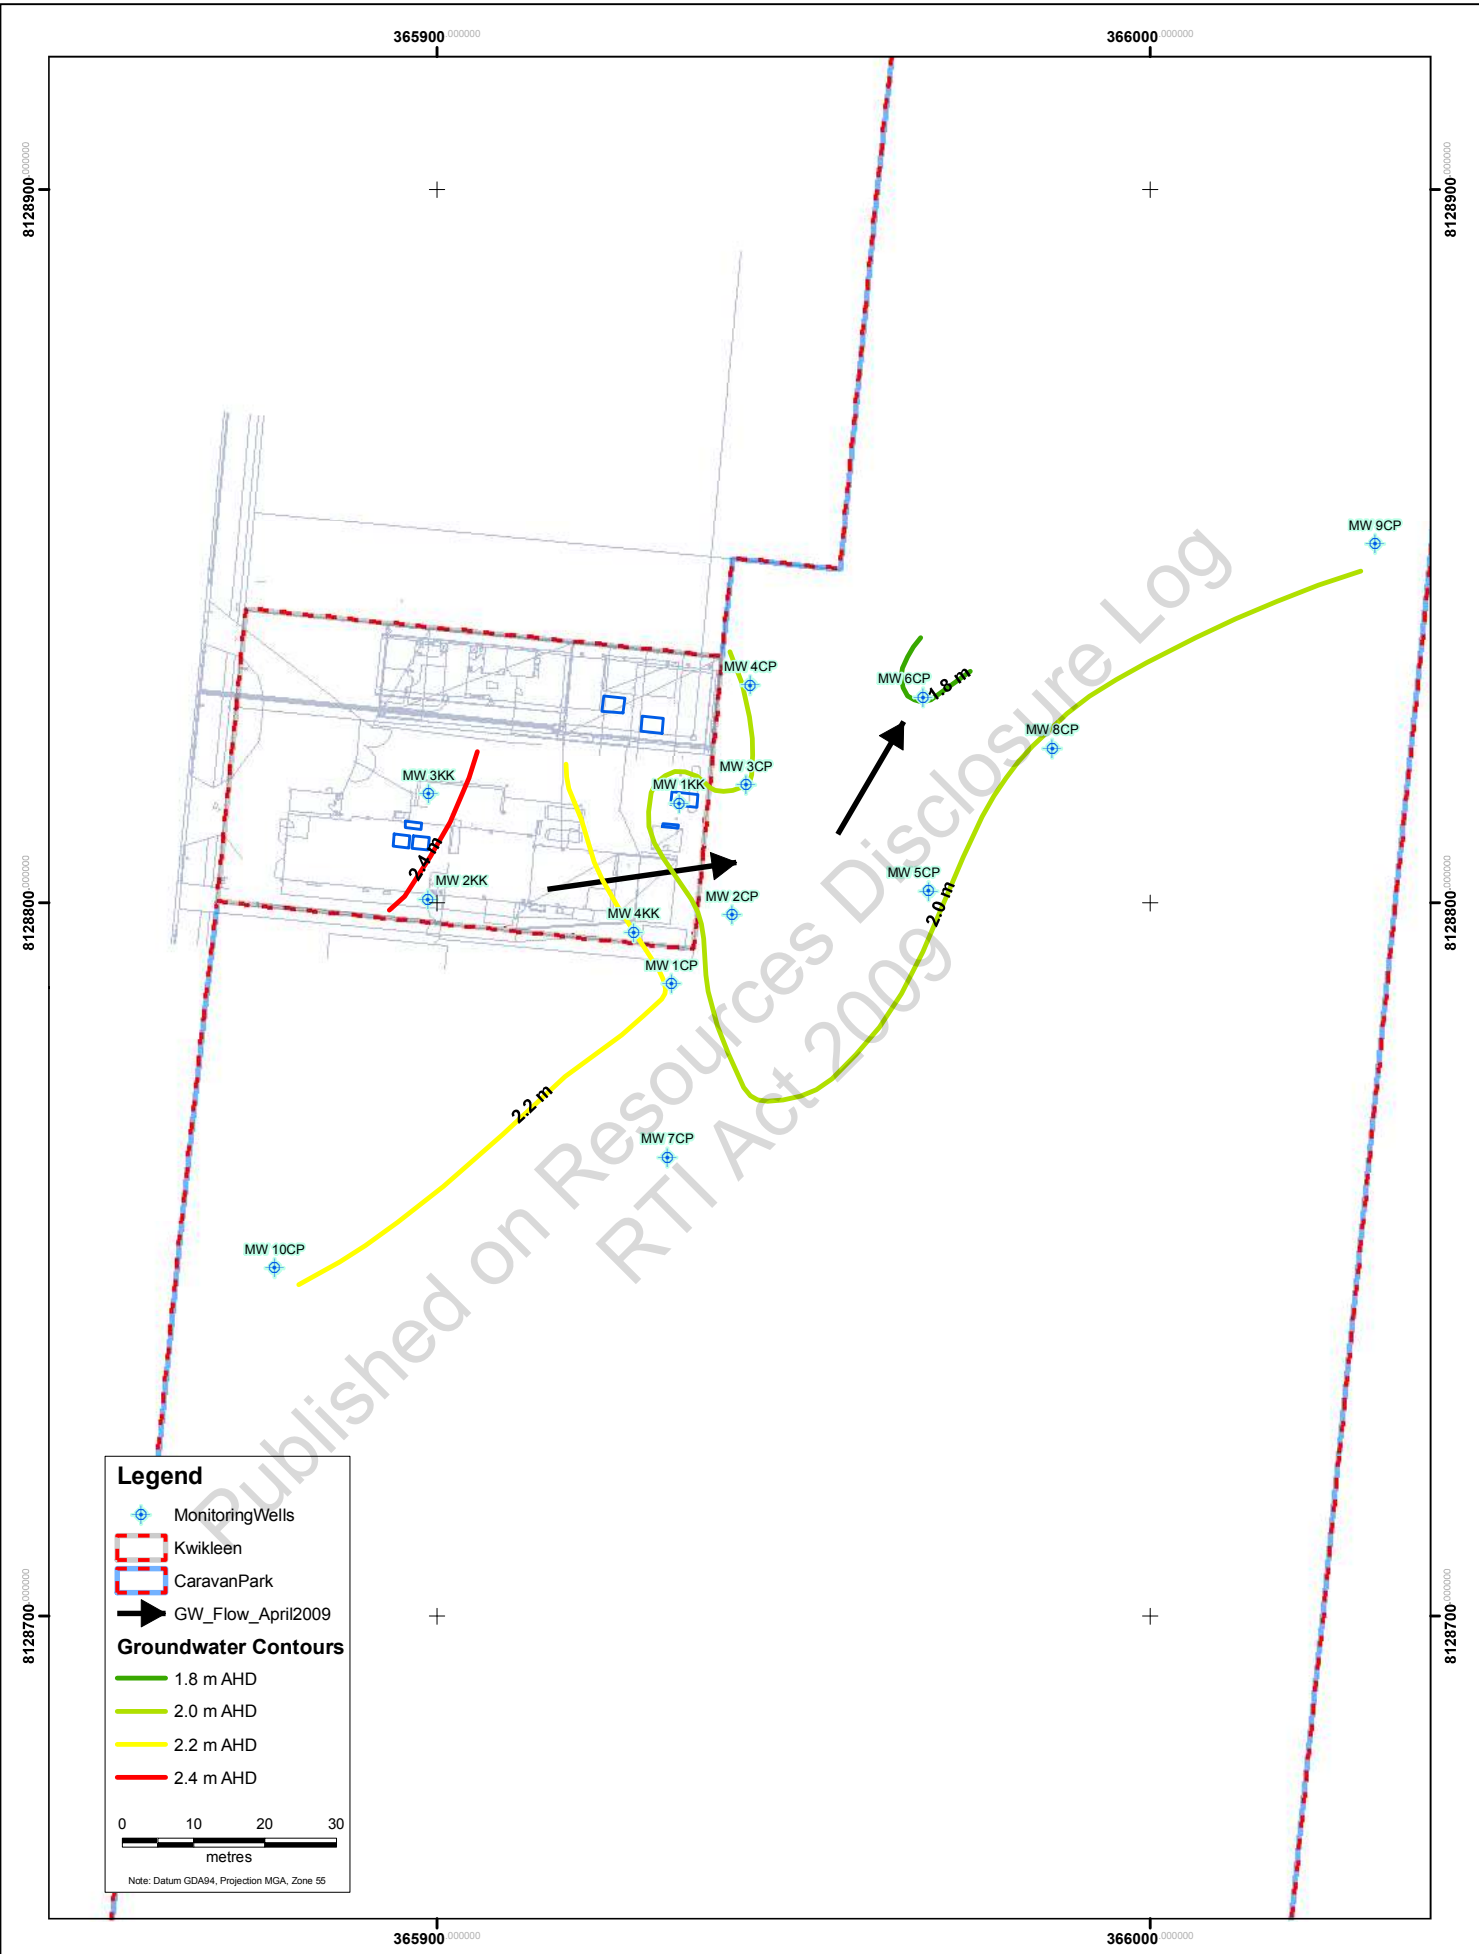
| | | CHECKED PKS | DATE 26 JUNE 2009 | Interpreted Groundwater Contours - April 2009 | |

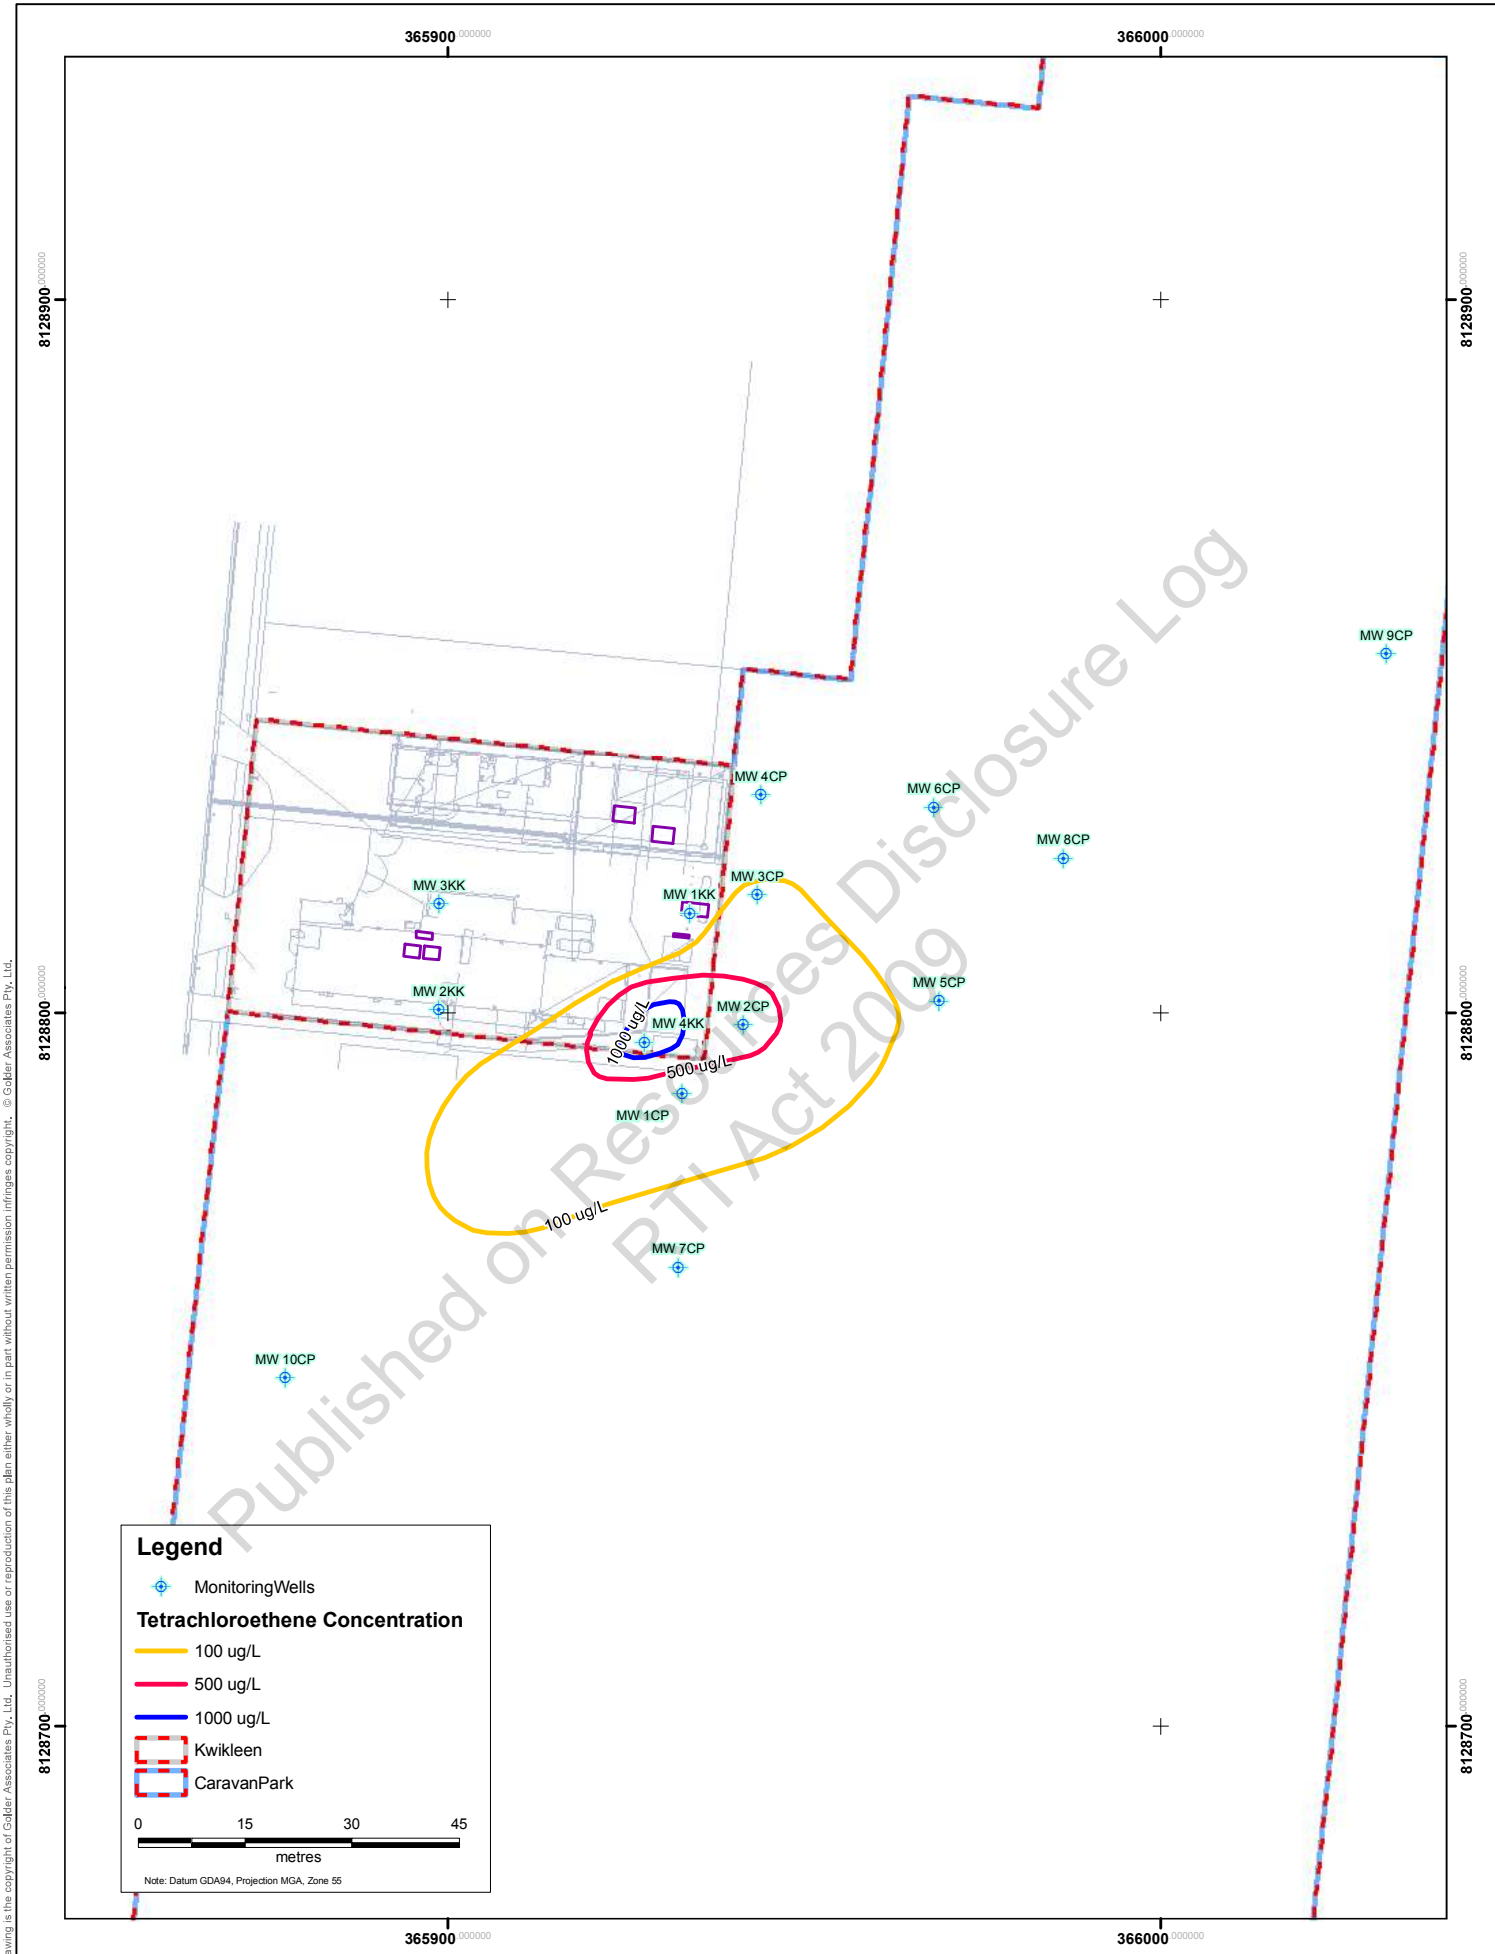
| | | CHECKED PKS | DATE 26 JUNE 2009 | Interpreted Tetrachloroethene Concentration Contours - April 2009 | |

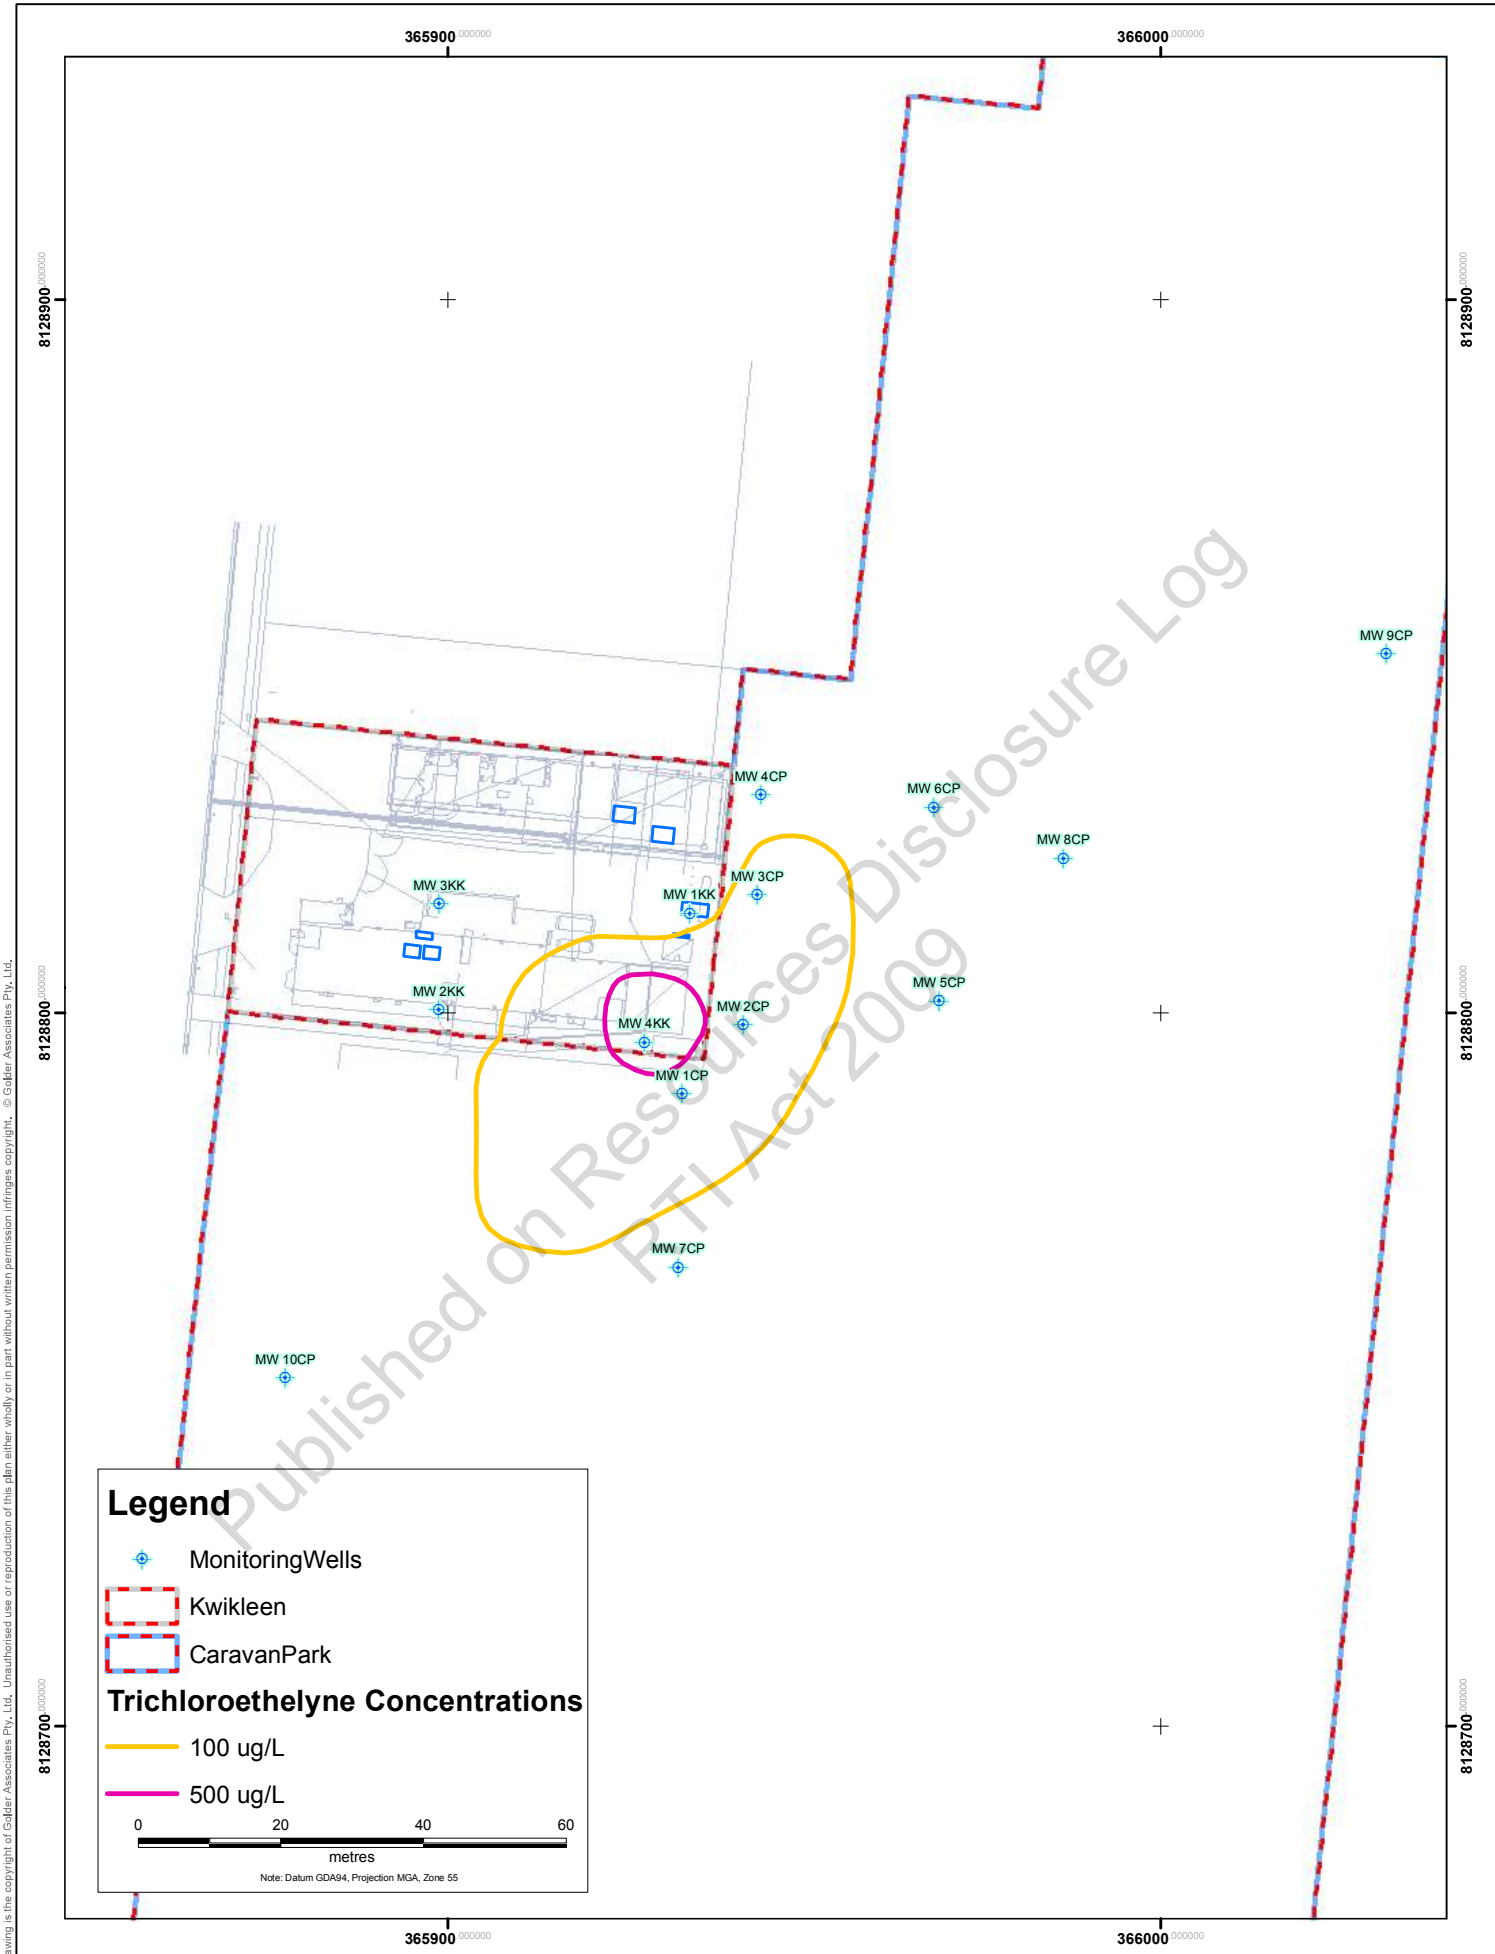
| | | CHECKED PKS | DATE 26 JUNE 2009 | Interpreted Trichloroethelyne Contours - April 2009 | |

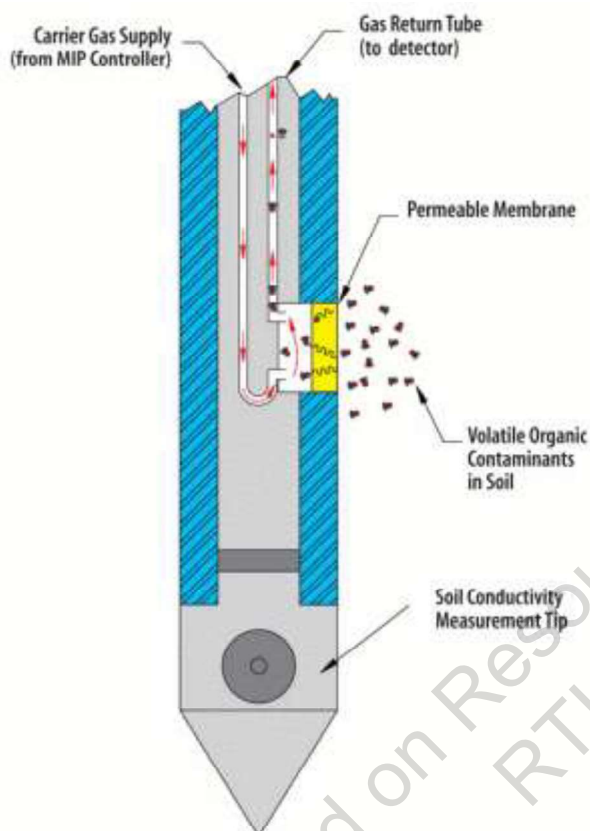
**Diagram 1 – Configuration of MIP Probe**  
(Courtesy of Geoprobe Systems)

As the MIP cone is advanced through the subsurface, it volatilises any VOCs via a heated membrane on the cone's sleeve (Diagram 1). This causes the heated compounds to thermodesorb from the soil and diffuse across the membrane. Inside the probe they are transported by a carrier gas stream through capillaries in the MIP cable up to a truck where they are detected with a gas chromatograph equipped with a photo-ionisation detector (PID), flame ionisation detector (FID) and a halogen specific detector (XSD).

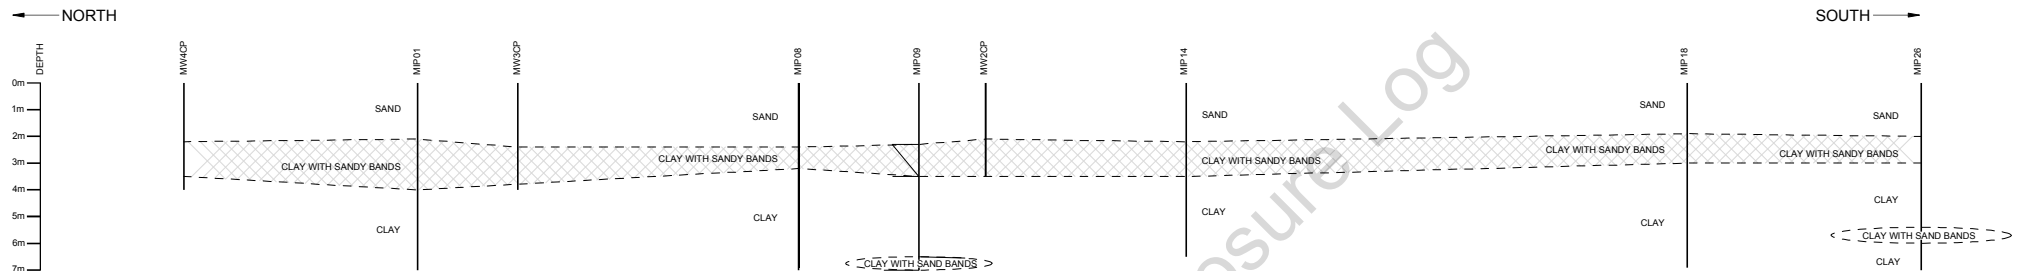
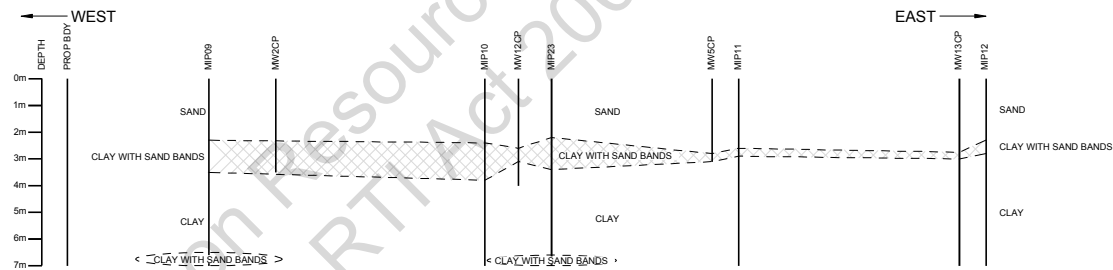
SCALE 1:200 **A** NORTH / SOUTH SECTION  
F001

SCALE 1:200 **B** EAST / WEST SECTION  
F001

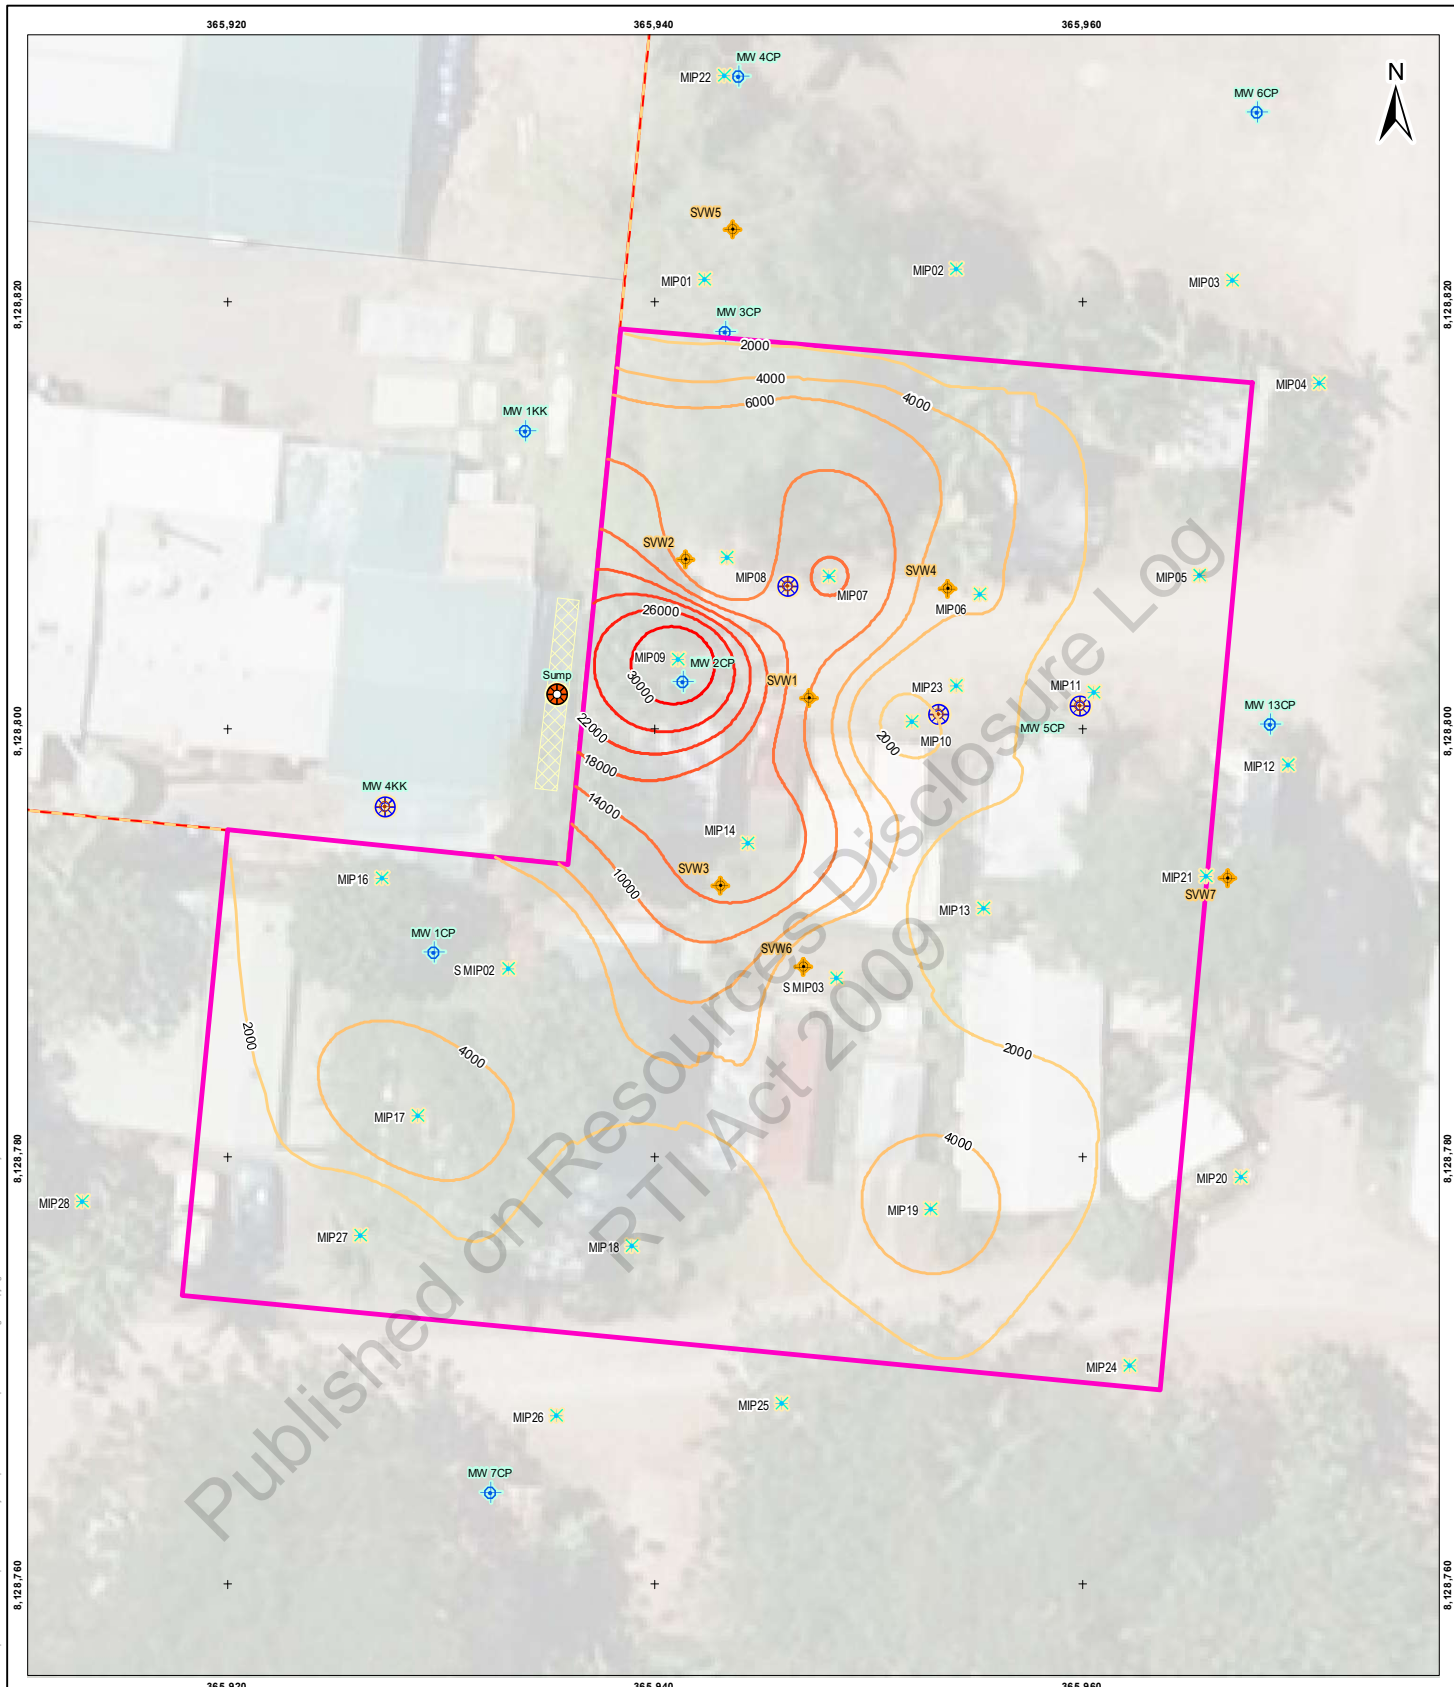
#### MIP CONTOURS UPPER SAND LAYER

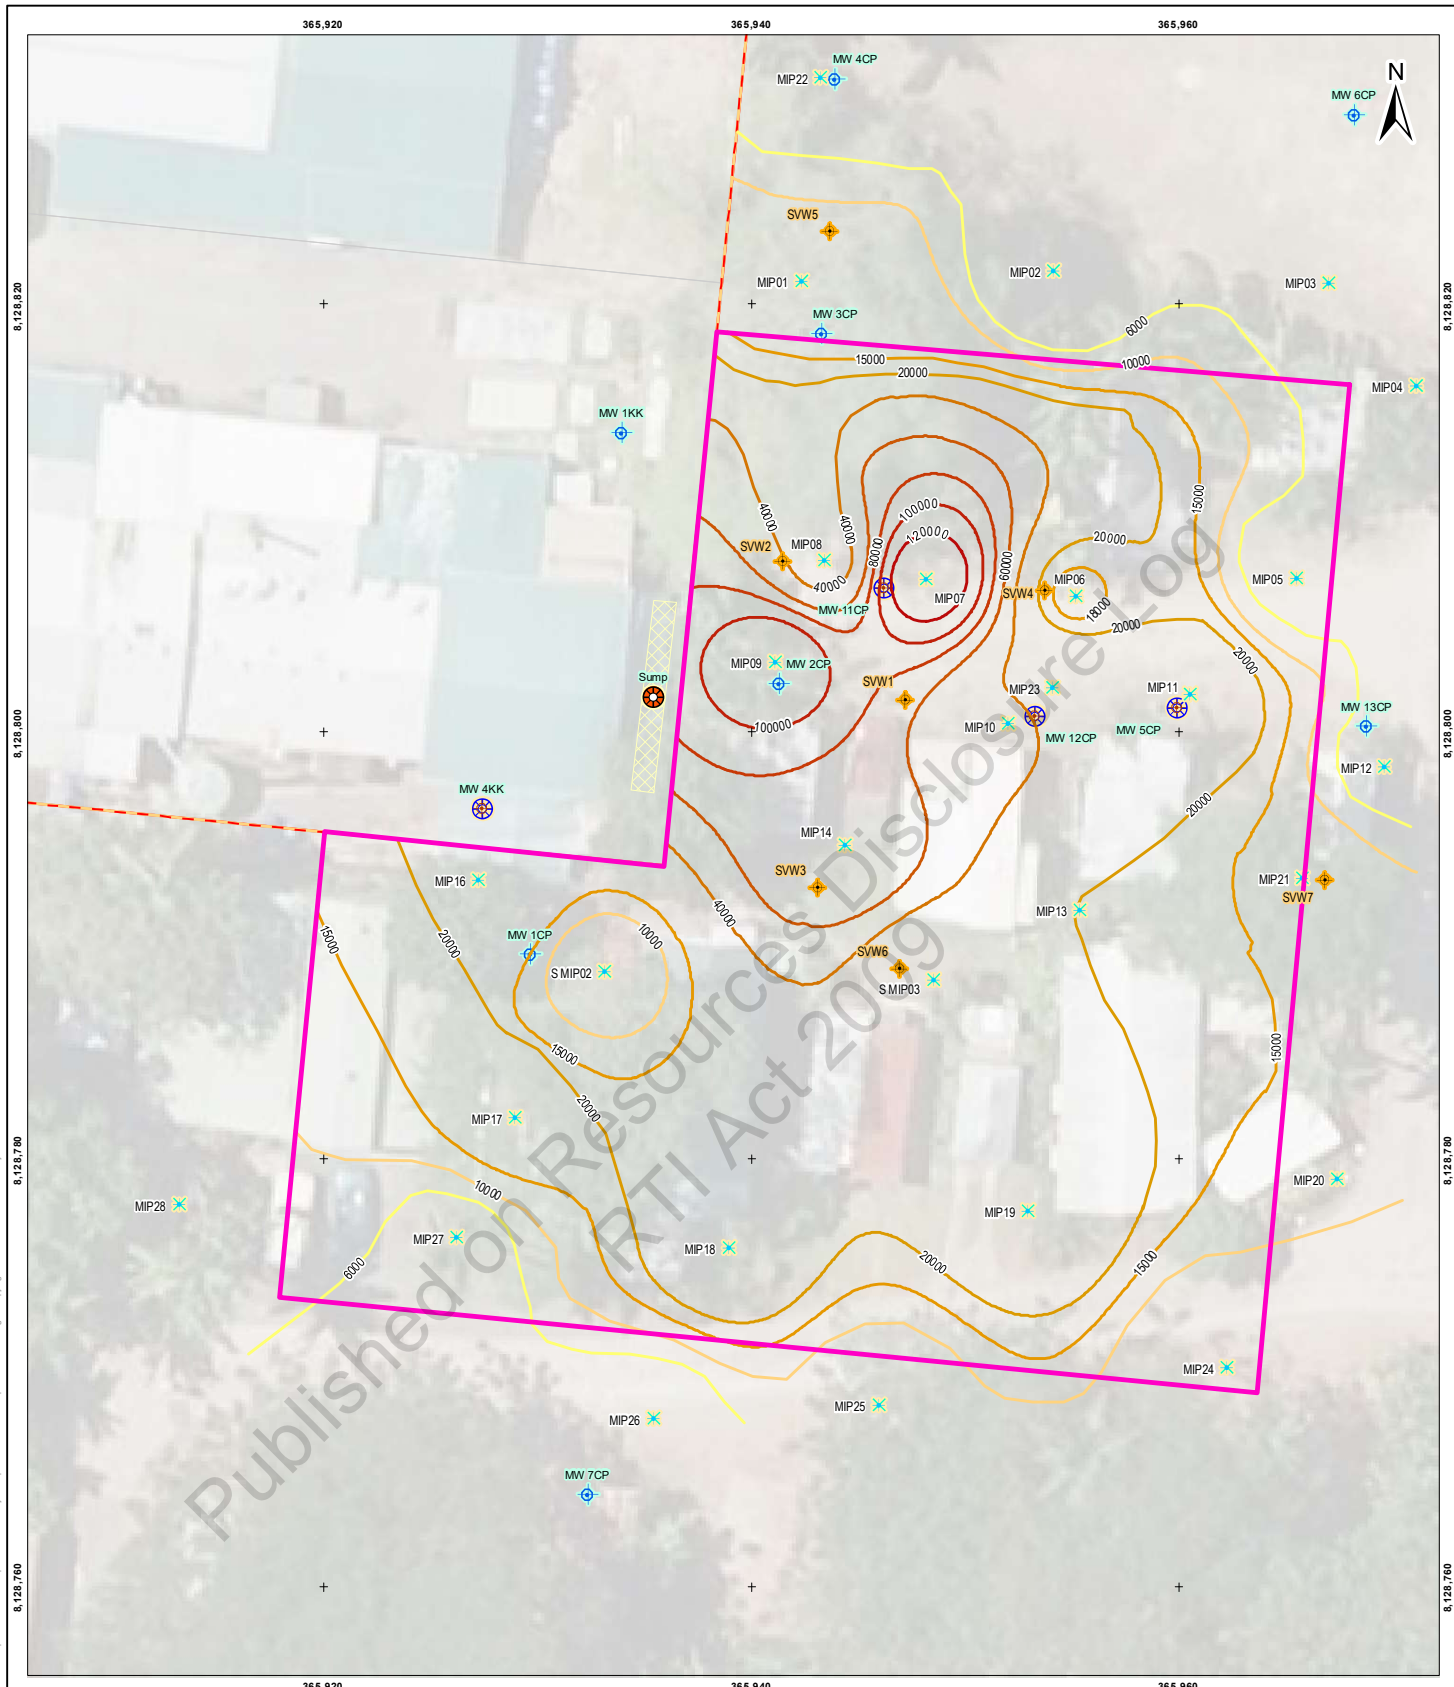
# MIP CONTOURS MARINE CLAY LEVEL
