**Re: WARN3142 – Queensland Bulk Handling Pty Ltd (QBH), Premise name, 3 Bulk Terminals Drive, Fisherman Islands.**

## Subject: Queensland Bulk Handling

**Subject (Detail):** Incident Reported regarding coal contaminated spill to Brisbane River.

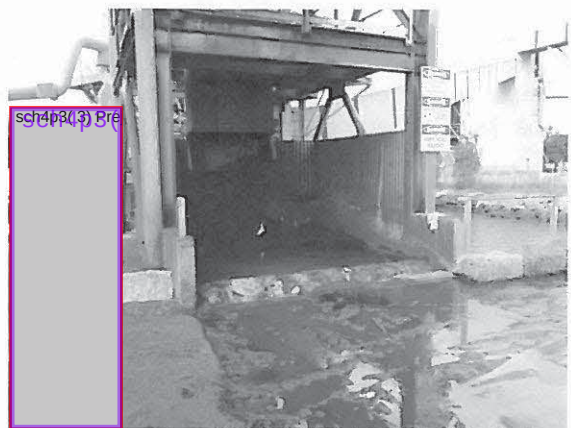
Figure 1-CV10 pit

- Figure 1 illustrates the CV10 pit area that was the source location of the spill
- Brad indicated that coal suspended in water had emanated beyond the bund of the CV10 sump and rolled toward the riverbed bank as illustrated by Figure 2.

- At the time of the inspection, the remedial actions seemed to be effective in containing the spill. Further to this, on-going commitments were made by QBH to prevent a re-occurrence of the spill including:
  - 2 hourly, visual checks by the site supervisor
  - Security guard of the wharf informed of requirements of development approval and required to also undertake a visual observation every hour.
- Whilst observing the driveway of the wharf I enquired whether the contaminated waters had been able to reach the street (seen in Figure 2). QBH advised waters had reached the street.
