# Asbestos Materials & Products Audit

**Site Address:** Koonjewarre Retreat  
Centre  
2806 Springbrook Road,  
Springbrook Qld 4213

## ASBESTOS MANAGEMENT PLAN

**Koonjewarre Retreat Centre**

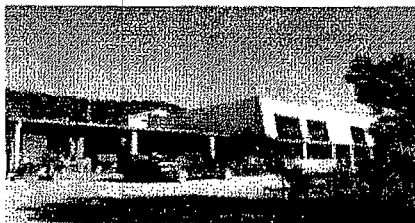
| Building Code Reference | | Location Details | | Item Details | | Removal/Management Details | | Photographs | |
|---|---|---|---|---|---|---|---|---|--|
| 2.0 | Managers Residence | Elevation: | Ground | Product Type: | - | Photo No: | 02 | | |
| | | Location: | External | Area: | - | Condition: | - | | |
| | | Position: | - | Sample Result: | - | Priority: | - | | |

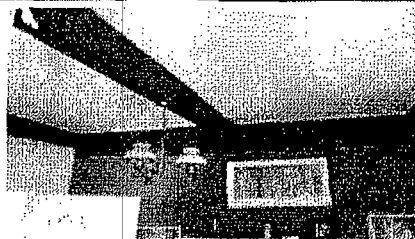
| Building Code Reference | | Location Details | | Item Details | | Removal/Management Details | | Photographs | |
|---|---|---|---|---|---|---|---|---|--|
| 2.1 | Managers Residence | Elevation: | Ground | Product Type: | - | Photo No: | 03 | | |

| Building Code Reference | | Location Details | | Item Details | | Removal/Management Details | | Photographs | |
|---|---|---|---|---|---|---|---|---|--|
| | | Location: | Internal | Area: | - | Condition: | - | | |
| | | Position: | Ceiling | Sample Result: | S01 – NAD | Priority: | - | | |

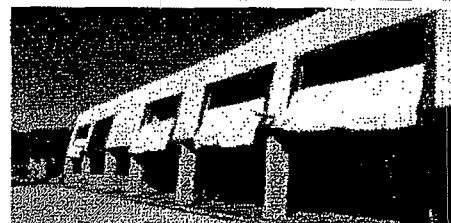
| Building Code Reference | | Location Details | | Item Details | | Removal/Management Details | | Photographs |
|---|---|---|---|---|---|---|---|---|
| 3.0 | Family Units | <b>Elevation:</b> | Ground | <b>Product Type:</b> | - | <b>Photo No:</b> | 06 | |
| | | <b>Location:</b> | External | <b>Area:</b> | - | <b>Condition:</b> | - | |
| | | <b>Position:</b> | - | <b>Sample Result:</b> | - | <b>Priority:</b> | - | |

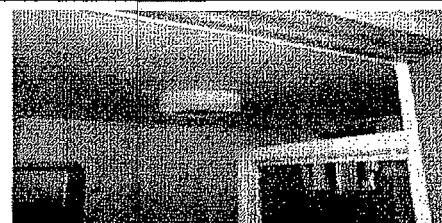
| Building Code Reference | | Location Details | | Item Details | | Removal/Management Details | | Photographs |
|---|---|---|---|---|---|---|---|---|
| 3.2 | Family Units | <b>Elevation:</b> | Ground | <b>Product Type:</b> | - | <b>Photo No:</b> | 08 | |

| Building Code Reference | | Location Details | | Item Details | | Removal/Management Details | | Photographs |
|---|---|---|---|---|---|---|---|---|
| | | <b>Location:</b> | Internal | <b>Area:</b> | - | <b>Condition:</b> | - | |
| | | <b>Position:</b> | Ceiling | <b>Sample Result:</b> | Similar to S03 – NAD | <b>Priority:</b> | - | |
| | | <b>Description:</b> | Lowered bathroom ceilings. | | | | | |

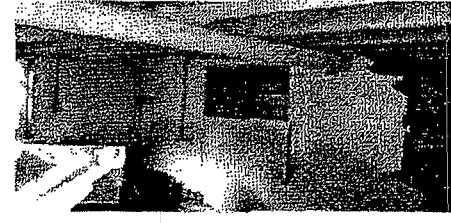
| Building Code Reference | | Location Details | | Item Details | | Removal/Management Details | | Photographs |
|---|---|---|---|---|---|---|---|---|
| 4.1 | Farm House | <b>Elevation:</b> | Ground | <b>Product Type:</b> | AC | <b>Photo No:</b> | 12 | |

| Building Code Reference | | Location Details | | Item Details | | Removal/Management Details | | Photographs |
|---|---|---|---|---|---|---|---|---|
| | | <b>Location:</b> | Internal | <b>Area:</b> | 6m <sup>2</sup> | <b>Condition:</b> | Poor | |

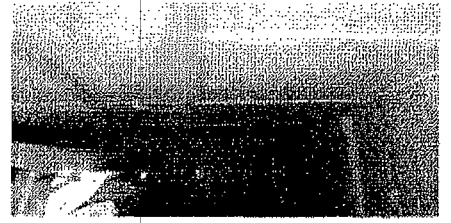
| Building Code Reference | | Location Details | | Item Details | | Removal/Management Details | | Photographs |
|---|---|---|---|---|---|---|---|---|
| 4.10 | Farm House | <b>Elevation:</b> | Level 1 | <b>Product Type:</b> | AC | <b>Photo No:</b> | 21 | |

| Building Code Reference | | Location Details | | Item Details | | Removal/Management Details | | Photographs |
|---|---|---|---|---|---|---|---|---|
| | | <b>Location:</b> | Internal | <b>Area:</b> | 12m <sup>2</sup> | <b>Condition:</b> | Good | |

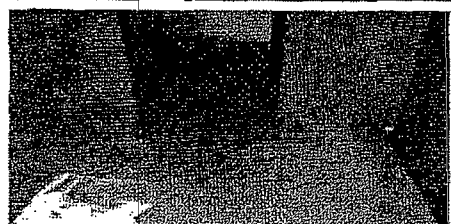
| Building Code Reference | | Location Details | | Item Details | | Removal/Management Details | | Photographs |
|---|---|---|---|---|---|---|---|---|
| 4.13 | Farm House | <b>Elevation:</b> | Level 1 | <b>Product Type:</b> | - | <b>Photo No:</b> | 24 | |

| Building Code Reference | | Location Details | | Item Details | | Removal/Management Details | | Photographs |
|---|---|---|---|---|---|---|---|---|
| | | <b>Location:</b> | Internal | <b>Area:</b> | - | <b>Condition:</b> | - | |

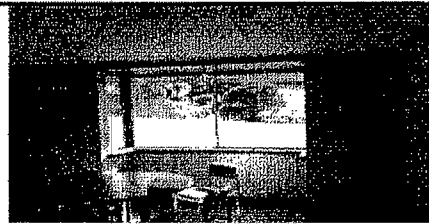
| Building Code Reference | | Location Details | | Item Details | | Removal/Management Details | Photographs |
|---|---|---|---|---|---|---|---|
| 4.14 | Farm House | <b>Elevation:</b> | Level 1 | <b>Product Type:</b> | - | <b>Photo No:</b> 25 | |

| Building Code Reference | | Location Details | | Item Details | | Removal/Management Details | Photographs |
|---|---|---|---|---|---|---|---|
| | | <b>Location:</b> | Internal | <b>Area:</b> | - | <b>Condition:</b> - | |
| | | <b>Description:</b> | Wall sheeting surrounding windows to reading room. | | | | |

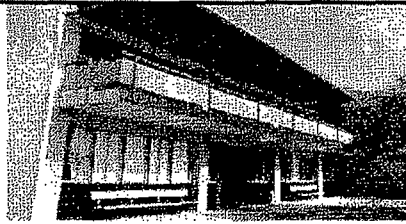
| Building Code Reference | | Location Details | | Item Details | | Removal/Management Details | | Photographs | |
|---|---|---|---|---|---|---|---|---|--|
| 5.0 | Kitchen / Recreation / Dining Hall | Elevation: | Ground | Product Type: | - | Photo No: | 28 | | |
| | | Location: | External | Area: | - | Condition: | - | | |
| | | Position: | - | Sample Result: | - | Priority: | - | | |

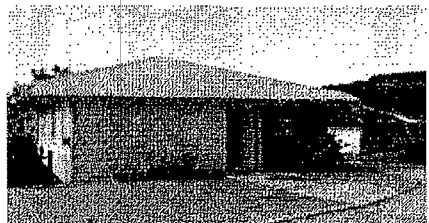
| Building Code Reference | | Location Details | | Item Details | | Removal/Management Details | | Photographs |
|---|---|---|---|---|---|---|---|---|
| 6.0 | Cottage | <b>Elevation:</b> | Ground | <b>Product Type:</b> | - | <b>Photo No:</b> | 33 | |
| | | <b>Location:</b> | External | <b>Area:</b> | - | <b>Condition:</b> | - | |
| | | <b>Position:</b> | - | <b>Sample Result:</b> | - | <b>Priority:</b> | - | |

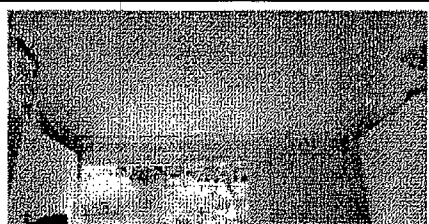
| Building Code Reference | | Location Details | | Item Details | | Removal/Management Details | | Photographs |
|---|---|---|---|---|---|---|---|---|
| 6.1 | Cottage | <b>Elevation:</b> | Ground | <b>Product Type:</b> | AC | <b>Photo No:</b> | 34 | |

| Building Code Reference | | Location Details | | Item Details | | Removal/Management Details | | Photographs |
|---|---|---|---|---|---|---|---|---|
| | | <b>Location:</b> | Internal | <b>Area:</b> | 2m <sup>2</sup> | <b>Condition:</b> | Good | |

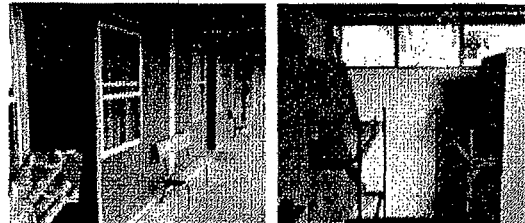
| Building Code Reference | | Location Details | | Item Details | | Removal/Management Details | | Photographs | |
|---|---|---|---|---|---|---|---|---|--|
| 7.2 | D Dormitory Block | Elevation: | Ground | Product Type: | AC | Photo No: | 39 & 40 | | |

| Building Code Reference | | Location Details | | Item Details | | Removal/Management Details | | Photographs | |
|---|---|---|---|---|---|---|---|---|--|
| | | Location: | External / Internal | Area: | 6 Rooms (20m² per room) | Condition: | Good | | |
| | | Description: | Internal / external cladding to dorm rooms. | | | | | | |

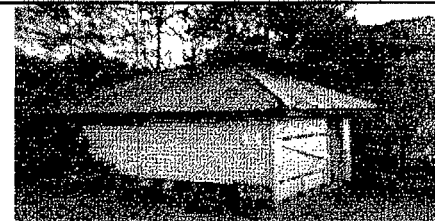
| Building Code Reference | | Location Details | | Item Details | | Removal/Management Details | | Photographs |
|---|---|---|---|---|---|---|---|---|
| 9.0 | Pump Shed | Elevation: | Ground | Product Type: | - | Photo No: | 45 | |
| | | Location: | External | Area: | - | Condition: | - | |
| | | Position: | - | Sample Result: | - | Priority: | - | |
