# File Note

## Subject: Photos from Site Visit February 22 2013

## **Site Visit – Former Tasman Tannery 16 November 2012**

## Subject: Photos from Site Visit 24 January 2013

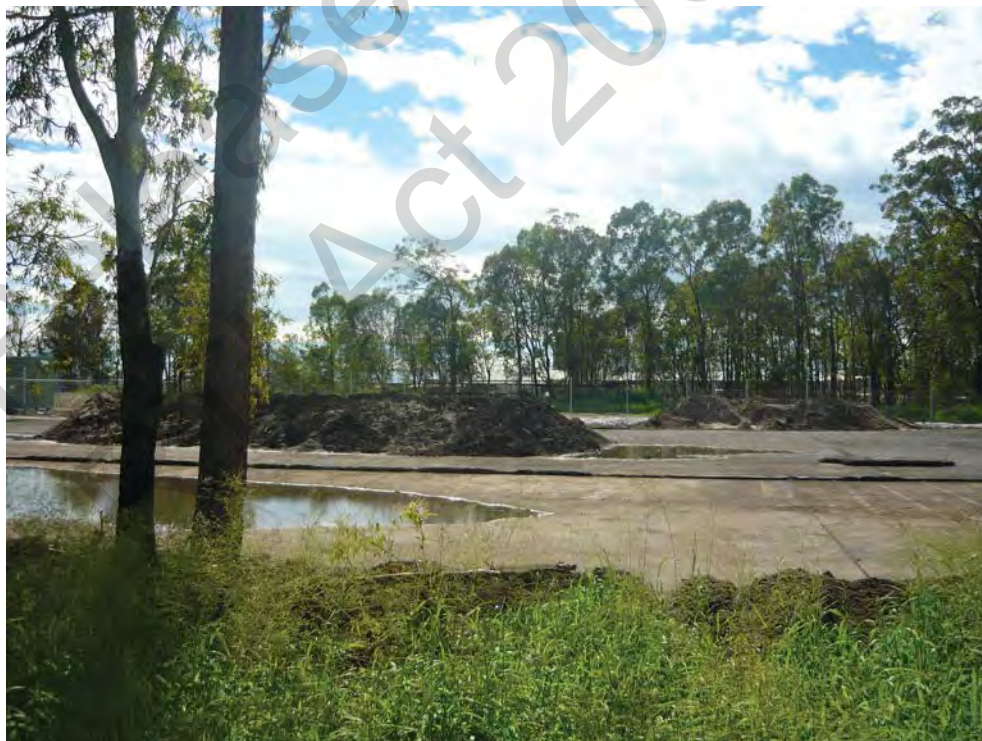
Photo 1 – The area where the destroyed building was situated along Potassium Street (facing east). Please note that the destroyed building has been removed and the concrete slab has been cleaned. The stock pile in the middle of the photo is the start of the land farming process. The officers believe the pooled water in the middle of the picture is from the heavy rainfall over the last few weeks.

DS and JP conducted a site visit at 6 Potassium Street, Narangba to assess what clean-up activities have been conducted since the incident on Tuesday 11 December 2012. See photos below. JP is to check with the land owner, Peter Moffat and his consultant about any remaining actions for the site, including the removal of the television picture tubes and signing off on the clean-up notice.

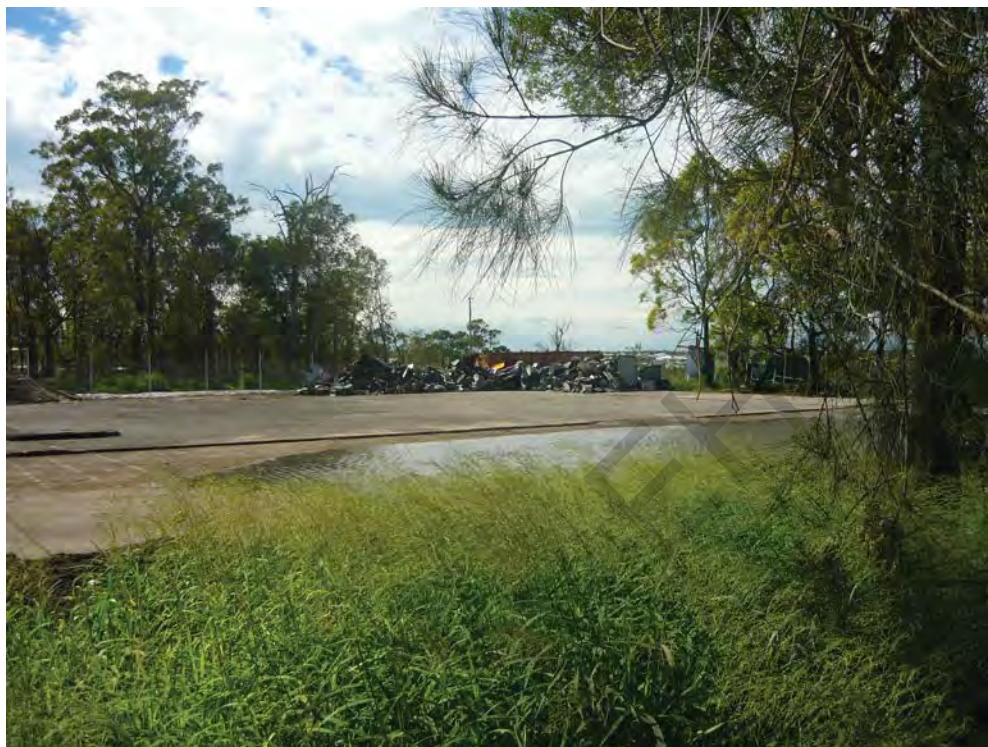
Photo 2 – Photo taken in the same location as photo 1. Looking more south east. The stock piles of television picture tubes are still located onsite. JP to contact Peter Moffat regarding their removal.

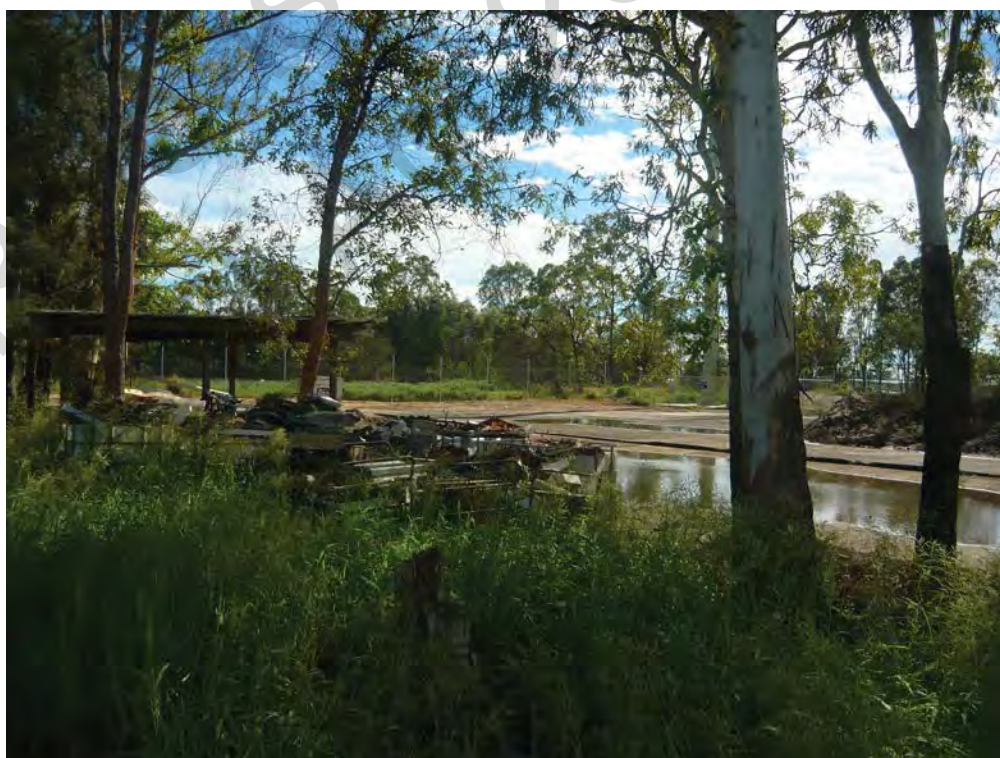
Photo 3 – Photo taken in the same location as photo 1. Looking more north east. The stock piles of television parts (stored in old IBC's) are still located onsite. JP to contact Peter Moffat regarding their removal.

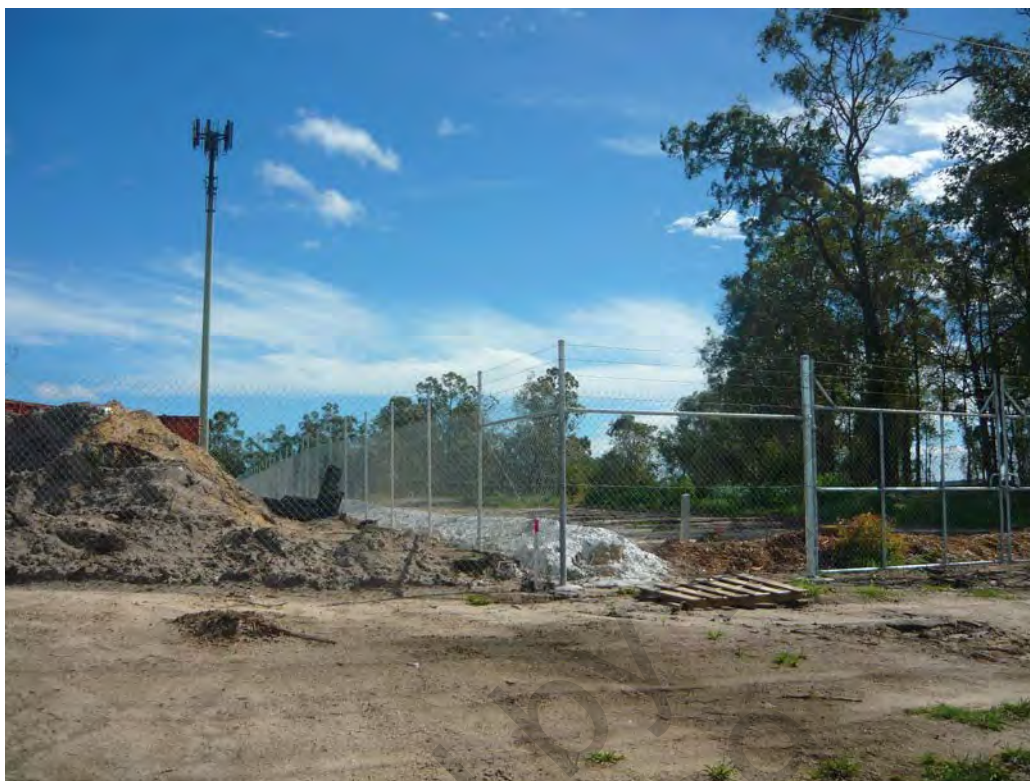
Photo 4 – The front of the incident site along boundary road (facing north). Note the polymer that has been applied to the top of the bund on the adjacent state land property. Also note further stock piles of material. JP to check when this material will commence being land farmed.

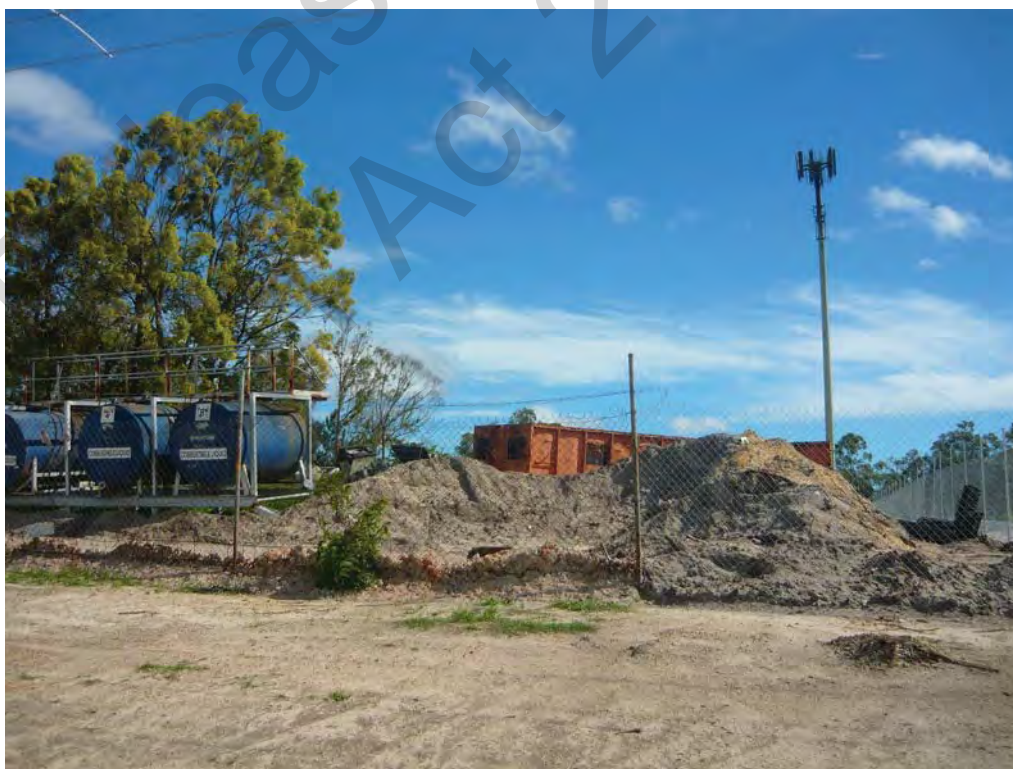
Photo 5 – The front of the incident site along boundary road (facing north). Note further stock piles of material. JP to check when this material will commence being land farmed. Also note the storage tanks to the left that are still onsite. JP to check when these will be removed with Peter Moffat.

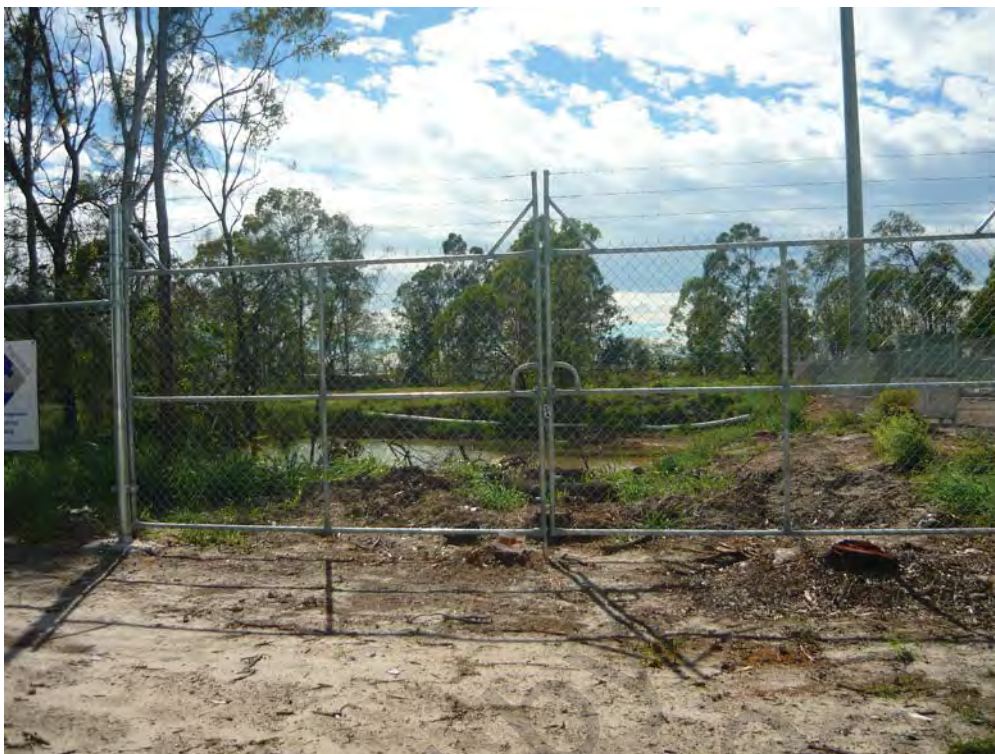
Photo 6 – The adjacent State owned land (facing east), along Potassium Street. Note the large amount of water now contained in the old tannery ponds. DSDIP consultants, Projex Partners, are looking into options for its removal.

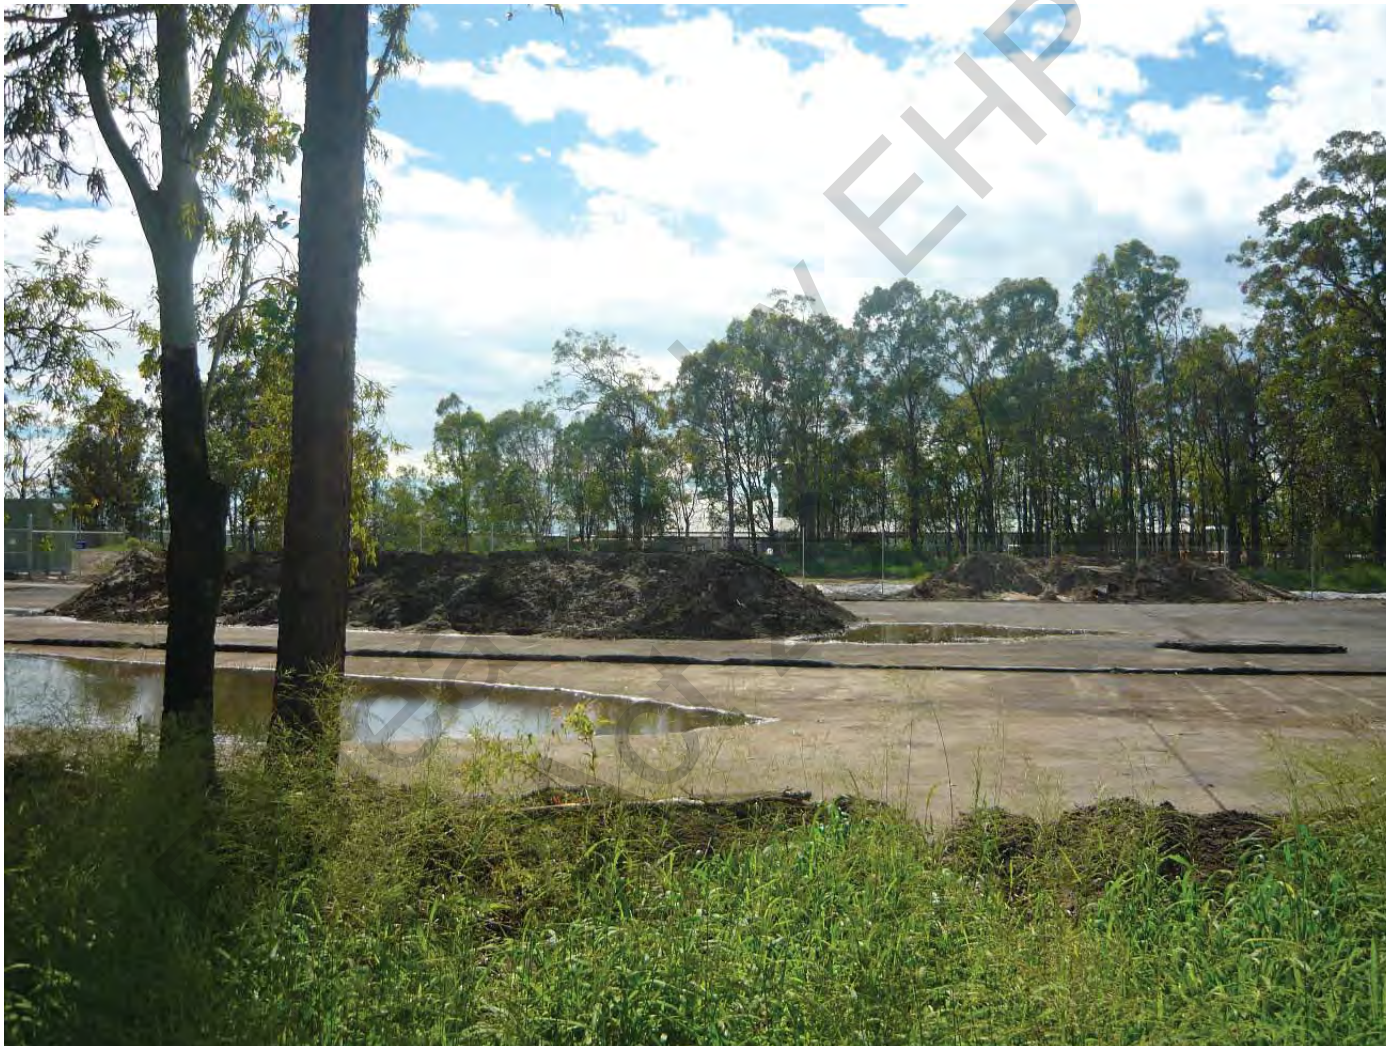
Photo 1 – Photo taken from Potassium Street looking at the southern end of the main building onsite. Note the large amount of tv's stored onsite. May indicate the operator is conducting a recycling service.

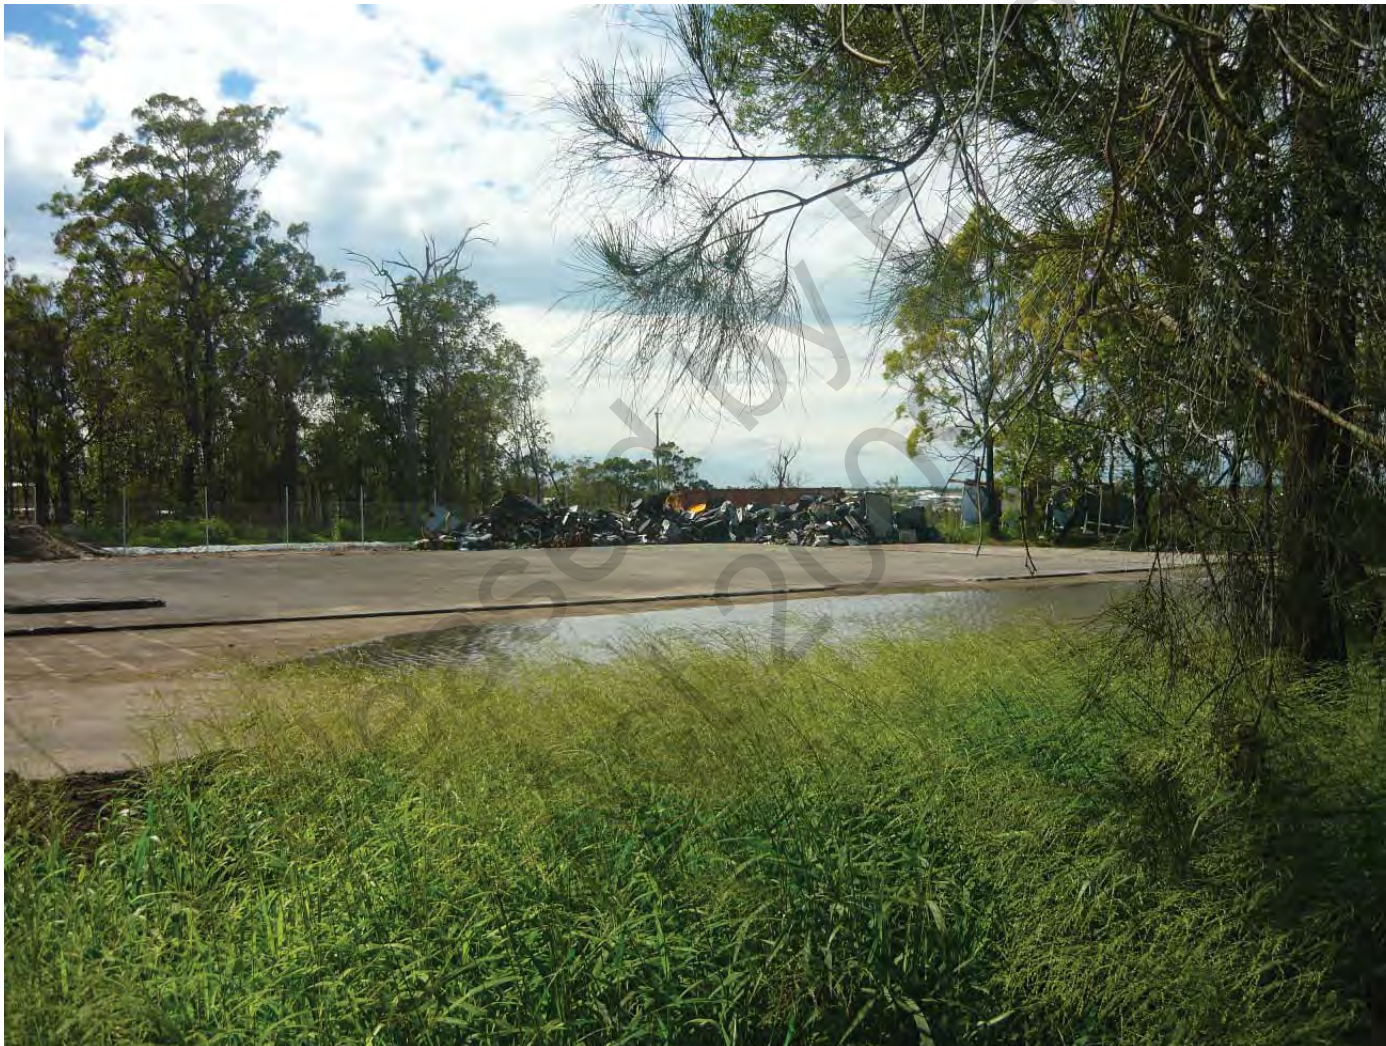
Photo 2 – Photo taken from Potassium Street looking at the northern end of the main building onsite. Note the IBC's stored outside the building. The IBC on the right looks full of a liquid product.

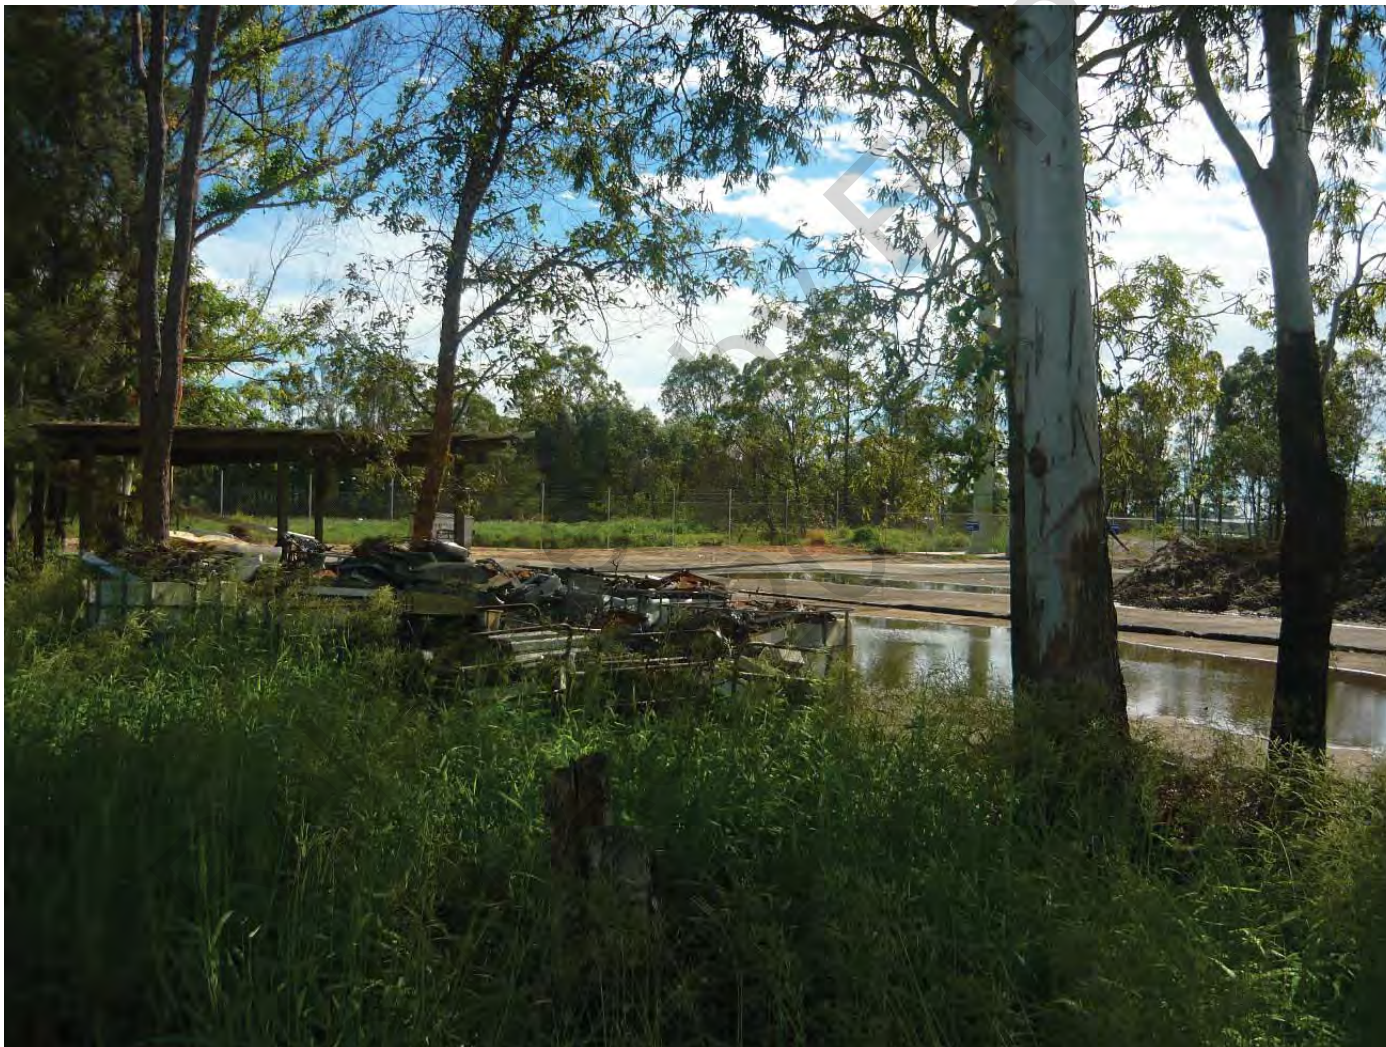
Photo 3 – Photo taken from Boundary Road looking at the southern end of the site. Note the large amount of tv's stored onsite. May indicate the operator is conducting a recycling service.

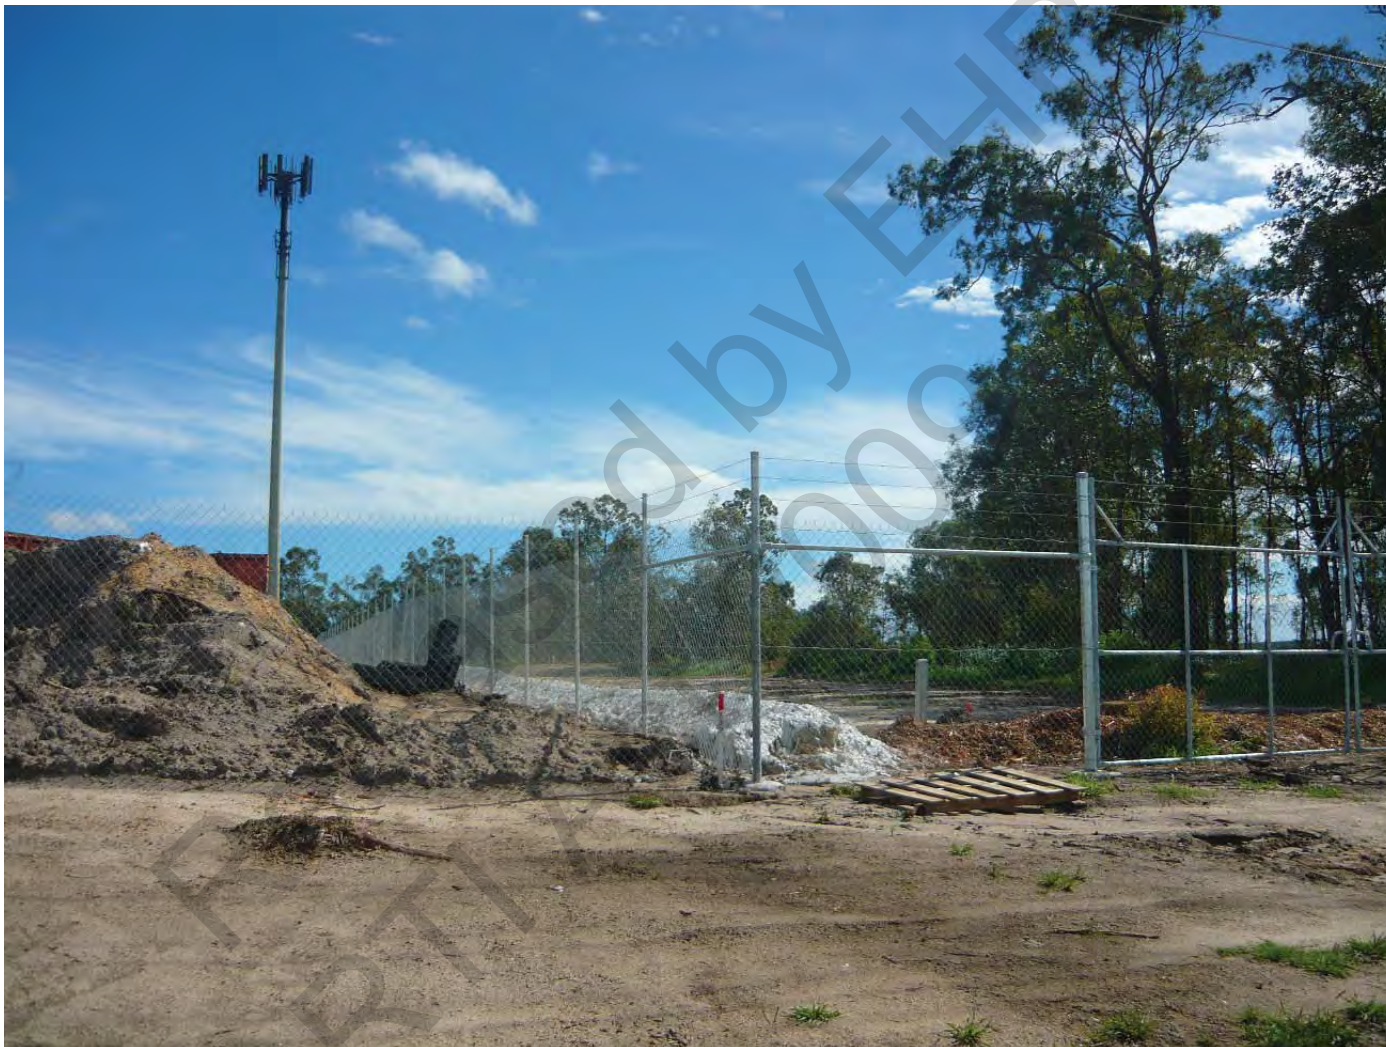
Photo 3 – Photo taken from Boundary Road looking at the southern end of the site. Note the large amount of tv's stored onsite (on the left side) and a large shipping container on the site. May indicate the operator is conducting a recycling service.

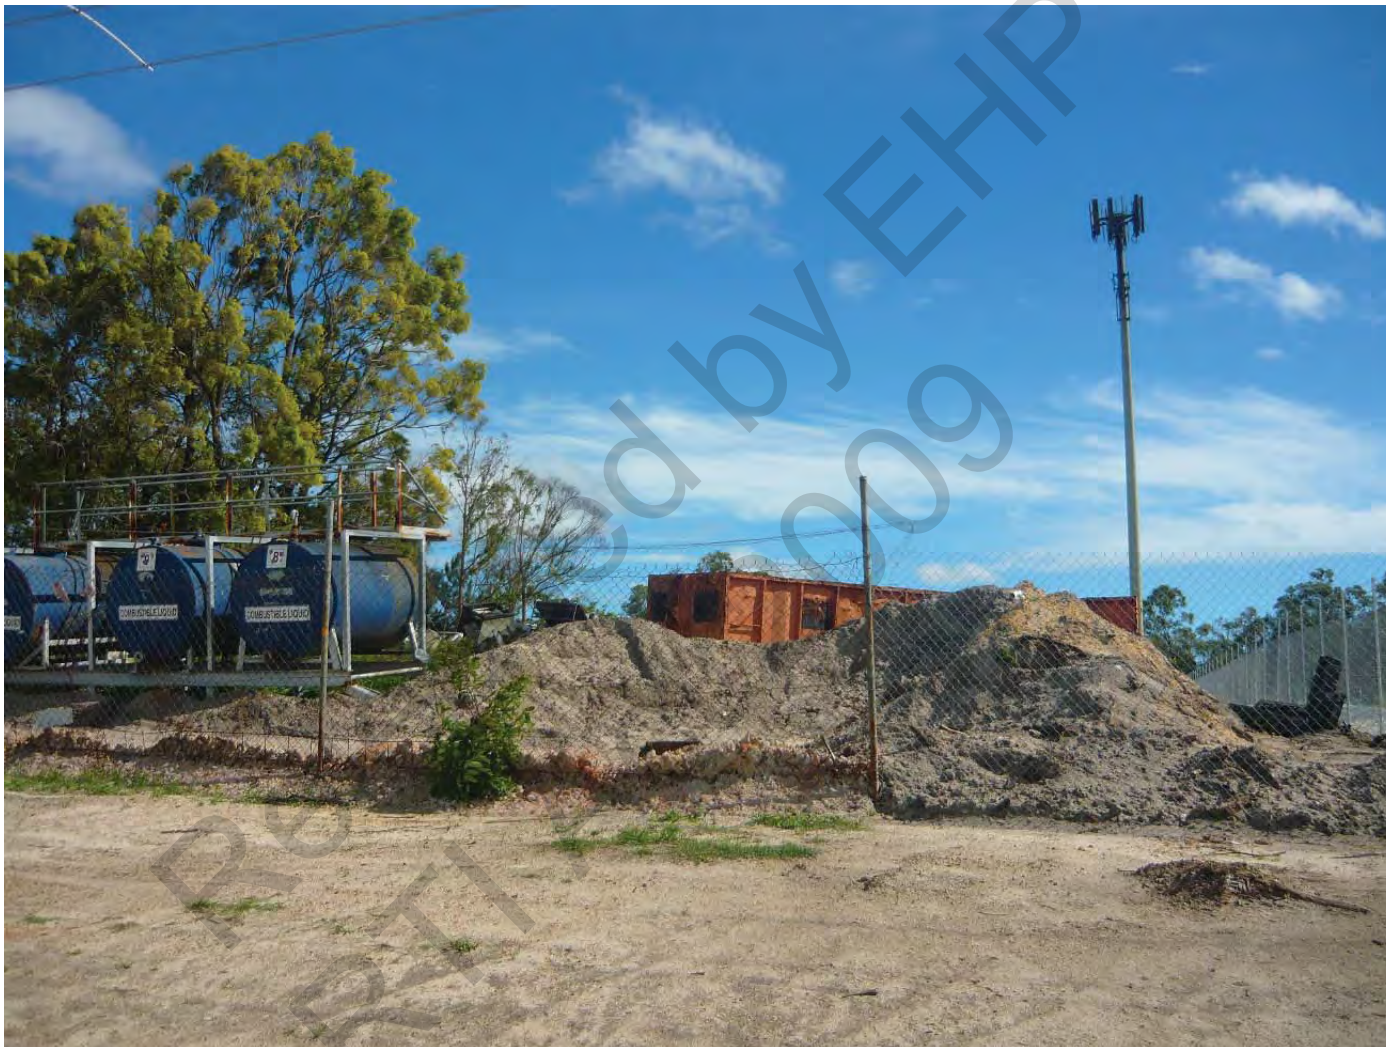
Photo 5 – Photo taken from Potassium Street looking at the southern end of the main building onsite. Note the combustible liquid storage.

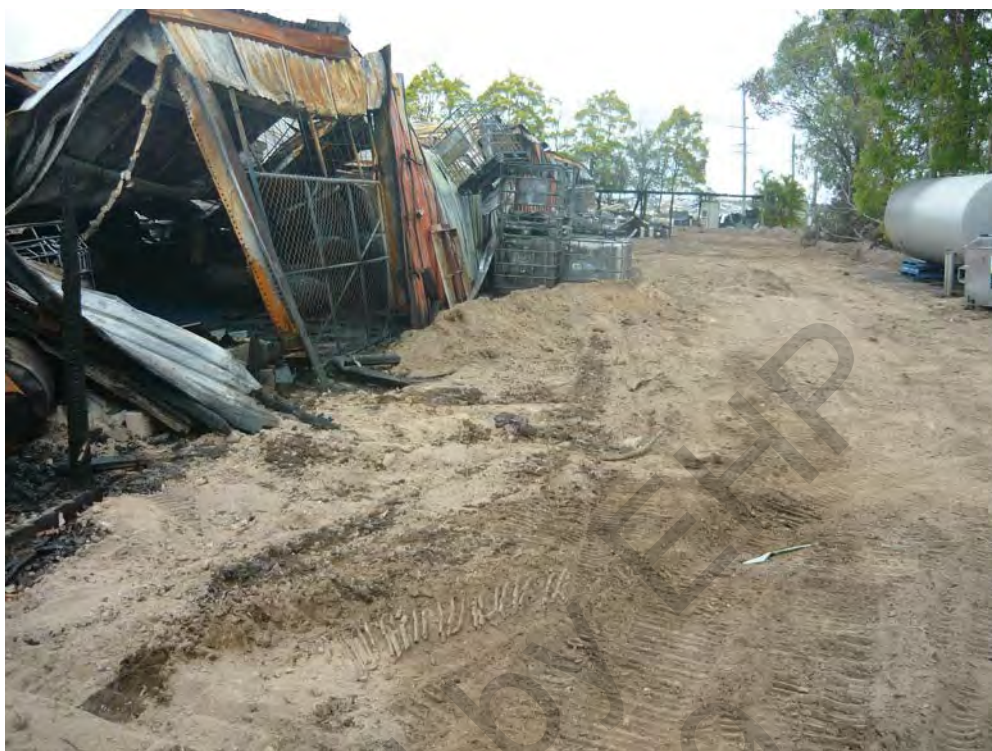
Photo 1 – The front of the destroyed building along Potassium Street (facing south). Further bunding has been placed around the building (see the bund on the left). Excess material has also been placed along the concrete slab to soak up any further containment in preparation for excess rainfall.

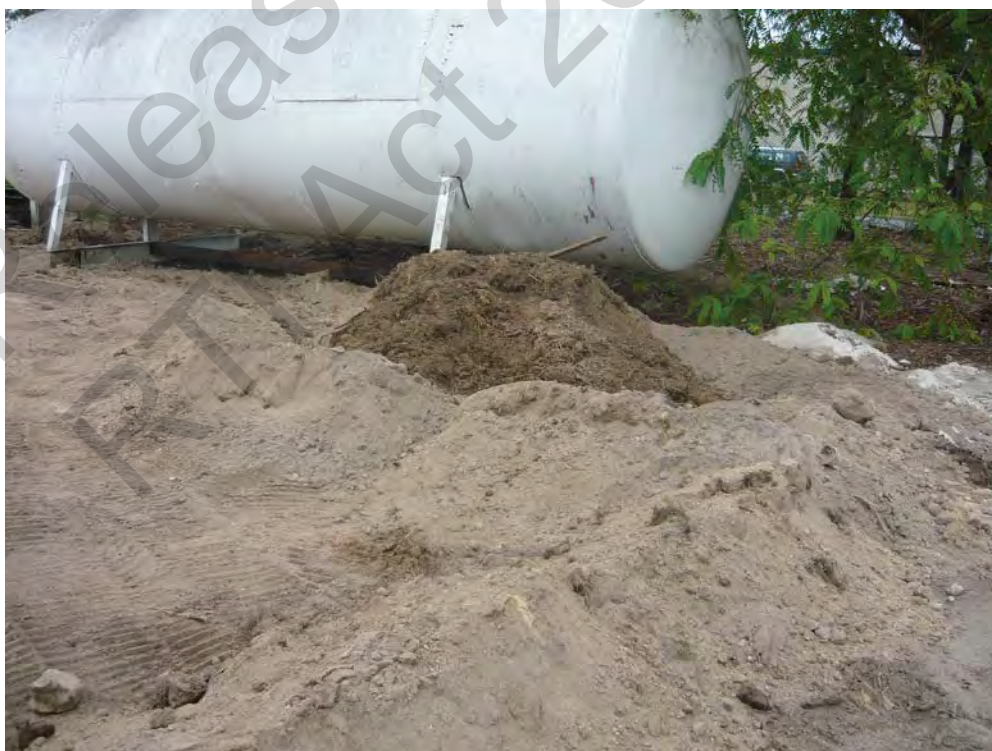
Photo 2 – Photo taken in the same location as photo 1. Looking more south east. Note that the existing bunding has been reinforced with further material. The pile in the centre of the photo is the contaminated soil which was scrapped off the Stockland land after the minor contamination incident on Tuesday. It is expected that this soil will be remediated as per the plan of operations.

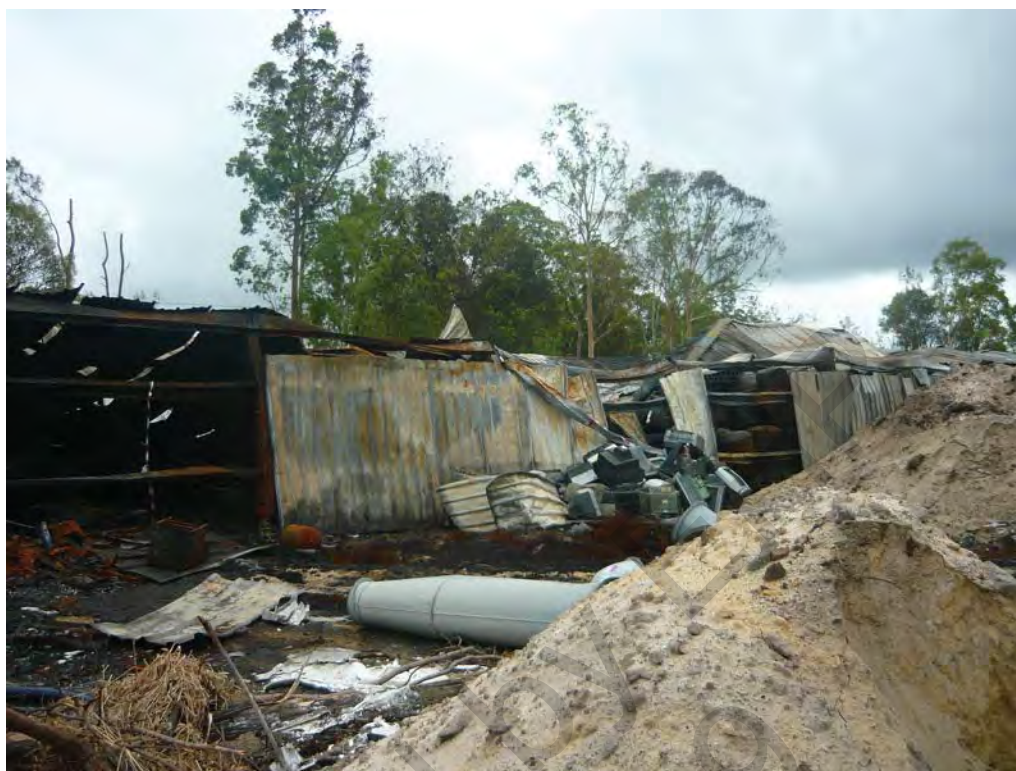
Photo 3 – The rear of the main building (facing north-west). No change from the site visit on 16 January 2013.

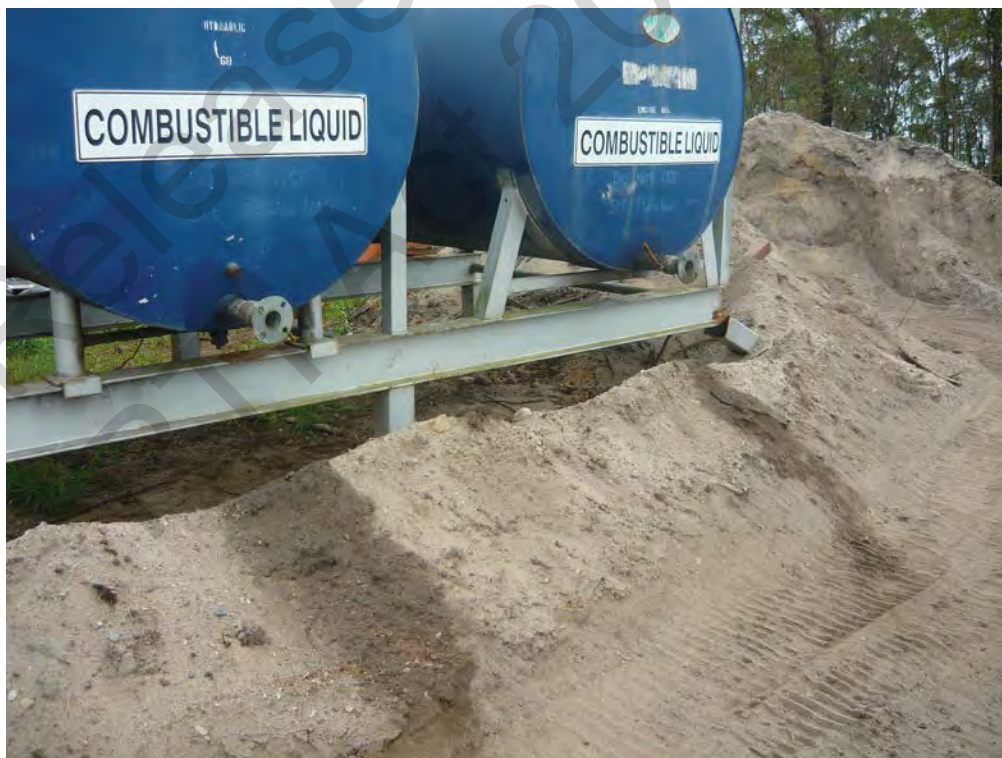
Photo 4 – Liquid storage tanks at the side of the main building (along Boundary Road). Note the moist soil under the taps in the tanks. This could indicate that the tanks are leaking or continually being emptied/released.

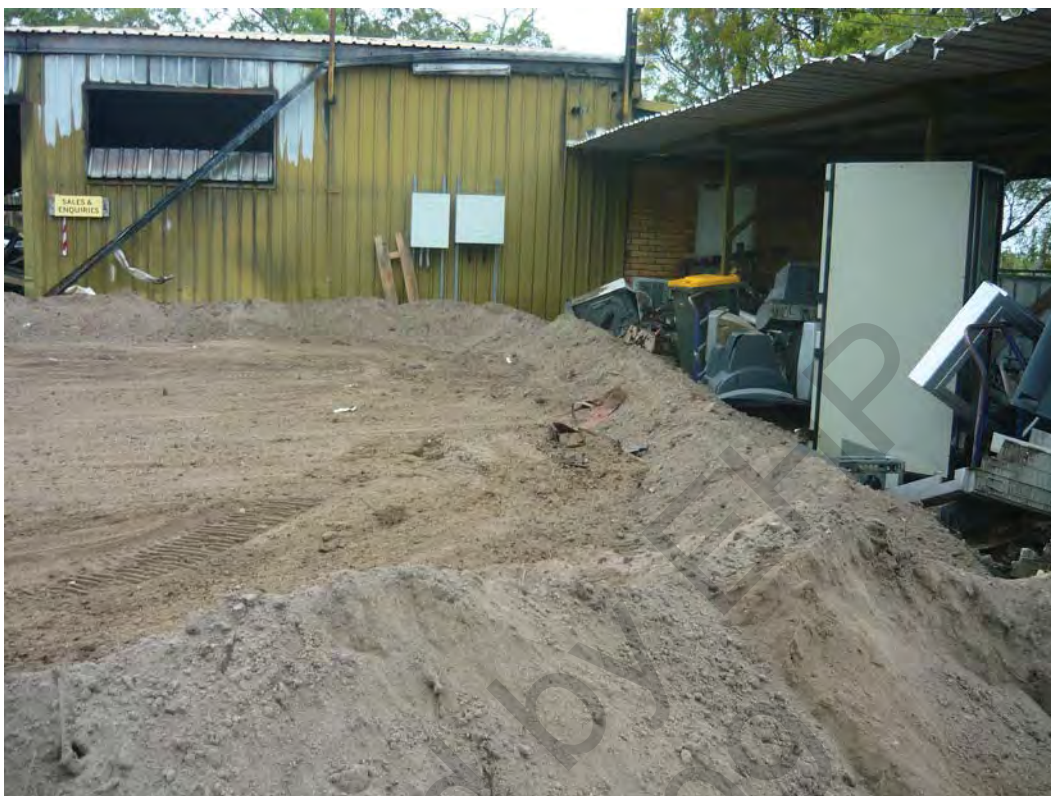
Photo 5 – The front of the main building (facing east) along Potassium Street. Note that the bunding has been reinforced with material and excess material has also been placed along the concrete slab to soak up any further containment in preparation for excess rainfall.

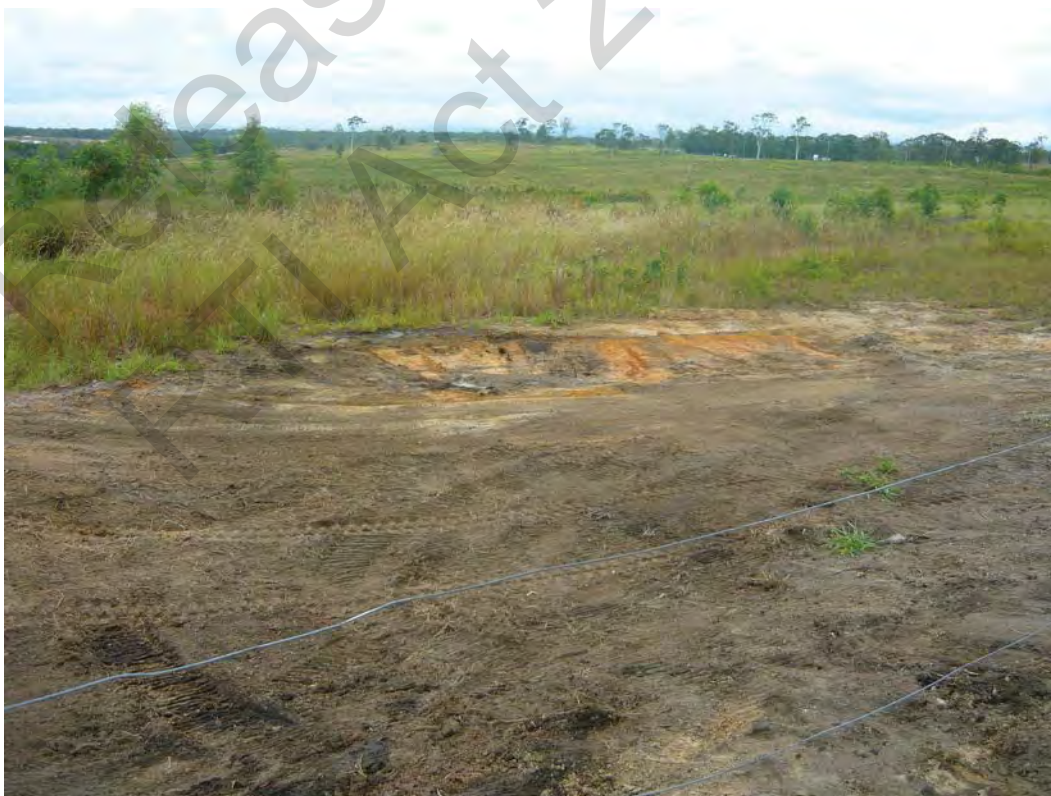
Photo 6 – The Stockland land adjacent to the incident site (along Boundary Road). Note that the contamination has been removed and the land has been scraped.

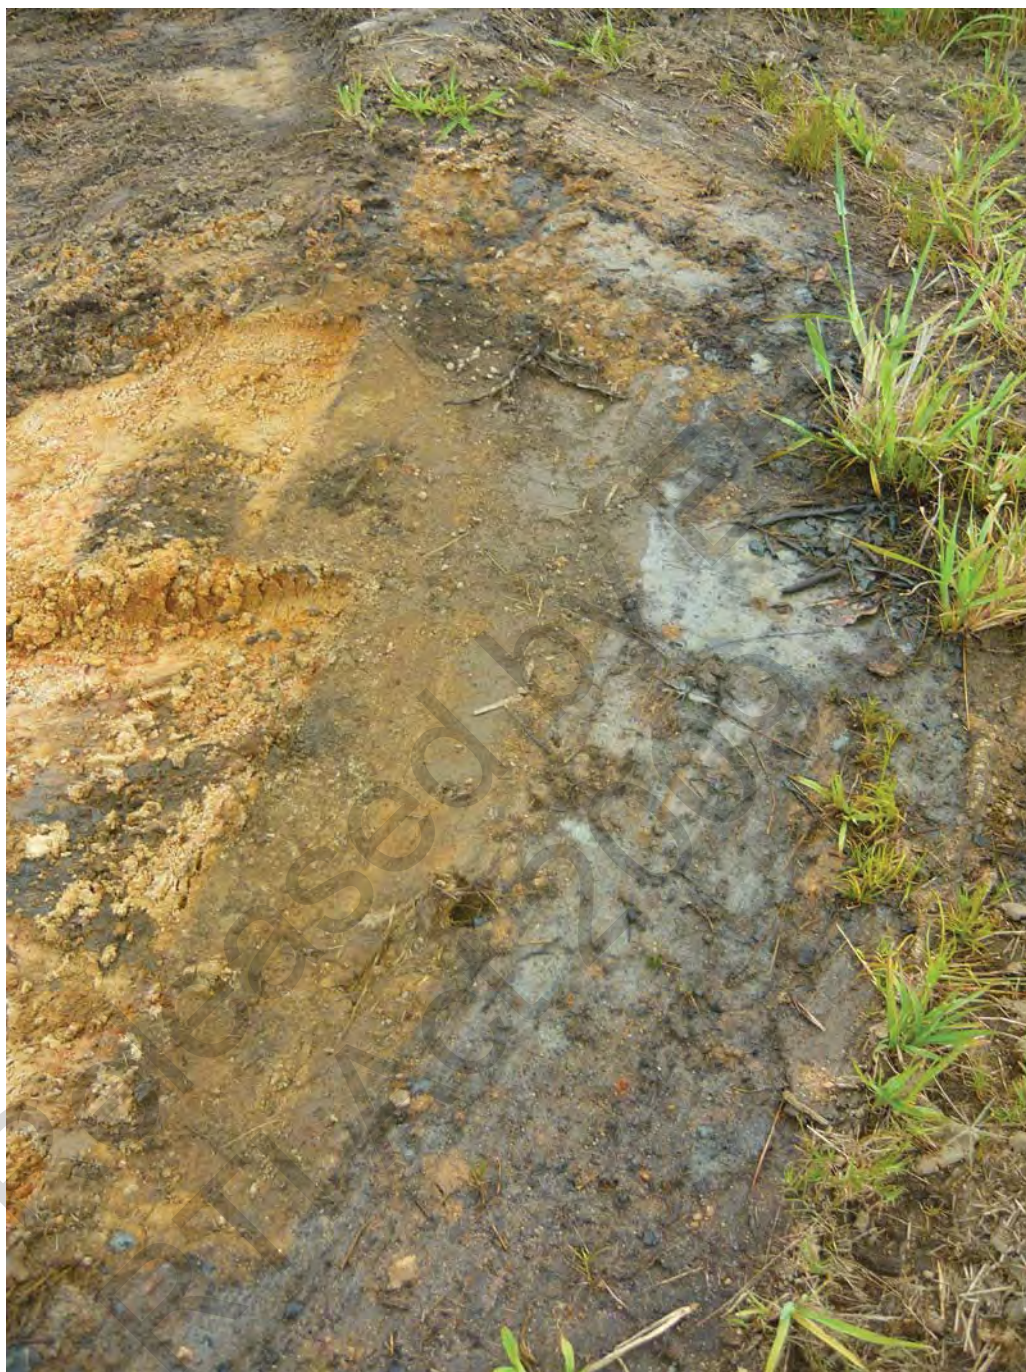
Photo 7 – Contaminates found on the Stockland land before the start of the grassy area (at the rear of the area where the contaminates pooled on Tuesday).

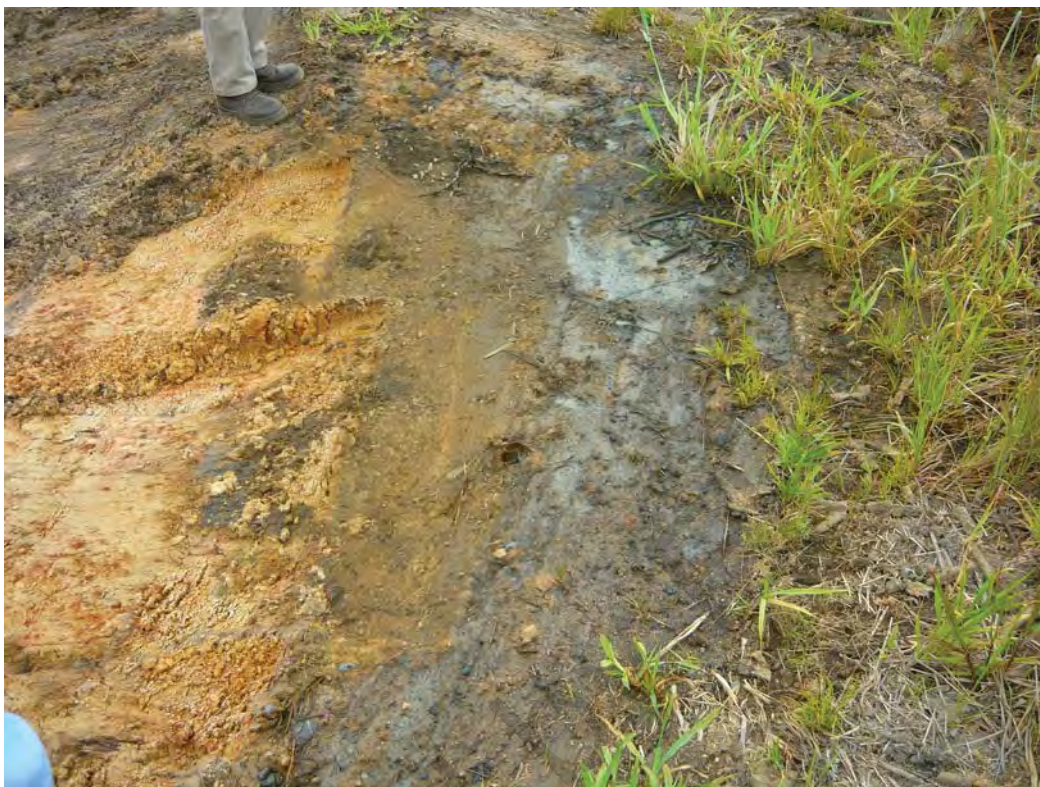
Photo 8 – Contaminates found on the Stockland land before the start of the grassy area (at the rear of the area where the contaminates pooled on Tuesday).

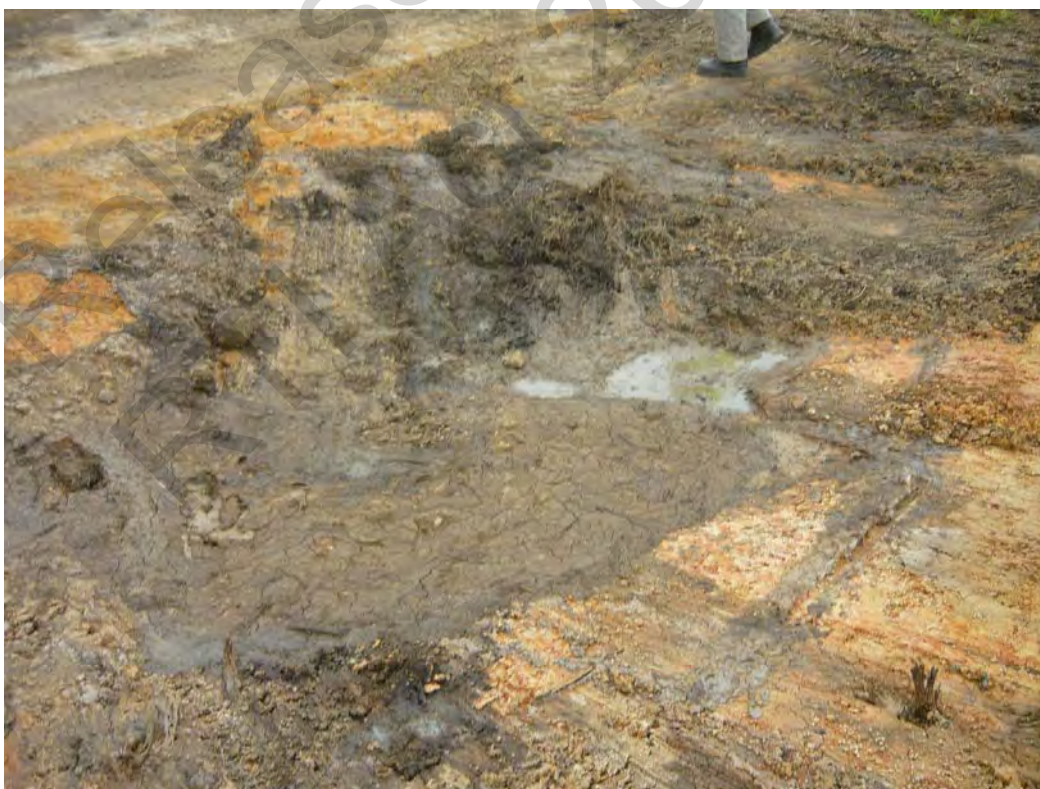
Photo 9 – The area on the Stockland land where the contaminates pooled on Tuesday. Shows that scraping has occurred on the land.

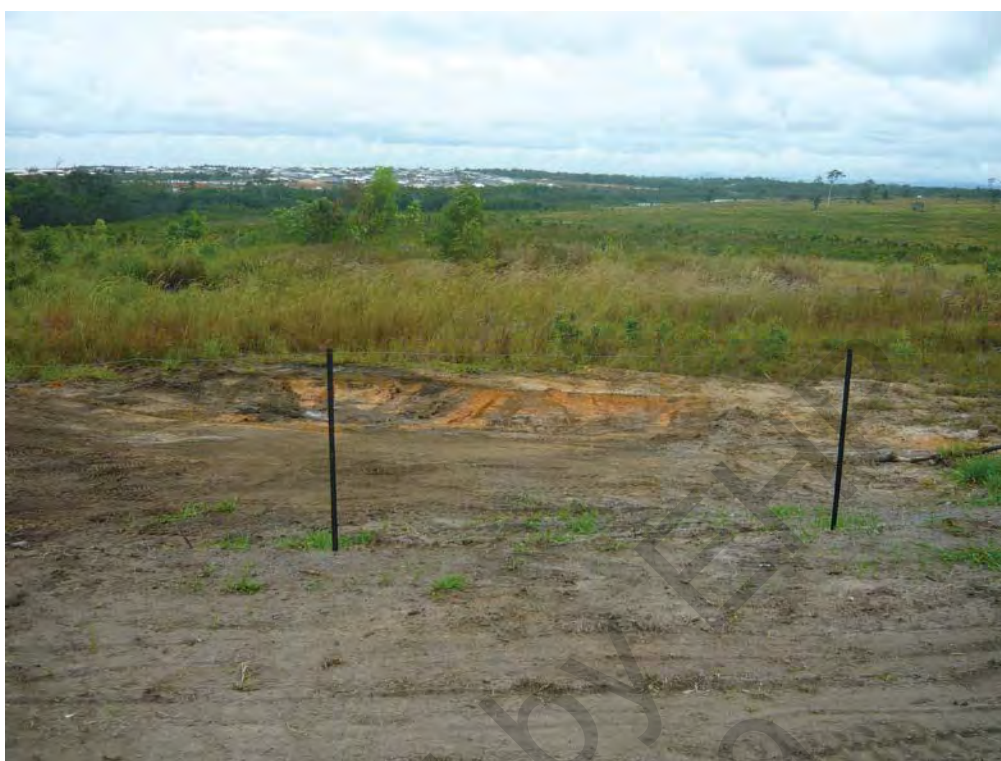
Photo 10 – An overview of the Stockland land (adjacent to Boundary Road facing south) that was affected by the contaminate release on Tuesday.
