**Re. Fire Incident – 11 December 202 – 6 Potassium Street, Narangba.**

## Subject: Photos from Site Visit 16 January 2013

## Subject: Photos from Site Visit 25 January 2013

## Subject: Photos from Site Visit 18 December 2012

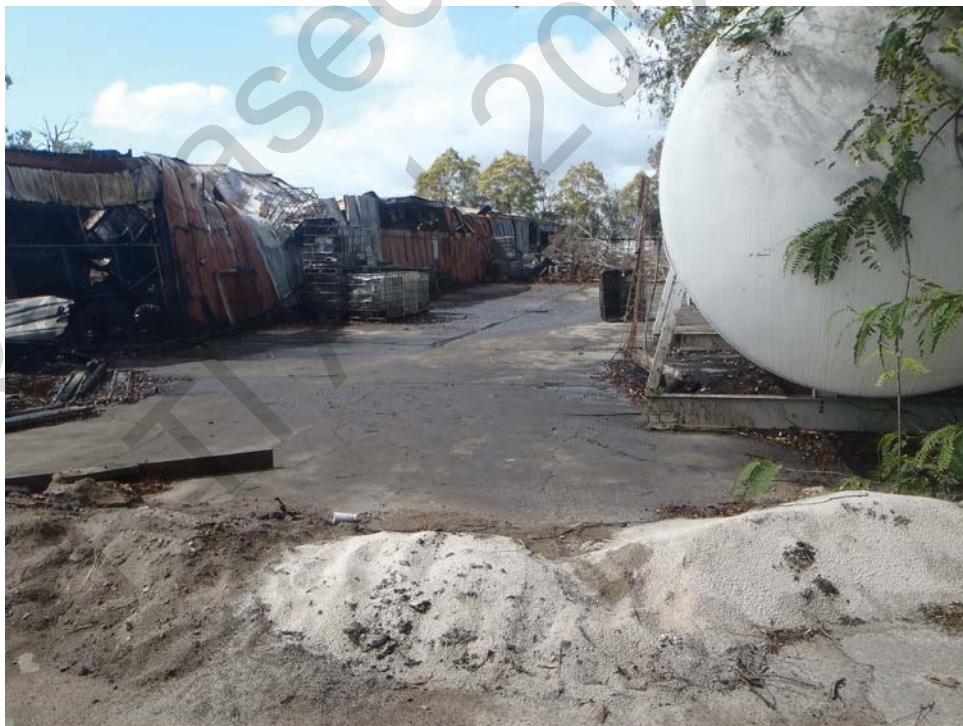
Photo 1 – The front of the destroyed building along Potassium Street (facing south). No change from the site visit on the 18 December 2012. Note some moisture on the ground, likely to be from rainfall. Also note that the bund is still in place around the main building.

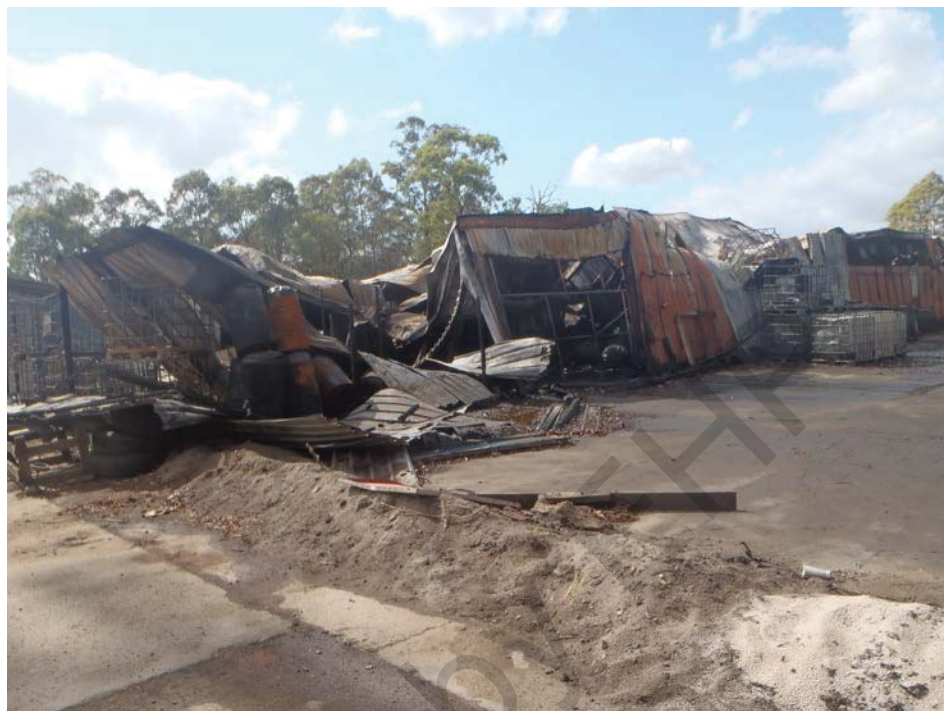
Photo 2 – Photo taken in the same location as photo 1. Looking more south east.

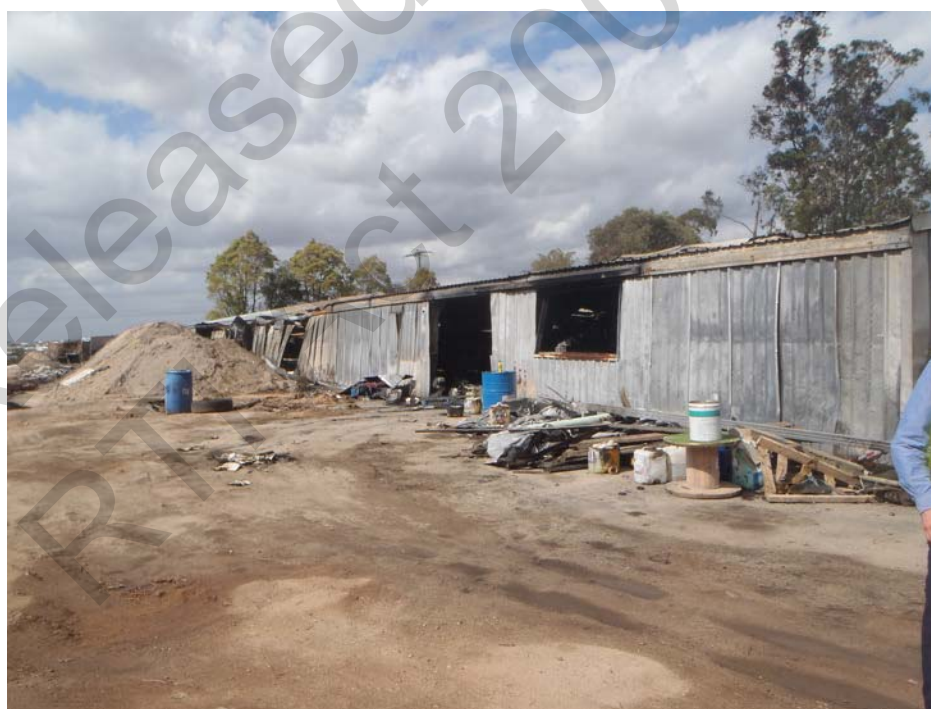
Photo 3 – The rear of the main building (facing south west). No change from the site visit on 18 December 2012. Note some moisture on the ground, likely to be from rainfall.

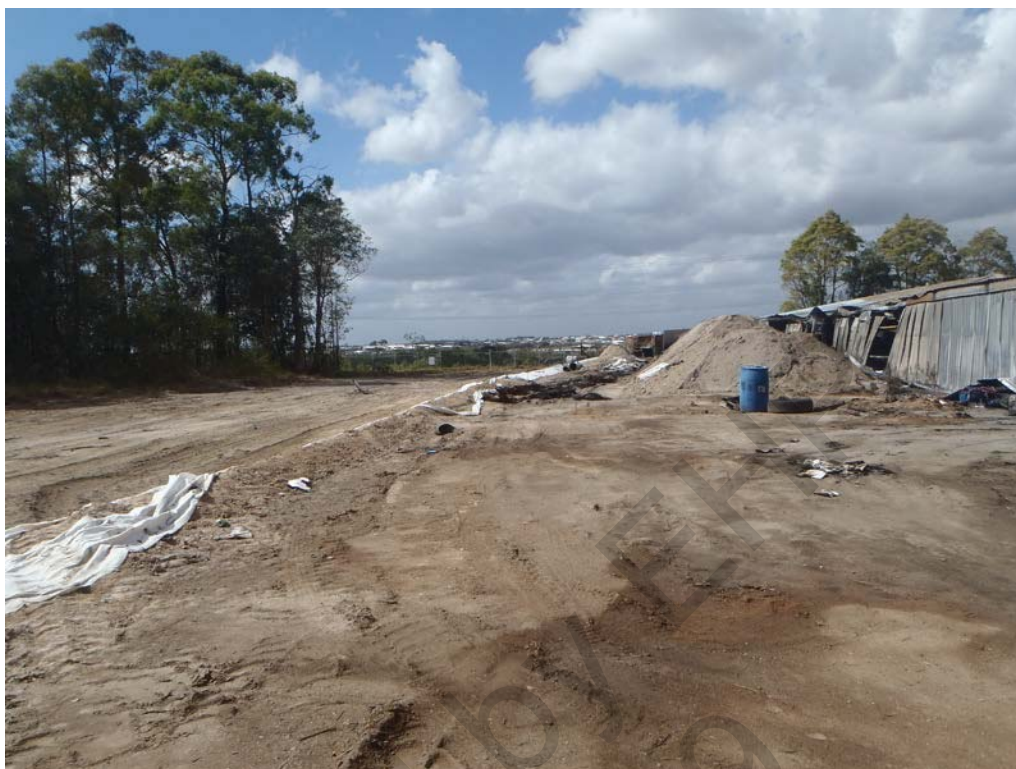
Photo 4 – The rear of the main building (facing south east). No change from the site visit on 18 December 2012. Note some moisture on the ground, likely to be from rainfall.

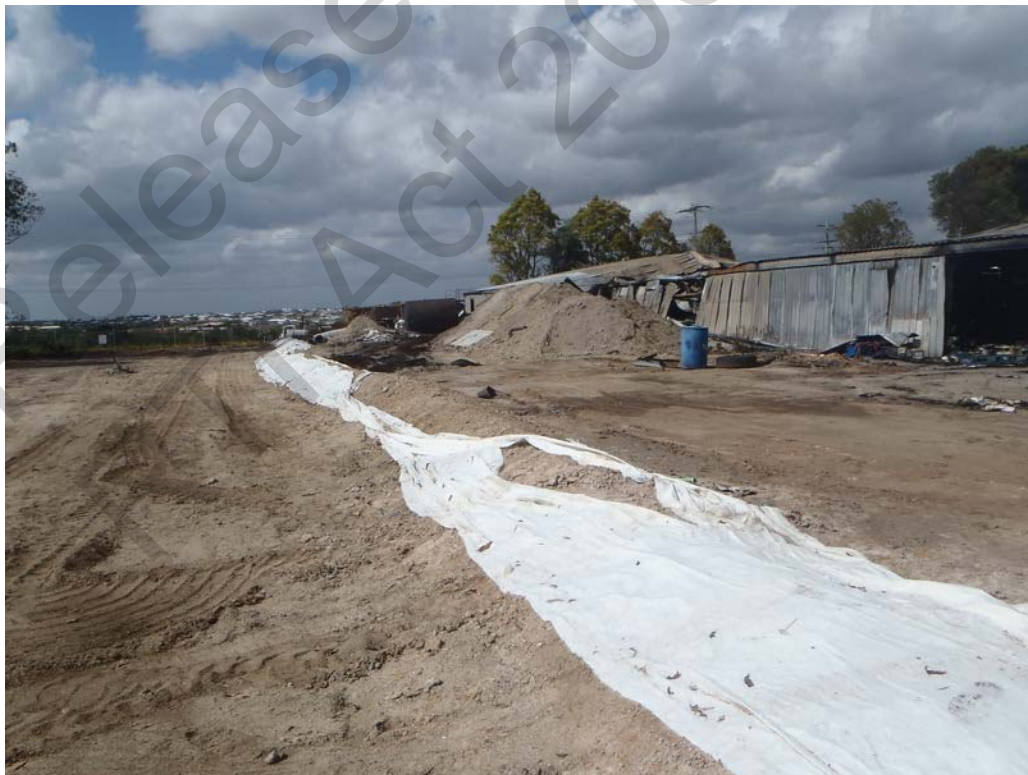
Photo 5 – The rear of the main building (facing south). No change from the site visit on 18 December 2012. Note some moisture on the ground, likely to be from rainfall.

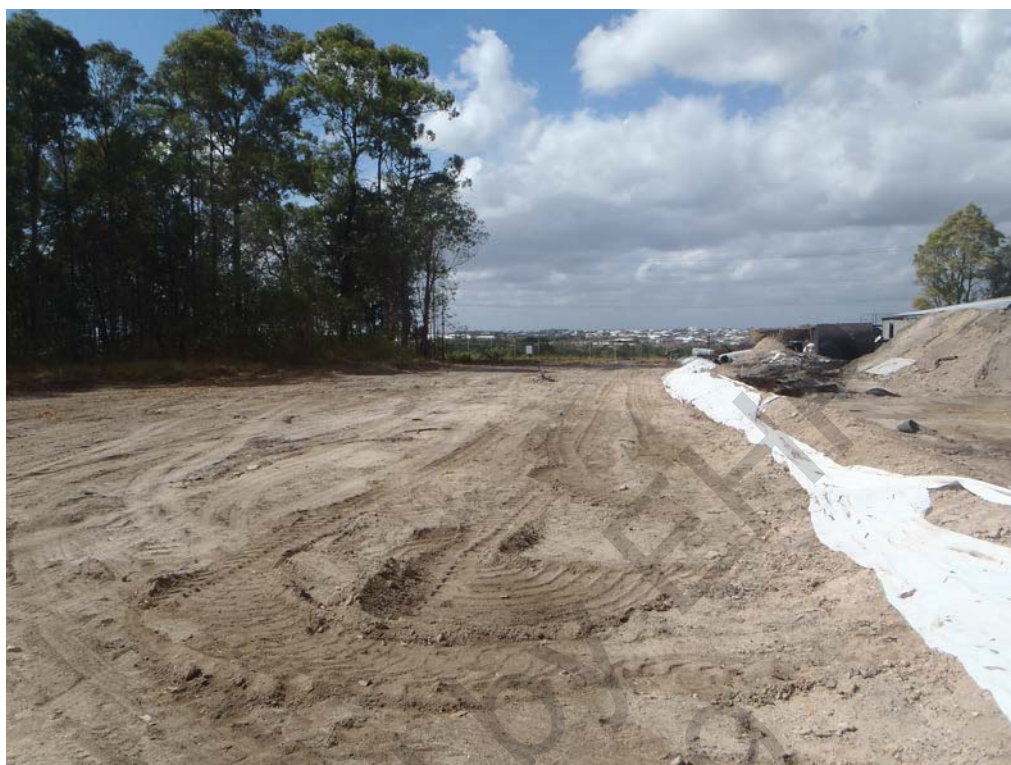
Photo 6 – The rear of the main building (facing south). No change from the site visit on 18 December 2012.

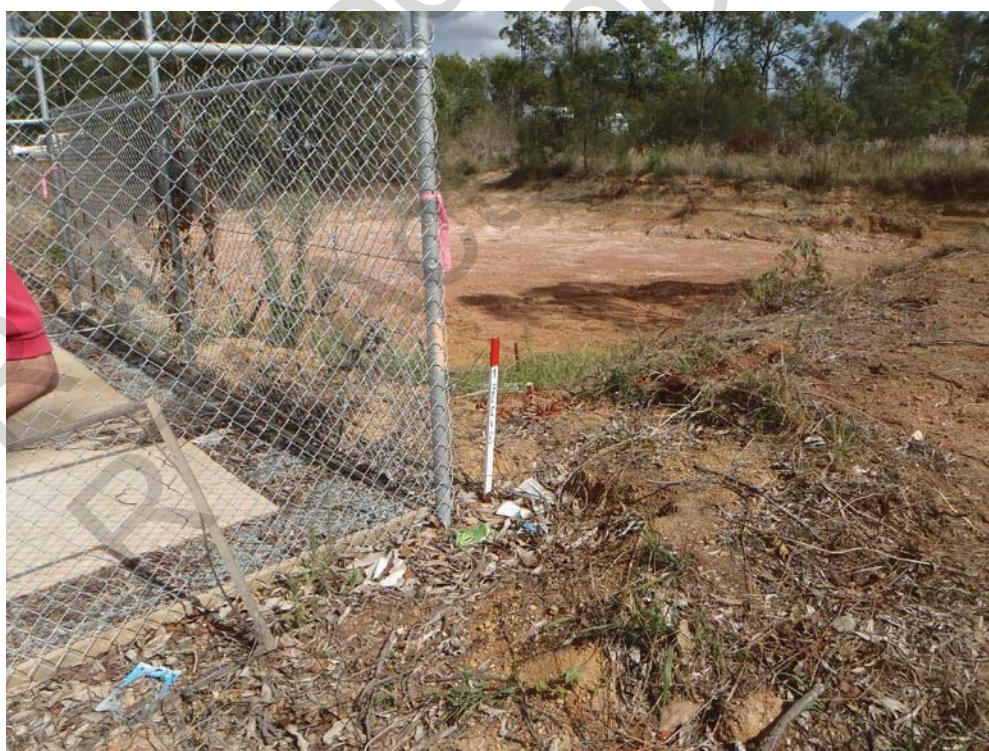
Photo 7 – The rear of the Telstra tower on the rear corner of the property. Note the white and red stake. This represents the boundary point from where DSDIP will construct a fence from towards boundary road.

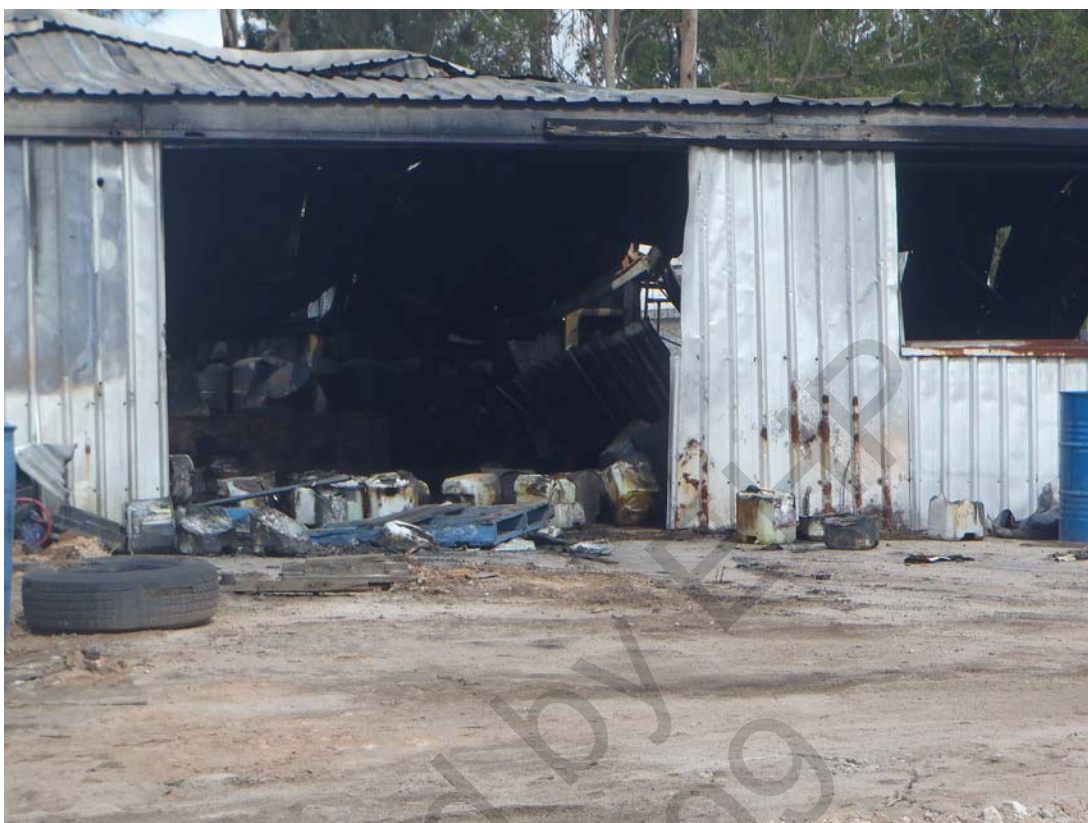
Photo 8 – Inside the main building from the rear of the property. No change from the site visit on 18 December 2012.

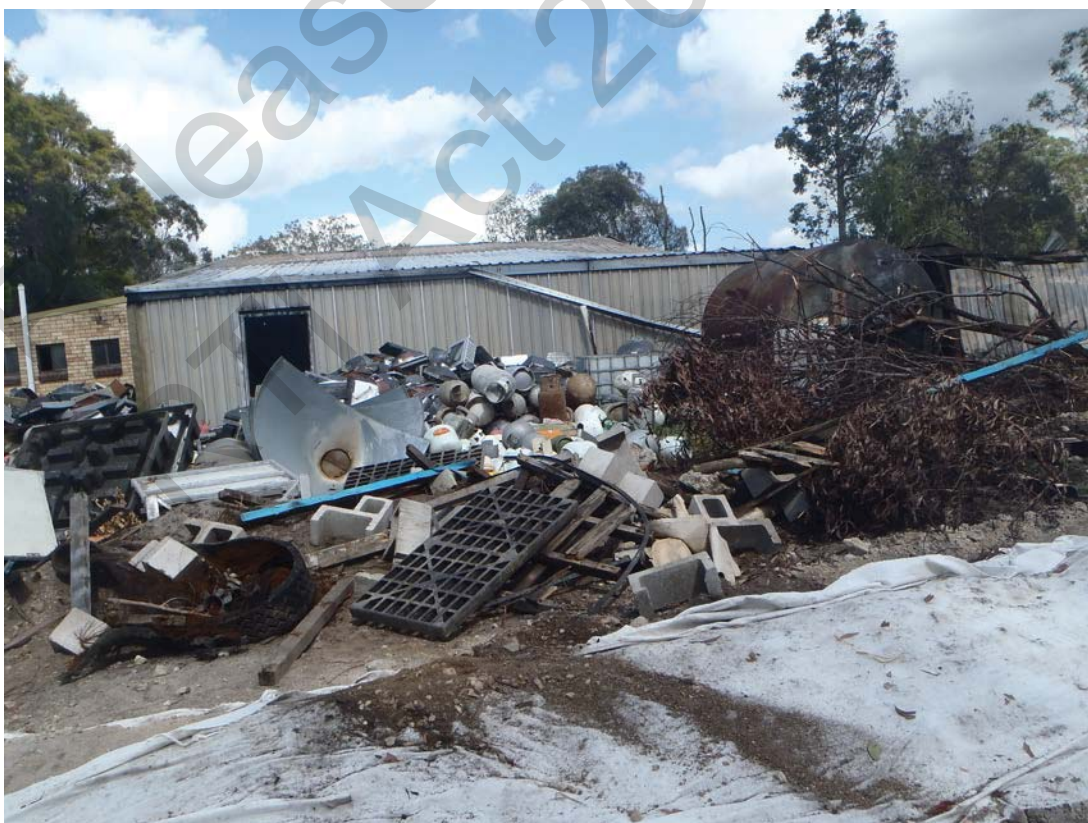
Photo 9 – Behind the main building from the rear of the property. No change from the site visit on 18 December 2012.

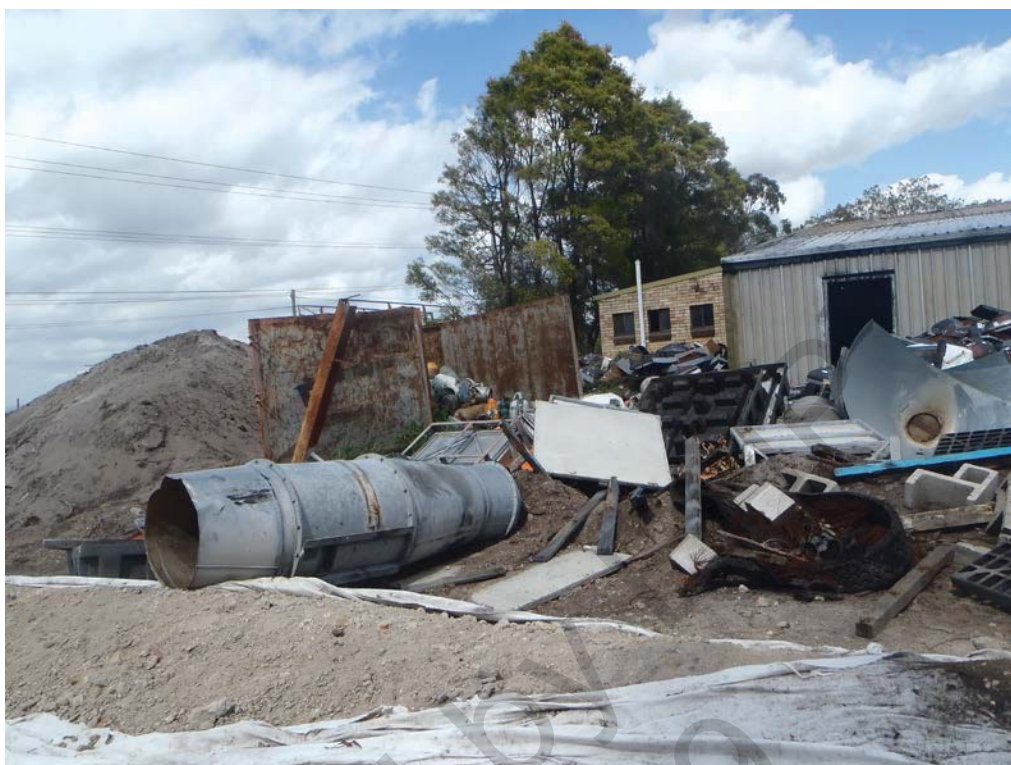
Photo 10 – Behind the main building from the rear of the property. No change from the site visit on 18 December 2012.

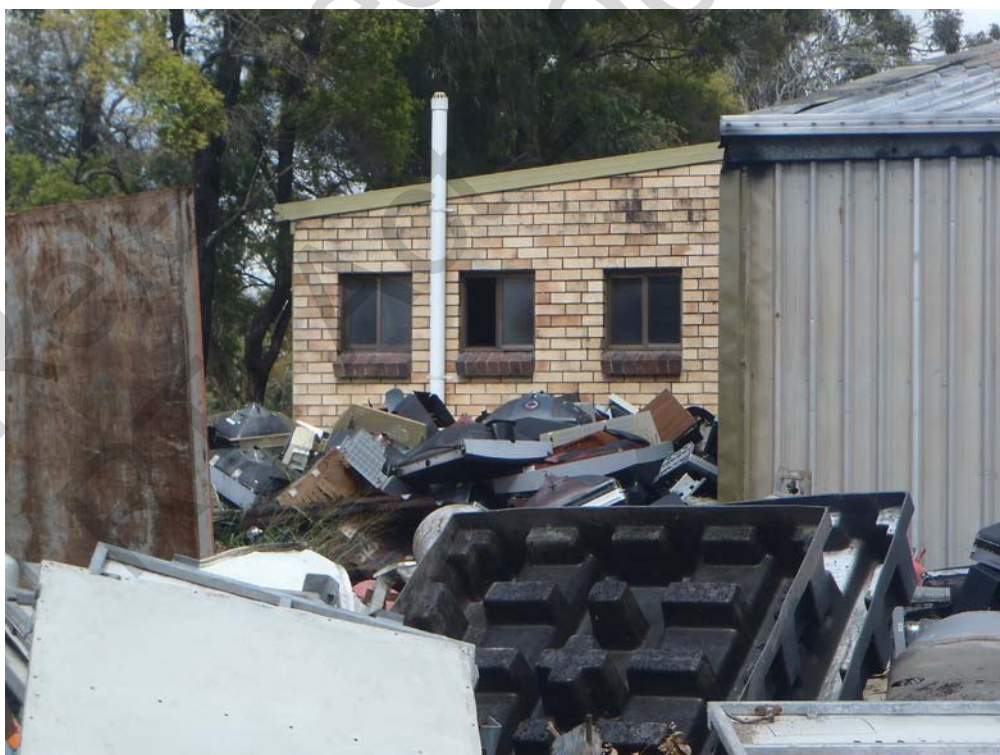
Photo 11 – Behind the main building from the rear of the property. No change from the site visit on 18 December 2012.

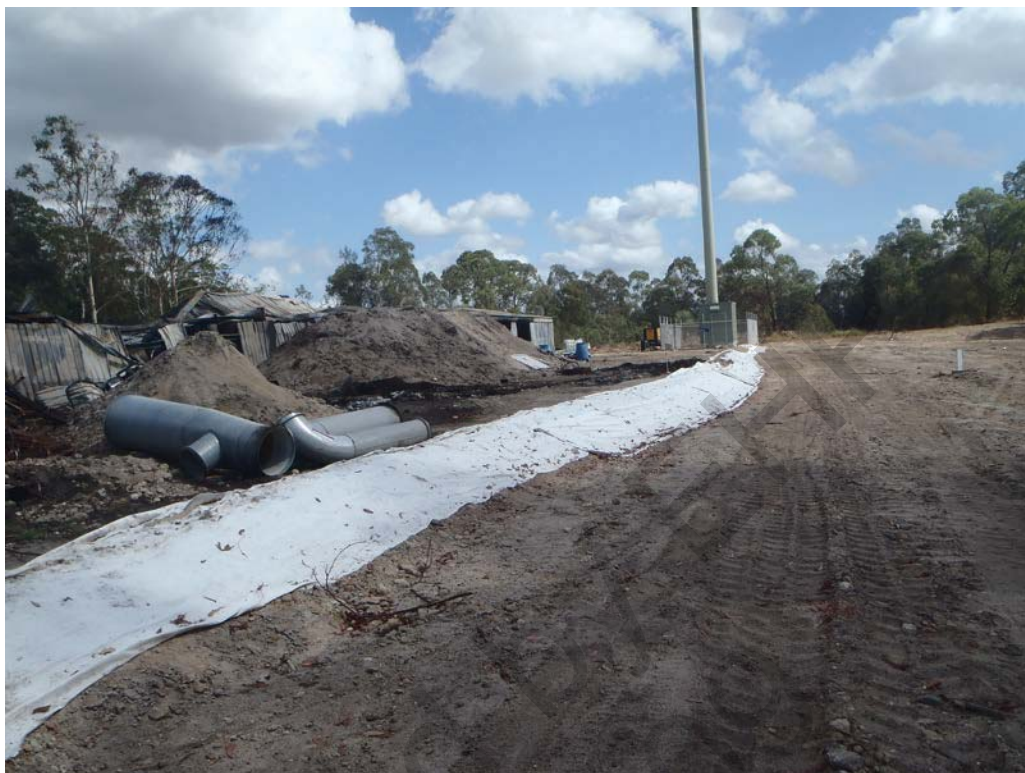
Photo 12 – Behind the main building at the rear of the property (looking towards the Telstra tower north). No change from the site visit on 18 December 2012.

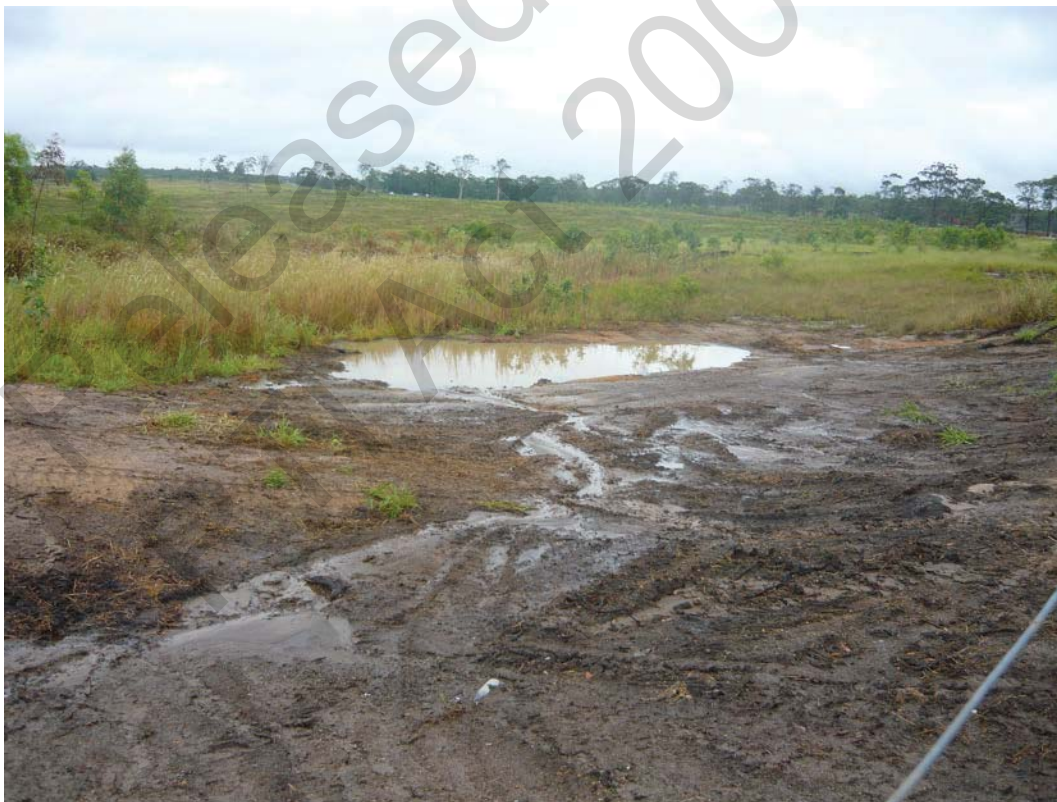
Photo 1 – The Stockland land adjacent the Tasman site, across Boundary Road. No contaminants can be seen, indicating that the capping on the pipeline has been successful. However water has started pooling due to the rainfall throughout the day.

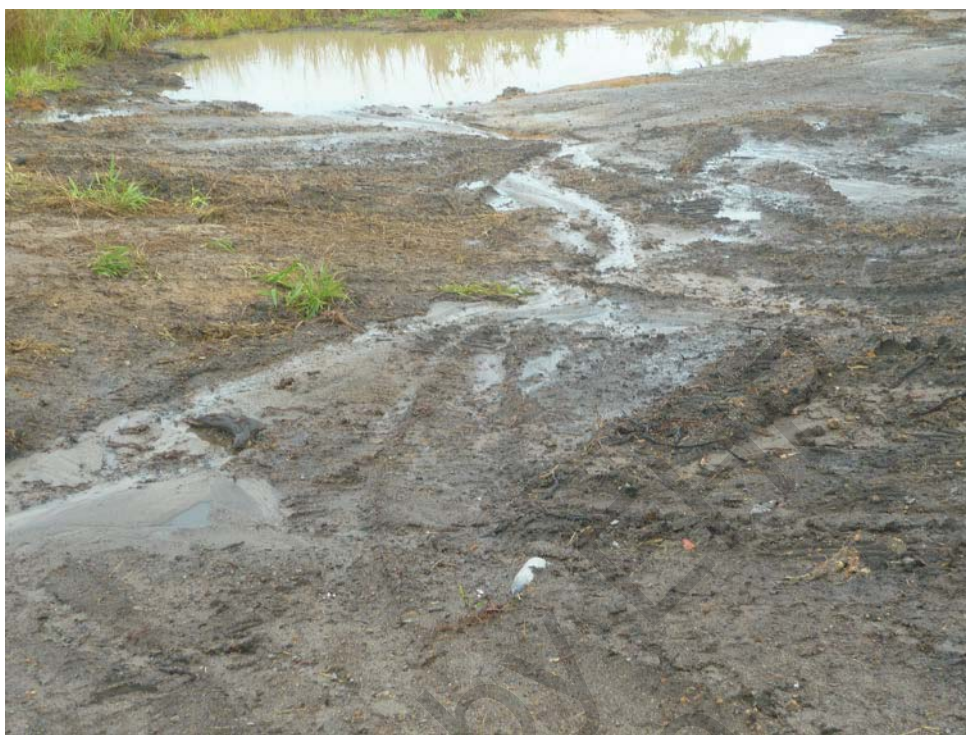
Photo 2 – Close up of the Stockland land adjacent the Tasman site, across Boundary Road. No contaminants can be seen, indicating that the capping on the pipeline has been successful. However water has started pooling due to the rainfall throughout the day.

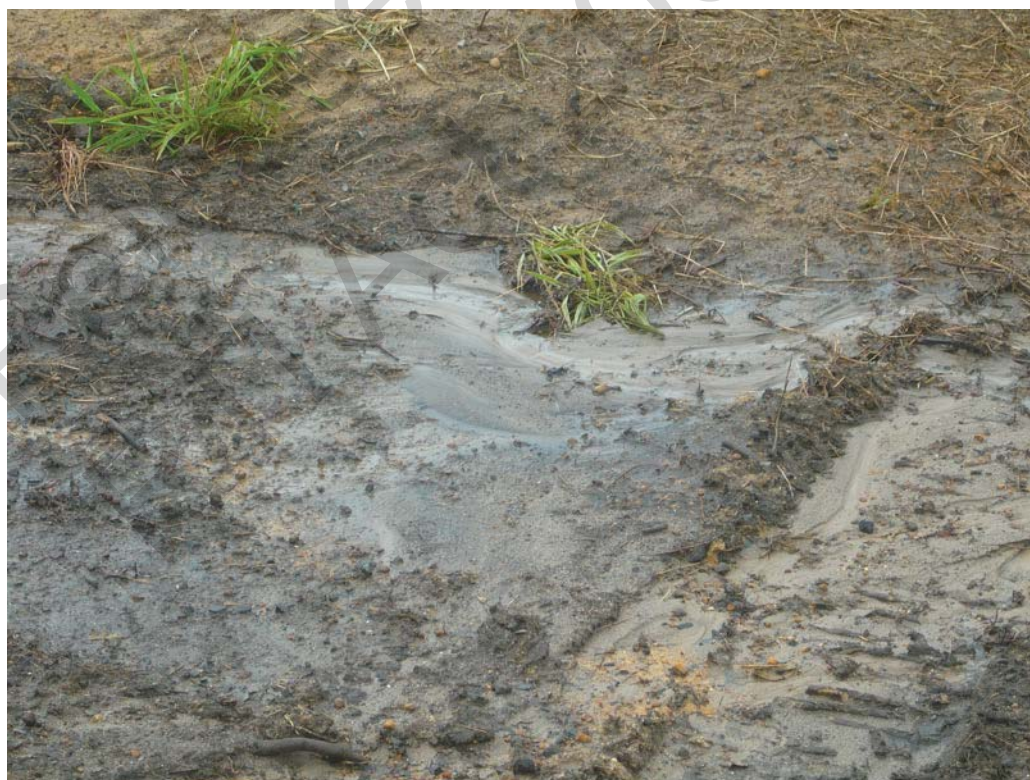
Photo 3 – Close up of the runoff into the Stockland land adjacent the Tasman site, across Boundary Road. No contaminants can be seen, indicating that the capping on the pipeline has been successful. Please note that the water looks clear.

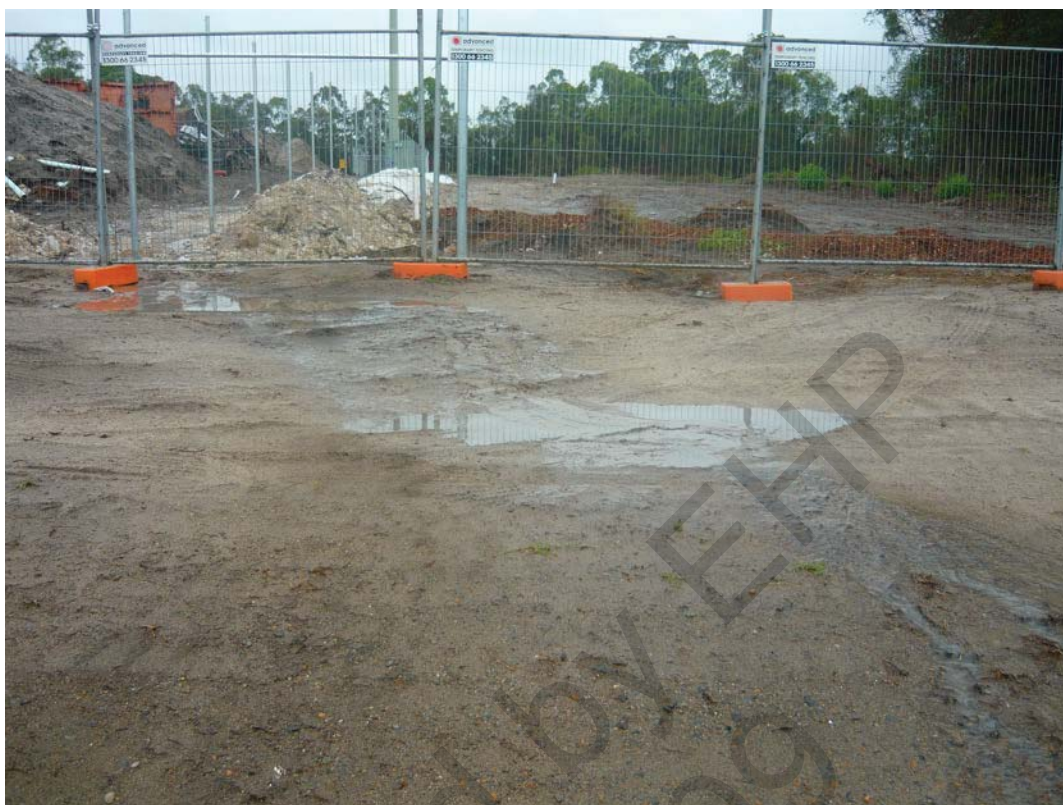
Photo 4 – Rain water running off the Tasman site onto the footpath due to a break in the bund in the top left corner of the photo. Please note that the runoff is clear and it is believe that it did not contain any contaminants.

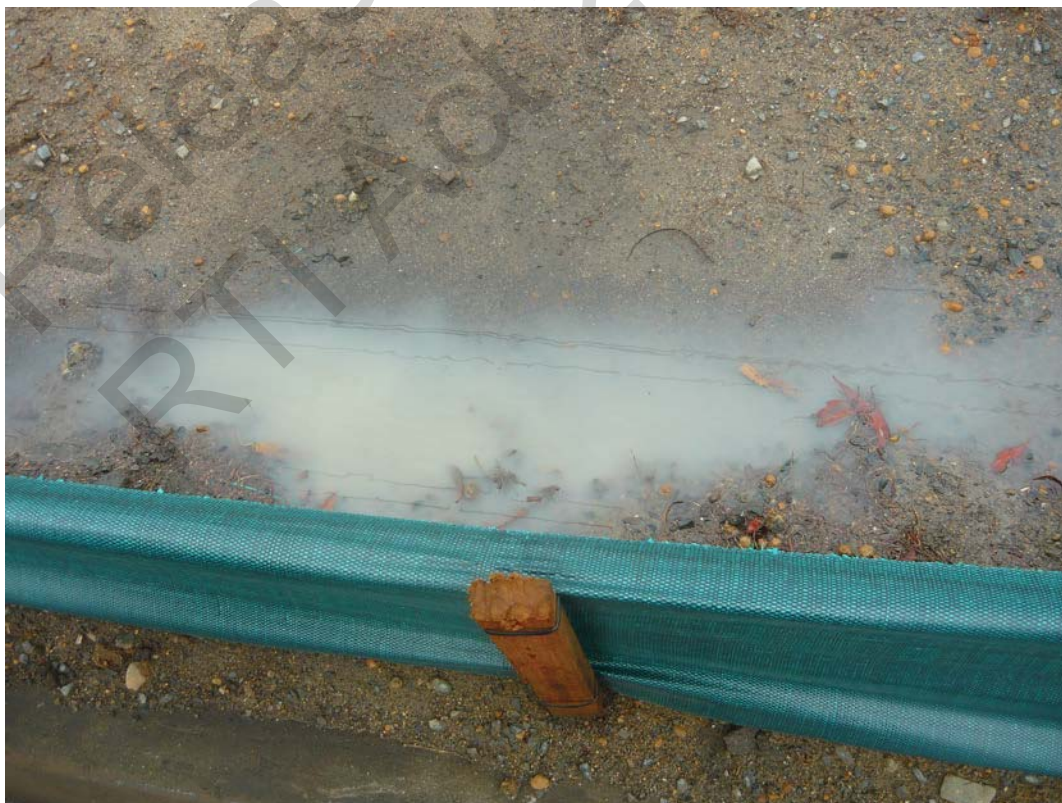
Photo 5 – Pooling rainwater seen in photo 4 above, at the sediment fence along the footpath of Boundary Road. Please note that there are not contaminants evident in the water.

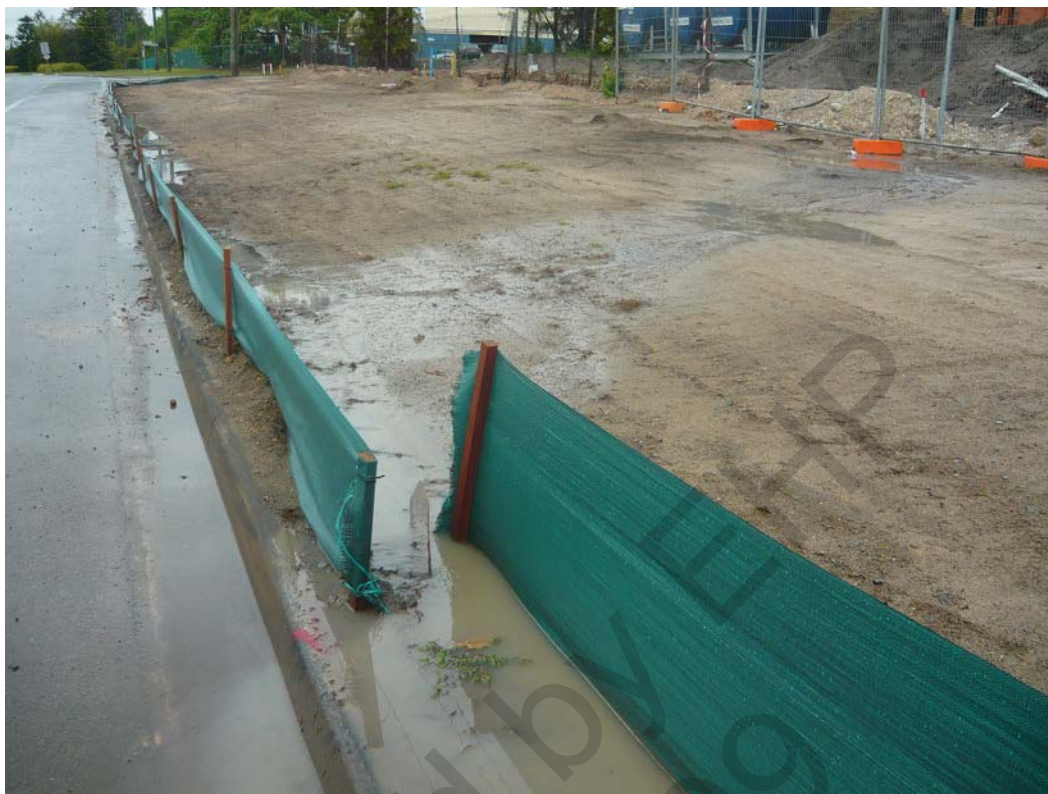
Photo 6 – Pooling rainwater seen in photo 4 and 5 above, at the sediment fence along the footpath of Boundary Road. Please note that there are not contaminants evident in the water.

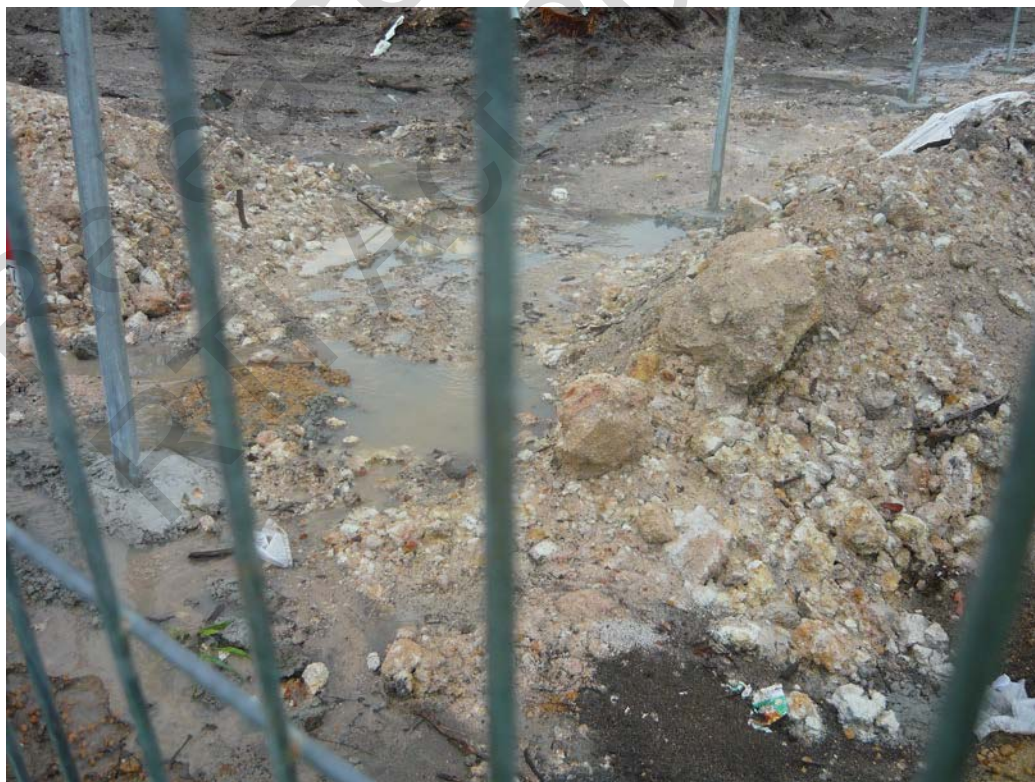
Photo 7 – The break in the bund wall (referenced in photo 4). This bund wall was installed by Projex Partners (DSDIP consultants). It is broken where the bund turns the corner and runs parallel with Boundary road. As the bund is broken where the new fence posts start, it is possible that the break could have been caused by the fence contractors (the fence contractors were seen onsite on Thursday 24/01/2013 – see file note)

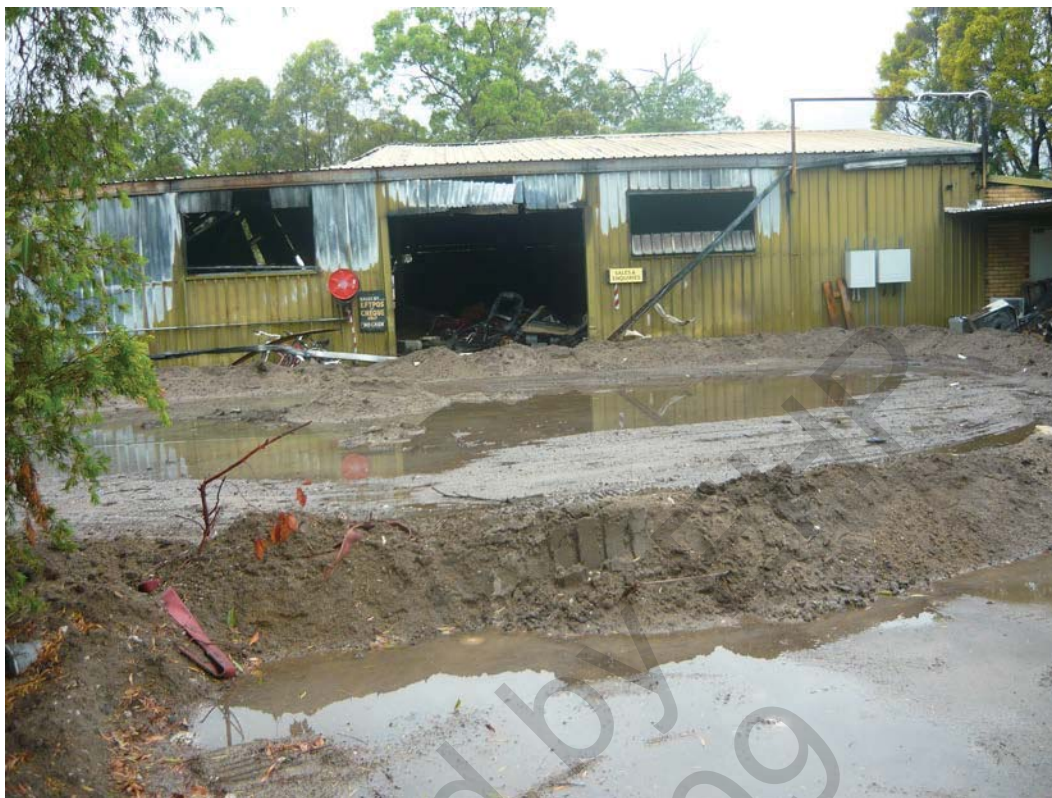
Photo 8 – Water pooling within the bunded area at the front of the southern end of the building (parallel to Potassium Street)

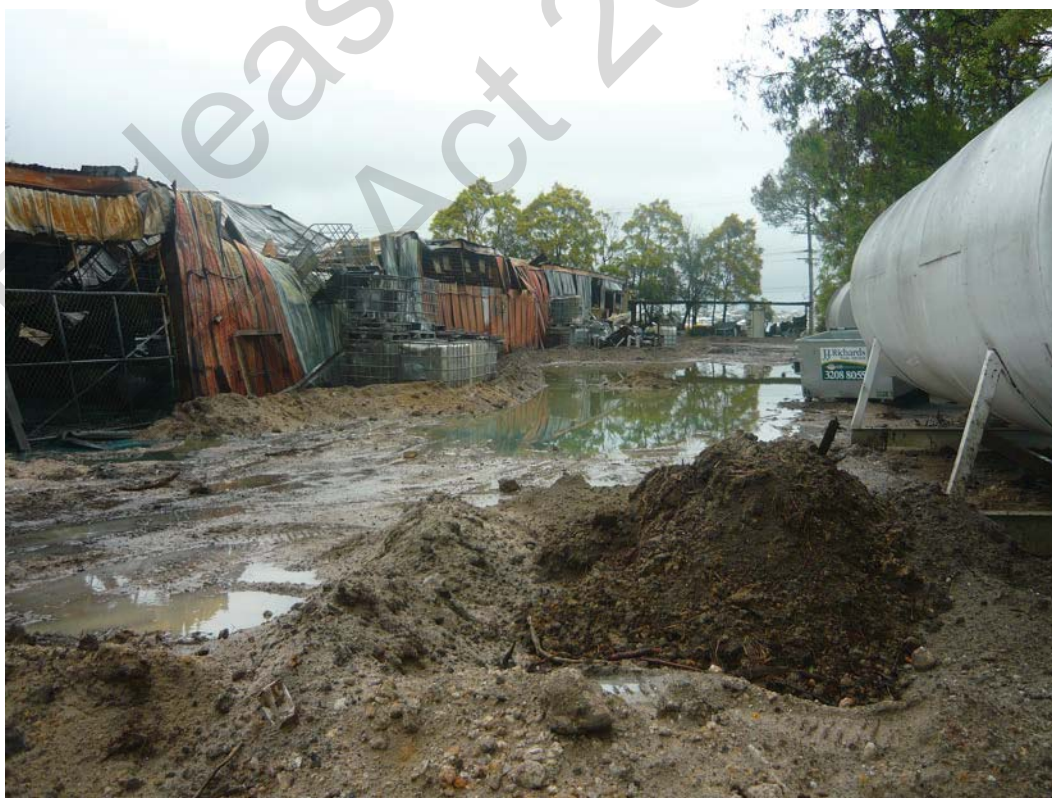
Photo 9 – Water pooling within the bunded area at the front of the building (photo is looking south from the northern end of the building – parallel to Potassium Street). Please note the blue sheen on the water indicating that contaminants are exiting the building due to the rainfall.

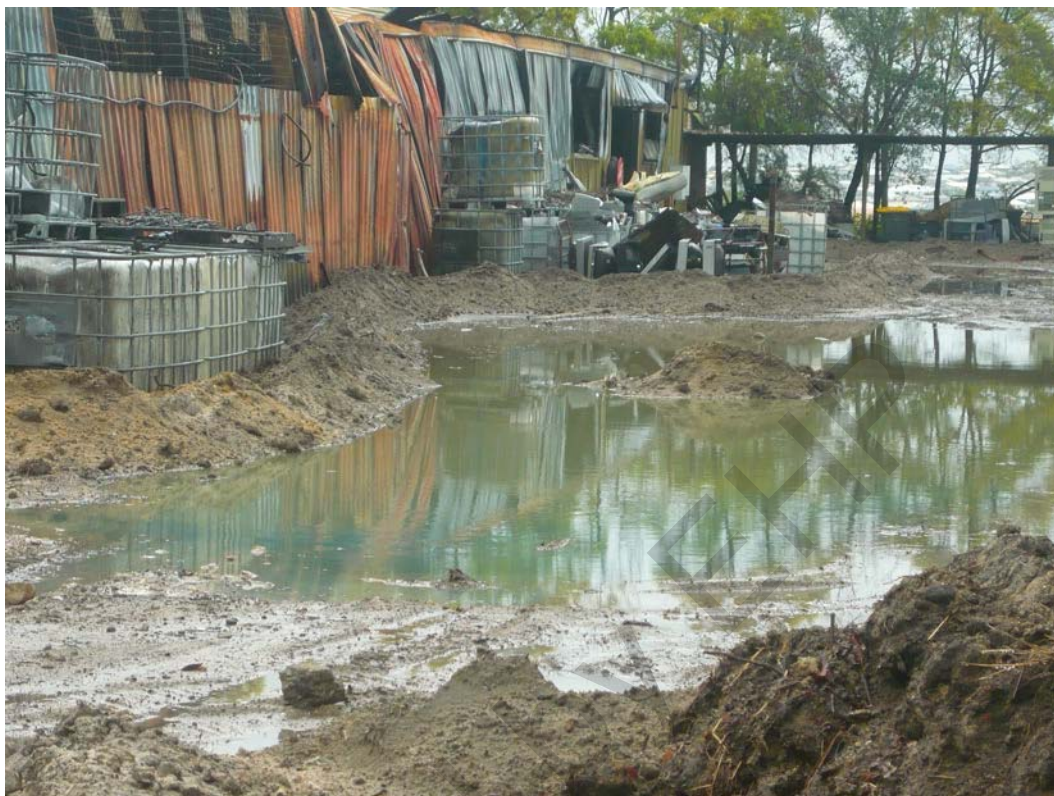
Photo 10 – Close up of the water pooling within the bunded area at the front of the building (photo is looking south from the northern end of the building – parallel to Potassium Street). Please note the blue sheen on the water indicating that contaminants are exiting the building due to the rainfall.

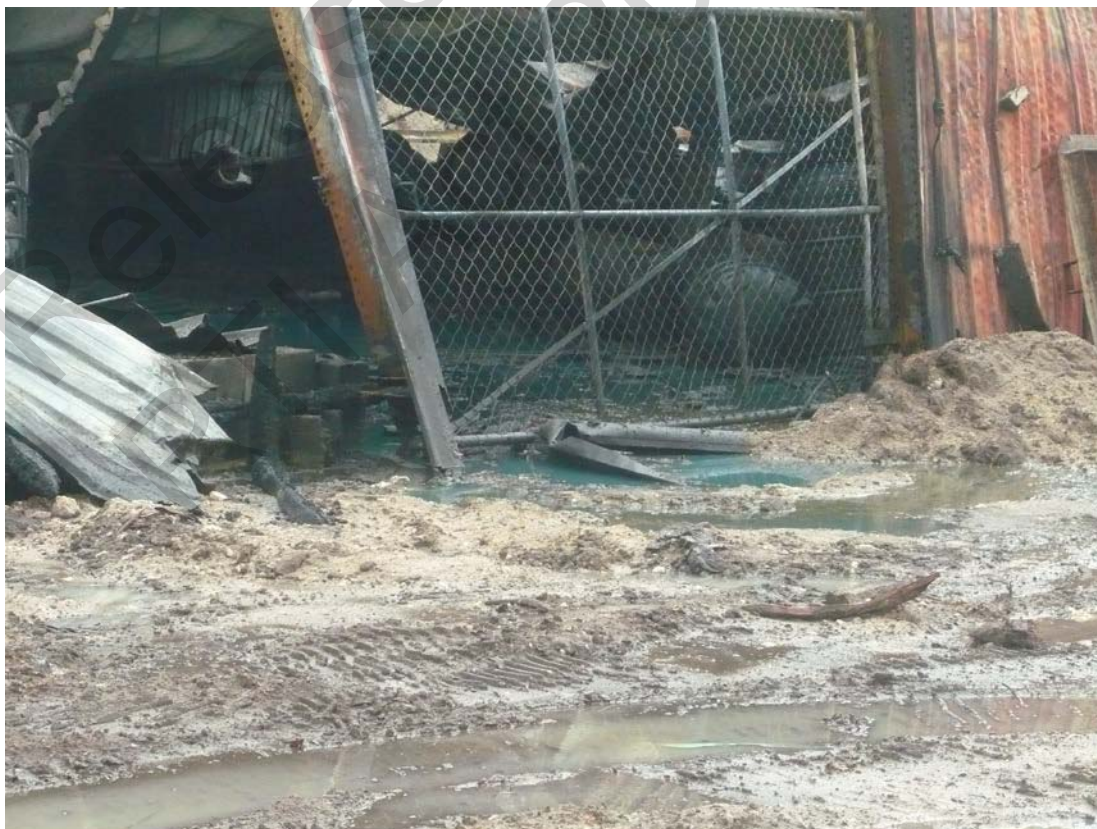
Photo 11 – Contaminants exiting the building due to the rainfall. Photo taken of the northern end of the building parallel to Potassium Street.

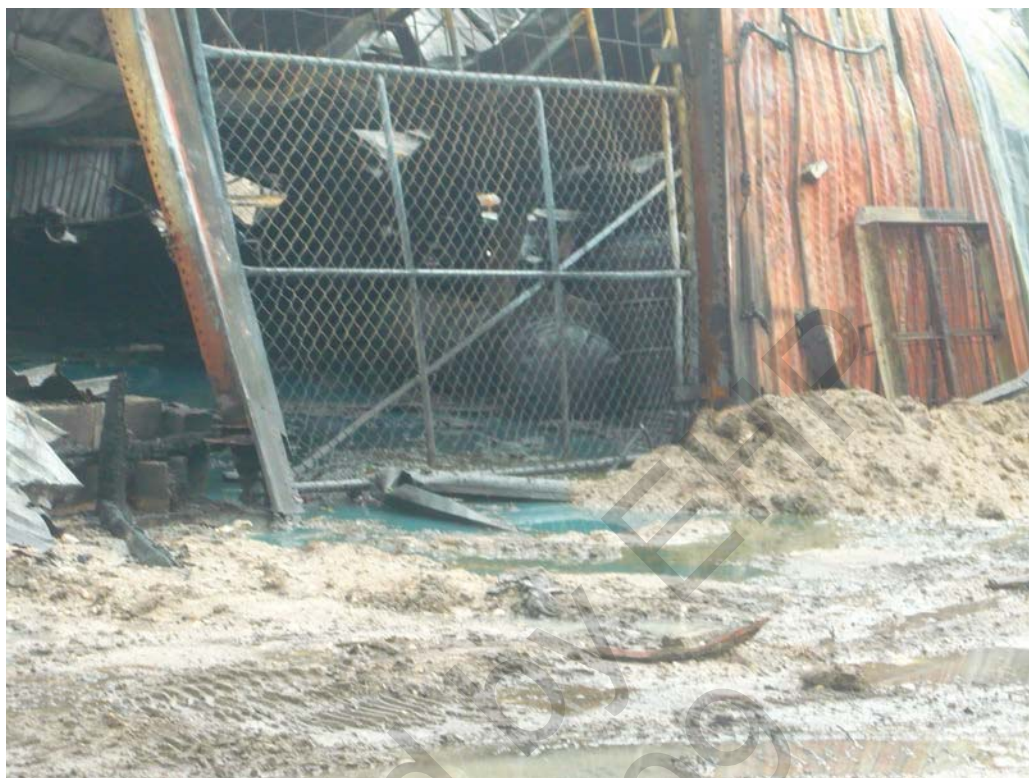
Photo 12 – Close up of the contaminants exiting the building due to the rainfall. Photo taken of the northern end of the building parallel to Potassium Street.

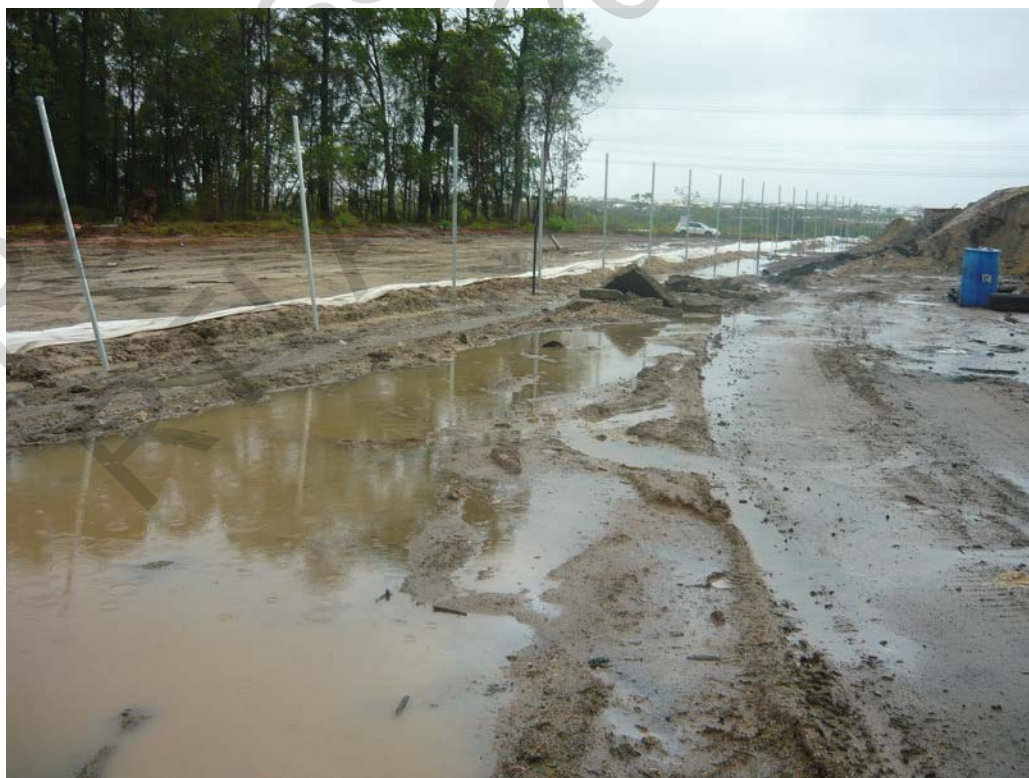
Photo 13 – Pooling of water on the eastern side of the building. Please note no contaminants can be seen in the pooled water.

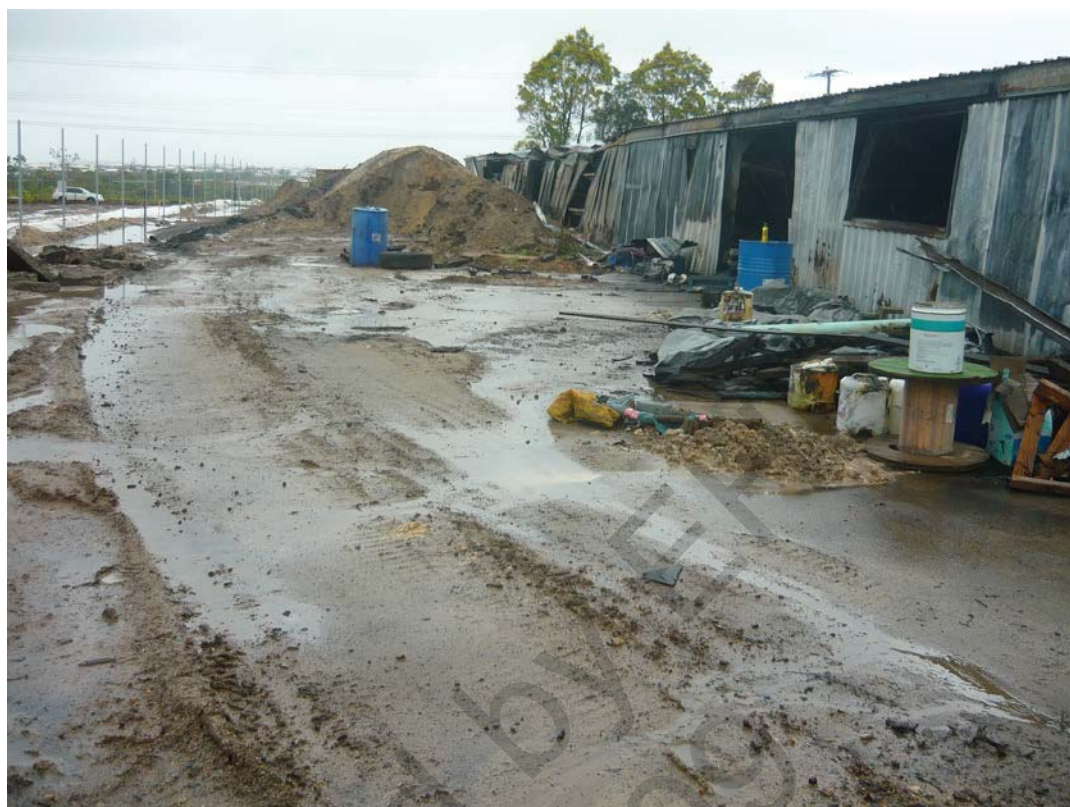
Photo 14 – The eastern side of the building. Please note no contaminants can be seen exiting the building on this side.

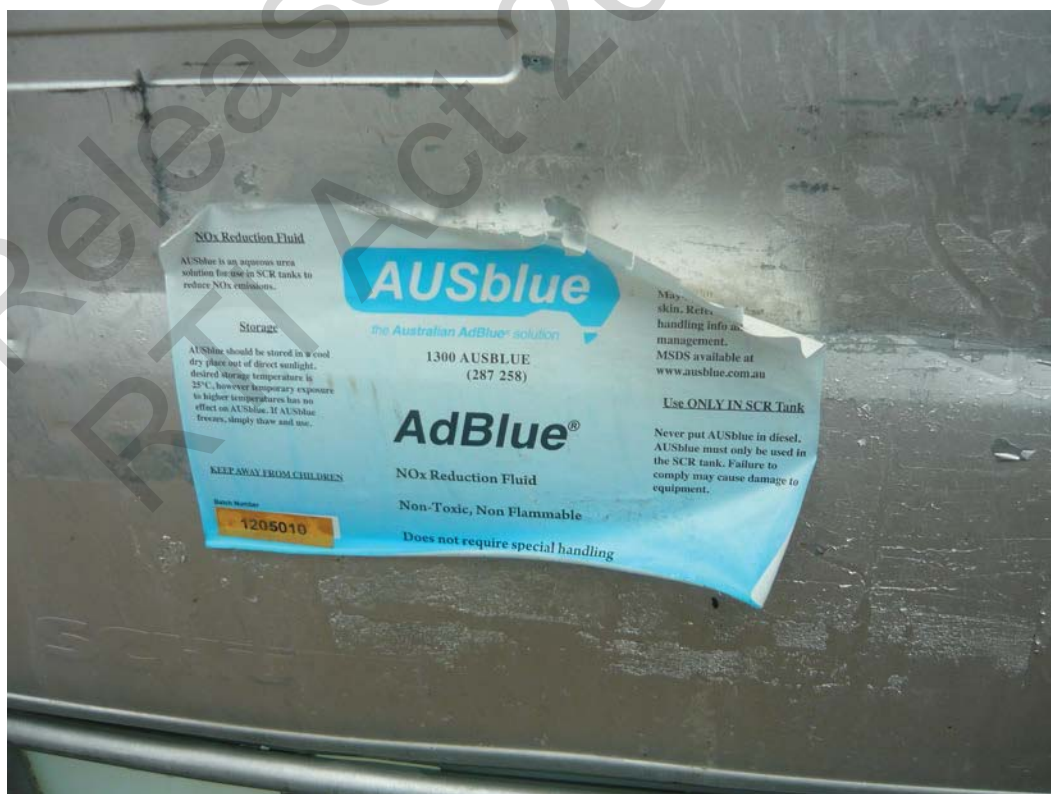
Photo 15 – An IBC of this product was seen at the northern end of the eastern side of the building. JP has not noticed this product on the site before and noted that it looked new and as if it had been recently used. AH could not determine what the product is use for once back in the office.
