**Re. Fire Incident – 11 December 202 – 6 Potassium Street, Narangba.**

## Subject: Photos from Site Visit 16 January 2013

## Subject: Photos from Site Visit 25 January 2013

## Subject: Photos from Site Visit 18 December 2012

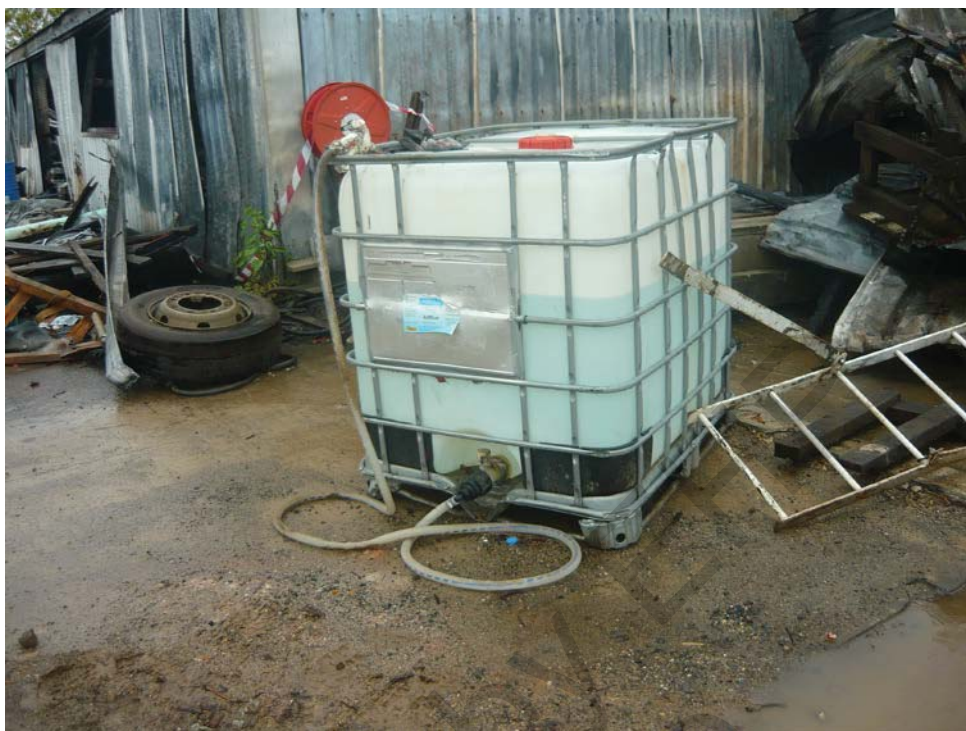
Photo 16 – An overview of the IBC in photo 15.

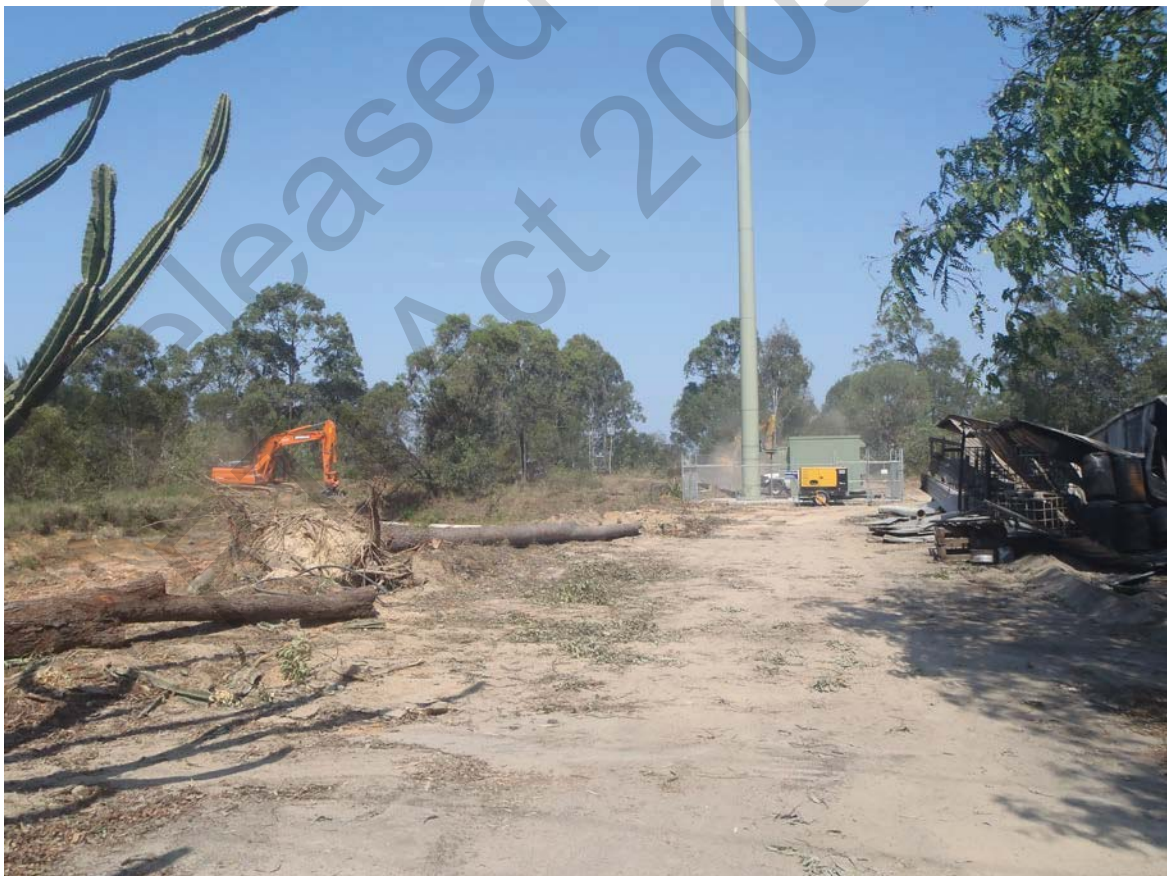
Photo 1 – Photo taken from the main driveway on Potassium Street facing east. Please note that the fence around the former tannery pond on the left has been removed and the vegetation along the fence boundary has also been removed. The former tannery ponds have also been drained.

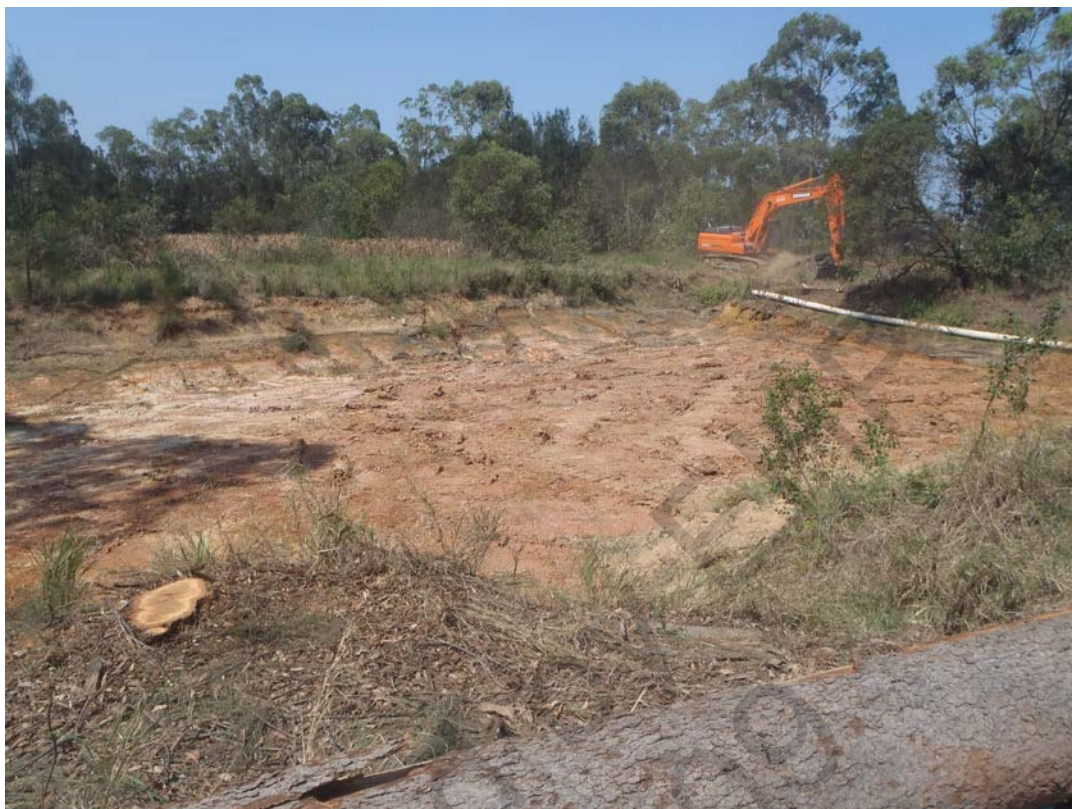
Photo 2 – This photo is taken from the same position as photo 1 but facing north. The middle of the photo shows the former tannery ponds which have now been drained.

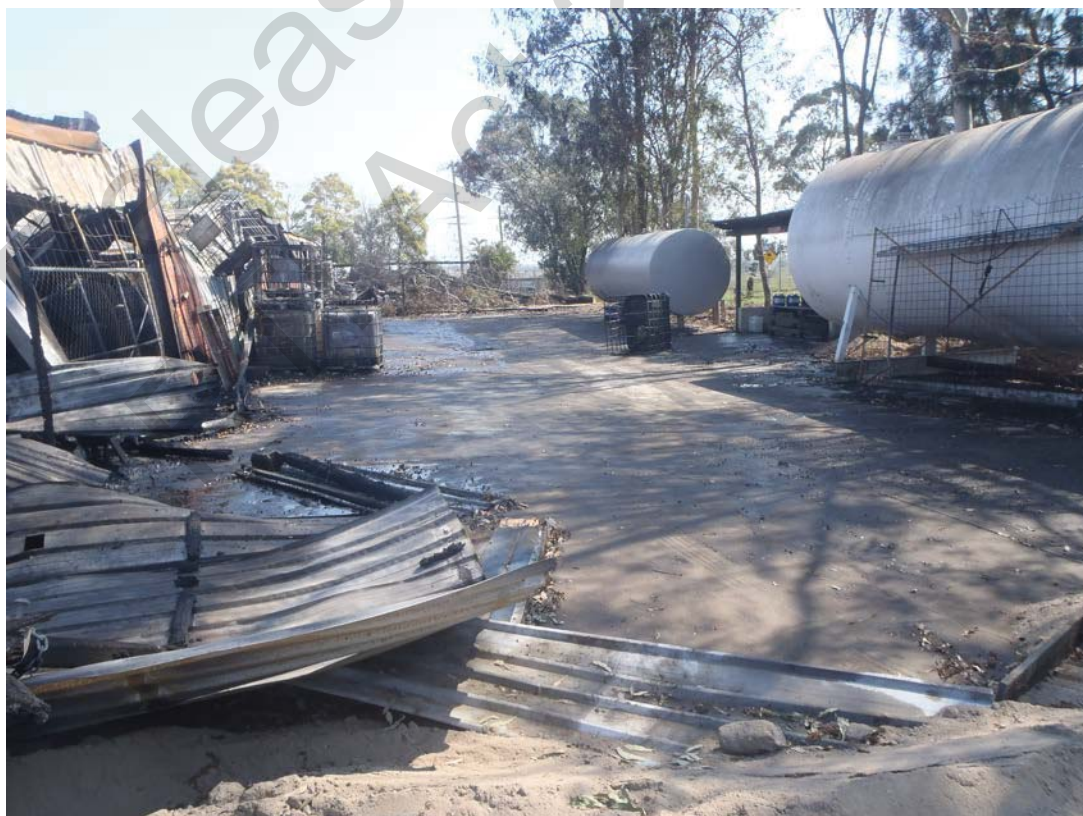
Photo 3 – This photo has been taken from the same location as photo 1 and 2 but facing south. Significant clean-up has occurred. Please note there is no contamination on the concrete.

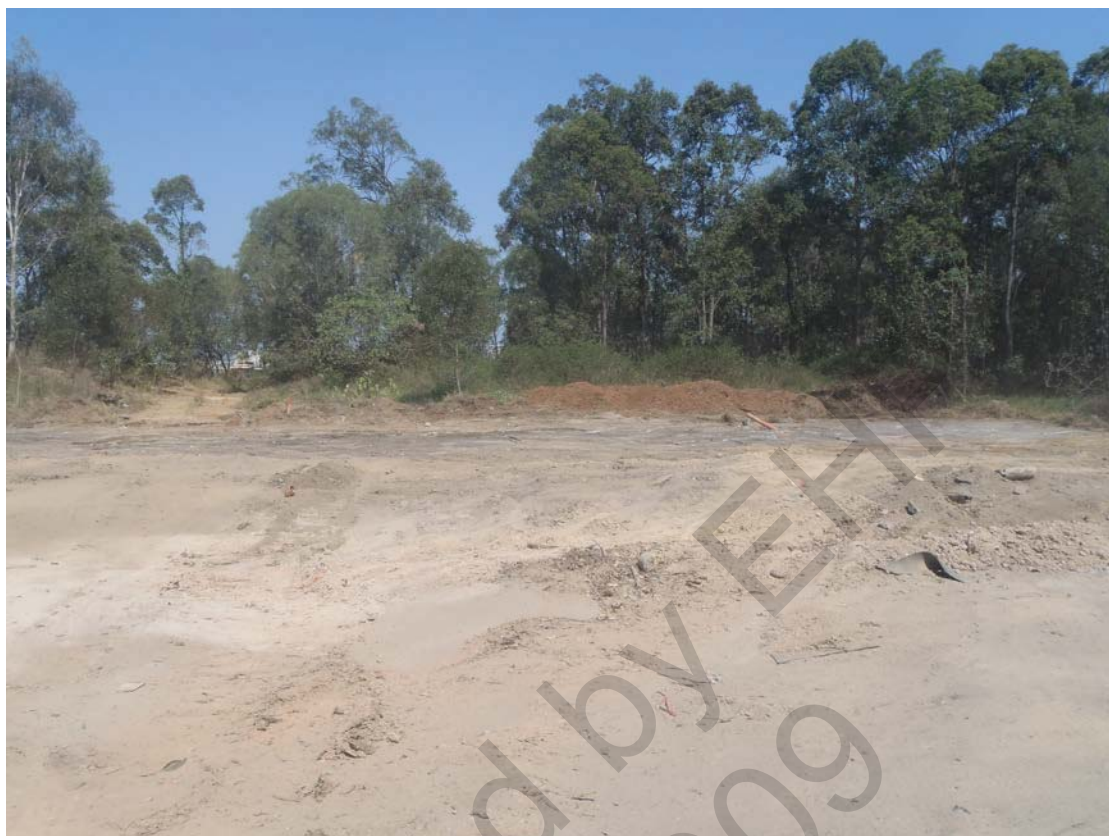
Photo 4 – The photo is taken at the rear of the main building on the site facing east. Please note the hardstand areas at the back of the site used for tank storage for the former tannery have been removed.

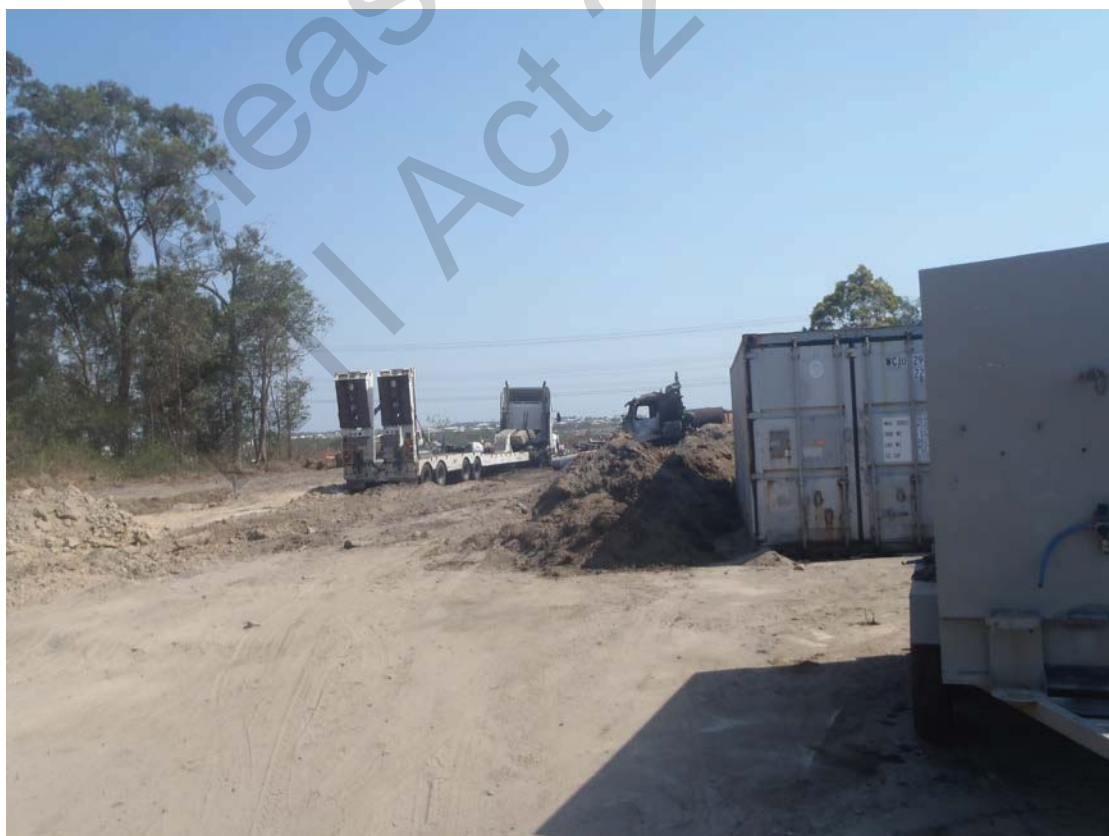
Photo 5 – The photo is taken from the same position as photo 4 but facing south. Significant actions have taken place including the removal of vegetation and the fence line to the left and the placement of a large bund in the middle of the photo.

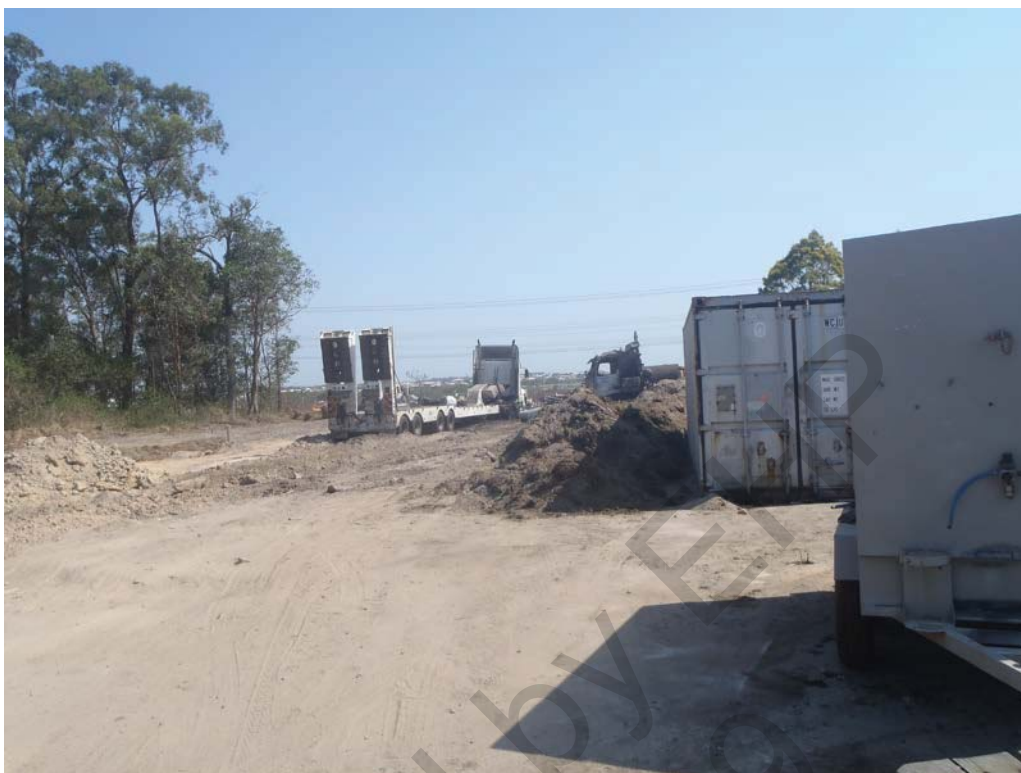
Photo 6 – The photo is taken from the same position as photo 4 but facing south. Significant actions have taken place including the removal of vegetation and the fence line to the left and the placement of a large bund in the middle of the photo.

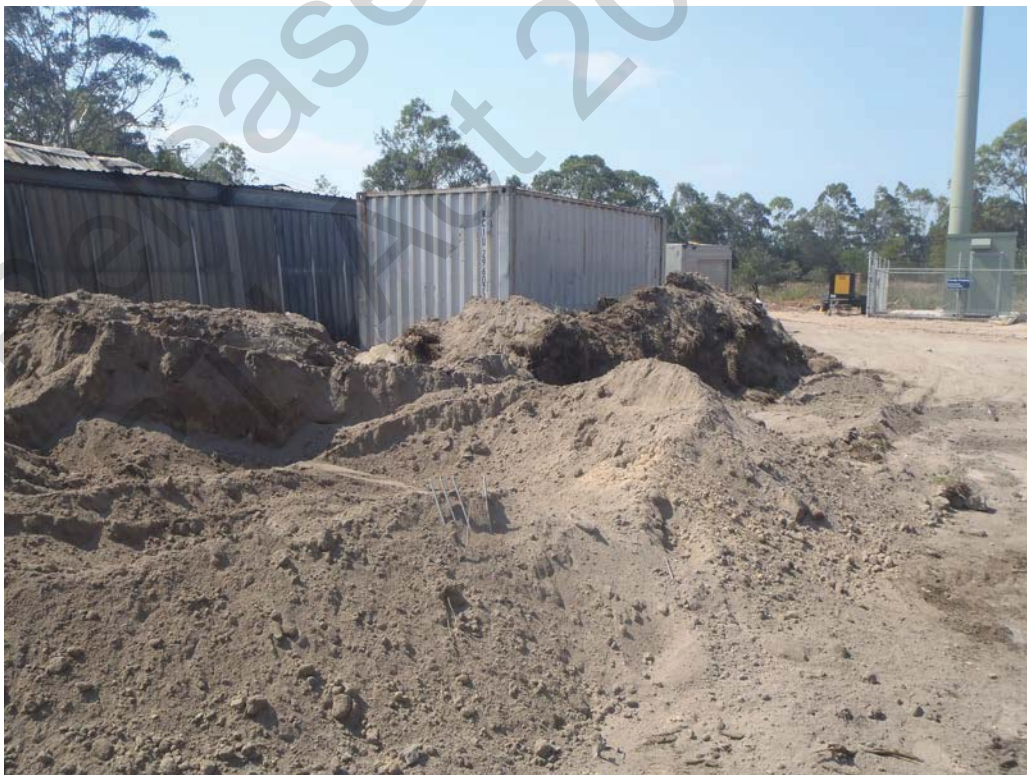
Photo 7 – The photo is taken from the rear of the site (behind the main building) towards the Boundary Road facing north west. Please note the large bund that has been placed around the building in the middle of the photo. This bund has been placed by SDIDP contractors to protect the adjacent state land from further contamination.

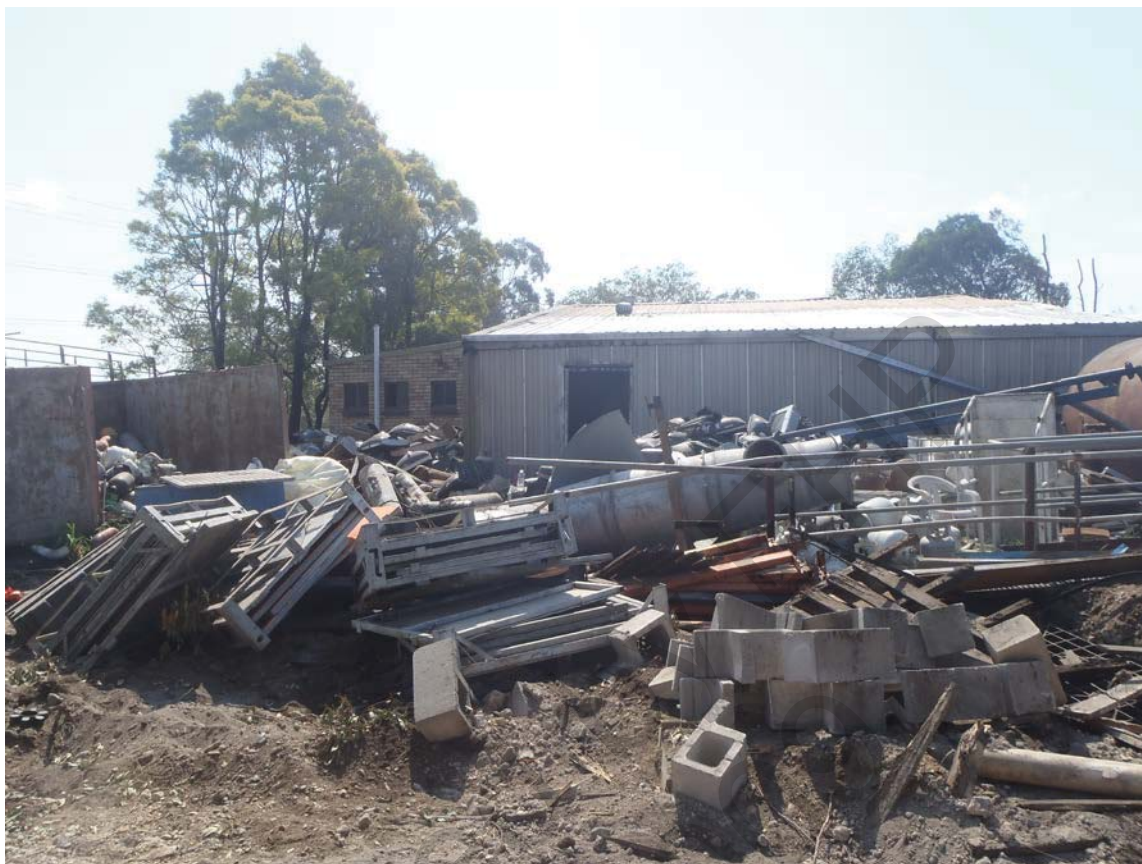
Photo 8 – This photo is taken from the same position as photo 7 but facing west. Please note the large amount of waste. Contaminants have made its way into these waste piles.

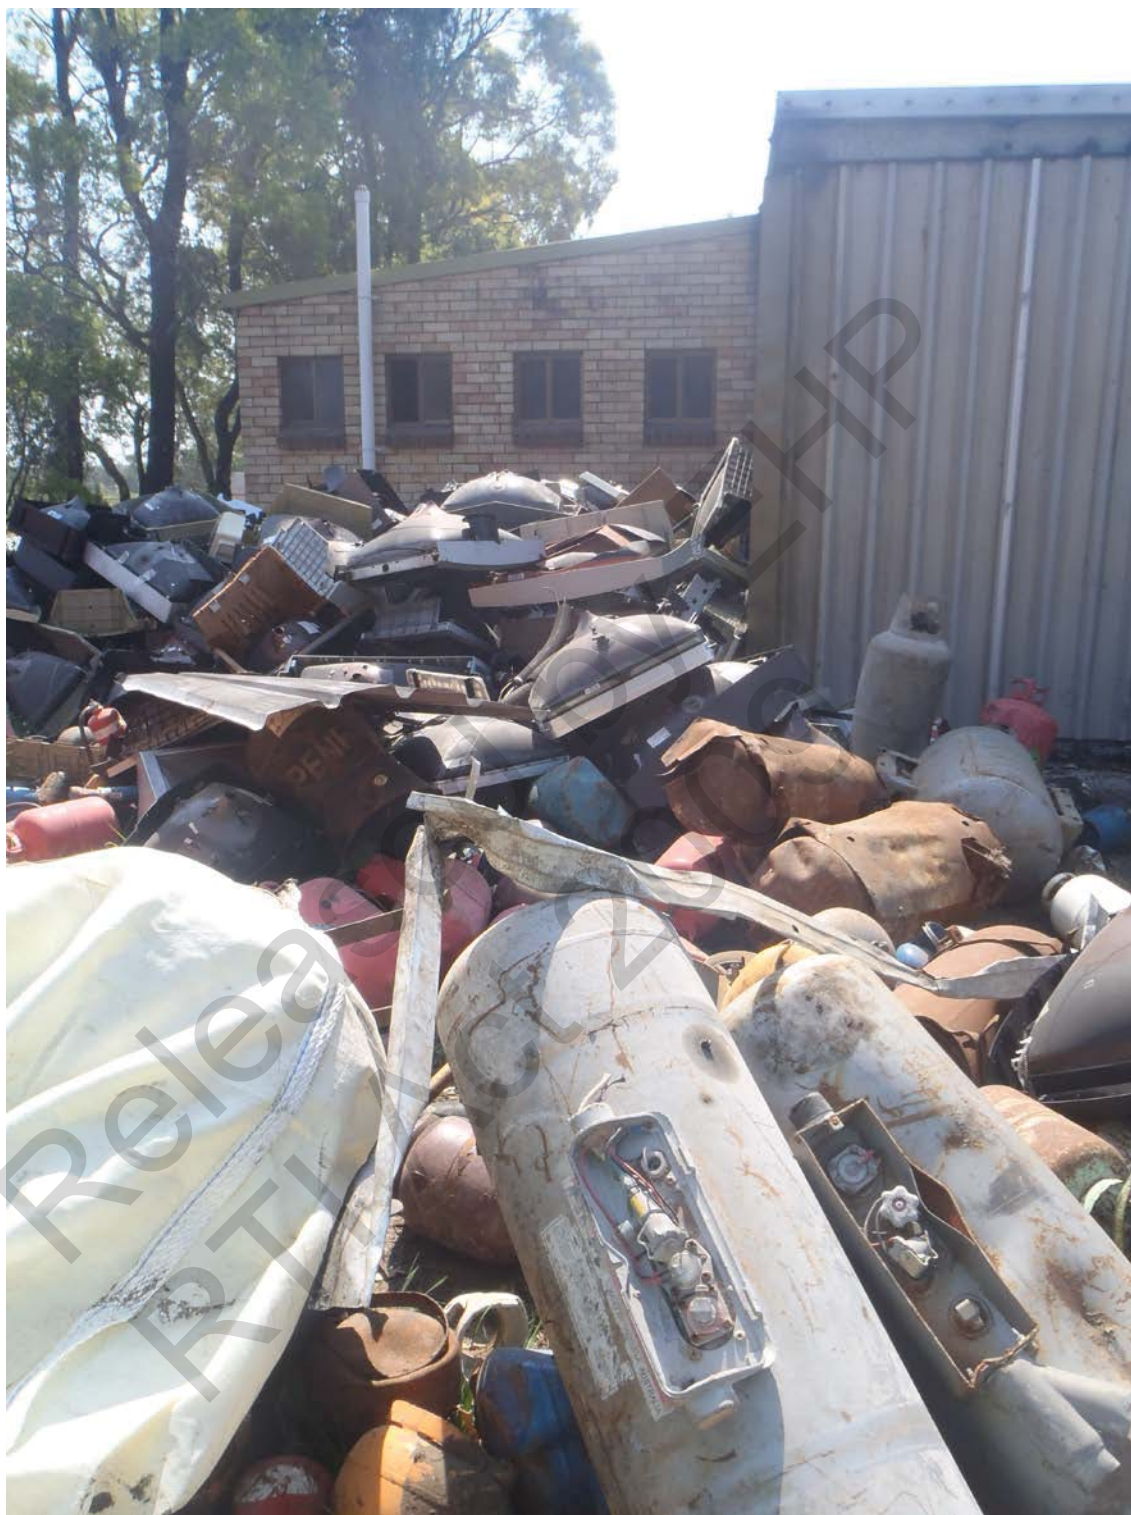
Photo 9 – This photo is a close up of the image taken from the same location photo 8. It shows the large pile of picture tubes at the back of the main building which has contaminants throughout the pile.

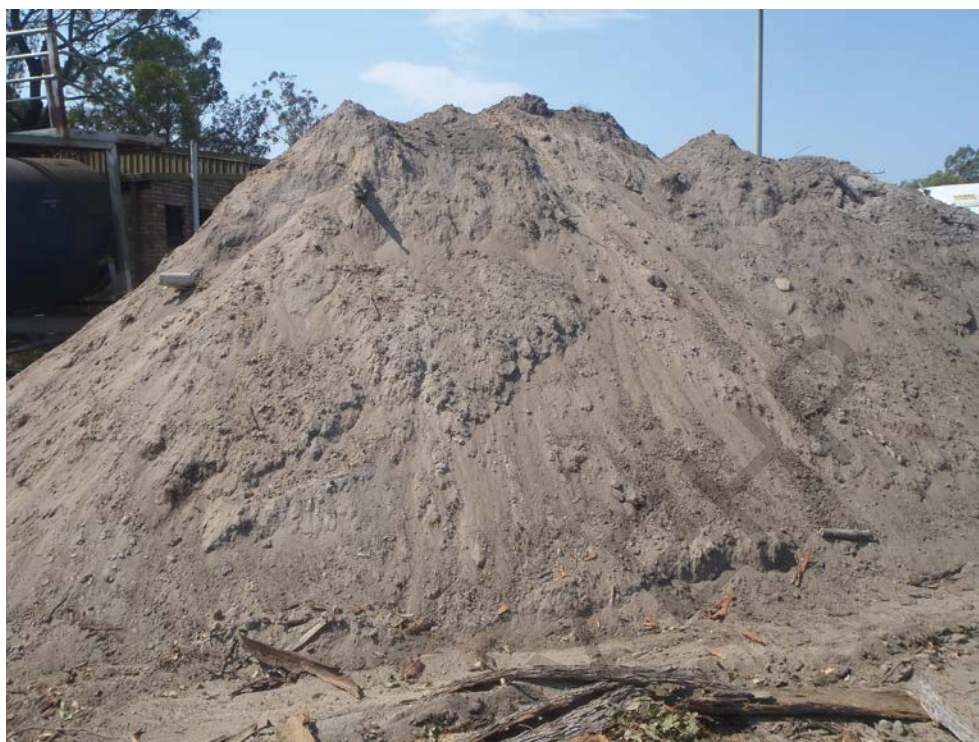
Photo 10 – The photo is taken from the rear of the site (behind the main building) towards the Boundary Road facing north west. Please note the large bund that has been placed around the building in the middle of the photo. This bund has been placed by SDIDP contractors to protect the adjacent state land from further contamination.

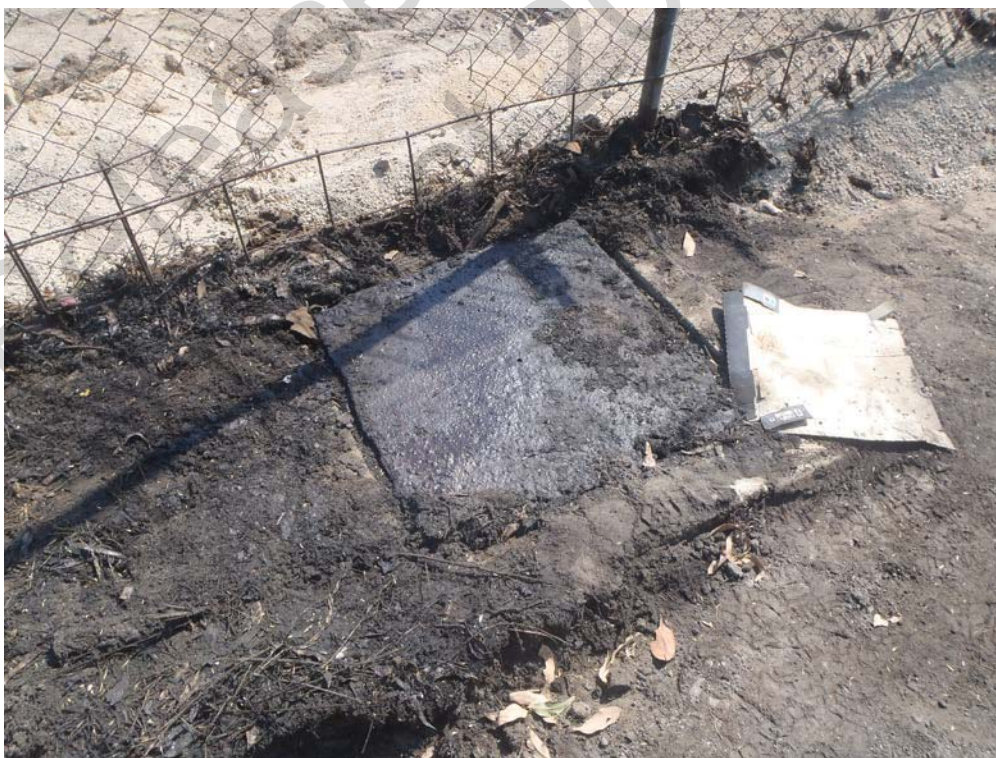
Photo 11 – This photo is taken from the boundary of the site along Boundary Road. This is a sump that catches contaminants before stormwater flows into a drain on the other side of Boundary Road (Stockland land). This sump is currently contaminated and must be remediated as part of the site clean-up.

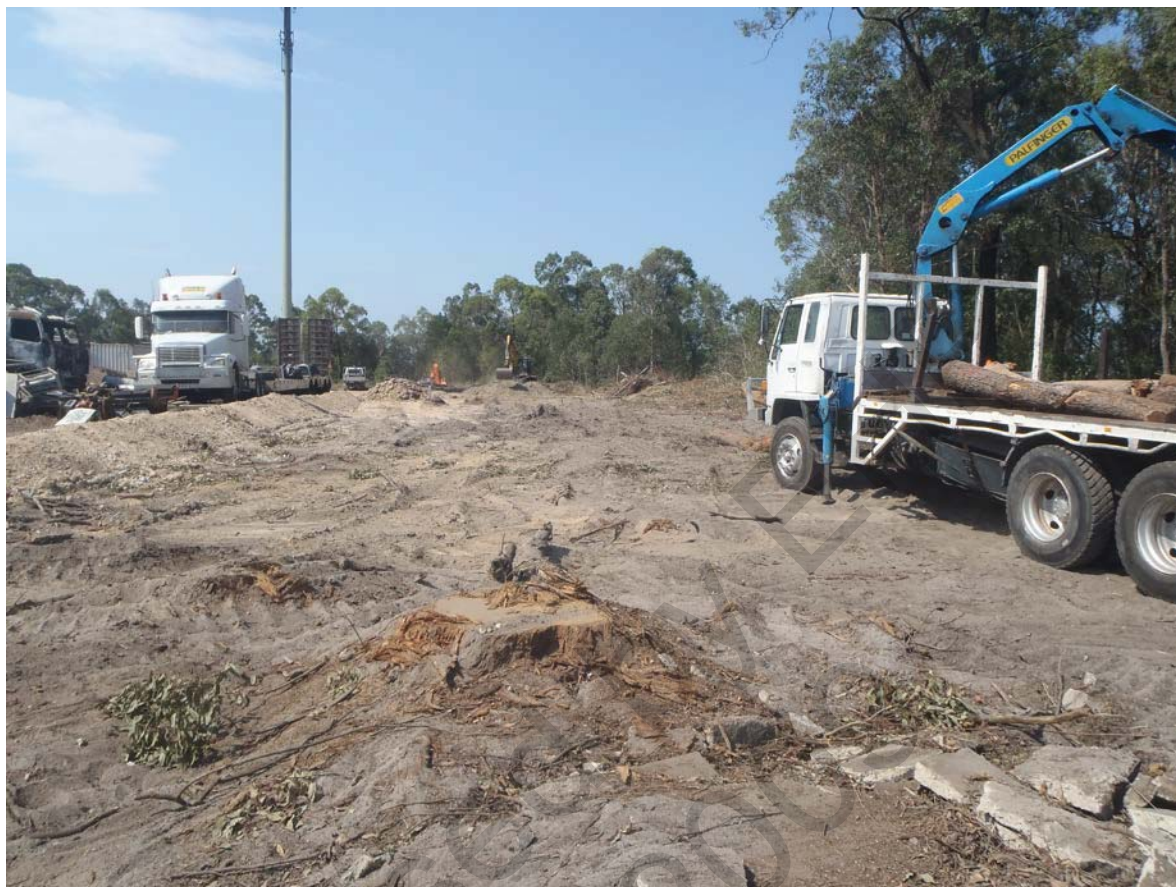
Photo 12 – This photo is taken from the site boundary along Boundary Road facing north. It shows the bund in place around the main building to the left and the remediation works by SDIDP on the right.

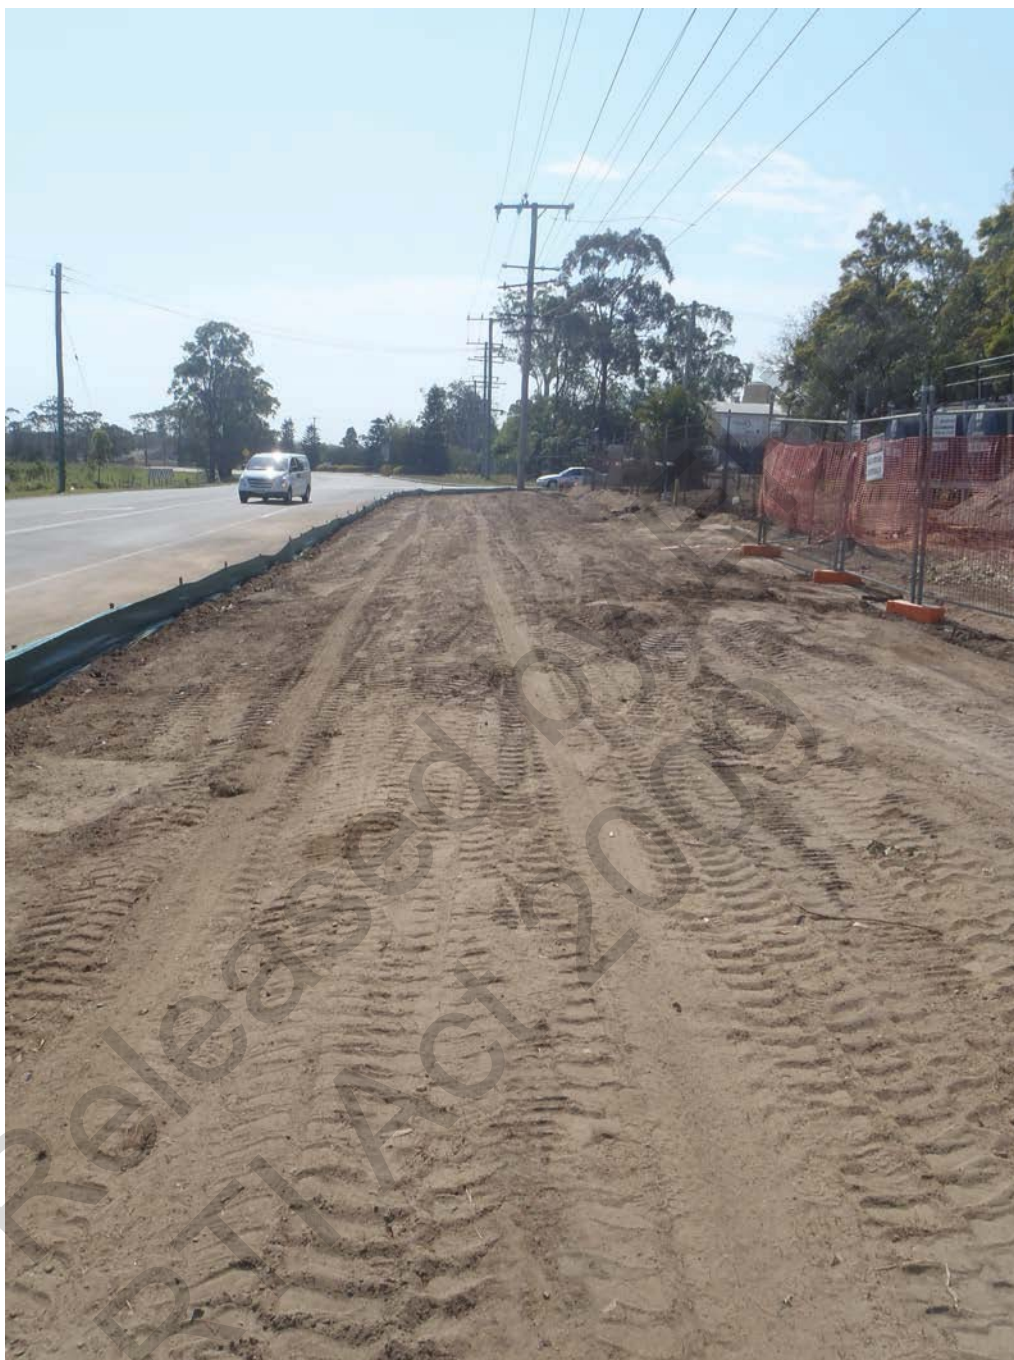
Photo 13 – This photo is taken from the same location as photo 12 but facing west. It shows the work Moreton Bay Regional Council has done along the footpath of the site to remediate the contaminated land. Please note the sediment fence that has been placed on the site boundary.

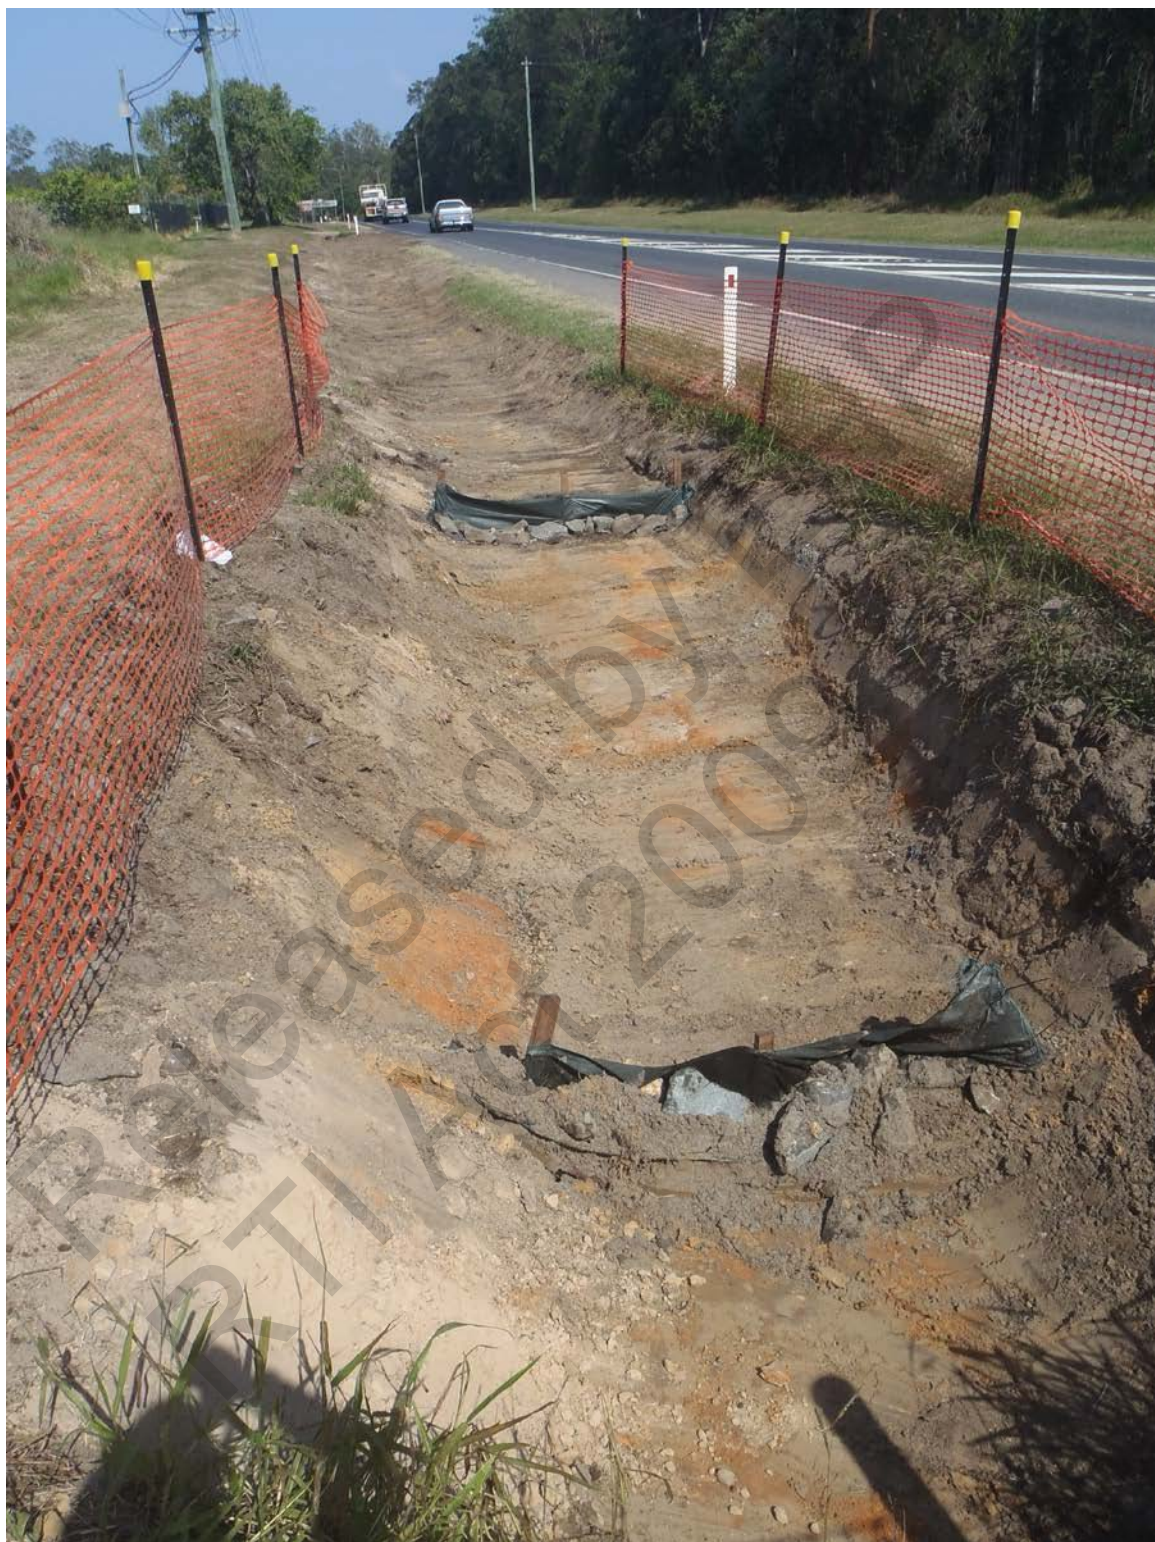
Photo 14 – This photo is taken where the concrete stormwater drain enters into a grass spoon drain approximately 200m done Boundary Road. Please note the remediation works completed by MBRC. This includes digging out the contaminated parts of the drain and installing sediment fences in the drain.

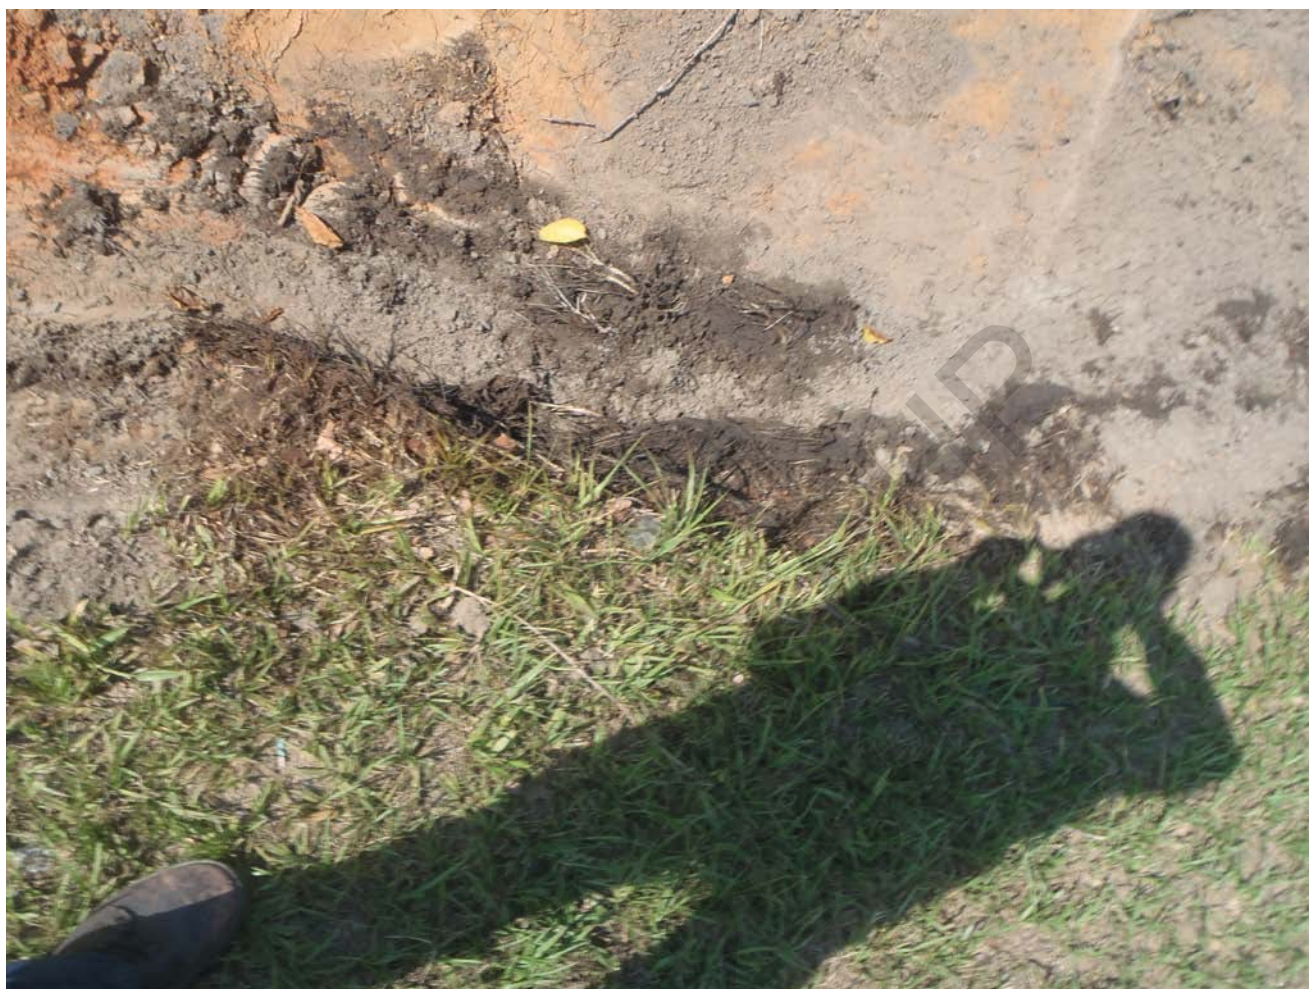
Photo 15 - This photo is taken approximately 30m from the location in photo 14. It shows some contaminated land that remains in the grass spoon drain after the MBRC remediation works.

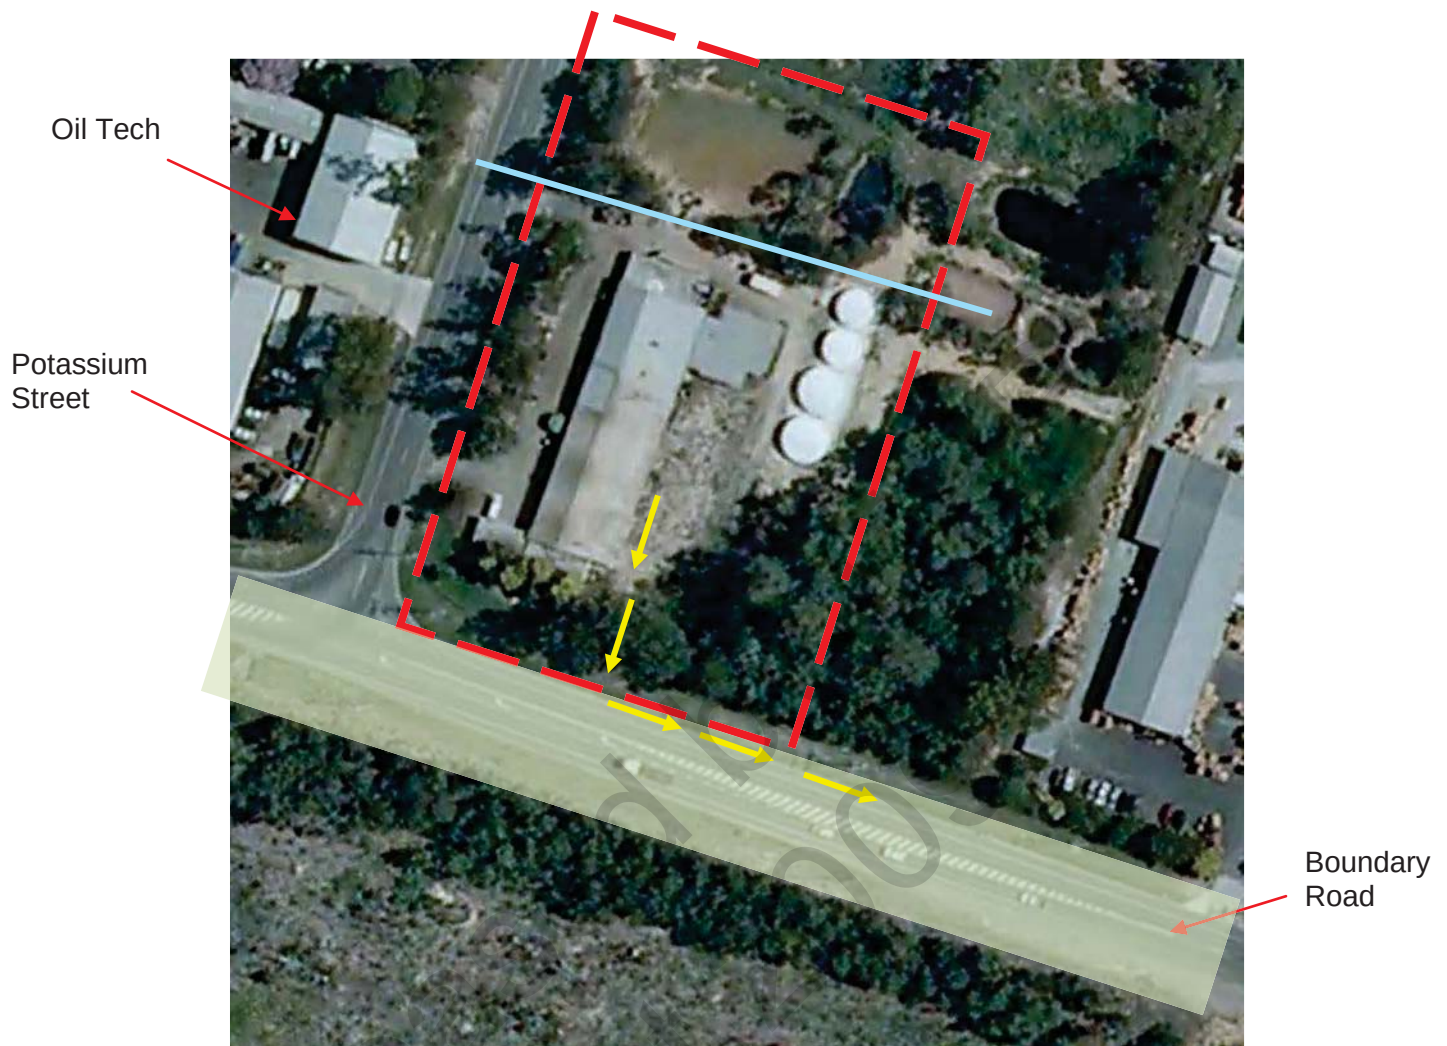
# MAP OR PLAN OF SITE:

- Flow of contaminants (please note that the contaminants were contained further east along Boundary Road by Moreton Bay Regional Council)
- Incident Site      --- No Contaminants were found (by visual inspection) north of this line
- Contaminants found offsite and clean-up facilitated by Moreton Bay Regional Council
