## Document Transmittal

| Quantity | Title | Comments |
|---|---|---|
| 1 Copy | Response to EPA Request<br>for Additional Information<br>ACU Site<br>53 Prospect Road, Mitchelton | |

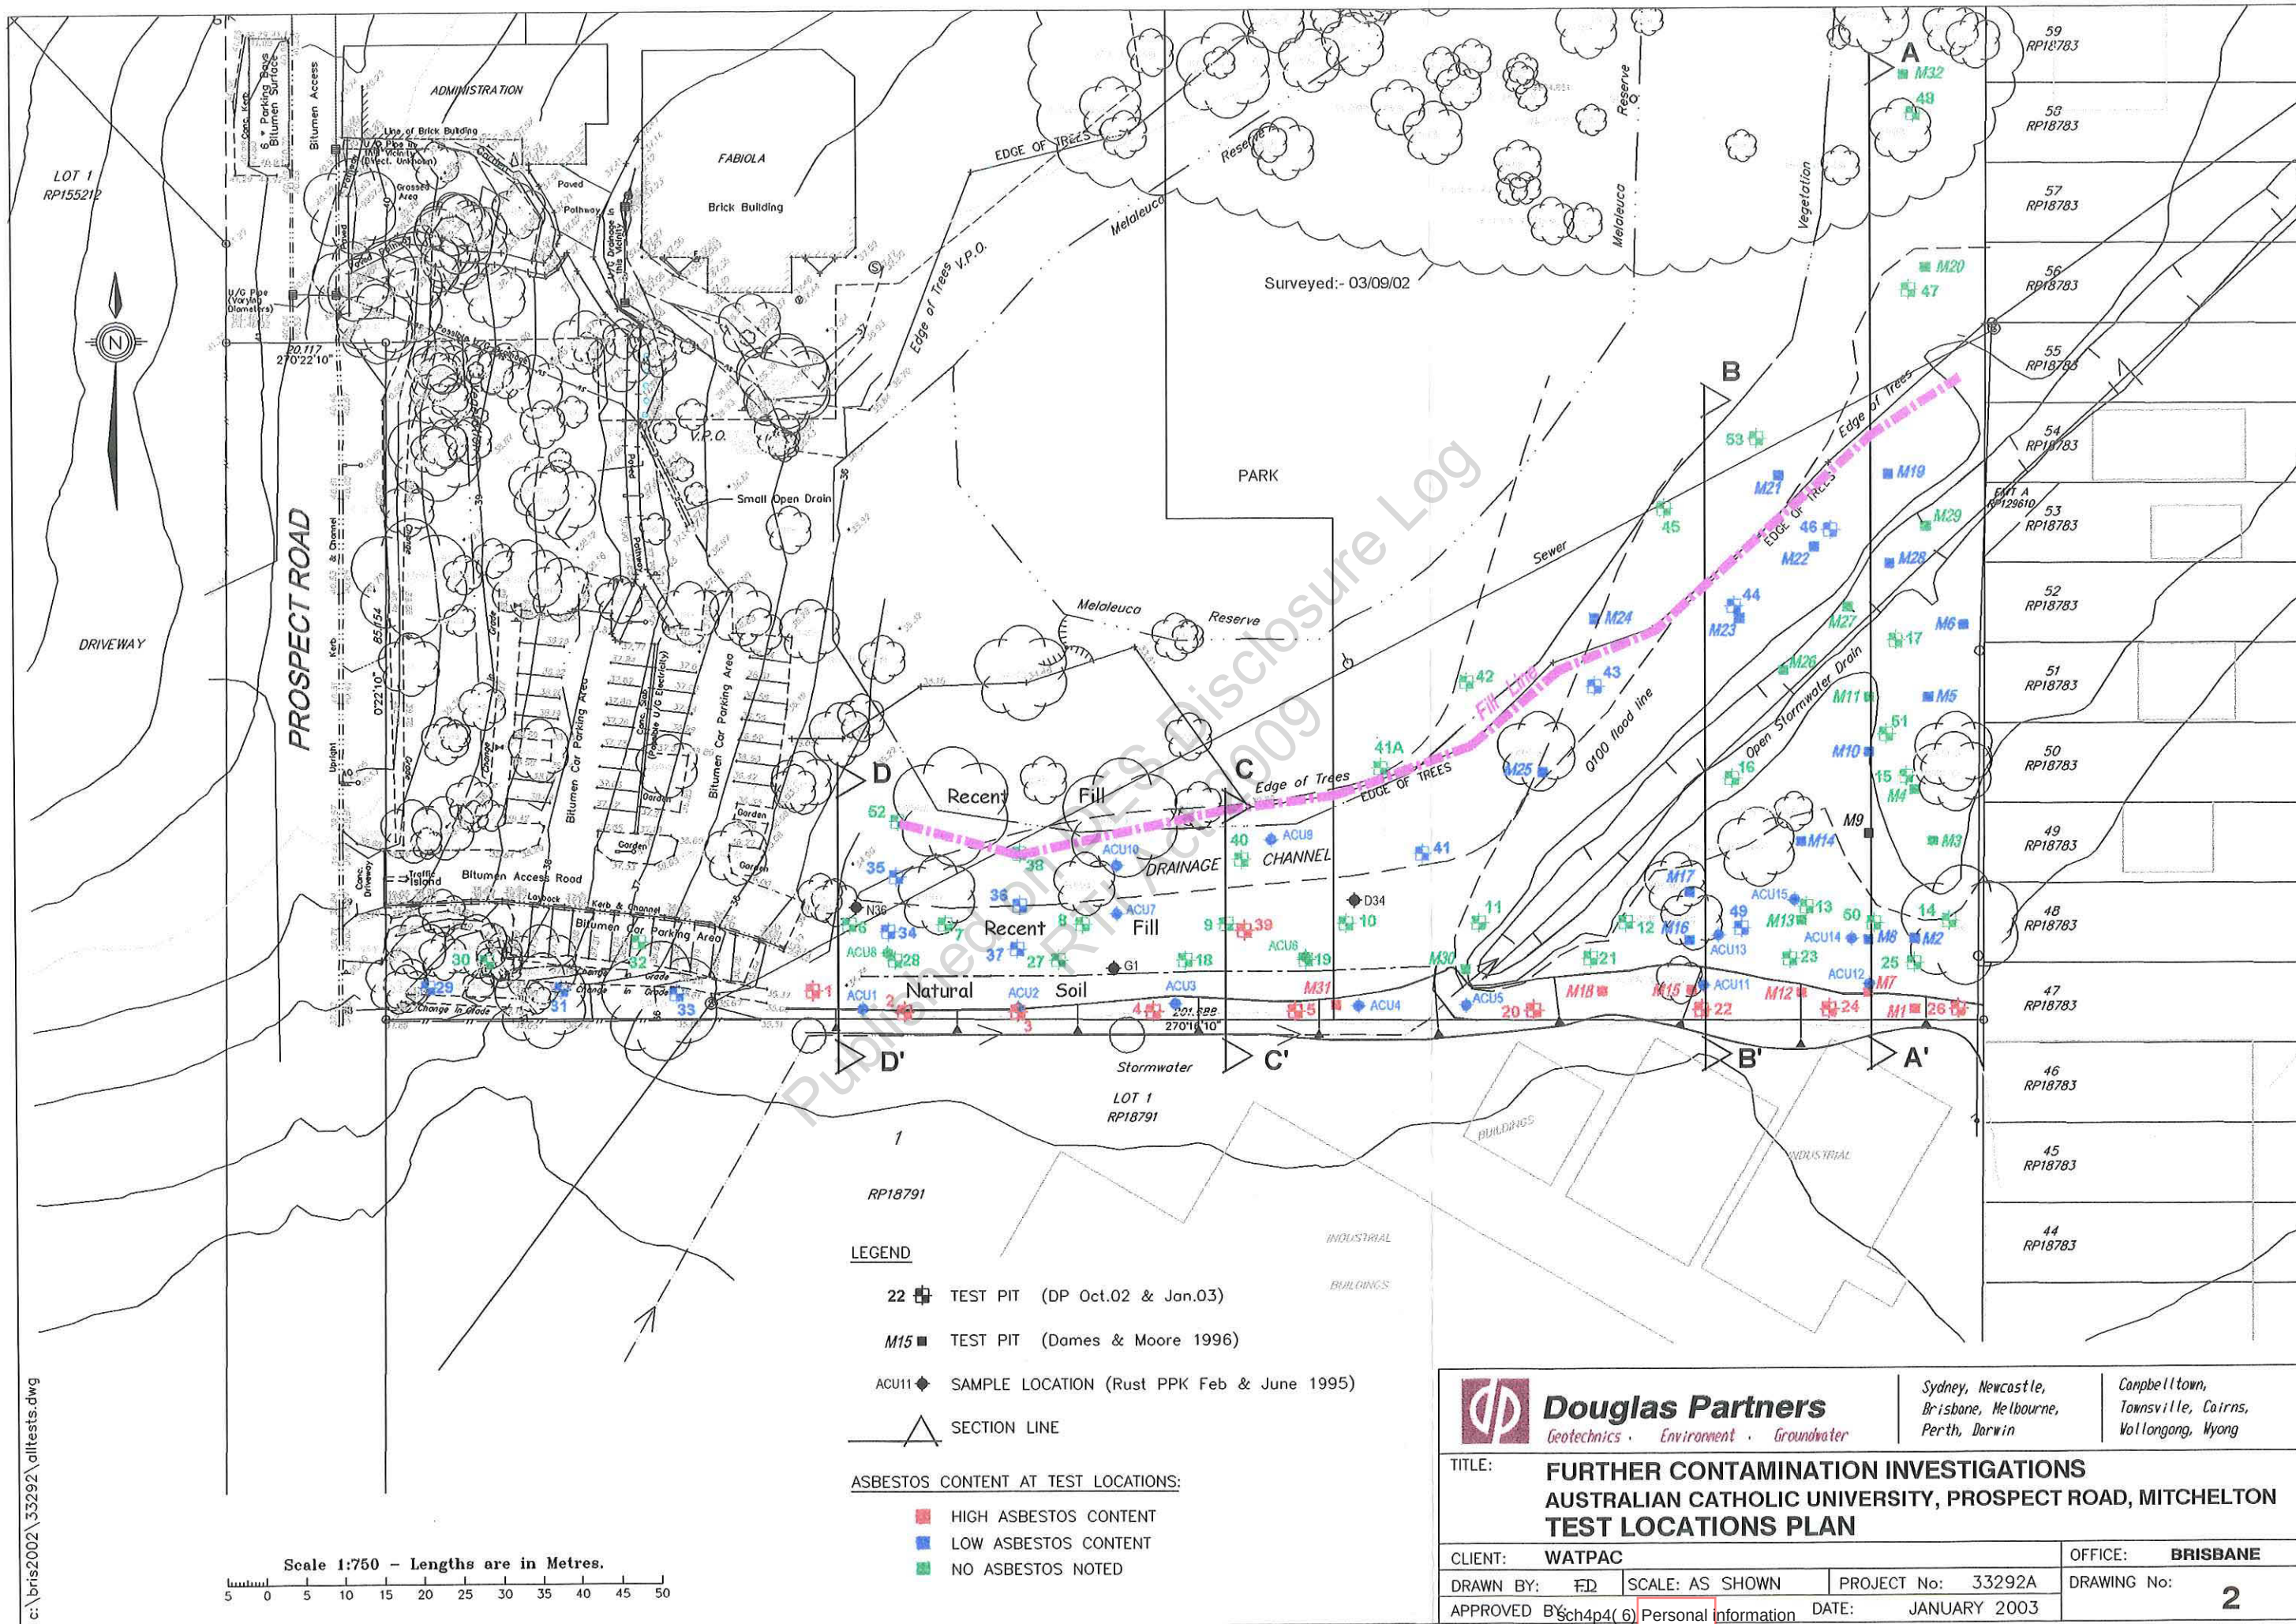
Test locations for the current and all previous investigations are shown on the attached Drawing No 2. Each test location has been highlighted in various colours to indicate whether asbestos was found.

Test locations have been coloured on Drawing No 2 according to whether asbestos was found at that location or not.

Test pits were located to assess contamination in the soil profile. Sampling locations are shown on Drawing No. 2 in Appendix C along with test locations of previous investigations. Each test pit was lithologically logged, and the subsurface conditions encountered and samples taken are described on the Test Bore Reports in Appendix C.

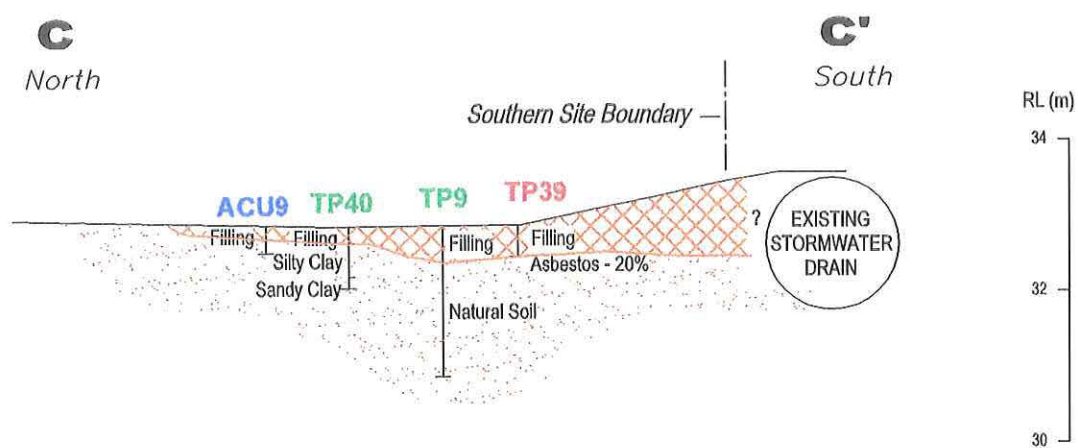
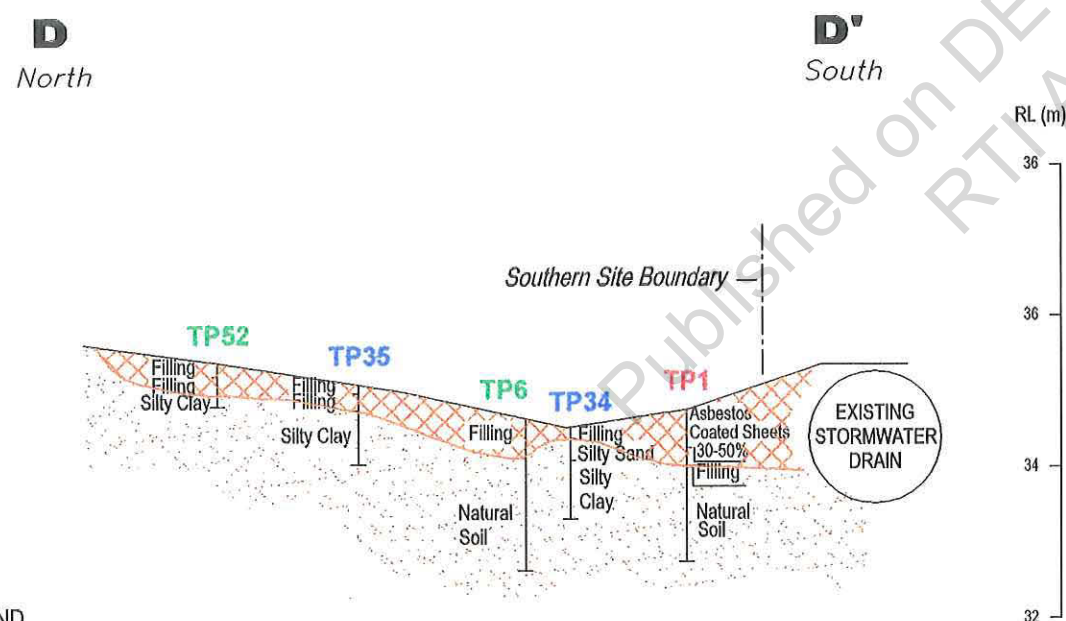
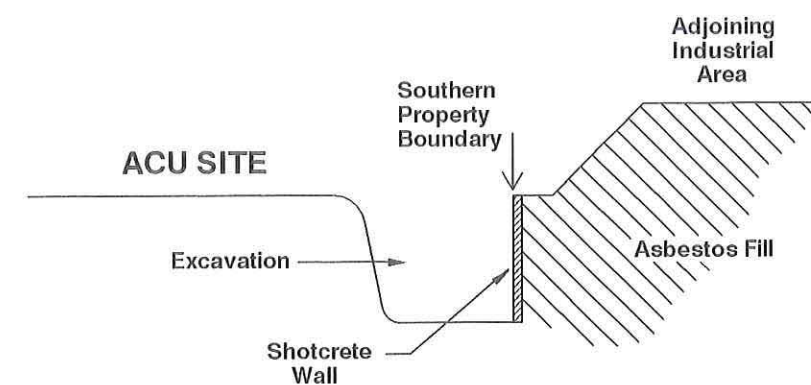
#### CROSS SECTION ALONG ACU SOUTHERN BOUNDARY DIAGRAMMATIC - NOT TO SCALE

1. High concentrations of asbestos in the soil (20-80 percent) exist along the southern boundary. This area is a strip 3-10 metres wide for the full length of the boundary (200 metres), and is shown as Area F in Drawing No 3 in Appendix C. The source of this material appears to be over-spill from the adjoining industrial property;
2. Low concentrations of asbestos in the soil (<1 to 20 percent) have been found in fill material adjoining Area F as shown in Drawing No 3. This area is 10-20 metres wide out from the high concentration area. The source of this material appears to be from surface activities such as filling, mowing *etc*, which have spread the more highly concentrated contamination around the adjoining area.

Shotcrete along a below-ground retaining wall to hold back asbestos fill under the adjacent industrial property
