**Water course crossing – Columboola Creek - PEN100953310 - PPL153**

The purpose of this document is to address Conditions 35, 36, 37 and 38 of **EPBC Approval 2008/4399** requiring the development of an Aquatic Values Management Plan for the QCLNG Pipeline, to be approved by the Commonwealth Department of Sustainability, Environment, Water, Population and Communities (SEWPaC).

# Gas Collection Header Watercourse Crossing Assessment

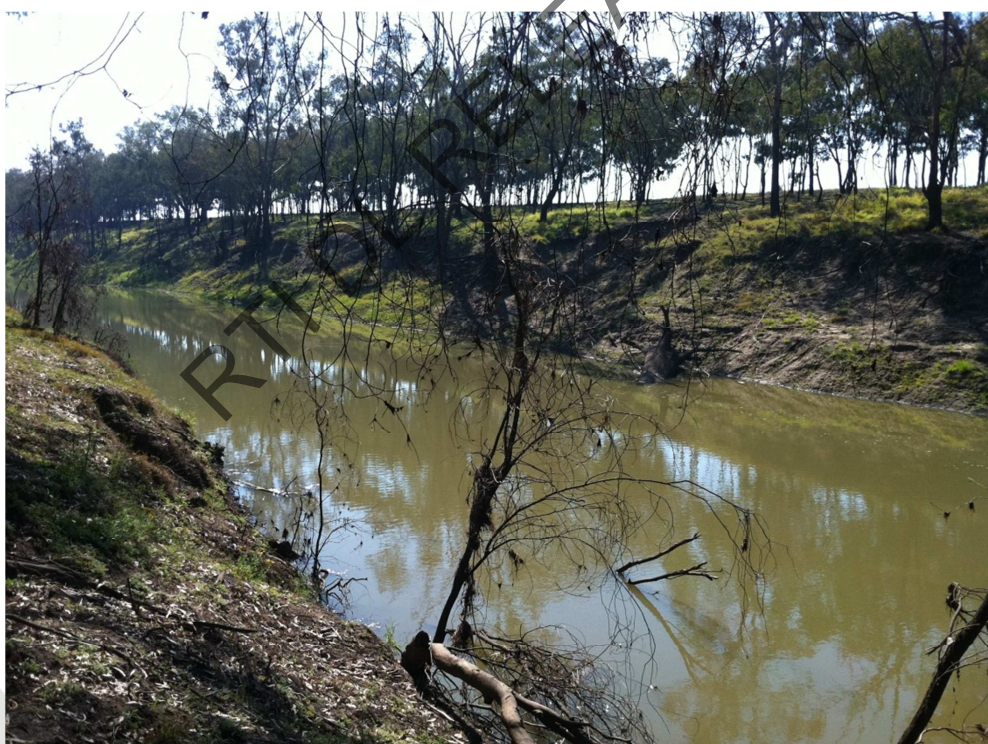
Figure 2. Condamine River crossing at KP 68.6. Presence of snags

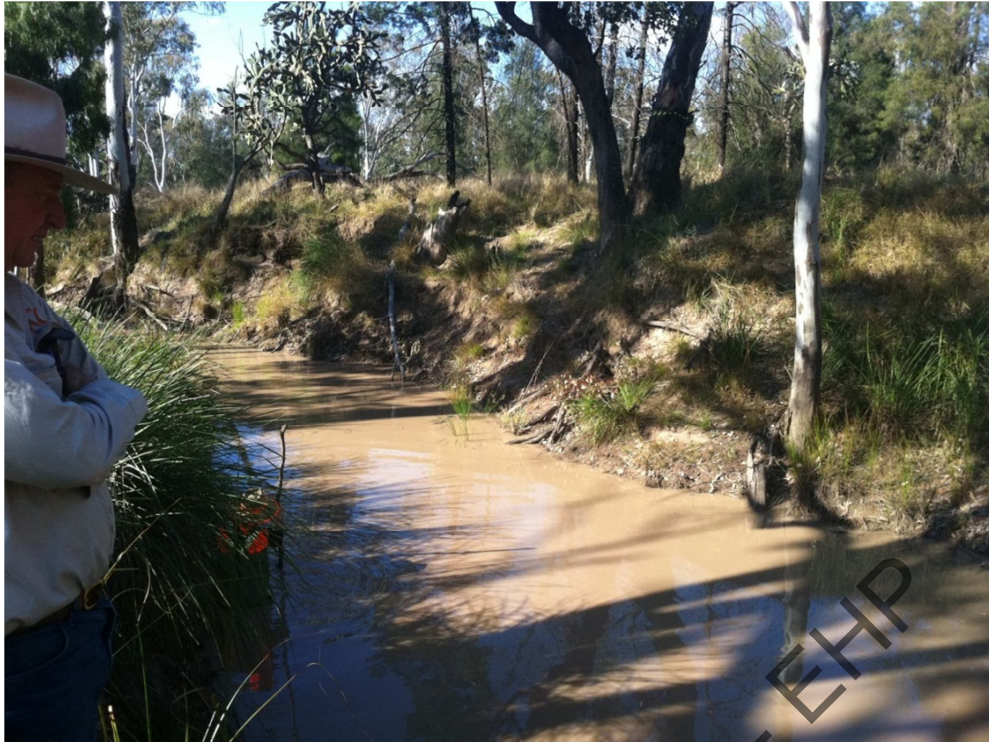
Figure 5: Columboola Creek Crossing at KP 90.1, wading survey.
