# Compliance inspections toolkit

## Checklist, on-site record & inspection report

| Description of business activity/ERAs:<br><b>ERA50 (1B) Bulk Mineral Handling, 100t ~ 50,000t per day</b> | File number:<br><b>ISA2944; NOR/086766</b> | |
| Street address:<br><b>Sir Hudson Fysh Drive, Cloncurry</b> | Real property description (lot on plan):<br><b>Lot 138 on Plan RP905659</b> | |

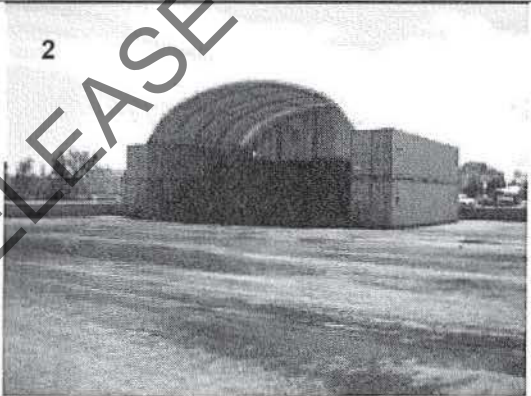
| <p><b>14 Dec 2011:</b> During site inspection, the remaining concentrate stockpiles onsite include the one located beside existing Storage Shed A, which was covered by tarpaulin as shown in Figure 1 and another stockpile within the hardstand area, which was provided with an "igloo shelter" as shown in Figure 2. David Peet said that magnetite concentrate will remain at Ernest Henry Mine until such time that a covered storage area is made available at Ostoic Handling Facility.</p> | | Y |
| <div style="display: flex; justify-content: space-around;"> </div> <p>Mineral stockpiles remaining onsite during the 14 December 2011 site inspection include (1) stockpile beside the storage shed covered with tarpaulin, and (2) stockpile within the hardstand area under an igloo shelter.</p> | | |

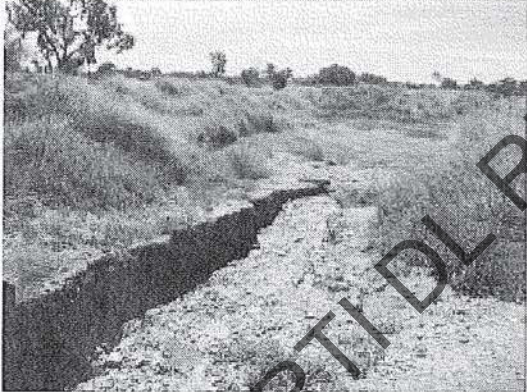
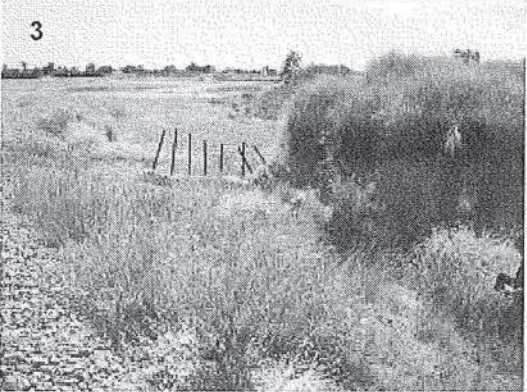
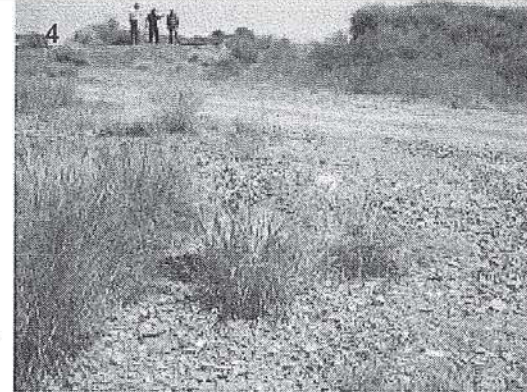
| <p><b>14 December 2011:</b> The Ostojic storage facility has been provided with earth bund on the east and northern part of the property to direct the stormwater runoff. A detention basin is situated north of the property while a large grassed channel is on the eastern part of the property. Inlets to the detention basin and channel are provided with straw bales as temporary erosion control measure. The detention basin is provided with spillway where the stormwater overflows. Overflows, both from the detention basin and large grassed channel, finally discharged to an unnamed creek situated north of the property.</p> <p>David Peet provided DERM a copy of the Site Based Stormwater Management Plan for the Ostojic storage facility. DERM advised Ostojic that the constructed spillways should be included in the new Ostojic Development Approval (DA) as a licensed discharge points.</p> | | Y |
| <p>(1) Existing detention basin situated north of the Ostojic storage site; (2) inlet to the detention basin provided with straw bale as erosion control measure; (3) outlet or spillway of the detention basin; (4) Discharge through the spillway will flow through a pipe culvert underneath the gravel-filled road.</p> | | |

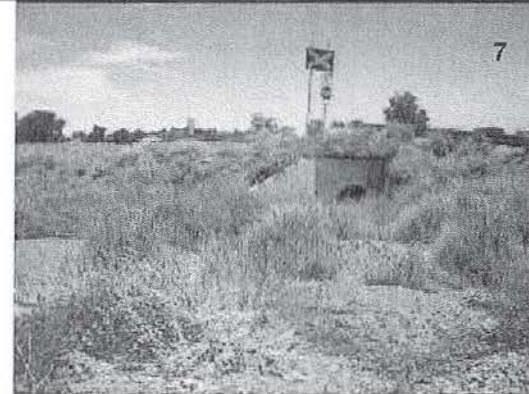
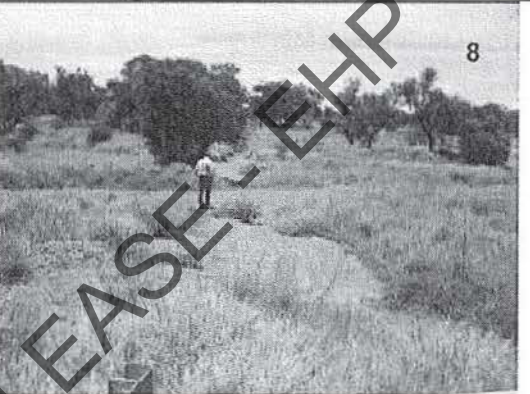
| <p>(5) The large grassed channel situated east of the storage facility; (6) inlet to the channel provided with gravel/straw bale as erosion control measures; (7) Flow from the large channel will flow through a concrete culvert; (8) Both discharges from the detention basin and channel will finally discharge to unnamed creek, situated north of the property.</p> | | |

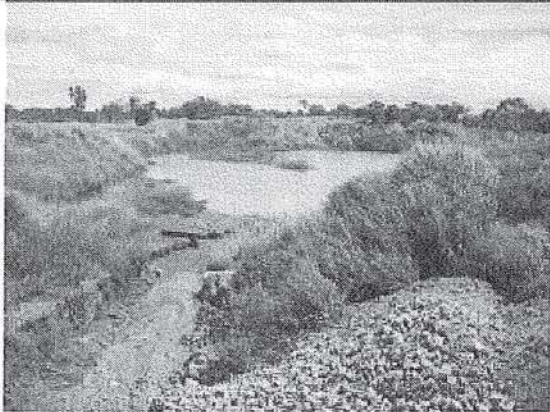
Ostojic Group Pty Ltd is in breach of SPDE01054010 Condition WA1 for not taking water sample from the stormwater pond within 2 hours of commencement of release as required by the condition. Having no sampling bottles during the time of release is not an acceptable justification for not taking samples. It is Ostojic responsibility to ensure that all necessary supplies, materials, equipment and manpower must be available to comply with all condition of the DA.

Figure 1: Stormwater settling pond.

It is recommended that a Penalty Infringement Notice (PIN) be issued to Ostoic Group Pty Ltd for breaching DA SPDE01054010 Conditions WA1 and WA3.

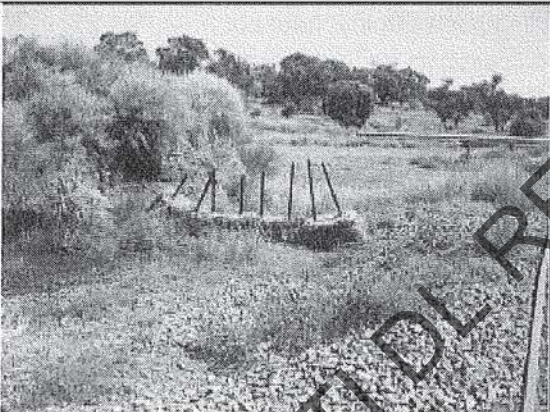
Figure 3: Release point/spillway of stormwater settling pond.

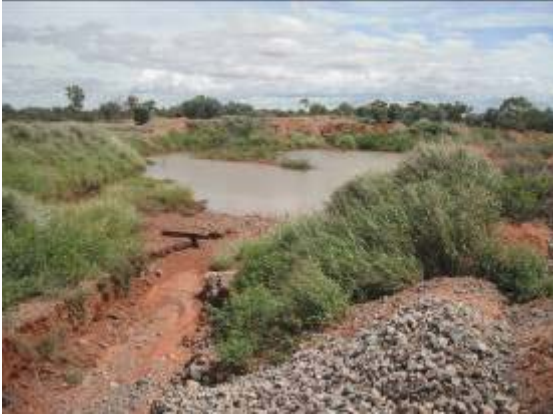
Ostojic Group Pty Ltd is in breach of SPDE01054010 Condition WA1 for not taking water sample from the stormwater pond within 2 hours of commencement of release as required by the condition. Having no sampling bottles during the time of release is not an acceptable justification for not taking samples. It is Ostojic responsibility to ensure that all necessary supplies, materials, equipment and manpower must be available to comply with all condition of the DA.

Figure 1: Stormwater settling pond.

It is recommended that a Penalty Infringement Notice (PIN) be issued to Ostoic Group Pty Ltd for breaching DA SPDE01054010 Conditions WA1 and WA3.

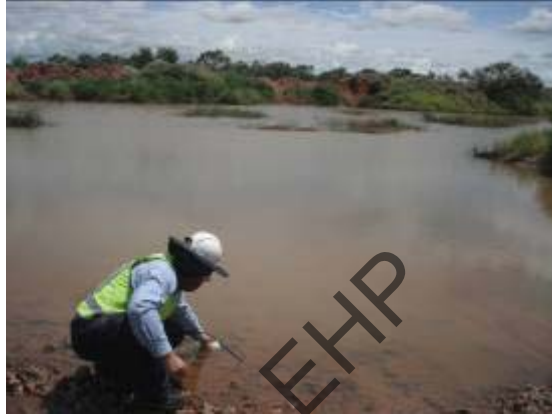
Figure 2: Water sampling at the stormwater settling pond on 31 January 2012

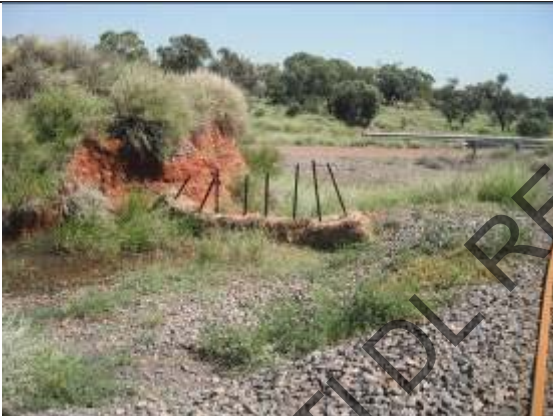
Figure 3: Release point/spillway of stormwater settling pond.

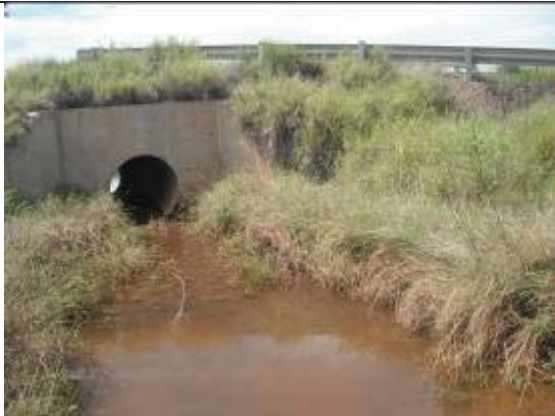
Figure 4: Downstream of the creek, about 30~40m from spillway of stormwater settling pond.

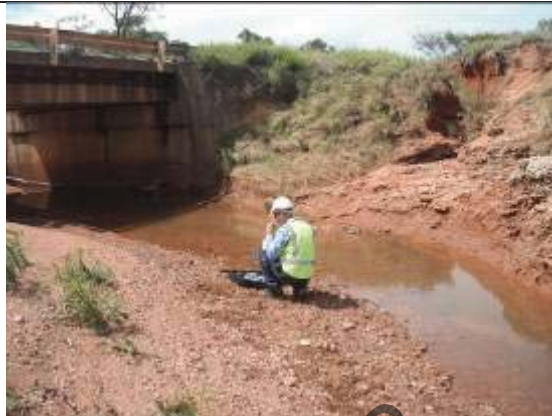
Figure 5: Downstream of the creek, approx. 500m from spillway of stormwater settling pond.

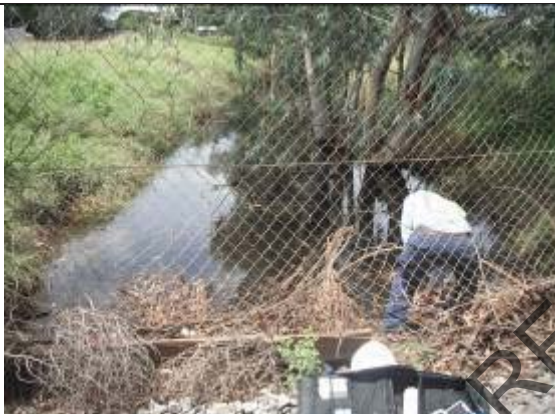
Figure 6: Upstream of the creek, just before the culvert crossing the railway.

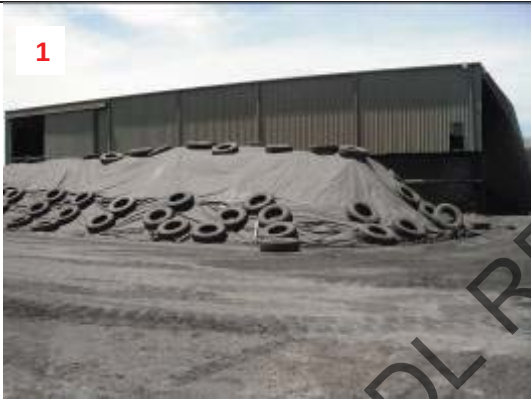
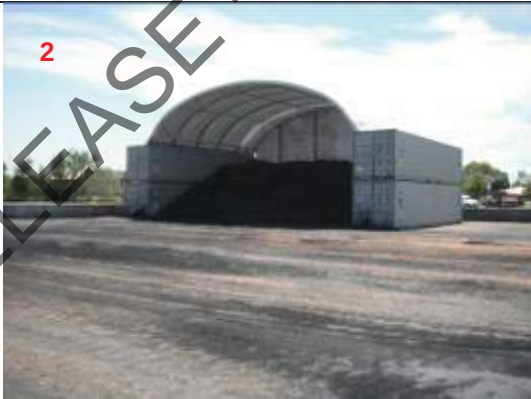
| Condition number: EPO STAT657 Requirement 1 | Compliant: Yes <input checked="" type="checkbox"/> No <input type="checkbox"/> | Photos taken Y/N |
|---|---|---|
| <p><b>14 Dec 2011:</b> During site inspection, the remaining concentrate stockpiles onsite include the one located beside existing Storage Shed A, which was covered by tarpaulin as shown in Figure 1 and another stockpile within the hardstand area, which was provided with an "igloo shelter" as shown in Figure 2. David Peet said that magnetite concentrate will remain at Ernest Henry Mine until such time that a covered storage area is made available at Ostoic Handling Facility.</p> <div style="display: flex; justify-content: space-around;"> </div> <p><i>Mineral stockpiles remaining onsite during the 14 December 2011 site inspection include (1) stockpile beside the storage shed covered with tarpaulin, and (2) stockpile within the hardstand area under an igloo shelter.</i></p> | | Y |

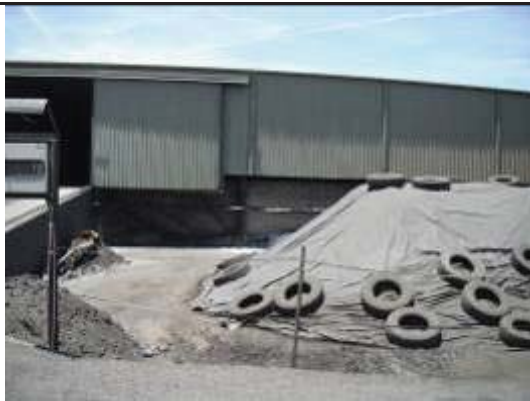
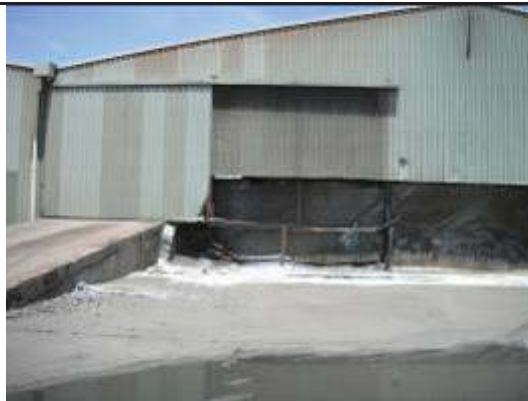
| Condition number: EPO STAT657 Requirement 2 | Compliant: Yes <input checked="" type="checkbox"/> No <input type="checkbox"/> | Photos taken Y/N |
|---|---|---|
| <p><b>14 December 2011:</b> Damaged claddings on the existing storage sheds were partially repaired. David Peet said that Ostoic will not be able to complete the repair/replacement of all damaged claddings by 19 Dec 2011 due to the delayed arrival of materials on Friday, 16 Dec 2011. He said that the cladding repair will be done by 23 Dec 2011. DERM officers advised Ostoic that a follow up inspection will be undertaken on 23 Dec 2011 to ensure compliance with this EPO Requirement.</p> | | Y |

14 December 2011 site inspection showed claddings on the walls of the concentrate storage sheds.

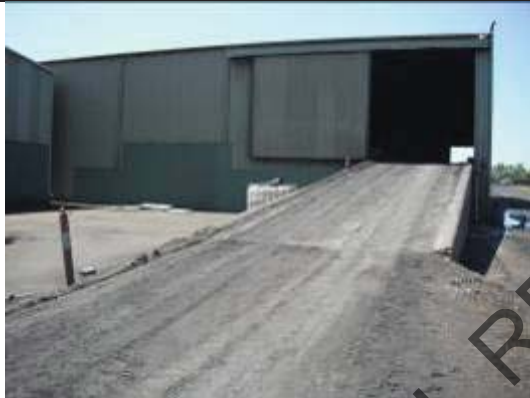
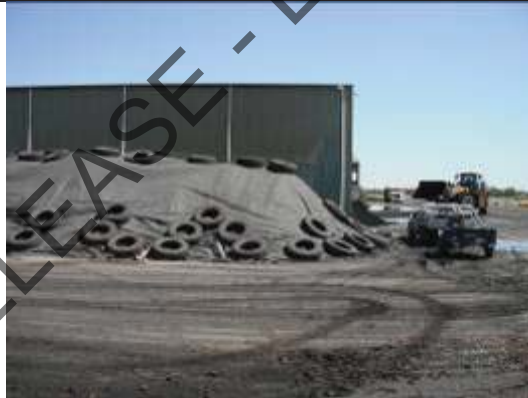
**23 December 2011:** A follow up inspection revealed that all damaged claddings were completely replaced/repared as shown in the below photos.

23 December 2011 site inspection showed concentrate storage shed claddings fully repaired and enclosed (except for the truck access/exit points).

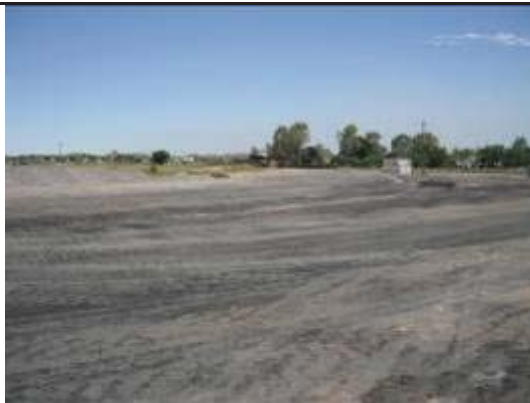
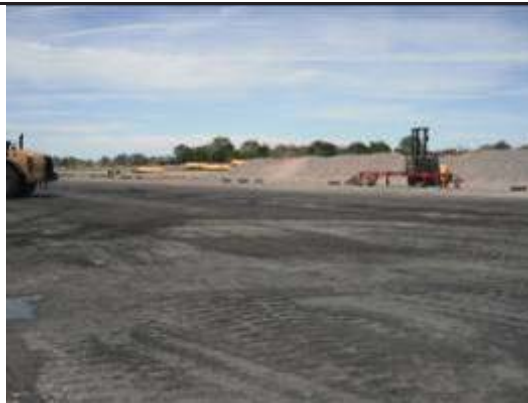
| Condition number: EPO STAT657 Requirement 3 | Compliant: Yes <input checked="" type="checkbox"/> No <input type="checkbox"/> | Photos taken Y/N |
|---|---|---|
| <b>14 December 2011:</b> Mineral concentrate spillage from the areas between the outdoor mineral concentrate stockpiling area and the railway line and other areas affected by the loading/unloading of materials were partially scraped and removed to Ernest Henry Mine site. Michael Mortimore said that approx. 85 tons of magnetite spillage were cleaned/removed from the site. | | Y |

*14 December 2011 site inspection revealed partially cleaned/scraped areas affected by mineral concentrate spillage.*

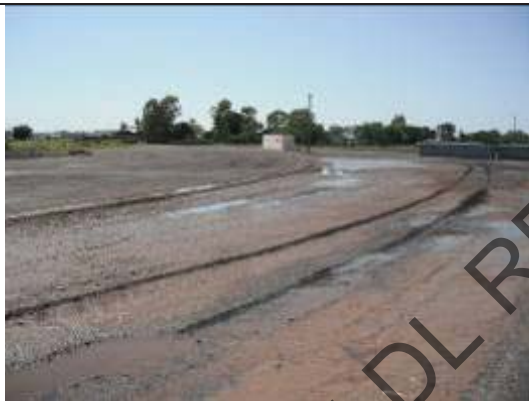
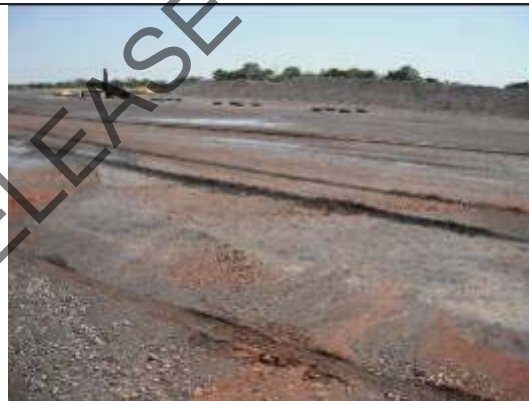
**23 December 2011:** A substantial amount of mineral spillage from the areas affected by the loading/unloading of materials were scraped and removed to Ernest Henry Mine. Michael Mortimore has indicated that it will be a continuous housekeeping/clean up work for Ostoic to maintain the area free from concentrate spill as possible.

*23 December 2011 site inspection showed evidence that mineral concentrate spillage from the areas have been scraped and removed in compliance with EPO Requirement No. 3. As the site received approx. 30mm of rain the night before the site inspection, the area was muddy but showed evidence of spillage removal.*

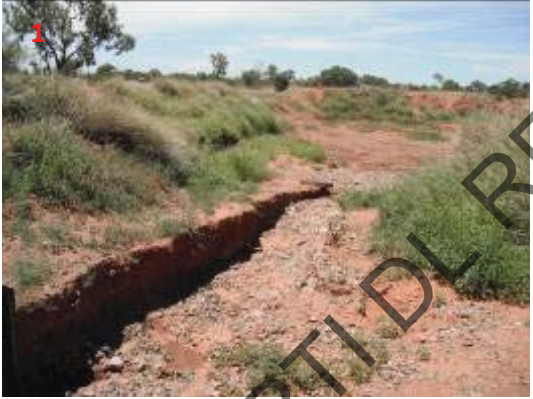
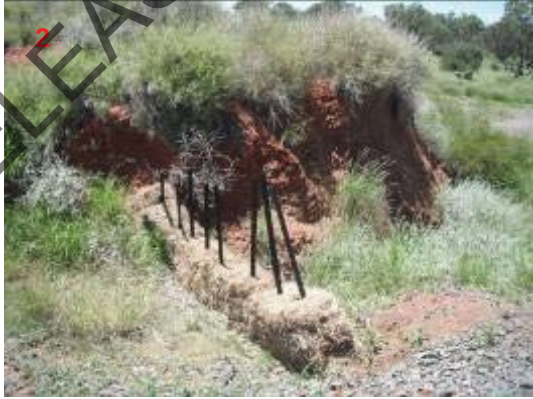
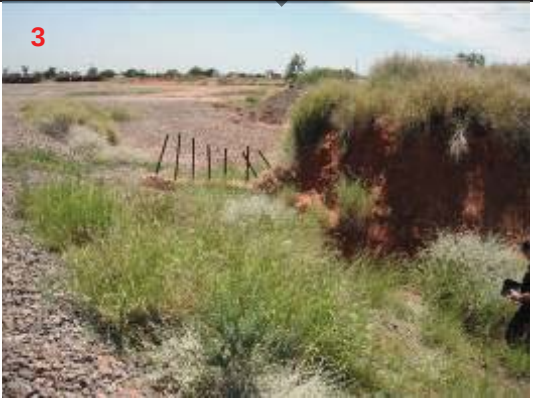
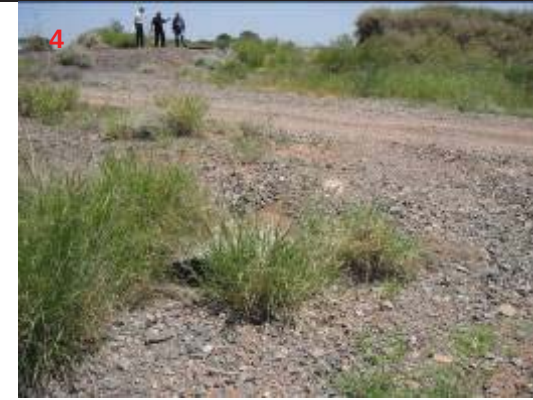
| Condition number: EPO STAT657 Requirement 4 | Compliant: Yes <input checked="" type="checkbox"/> No <input type="checkbox"/> | Photos taken Y/N |
|---|---|---|
| <p><b>14 December 2011:</b> The Ostojic storage facility has been provided with earth bund on the east and northern part of the property to direct the stormwater runoff. A detention basin is situated north of the property while a large grassed channel is on the eastern part of the property. Inlets to the detention basin and channel are provided with straw bales as temporary erosion control measure. The detention basin is provided with spillway where the stormwater overflows. Overflows, both from the detention basin and large grassed channel, finally discharged to an unnamed creek situated north of the property.</p> <p>David Peet provided DERM a copy of the Site Based Stormwater Management Plan for the Ostojic storage facility. DERM advised Ostojic that the constructed spillways should be included in the new Ostojic Development Approval (DA) as a licensed discharge points.</p> | | Y |
| <p>(1) Existing detention basin situated north of the Ostojic storage site; (2) inlet to the detention basin provided with straw bale as erosion control measure; (3) outlet or spillway of the detention basin; (4) Discharge through the spillway will flow through a pipe culvert underneath the gravel-filled road.</p> | | |

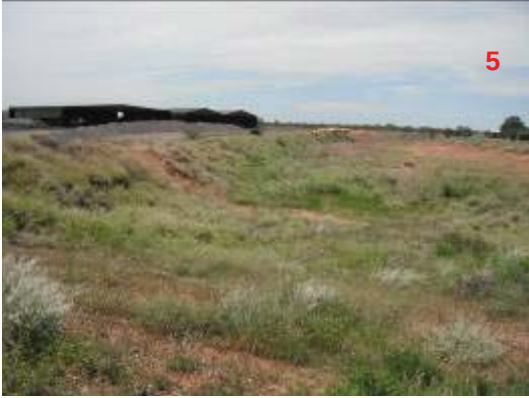
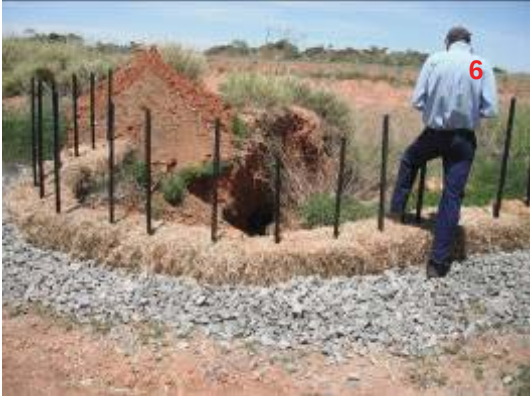
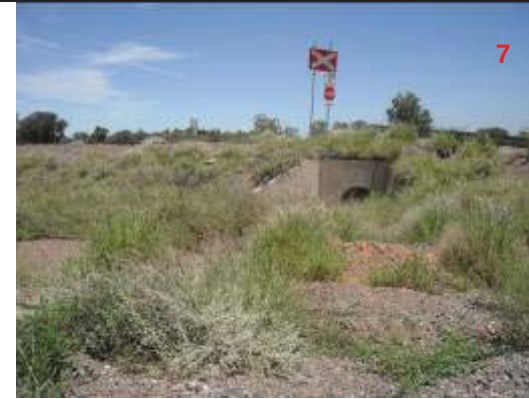
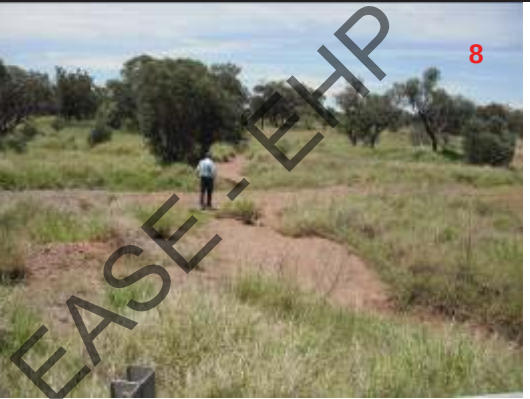
| <p>(5) The large grassed channel situated east of the storage facility; (6) inlet to the channel provided with gravel/straw bale as erosion control measures; (7) Flow from the large channel will flow through a concrete culvert; (8) Both discharges from the detention basin and channel will finally discharge to unnamed creek, situated north of the property.</p> | | |
