CROYDON GOLD MINE  
REHABILITATION MONITORING PROGRAM

NOVEMBER 2014

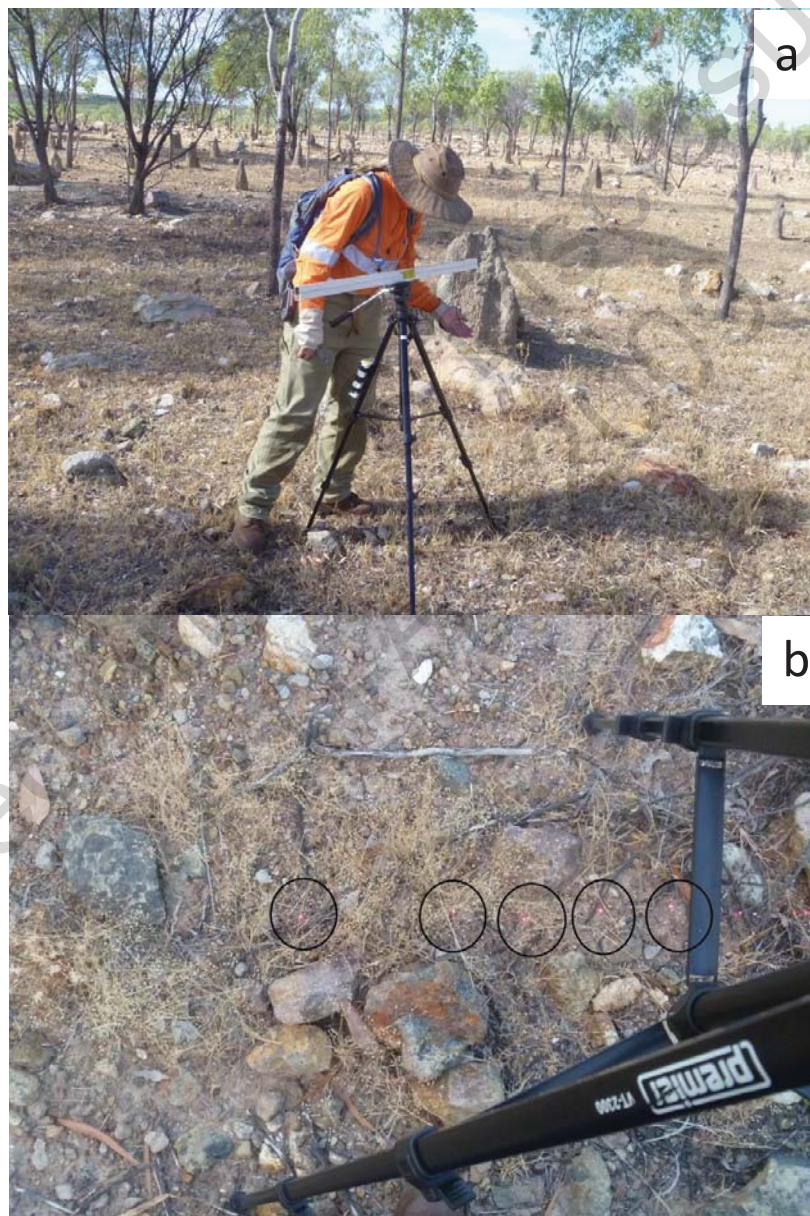
**Figure 2.** The laser method of sampling the point cover abundance of plants and bare ground etc (developed by Cedar Creek Associates, Colorado USA). The laser dots are circled in photo “b”.
