# Headland Car Park - Agnes Water Beach Walking Track

## Project Brief

August 2016

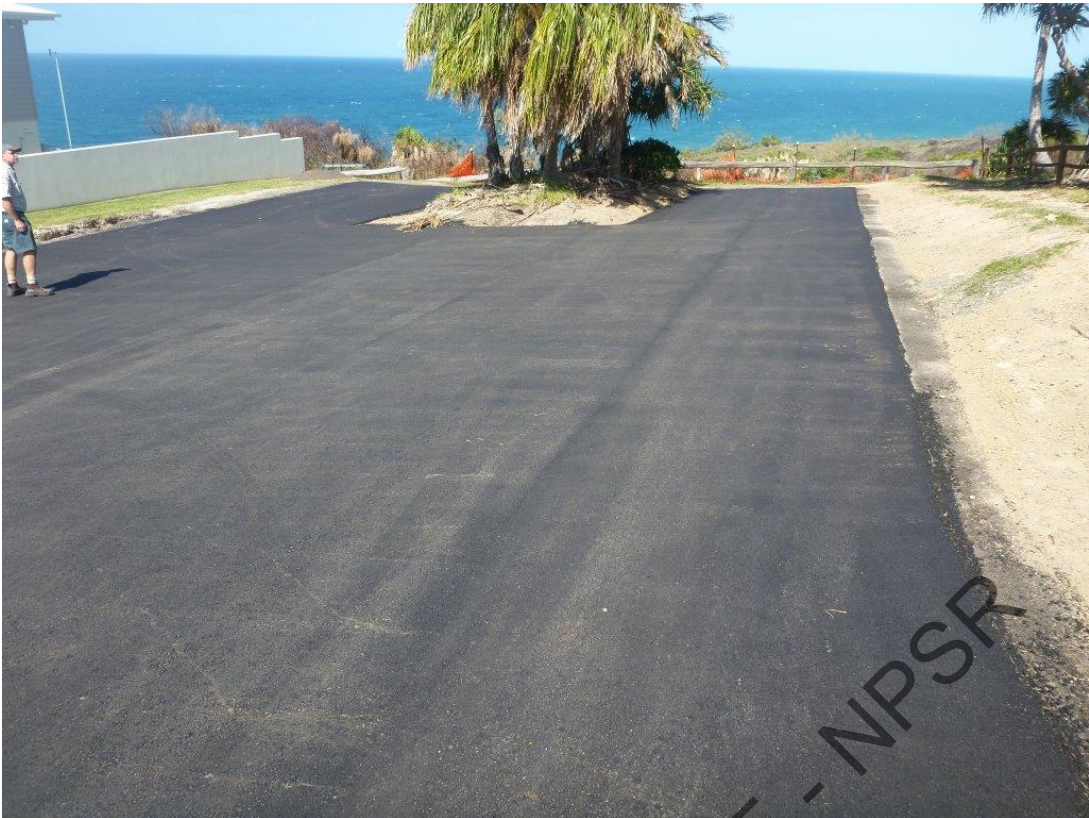
Image 1 – Tupia Street Car Park (under construction by Gladstone regional Council) commencement of track.

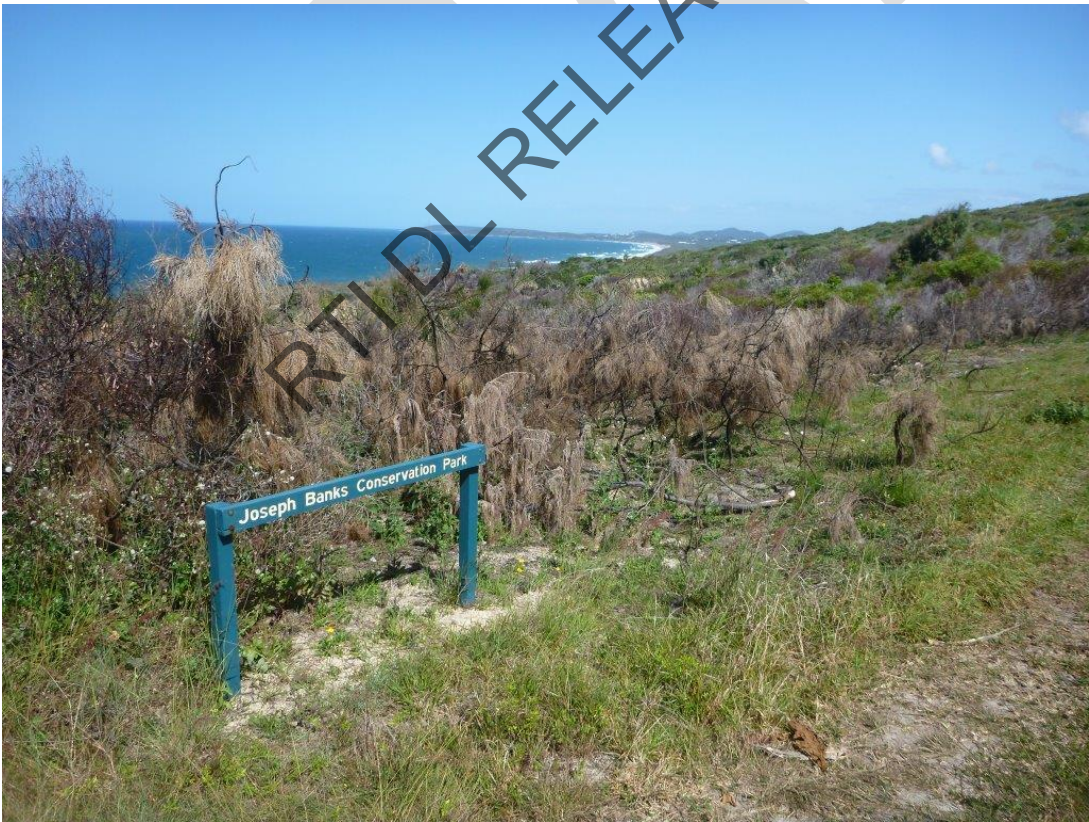
Image 2 – Commencement point, existing informal track

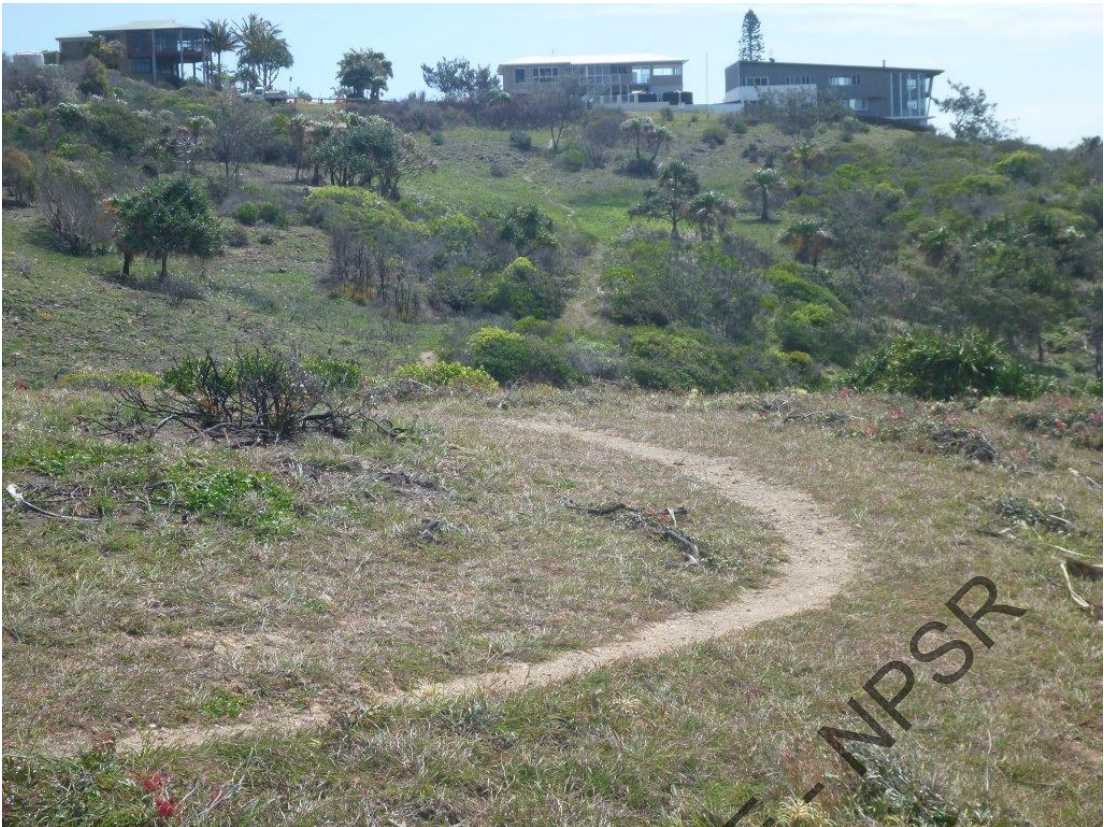
Image 3 – Class 3 section looking north to Tupia St Car Park

| Description | Advantages | Disadvantages |
|---|---|---|
| 2. Only complete 300m Class 3 section of track from Tupia street | Cheaper and quicker to complete.<br>Less infrastructure required and therefore savings in spending | Visitors will still need to traverse Tupia St, Ocean Dve and Sir Raphael Cilento Dve.<br>Safety issues in proposed class 4 section not addressed.<br>Master plan would not be completed. |

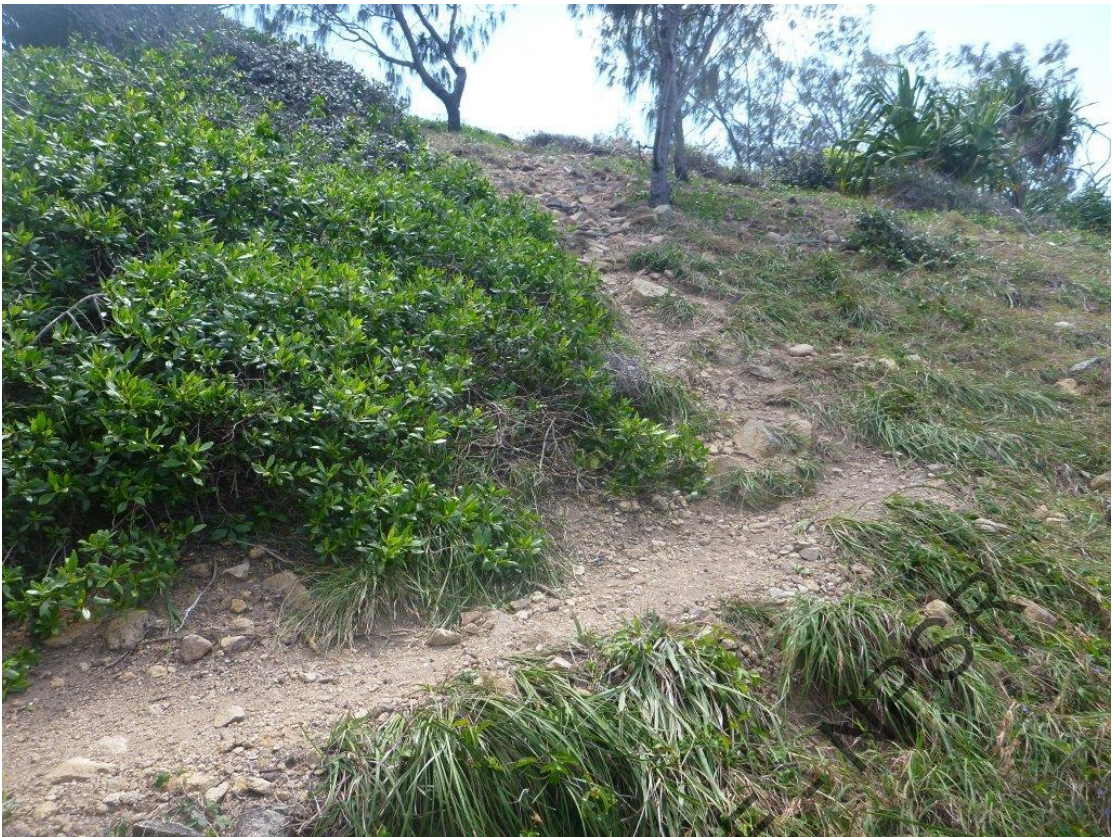
Image 5 – Steep rock gully section

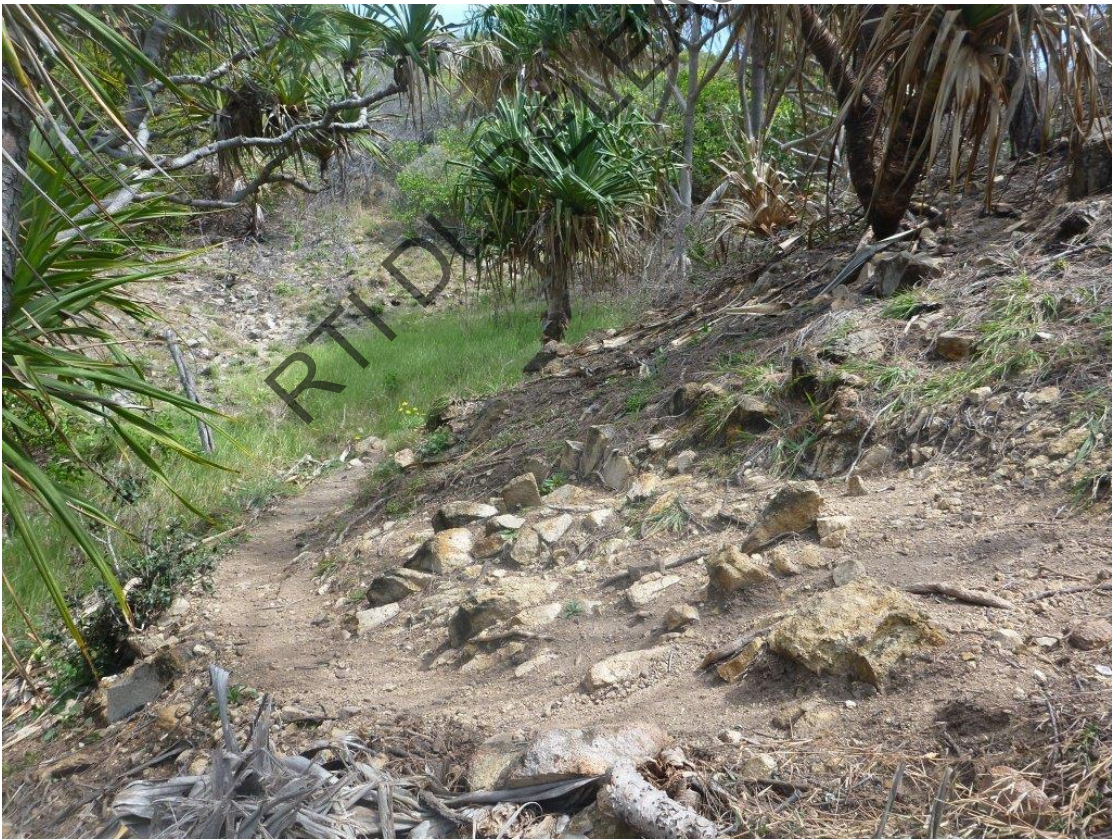
Image 6 – Steep rocky gully section

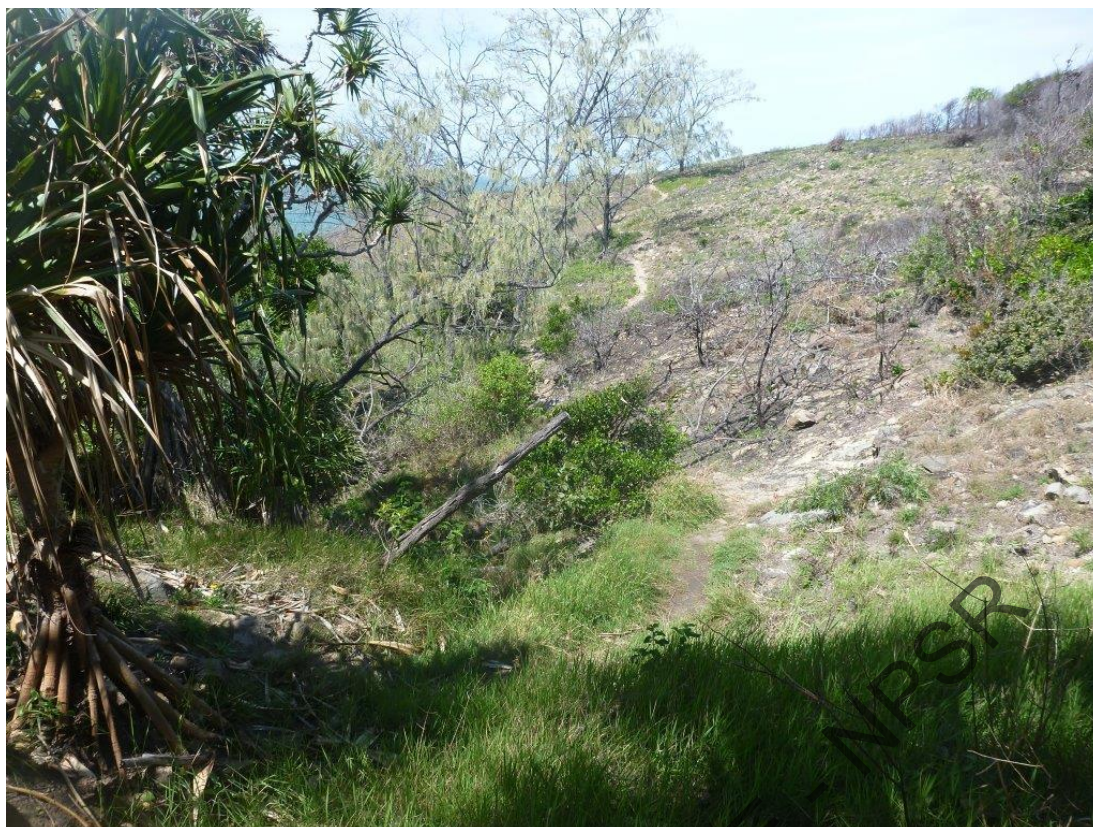
Image 7 – Rocky Gully section

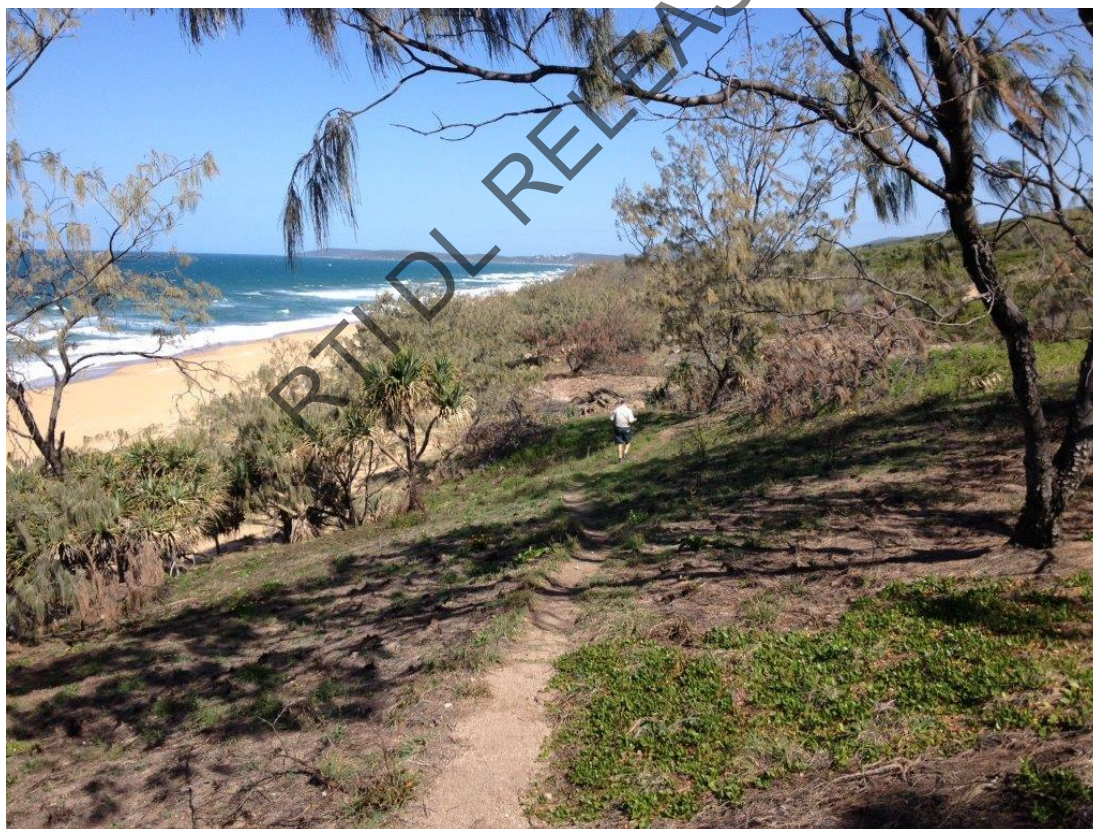
Image 8 – Last section of proposed track at Agnes Water Beach access point

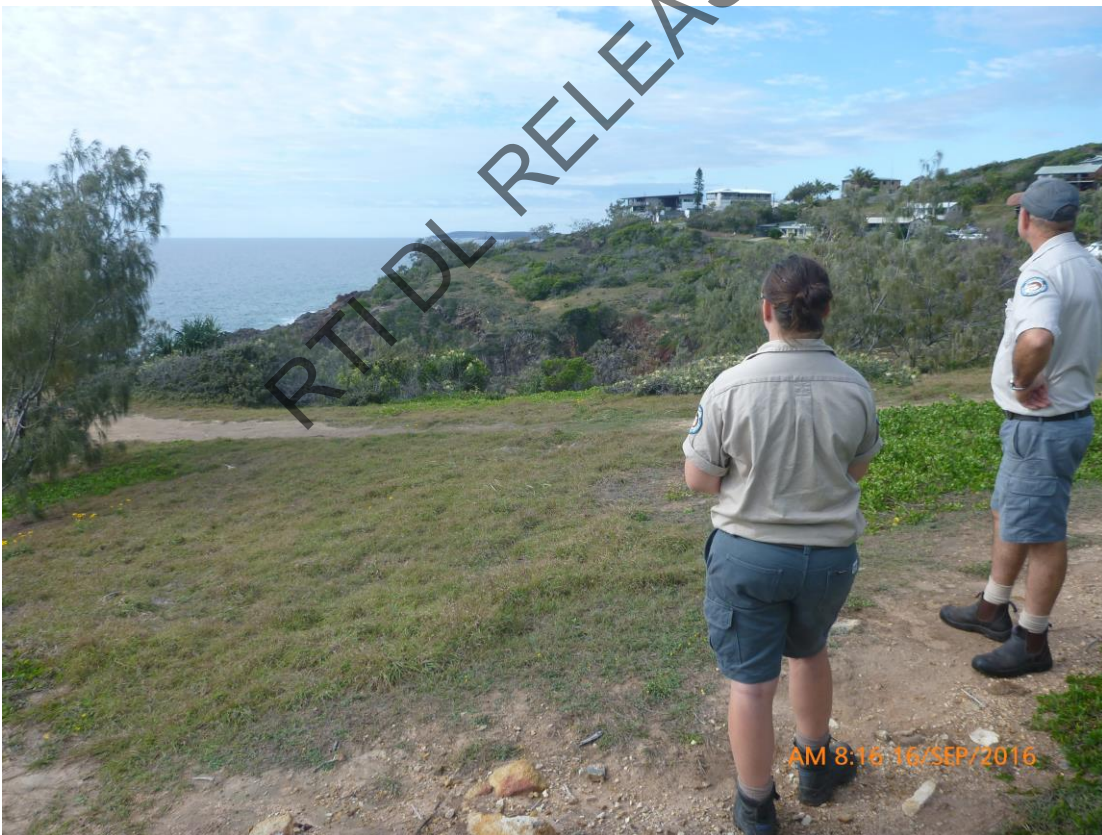
Image 10 – View of informal existing trail from Headland car park looking south

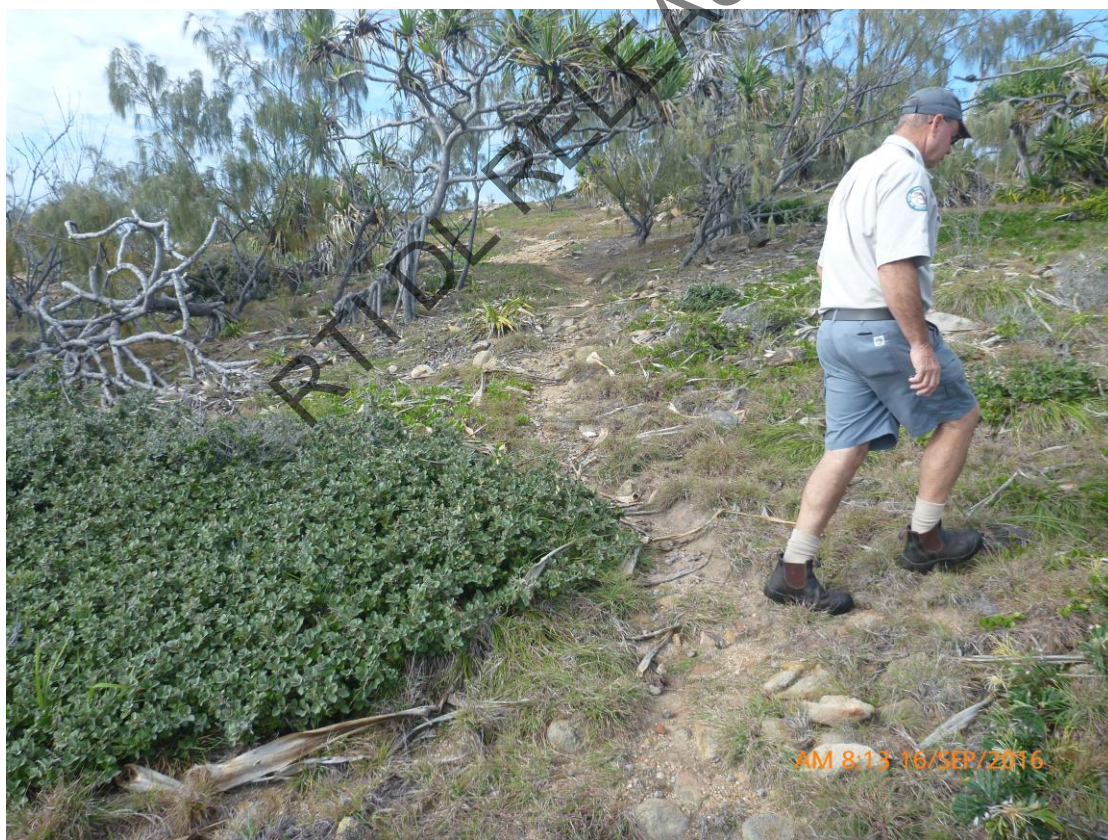
Image 12 – View of informal trail alignment requiring upgrade to reduce risk.

- The informal track is not made to any QPWS standard and has no interpretative infrastructure in place. Formalising this track will greatly improve user safety and minimise risk to members of the public and the environment.
