## Application for Assessment of a Site Investigation Report (Contaminated Land) Checklist

- DERM TPR application;
- Meetings with GQL, ML Design, SKM and various contractors;
- Site visit and meeting with SKM to confirm previous site information and verify current site conditions;
- Review of the SKM Sampling and Analysis Plan dated April 2009;
- TPR review of the SKM Interim Summary Report dated July 2009;
- Provision of comments for the above report;
- TPR review of the SKM Contaminated Site Investigation report (May 2010);
- Provision of comments for this report;
- Production of a TPR Certification Report.

# Logan Greyhound Facility Supplementary Site Investigation

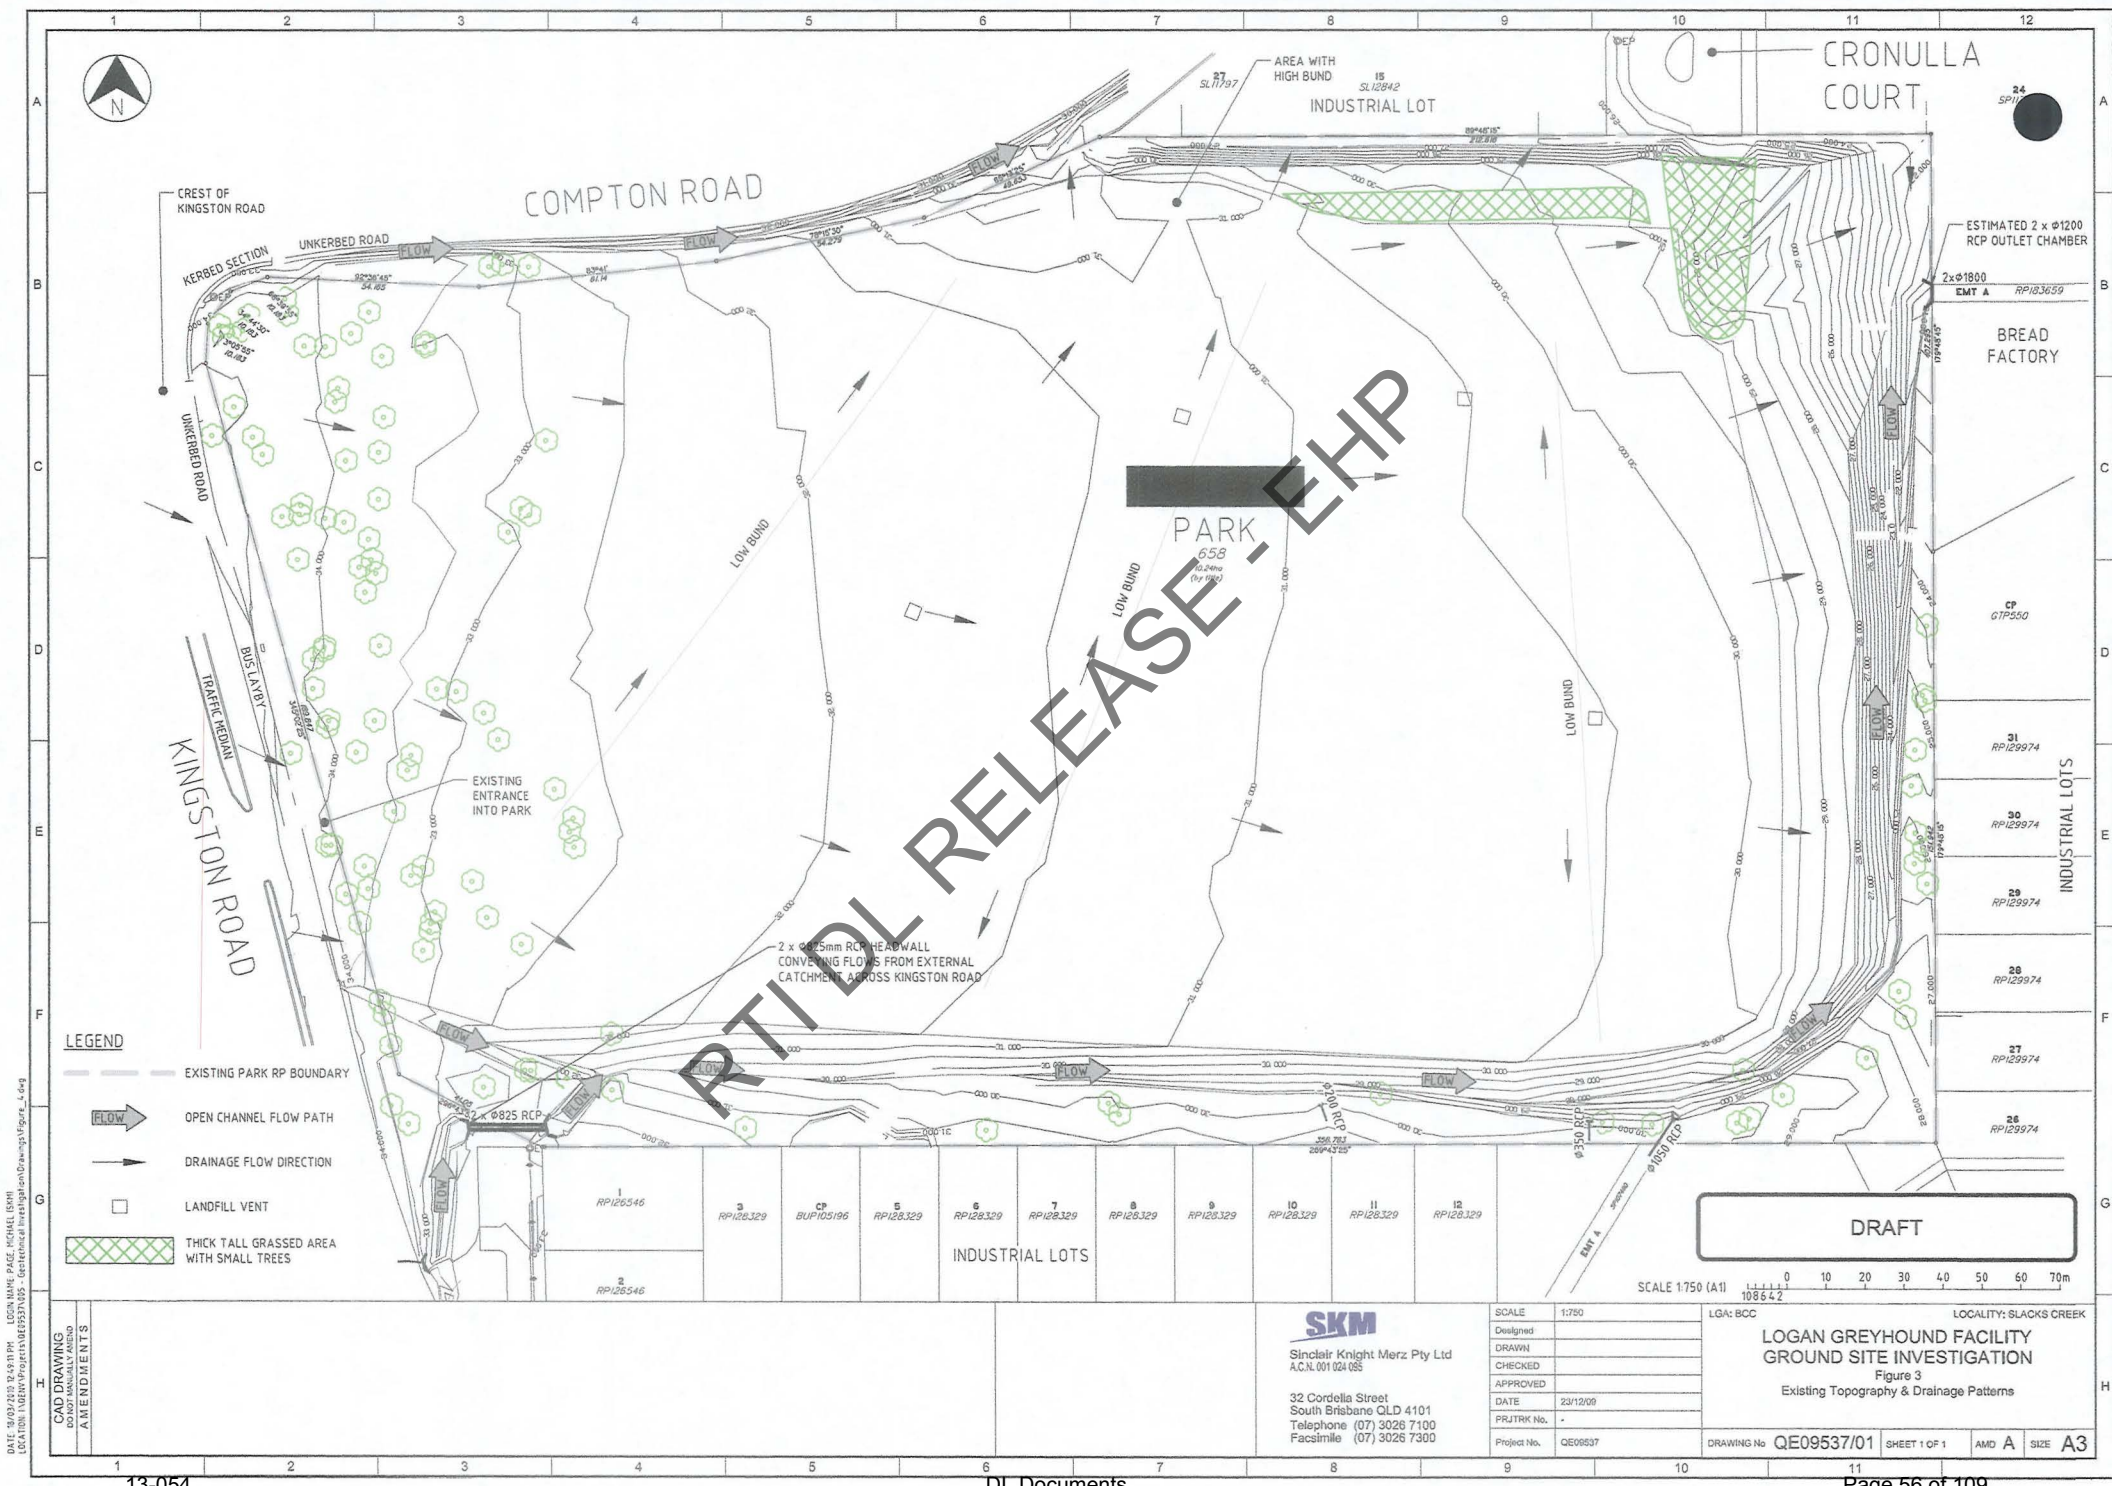
LOCALITY: SLACKS CREEK  
LOGAN GREYHOUND FACILITY  
GROUND SITE INVESTIGATION  
Figure 3  
Existing Topography & Drainage Patterns

- LEGEND**
- EXISTING PARK RP BOUNDARY
  - OPEN CHANNEL FLOW PATH
  - DRAINAGE FLOW DIRECTION
  - LANDFILL VENT
  - THICK TALL GRASSED AREA WITH SMALL TREES

Low bunds have been constructed over parts of the site to assist with the shedding of rainfall run-off from the surface material into the drains on the northern and southern boundaries of the site. These surface water drainage measures and the low permeability of the clay based surface material assist in limiting the infiltration of rainfall into the landfill.

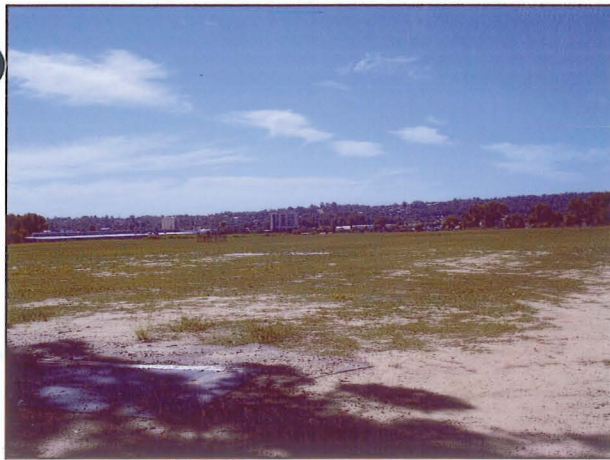
**Photo 1: General View of site looking north east from area of former UST 17/04/09**

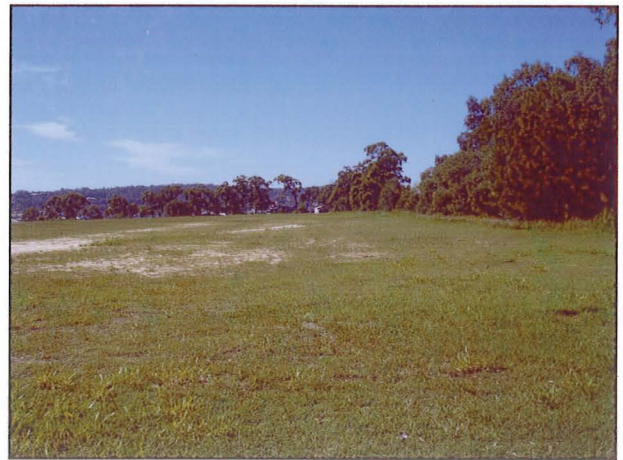
**Photo 2: General View of site looking south east towards to surface drain 17/04/09**

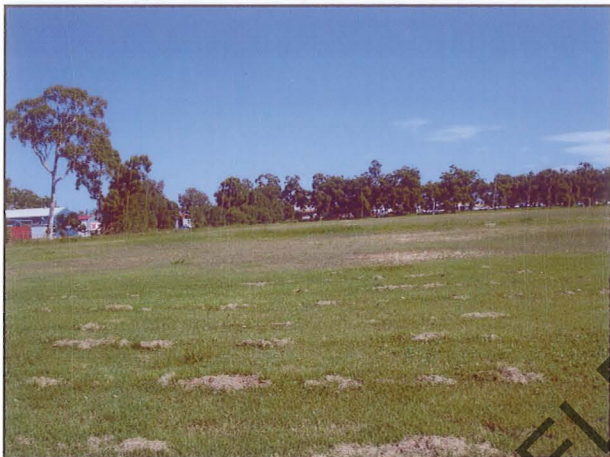
**Photo 3: General View of western area of the site showing mature trees 17/04/09**

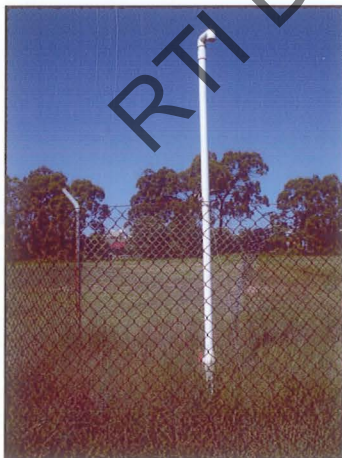
**Photo 5: General View of existing gas vent 17/04/09**

In the majority of monitoring rounds, low or non-detectable concentrations of methane and carbon dioxide were detected from the monitoring ports attached to the landfill vents. In one monitoring round, an elevated detection of methane which exceeded the LEL was found in one vent; all other vents, however, had concentrations of methane which were below the LEL or below detection limits.
