# Annual Monitoring Report 2015

## MMG Century - Lawn Hill

**CENTURY MINE SEDIMENT QUALITY MONITORING PROGRAM (SQMP)  
REVIEW, 2018**

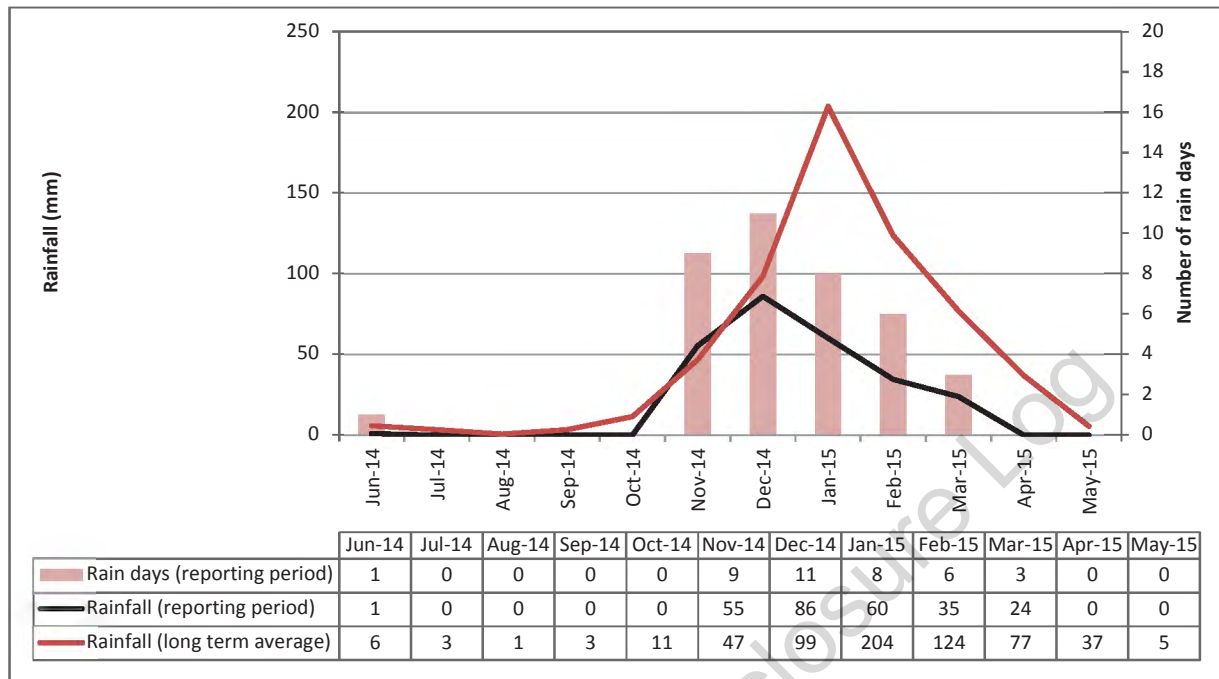
Figure 1 Rainfall data – Century Mine (BOM)

Rainfall measured during the reporting period at the permanent weather station adjacent to Century Mine Airport (maintained by the Bureau of Meteorology) was below average precipitation. In the reporting period, 261mm rain was recorded over 38 rain days. Average annual rainfall (2004 – current) is 634mm over 60 rain days (Figure 1).

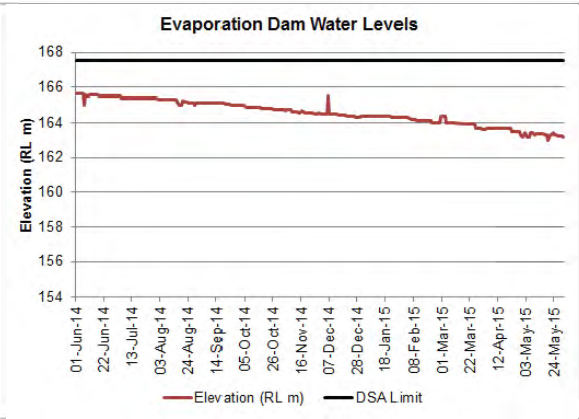
Figure 12 Evaporation Dam water level

Weekly water level monitoring is provided in Figure 12 to Figure 15, for the evaporation dam and tailings storage facility decant structures. Note: DSL = design storage allowance level and MRL = mandatory reporting level.

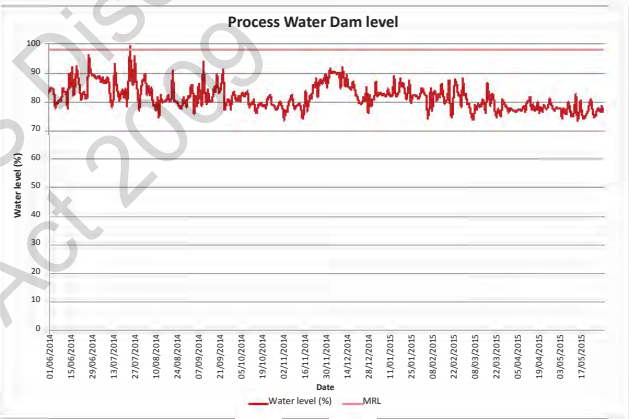
Figure 15 Process Water Dam water level (MRL is 50mm below the spillway)

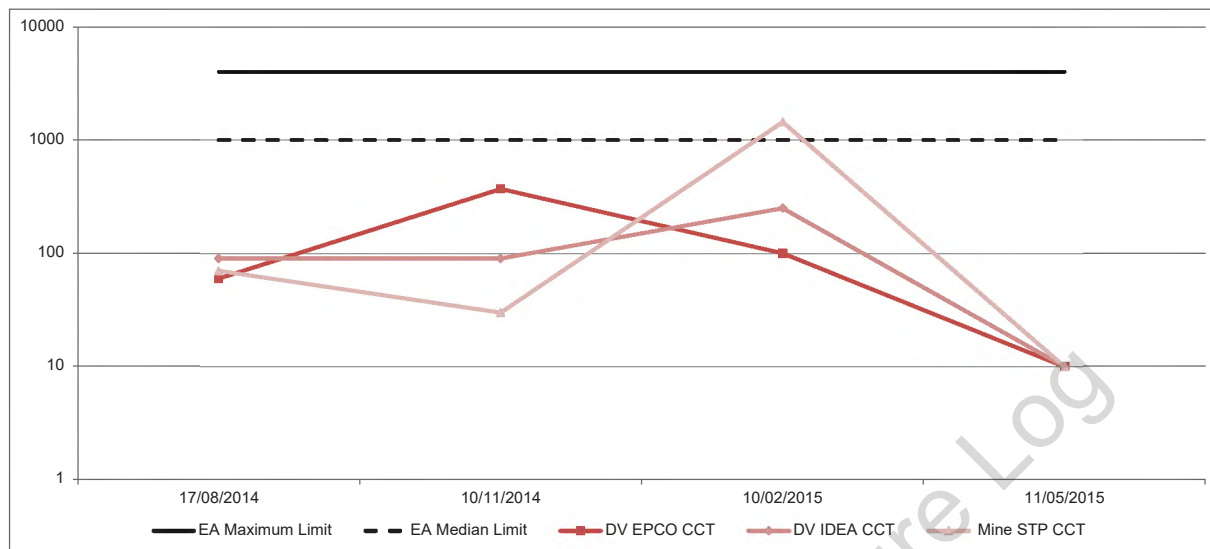
Figure 18 Sewage effluent – quarterly thermotolerant coliforms (E. coli; CFU/100ml)  
\*Median of 5-10 consecutive samples

Note: The median of five consecutive samples for Mine STP CCT from April 2014 to May 2015 was 70 mg/L, compared to the median limit of 1,000 mg/L. The April 2014 result was 110 mg/L.

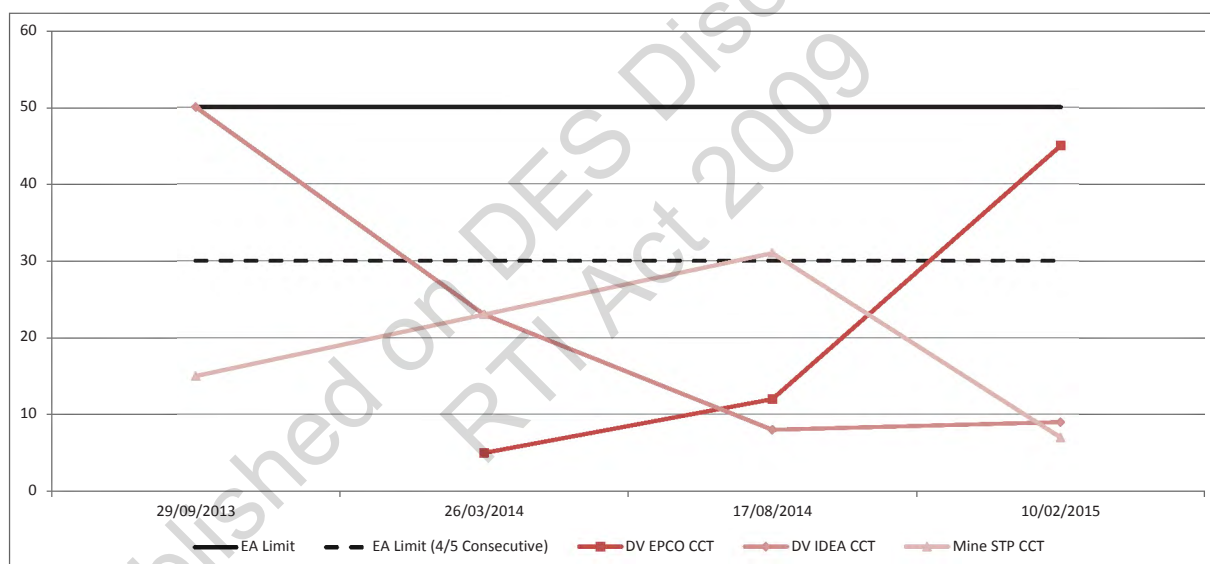
Figure 19 Sewage effluent – six monthly TSS (mg/L)

Note: Four of five consecutive samples for the Mine STP CCT were below the EA limit of 30 mg/L - the February 2014 TSS result was 4 mg/L and the July 2013 result was 7 mg/L.

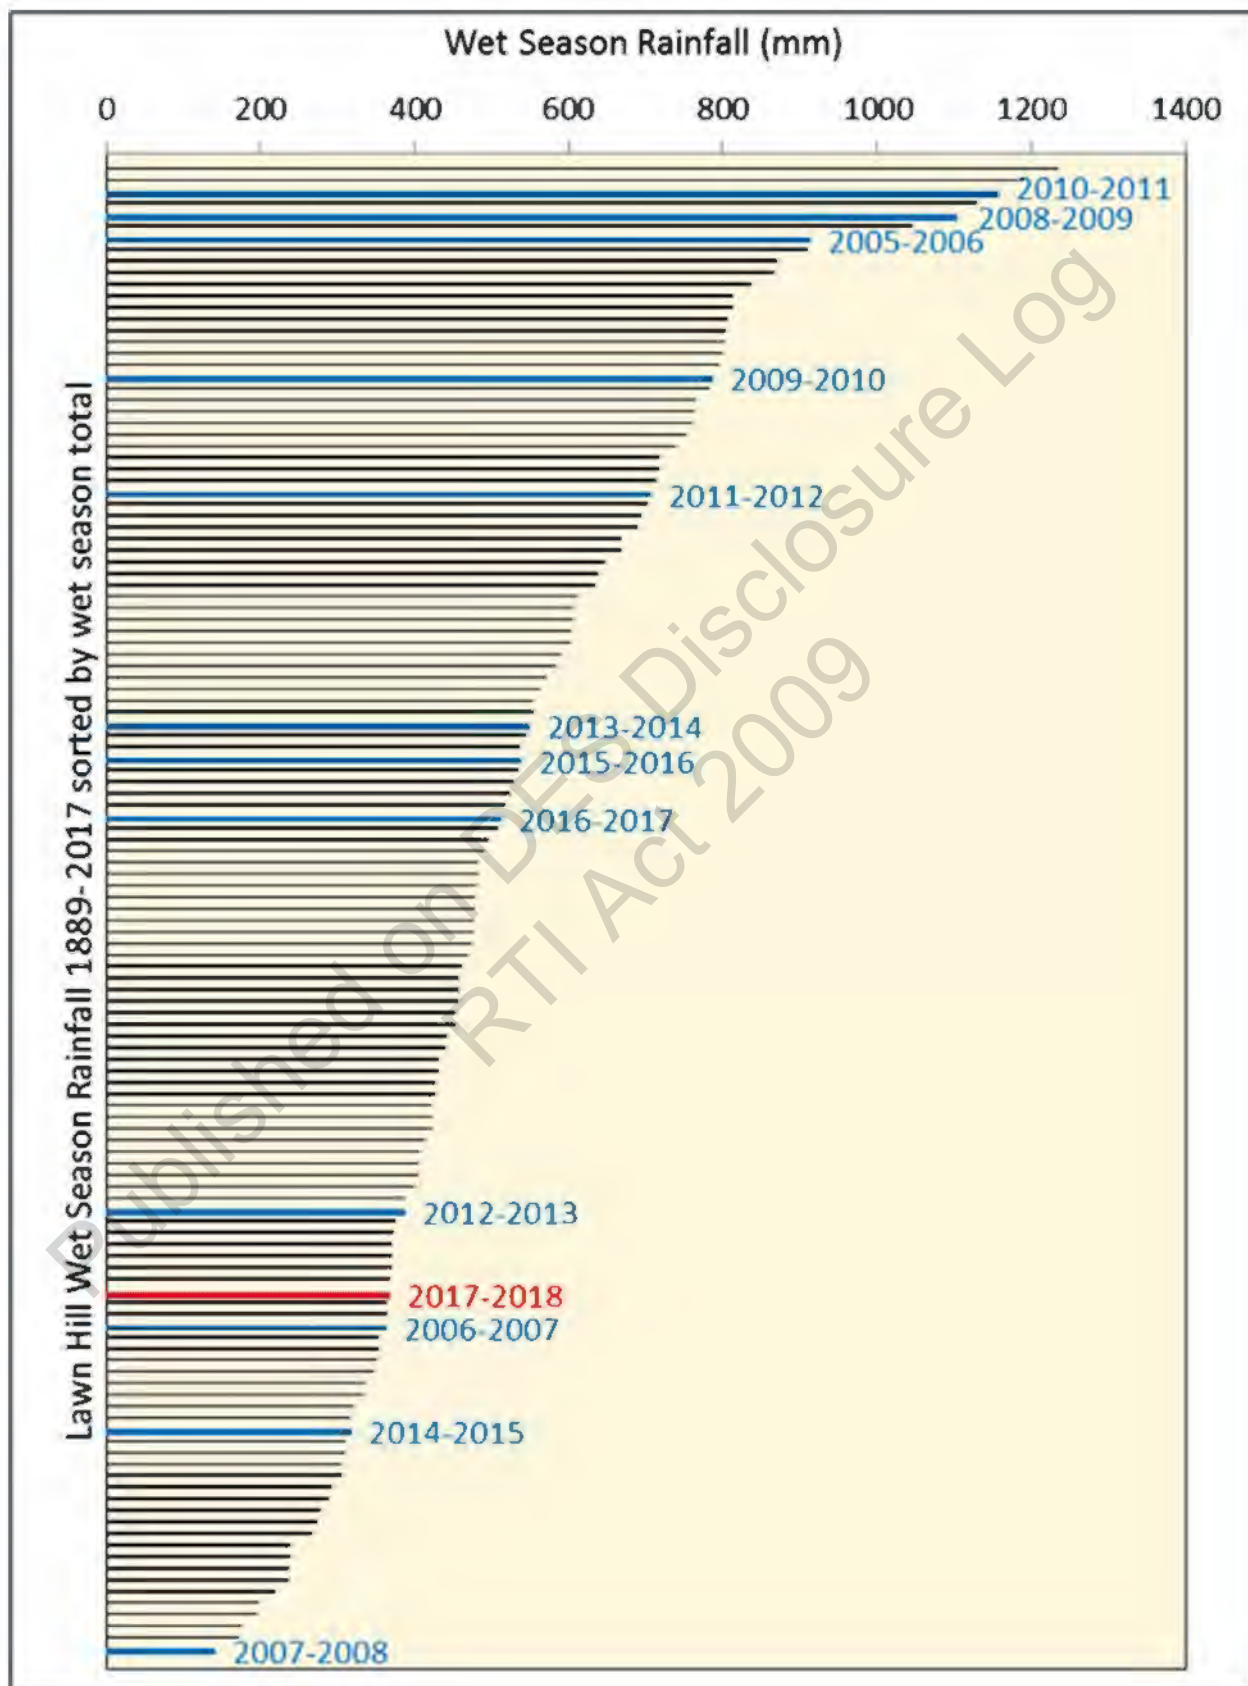
Long term records for Lawn Hill (Figure 1.1.2) indicate that annual rainfall has consistently been less than or equal to the long term average since 2012. Conditions were particularly dry in the 2012-2013 and 2014-2015 wet seasons and the effects of that (low groundwater levels and parched soils) carried through into the intervening years resulting in lower than normal streamflow even in the average rainfall years. The 2017-2018 wet season is the sixth consecutive year that none of the ephemeral creeks in the Century Mine receiving environment have experienced any swiftflow events with sufficient energy to mobilise significant quantities of streambed sediment.

**Figure 1.1.2** Annual wet-season rainfall at Lawn Hill 1889-2018 ranked in order of decreasing total rainfall (mm). Data from Climate Data Online, Bureau of Meteorology. <http://www.bom.gov.au/climate/data>. Bureau of Meteorology station number: 29031, Station name: LAWN HILL (note that 2016-17 data was derived in part from Century Mine rainfall data due to missing records in the Lawn Hill BOM data).

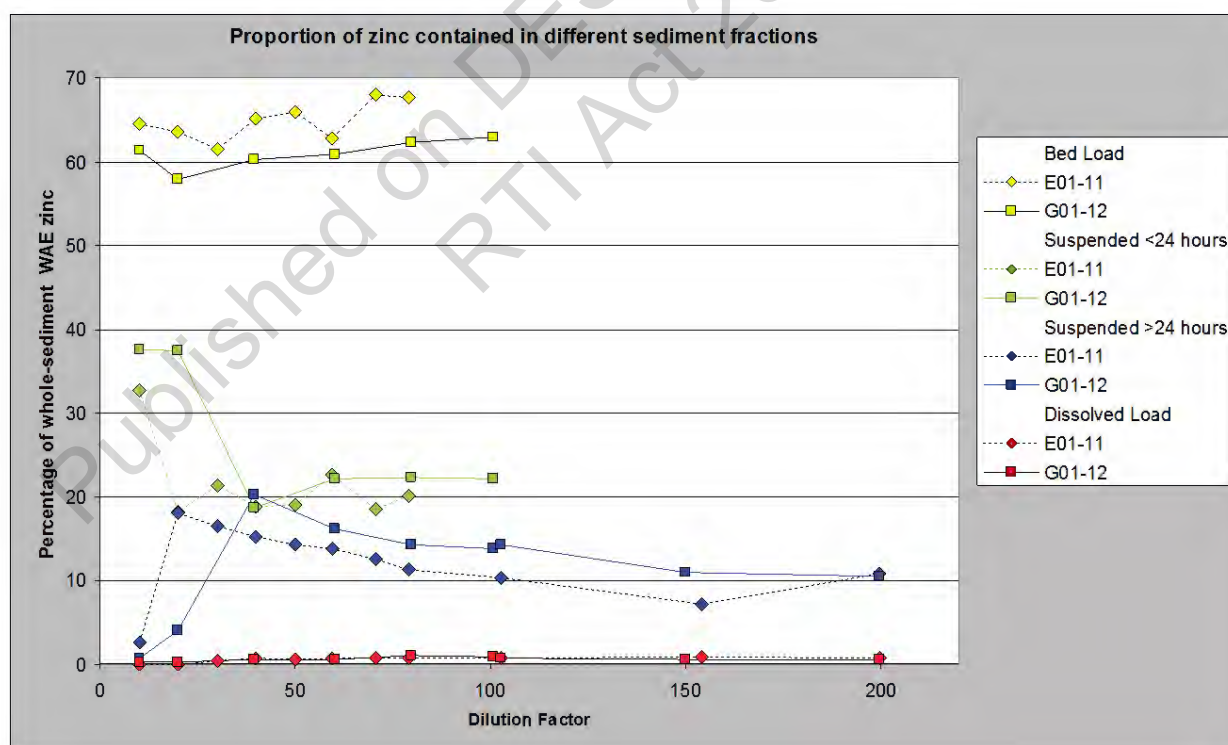
Analysis of the concentration changes that have occurred over time, and visual observations on site, both suggest that much of the metal-enriched sediment in Page Creek is being transported in the form of small discrete slugs which move *en masse* during the peak of flow events. This is a common occurrence when dealing with coarse-grained sediments which are too heavy to become suspended in the water column and instead move downstream by saltation (i.e. rolling/bouncing along the bottom). This observation is consistent with expectations based on laboratory testing (ACTFR 2012) which found that the majority of the contaminated sediment comprised sands which were not readily suspendable (see Figure 2.1.4).

**Figure 2.1.4** Results of laboratory tests involving the agitation of sediment samples at varying water:sediment dilution ratios to determine the potential instream mobility of the sediment under simulated turbulent high flow conditions (ACTFR 2012).

The contaminated sediments were therefore considered to be readily amenable to capture in sediment traps. In response to that finding a sediment trap was installed in the lower reaches of Page Creek in 2014 (location shown in Figure 2.1.2) in order to prevent the sediment from reaching Lawn Hill Creek. It is planned that sediment trapped by this structure will be removed on a routine annual basis.

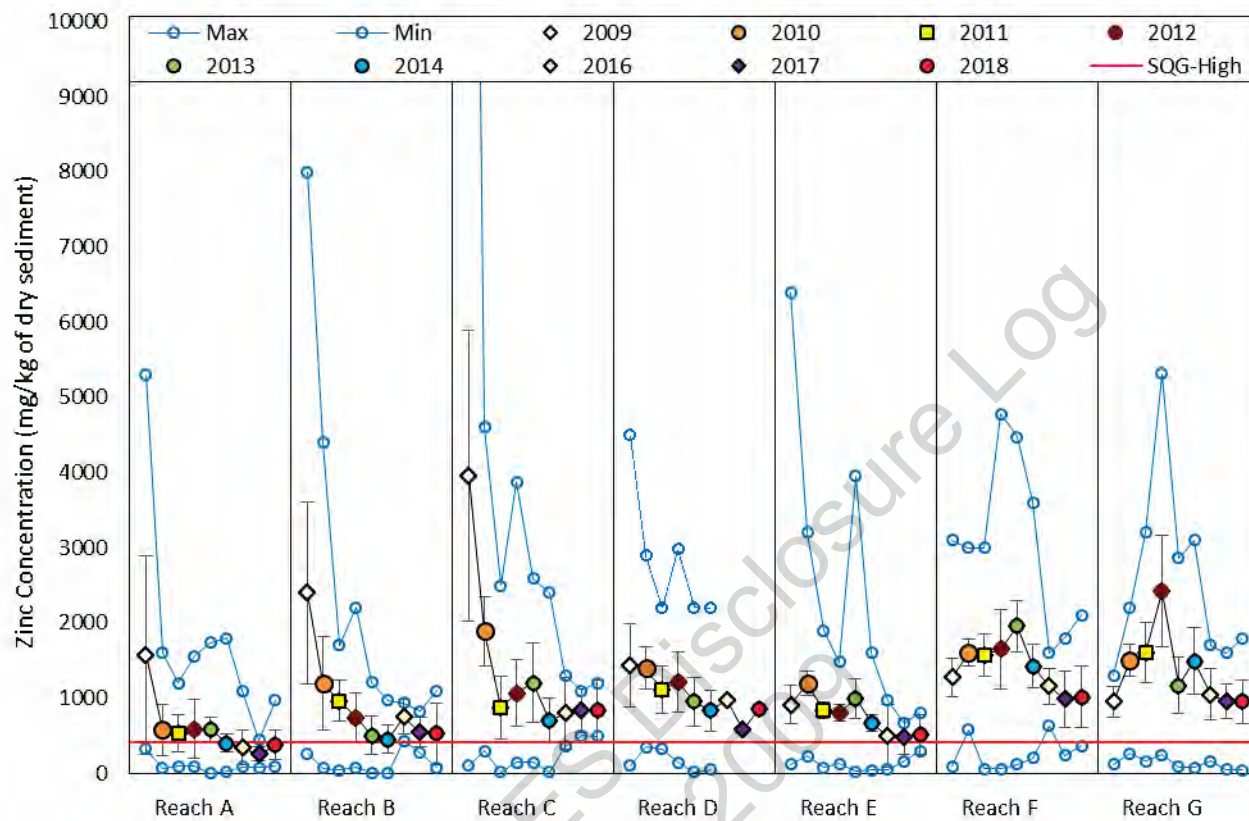
Temporal trends in Zn concentrations within each individual stream reach are plotted in Figure 2.2.5. Analysis of the SQMP datasets for 2009 to 2018 indicates that the mean zinc levels in most reaches have declined moderately since 2013 although Reach F is the only case where the apparent decline was statistically significant and Reach A (the diversion channel) is the only reach where mean zinc levels were below the ISQG-High (the Cd in that Reach was also below the ISQG-Low). On face value this appears to indicate that recent inputs to Page Creek from the mine have been low and that pre-existing sedimentary metal residues have been moderately diluted by natural sediment inputs. These effects could potentially be a temporary consequence of the lack of large flow events since 2012 (resulting in surface deposition of unenriched natural sediments from localised soil sources) and an absence of movement within the streambed.

**Figure 2.2.5.** Spatiotemporal variations in Page Creek sediment zinc concentrations since 2009 clustered by reach. Error bars are 95% confidence intervals of the mean. An outlier of 15000 mg/kg for Reach A in 2009 and a maximum value of 23000 mg/kg for Reach C in 2009 are not shown:

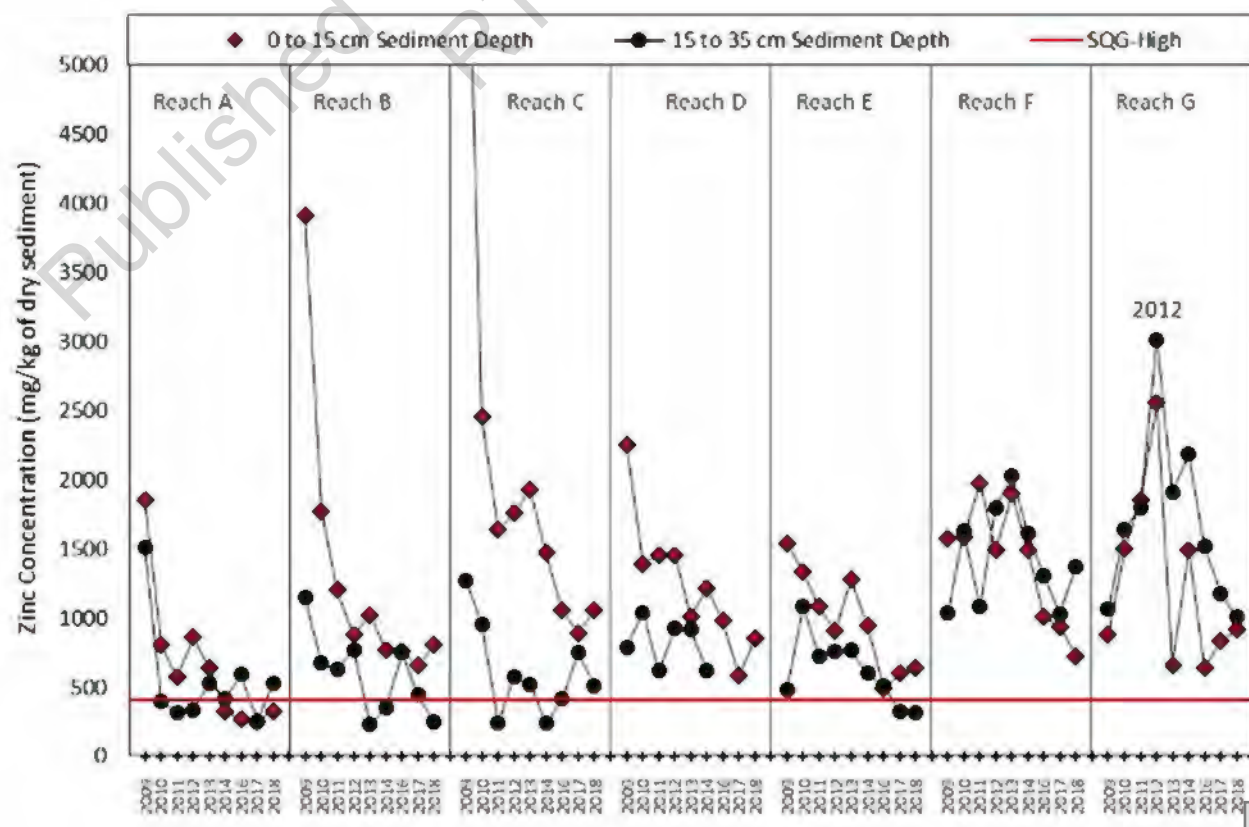
**Figure 2.2.6** Variations in Page Creek zinc concentrations with sediment depth since 2009 clustered by stream reach. Points are mean values and are arranged chronologically as in Figure 2.2.5.

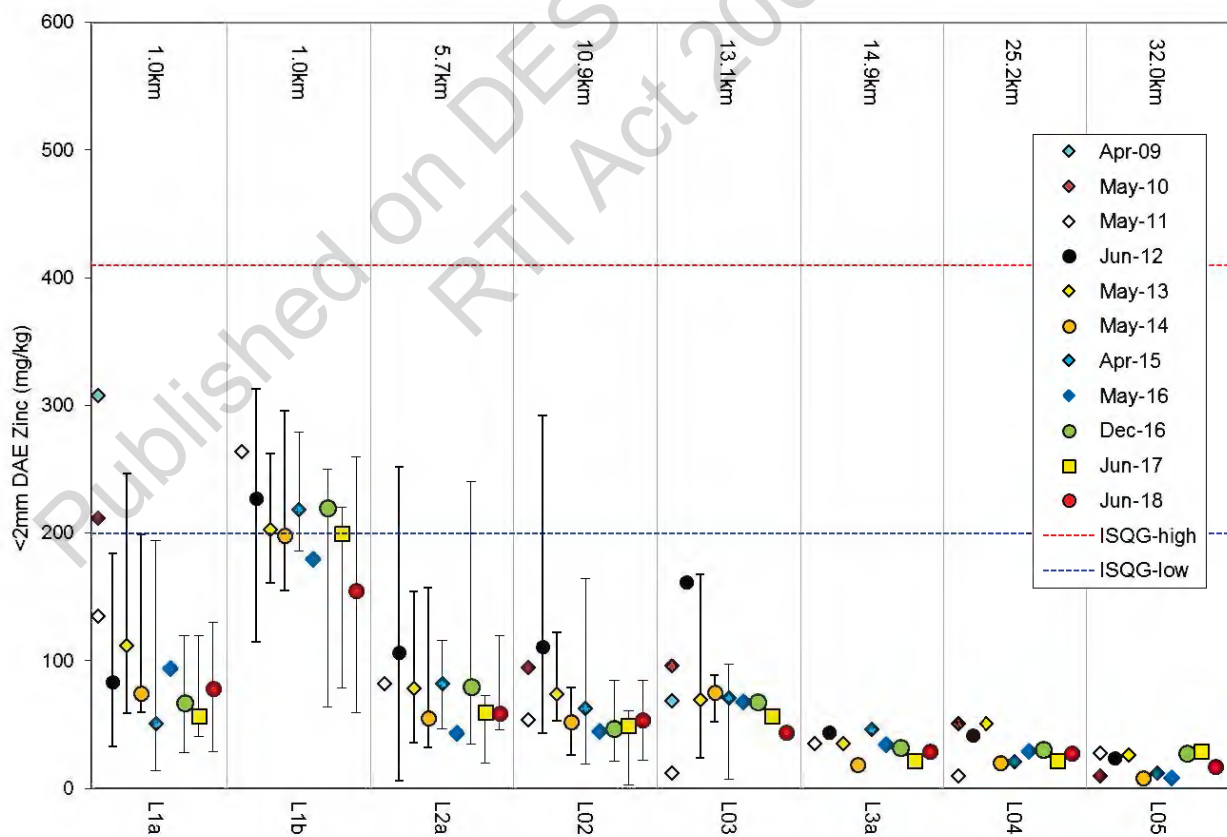
**Figure 3.2.1.** Spatiotemporal variations in Lawn Hill Creek sediment zinc concentrations since 2009. Points without error bars are obtained from composite samples. Points with error bars indicative of minimum and maximum values are medians obtained from 8 transect samples. Points are arranged chronologically within each site group. Data for upstream reference sites RL0 to RL3 (n=32; mean=11 mg/kg; maximum=25 mg/kg) are not shown.

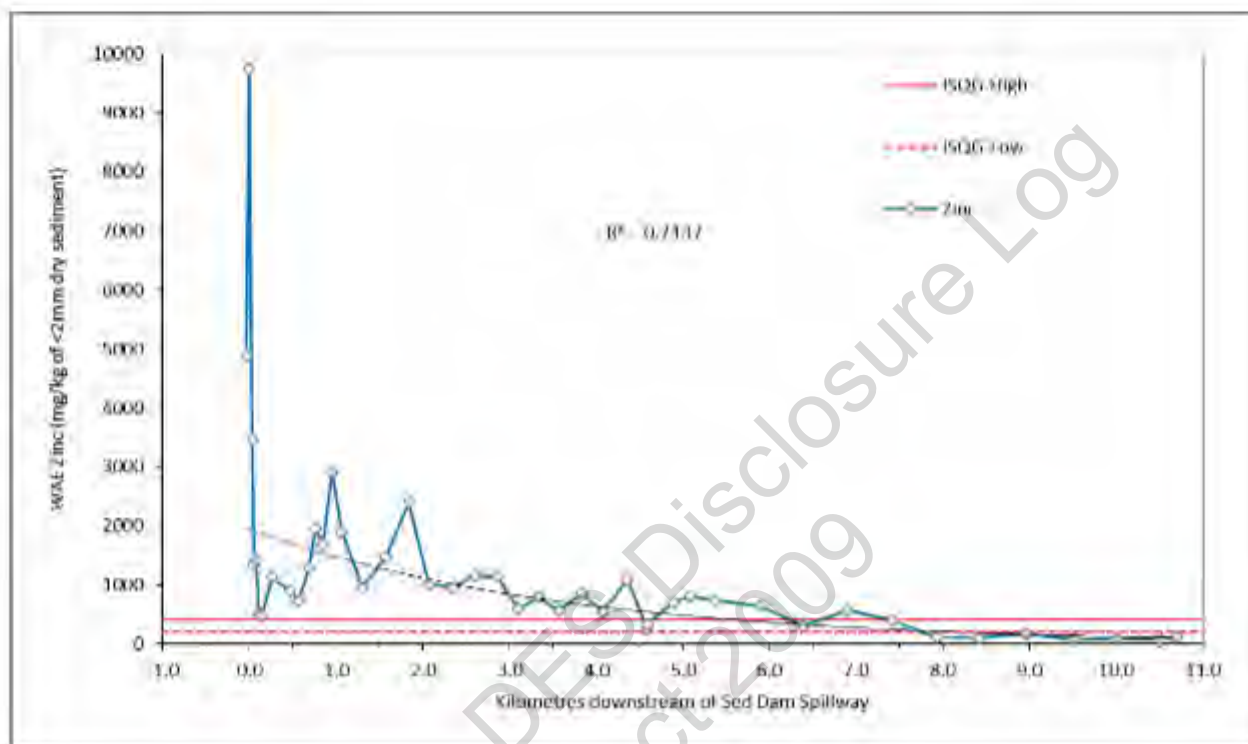
The results of that sediment sampling survey, completed in October 2014, indicated that sediments within a 7.4 km section of North Mitton Creek, between Sediment Dam One and the entry point of Gum Hole Plains tributary, contained elevated concentrations of mine-sourced zinc (plus minor quantities of cadmium and lead). Zinc concentrations within that stream-reach attenuated significantly with distance downstream (see Figure 4.1.2), but only three of the 42 sites sampled reported results that did not exceed the ANZECC 2000 ISQG-High, indicating that immediate remedial action was warranted. Zinc loads in the contaminated section of the creek totalled approximately 1400 kg, 540 kg of which was contained within a 1.32 km length of stream situated within 2 km of the sediment dam.

**Figure 4.1.2** Spatial distribution of Zn concentrations in North Mitton Creek sites prior to removal works in December 2014.

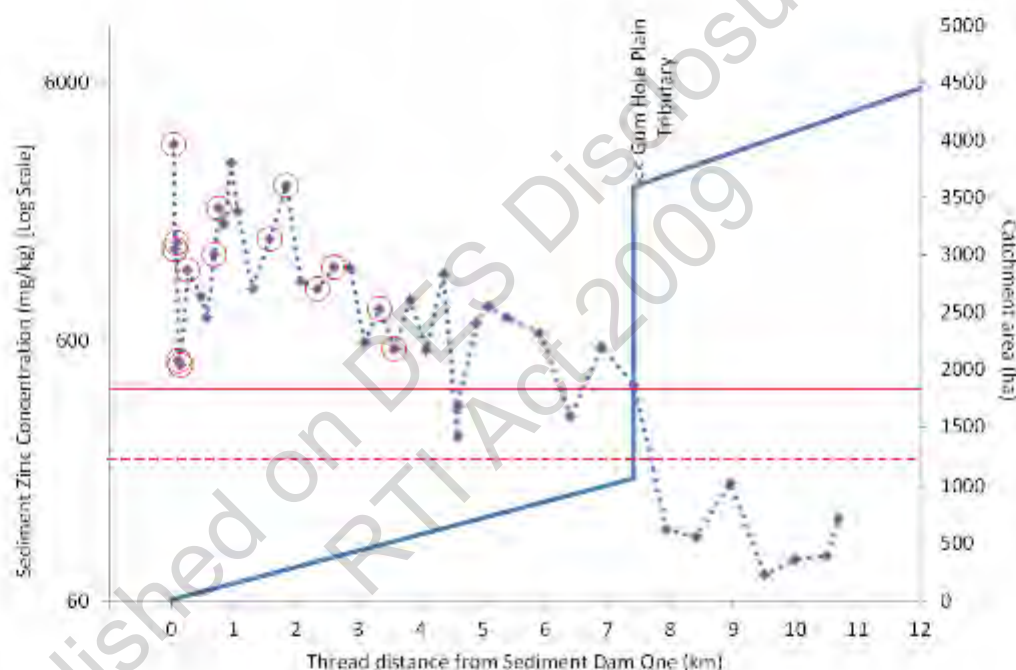
It can be seen that there is a quantum increase in effective catchment area about 7.4 km downstream from SD1 at the point where North Mitton Creek intersects an unnamed tributary which drains Gum Hole Plain (situated to the north of the creek). The 2014 investigation suggested that natural sediment supplies to the

**Figure 4.1.4** Graph showing the effect of increasing catchment area on the sediment zinc concentrations in North Mitton Creek. The blue represents catchment area. The solid red line is the ISQG-High and the broken red line is the ISQG-Low. Red Circles denote sites where removal works were conducted in 2014.

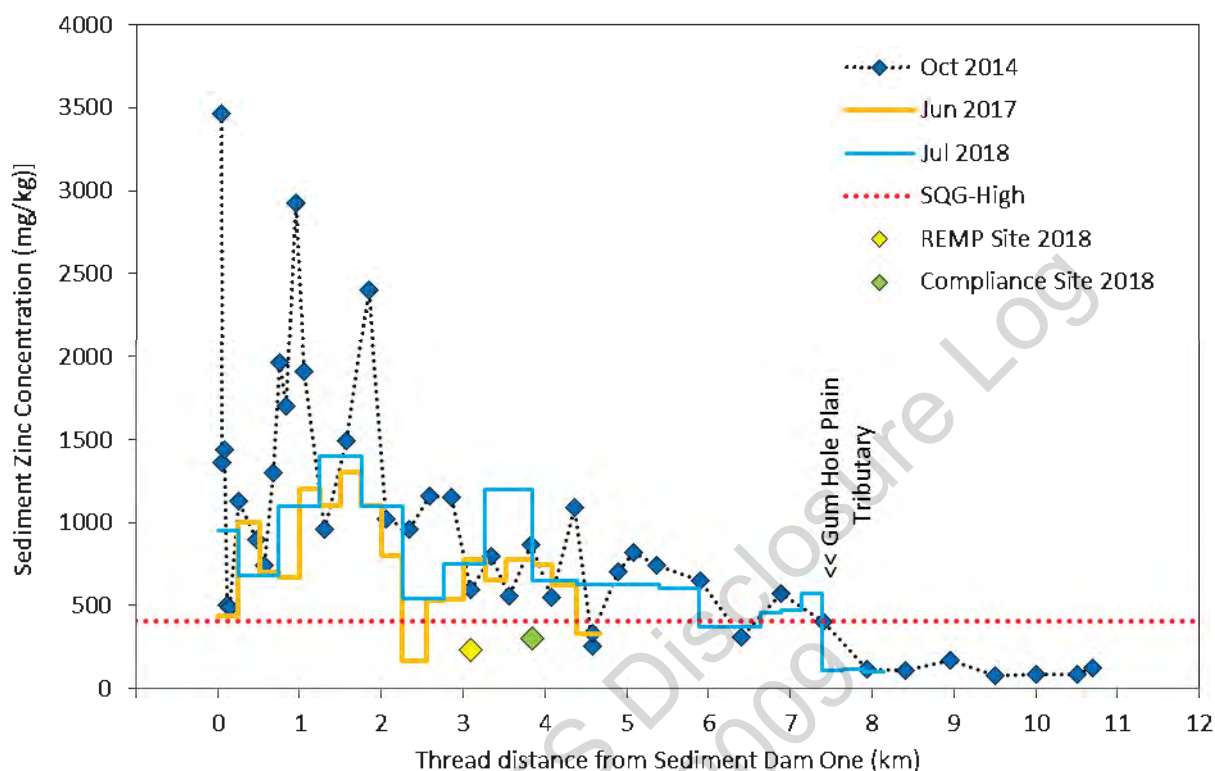
**Figure 4.2.1** Zinc concentrations in 2017 and 2018 compared to 2014 (prior to sediment removal works). The 2017 samples were composites indicative of the mean concentration within each stream reach.

As noted previously, due to the small size of North Mitton's upper catchment area and the consequent paucity of natural water and sediment supply, it may take a long time for these residual sediments to become diluted. In risk terms the lack of water supply is also an extenuating factor as it decreases the likelihood of the contaminated bedload being carried downstream to more valuable environments.
