# **LADY ANNIE OPERATIONS**

**30<sup>TH</sup> OF JANUARY 2009**

**DISCHARGE EVENT REPORT**

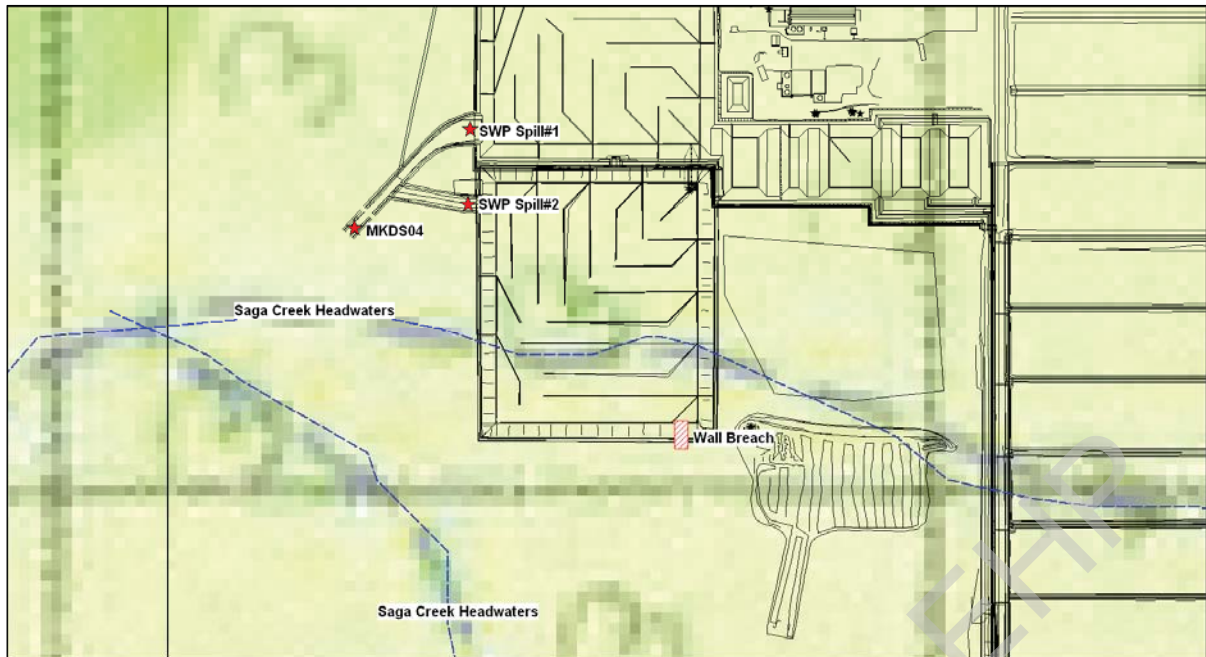
Figure 3: Topographic Map showing Plant in relationship to Saga Ck catchment.

Figure 3 shows the location of the three sample point locations (red stars) downstream of the LAO Storm Water Ponds. There is one sample each for the two spillways, and one at the Licence Condition monitoring location MKDS04, as required by the LAO Environmental Authority MIN100401006.

Also shown is the location of the wall breach on the south-eastern side of the southern pond wall (Figures 10 & 11).

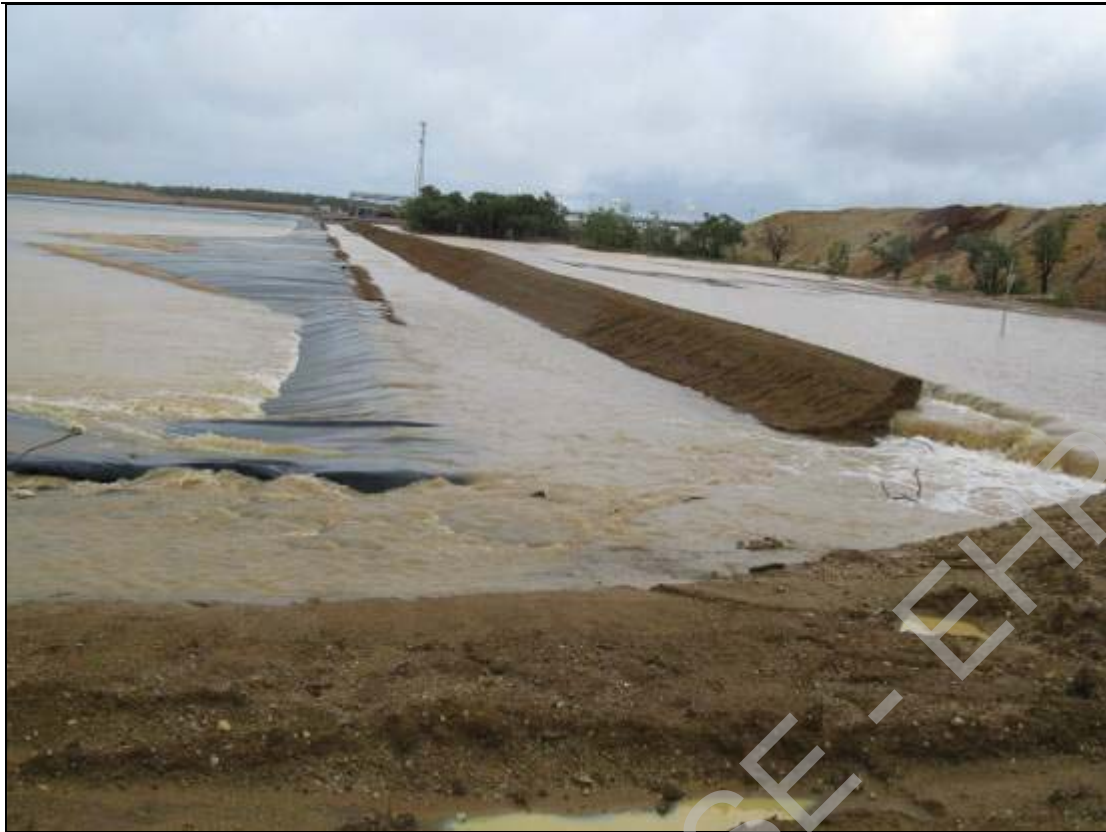
*Figure 12: SW Pond #2 looking north towards Processing (Taken 1000 on 30JAN09).*

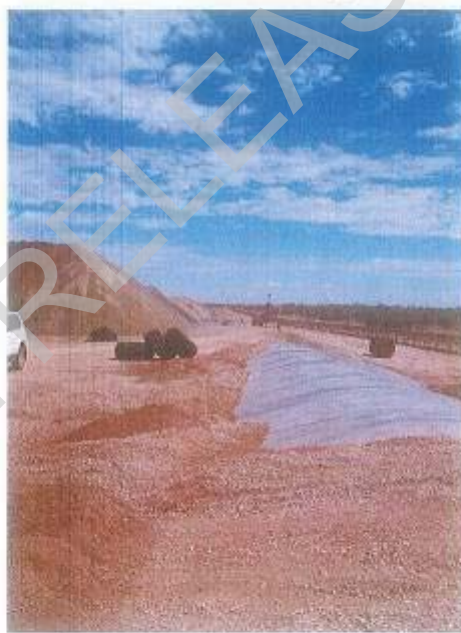
Not all sections of the leech pads were accessible due to construction of stage 2. The collection drains to the west were visible from a short distance and appeared to be in good condition. The visible elements of the liner all appeared to be in good condition.

Figure 1: Eastern side of Leech Pad Stage 1

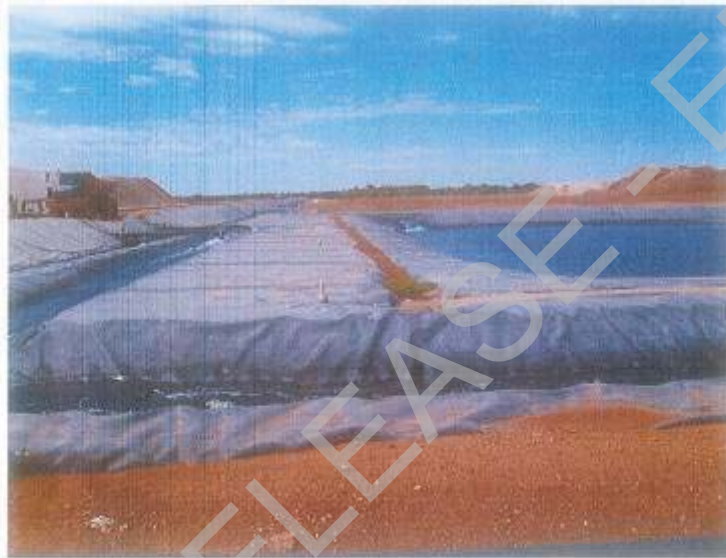
The process ponds all appeared to be in good condition. Some scour was evident in the soil bund at the top of the collection drains and above the process ponds and some of the soil had been washed into the ponds.

The liner for the process ponds and collection drains appear to be in a good condition.

Figure 2: Eastern side of Process Ponds

Repair methods should follow the original construction methods to prevent or minimise further degradation.

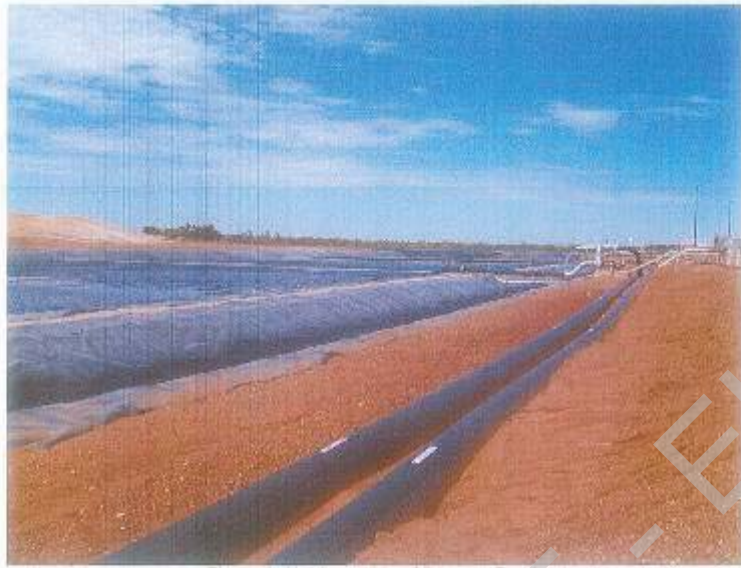
Figure 3: Northern side of Process Ponds

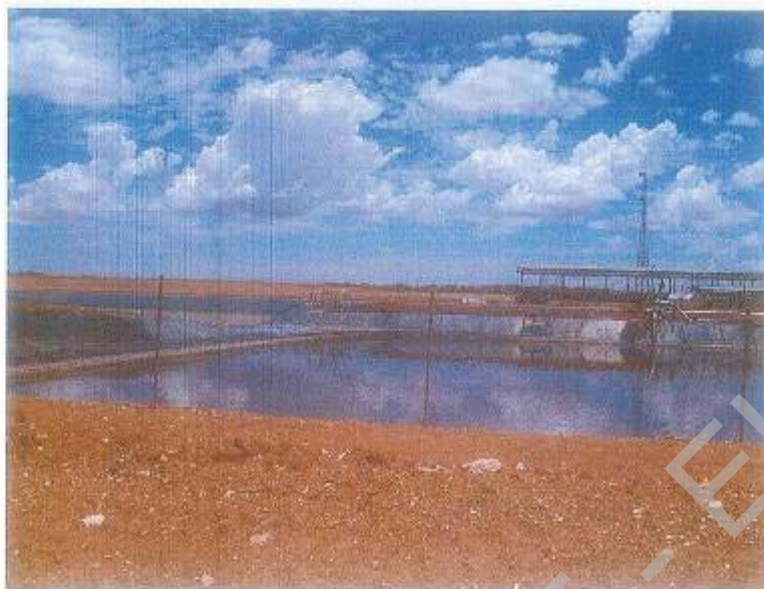
Figure 5: South Western End of Process Ponds

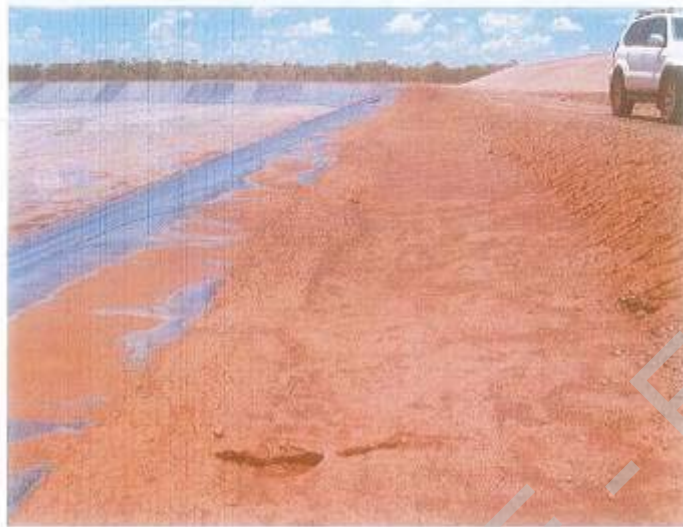
On the north side of the stormwater pond No.1 towards the eastern edge a medium sized crack in the soil was evident. It is located approximately 300mm from the edge of the liner and has been most likely formed by water soaking into the ground and settling the soil.

Some scour was evident at the crest of the stormwater ponds at this location also. This should be fixed before further degradation occurs.

Figure 6: Northern side of Stormwater Pond No. 1

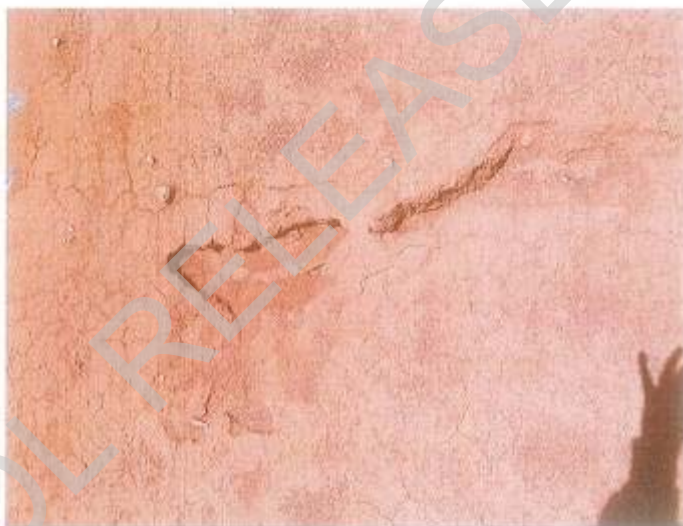
Figure 7: Depression in ground on northern side of Stormwater Pond No. 1

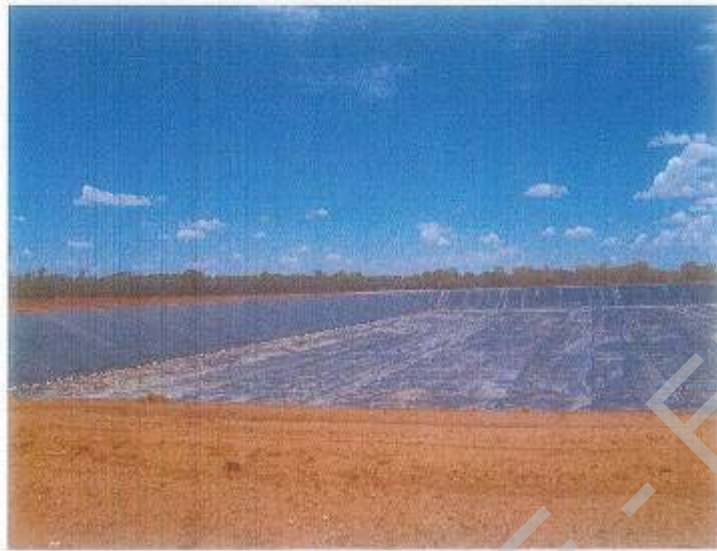
Figure 8: Southern Side of Stormwater Pond No. 2

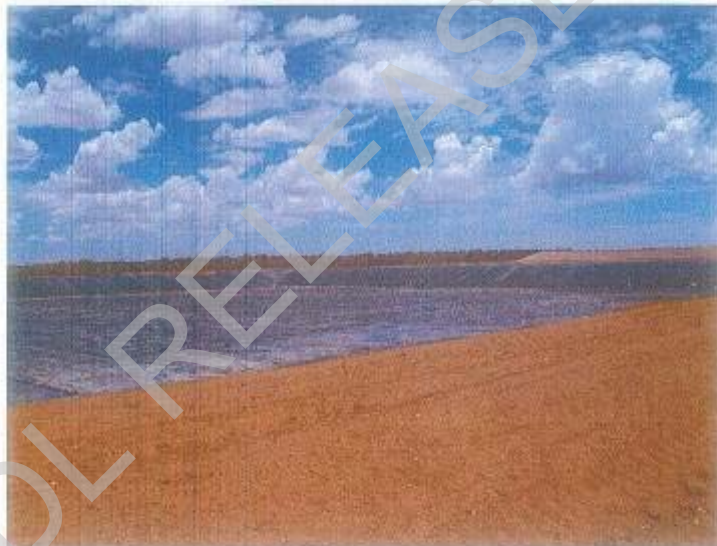
Figure 9: Stormwater pond No.2 looking to north-west

The stormwater ponds are currently empty in anticipation of seasonal storms. The visible liner appeared to be in a good condition.

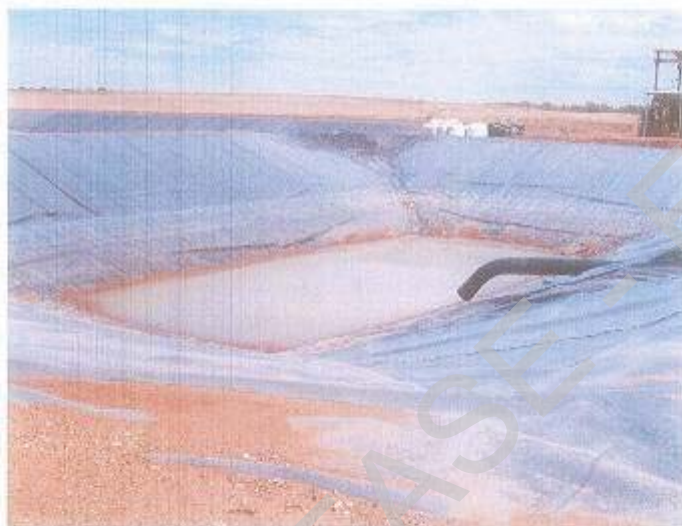
The containment pond was partially filled at the time of the inspection. The visible liner appeared to be in a good condition.

Figure 10: Containment Pond
