# Criterion Hotel, Warwick: Site Inspection Report

Queensland Heritage Register place ID 600962

On the 23 August 2019 heritage officers from the Department of Environment and Science (DES) undertook a site inspection of the Criterion Hotel at the request of the owners to inspect recent damage to the place. The Criterion Hotel is located at 84 Palmerin Street, Warwick and is entered in the Queensland Heritage Register (QHR) as a State heritage place (QHR place ID 600962). The owners and their representatives have identified that the building is showing large cracks in the front section of the building, which they state is being caused by ground shrinkage. While there is a severe drought affecting the district, the owners and their representatives allege that the ground shrinkage is being caused or exacerbated by trees planted by Southern Downs Regional Council (SDRC) in the road reserve along Palmerin Street, including in front of the Criterion Hotel. The purpose of the site visit was not to investigate the cause of the damage, but rather gather background information, assess the extent of the damage to the heritage place and provide preliminary advice on repairs.

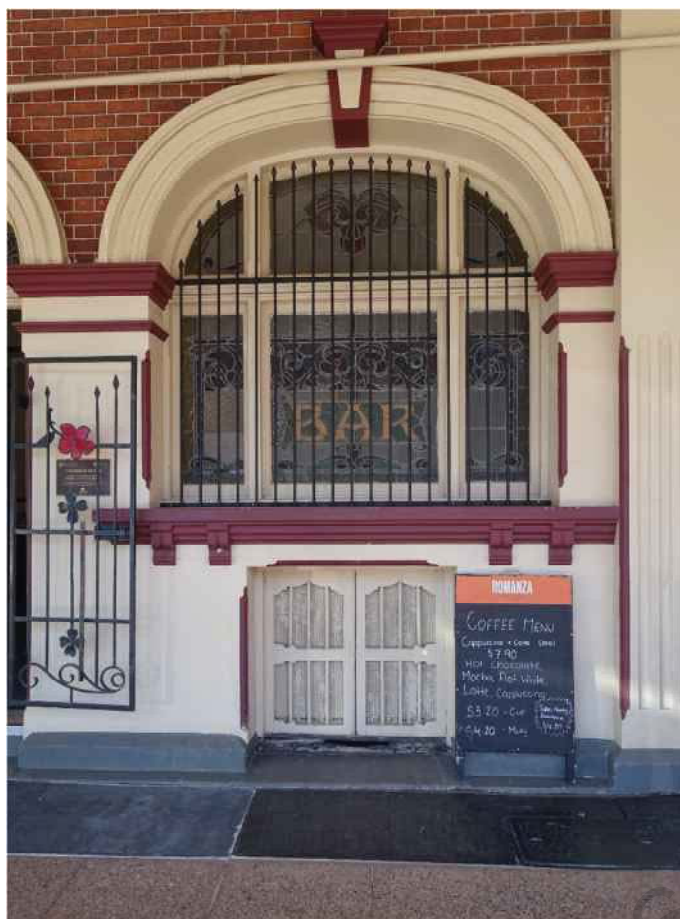
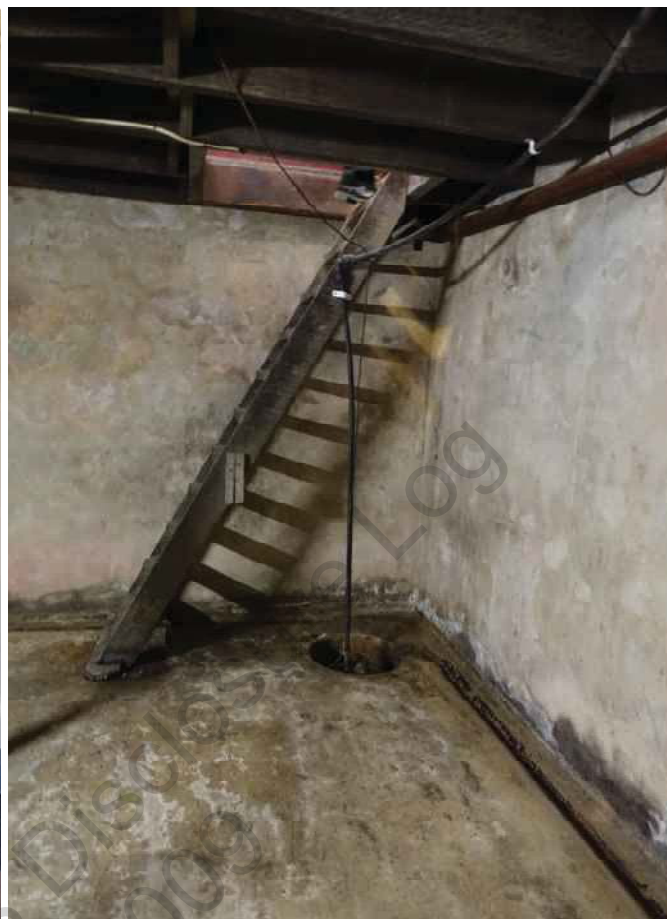
Image 13 (left): The access doors to the hotel's historic cellar in the basement (DES, 23 August 2019). Image 14 (right): the access point and ladder leading from the front north west corner of the public bar. Note the spoon drain and sump in the front right hand corner under the ladder. (DES, 23 August 2019.)

The walls are grey render and there is a concrete floor with an open spoon drain around the edge that feeds into a sump with an automated water pump; the sump contained water. Advice on site from the owner was that they removed an elevated tank above the first floor. This is complimented by historical research in the *Warwick Daily News* on 24 March 1924 (p.4) that indicates that a water bore was previously accessed on site.

There is clear evidence of water staining and efflorescence in the lower portions of the rendered wall immediately above the spoon drain. It is understood from discussions with the owner that there has been previous flooding in the basement, up to 300mm above the basement floor level, due to the pump not working. This height appears to align with the water staining and efflorescence migrating to the surface. The flooding had been rectified within the last 6 months. It should be noted that application of a moisture barrier or acrylic paint on the walls is not recommended as the problem may result in irreversible damage to the substrate and may allow the salts to become trapped under non-permeable coatings. The sump and pump needs to be routinely checked to ensure rising ground water (presumably from a bore) does not exacerbate long term issues within the basement.

It is noted some repair works have been undertaken to the walls with a high cement content in the render mix. It is suggested these repairs be removed and rendered with a compatible mix that matches the original render. It would be expected that a render dating to 1917 would have a high lime content and may contain little or no cement within the mix. These repair works are recommended to be undertaken by a contractor who is familiar with lime renders and buildings of this period.

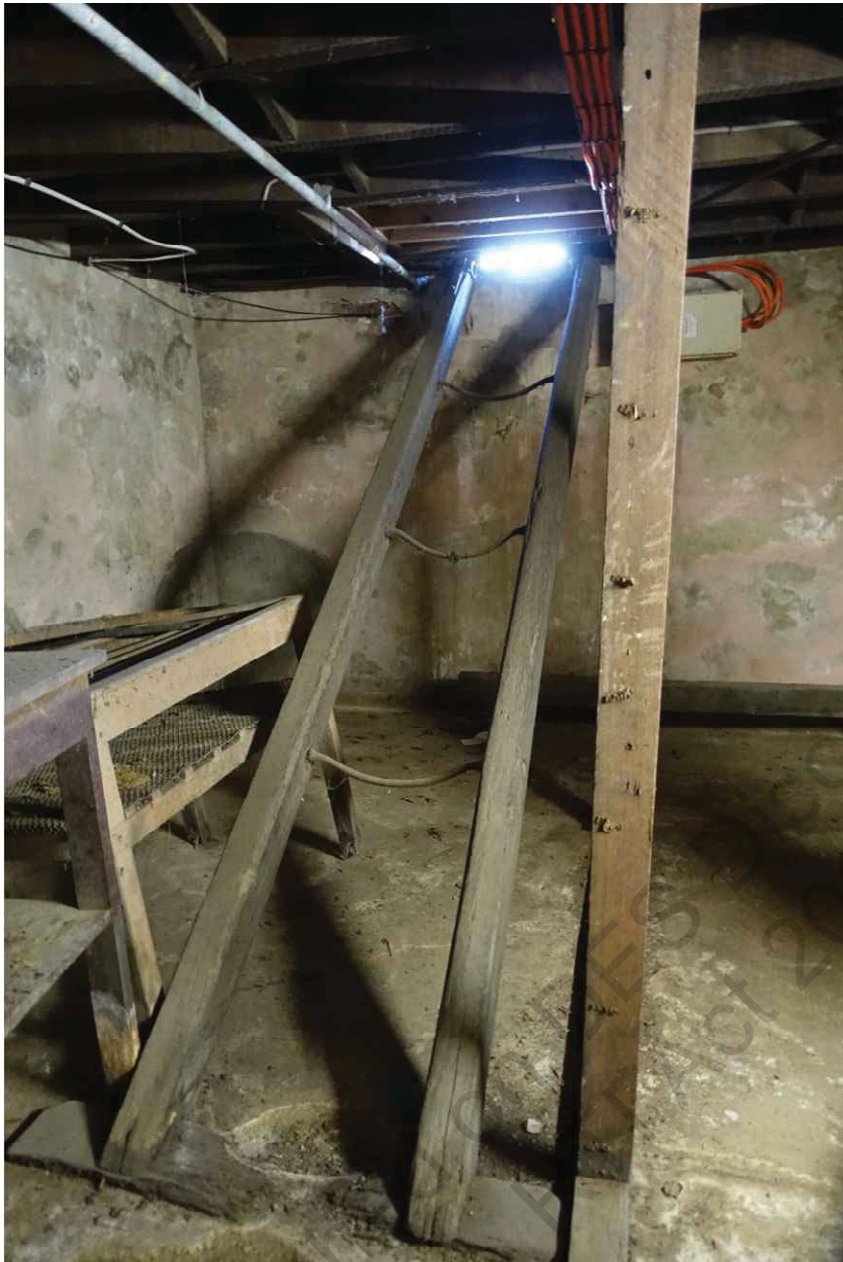
Image 14a (left): The internal keg loading ramp from Palmerin Street (DES, 23 August 2019).
