**RE: Follow-up report on Jackson 15 flowline leak**

**Photographs of Incident: Jackson #38 oil release**

Photographs of Remediation Progress: Jackson #38 oil release

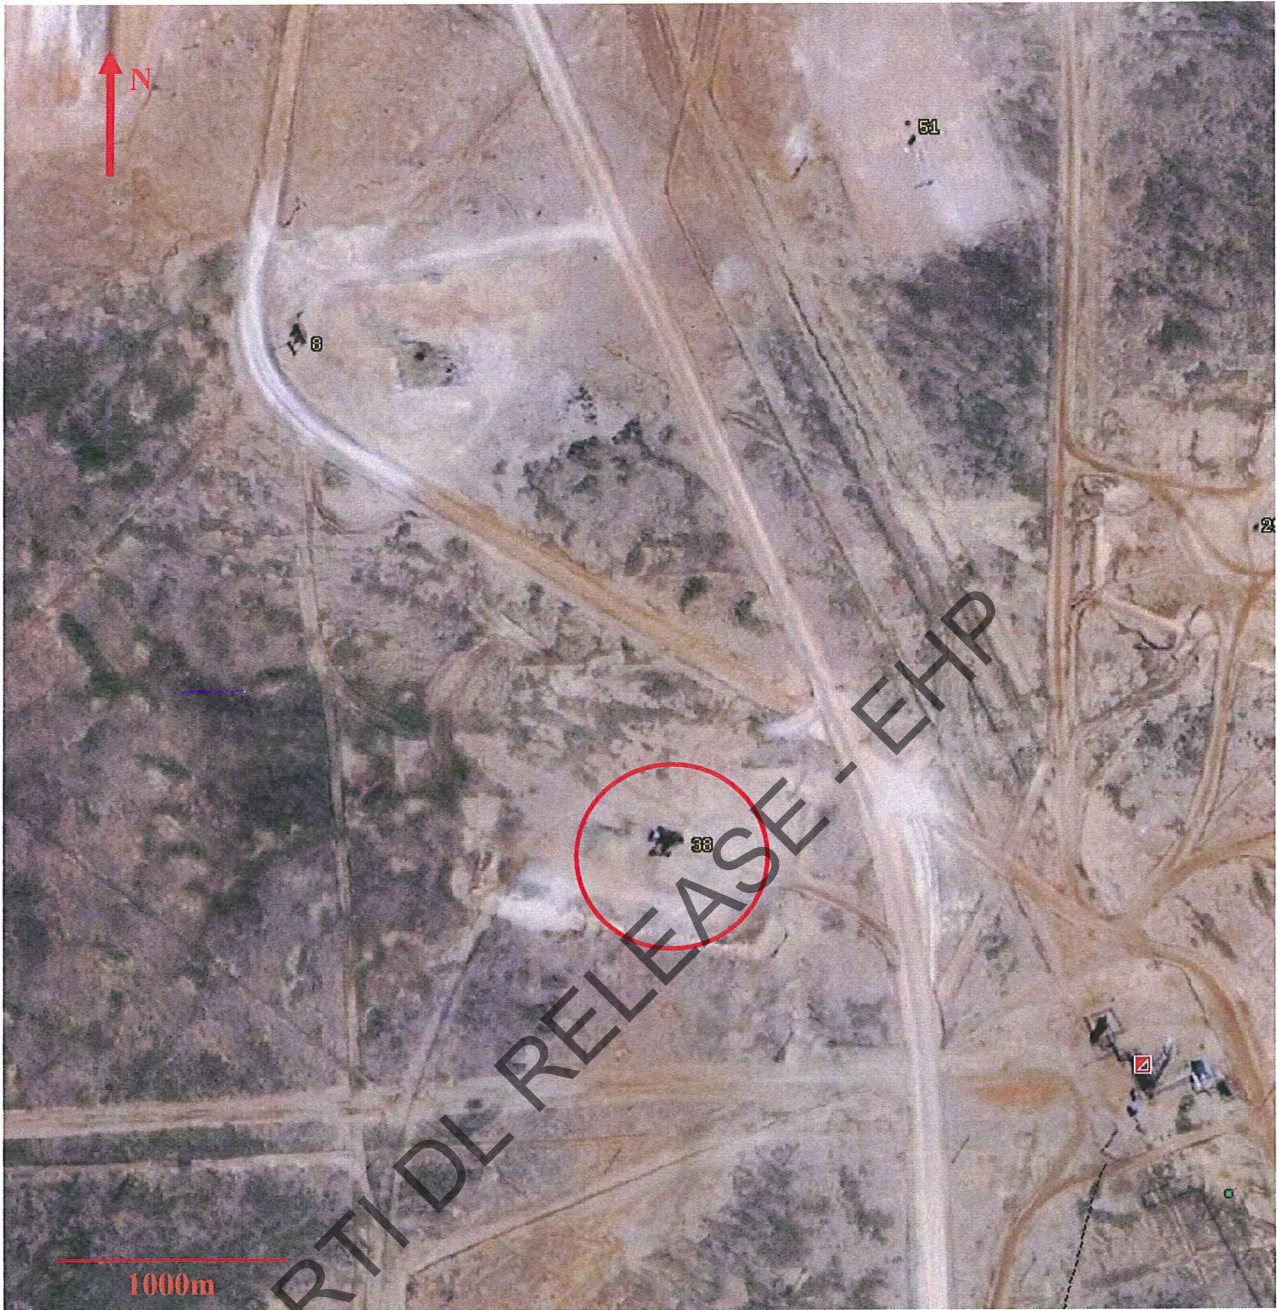
The release was discovered at Jackson #38 at 0830 hours on Thursday 16 September. Jackson #38 is a producing oil well with a beam pump. Currently, fluid from Jackson #38 is approximately 88% produced water. The pump has an environmental stuffing box (ESB) installed to minimise leaks from the pump shaft. The beam pump packers failed and released hydrocarbon to the ESB. As the ESB filled, as expected, it tripped the well closed, preventing a hydrocarbon release. The non-return valve (NRV) in the piping connecting Jackson #38 to the local manifold was passing, allowing backflow from other wells connected to the same manifold. Consequently the well head cellar filled and overflowed.

Incident investigation has identified that a piece of rod guide material had become lodged in the NRV seat preventing the valve from closing. The NRV has been scheduled for replacement.

Aerial photograph showing location of Jackson #38

- Non return valve replaced with a new valve – proactive
- Well rod packers replaced
- Environmental stuffing box inspected
- Well head cellar emptied
