DEVINE BELMONT ESTATES PTY LIMITED

DECONTAMINATION

HO10070  
MAY 1990

HOLLINGSWORTH DAMES & MOORE

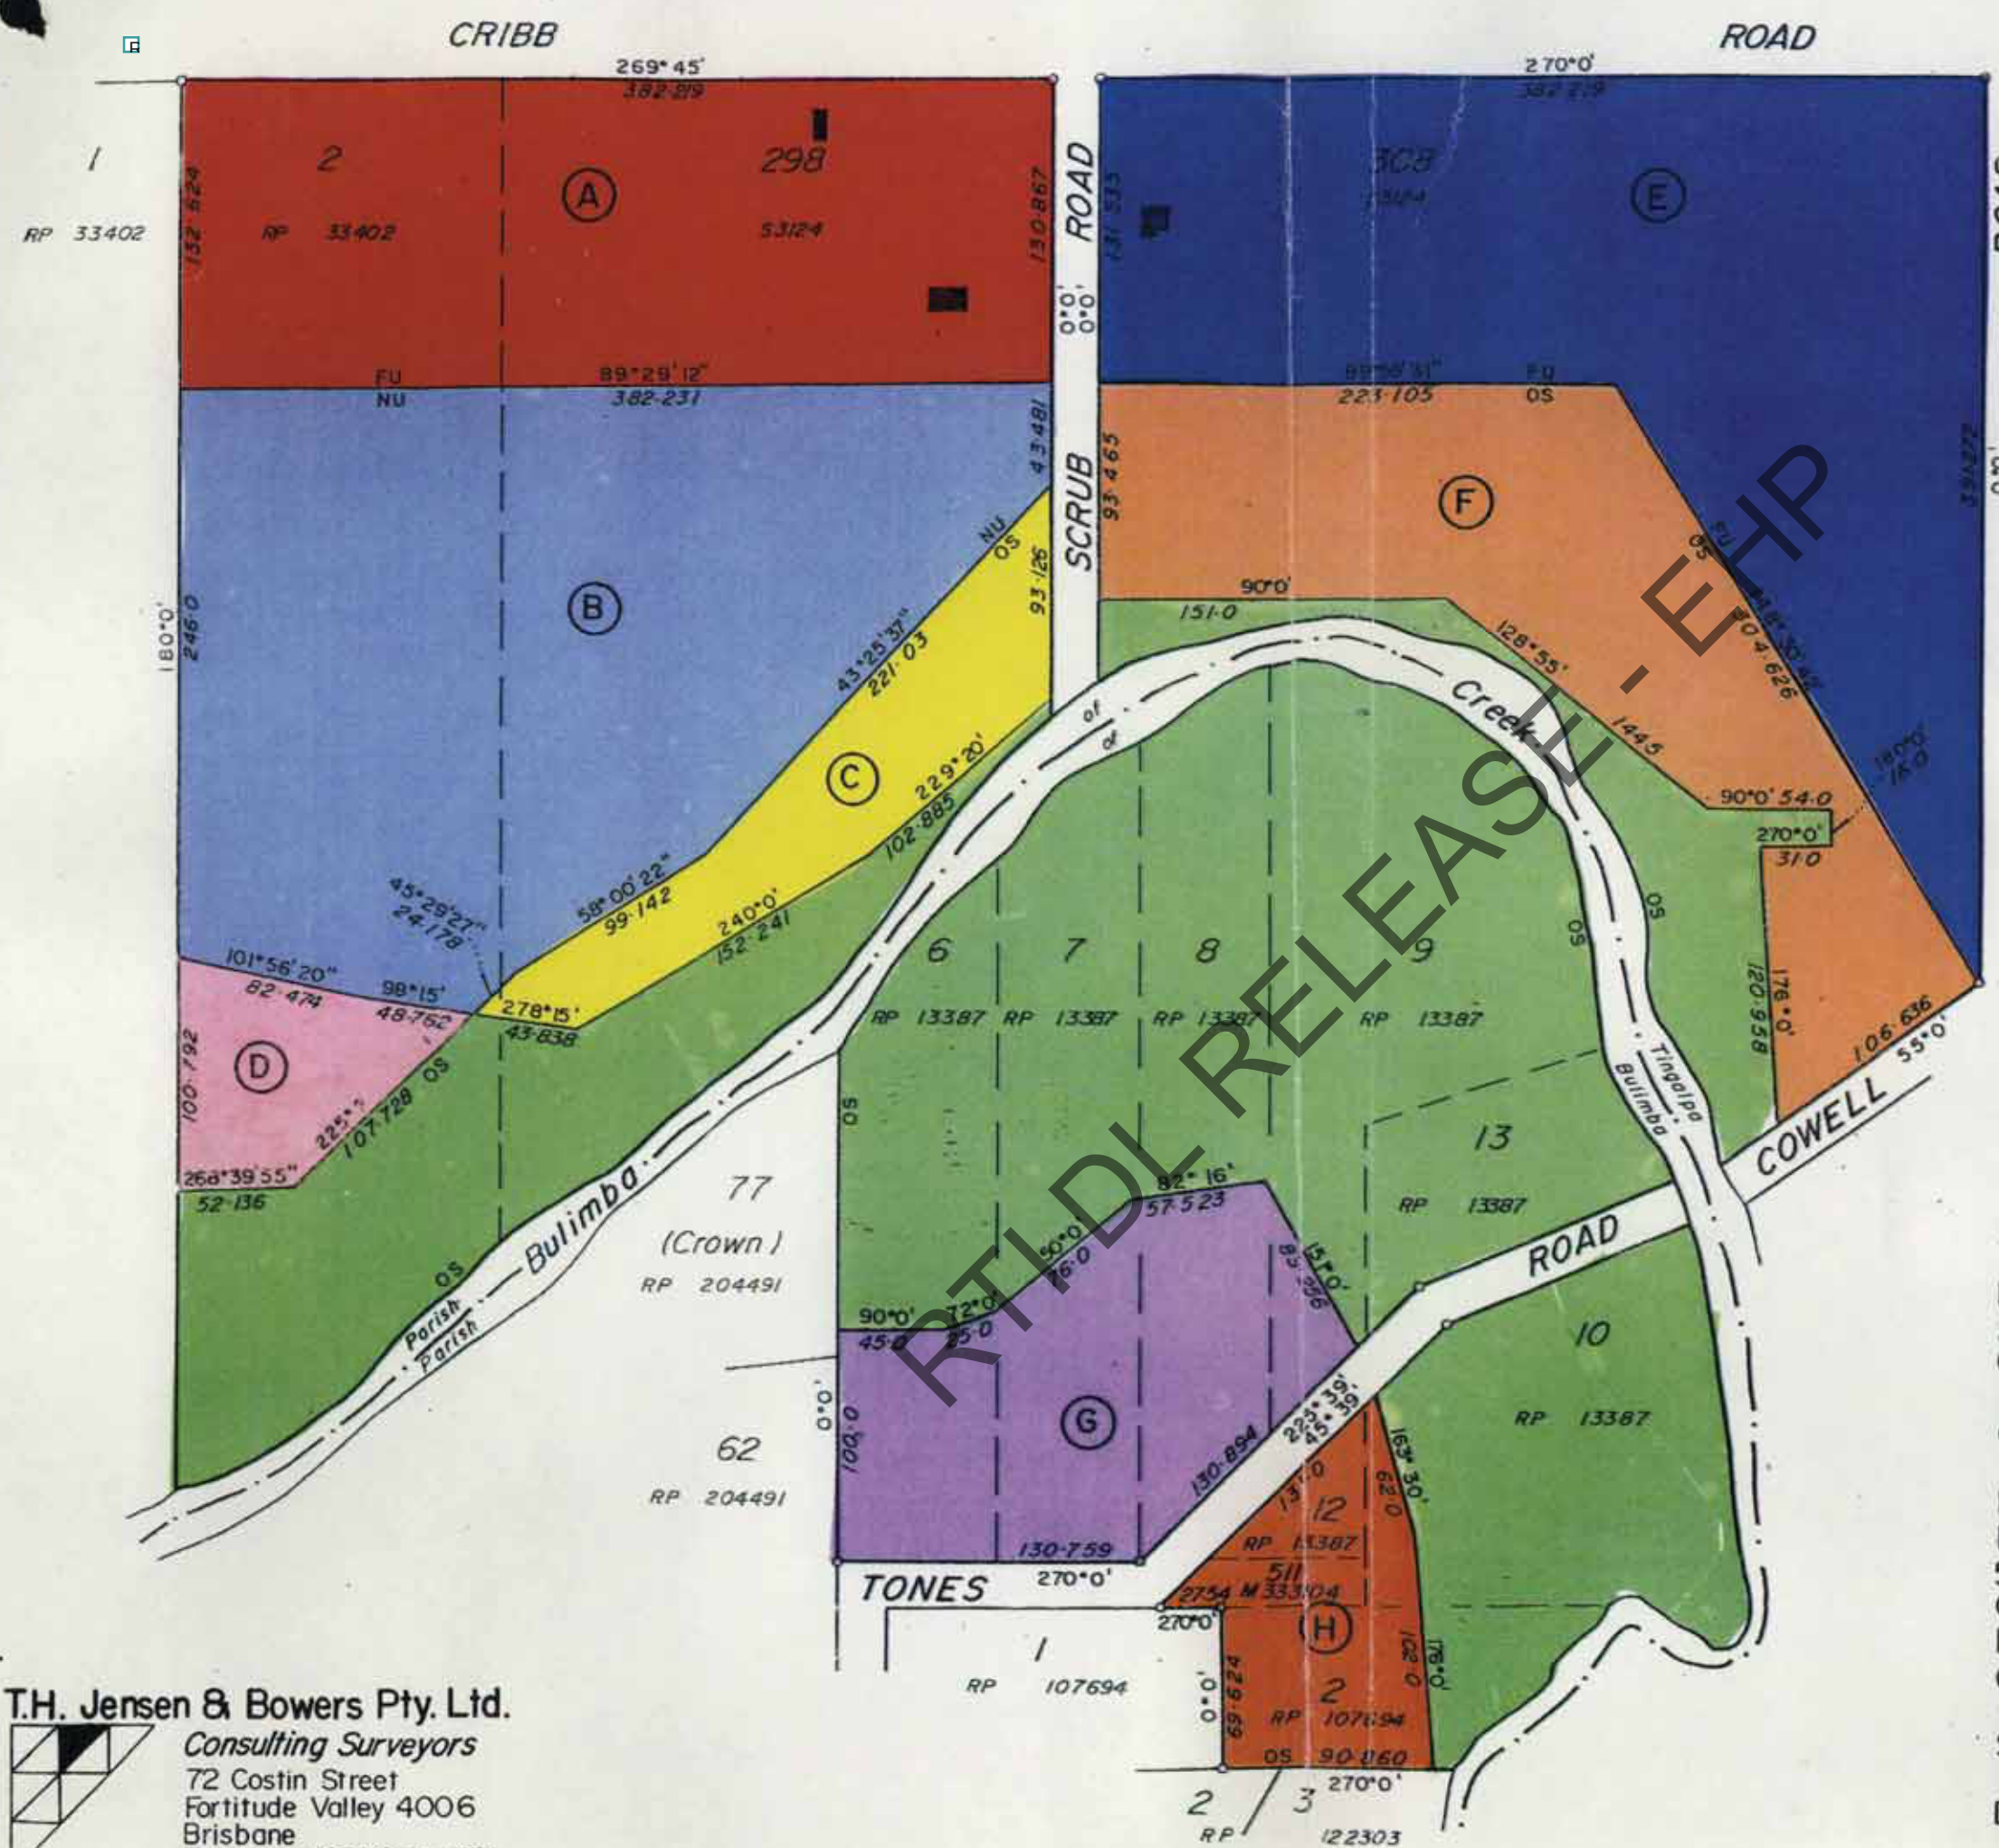
- (b) Sections C and D were found to not contain contamination levels greater than 50mg/kg.
- (c) Some areas of section B (as shown in Figure 2) were found to contain arsenic contamination levels greater than 50mg/kg.

In accordance with the processes as set out in this report the soil disposed of to locations (b) and (c) was first tested and, if necessary, mixed with clean soil, so that the concentration of arsenic was less than 50mg/kg in accordance with CHEM unit recommendations.
