## SONOMA MINE MANAGEMENT PTY LTD

### Two Mile Creek Diversion Operations Monitoring 2019

Sonoma Coal Mine

June 2019

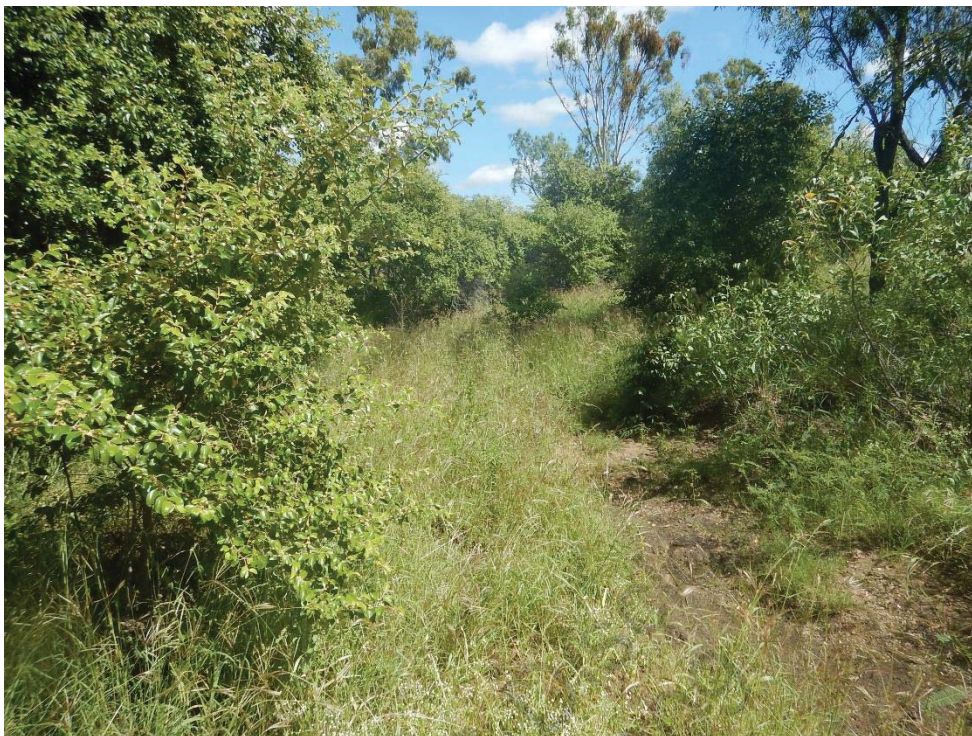
- There is increased ground cover along the waterway including in the bed of the channel at some locations (Figure 6.2). This is despite the below average annual rainfall and is likely due to the late season rainfall in the months prior to the inspection.

Figure 6.2 Grass Establishment in Channel At TMC-US2

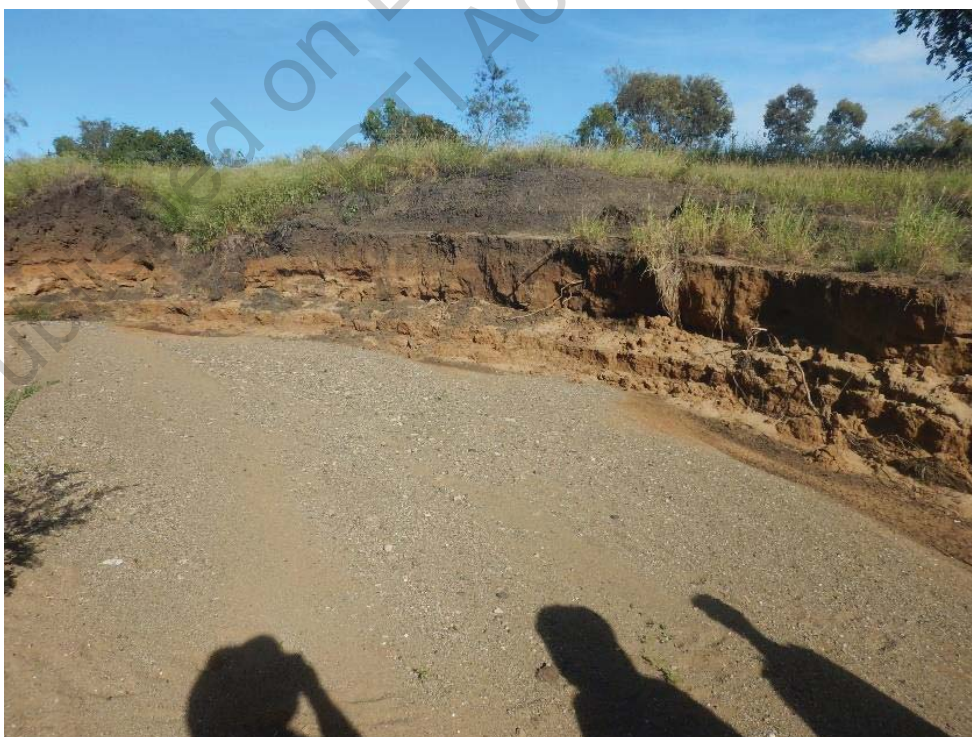
- Southern Tributary (TMC-US3 and TMC-US4):
- The southern tributary is generally in a similar condition to the northern reach.
  - As with the Northern Tributary, bank erosion and steepening were evident at a number of locations along the waterway (Figure 6.3 and Figure 6.4). This is generally consistent with previous inspections and the condition appears to be relatively stable.

Figure 6.3 Bank Erosion Upstream Of TMC-US4

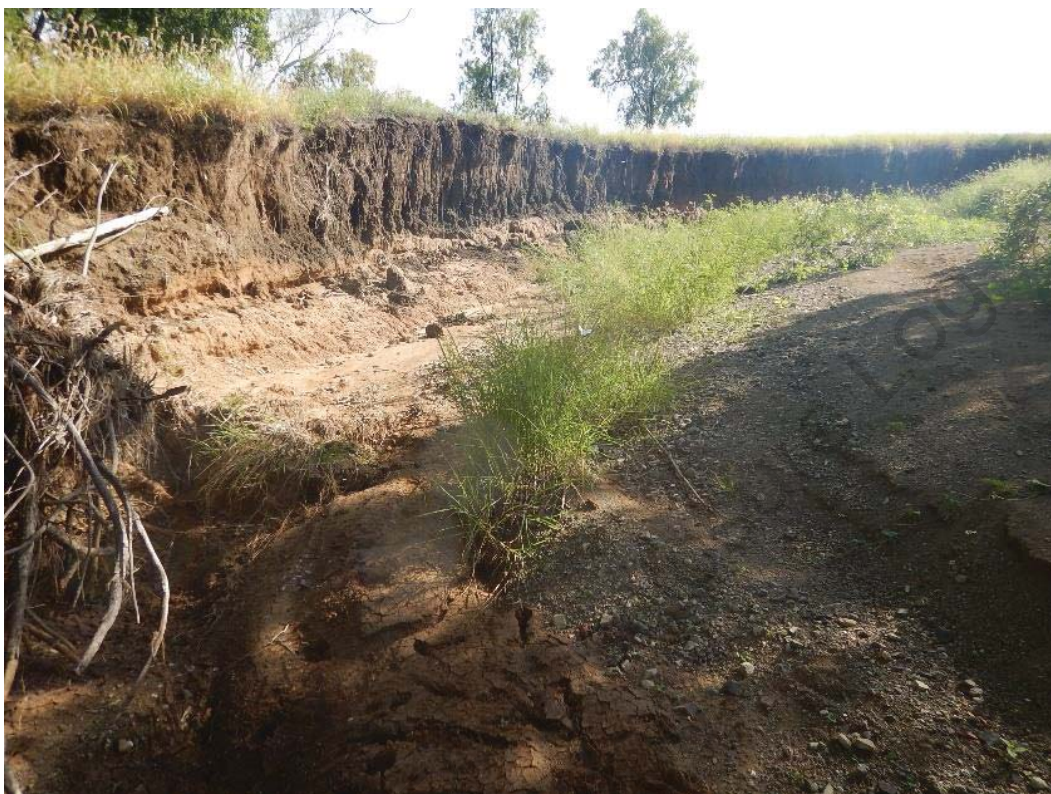
Figure 6.4 Bank Erosion Upstream Of TMC-US4

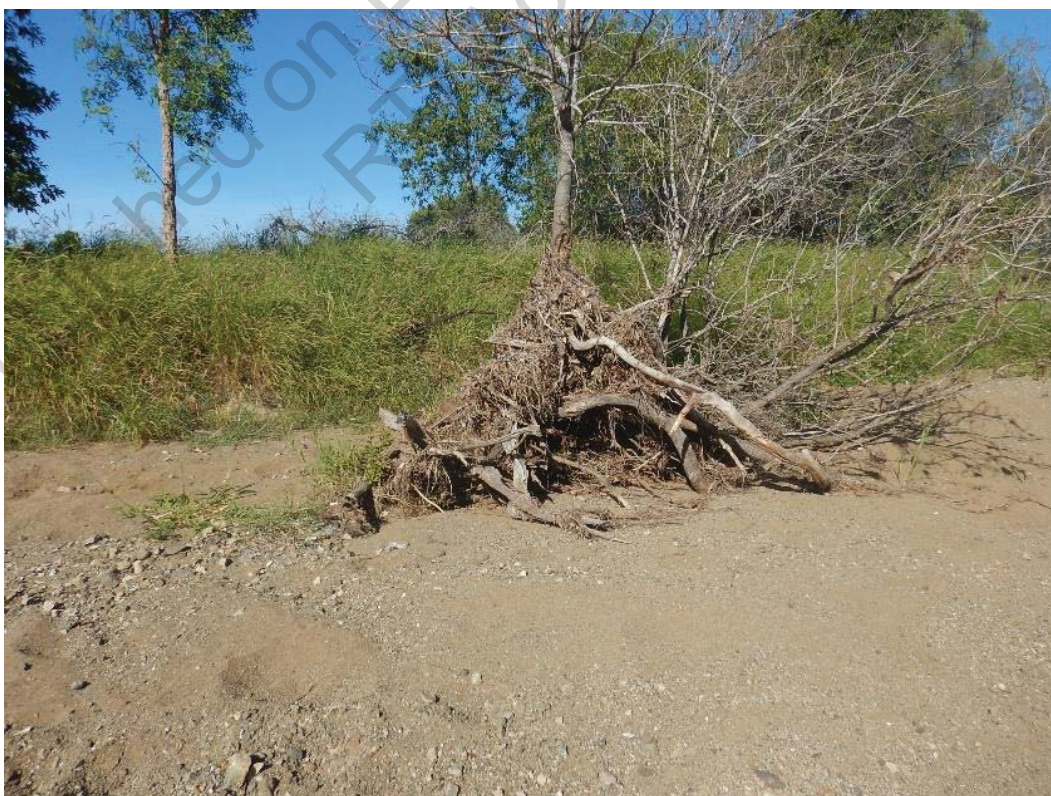
- Flood debris and fallen trees remained evident throughout the reach (Figure 6.5) and are attributed to the rainfall and strong winds during previous storm events (e.g. Tropical Cyclone Debbie).

Figure 6.5 Flood Debris Upstream Of TMC-US4

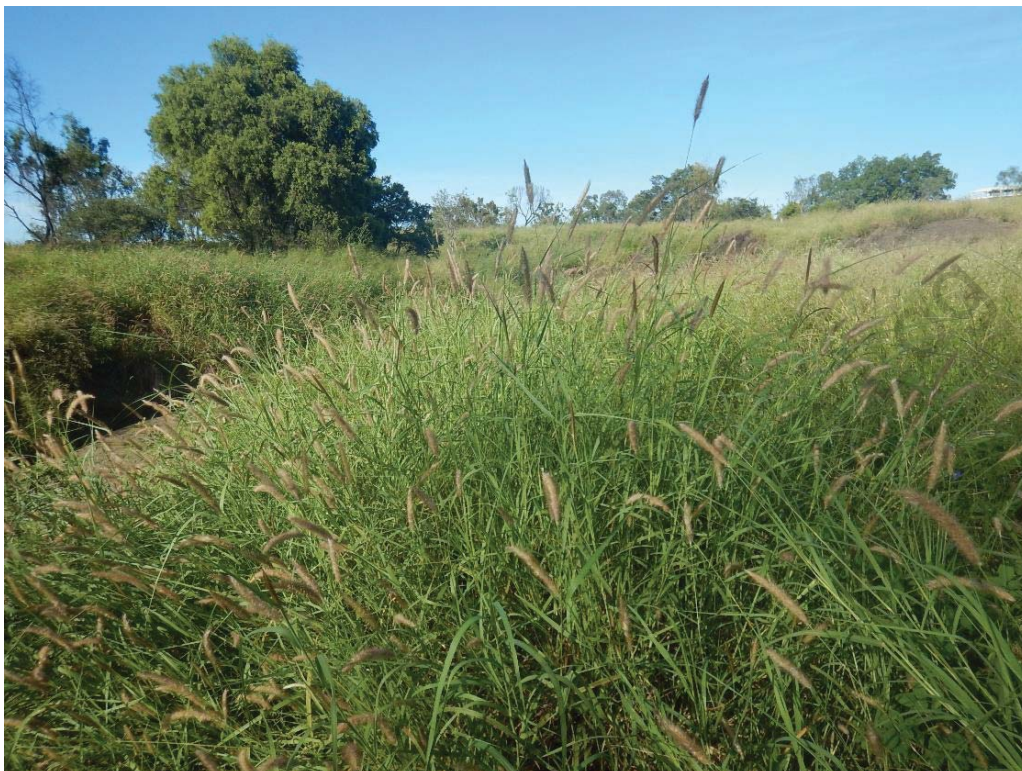
- Increased ground cover was observed along the waterway including on benches and some of the previous eroded batters (Figure 6.6).
  - Small residual pools were observed in several locations along the Southern Tributary (Figure 6.7).

Figure 6.6 Grass Establishment on Bench and Batters At TMC-US4

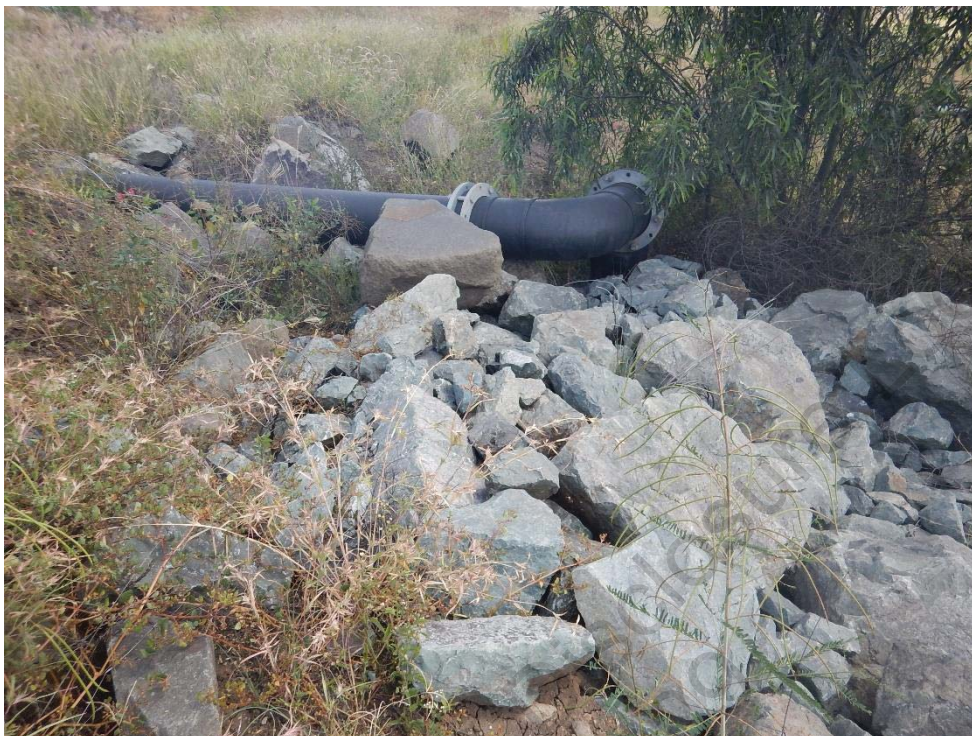
Figure 6.17 Vegetation Establishment at Location of Previous Scour at Outlet of SD5 Gravity Discharge Pipe

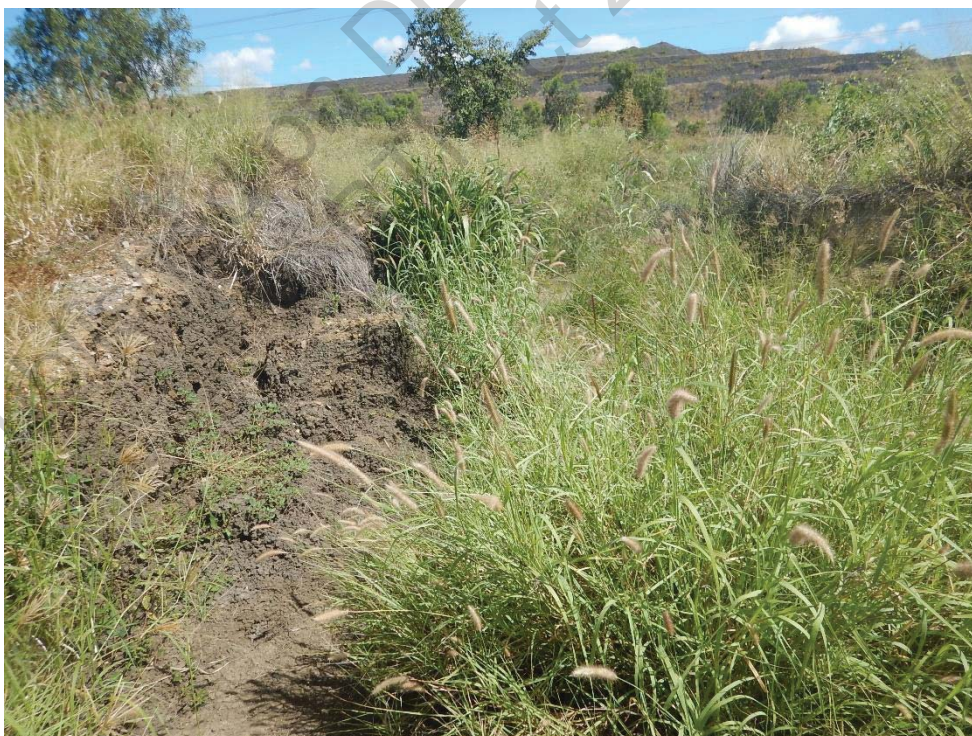
Figure 6.18 View Along Erosion Gully on Left Bank of Diversion Downstream Of TMC-Div2

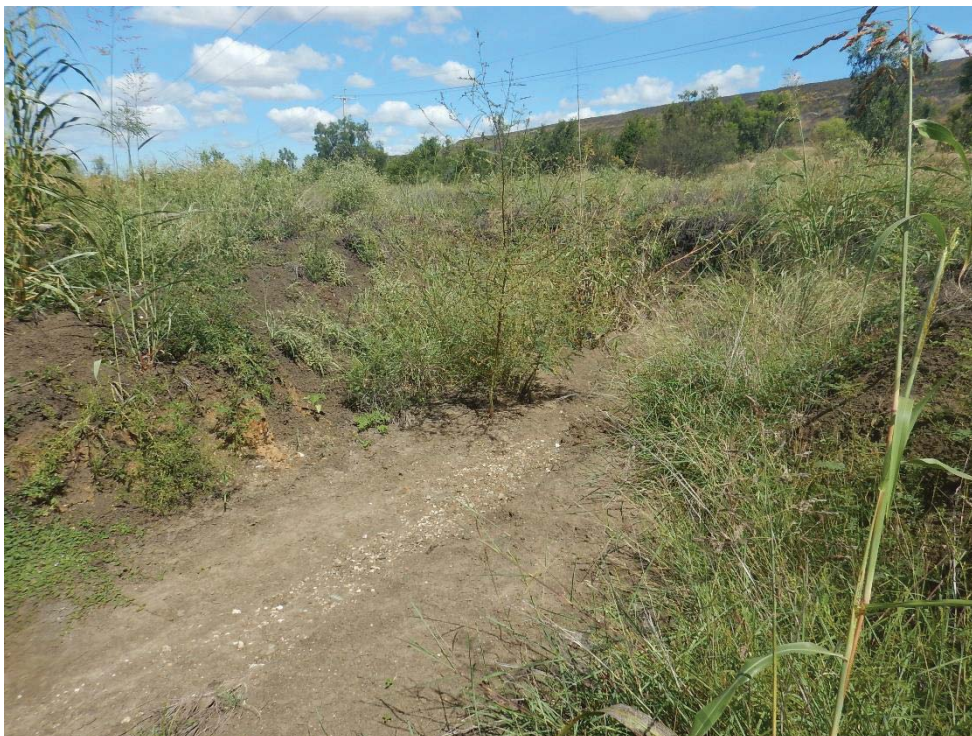
Figure 6.19 Upstream Limit of Erosion Gully (View Towards SD5 and MIA)

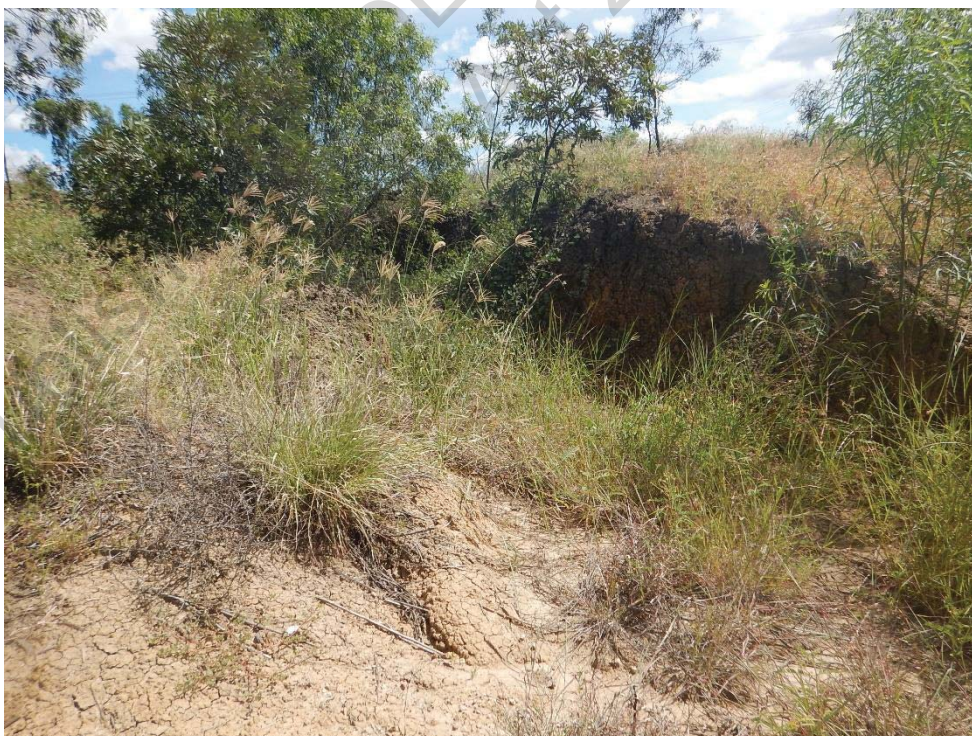
Figure 6.20 Secondary Smaller Erosion Gully Near Light Vehicle Road Crossing

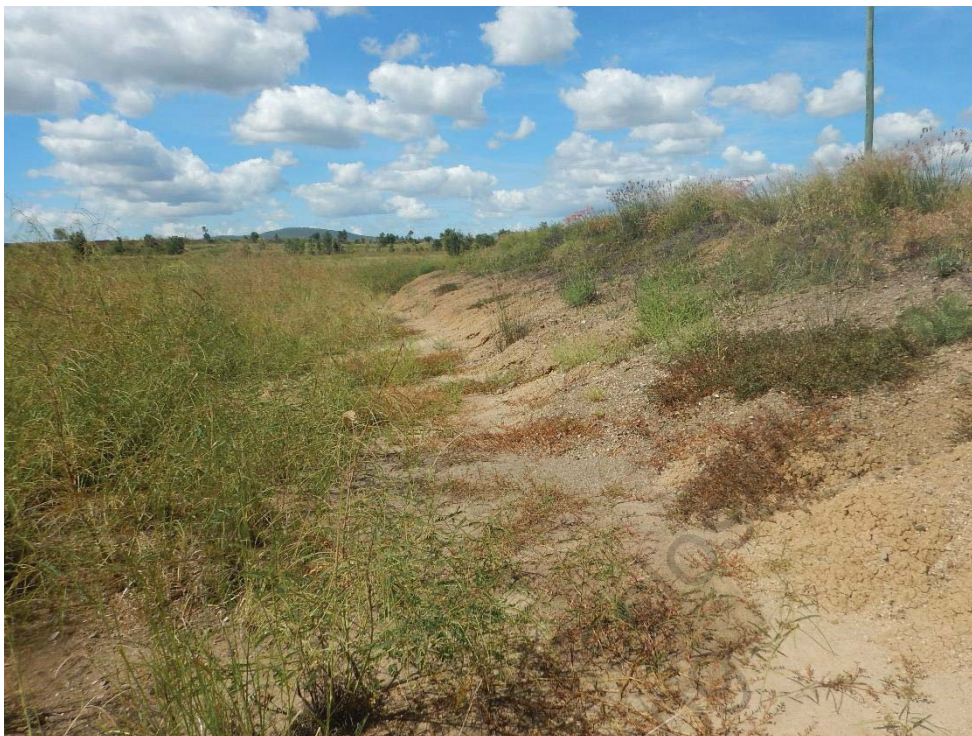
Figure 6.21 Scour at Toe of Embankment Upstream of Light Vehicle Road Crossing

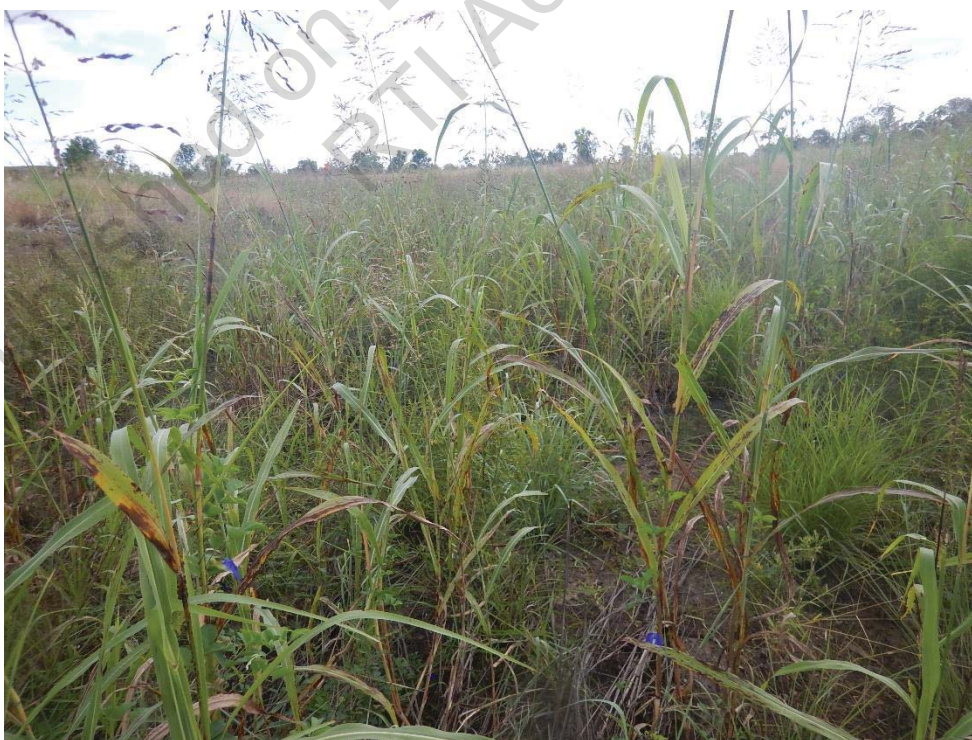
Figure 6.24 Vegetation Establishment in Bed of Channel At TMC-Div4

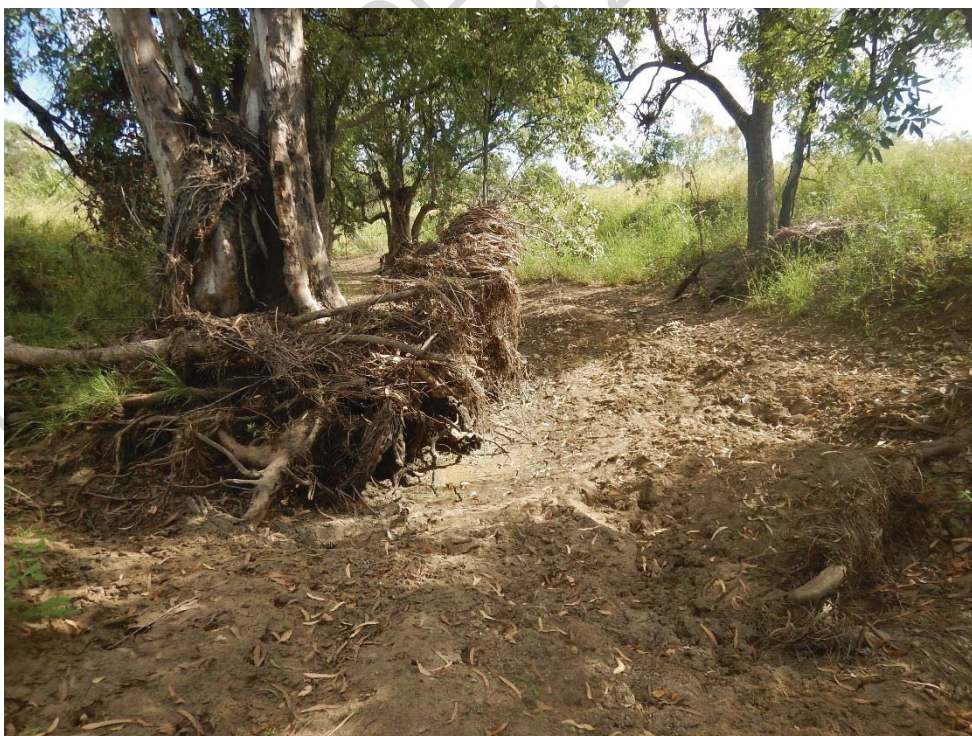
Figure 6.27 Flood Debris Downstream Of TMC-DS1

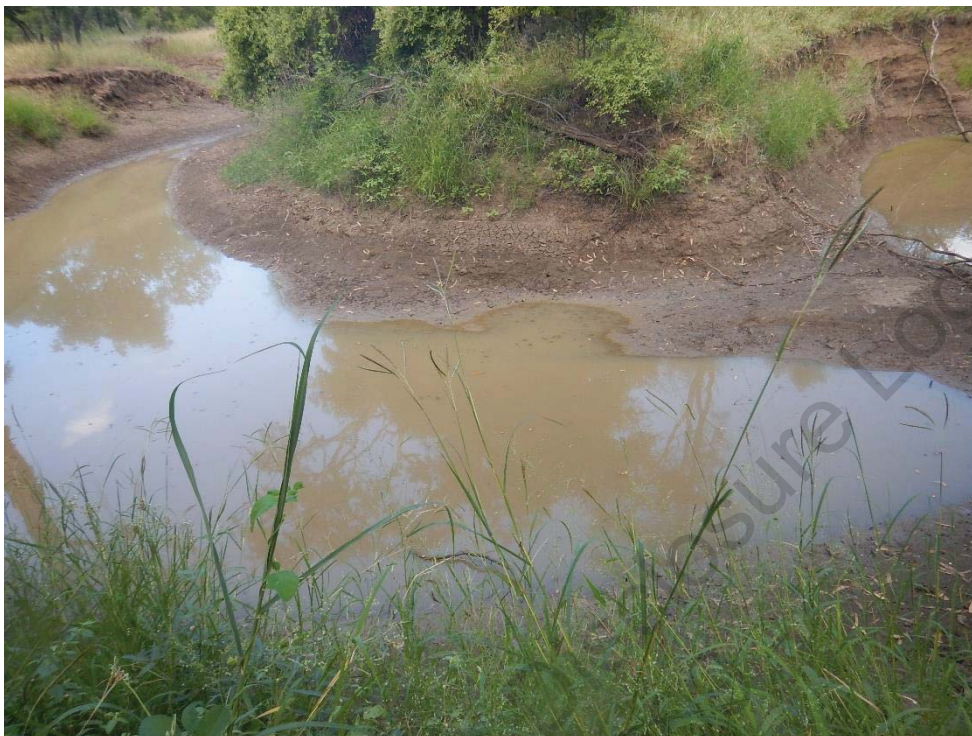
Figure 6.28 Ponding At TMC-DS3

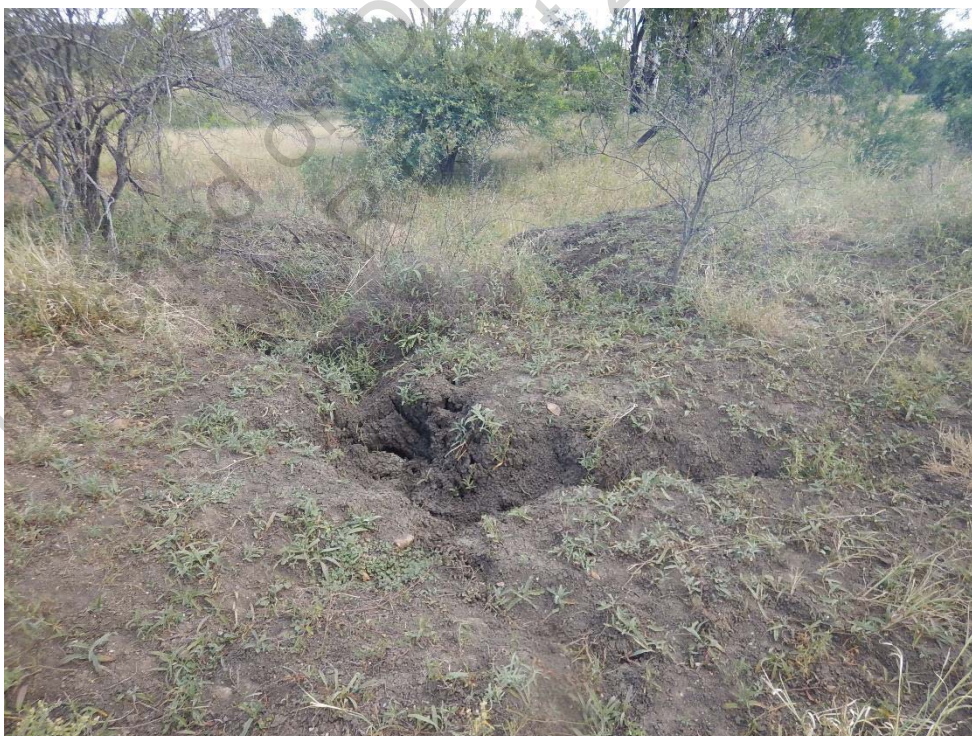
Figure 6.29 Gully Erosion on Right Bank Downstream Of TMC-DS3

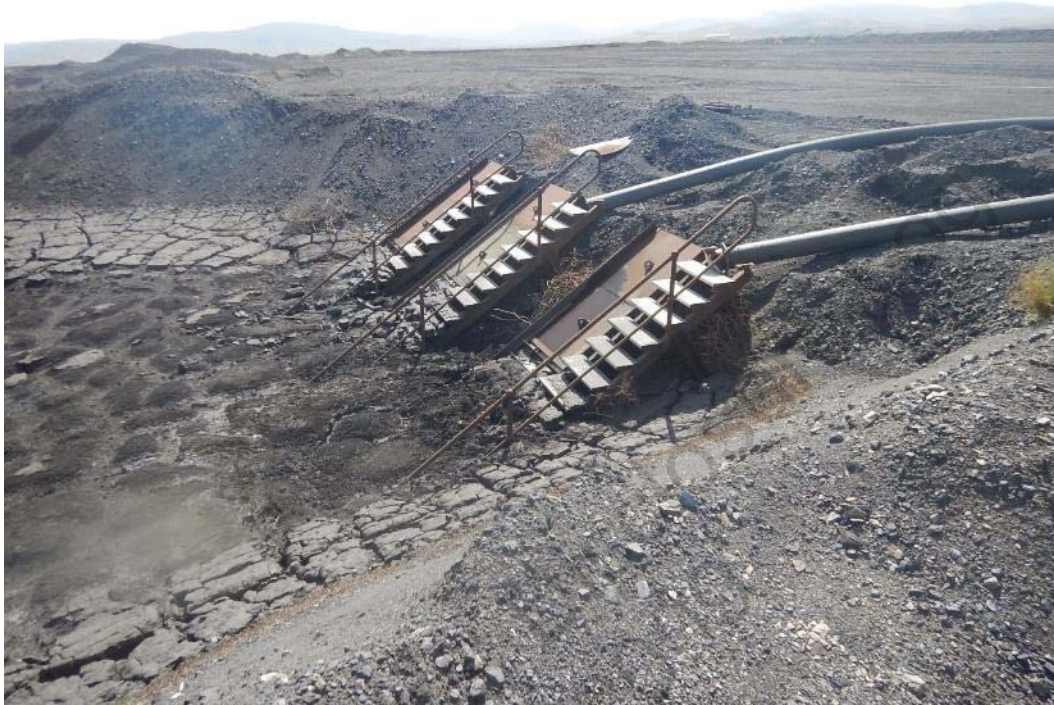
Photo 3 Decant Inlet Structure

3. Rainfall falling onto CDA1/2 is directed into the eastern solution trench via a decant inlet structure and pipelines (Photo 3 in Appendix A). Two pipelines were discharging into the CDA1/2 decant inlet structure at the time of the inspection (Photo 17 in Appendix A). These pipelines were transferring water from the Cell 3 Decant Pond as discussed in Section 3. It is understood that prior to finalisation of the annual inspection report, the need for these pump transfer pipelines was resolved and they have now been removed from the CDA1/2 decant inlet structure.

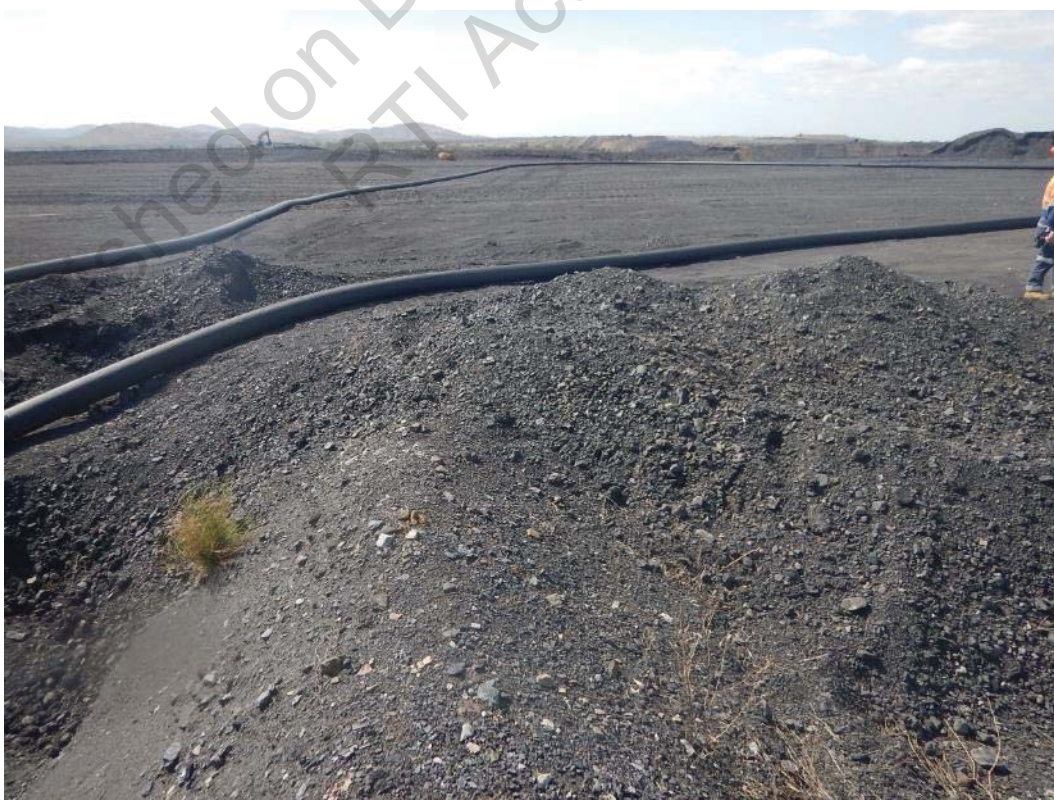
Photo 4 Re-shaping of Southern End of CDA1/2 to Form Overflow to Cell 3

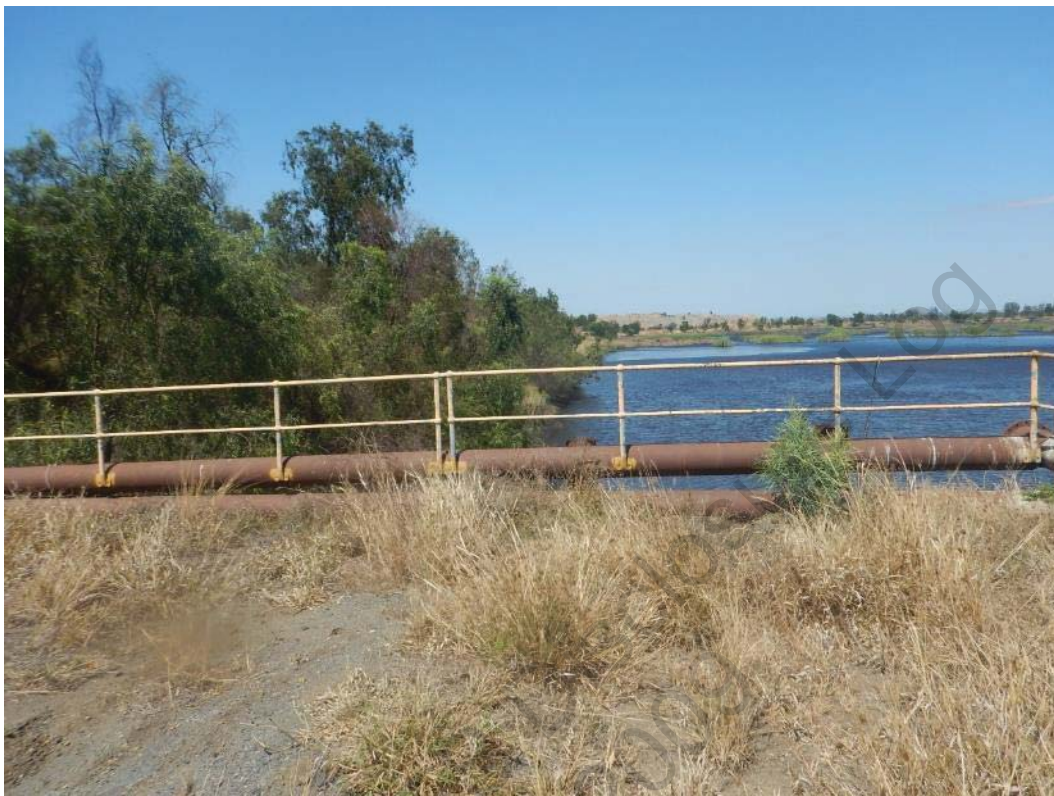
7. Large established trees are growing on the northern starter embankment adjacent to the Return Water Dam (Photo 1 and 5 in Appendix A).
8. Seepage expression through the first lift reject wall (first wall above the top of the starter bund) was observed at numerous locations along the northern and western sides of CDA1/2 (Photos 7, 8 and 10 in Appendix A). There were no visible signs of instability in the rejects wall or starter walls. The most significant seepage flows were observed at the toe of the first lift reject wall near the south-western corner of Cell 2 (Photos 8 and 10 in Appendix A) adjacent to Cell 3. Given the period of time since rejects were deposited in CDA1/2 and the proximity of the Cell 2 seepage flows to Cell 3, it is considered likely that water from Cell 3 may have seeped through the internal wall and into Cell 2 and expressed on the outer wall. The seepage flows along the western side of Cell 2 were expressing up to 1 m above the base of the drain on the inside of the starter bund and appeared to be consistent with what was observed in the 2018 annual inspection, despite the higher decant pond level in Cell 3. Given that the elevation of the Cell 3 water level will continue to increase with ongoing rejects deposition in CDA3/4, the elevated phreatic surface level along the western side of Cell 2 is a potential stability concern. It is recommended that a review of the original stability analyses for the dam be undertaken and additional stability analyses be performed if the current phreatic surface conditions in the dam differs significantly from that assumed in the original stability analyses.

Photo 5 Return Water Dam and Trees Growing on Return Water Dam Batter and Northern Starter Bund

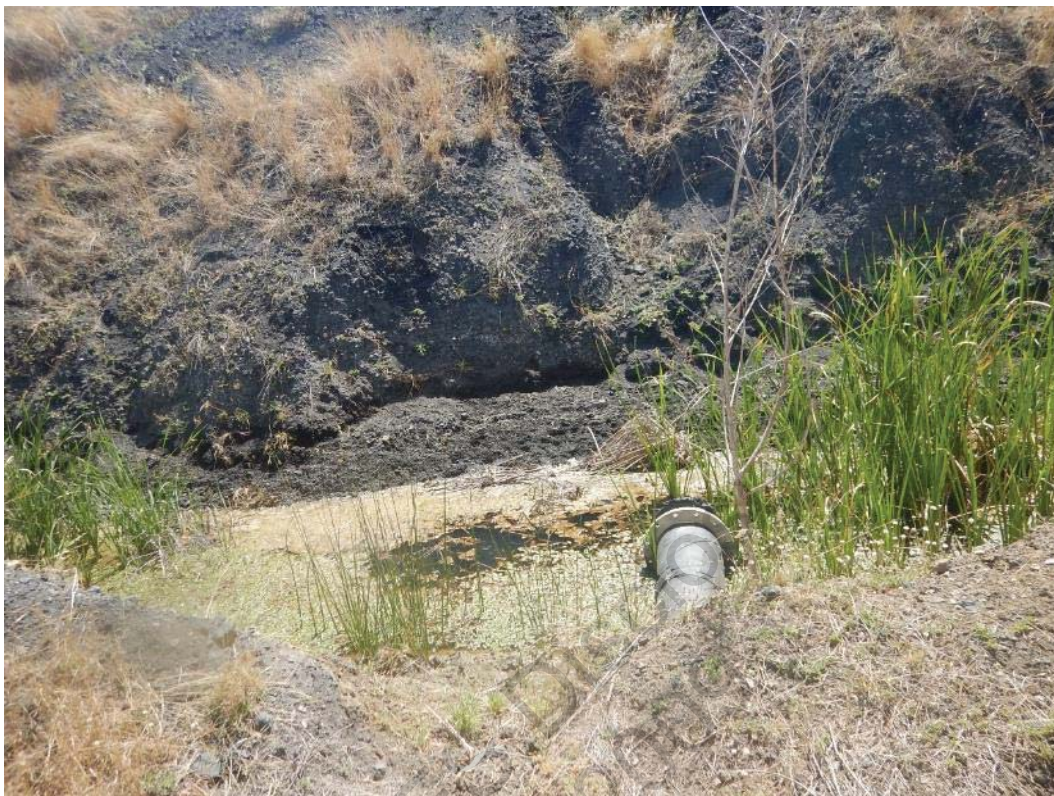
11. Generally, drainage inside the starter bund around the three sides of CDA1/2 (between the toe of the first external coarse reject wall and the starter wall) is fair, with seepage flows and ponding observed in numerous places. Ponding is due to either high invert levels of seepage relief pipes, drain grade or blockage by reeds/sedimentation (Photo 7 in Appendix A).

Photo 7 Ponding in Drain above Starter Bund - Northern Side of Cells 1 and 2

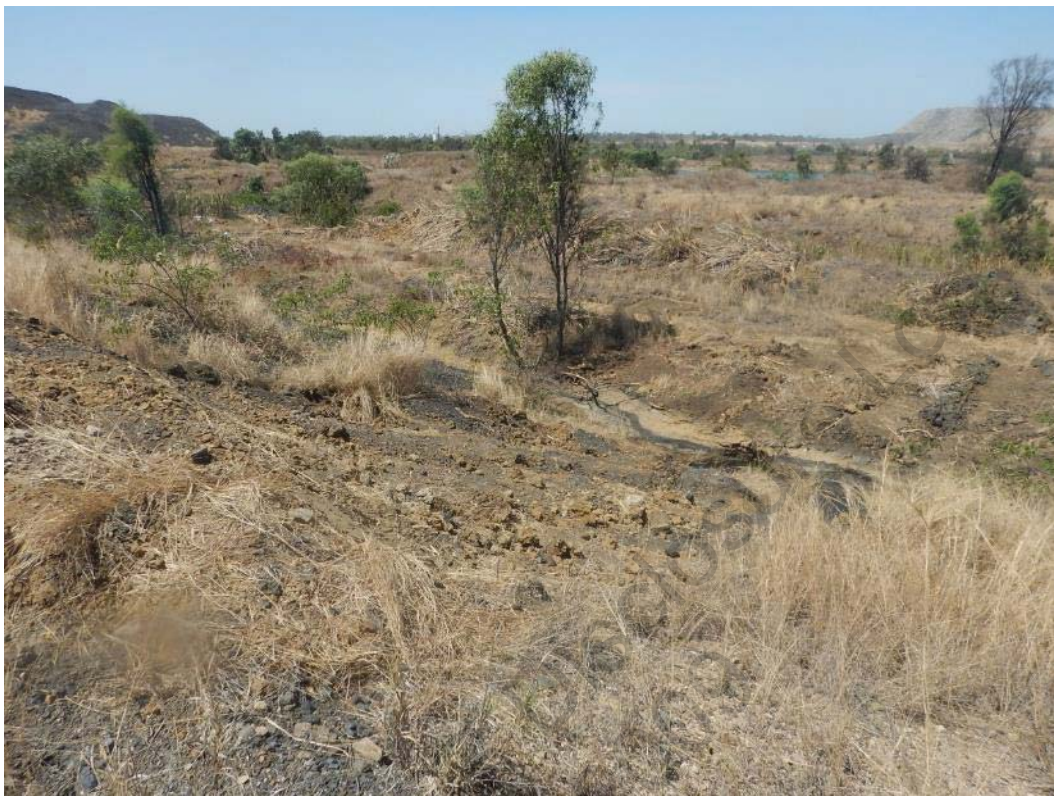
Photo 9 Western Solution Trench

5. The downstream embankments of the starter walls appeared to be in reasonable condition with moderate grass cover and generally no evidence of erosion of the batters from surface runoff (Photos 8, 9, 12 and 13 in Appendix A).

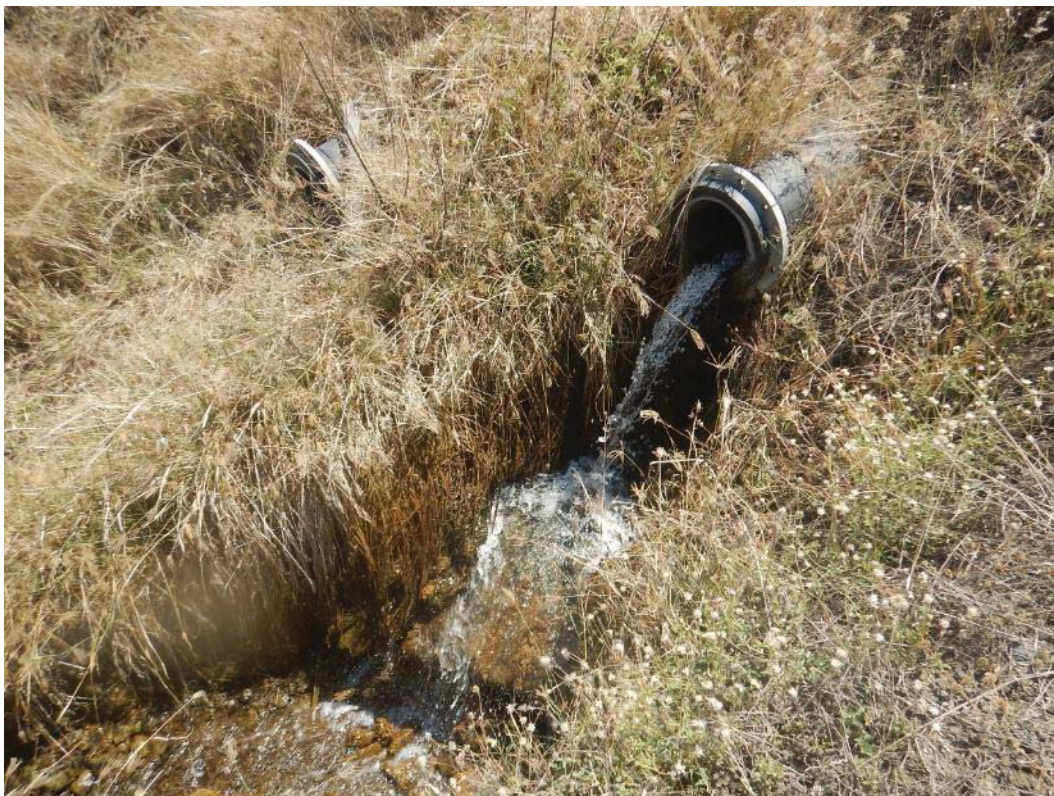
9. Seepage collection pipes through the starter walls were observed to be flowing at the time of the inspection, indicative of continued dewatering of the CDA1/2 material expected after the cessation of active deposition (Photo 11 in Appendix A). The design

- of the co-disposal cells has allowed for seepage collection via these pipes. As such, this flow is expected.
10. A number of the seepage collection pipes on the western side of CDA1/2 discharge at an elevation close to the crest of the starter walls resulting in localised scouring of the downstream embankment slope of the starter walls around the pipes (Photo 11 in Appendix A). This scouring has not significantly changed for a number of years and is not expected to get any worse in the future especially as the rate of flow in these pipes is expected to decrease

Photo 11 Discharge from Drainage Pipe Outlet into Western Solution Trench

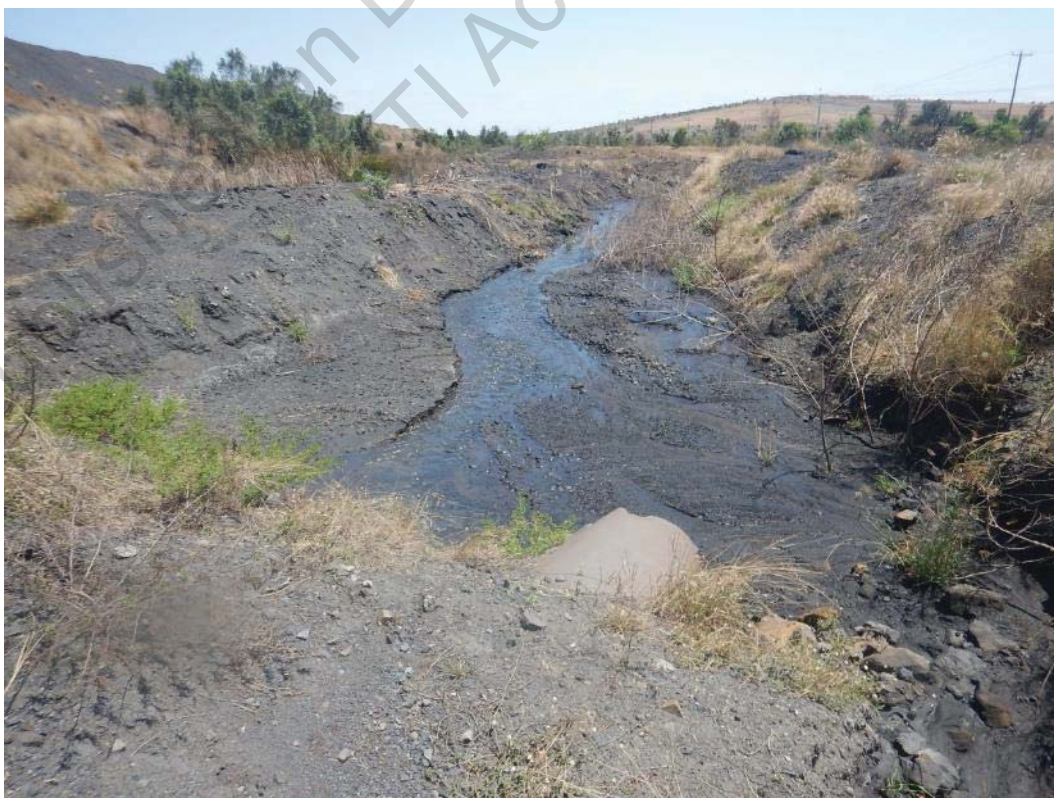
Photo 12 Eastern Solution Trench and Eastern Wall of Cell 1

6. Numerous small to medium sized trees were observed to be growing on the downstream embankments of the starter walls on the northern, eastern and western sides of CDA1/2 (Photos 8, 12, 13 and 16 in Appendix A).

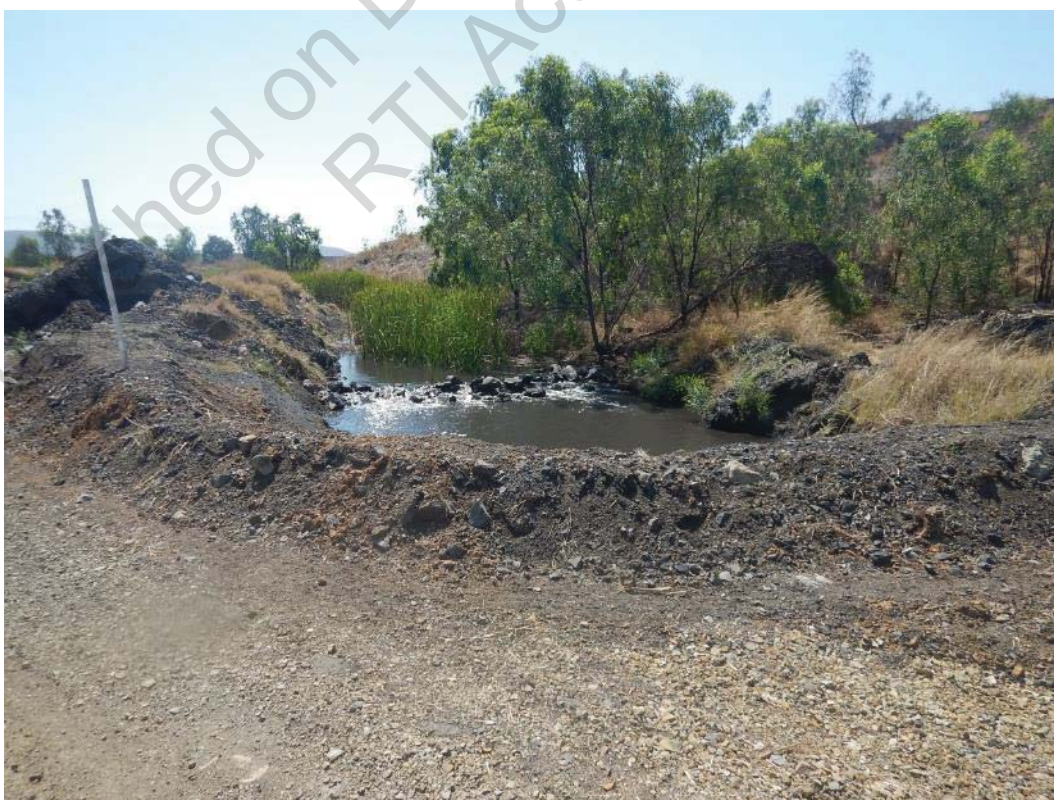
Photo 14 De-silted Channel at Downstream End of Eastern Solution Trench

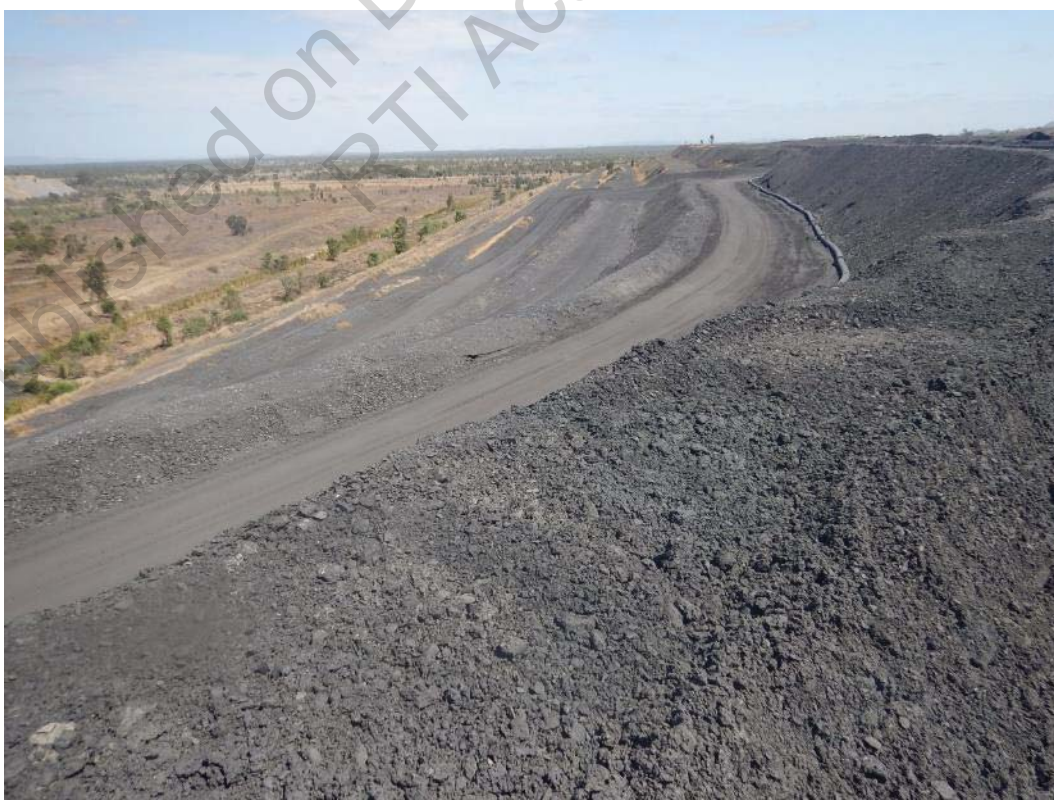
Photo 16 Western wall of Cell 2 Viewed from Top of Cell 3/4

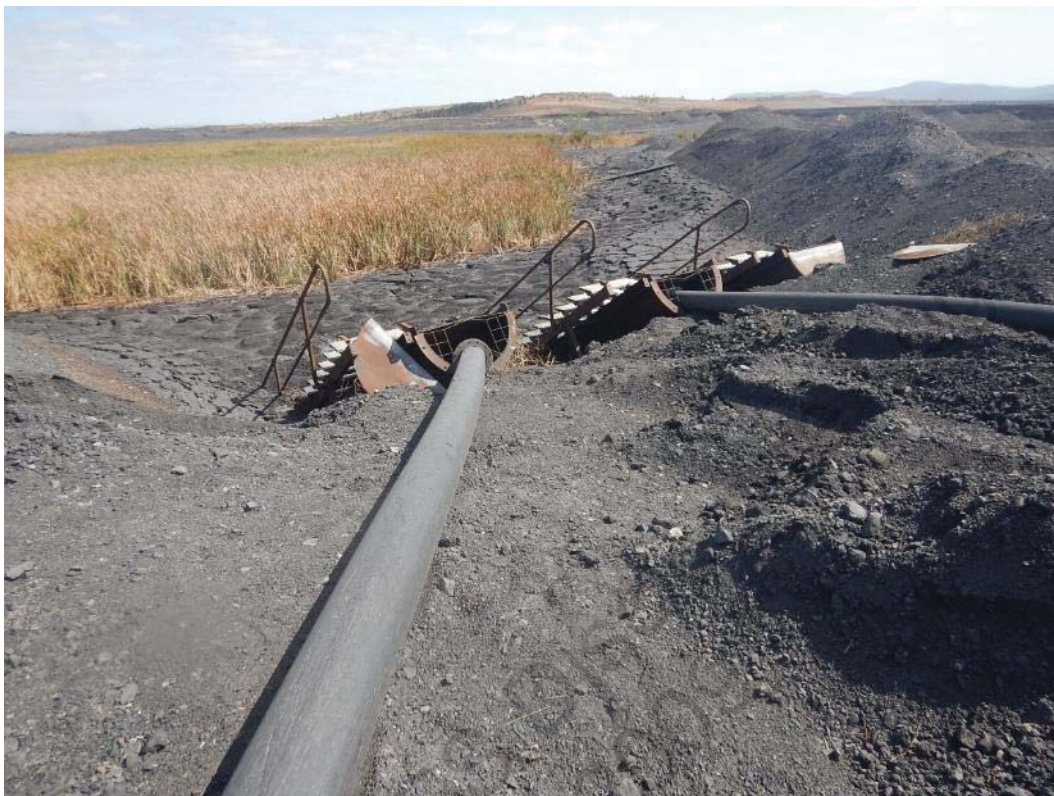
Photo 17 Pump Discharge Lines from Cell 3 Decant Pond into Decant Inlet of CDA1/2

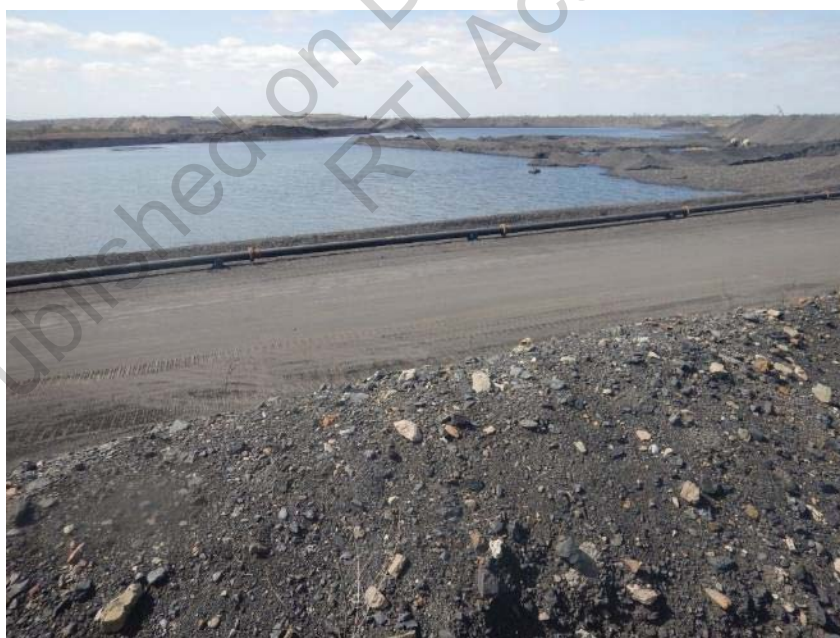
Photo 2 CDA3/4 Reservoir Area Viewed from Southern Wall of Cell 1

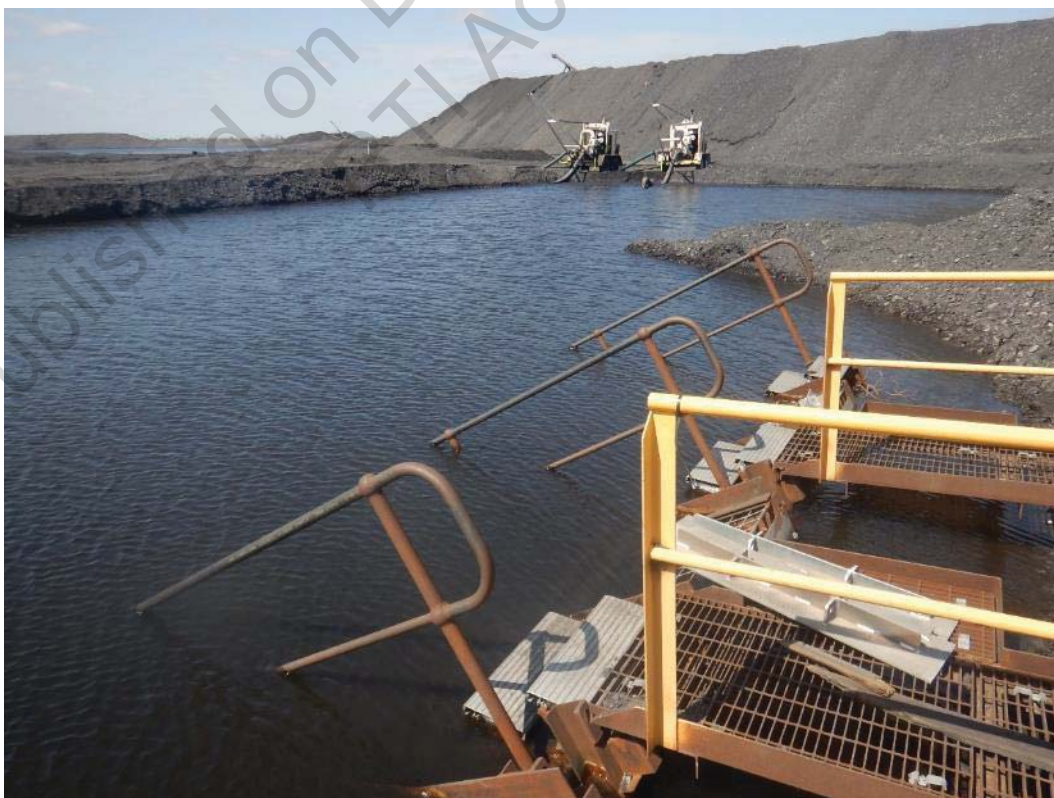
Photo 4 Decant Inlet Structure and Two Trailer Mounted Pumps Located at Cell 3 Decant Pond

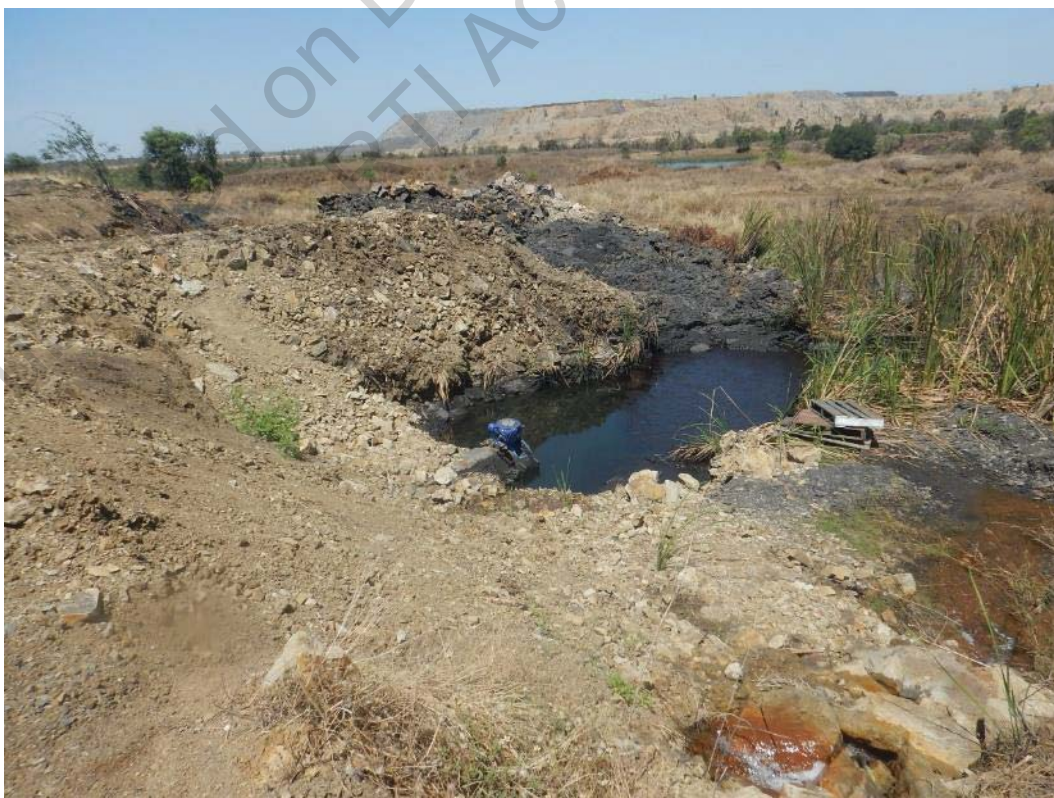
Photo 6 Decant Pipe Outlet into Western Solution Trench Adjacent to Cell 3 with Valve Closed
