## SONOMA MINE MANAGEMENT PTY LTD

### Two Mile Creek Diversion Operations Monitoring 2019

Sonoma Coal Mine

June 2019

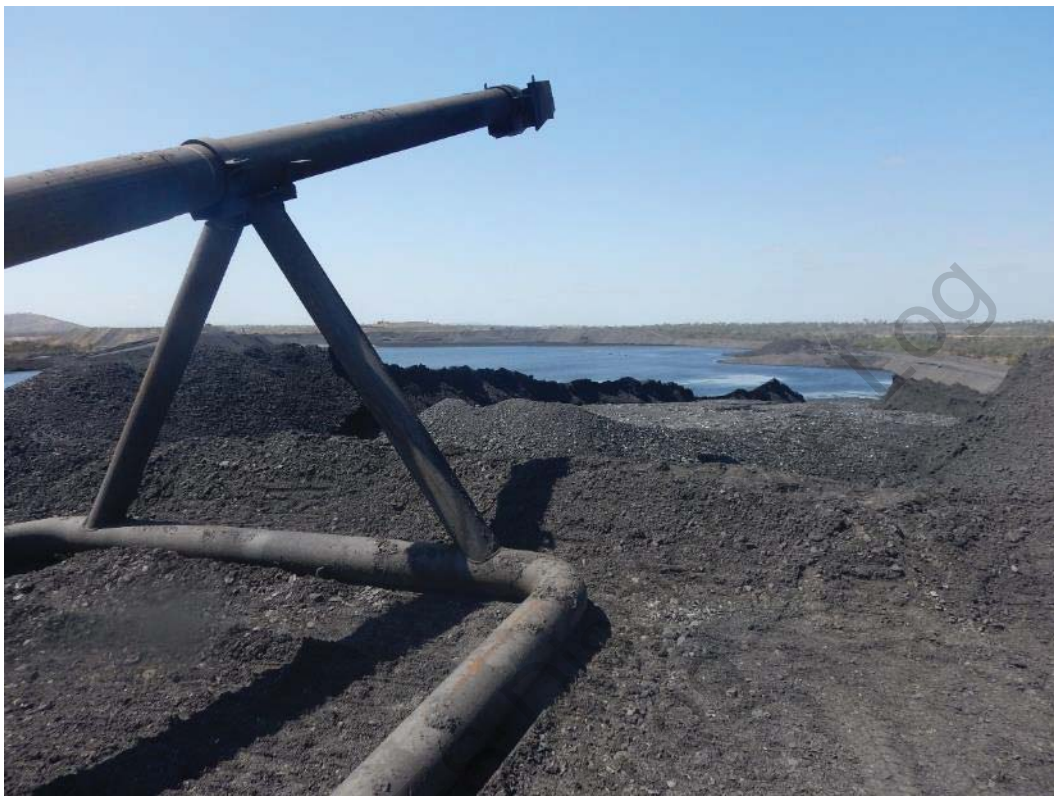
Photo 7 Western Side of Cell 3/4 Viewed from the Top of Partially Constructed Fifth Wall Raise

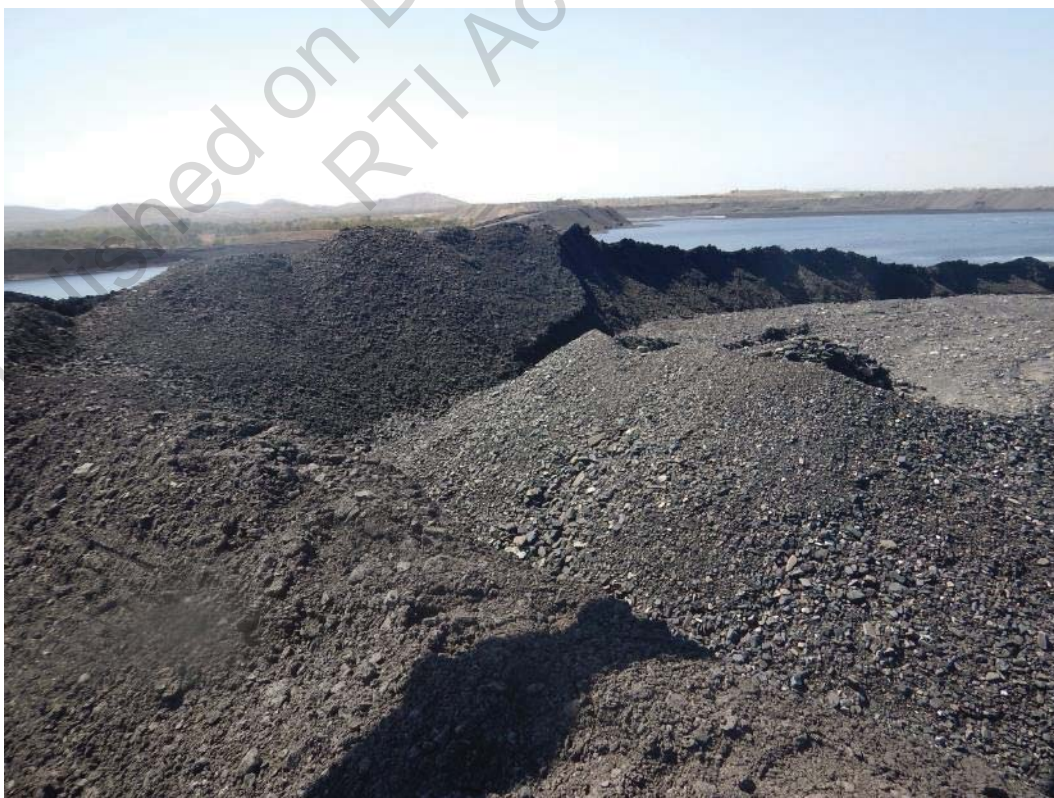
Photo 8 Rejects Deposition on Eastern Side of Cell 4

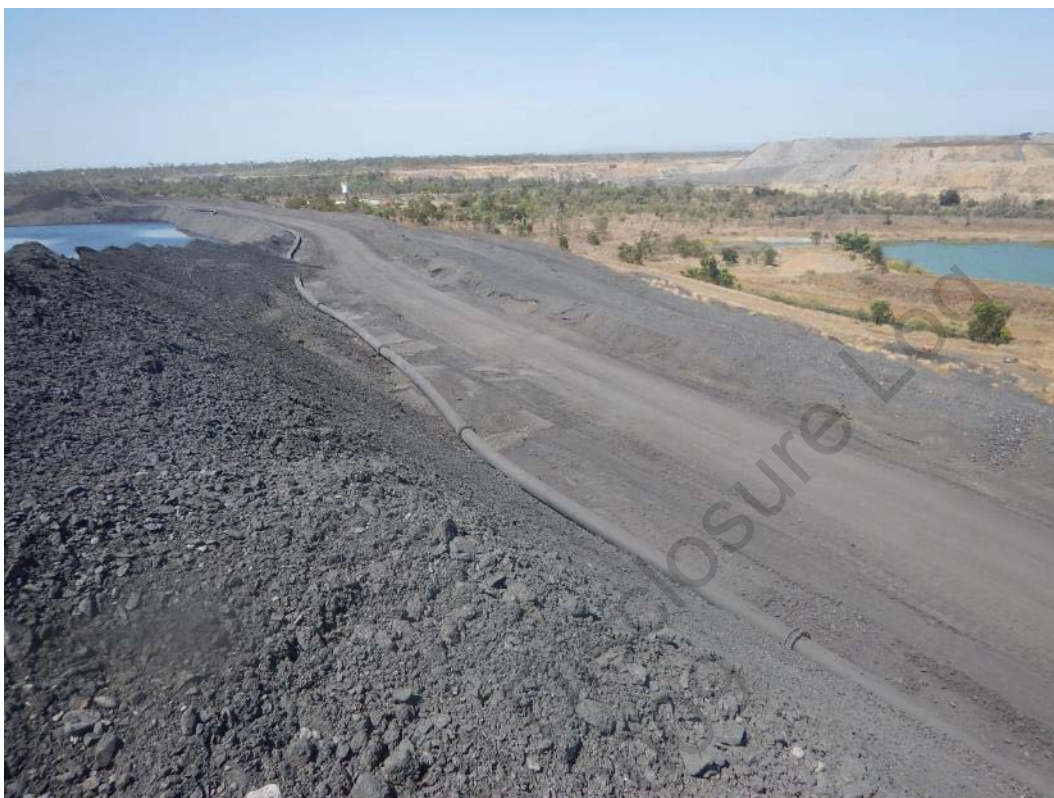
Photo 9 Western Side of Cell 3 Viewed from Top of Cell 3/4

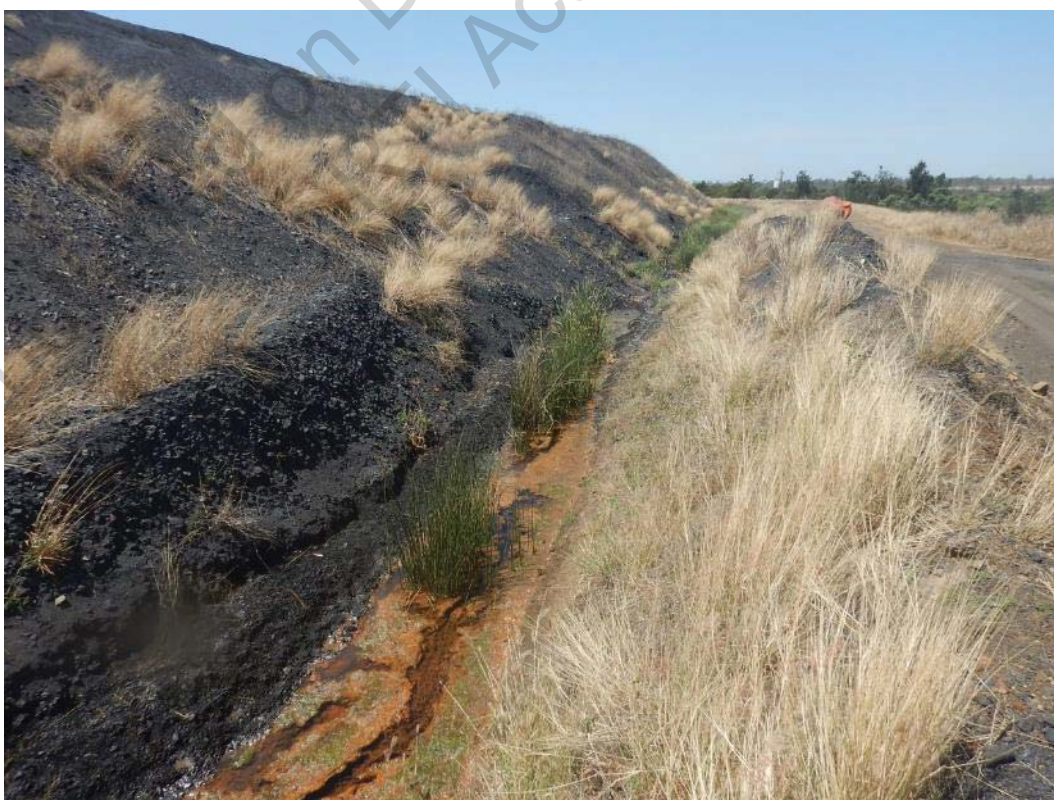
Photo 10 Western Side of Cell 3 Including Seepage Flows in Drain above Starter Bund

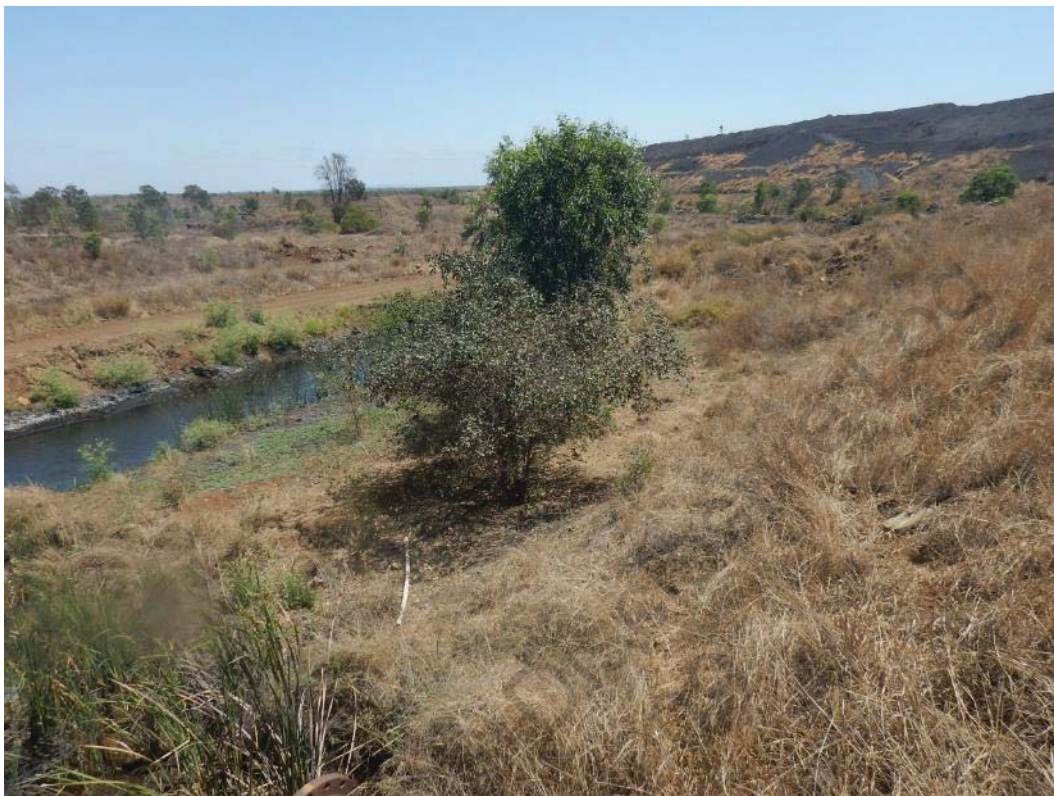
Photo 11 Western Solution Trench Adjacent to Cell 3

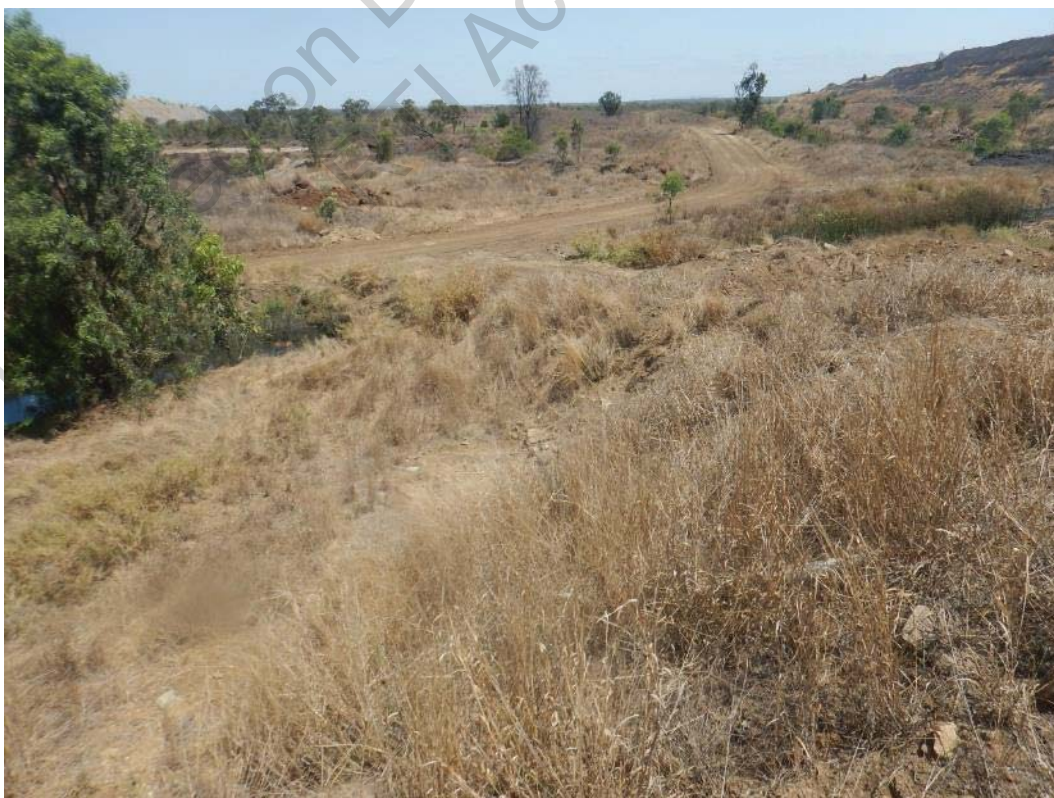
Photo 12 Access Track Crossing of Western Solution Trench - North-Western Corner of Cell 3

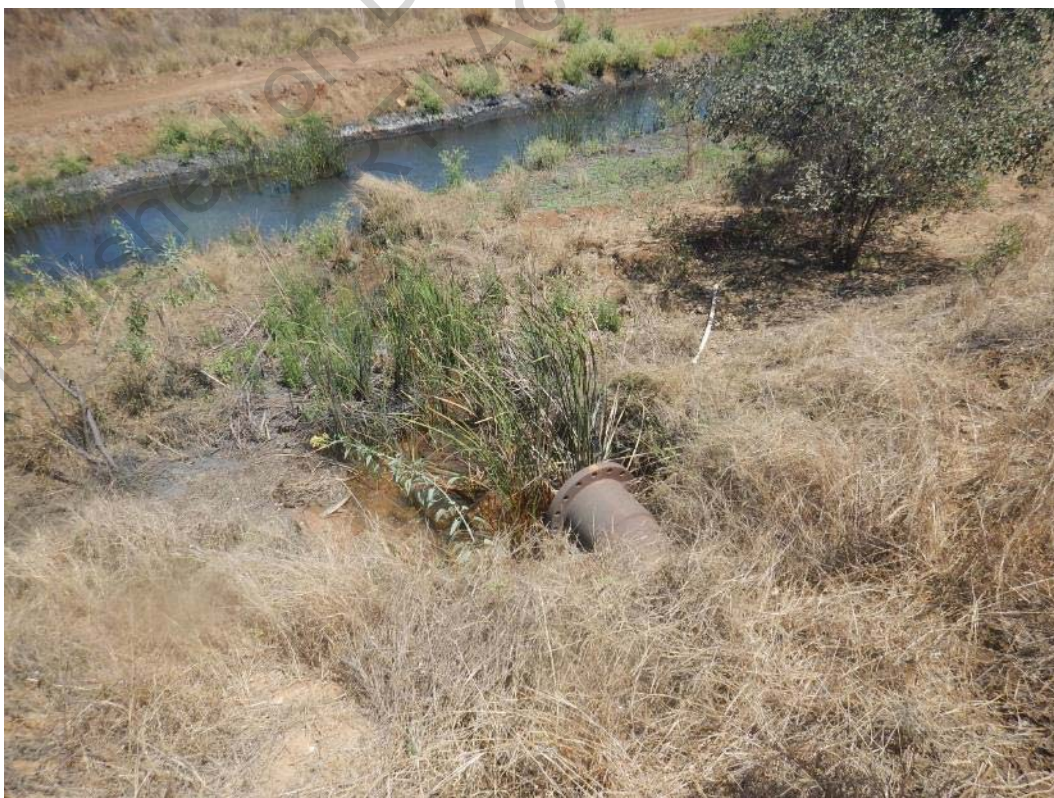
Photo 14 Discharge from Drainage Pipe Outlet into Western Solution Trench – Western Side of Cell 3

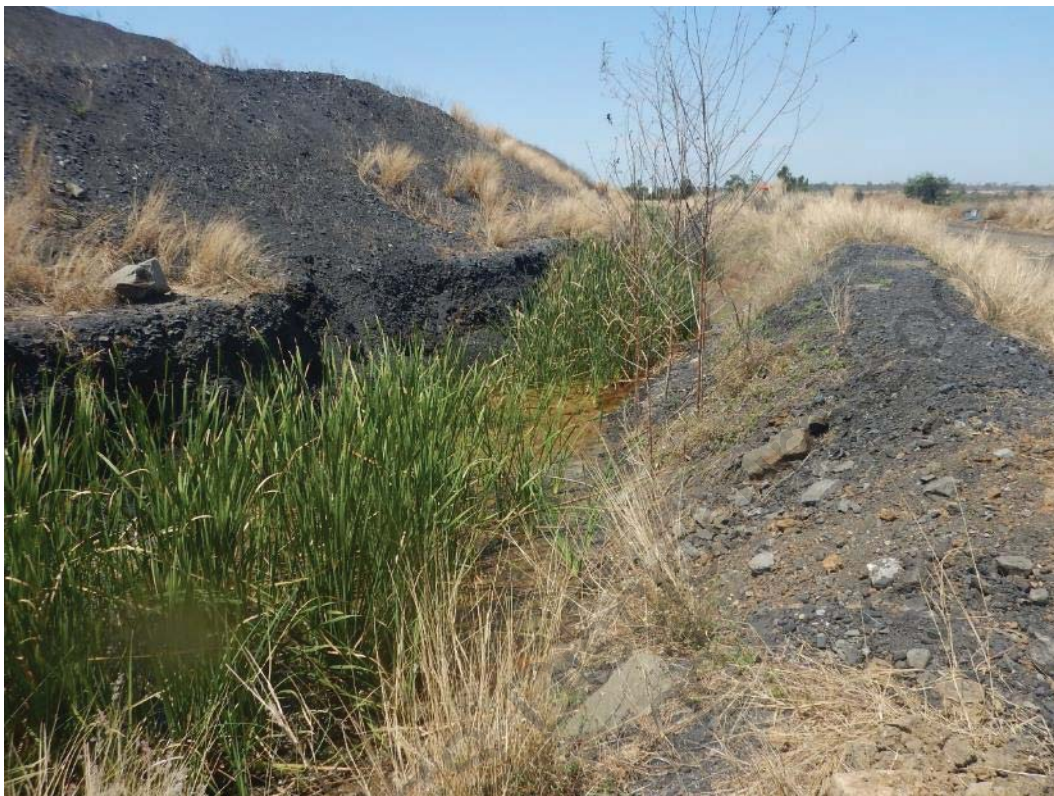
Photo 15 Reeds Growing in Drain above Starter Bund - Western Side of Cell 3

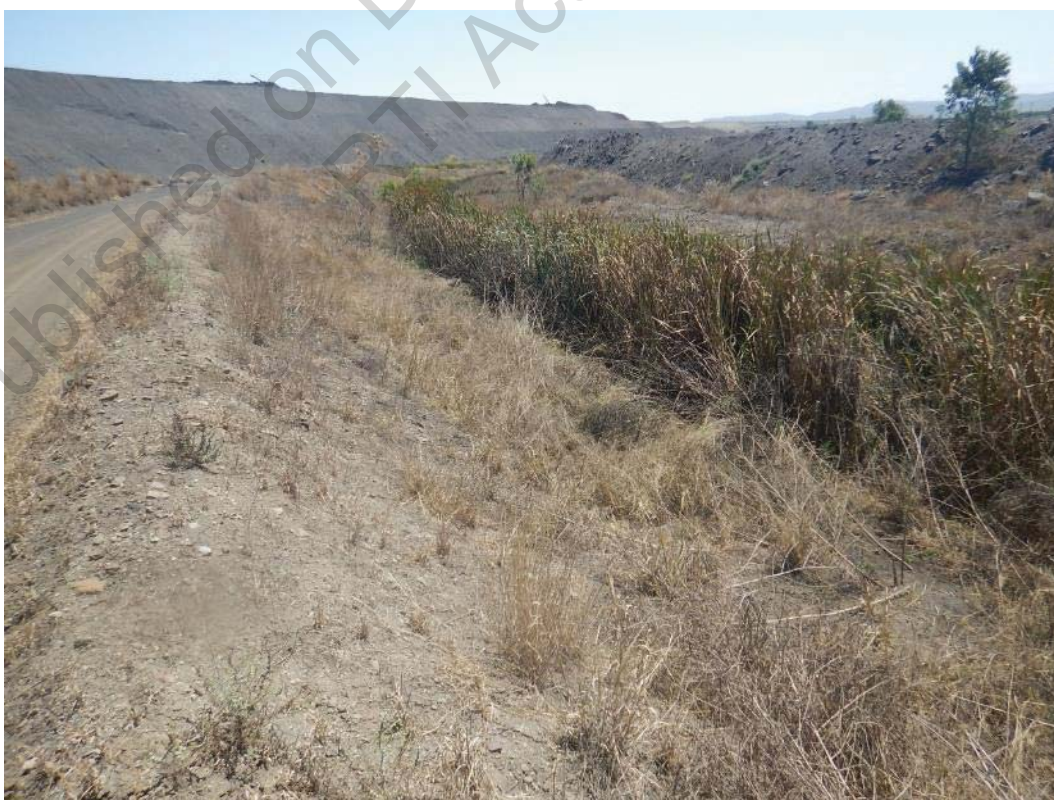
Photo 18 Eastern Solution Trench Adjacent to Cell 3

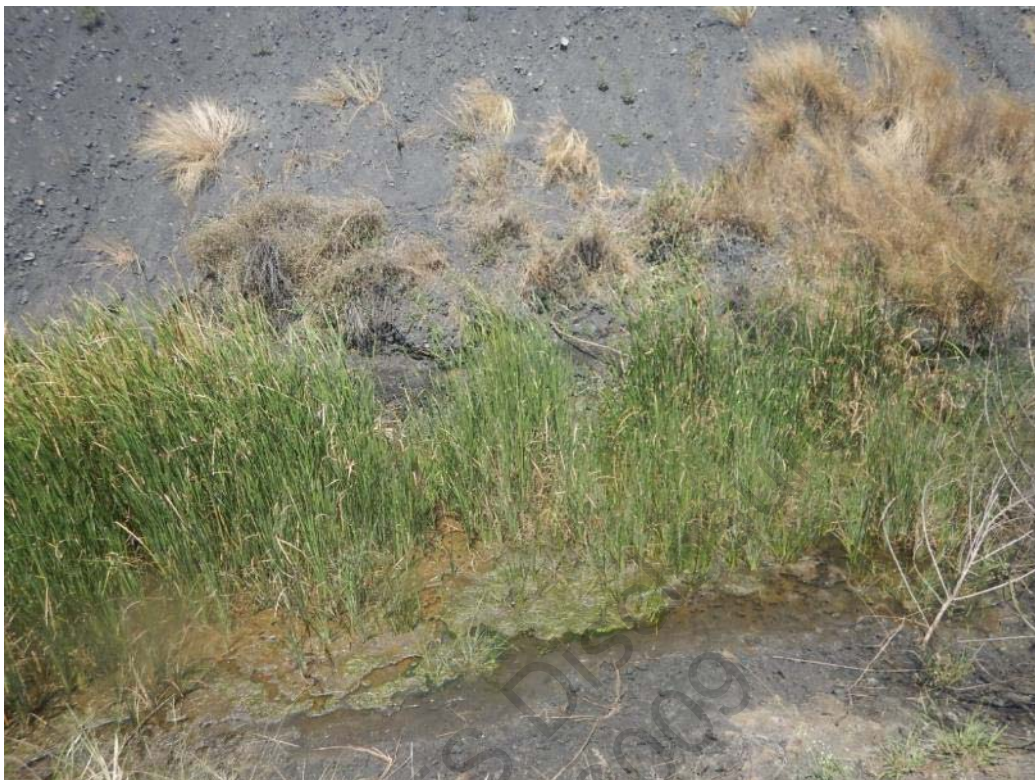
Photo 19 Seepage Expression Above Starter Bund – Eastern Side of Cell 4 near Cell 3

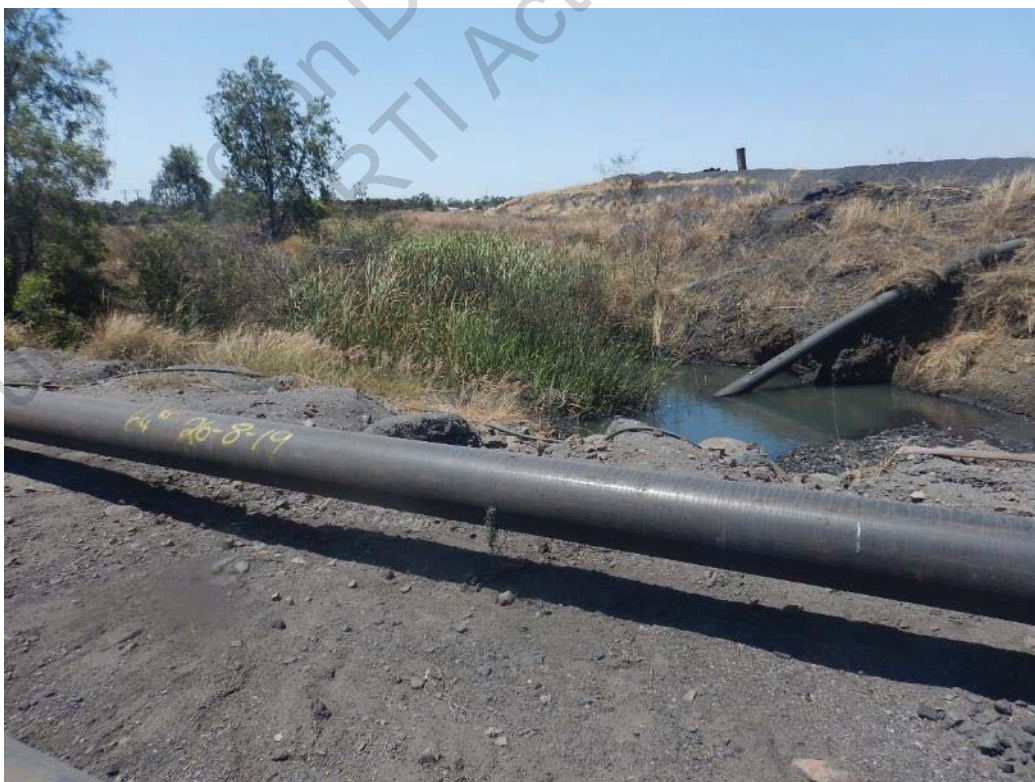
Photo 20 View Upstream Along Eastern Solution Trench from Road Crossing of Clean Water Drain and Eastern Solution Trench at North-Eastern Corner of Cell 3

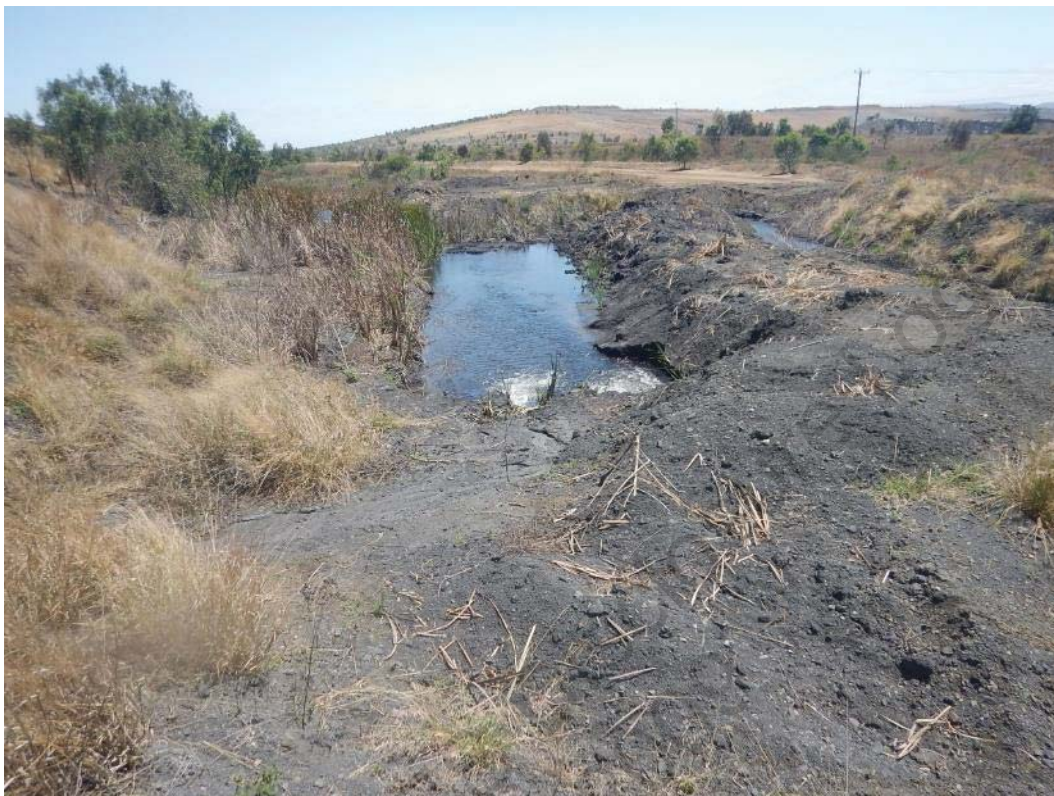
Photo 21 View Downstream Along Eastern Solution Trench and Clean Water Drain from Road Crossing at North-Eastern Corner of Cell 3

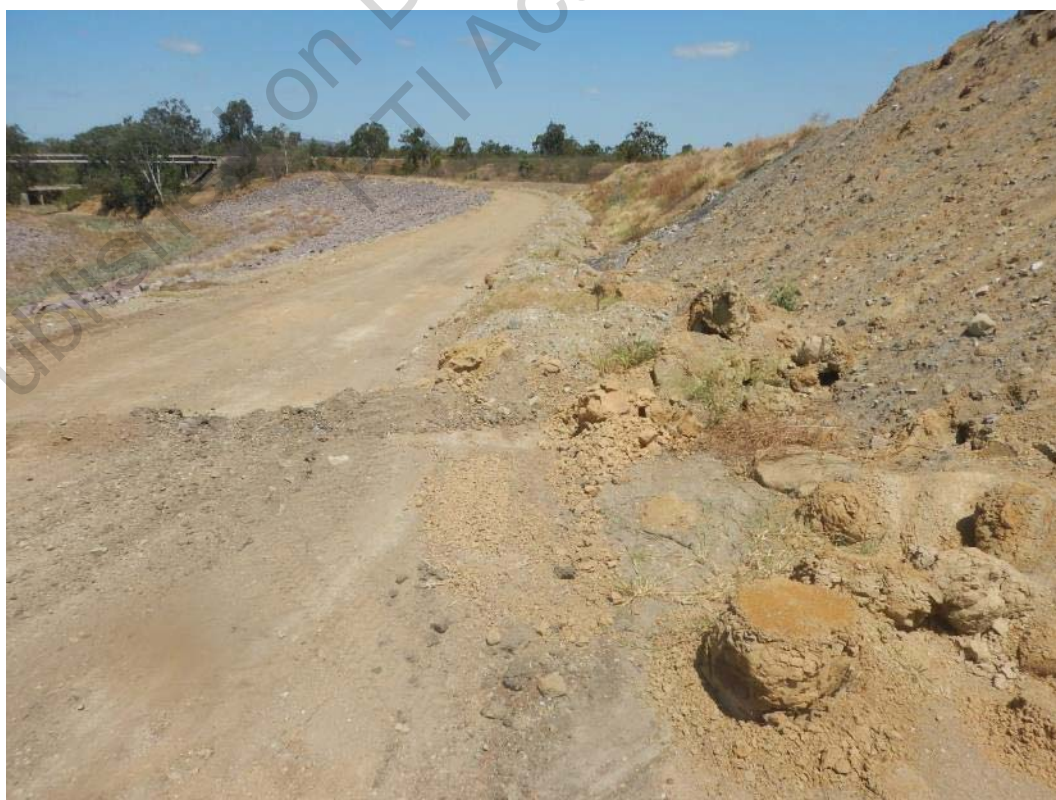
3. The plug has only experienced relatively small rainfall events since construction was completed.
4. The NSCD Upstream Plug crest was in good condition at the time of the inspection (Photo 2 and 3 in Appendix C). Vehicle access is available along the crest and no safety bunds have been constructed due to the flat slope of the upstream embankment batter.

5. The downstream batter of the plug has been dumped out by the North Pit spoil dump, which is acting to buttress the plug and provide additional flood protection to North Pit (i.e. the dump crest levels are above the crest of the plug) (Photo 1 to 4 in Appendix C). A shallow drain has been formed between the downstream batter of the NSCD Upstream Plug and the batter of the North Pit Dump with flow directed along the plug to a settling area located at the south-eastern end of the plug (Photo 2 and 4 in Appendix C). This settling area is acting as a form of sediment control for the unrehabilitated dump batter. There was no water ponding in the settling area at the time of the inspection. It is noted that the NSCD Upstream Plug was not designed with the intention to act as a drain for runoff from the dump or to act as a water retaining embankment. Furthermore, in a large rainfall event, this settling area could fill and spill into the NSCD over the Upstream Plug. It is recommended that QCoal review the Sonoma North Pit spoil dump design and operations along the southern bank of the NSCD in consideration of drainage and develop a plan to convey runoff to designated water management structures or into the NSCD via a designated flow path.

Photo 2 Crest and Downstream Side of Plug (View from North-West End)

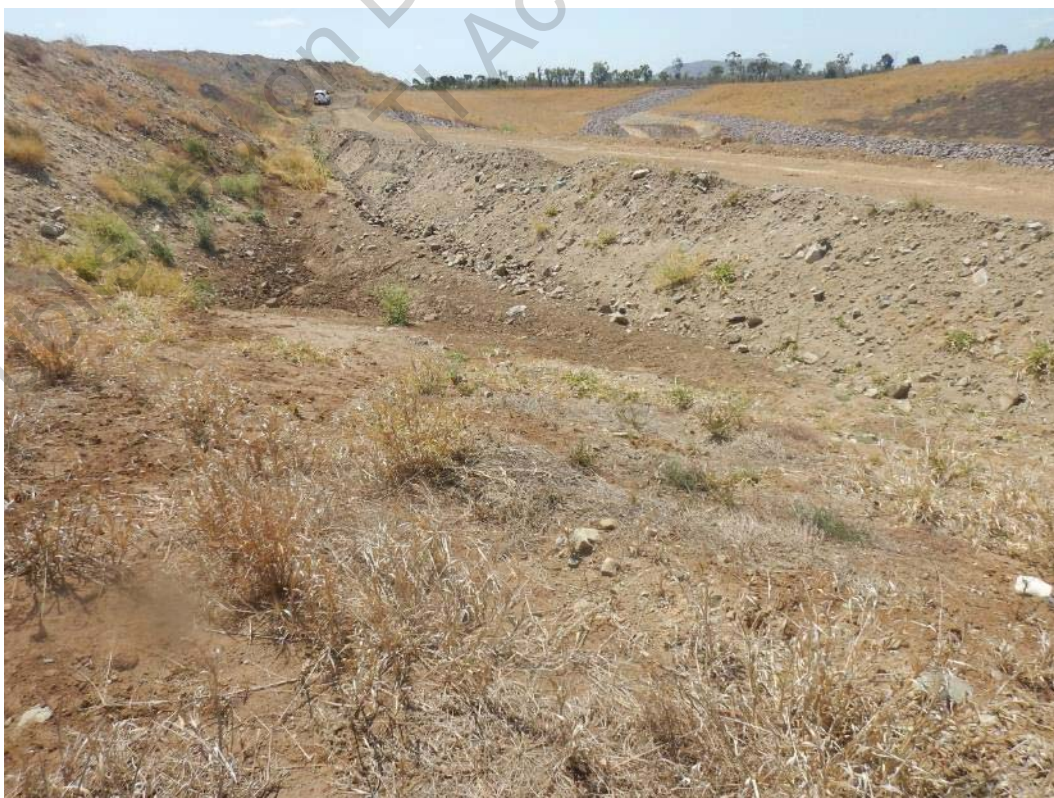
Photo 4 Downstream Side of Plug with Buttrressing by North Pit Spoil Dump

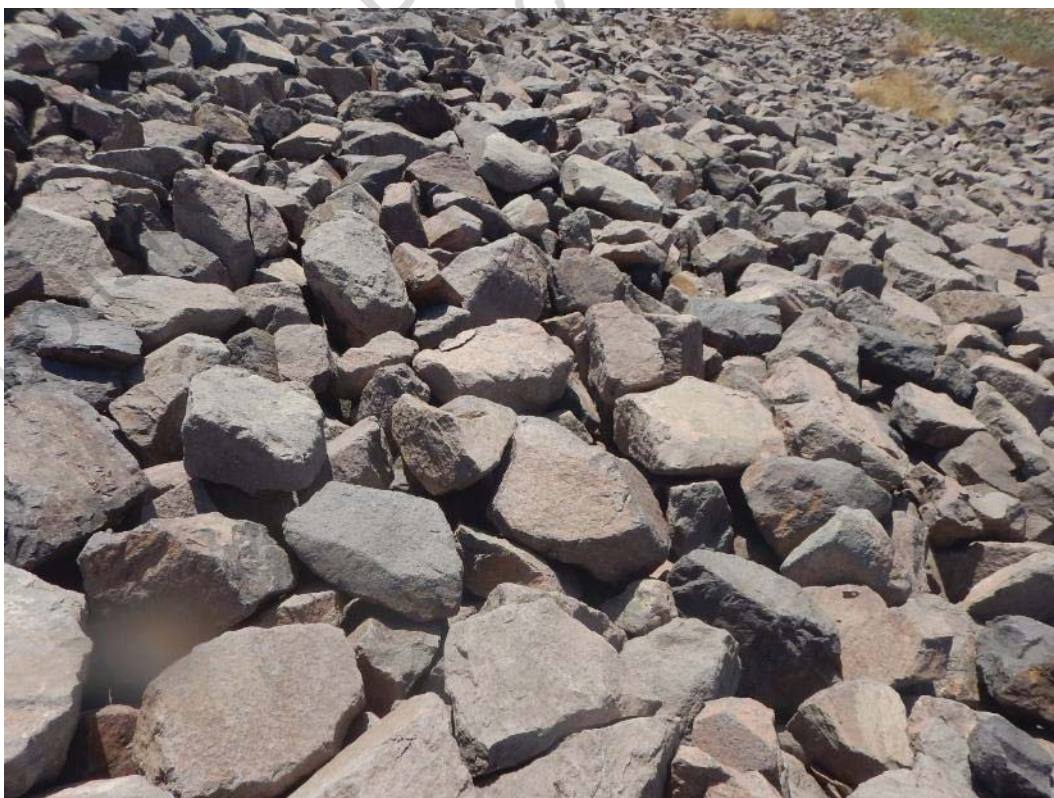
6. The upstream batter of the NSCD Upstream Plug is entirely rock lined to provide scour protection for flows in Coral Creek (Photo 3, 6, 7 and 8 in Appendix C). The dumped rock is in good condition and in accordance with the Design Plan (Engeny, 2018c). Grasses are beginning to establish within the extent of the dumped rock and will provide further stabilisation to the plug. The transition between the dumped rock and vegetated batters of the NSCD are in good condition (Photo 9 in Appendix C).

Photo 6 Rock Surface Treatment on Upstream Side of Plug

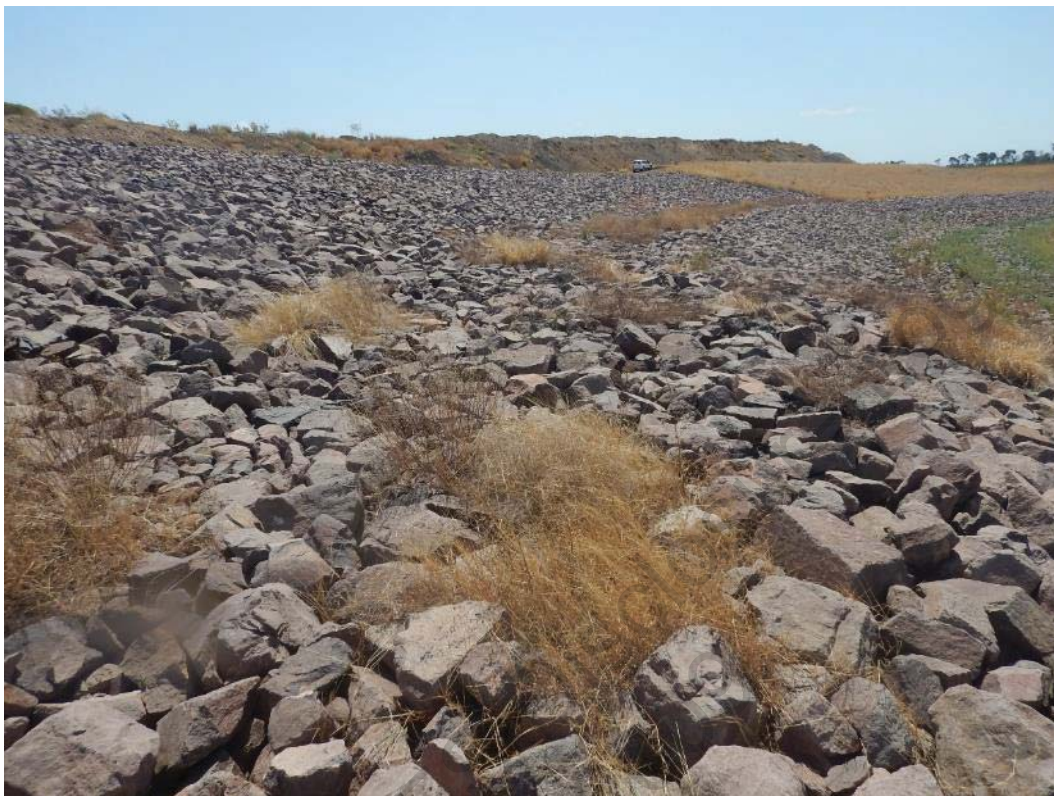
Photo 7 Upstream Side of Plug Viewed from Bench at Upstream End of Plug

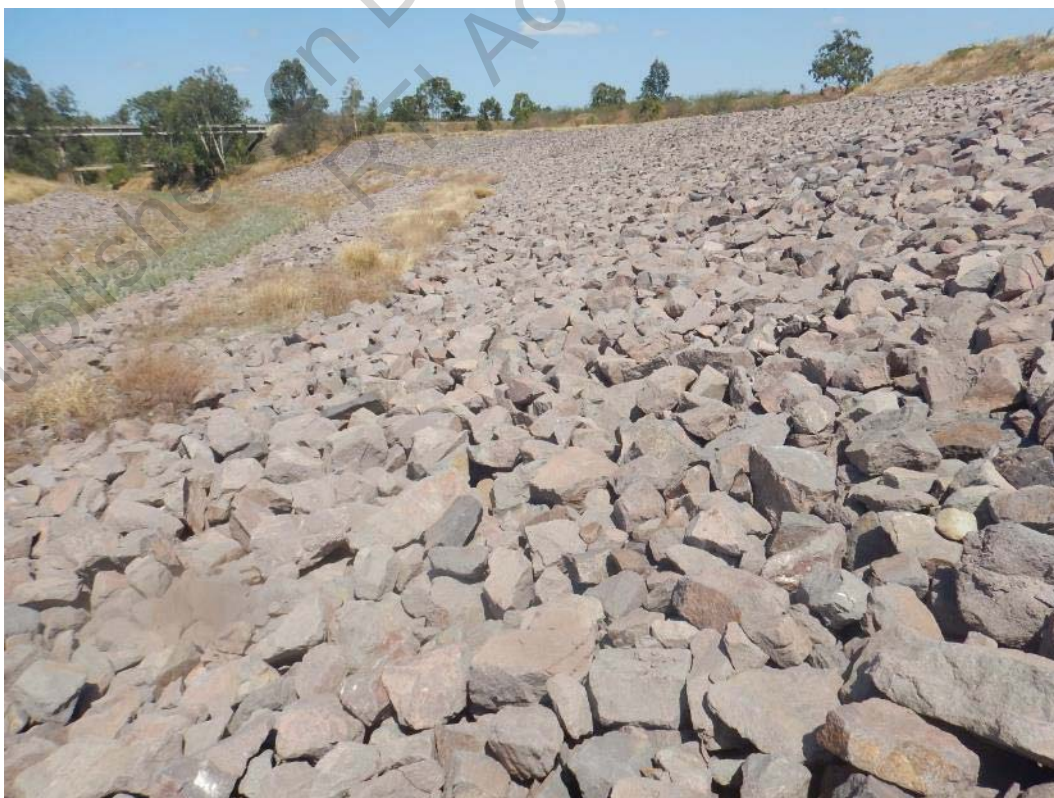
1. No changes have been made to the NSCD Upstream Plug since construction was completed.
2. There was no water flowing through or ponded in the NSCD adjacent to the Upstream Plug at the time of the inspection (Photo 3, 8 and 9 in Appendix C).

Photo 8 Upstream Side of Plug Viewed from Bench at Downstream End of Plug

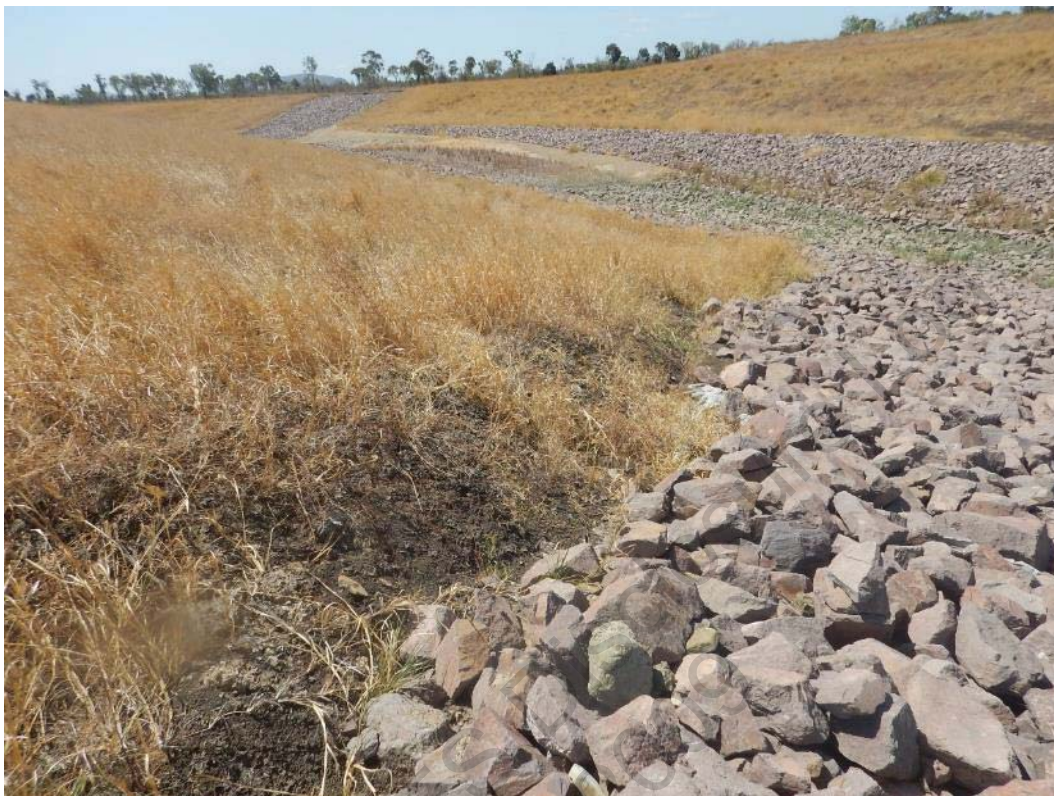
Photo 9 Interface Between Dumped Rock and Vegetation at Upstream End of Plug

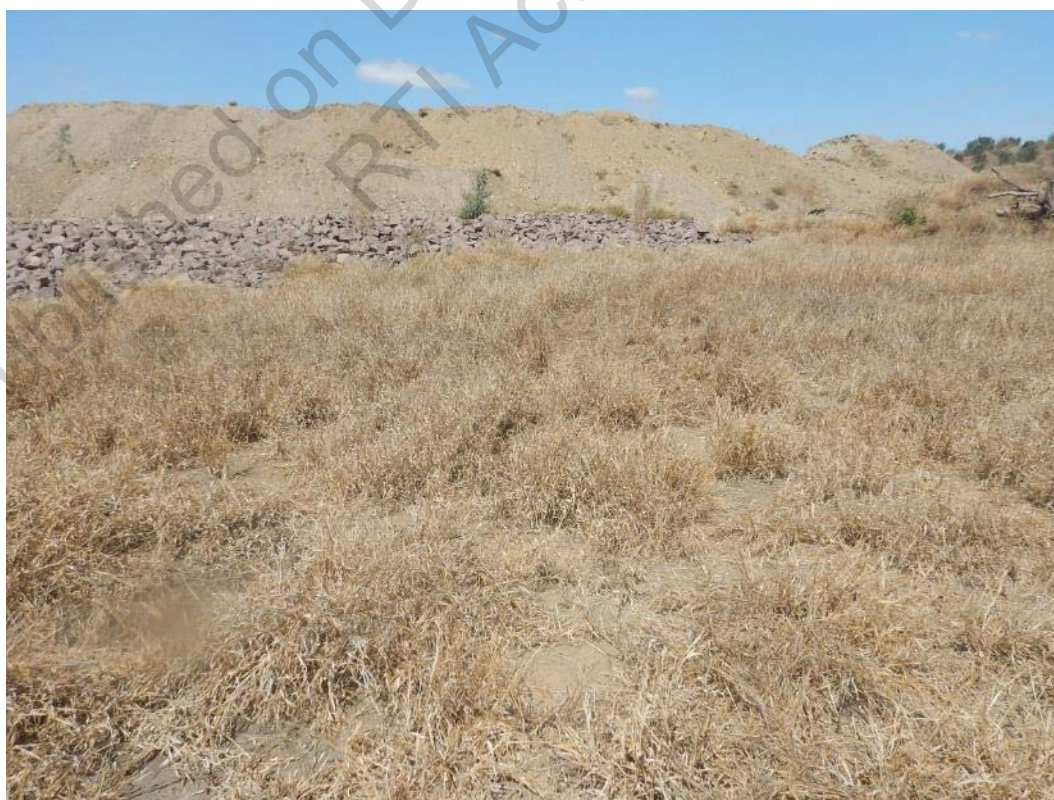
Photo 2 Upstream Side of Plug at Downstream End of Plug

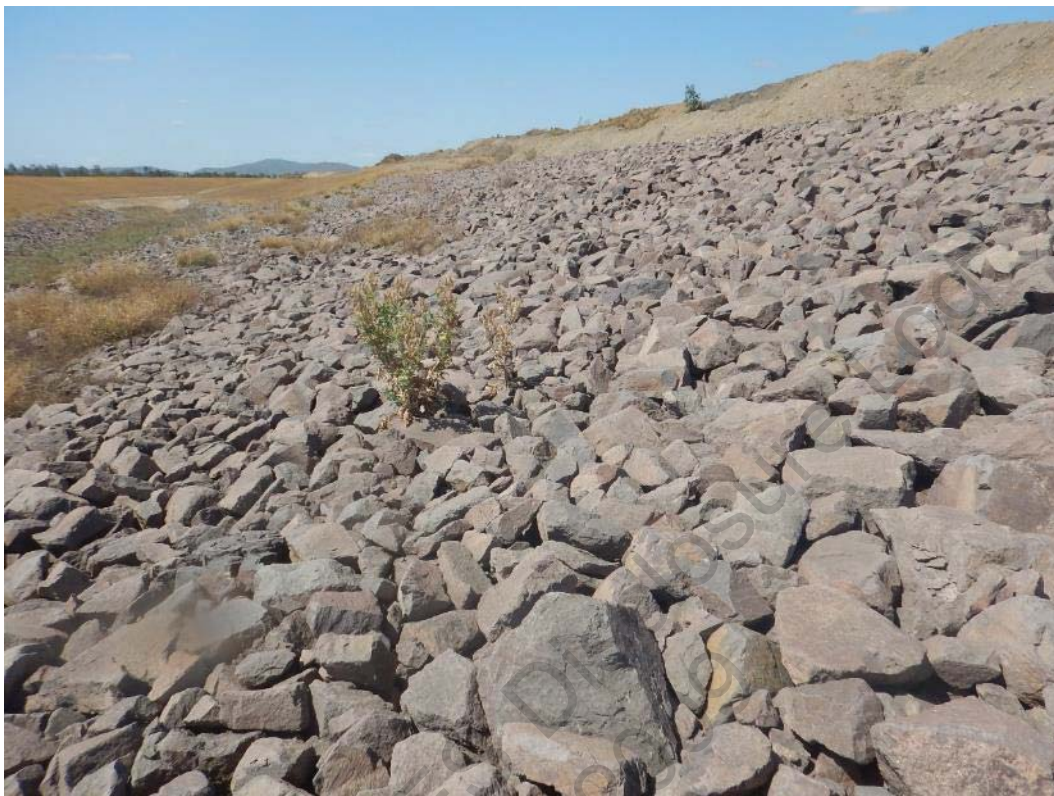
1. No changes have been made to the NSCD Downstream Plug since construction was completed.
2. There was no water flowing through or ponded in the NSCD adjacent to the Downstream Plug at the time of the inspection (Photo 3 and 7 in Appendix D).

Photo 3 Upstream Side of Plug Viewed from Bench at Downstream End of Plug

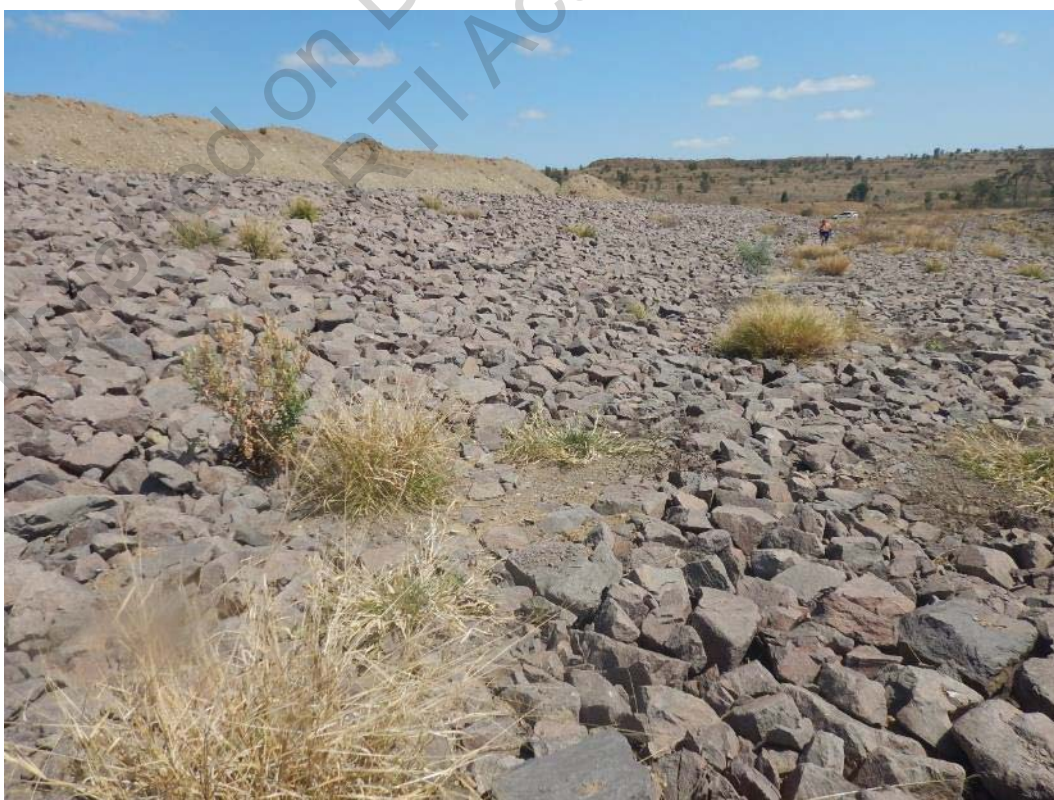
Photo 4 Upstream Side of Plug Viewed from Bench at Upstream End of Plug

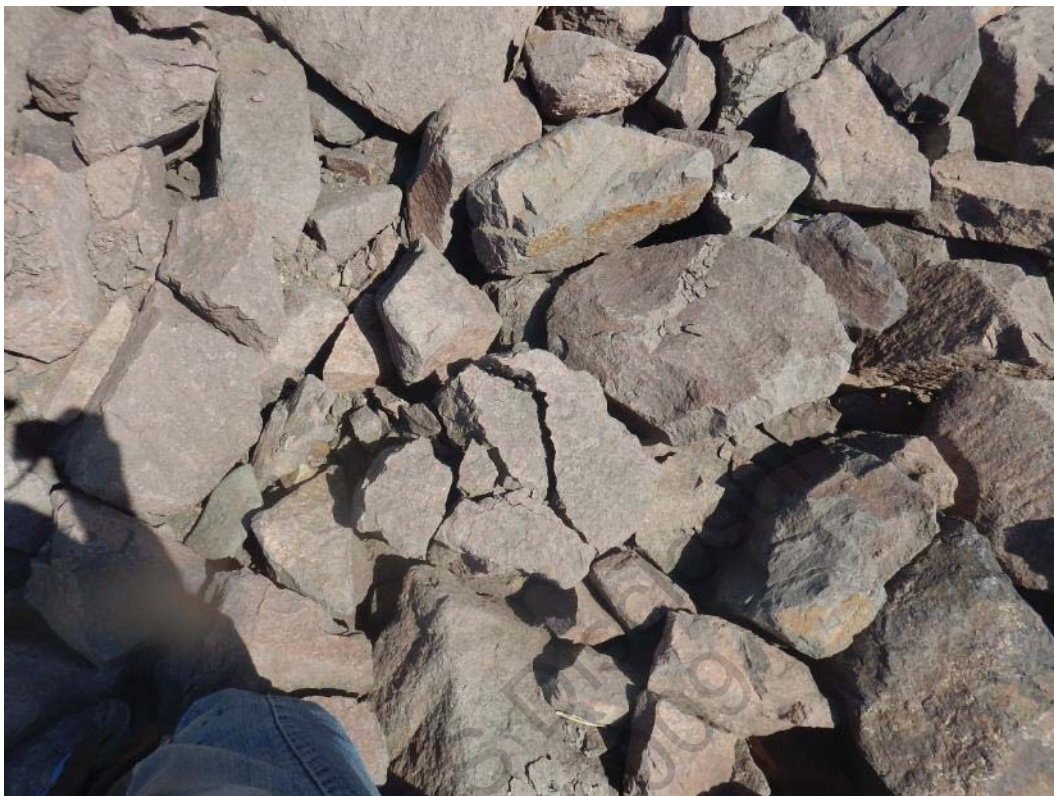
Photo 5 Rock Surface Treatment on Upstream Side of Plug

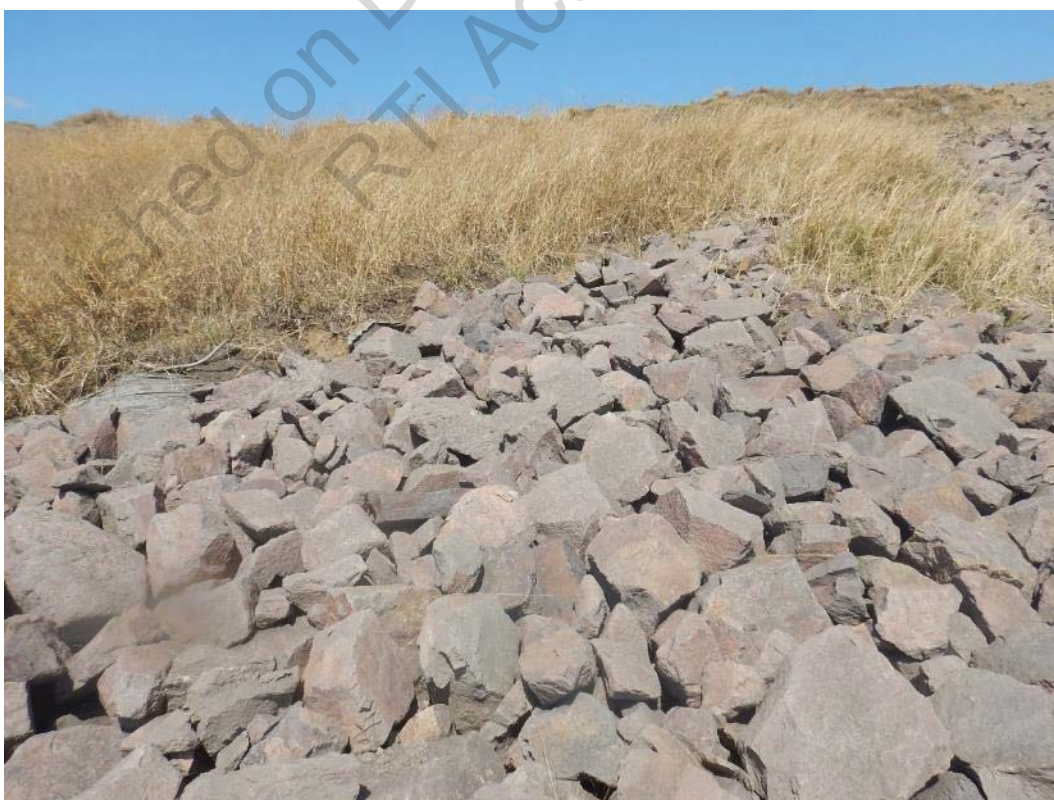
Photo 6 Interface Between Dumped Rock and Vegetation at Upstream End of Plug

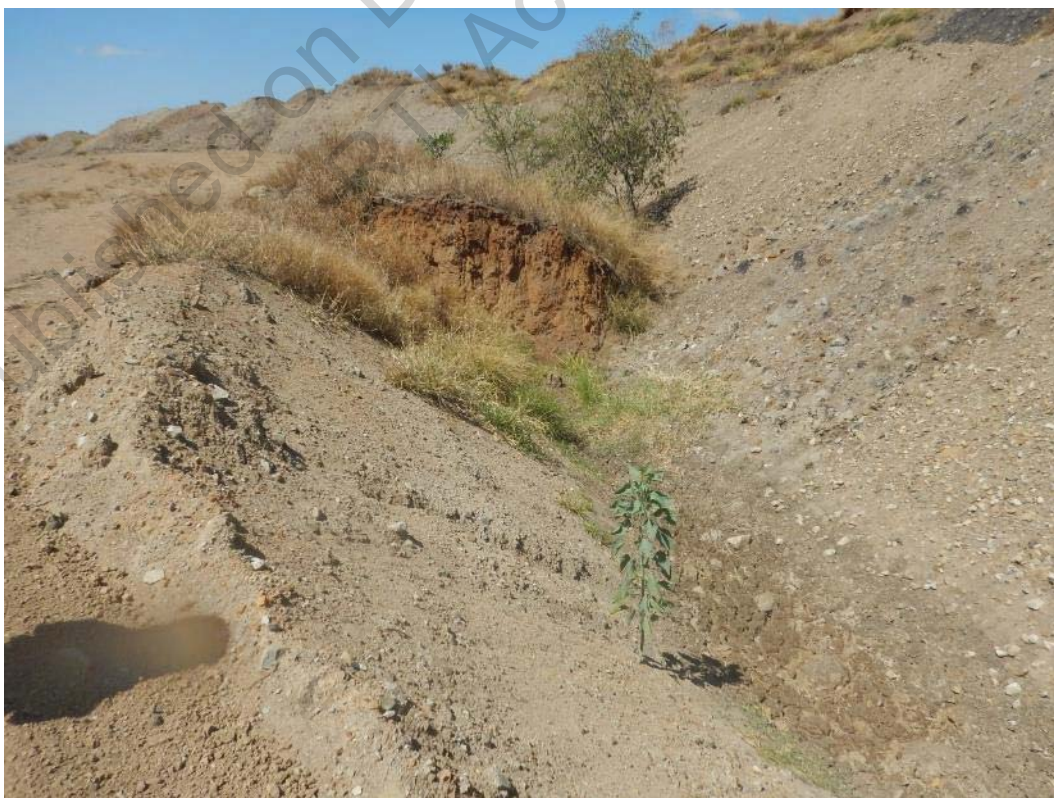
Photo 8 Insitu Creek Bank and North Pit Dump at Upstream End of Plug

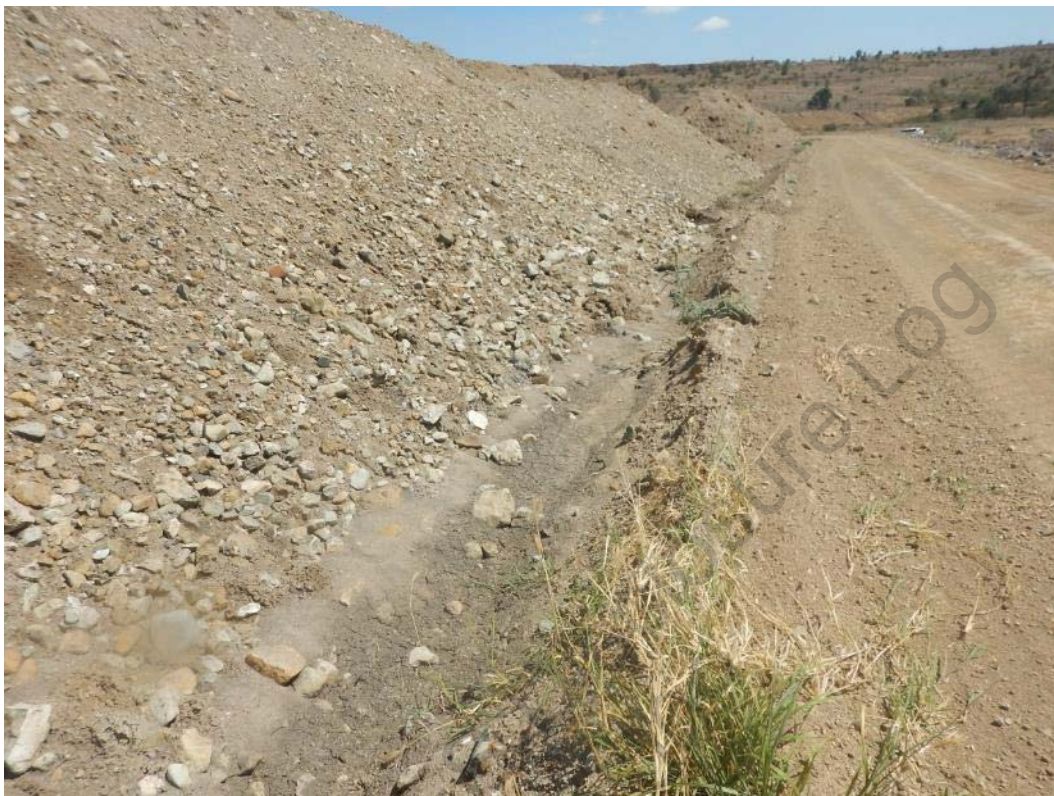
Photo 9 Crest and Downstream Side of Plug (View from North-East End)

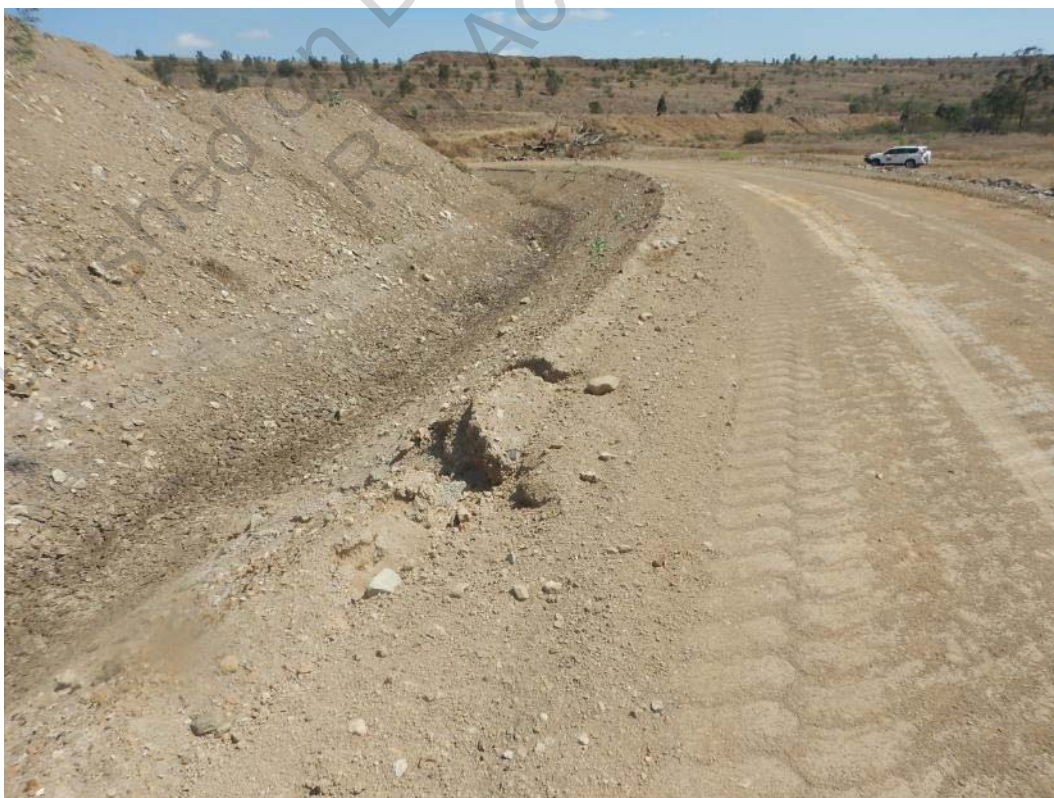
Photo 10 Crest and Downstream Side of Plug (Approximate Chainage 100m)
