## SONOMA MINE MANAGEMENT PTY LTD

### Two Mile Creek Diversion Operations Monitoring 2019

Sonoma Coal Mine

June 2019

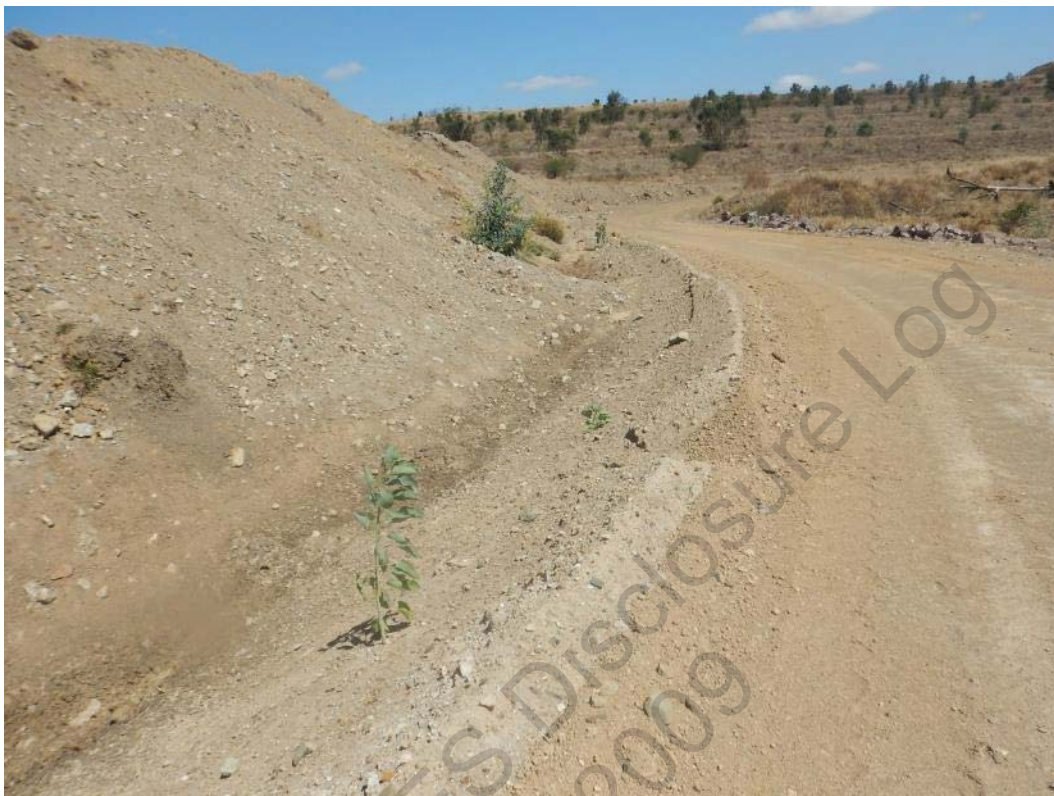
Photo 11 Crest and Downstream Side of Plug (Approximate Chainage 140m)

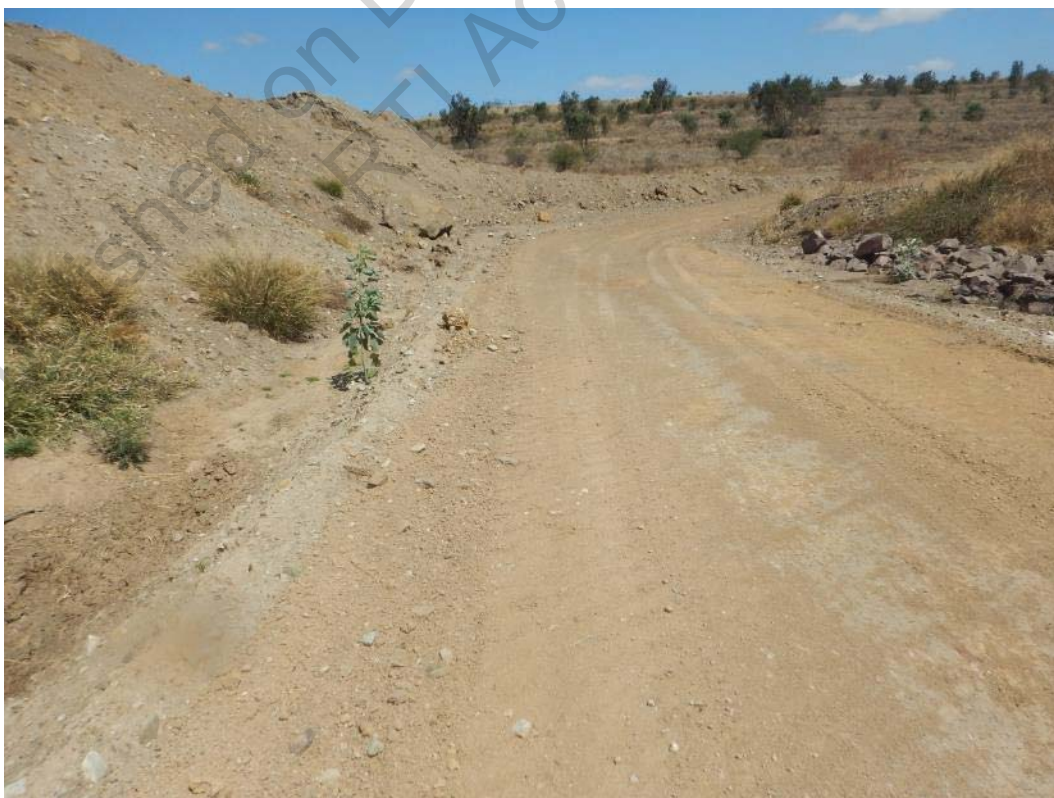
Photo 12 Crest and Downstream Side of Plug (Approximate Chainage 170m)

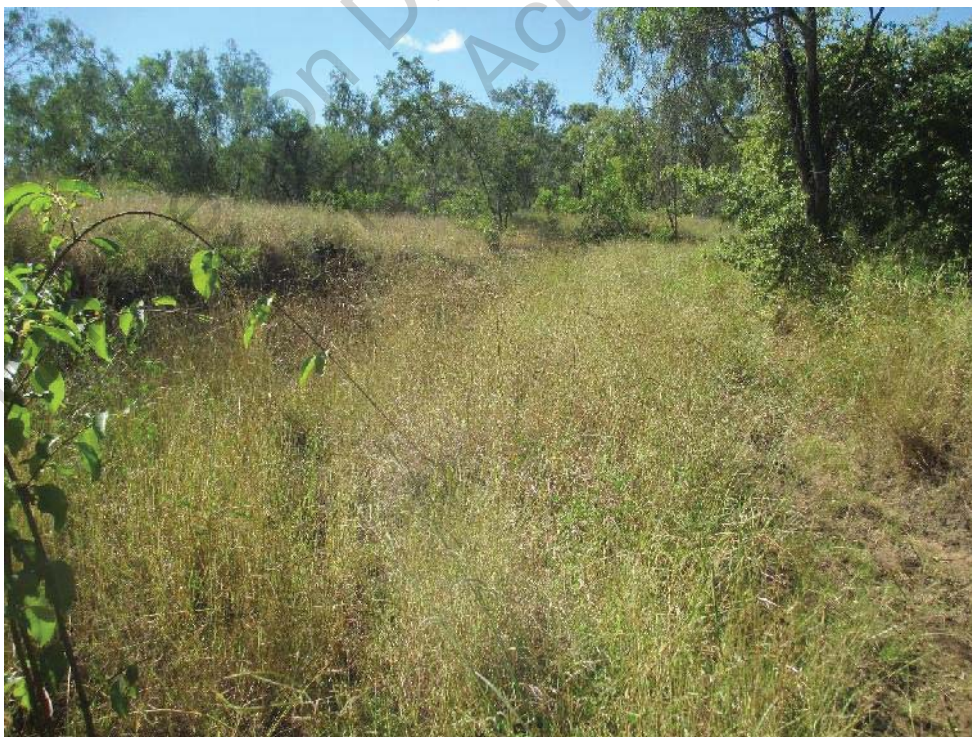
- There is increased ground cover along the waterway including in the bed of the channel at some locations (Figure 6.2). This is evidence of a successful wet season with average rainfall.

Figure 6.2 Grass Establishment In Channel At TMC-US2

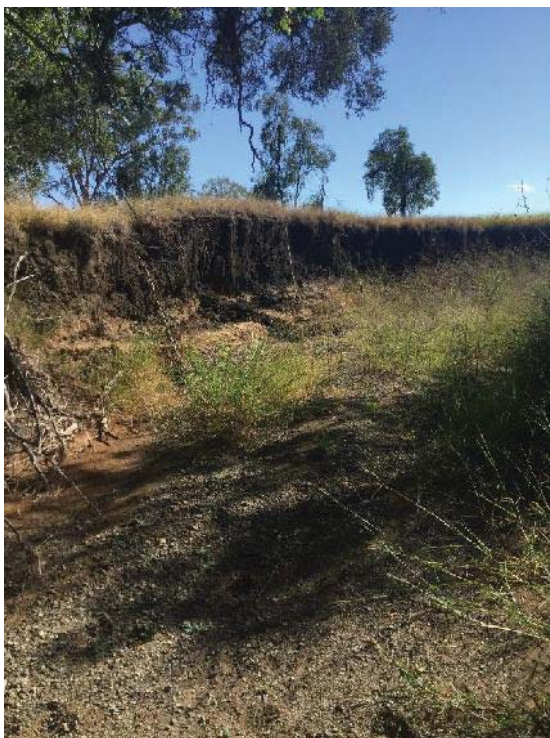
- Southern Tributary (TMC-US3 and TMC-US4):
  - The southern tributary is generally in a similar condition to the northern reach.
  - As with the Northern Tributary, bank erosion and steepening were evident at a number of locations along the waterway (Figure 6.3 and Figure 6.4). This is generally consistent with previous inspections and the condition appears to be relatively stable.

Figure 6.3 Bank Erosion Upstream Of TMC-US4

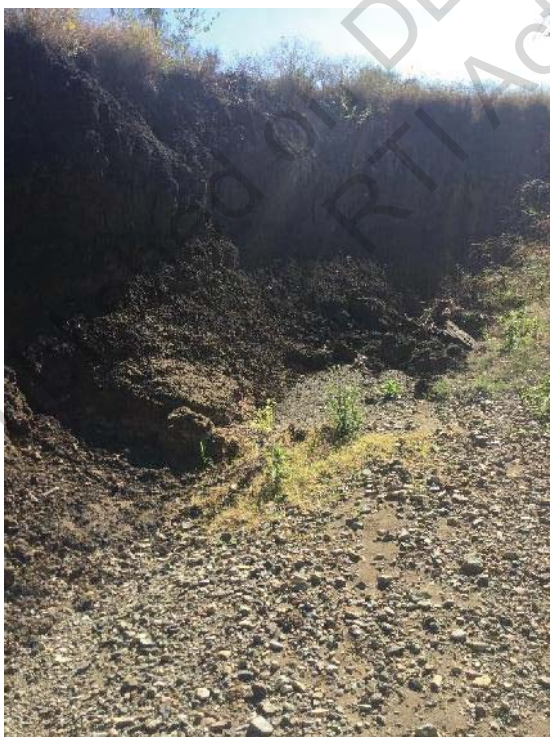
Figure 6.4 Bank Erosion Upstream Of TMC-US4

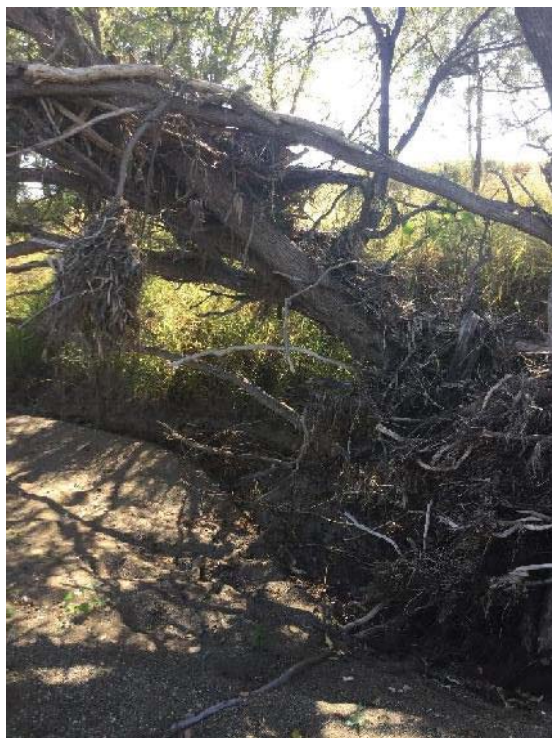
- Flood debris and fallen trees remained evident throughout the reach (Figure 6.5) and are attributed to the rainfall and strong winds experienced during Tropical Cyclone Debbie.

Figure 6.5 Flood Debris Upstream Of TMC-US4

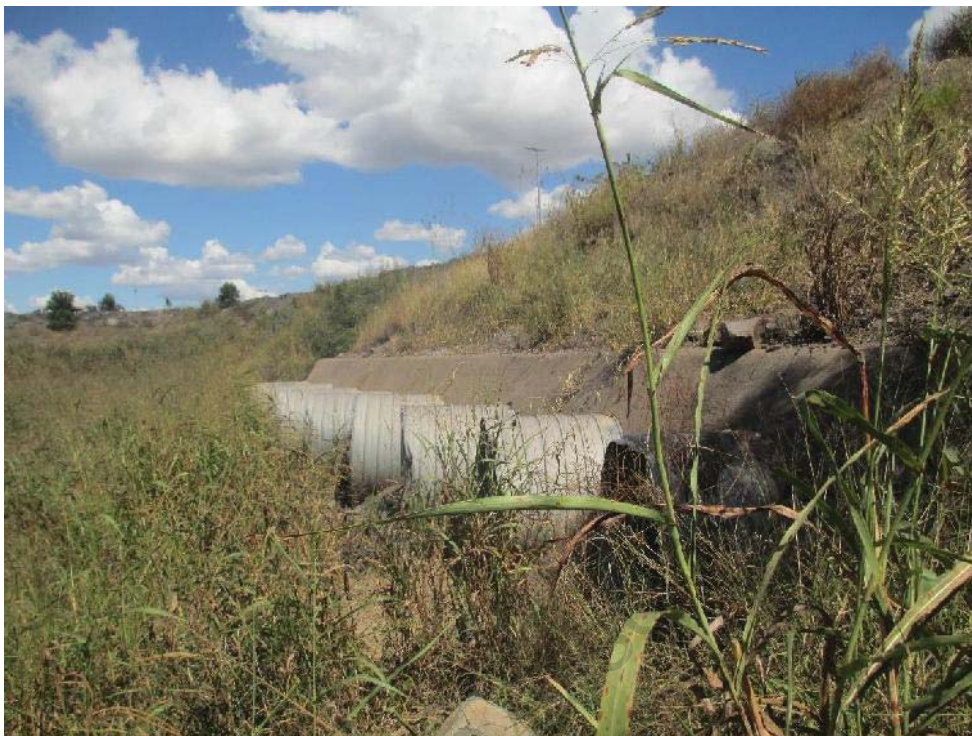
Figure 6.9 High Level Culverts At Upstream Side Of Haul Road

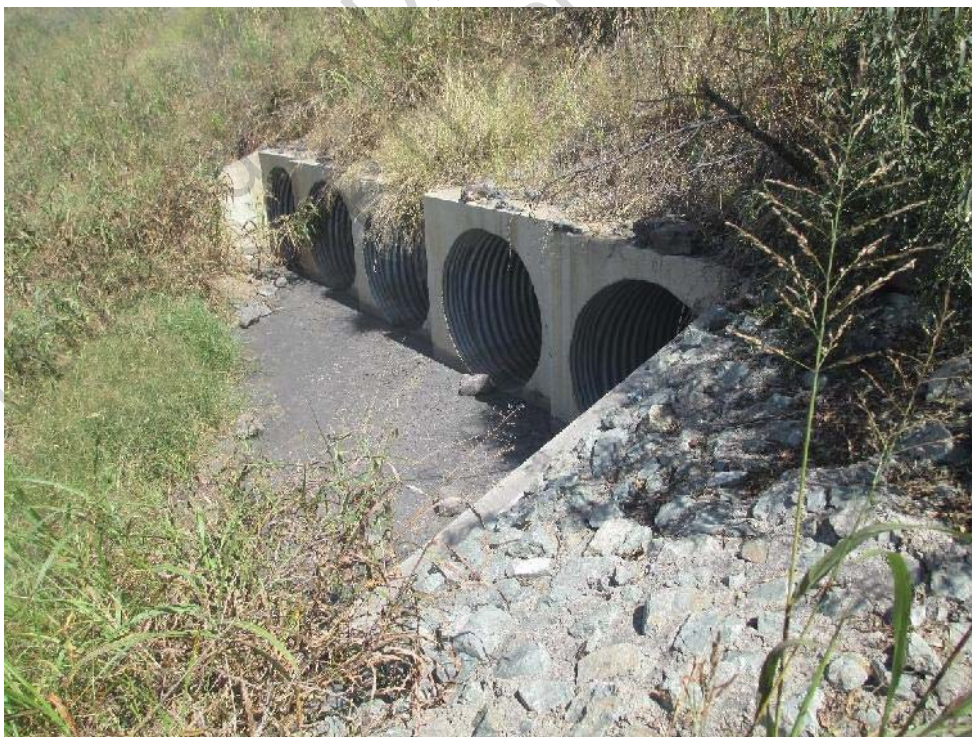
Figure 6.10 Low Flow Culverts At Upstream Side Of Haul Road

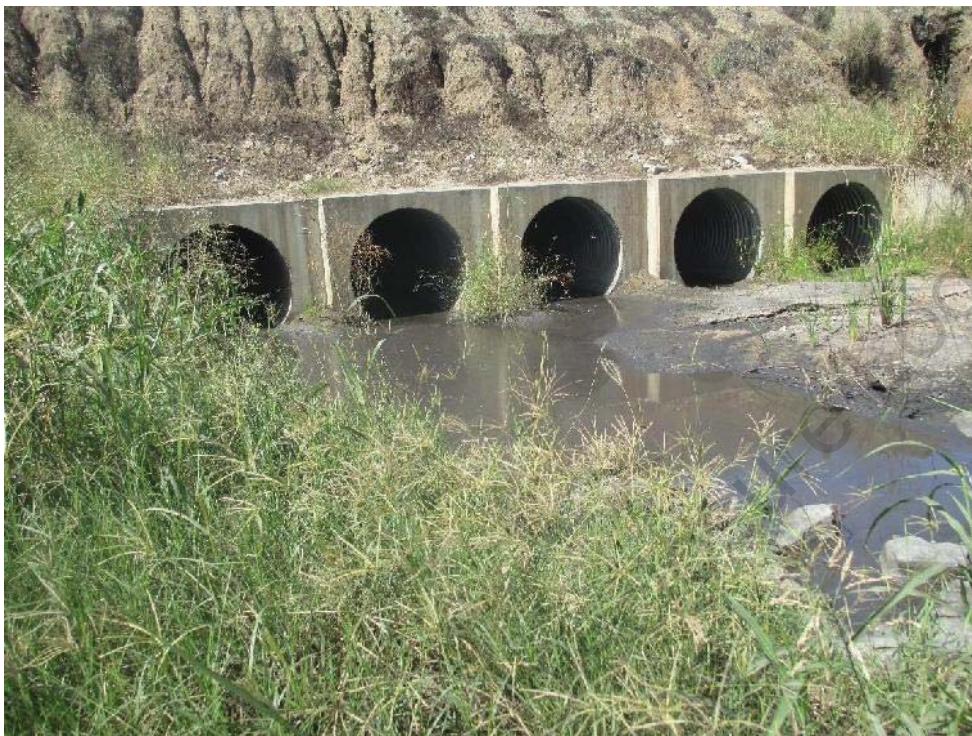
Figure 6.13 Downstream Headwall Of Low Level Haul Road Culverts

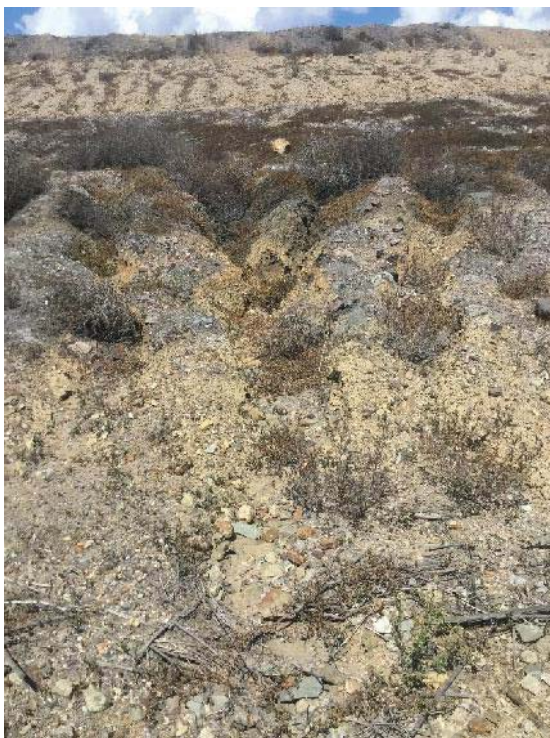
Figure 6.15 Rilling In The Vicinity Of TMC-Div2

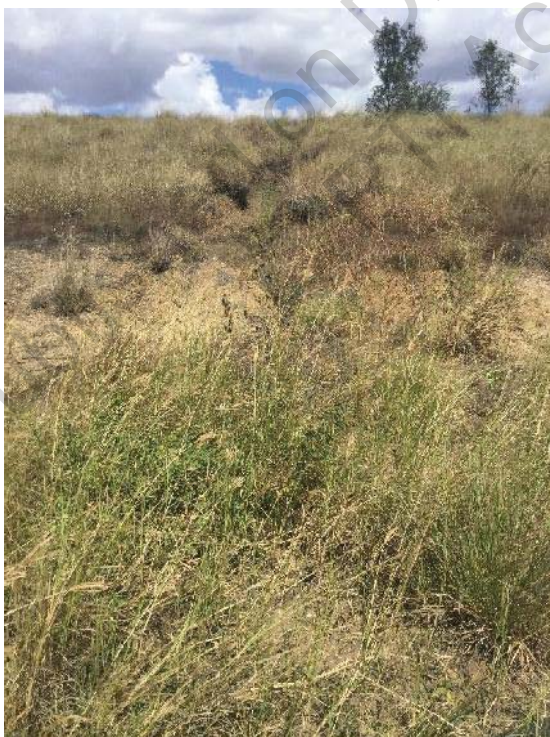
Figure 6.16 Gully Erosion Downstream Of TMC-Div2

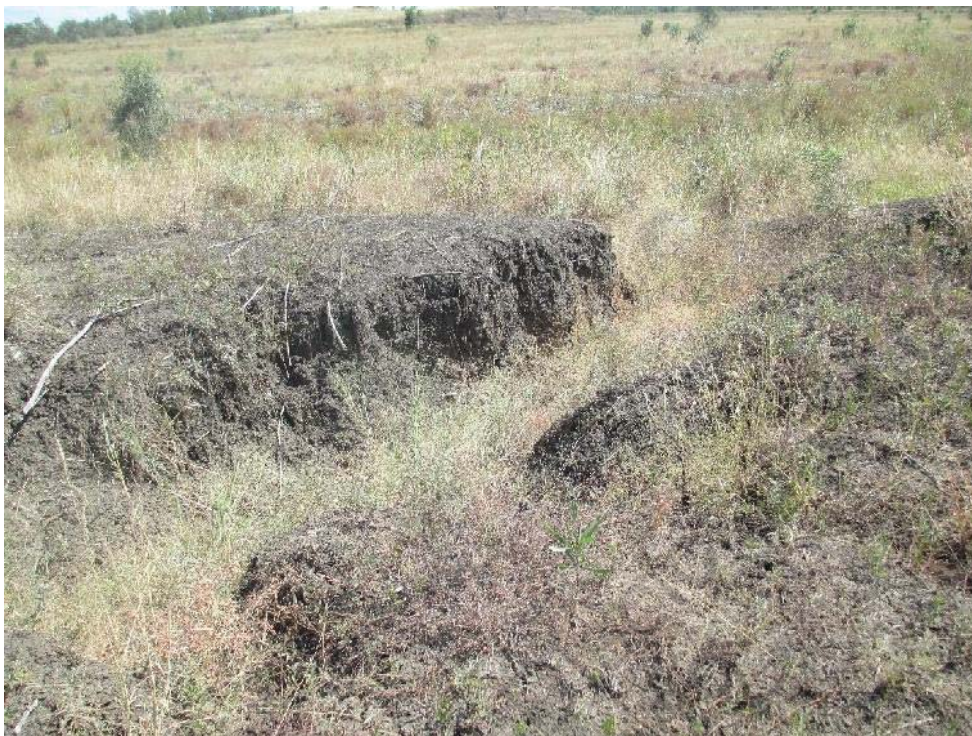
Figure 6.17 Gully Erosion Of Right Bank Upstream Of TMC-Div3

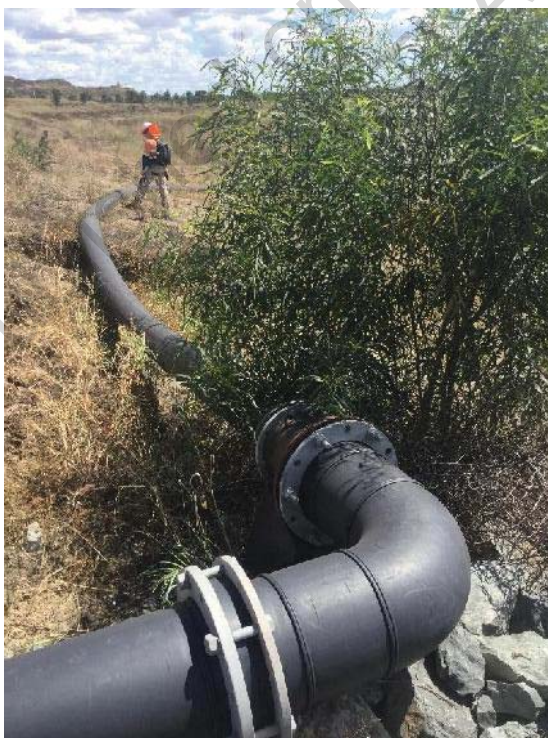
Figure 6.18 Vegetation Establishment At Location Of Previous Scour At Outlet Of Sd5 Gravity Discharge Pipe

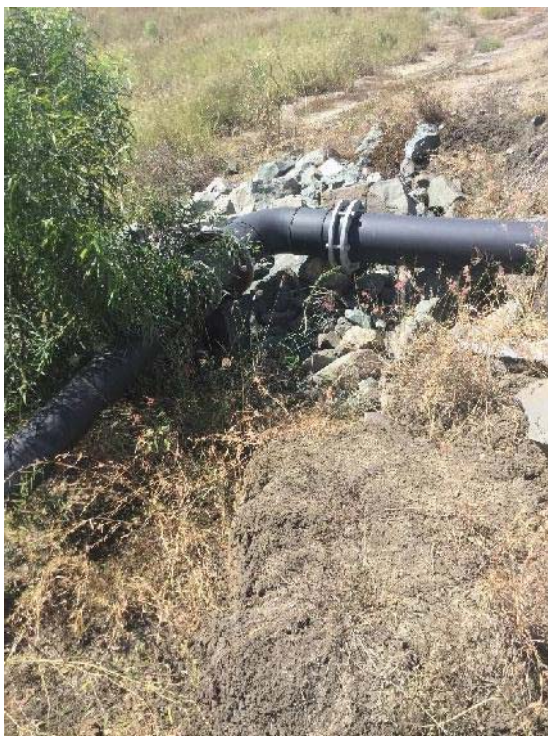
Figure 6.19 Sd5 Release Pipeline Off Mounting Blocks

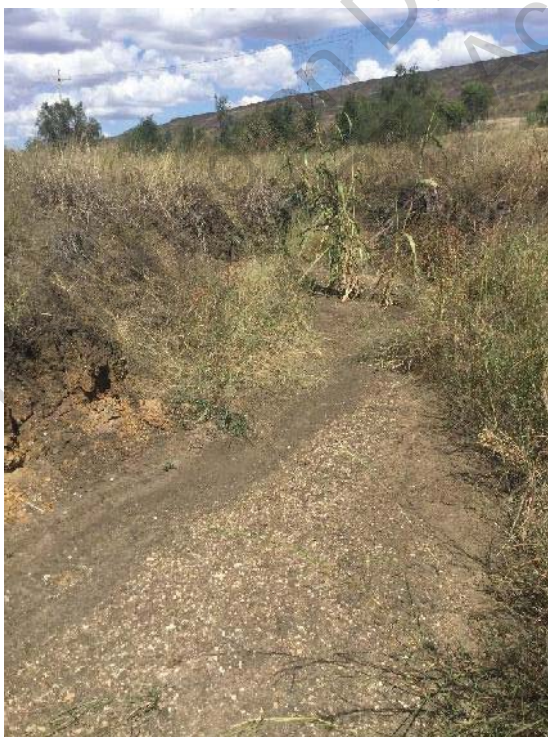
Figure 6.20 View Along Erosion Gully On Left Bank Of Diversion Downstream Of TMC-Div2

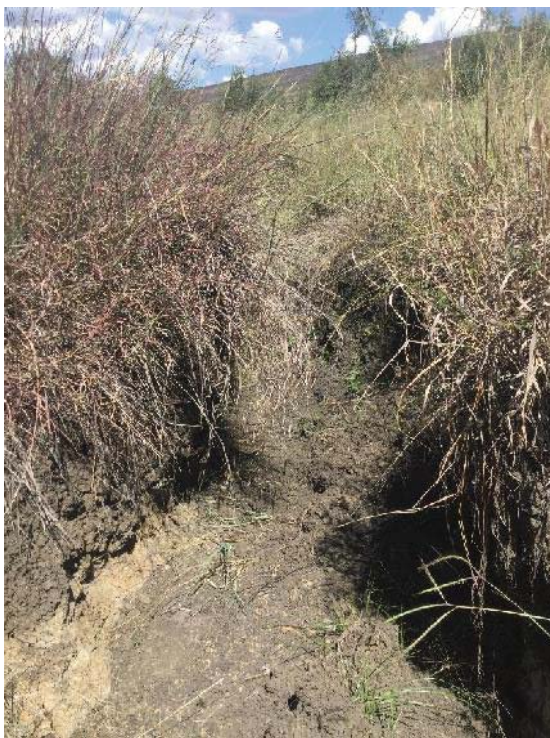
Figure 6.21 Upstream Limit Of Erosion Gully (View Towards SD5 And MIA)

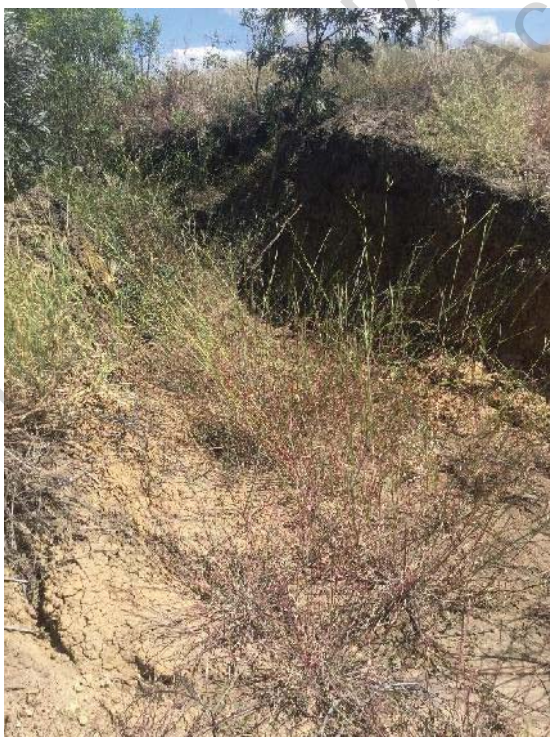
Figure 6.22 Secondary Smaller Erosion Gully Near Light Vehicle Road Crossing

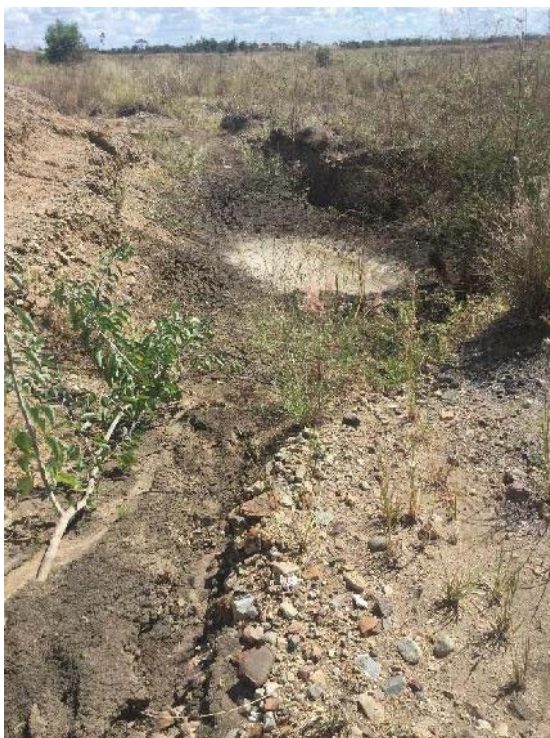
Figure 6.23 Scour At Toe Of Embankment Upstream Of Light Vehicle Road Crossing

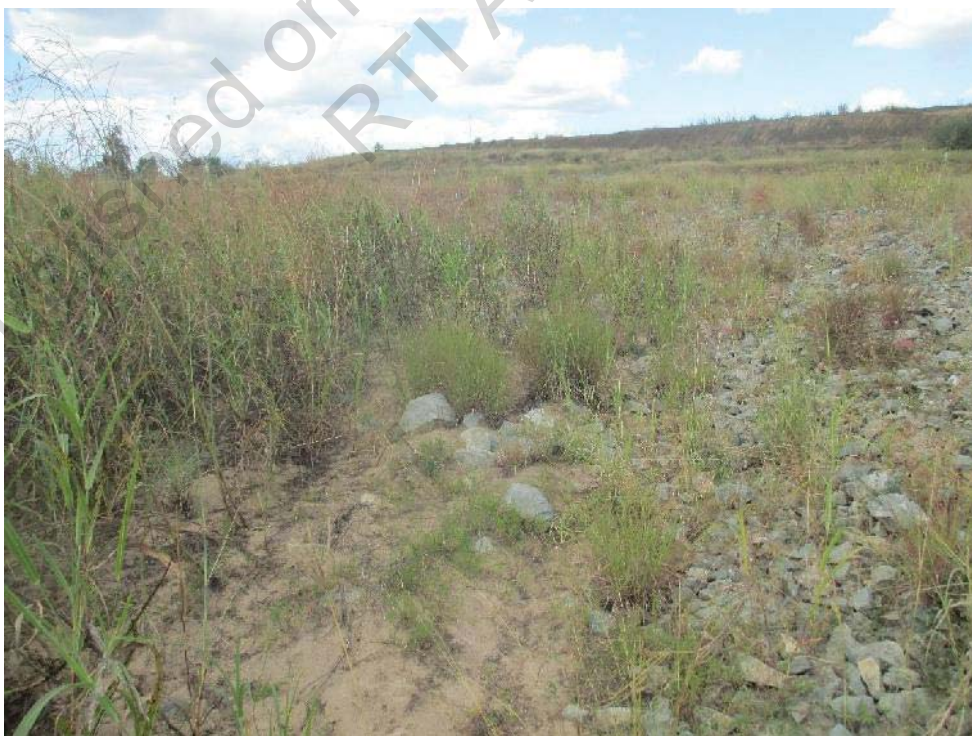
Figure 6.26 Vegetation Establishment In Bed Of Channel At TMC-Div4

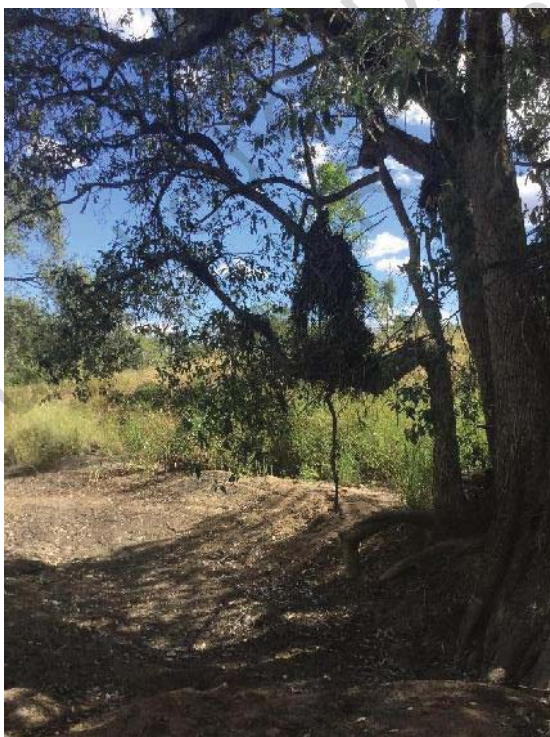
Figure 6.29 Flood Debris Downstream Of TMC-DS1

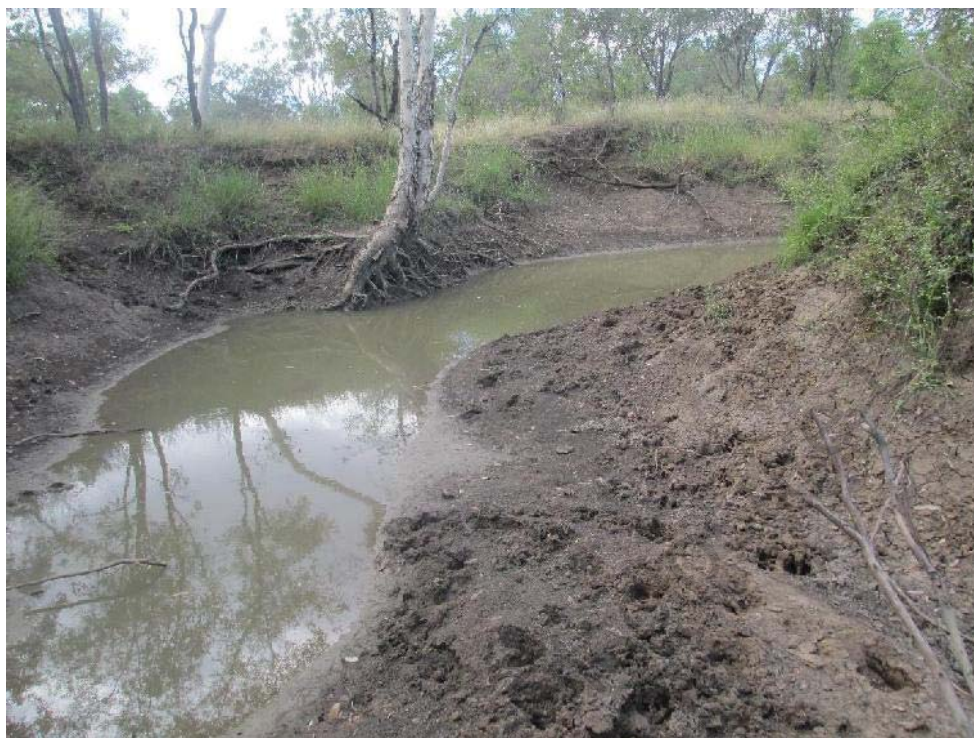
Figure 6.30 Ponding And Evidence Of Stock Access At TMC-DS3

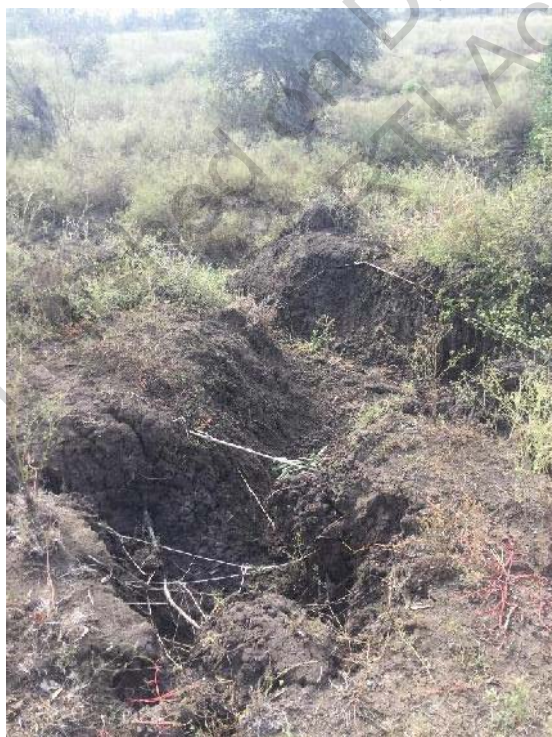
Figure 6.31 Gully Erosion On Right Bank Downstream Of TMC-DS3

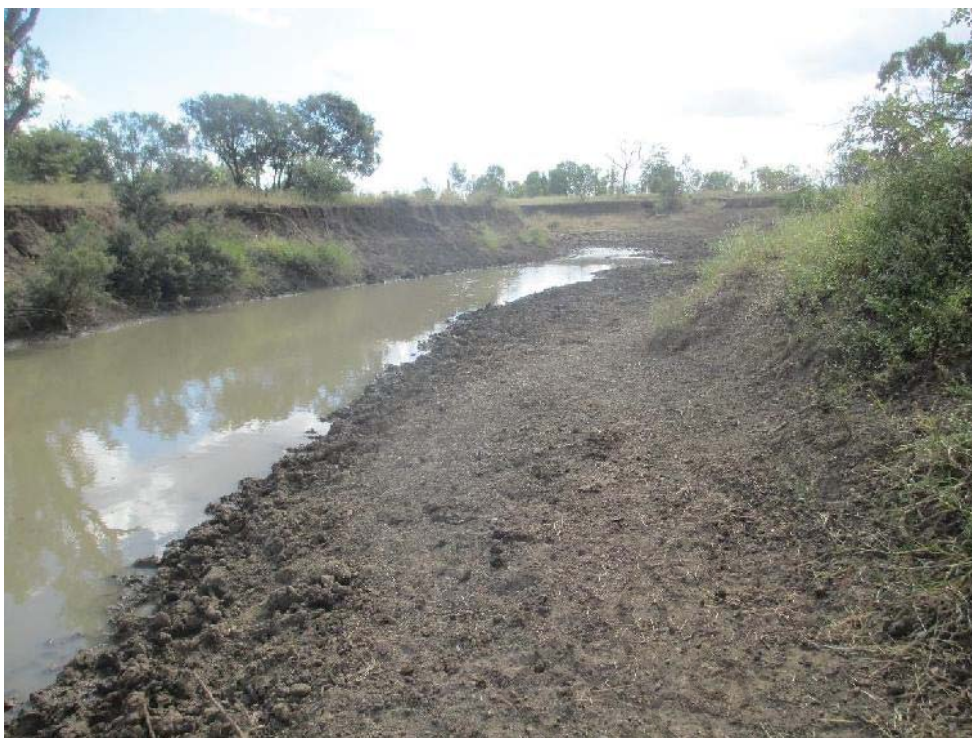
Figure 6.32 Ponding And Bank Steepening At TMC-DS4
