Department of  
**Environment and  
Heritage Protection**

**Re: Compliance Inspection of ACI Operations Pty Ltd for ERA 44 Glass or glass fibre manufacturing**

I refer to the inspection of ACI Operations Pty Ltd at 137 Montague Road, South Brisbane on 19 February 2014, conducted by officers of the department.

## O-I Australia Ltd (ACI) Level C compliance inspection – Schedule B Air

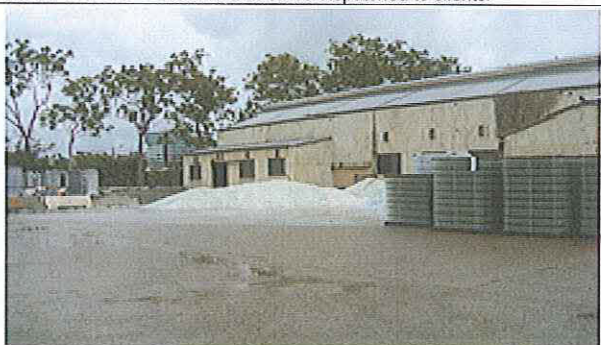
Photo: 1020594 – Hardstand area – crushed glass is banded – the product is recycled.

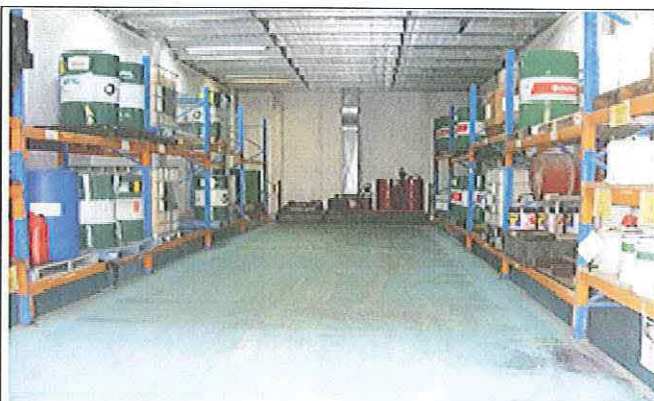
Photo: 1020631 – Chemical storage – rollover bund at entrance

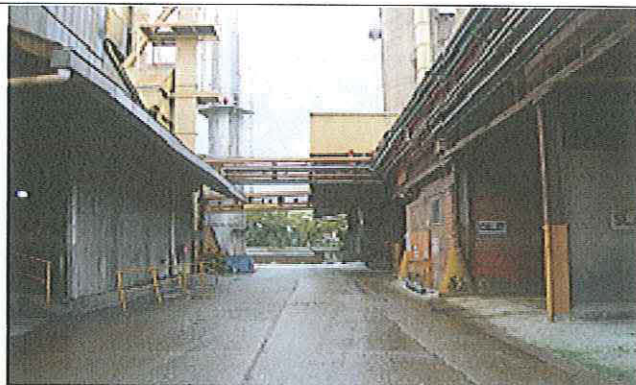
Photo: 1020635 – Housekeeping has improved since the last inspection in 2009.

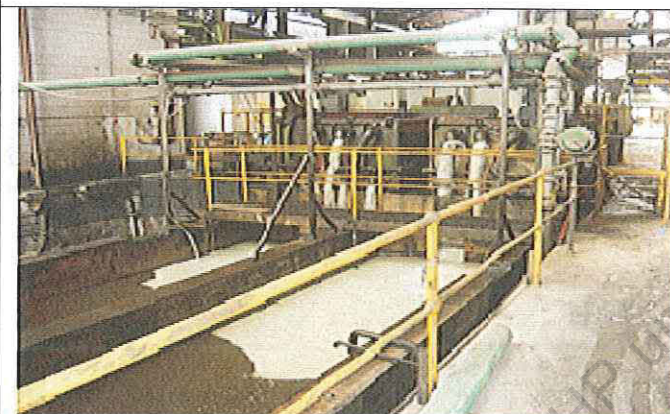
Photo: 1020654 – Collection area for runoff from the production area – oil and trade waste end up here from QE3.

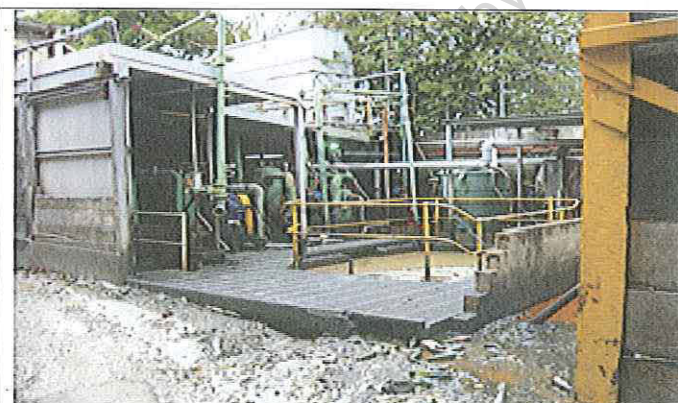
Photo: 1020664 – Back of main production building – the production building is fully bunded including the area shown in the picture – The water here is cooled in the cooling pond and recycled through QG1.

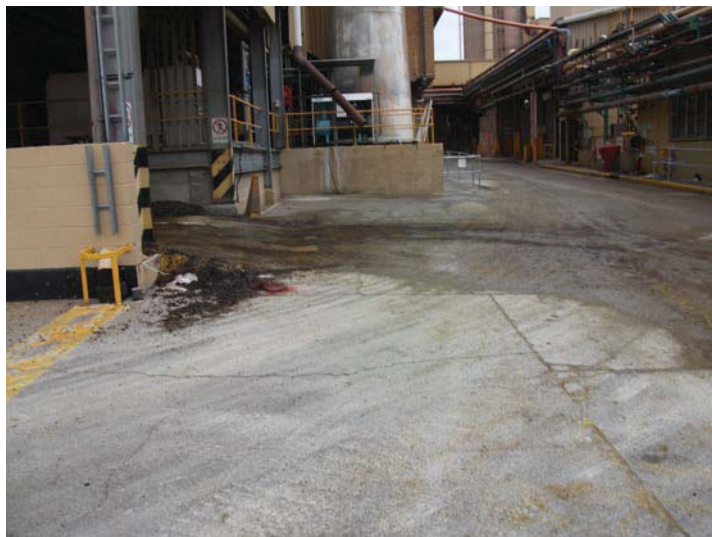
1. Outside the loading bay (diagonal to the mould shop), sediment laden water was observed leaving the bay and entering a stormwater drain (please refer to photo 1 and 2 in attachment 1). ACI staff informed officers that a Drain Warden was installed within the stormwater drain to contain oil and sediment run-off.

**Photo 1.** Loading bay diagonal to mould shed/spray booth.

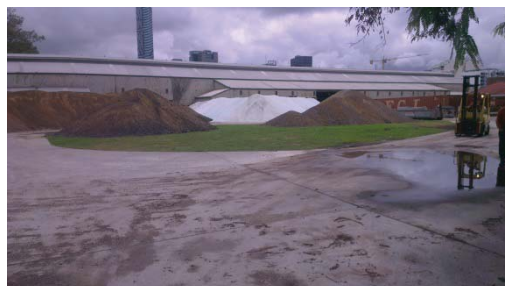
**Photo 4** – Surplus stockpiling of crushed glass and silica sand.

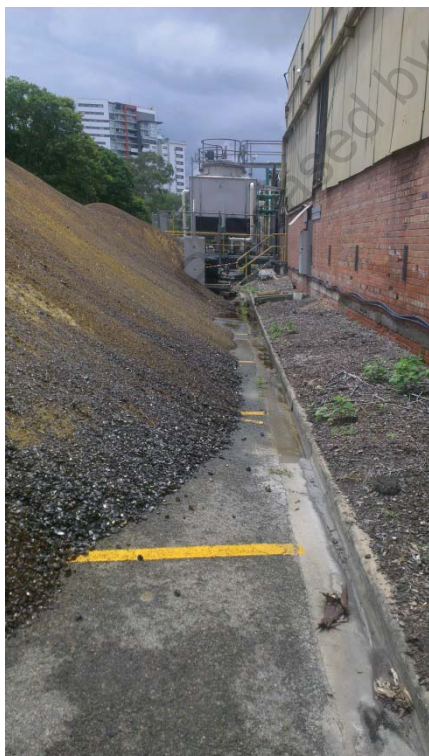
Photo 6 – Surplus stockpiling of crushed glass, banded by cement bollards.

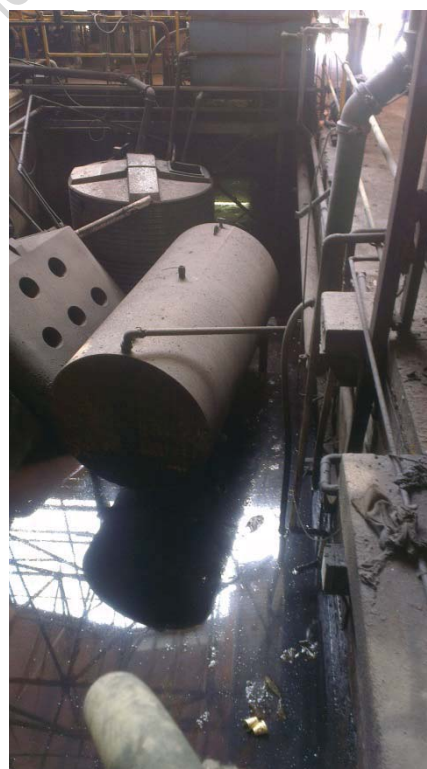
Photo 6 – Water treatment system.

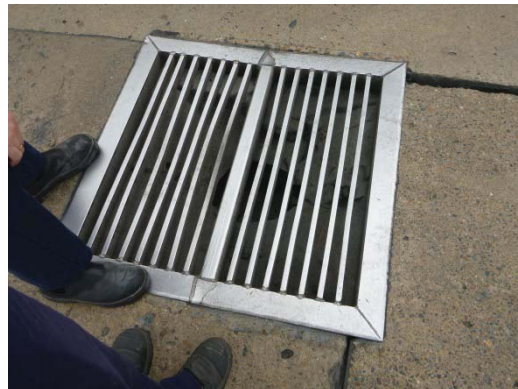
Photo 5 – Stormwater drain with drain warden (filter sock)

- Officers observed the drain warden in place in the stormwater system which was quite full of sediment. Jason advised that the drain wardens are inspected every 6 months or earlier if necessary, with removal and replacement carried out by contracted company – Absorb Environmental. He noted that they would need to be replaced soon and that they were intending to get the water quality tested at the time of removal, using the guidelines that were sent to him prior to the inspection as he requested. The test results will indicate whether the drain wardens are effective enough for stormwater protection and shall be provided to EHP.

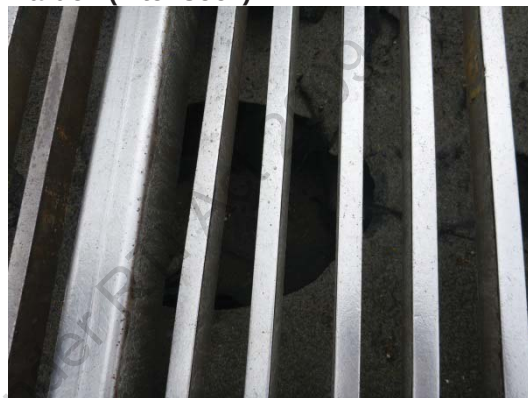
Photo 6 – Close up of stormwater drain

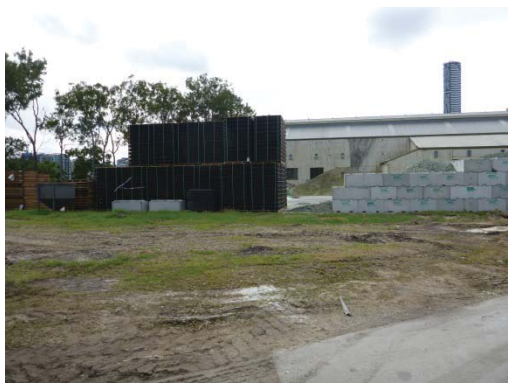
Photo 12 – Grass area that was covered with stockpiled glass shards during last inspection

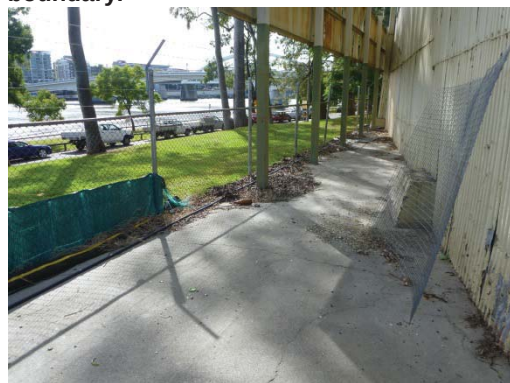
Photo 16 – Dust/particulate fence finishes before the end of the site boundary.

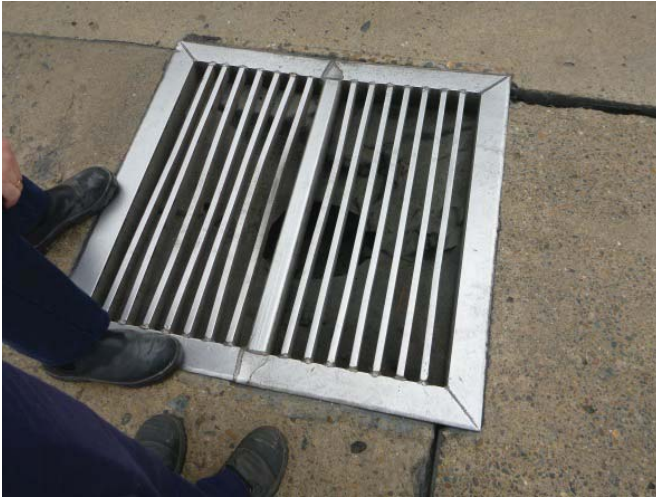
Photo 5 – Stormwater drain with drain warden (filter sock)

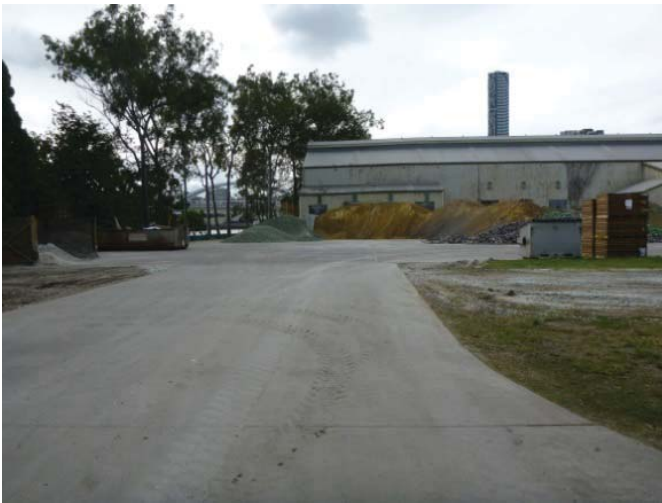
Photo 13 – Hardstand where glass shards were stored during previous inspection.

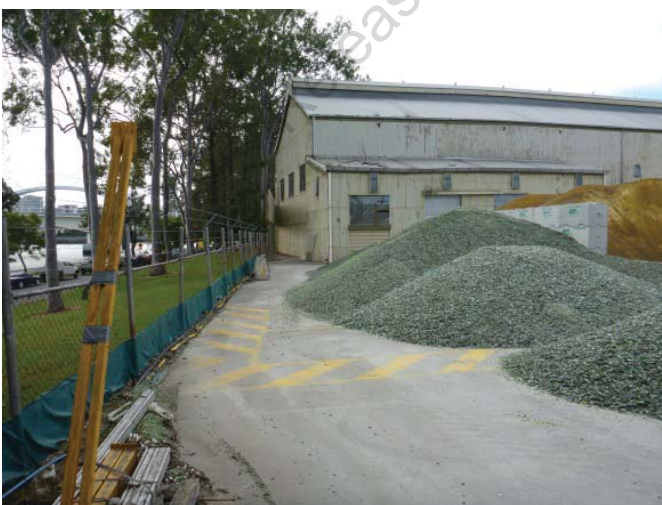
Photo 14 – Current stockpiles of glass for recycling.

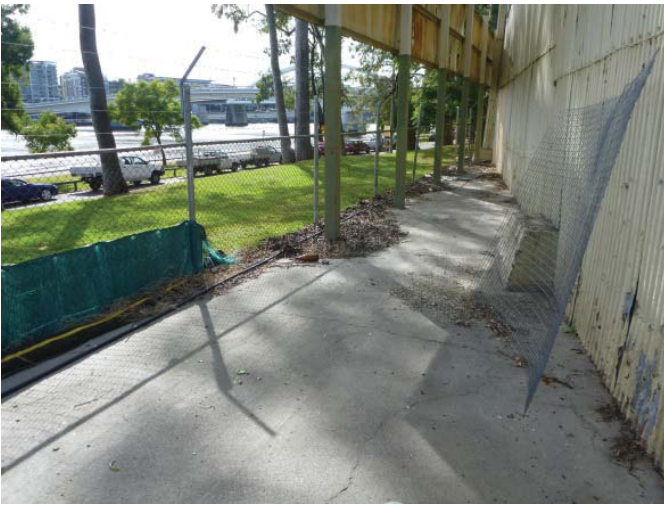
Photo 15 – Glass stockpiles the hardstand. Dust/glass particulate fence along site boundary.

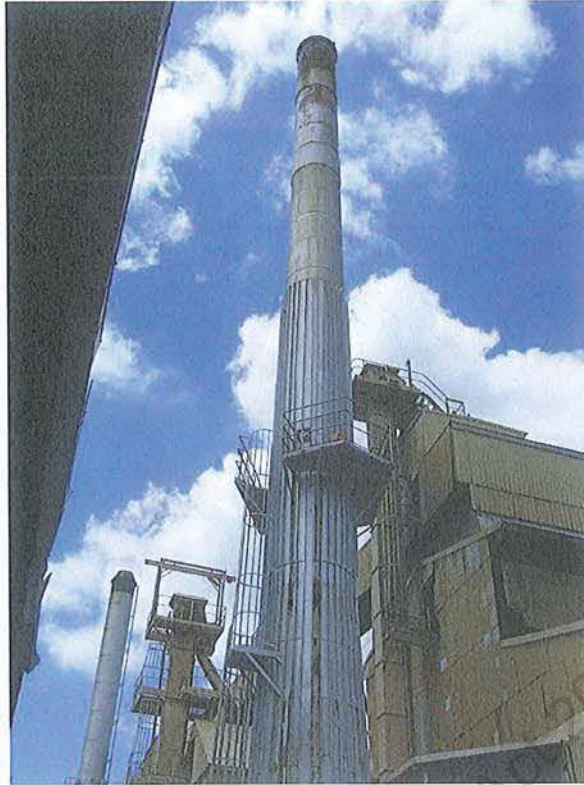
View of Release Point 1 – the QG1 furnace stack.

**Recommended action 2:** that release points be labelled in accordance with the requirements of conditions B11 and B12.

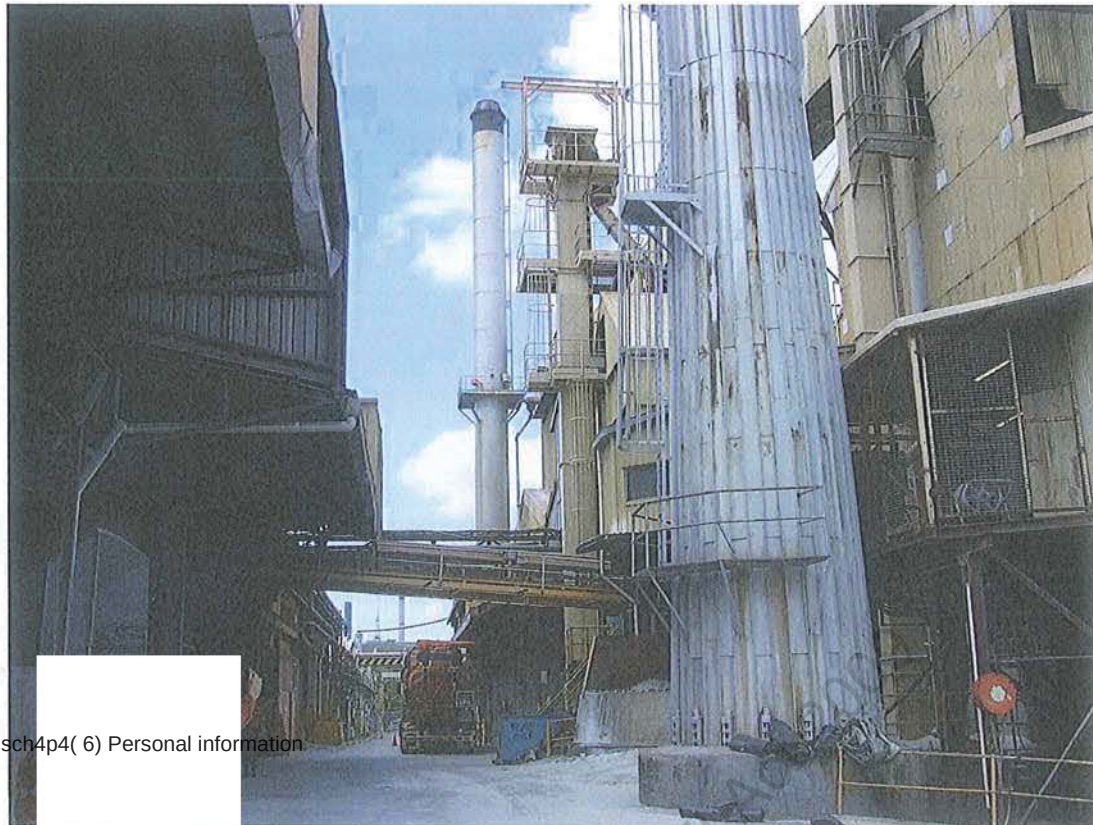
View of Release Point 2 – the QG2 furnace stack at centre-rear of the photograph.

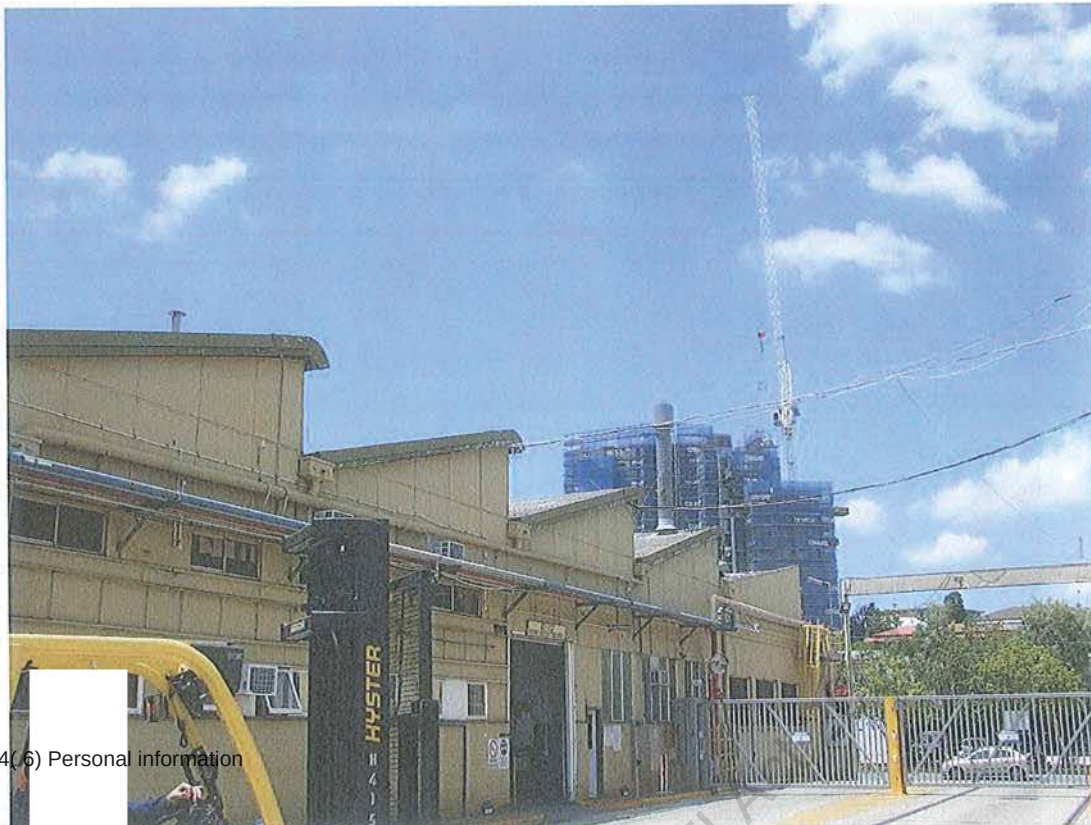
View of Release Point 3 – Machine shop fume extraction (larger stack framed by the high-rise construction).

**Recommended action 1:** that release points be assessed for compliance with the requirements of *Australian Standard AS 4323.1-1995 Stationary source emissions - Selection of sampling positions*.

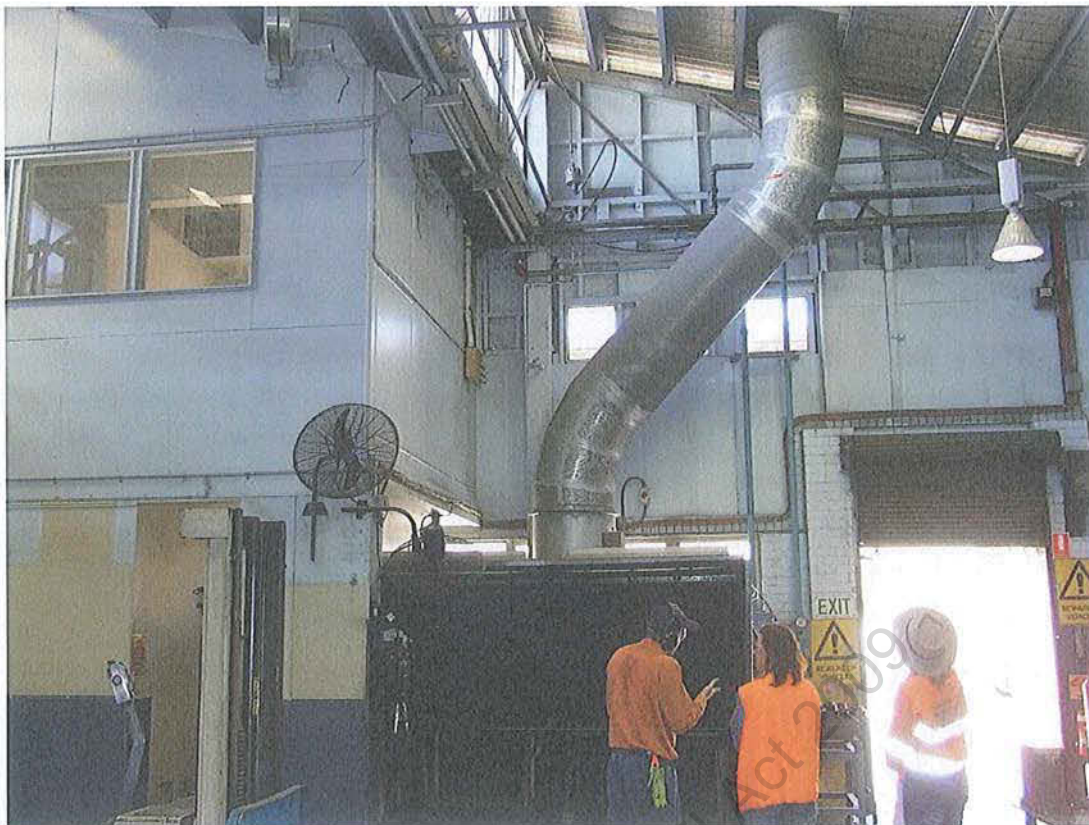
View of Release Point 4 – Mould shop solid film lubricant spray booth. The booth is fitted with a fabric filter as required by condition B13.

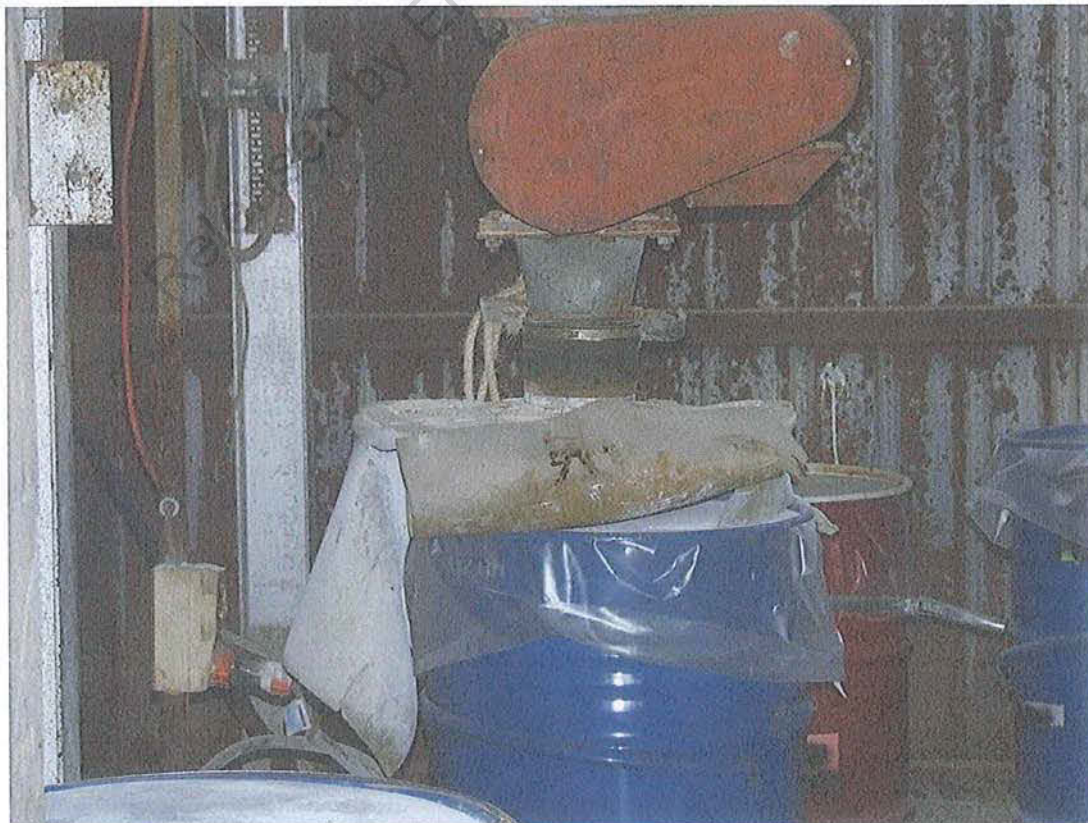
View of the 200 litre drum used to collect the stannic chloride and ammonia chloride particulate matter for disposal in accordance with condition B15.

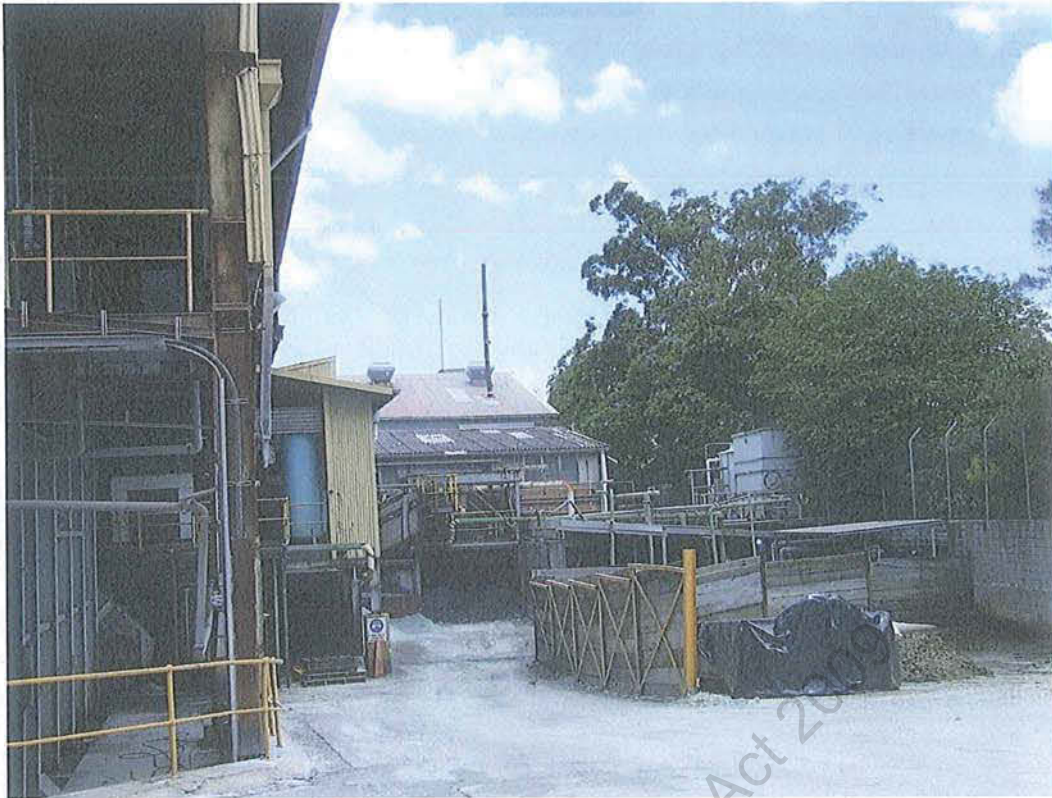
View of Release Point 6 – delivery cleaning oven.

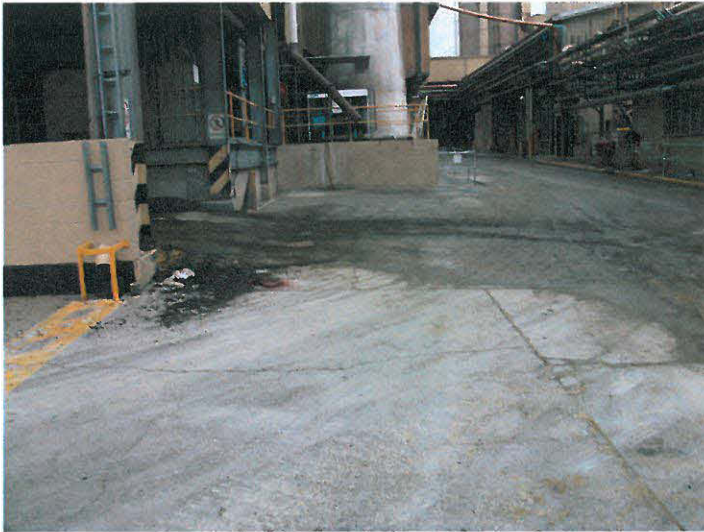
1. Outside the loading bay (diagonal to the mould shop), sediment laden water was observed leaving the bay and entering a stormwater drain (please refer to photo 1 and 2 in attachment 1). ACI staff informed officers that a Drain Warden was installed within the stormwater drain to contain oil and sediment run-off.

Furthermore the site appears to rely predominantly on water treatment systems such as Drain Wardens to manage the risk of contaminant releases to receiving waters (please refer to photo 1 and 2 in attachment 1). This management approach is confirmed in the Stormwater Management Plan and Stormwater Inspection documents supplied i.e. site sediment is marked for cleaning once in the drain, it is not addressed at the source.

**Photo 1.** Loading bay diagonal to mould shed/spray booth.
