### Application to amend an environmental authority (mining activities) for a level 1 mining project

This Groundwater Monitoring Report has been prepared in accordance with EA Condition F4-4:

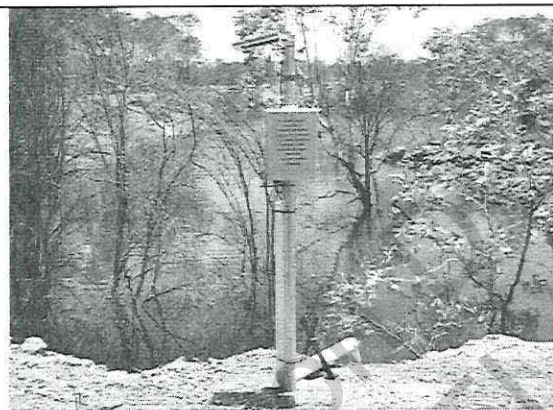
Figure 10: Croydon Pit Lake water level monitoring stations

d. Using survey equipment

e. Reference RL's: Content Pit 103.7m; Golden Butterfly Pit 114.5m; Lady Isabella Pit 109.7m; Golden Butterfly North Pit 122.7m

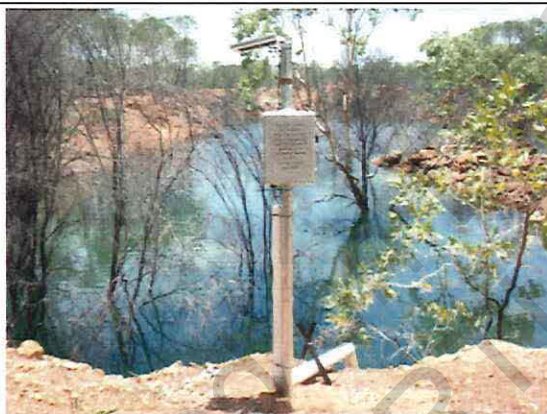
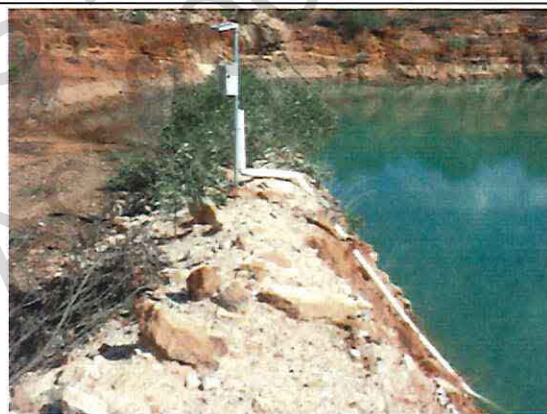
d. Using survey equipment

e. Reference RL's: Content Pit 103.7m; Golden Butterfly Pit 114.5m; Lady Isabella Pit 109.7m; Golden Butterfly North Pit 122.7m

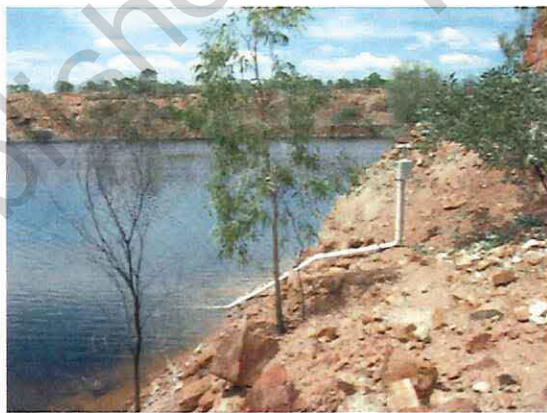
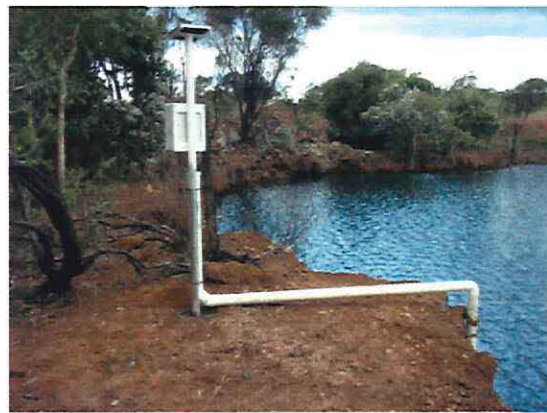
**Content Pit****Figure 8: Croydon Pit Lake water level monitoring stations**

In order to provide additional information to assist in refining the conceptual hydrological model, a series of water level monitoring stations have been installed during November 2011 in each of the pit lakes at Croydon (Figure 8). Each of these stations is fitted with a pressure sensor transducer connected to a data logger with solar powered battery supply. Additionally, in the event of a further discharge from the Content Pit, a measuring flume has been installed in the v-drain which will direct any outflow from the Content Pit.

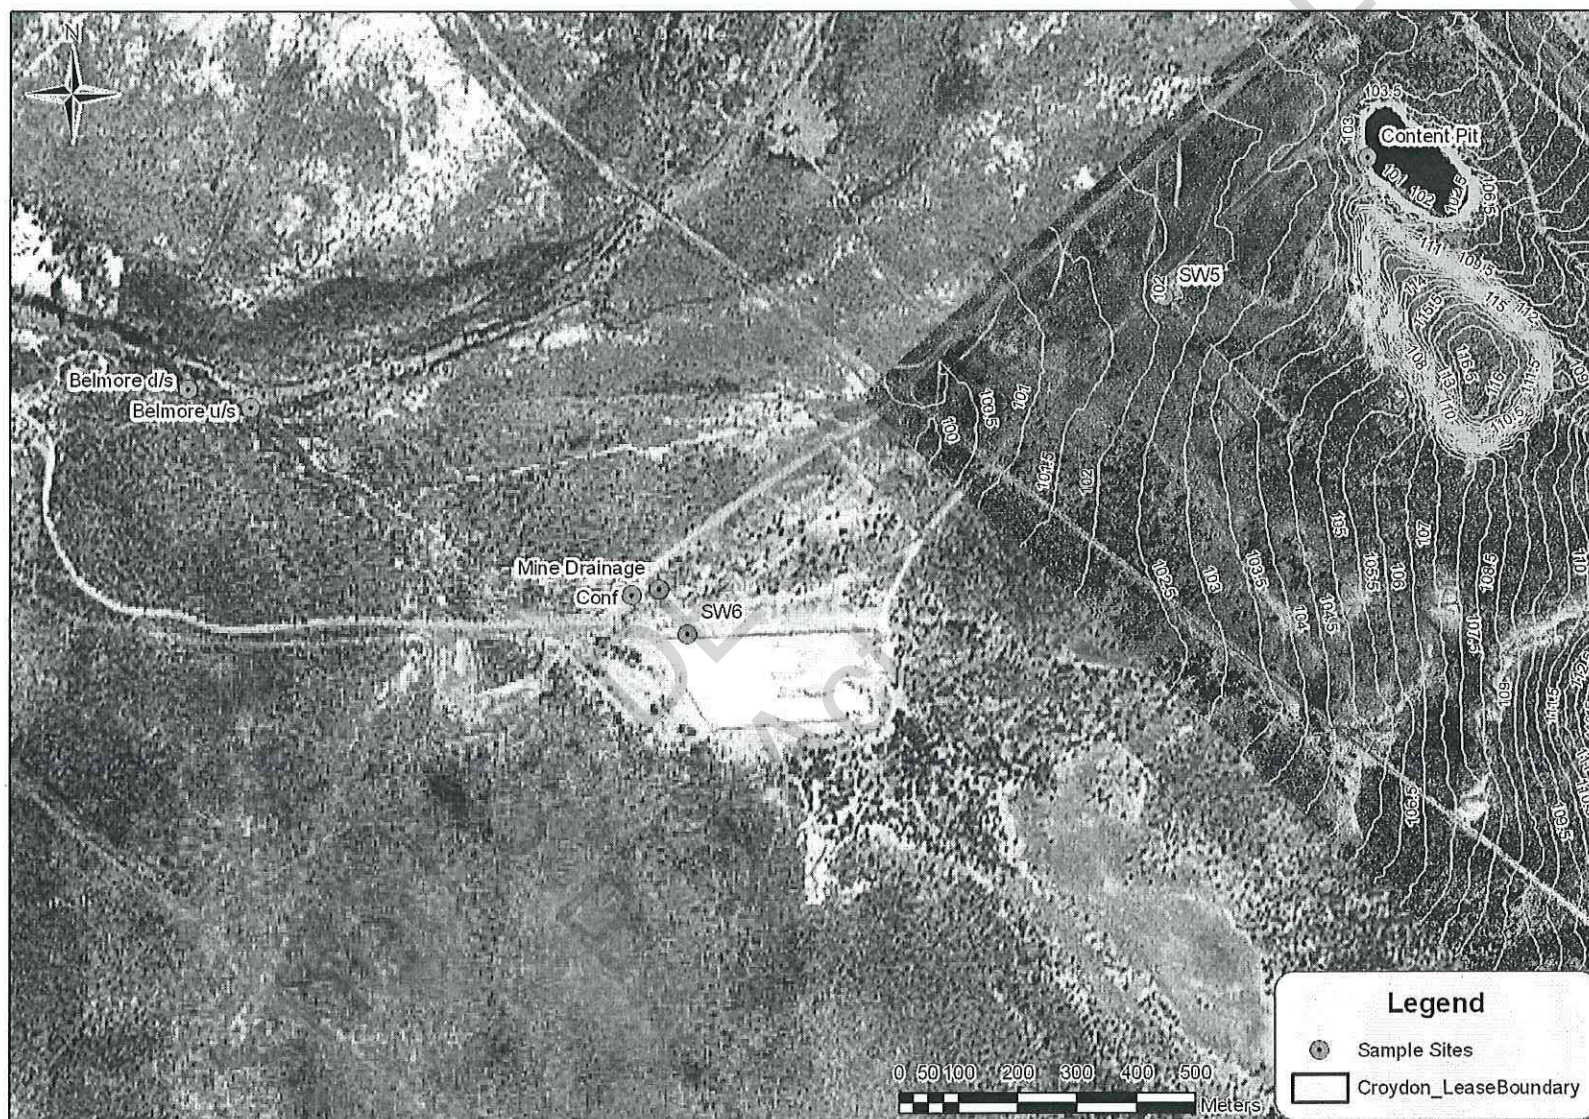
Figure 3: Sample Site Locations

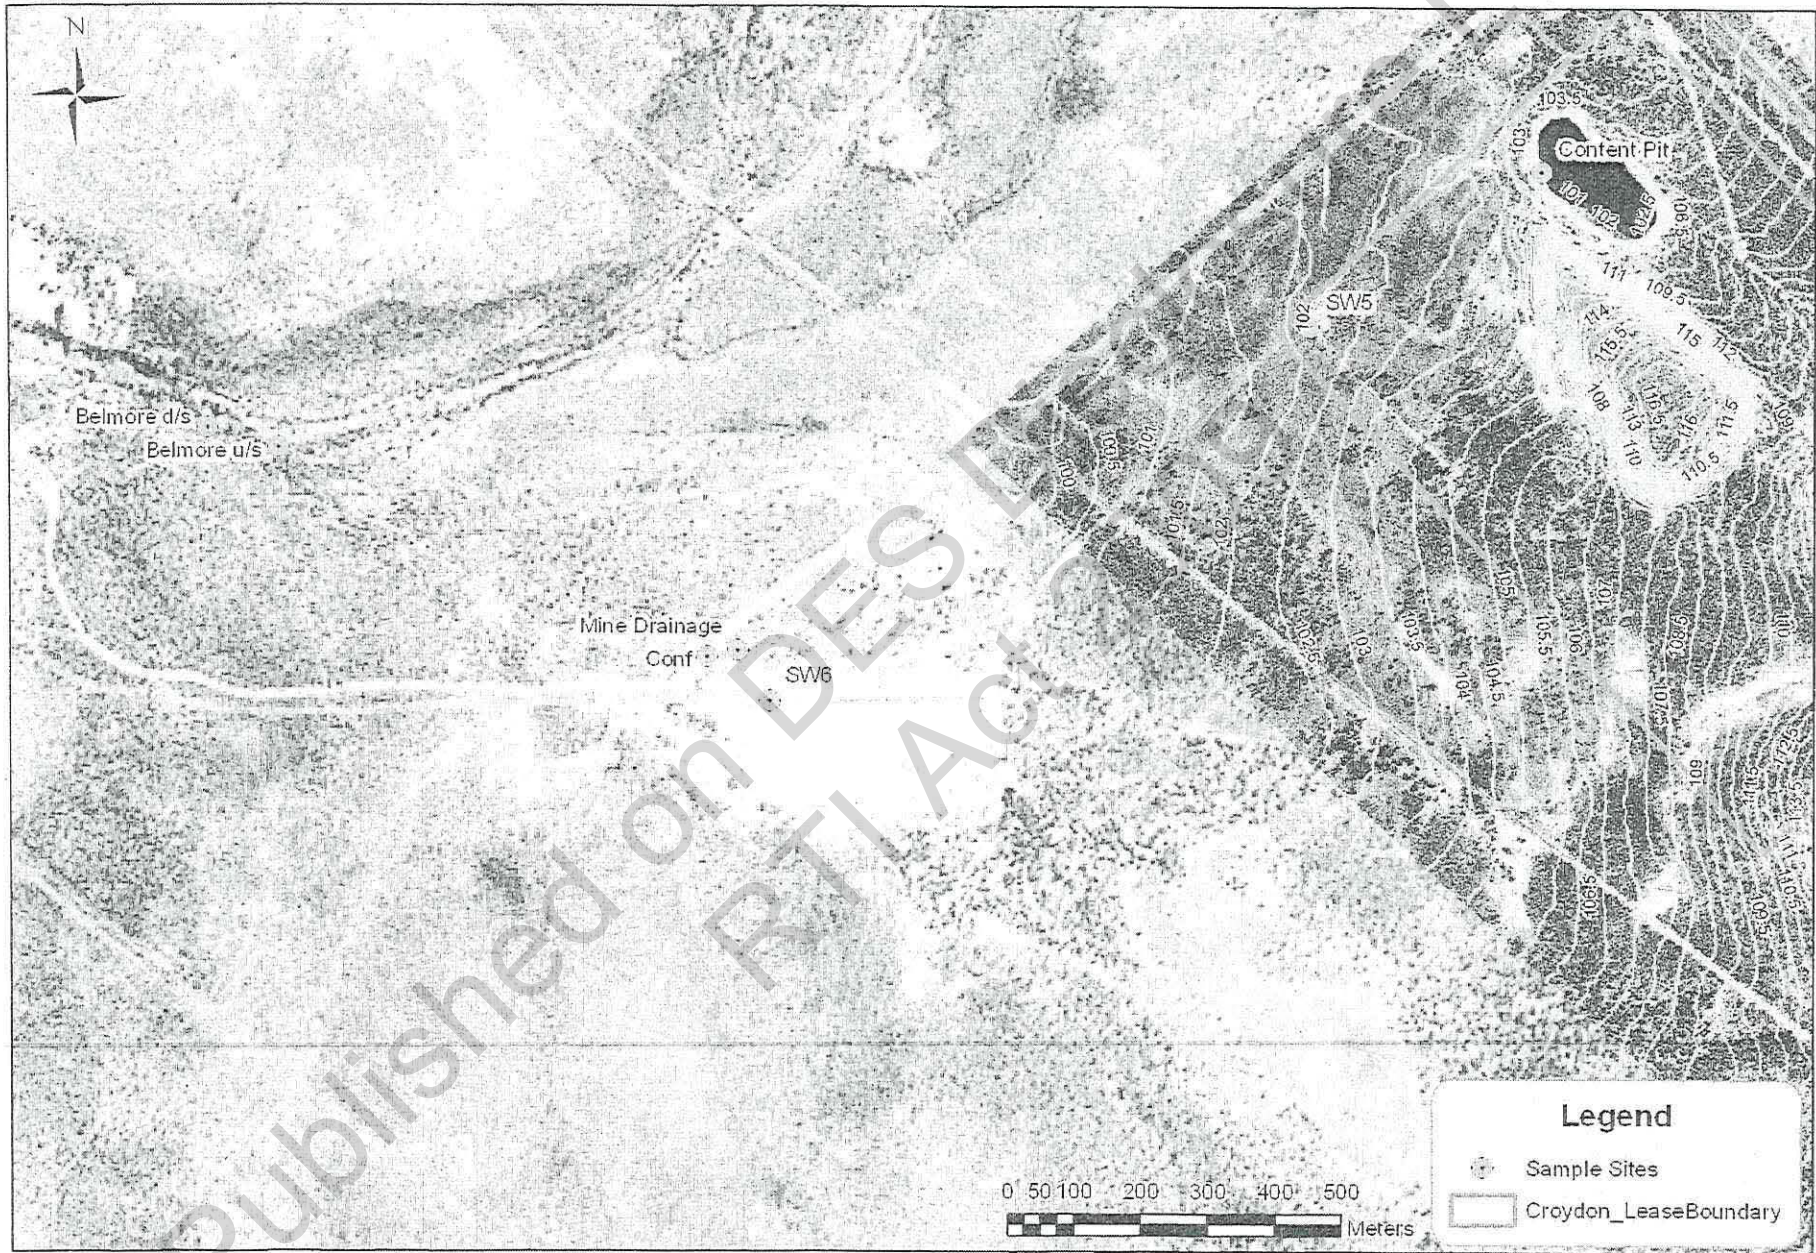
Figure 1: Sample Site Location

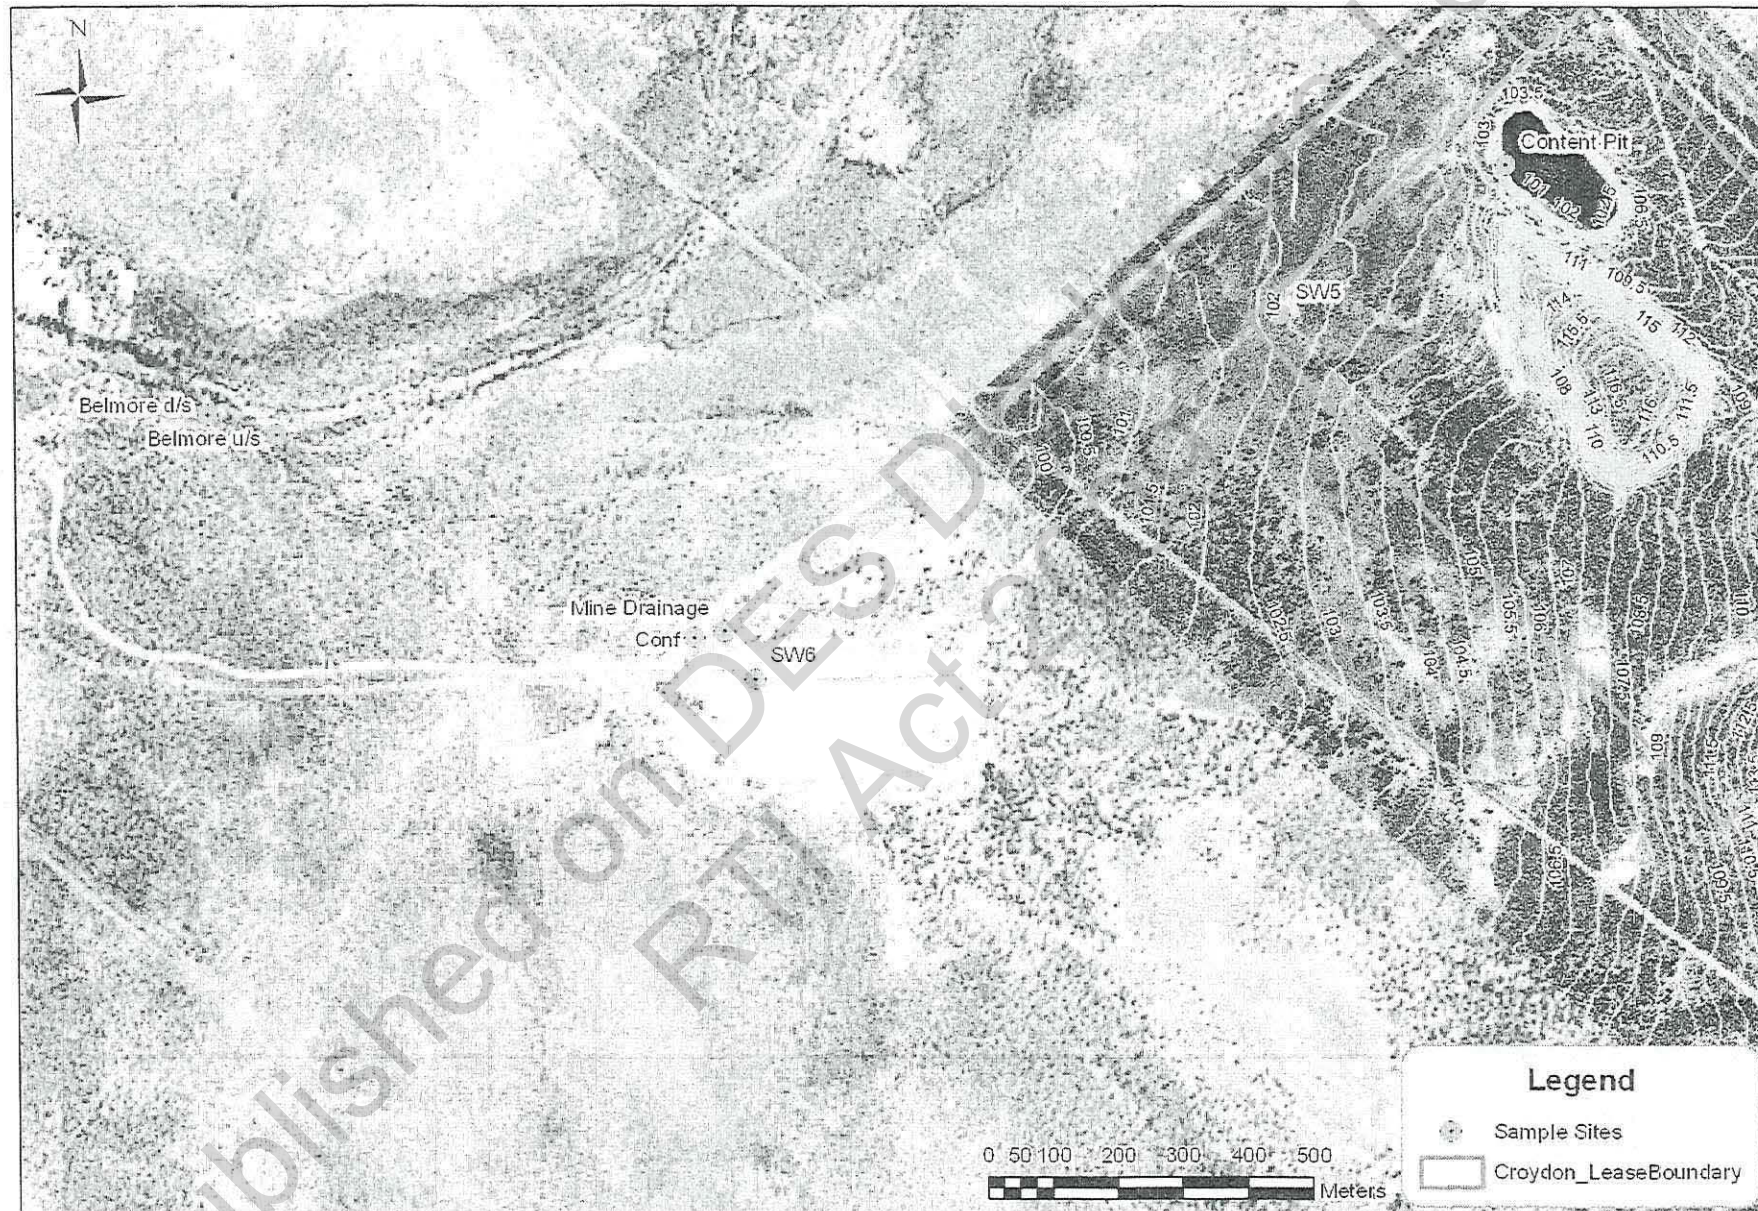
Figure 2: Sample Site Location

<sup>1</sup> See Figure 1 for sample site locations.

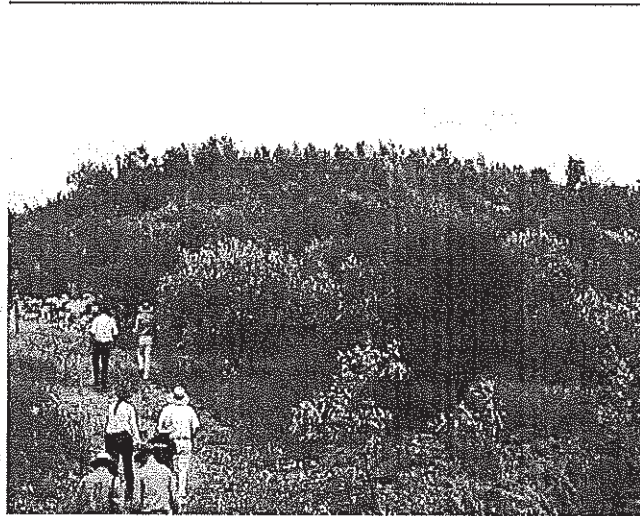
**Plate 1: Vegetation Cover on Golden Butterfly Waste Rock Dump (February 2001)**

The monitoring of vegetation and landscape function shows that the ecosystems on the rehabilitated waste rock dumps and hardstand areas are continuing to develop and trend towards the control site. Vegetation cover on the waste rock dumps is increasing and the vegetation is generally progressing towards a stable ecosystem (see Plate 1 and Plate 2).

The rehabilitation work on the Golden Butterfly waste rock dump has proven effective in eliminating the acid drainage that apparently occurred from this site, as demonstrated by the surface water monitoring program (Section 4.3.3). In addition, the good establishment of vegetation on the dump (see Plate 1) is demonstration of the continued integrity of the rehabilitation cover.
