**Q BUILD PROJECT SERVICES**

**FURTHER INVESTIGATION  
LAND CONTAMINATION  
QUEENSLAND COTTON  
CORPORATION SITE  
EAGLE FARM**

22707-003-362  
NOVEMBER 1992

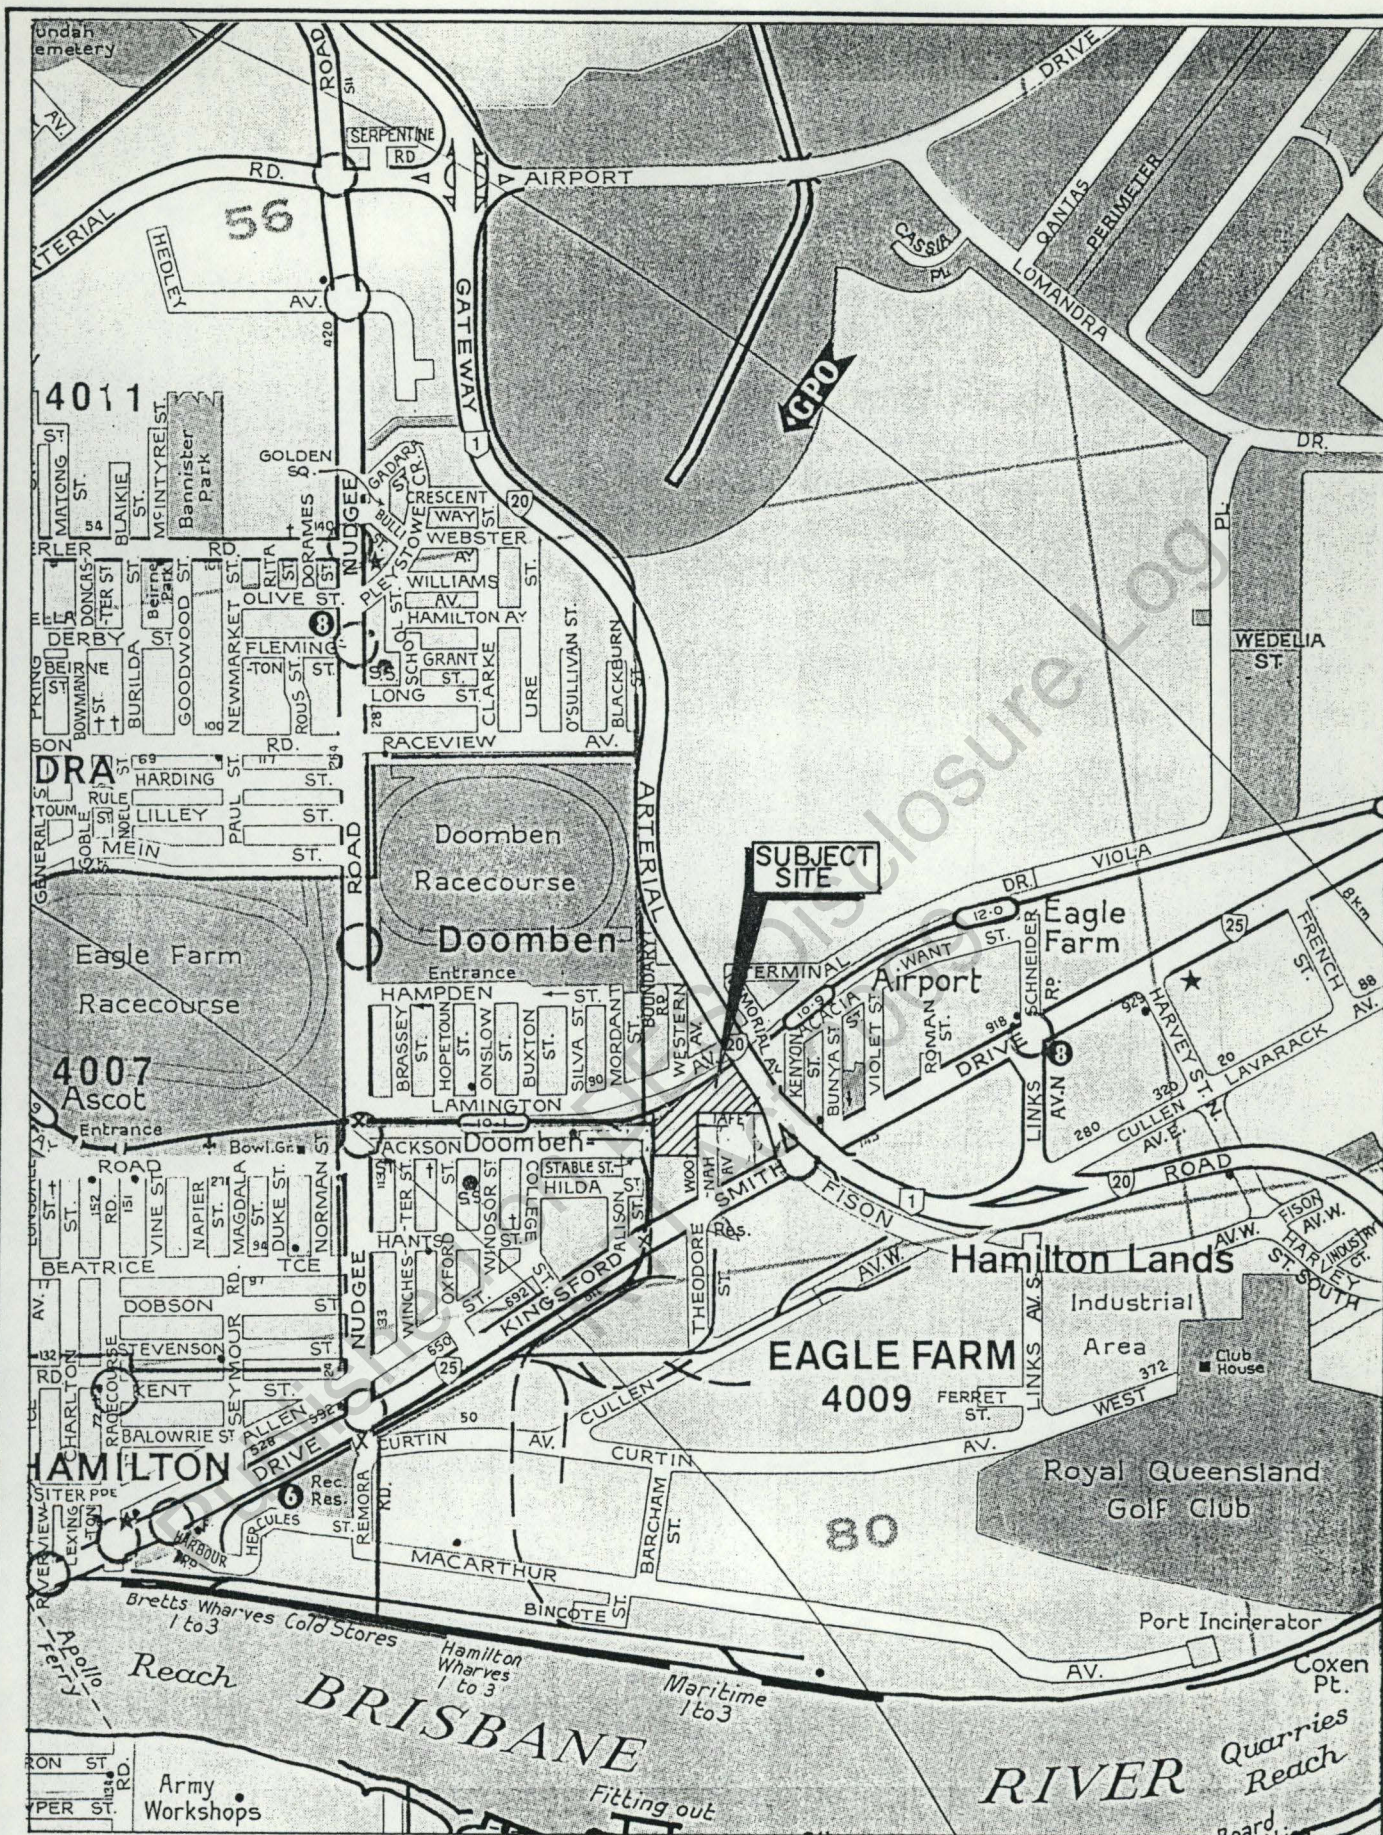
The site is located at the corner of Kingsford Smith Drive and Woonah Avenue as indicated in Figure 1. The site is bounded in the north by the Brisbane-Pinkenba rail link. The remainder of the site is bounded by real property boundaries and by Woonah Avenue.

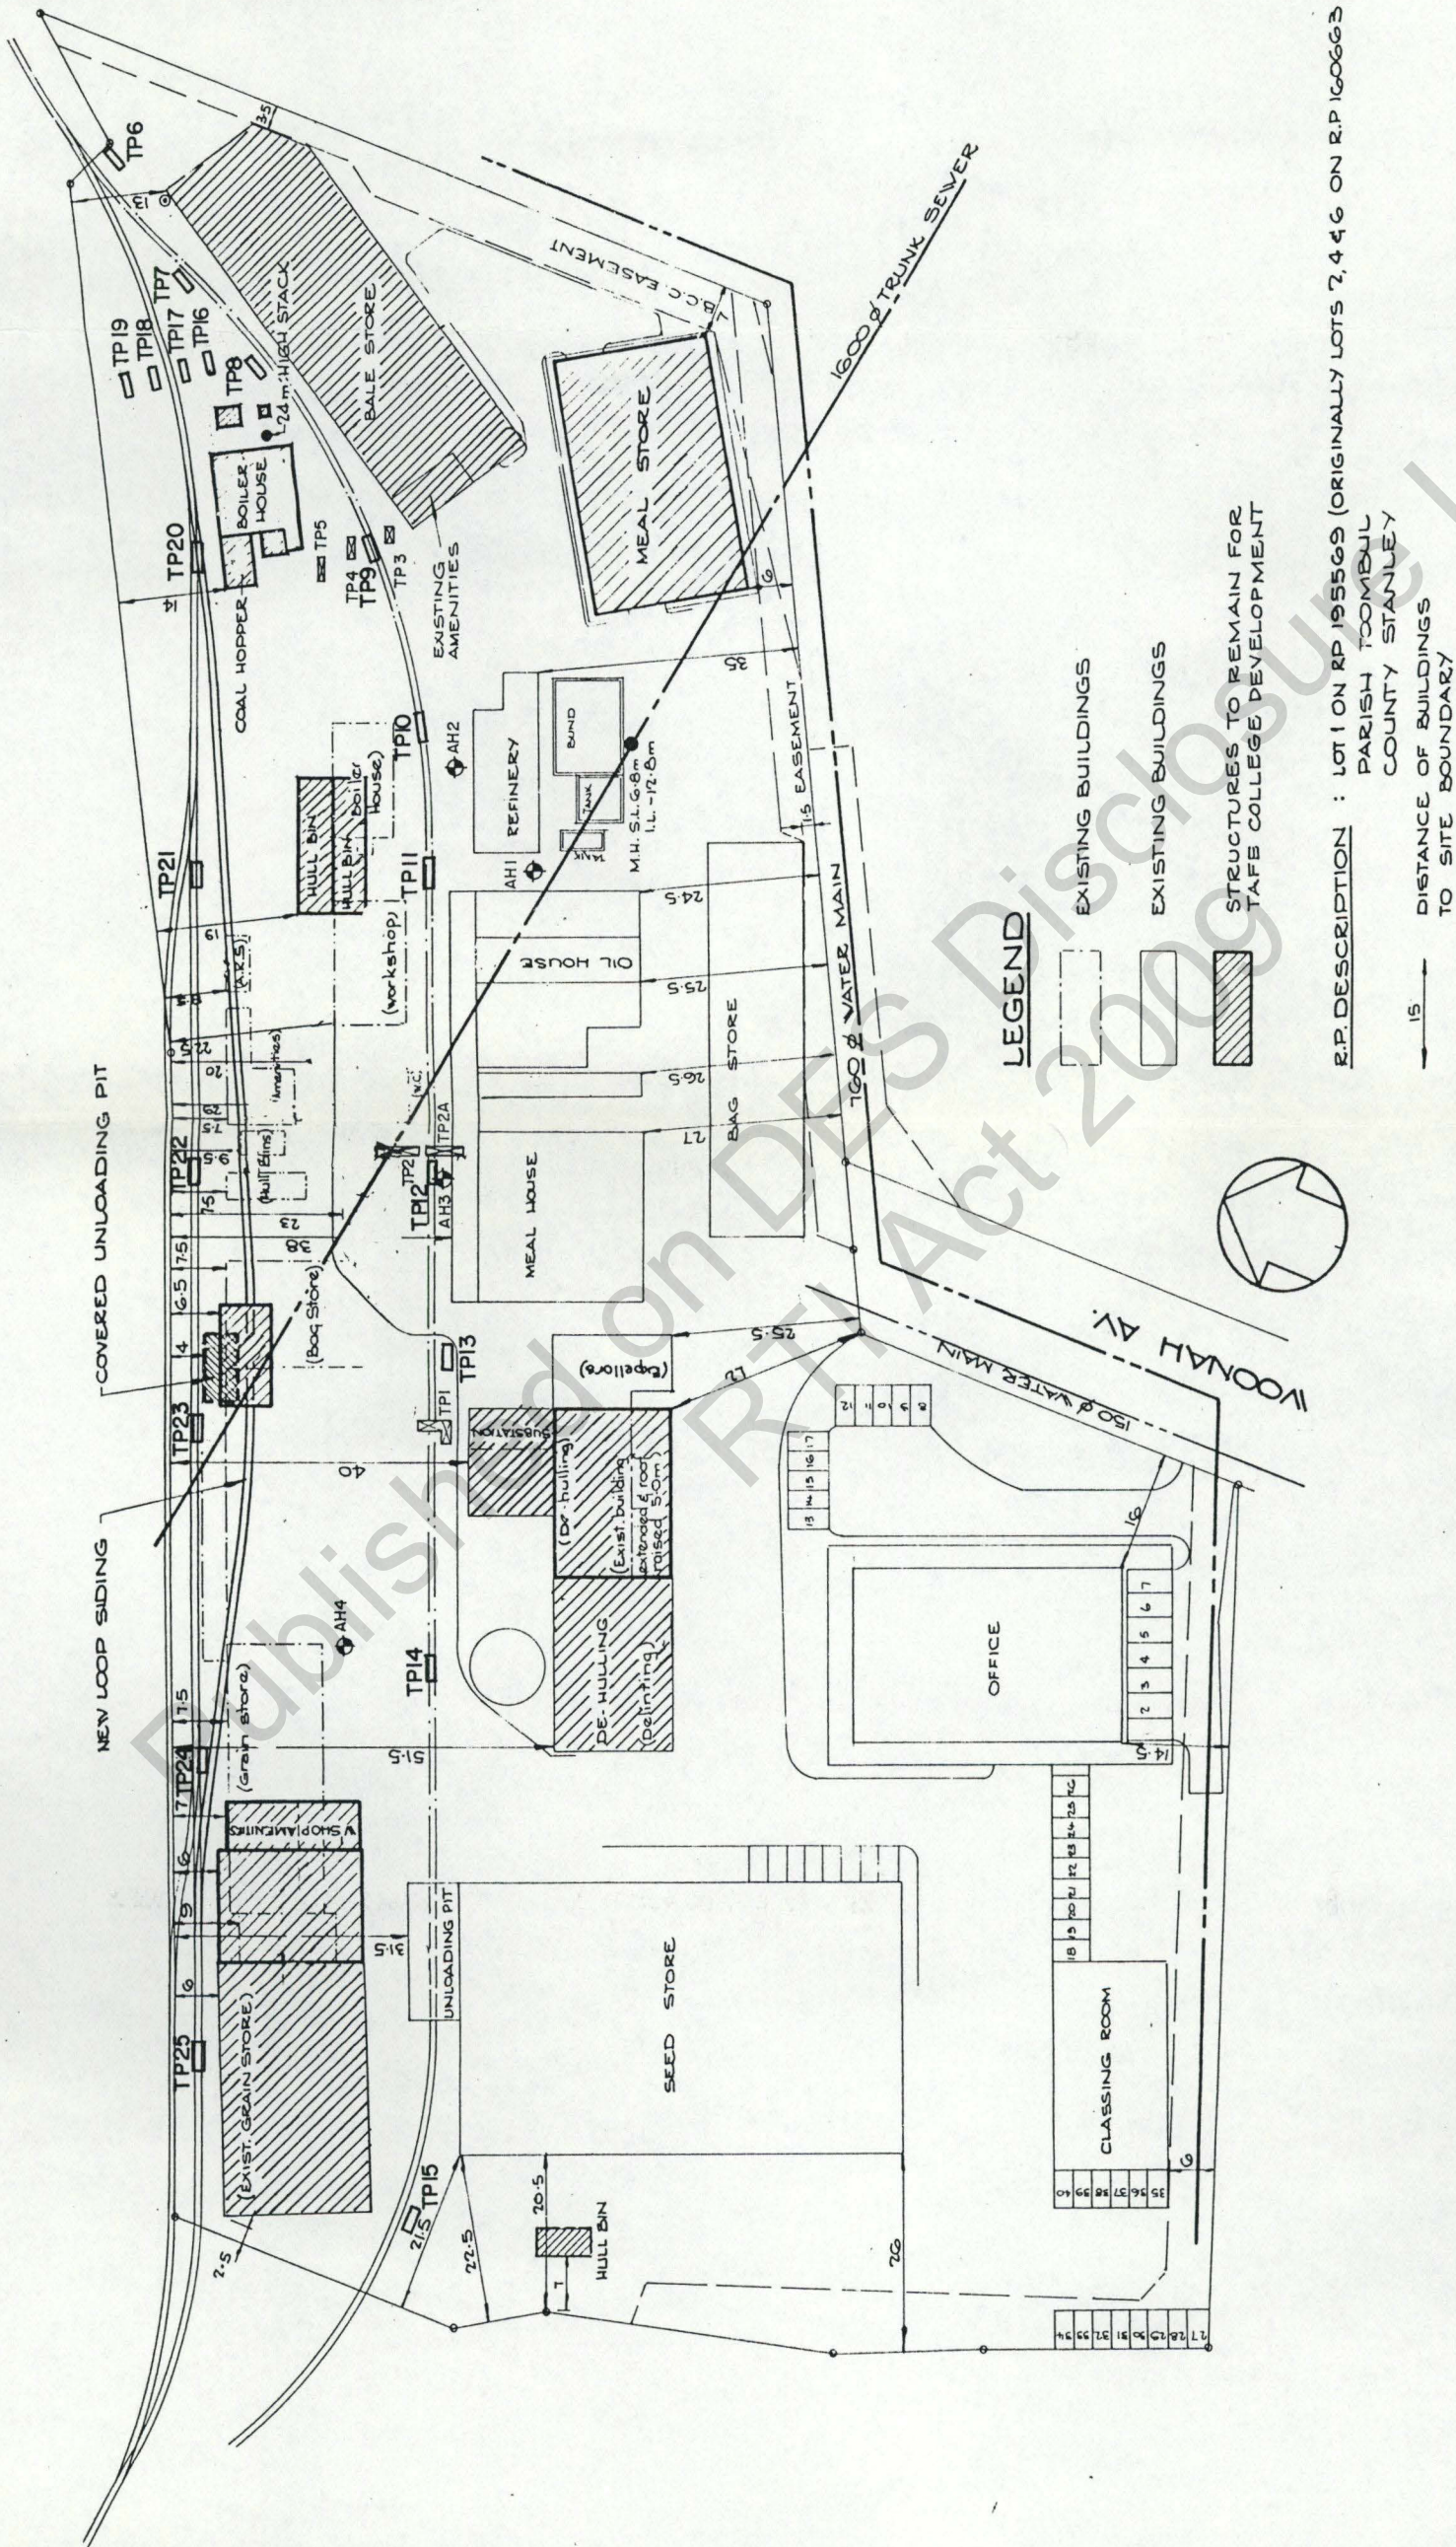
Figure 2

The site is relatively flat and is predominantly covered with existing buildings and concrete slabs. Railway tracks are located to the north of the site. A site plan showing the layout of existing site and associated features is presented as Figure 2.

Samples were recovered from a total of 20 test pits at the locations indicated in Figure 2. The test pits were excavated to a depth of 1.0 m using a backhoe. Representative duplicate soil samples were recovered from discrete levels within the test pits.

Auger Holes QCC Pre Disposal Assessment, July 1991  
Test Pit QCC Pre Disposal Assessment-Phase 2, Sept. 1991  
Test Pit Q Build Supplementary Investigation, November 1992

Existing Railway Lines  
Dismantled Railway Line

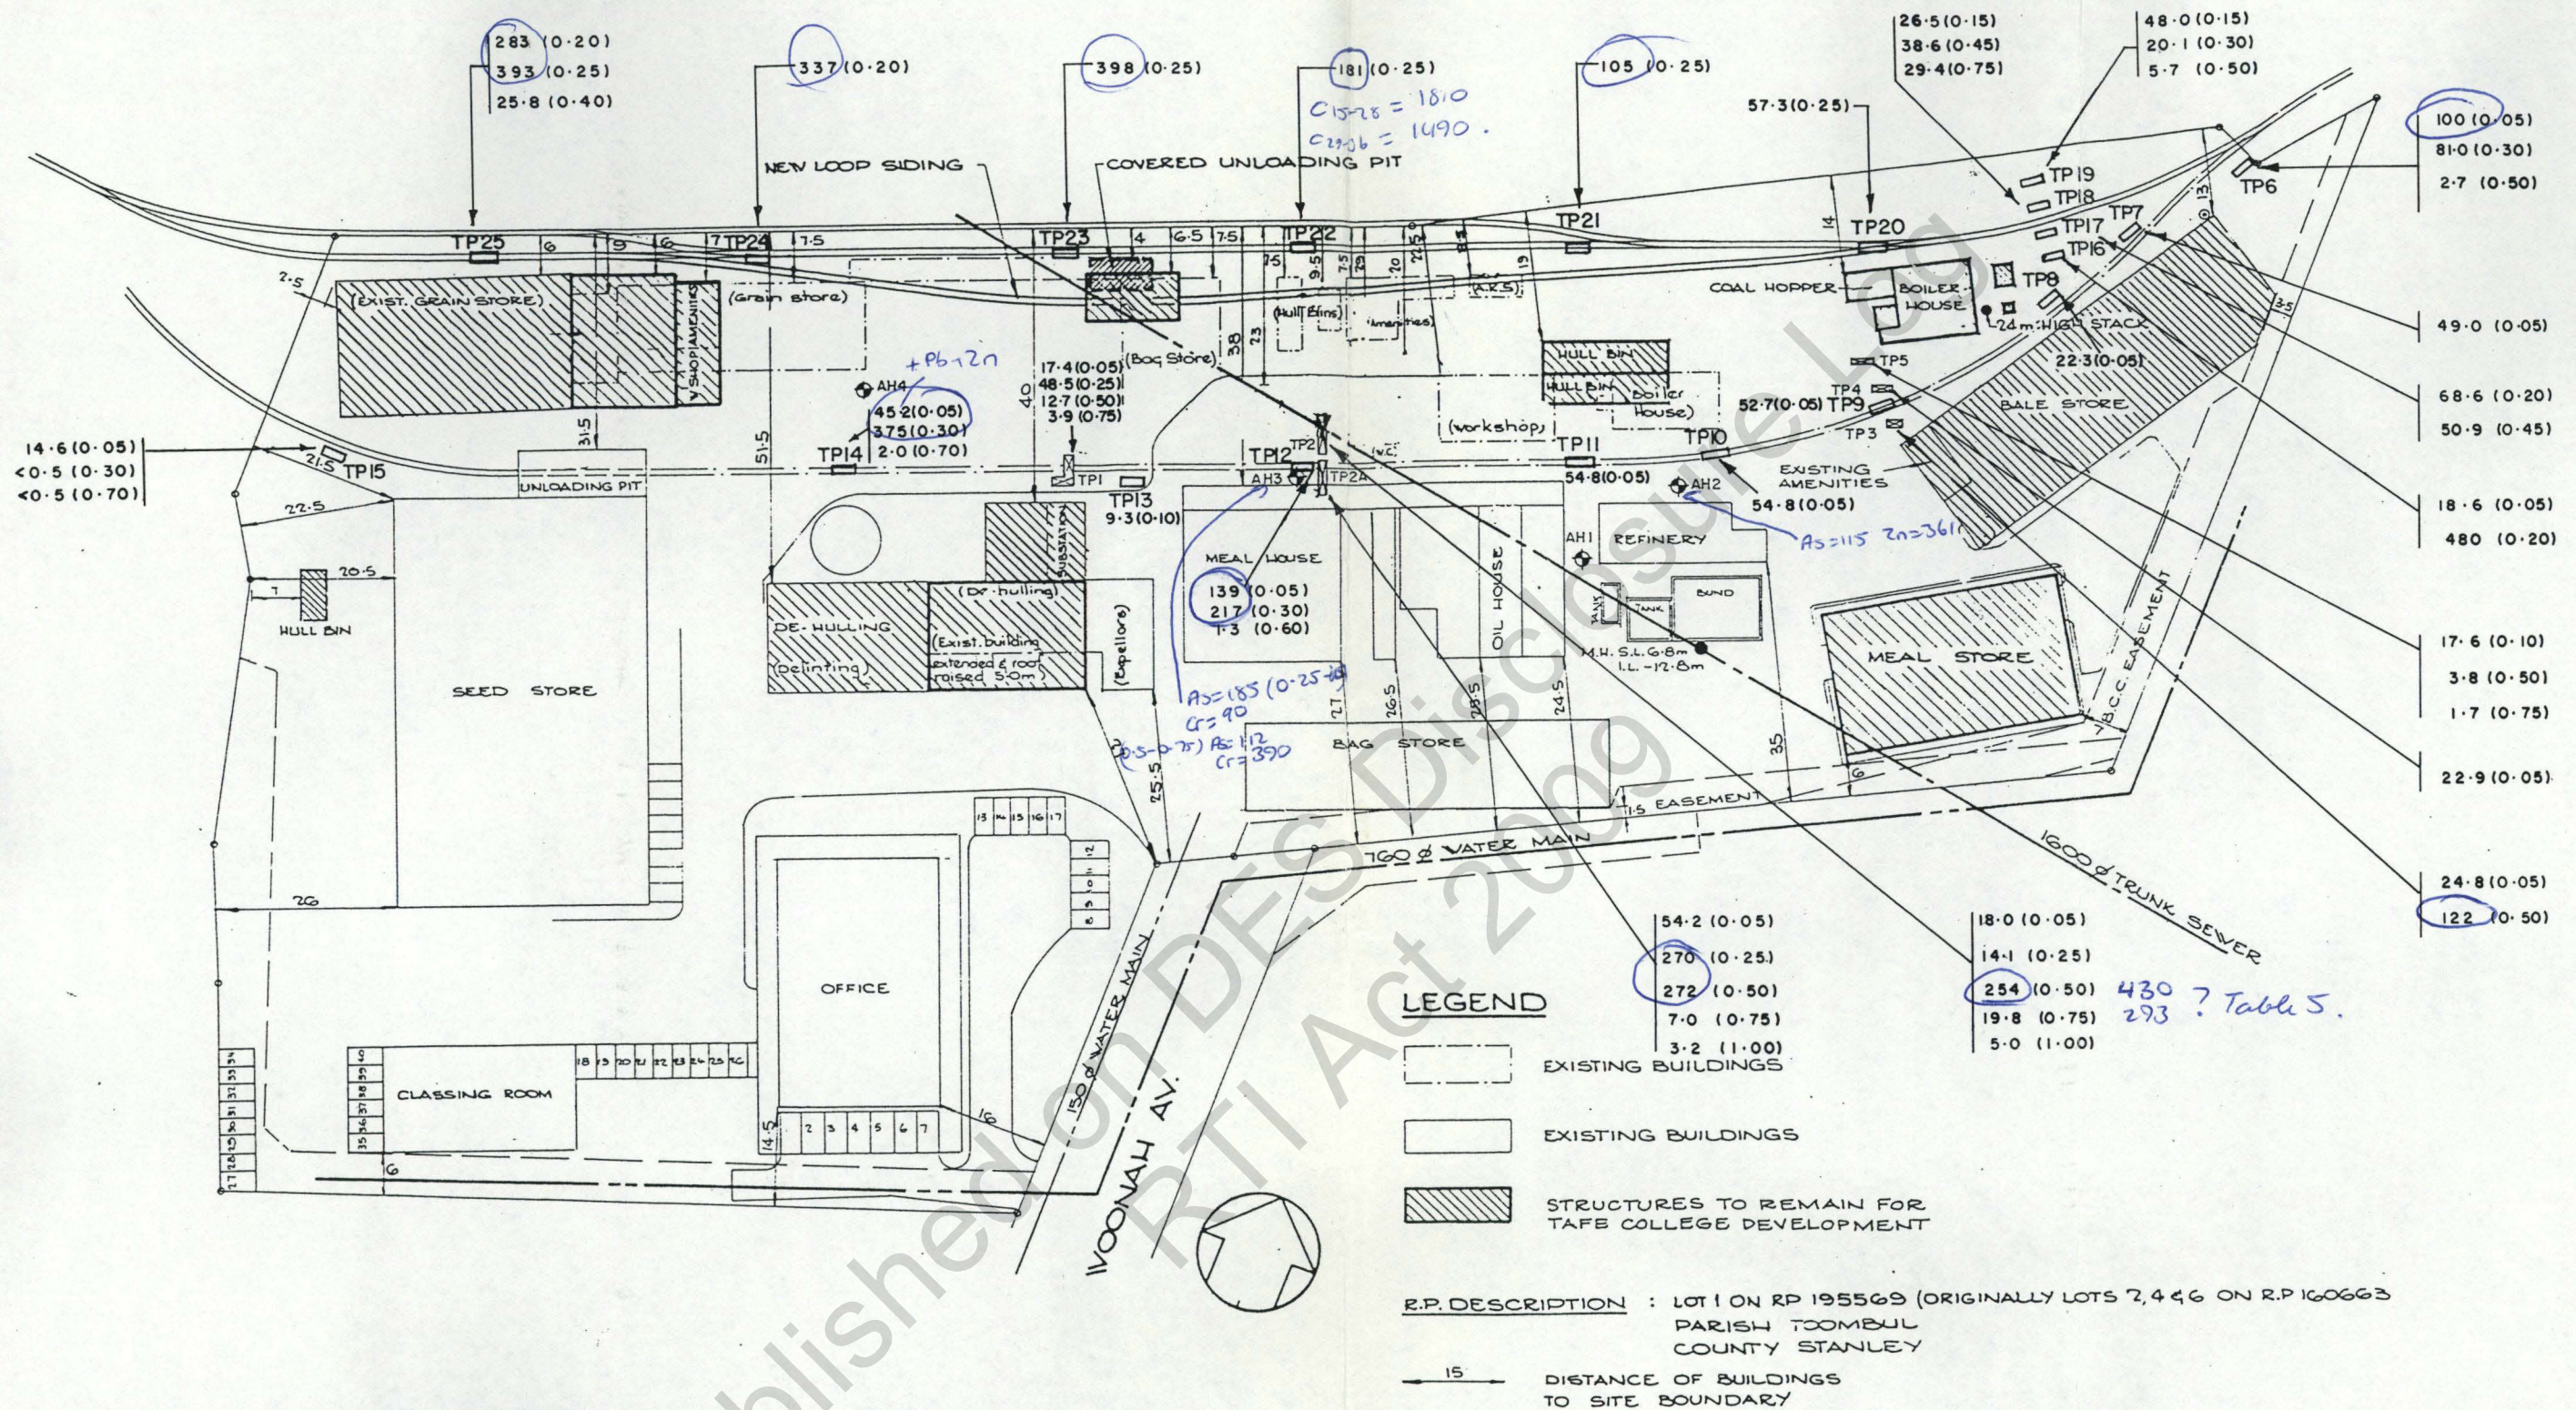
Figure 3

| HOLLINGSWORTH DAMES & MOORE | | Engineers and Planners |
|---|---|---|
| <div> <div>DRAWN</div> <div>GEP/AB</div> </div> <div> <div>CHECKED</div> <div>GEP</div> </div> <div> <div>DATE</div> <div>November 1992</div> </div> <div> <div>FILE REF.</div> <div>H010170<br/>22707-003-362</div> </div> | <div>Q-BUILD PROJECT SERVICES</div> <div>SUPPLEMENTARY INVESTIGATION</div> <div>ARSENIC CONCENTRATIONS</div> | |

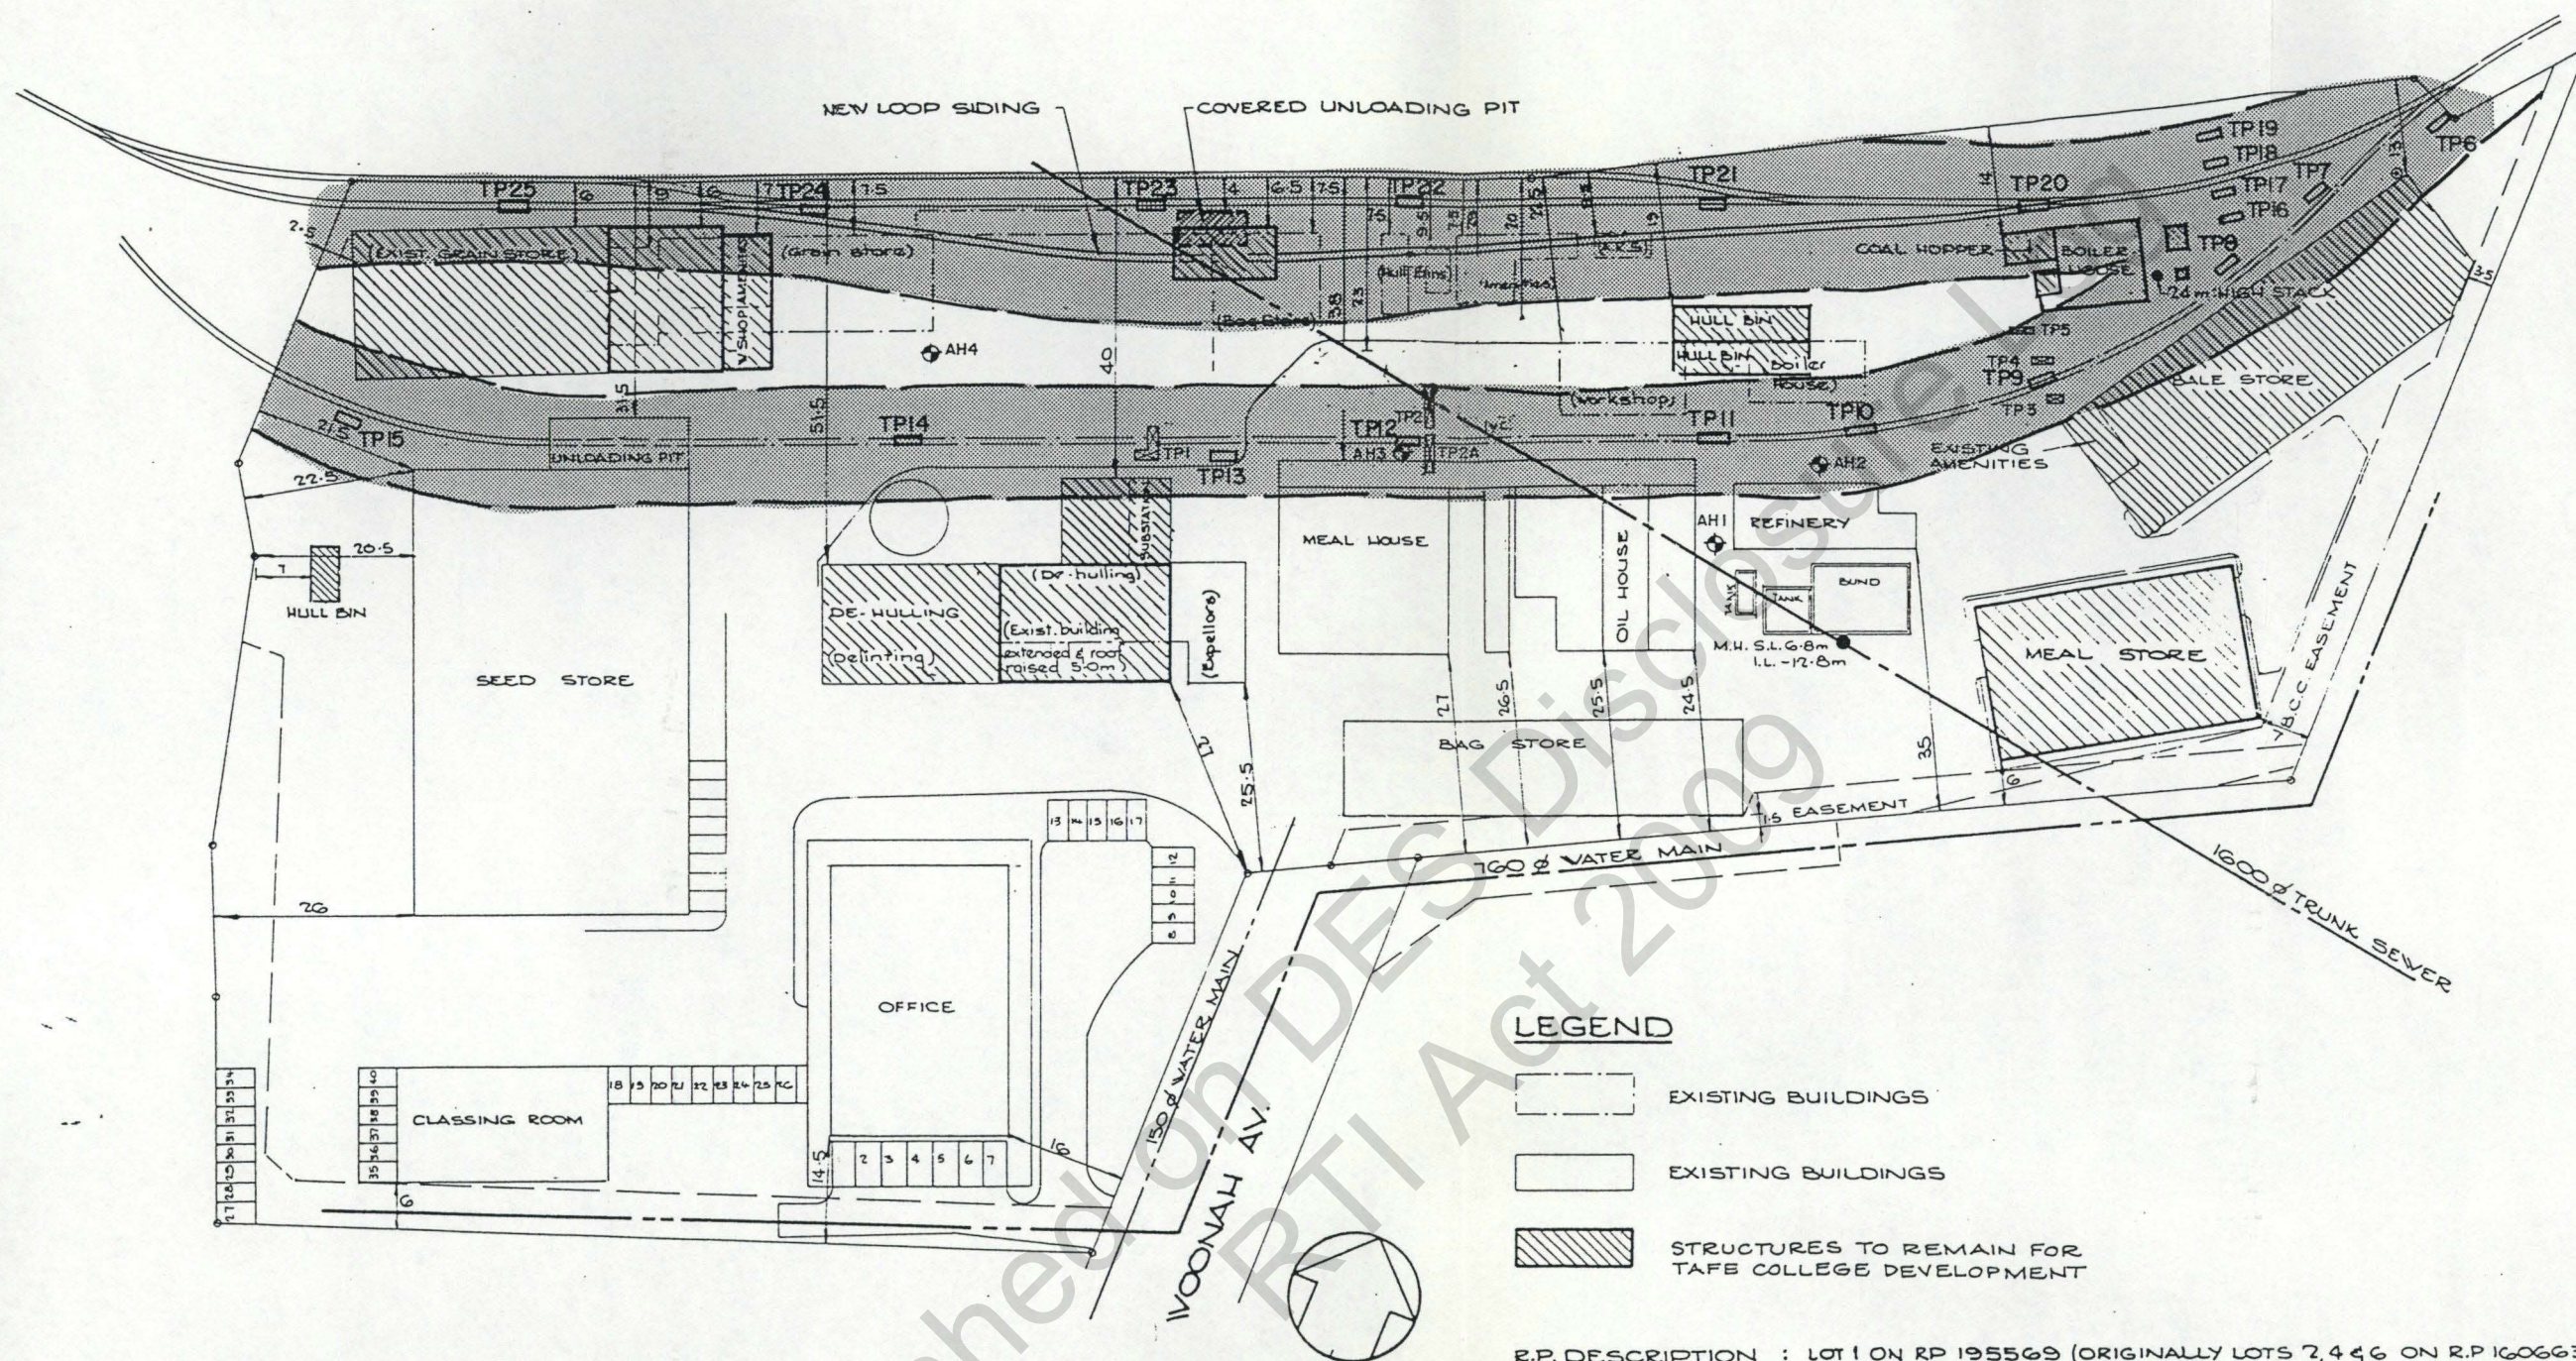
The laboratory analysis results confirm that the upper soil profile surrounding both the existing and dismantled railway lines consistently exhibit arsenic contamination. The distribution of arsenic concentration is presented in Figure 3.

Based on the potential area of contamination including 15 m wide corridors and with excavation to 0.5 m this option would involve approximately 4,500 m<sup>3</sup> of contaminated soil. Replacement with inert fill should enable classification of the site as a "former" site (Reference 3) in the Contaminated Land Register.
