**From:** Suthers, Steve [Steve.Suthers@sibelco.com.au]  
**Sent:** Wednesday, 31 October 2012 12:15 PM  
**To:** Crane Leonie  
**CC:** Strahley, Darrel  
**Subject:** Re: Dust complaint- Marmor,

## MONITORING DATA REGISTER

## MARMOR MONITORING POINTS

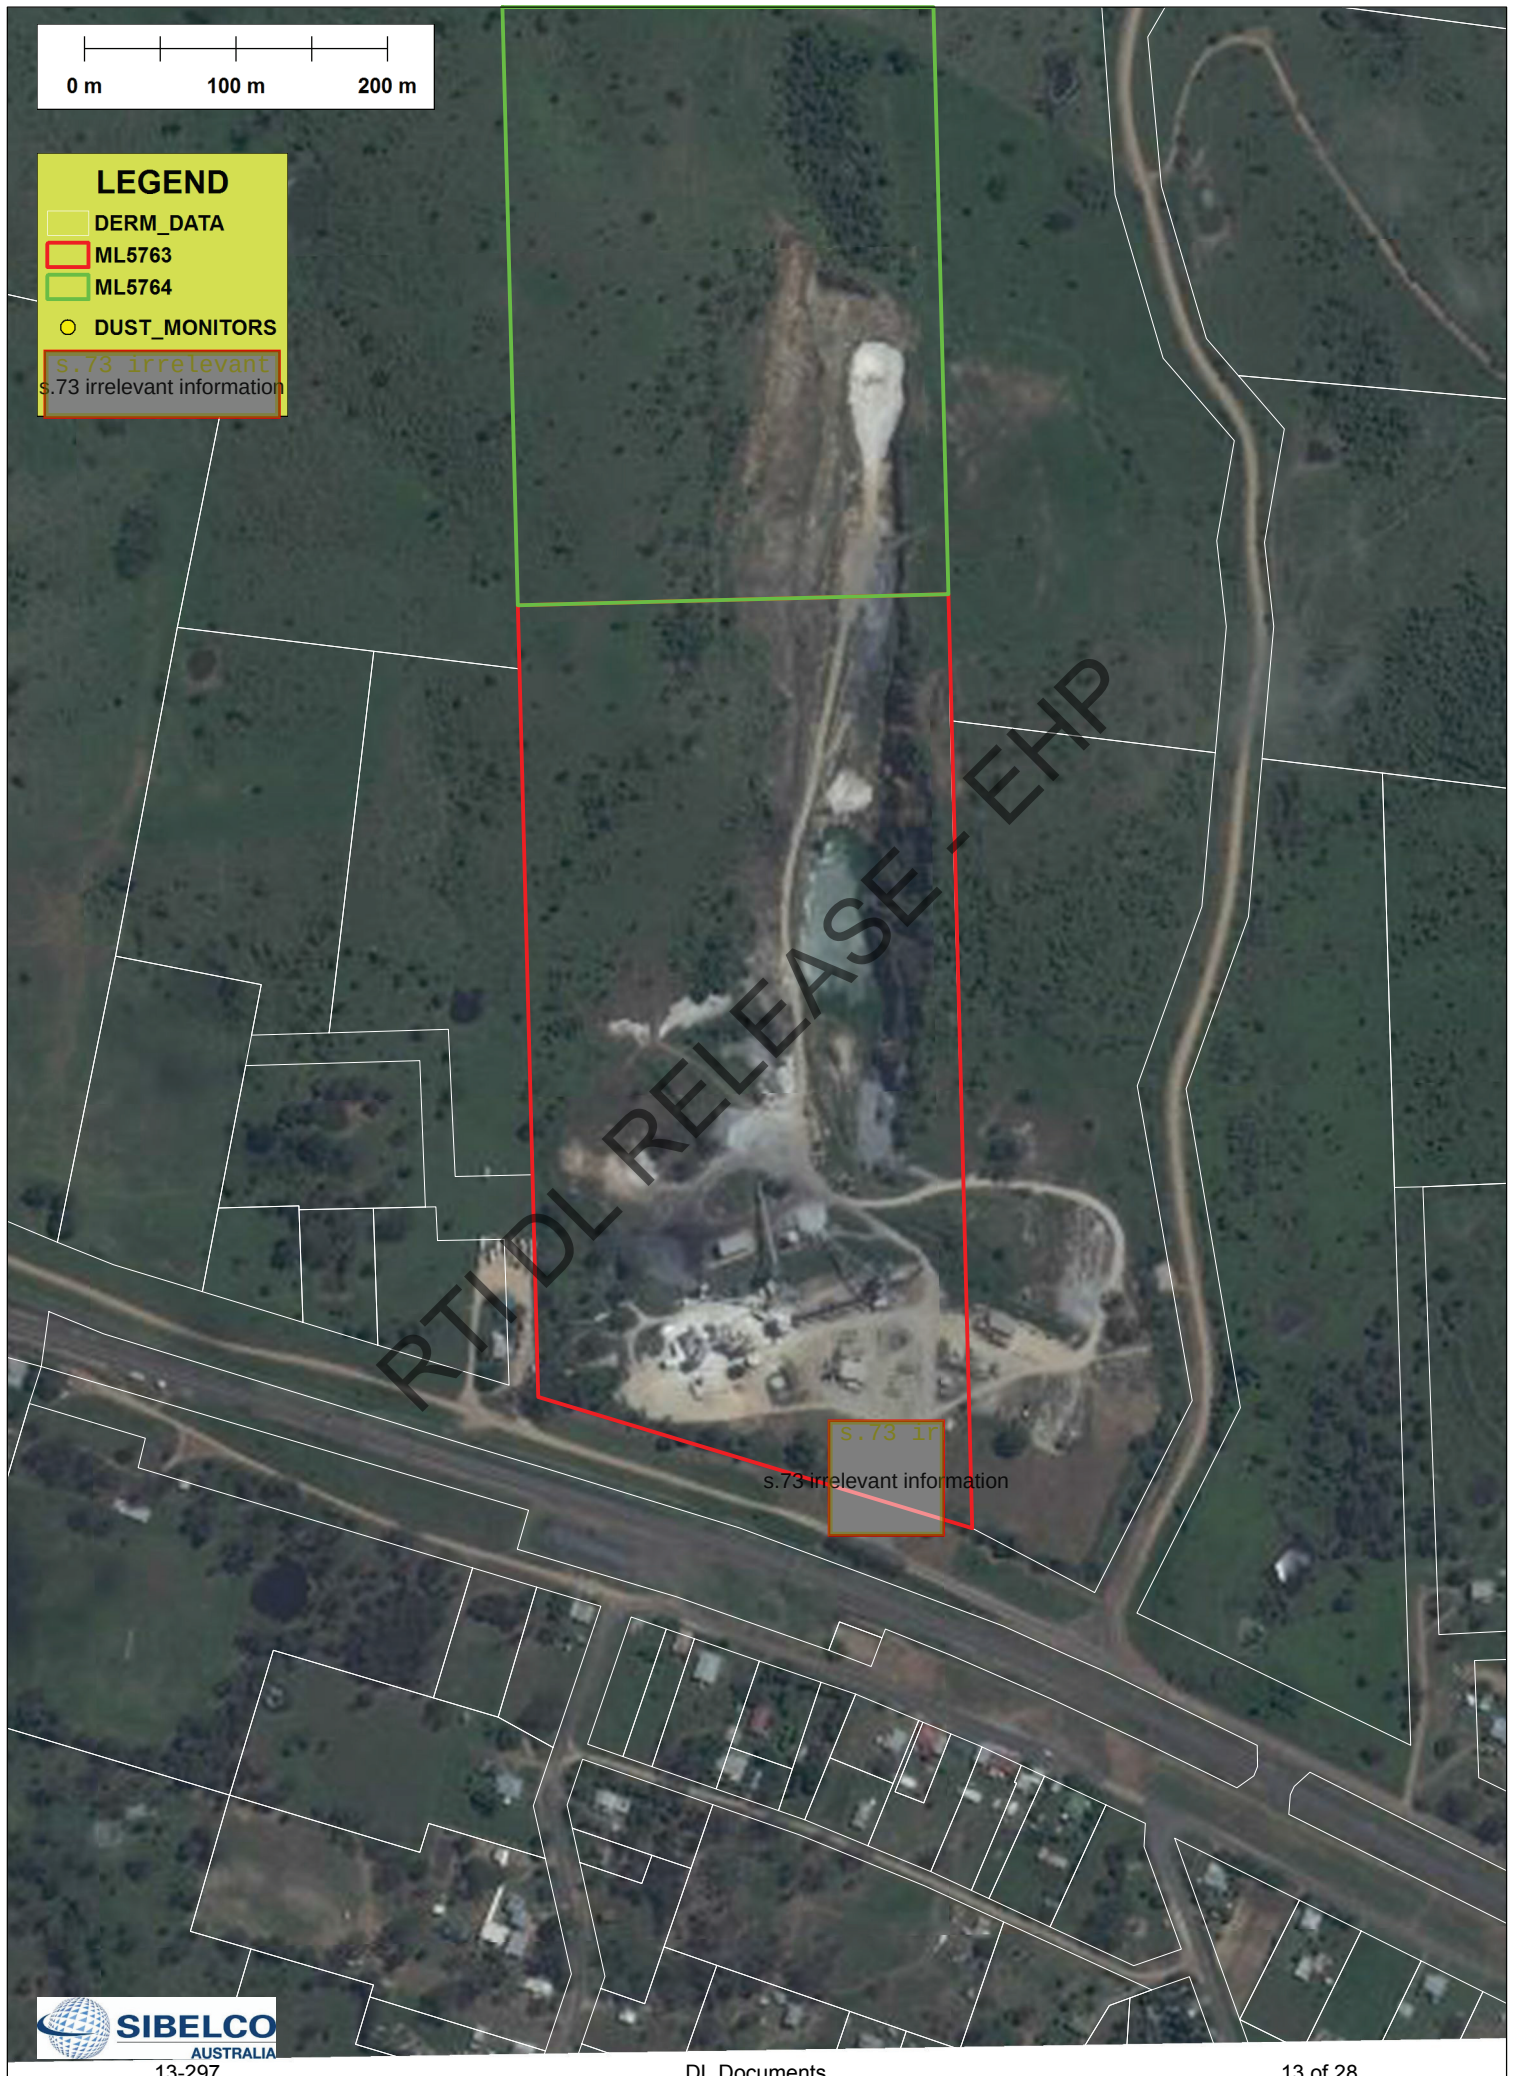
Please find attached a copy of the current dust deposition gauge monitoring locations.

- We have moved dust gauge no. 2 to the residential area beside the complainant's residence. The no. 2 gauge was close to no.1 gauge and providing redundant data.
- We have moved the no. 4 gauge from up on the hill, close to the plant to across the road near the rail crossing as this area provides the best "representative" background or upwind monitoring location.

This will enable the data from the sensitive residential area to be compared to the background dust gauge that will receive the same influence from the coal trains and the traffic travelling on the unsealed roads. The difference should be the impact from the plant (less any local activity occurring in the immediate area).

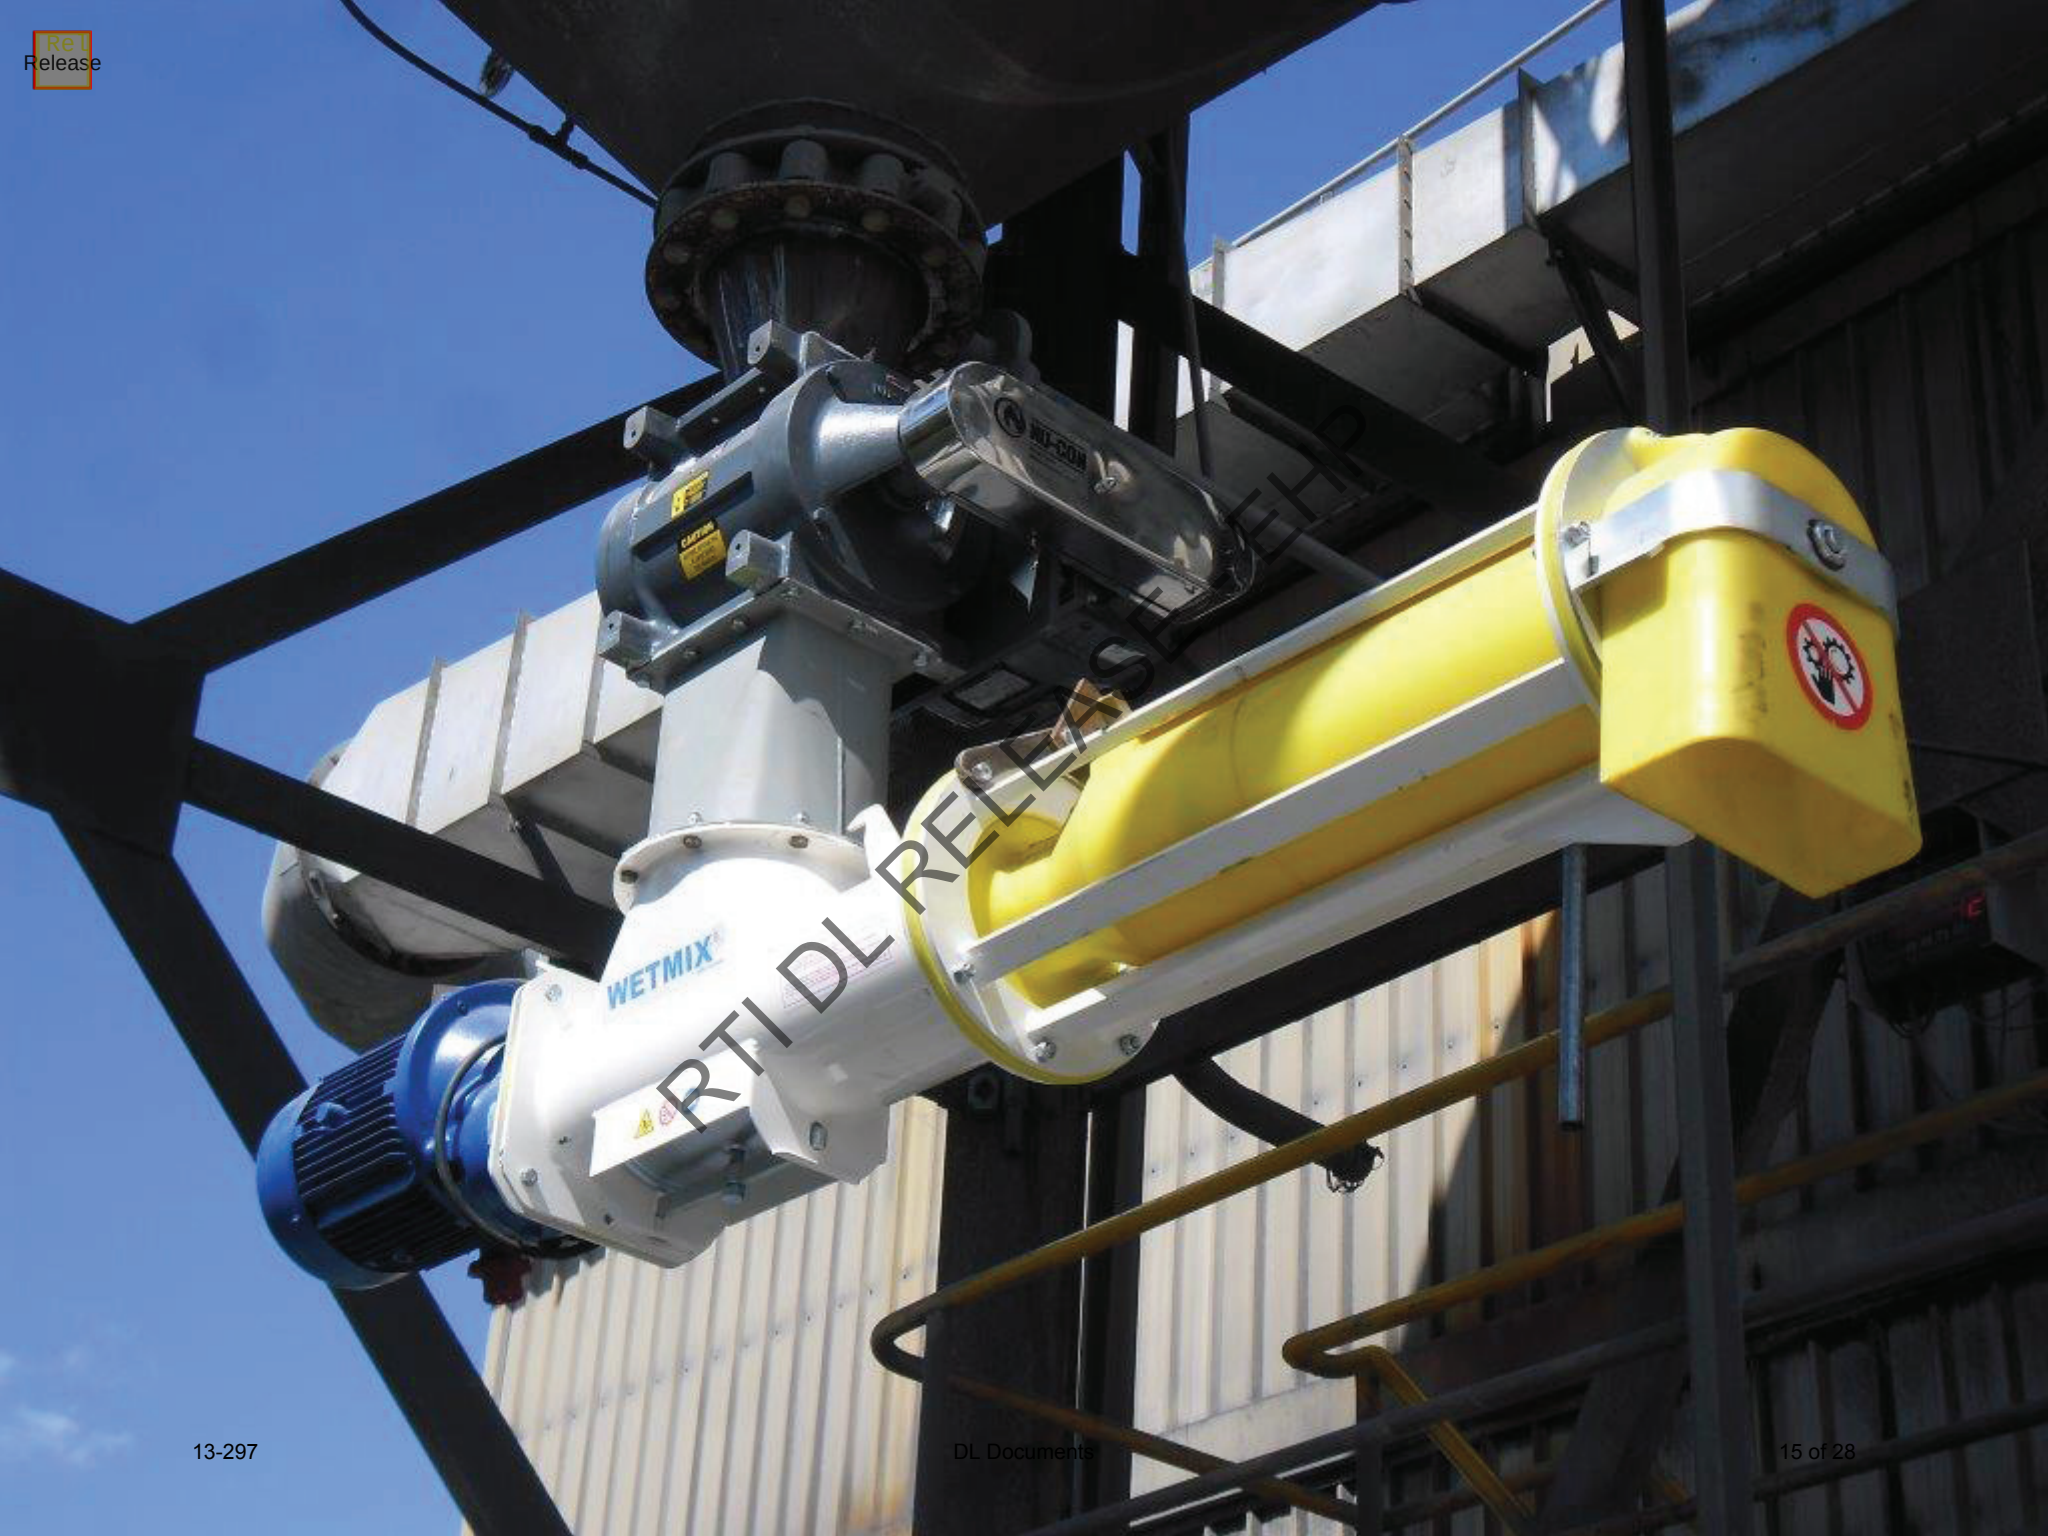
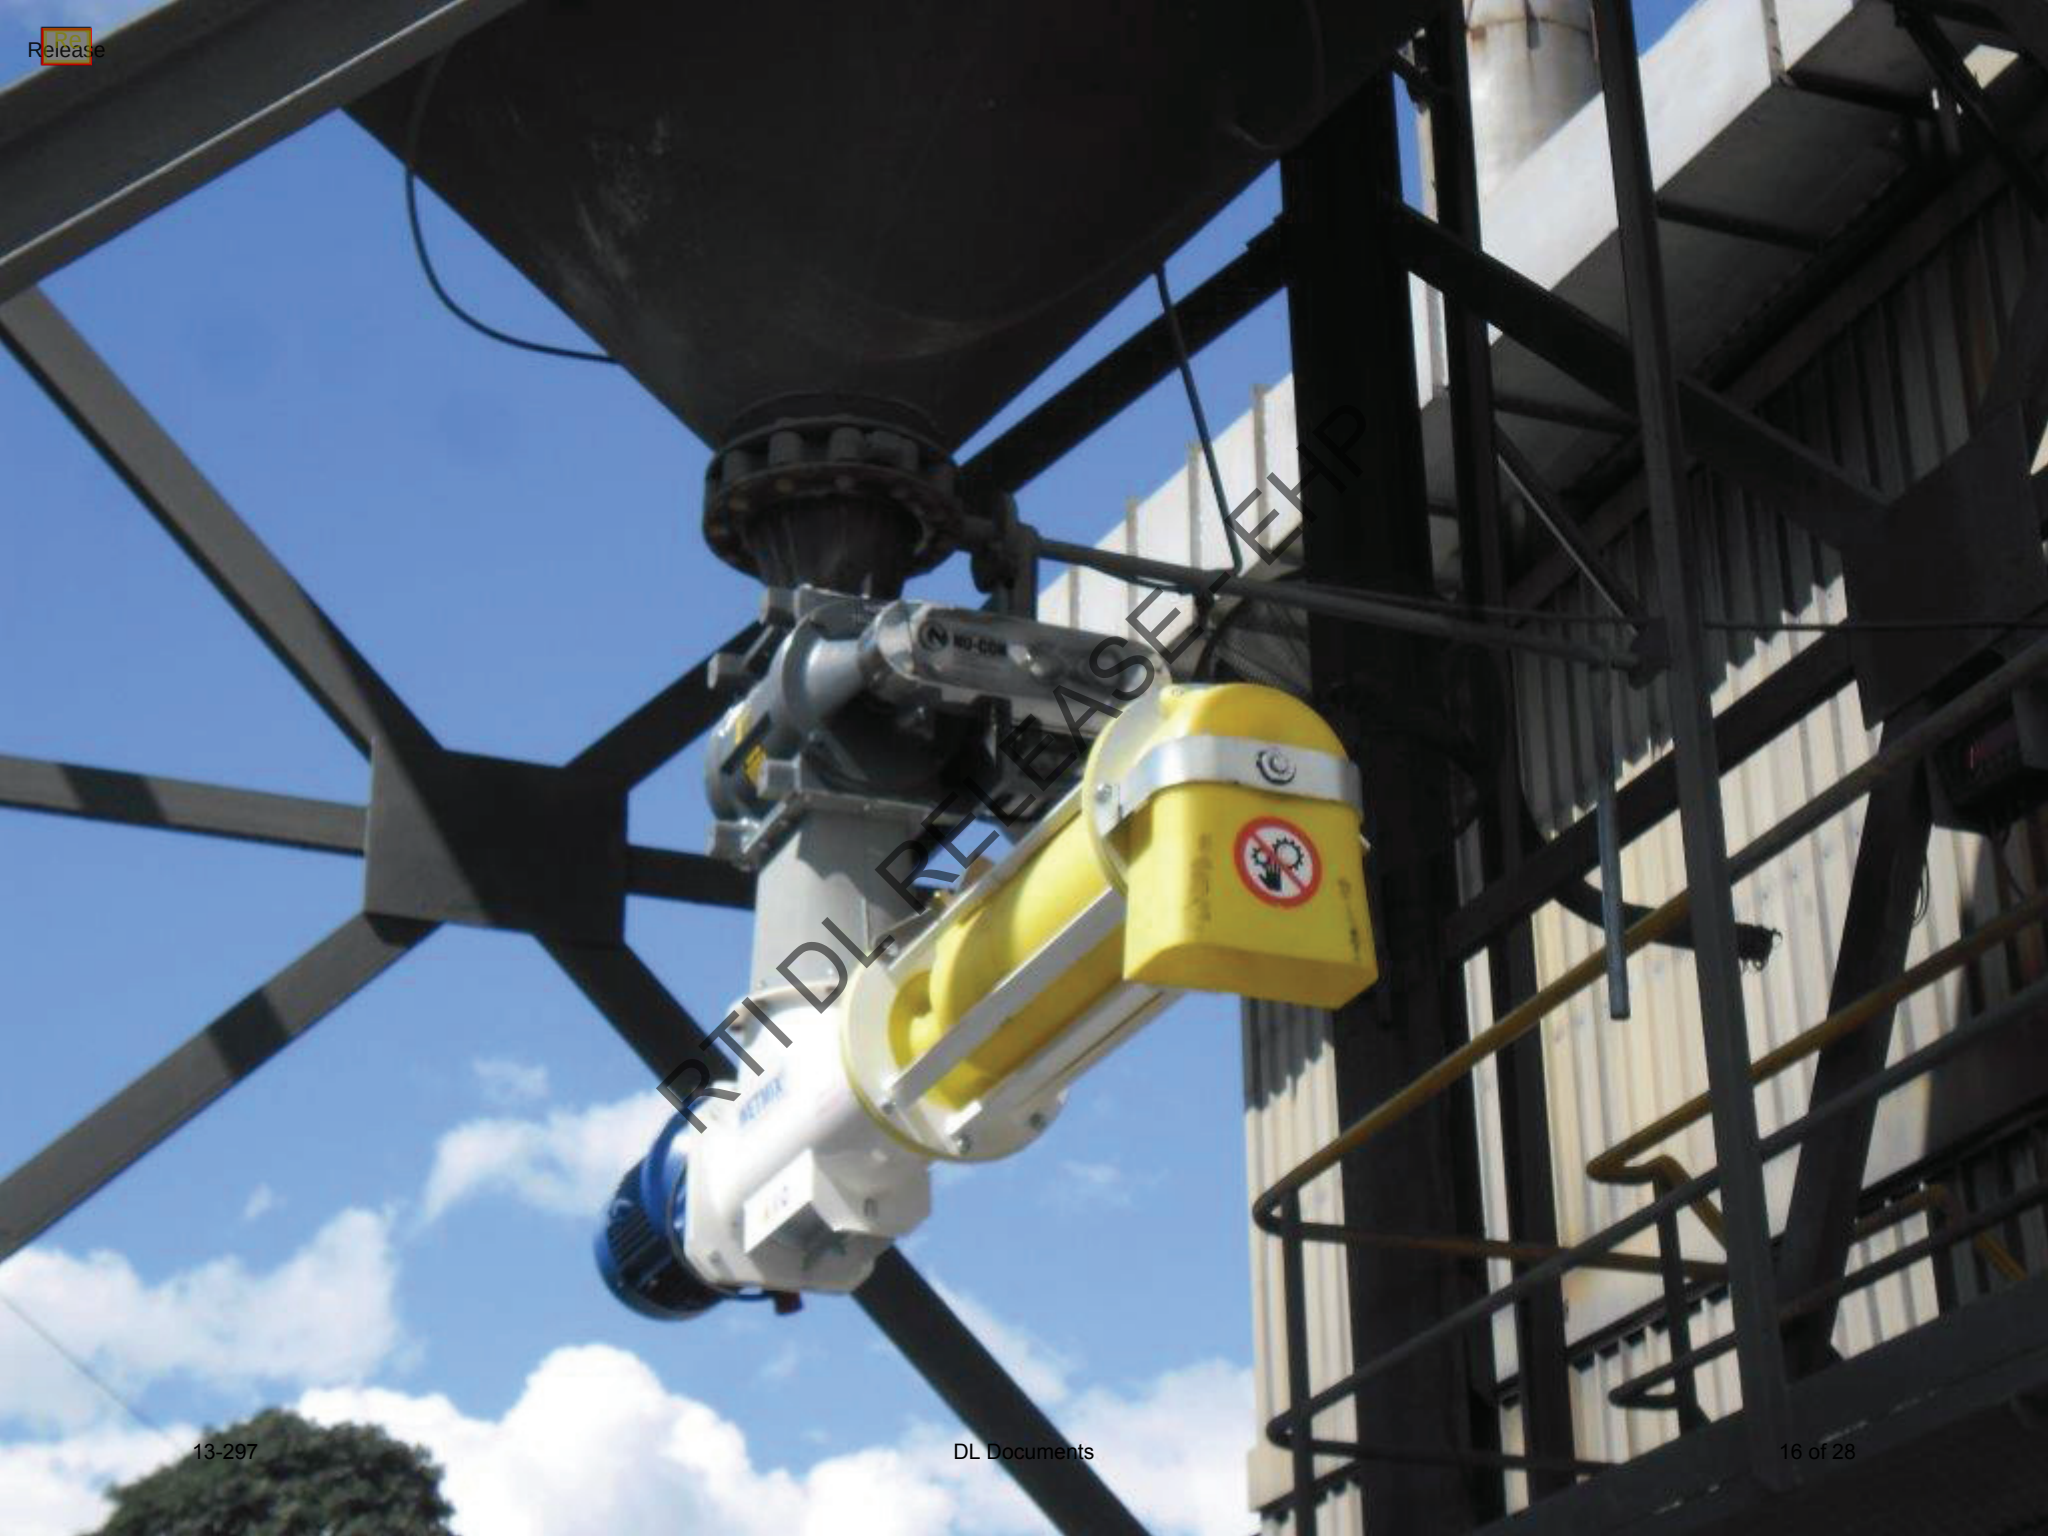
Following our discussion today, please find attached a couple of photos of the newly installed "pug mill" that will pelletise the kiln dust ash from the bag house where it will then be transported to the pit. This will significantly reduce any dust emission during the disposal process of the kiln bag house.

You may be interested that we have the new pug screw install and have a video of it running as per attachment...No dust at all from the new process.

The pug screw has been installed and is now going after many issues, all electrical. Doing a good job.
