## SONOMA MINE MANAGEMENT PTY LTD

### Two Mile Creek Diversion Operations Monitoring 2019

Sonoma Coal Mine

June 2019

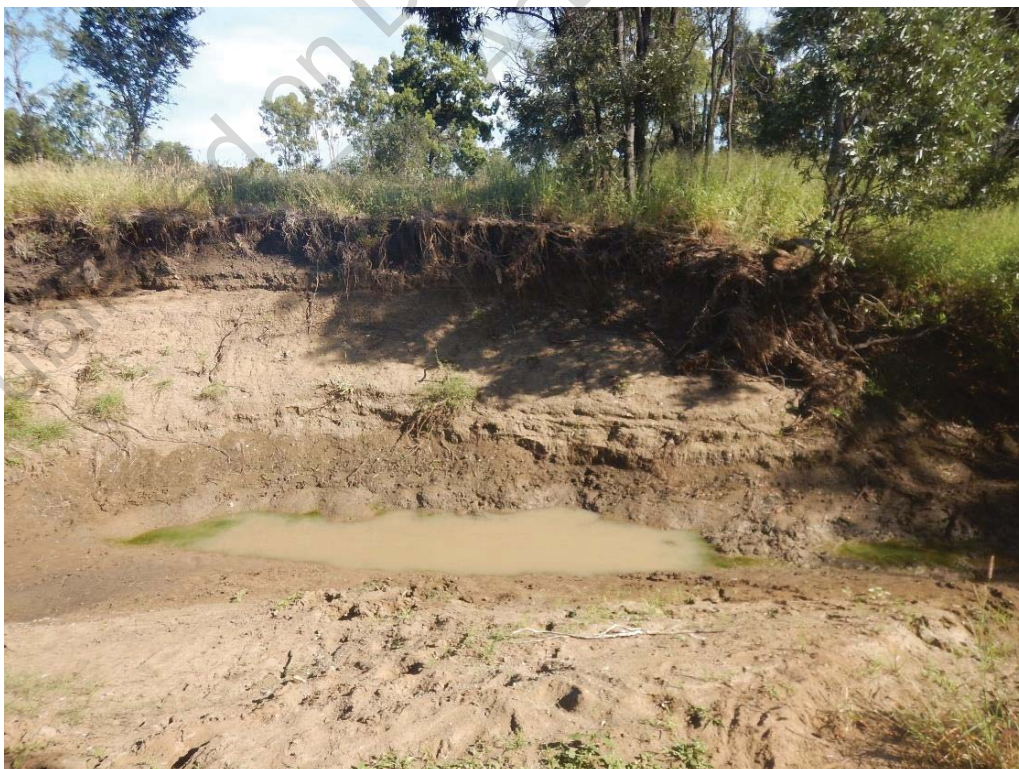
- Increased ground cover was observed along the waterway including on benches and some of the previous eroded batters (Figure 6.6).
  - Small residual pools were observed in several locations along the Southern Tributary (Figure 6.7).

Figure 6.7 Small residual pool upstream of TMC-US4

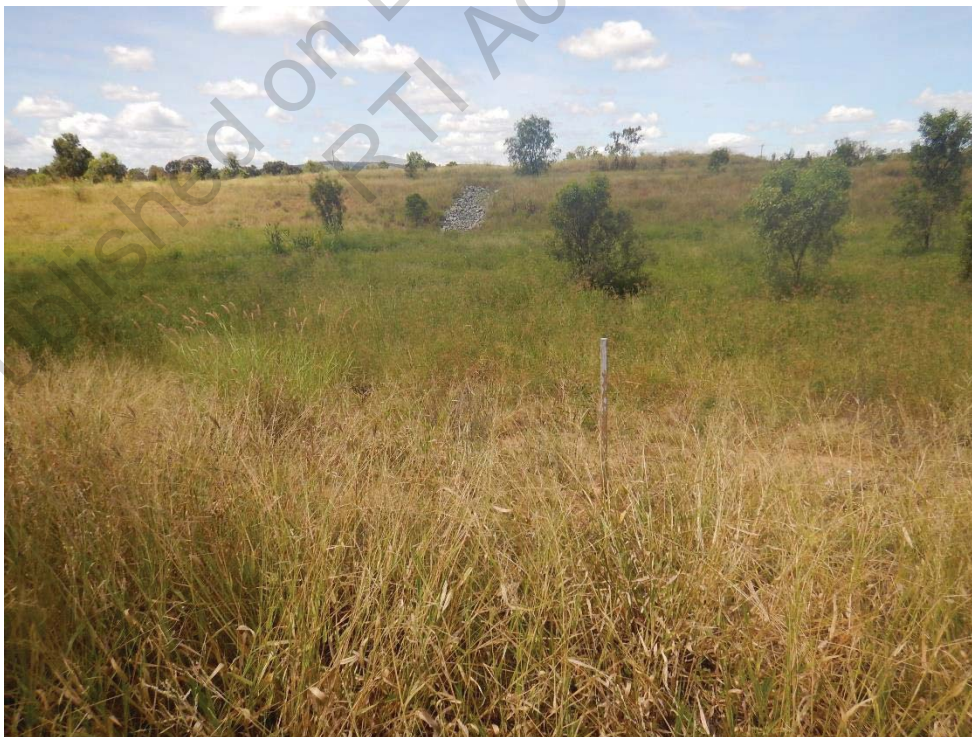
- The trend towards better vegetation establishment within the diversion has increased. In particular, the good grass cover and increased understorey establishment previously observed upstream of the haul road has extended to downstream sections of the diversion reach (Figure 6.8 and Figure 6.9).

Figure 6.8 Extensive Groundcover with Increased Understorey and Overstorey at TMC-Div1

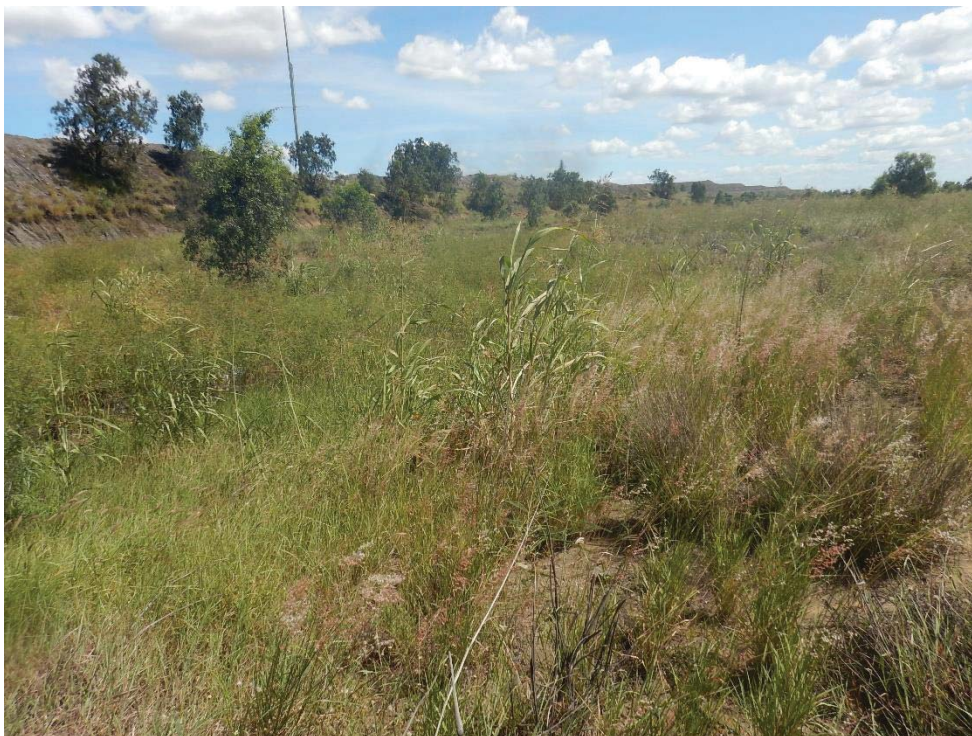
Figure 6.9 Extensive Groundcover with Increased Understorey and Overstorey Downstream of Haul Road

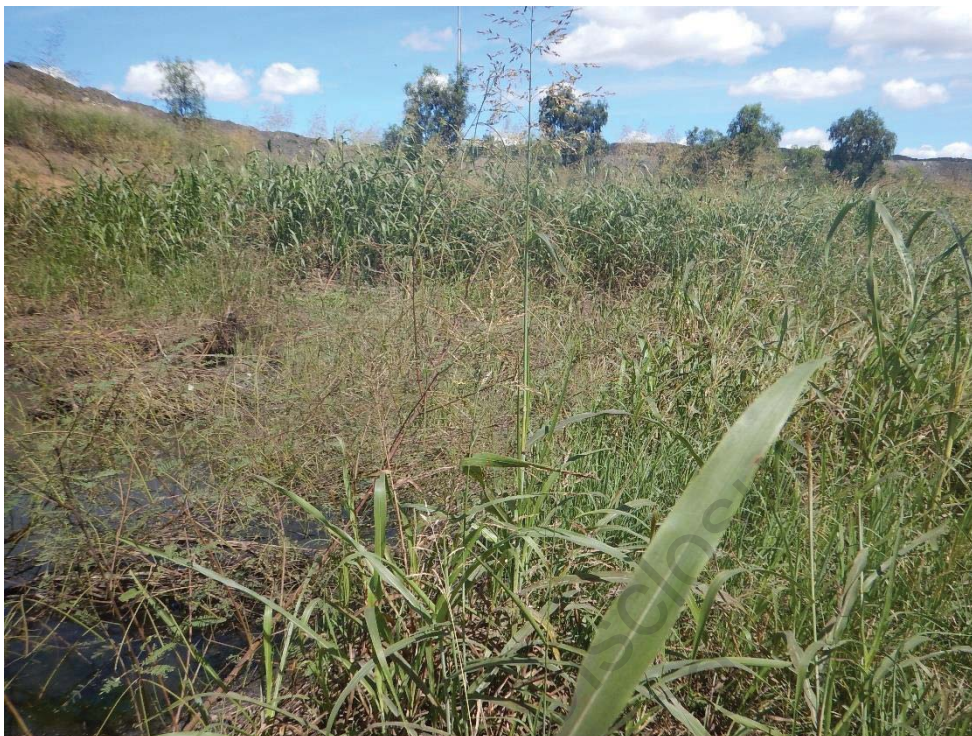
Figure 6.15 Grass Establishment in Low Flow Channel Downstream of Haul Road

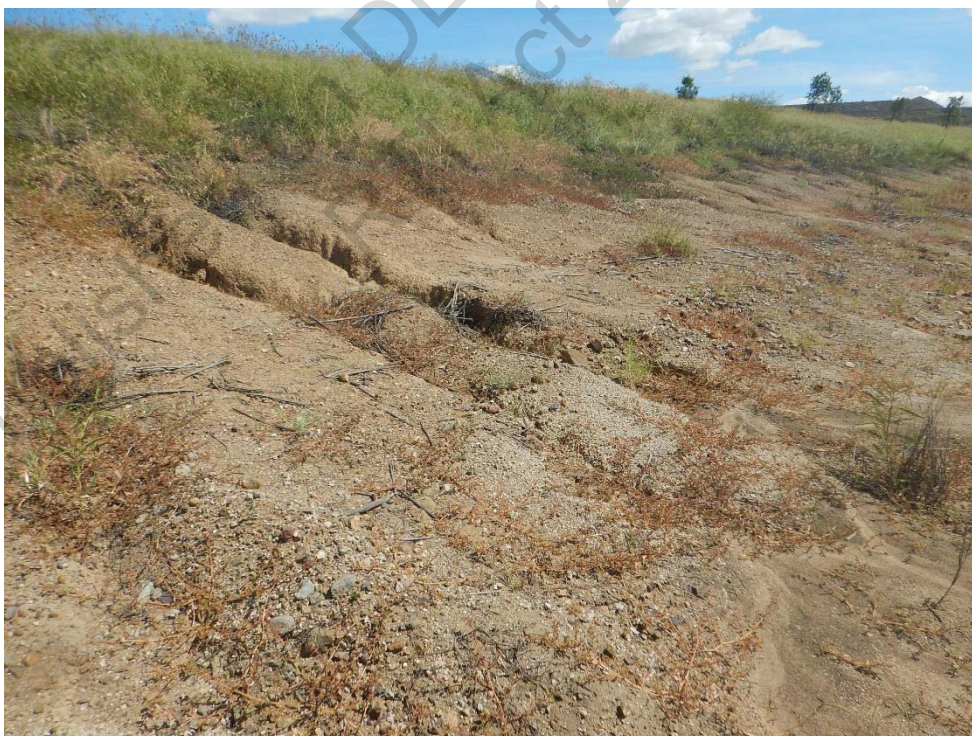
Figure 6.16 Rilling In the Vicinity Of TMC-Div2

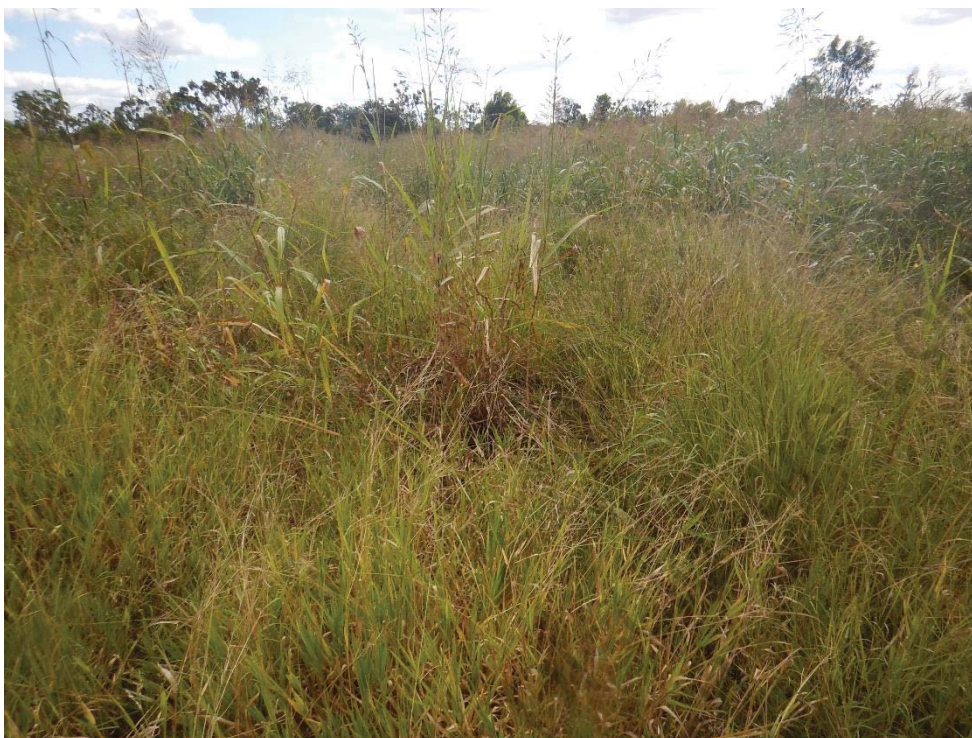
Figure 6.25 Dense Ground Cover at Downstream End of Diversion

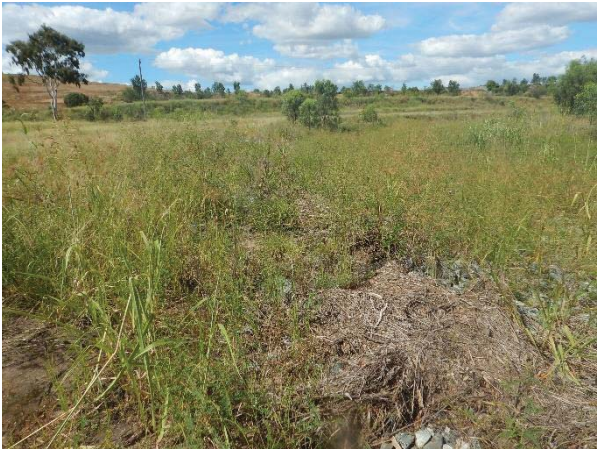
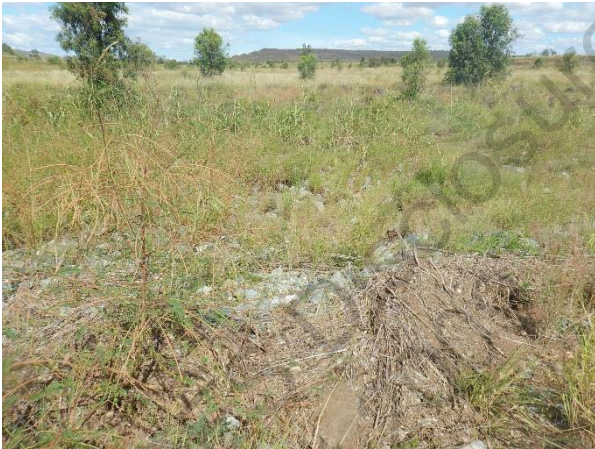
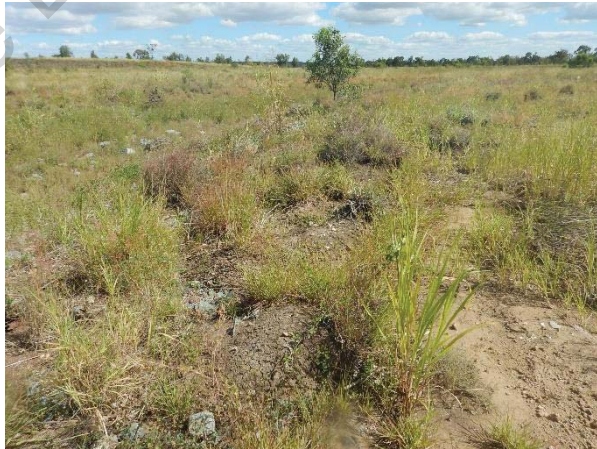
**Two Mile Creek Diversion Inspection (2019 vs 2018 Photographic Record)**  
**Monitoring Point: TMC-Div3 (no survey peg installed – 2019 photo location inconsistent)**

- Replace the eight (8) physical markers that have been washed away in order to maintain consistency in the photo reference point for the purpose of ongoing monitoring (TMC-US1, TMC-US2, TMC-US3, TMC-US4, TMC-Div3, TMC-DS1, TMC-DS2 and TMC-DS3).

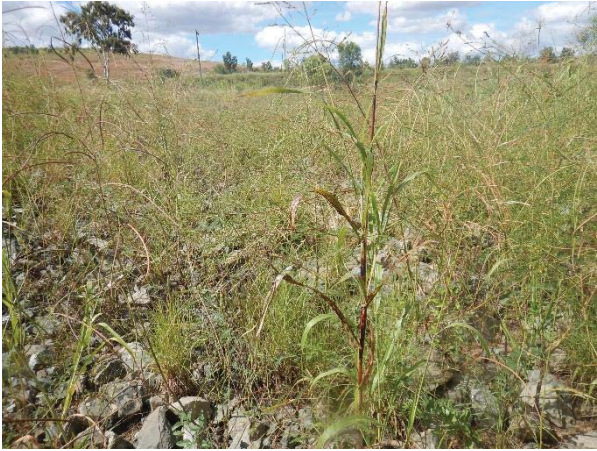
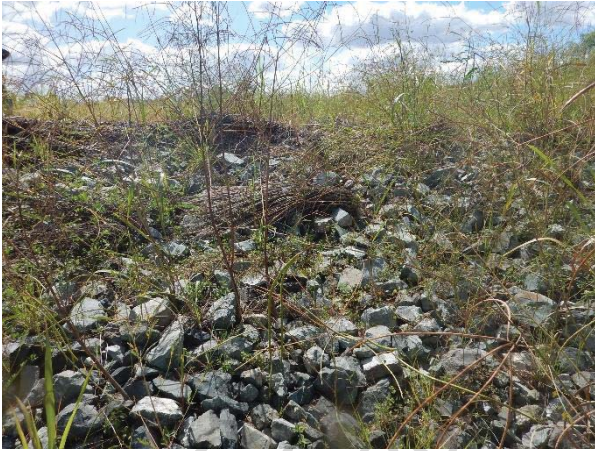
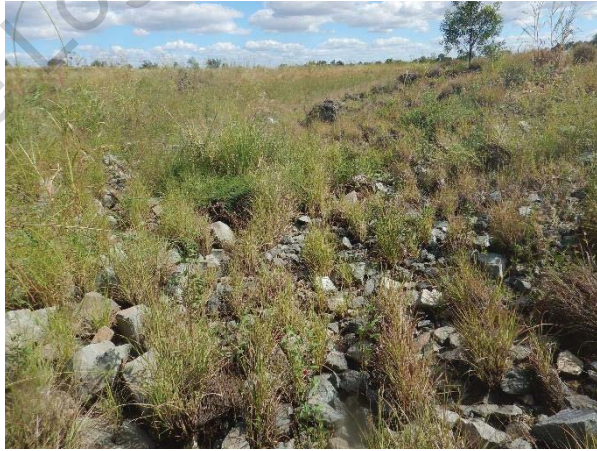
**Two Mile Creek Diversion Inspection (2019 vs 2018 Photographic Record)**  
**Monitoring Point: TMC-Div3 (no survey peg installed – 2019 photo location inconsistent)**

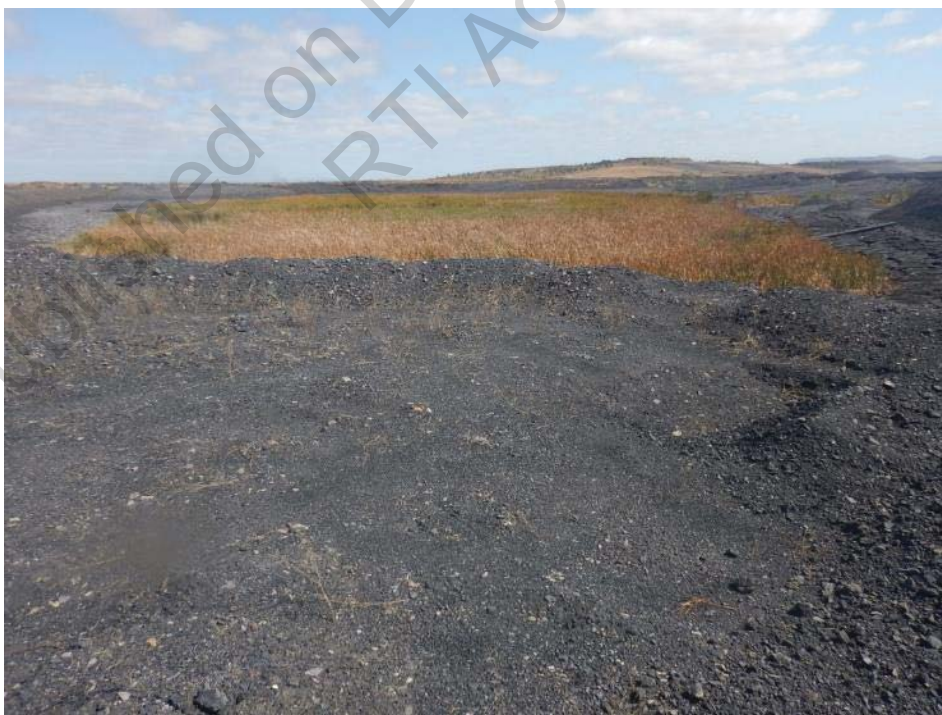
Photo 2 Decant pond

1. CDA1/2 has reached the end of its operational life, with only minor future rejects deposition planned to facilitate final surface shaping and closure. No active rejects deposition has occurred in CDA1/2 for approximately 6 months (sch4p4( 6) Personal inf pers. comm.). At the time of this report, it is understood that QCoal has commenced construction of a ramp from the Drake pits to the top of CDA1/2 to allow final shaping and encapsulation of CDA1/2 with spoil material.
2. The CDA1/2 decant pond was dry as a result of the recent dry weather conditions and cessation of active rejects deposition (Photo 2 in Appendix A).

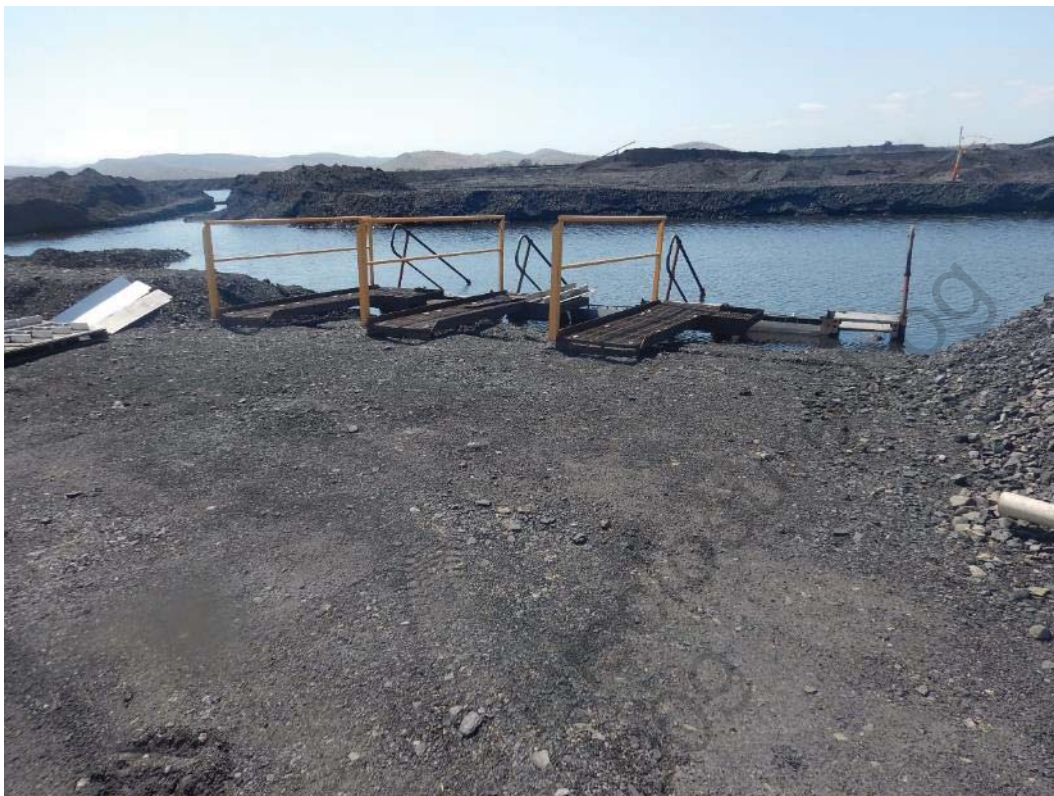
Photo 3 Decant Pond in Cell 3

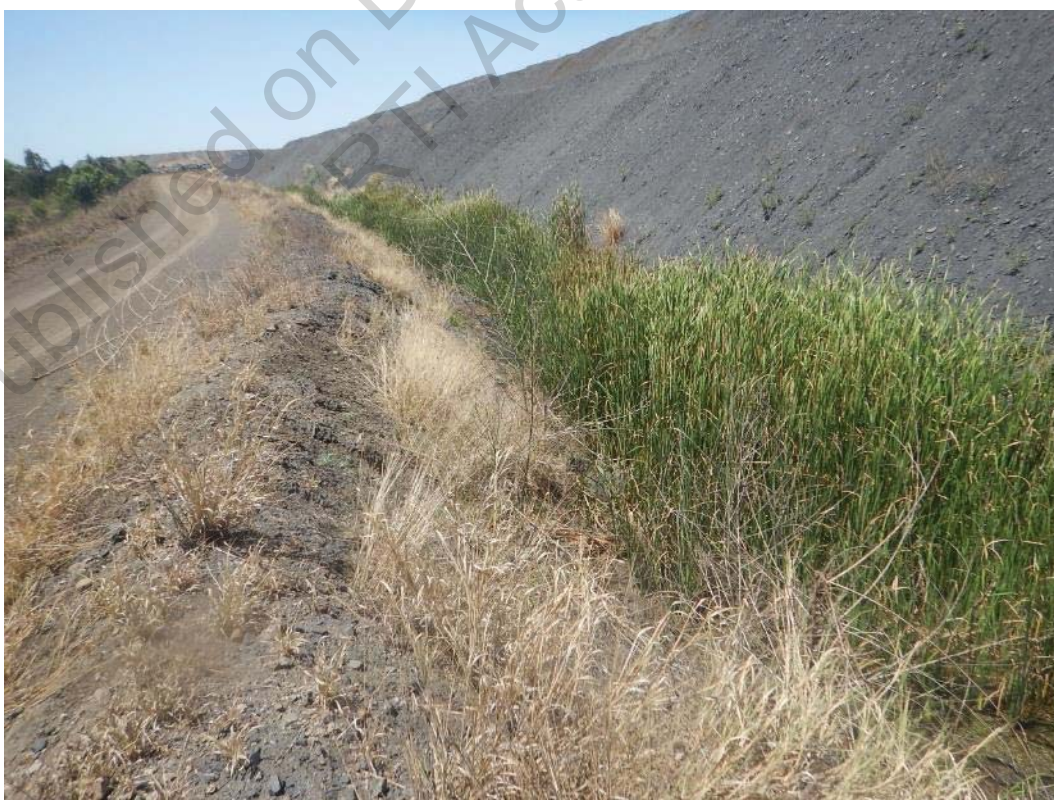
Photo 16 Eastern Side of Cell 4

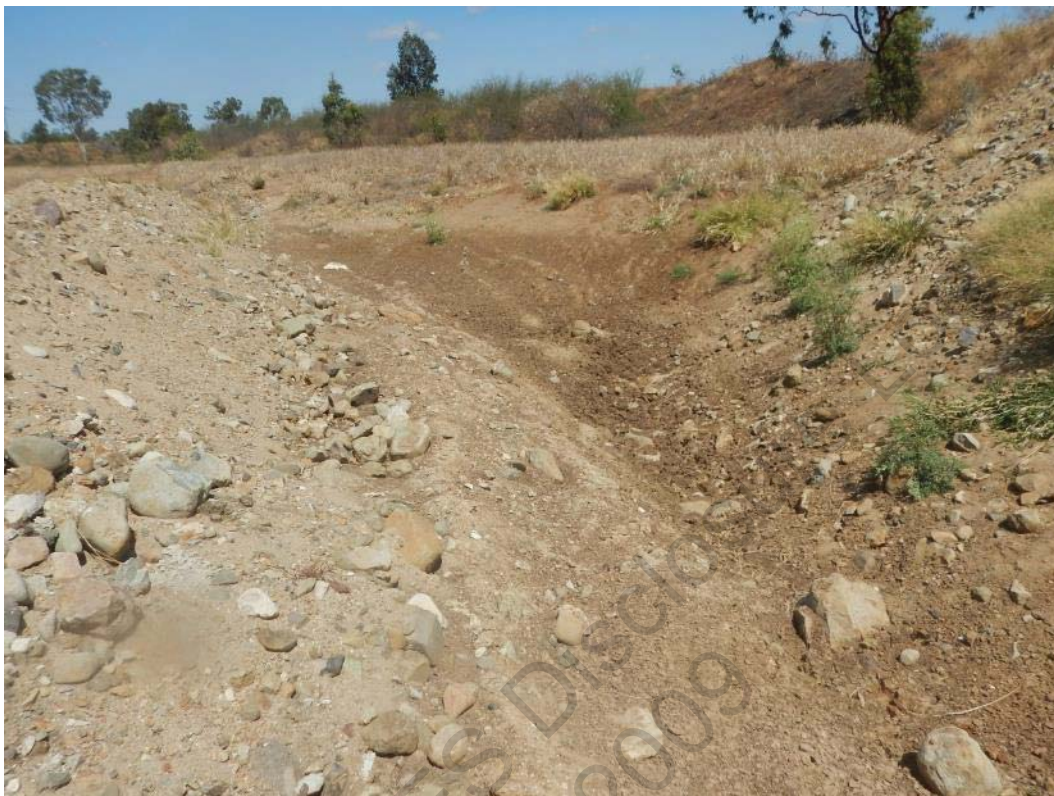
Photo 5 Settling Area on Downstream Side of Plug Formed by North Pit Dump

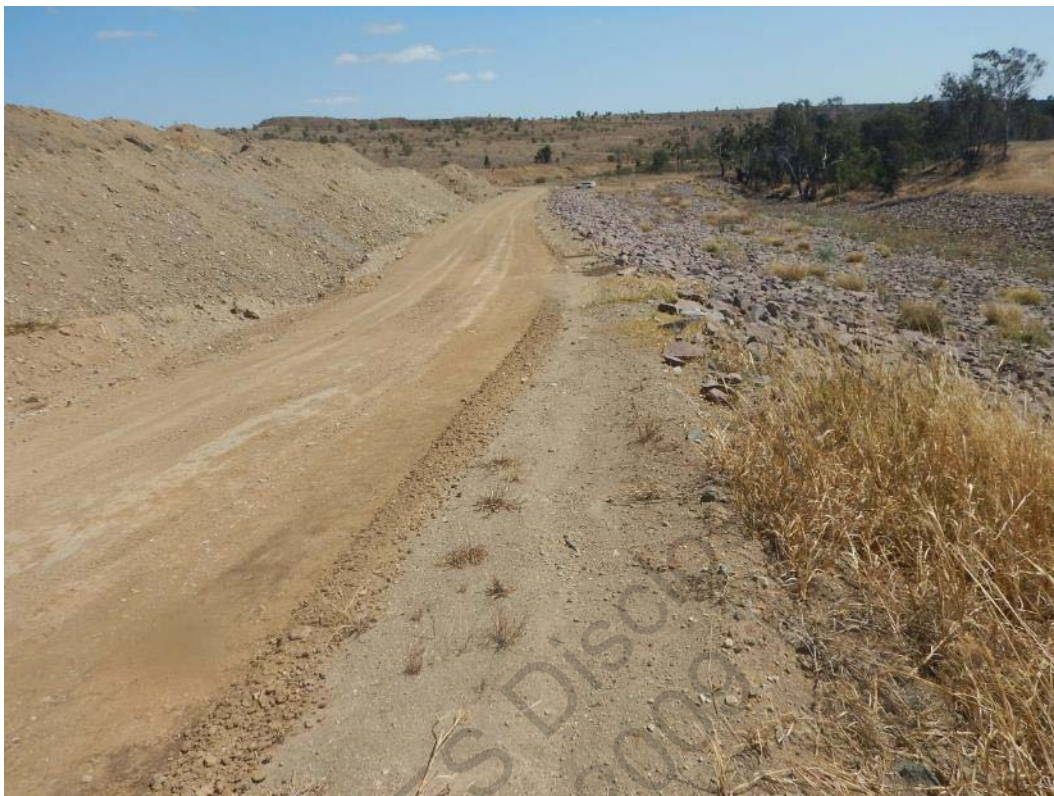
1. No changes have been made to the NSCD Downstream Plug since construction was completed.
2. There was no water flowing through or ponded in the NSCD adjacent to the Downstream Plug at the time of the inspection (Photo 3 and 7 in Appendix D).

Photo 7 Crest and Upstream Side of Plug (View from North-East End)

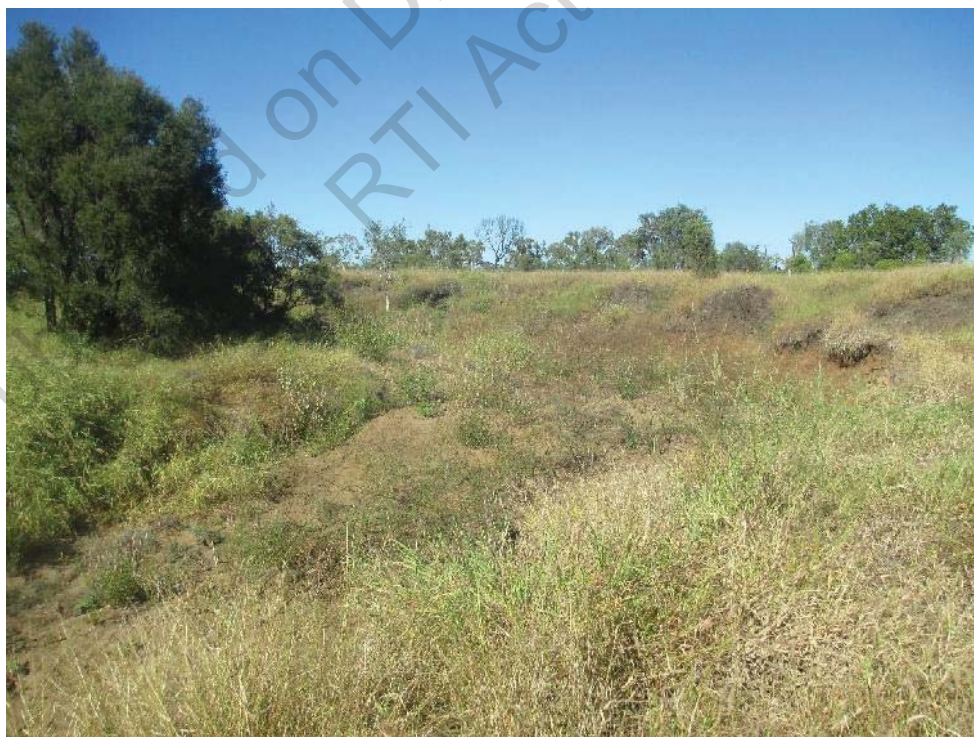
- Increased ground cover was observed along the waterway including on benches and some of the previous eroded batters (Figure 6.6).
  - Minimal ponded water was observed in either tributary.

Figure 6.6 Grass Establishment On Bench And Batters At TMC-US4

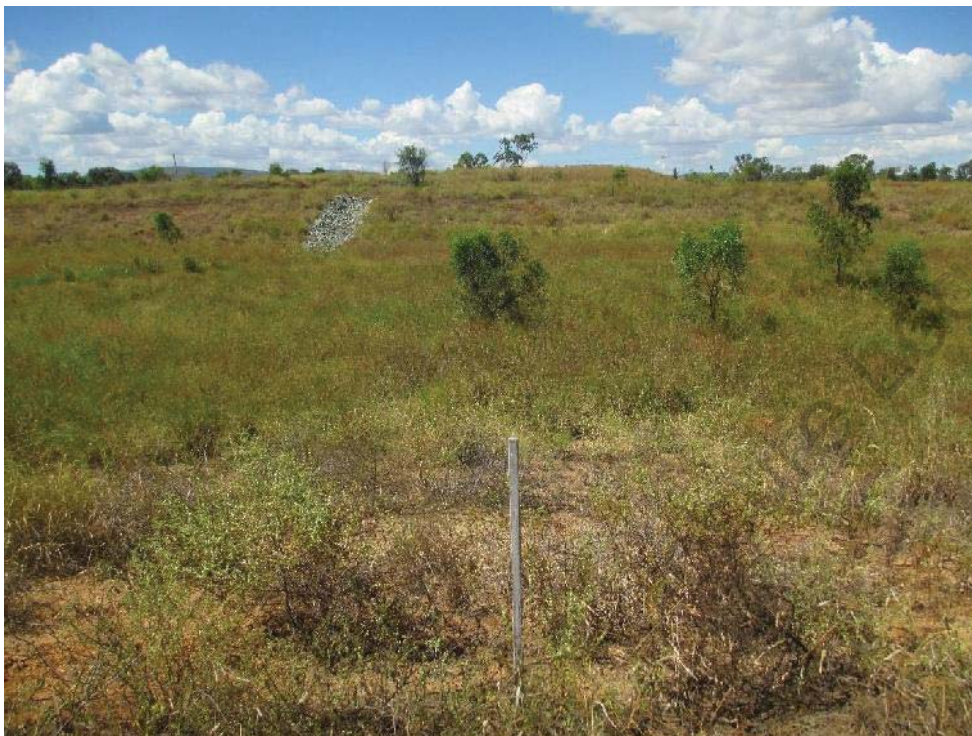
Figure 6.7 Extensive Groundcover With Increased Understorey And Overstory At TMC-Div1

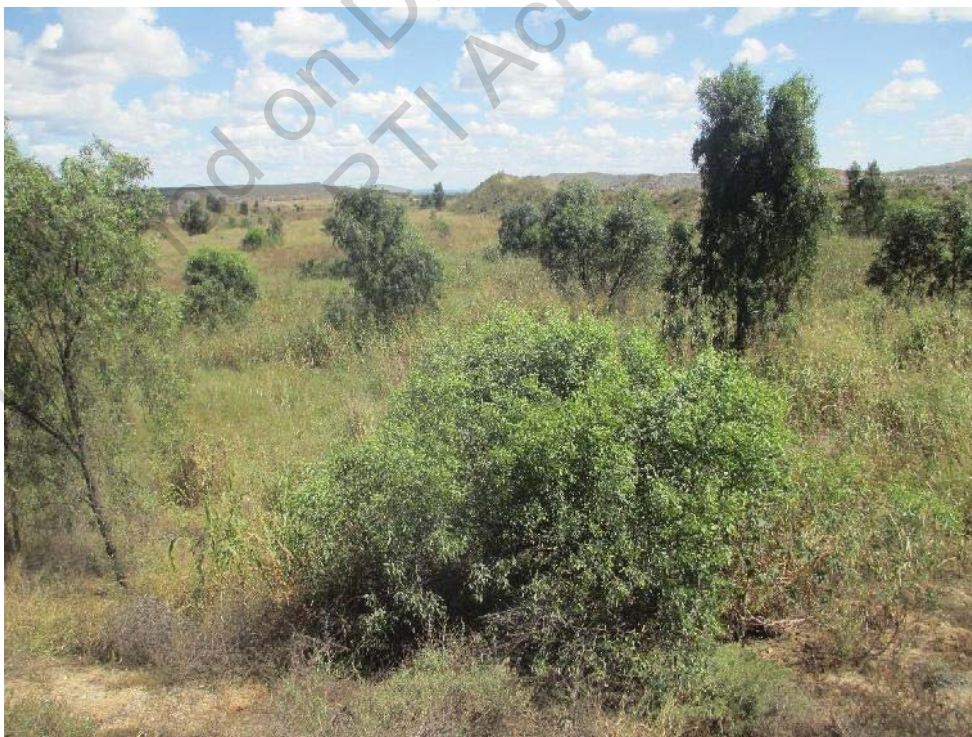
Figure 6.8 Extensive Groundcover With Increased Understorey And Overstory Downstream Of Haul Road

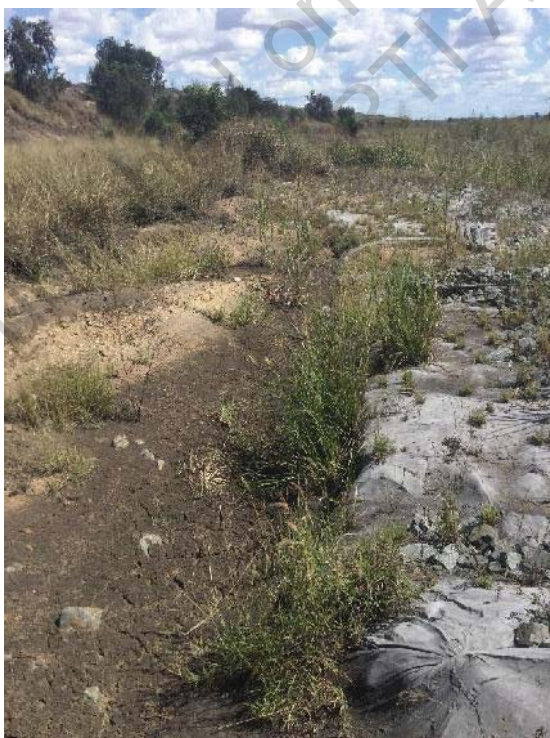
Figure 6.14 Grass Establishment In Low Flow Channel Downstream Of Haul Road

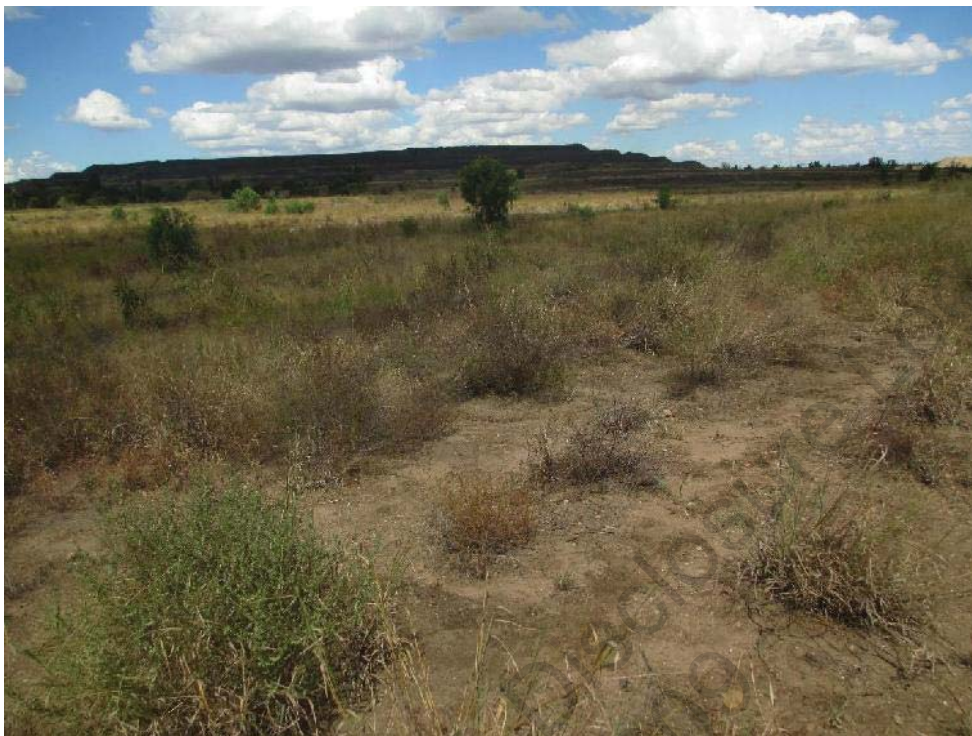
Figure 6.25 Vegetation Establishment On Right Bank Downstream Of TMC-Div3

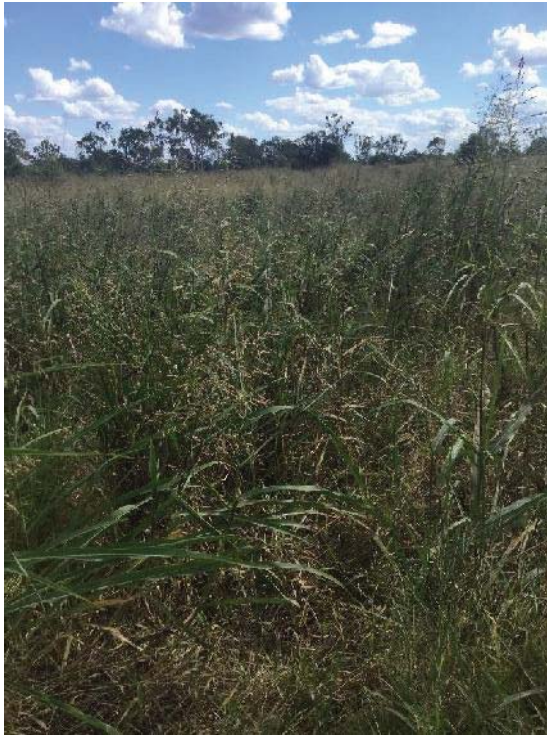
Figure 6.27 Dense Ground Cover At Downstream End Of Diversion

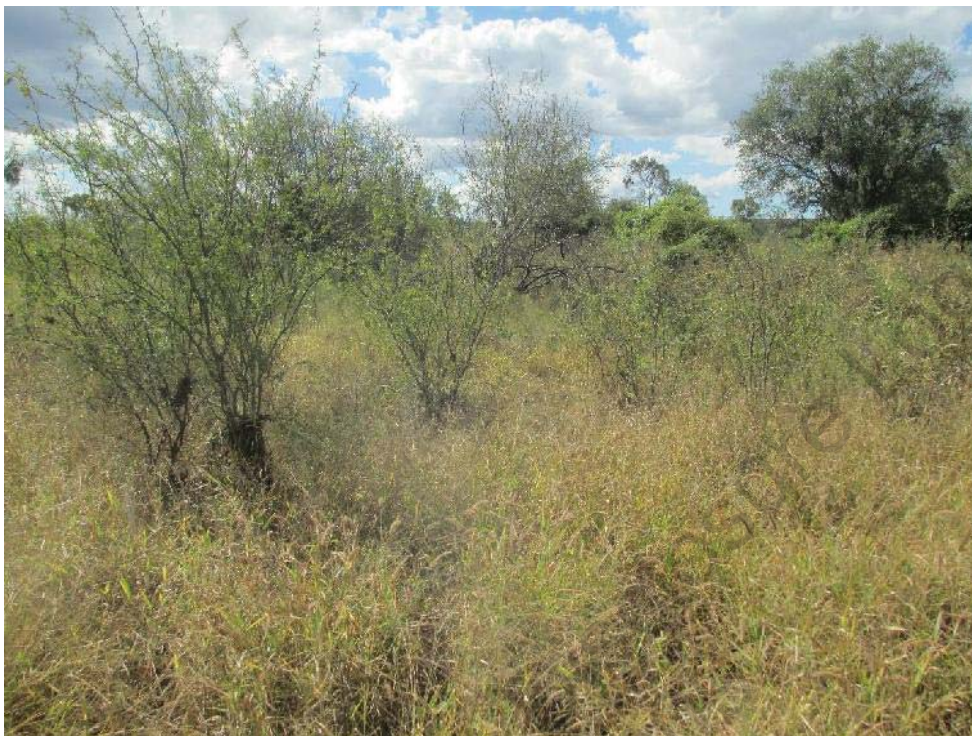
Figure 6.28 Dense Ground Cover At TMC-DS1
