Department of  
**Environment and  
Heritage Protection**

**Re: Compliance Inspection of ACI Operations Pty Ltd for ERA 44 Glass or glass fibre manufacturing**

I refer to the inspection of ACI Operations Pty Ltd at 137 Montague Road, South Brisbane on 19 February 2014, conducted by officers of the department.

## O-I Australia Ltd (ACI) Level C compliance inspection – Schedule B Air

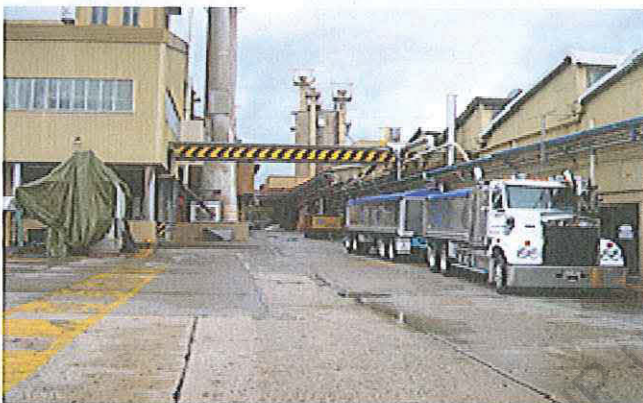
Photo: 1020681 – Improved housekeeping

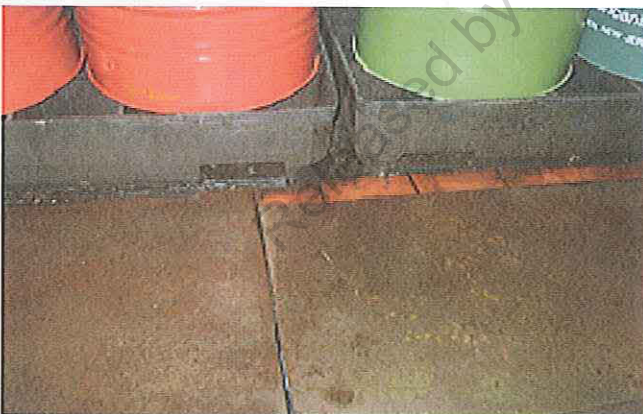
Photo: IMG2783 – What is the integrity of the tile and what is under the tile?

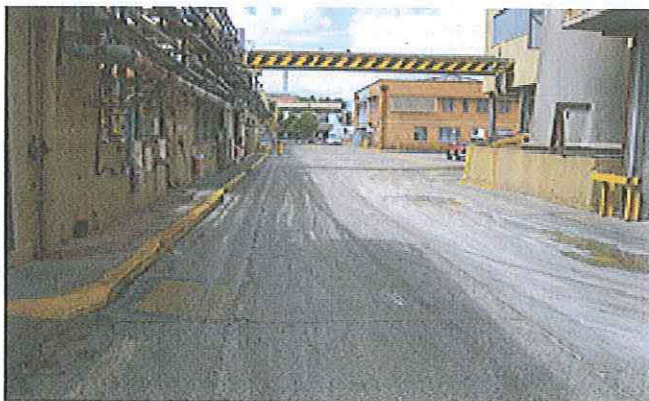
Photo: IMG2843 – Housekeeping in 2009.

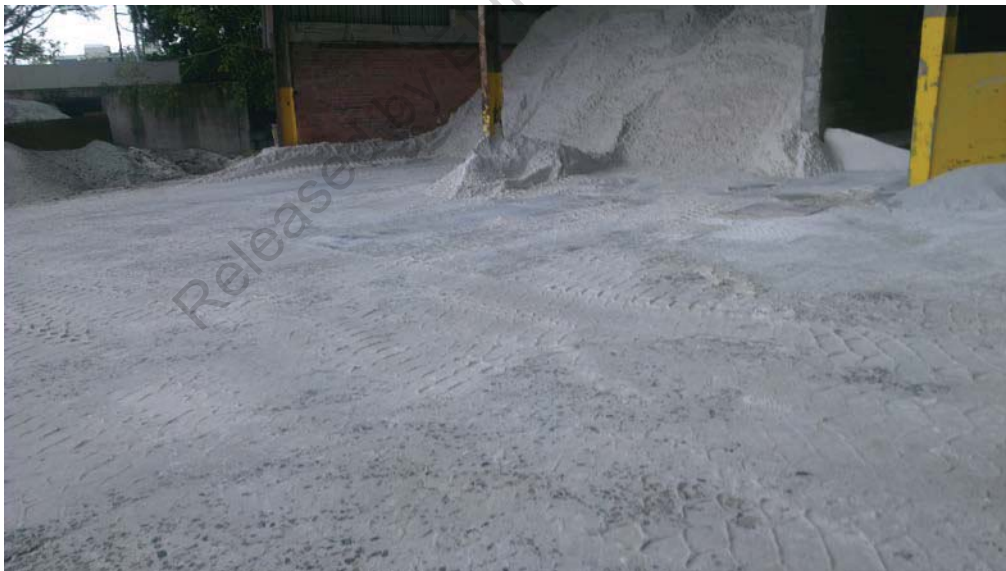
2. General housekeeping of the site (note previous compliance inspections by the department have indicated that housekeep was of a high-quality, unfortunately this was not the instance on 13<sup>th</sup> January 2015). Storage and stockpile management throughout the site was managed in haphazard manner, which appears to be exacerbated by surplus material following reduced production (please refer to photo 3 and 4 in attachment 1).

**Photo 4.** Stockpile management of raw material.

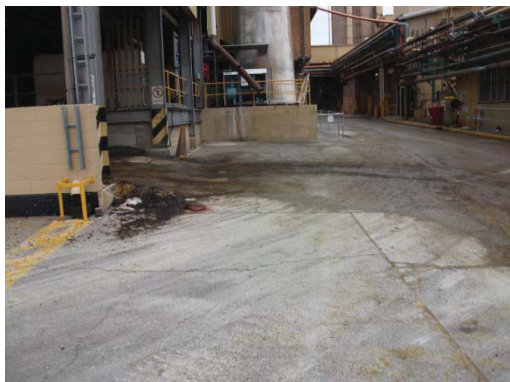
**Photo 1** – Loading bay diagonal to mould shed.

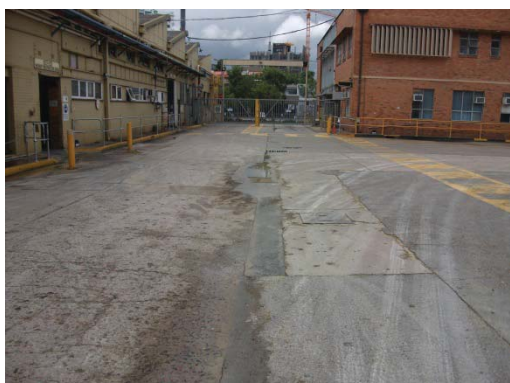
**Photo 2** – Photo captured looking at the entry driveway near Montague Road/Brereton Street. Note sediment laden water in channel flowing to stormwater drain.

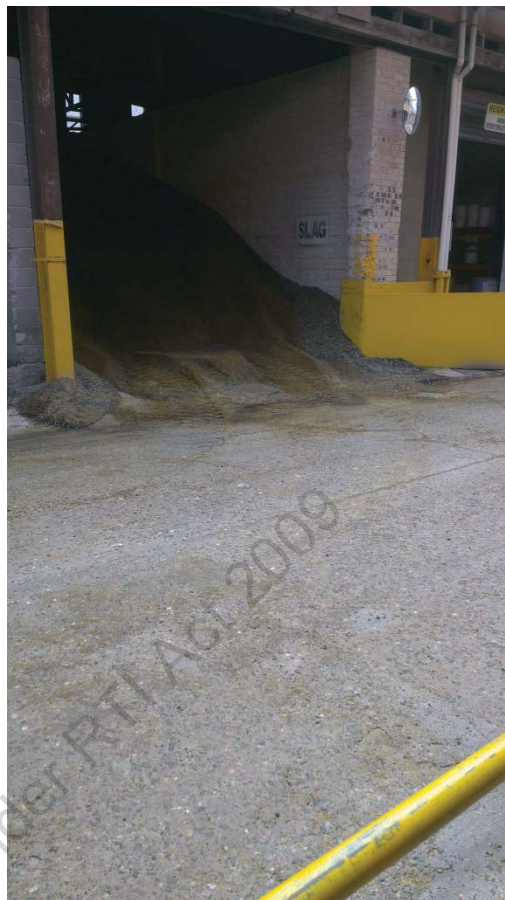
**Photo 3** – Loading bay.

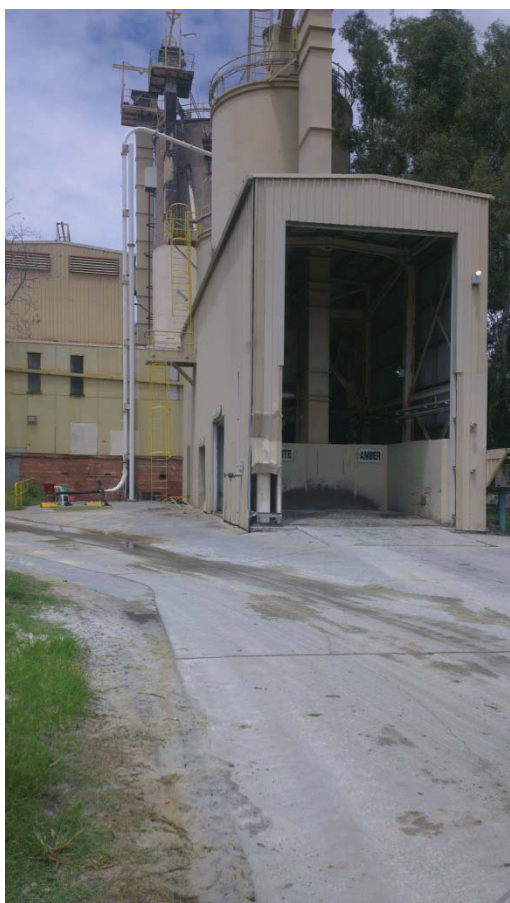
Photo 5 – Bag house.

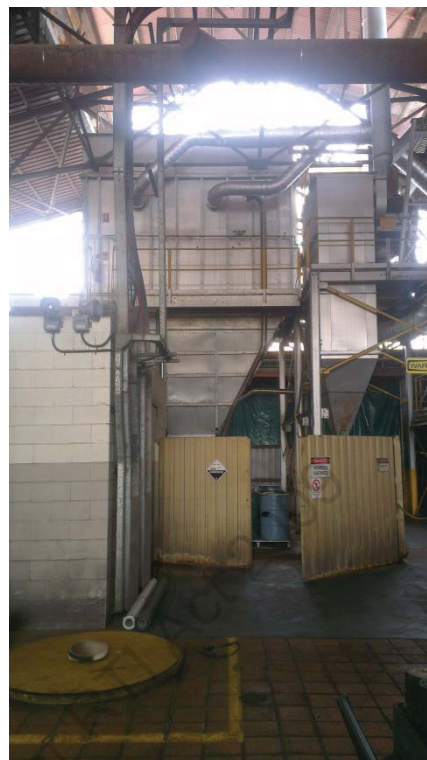
Photo 7 – Bag house.

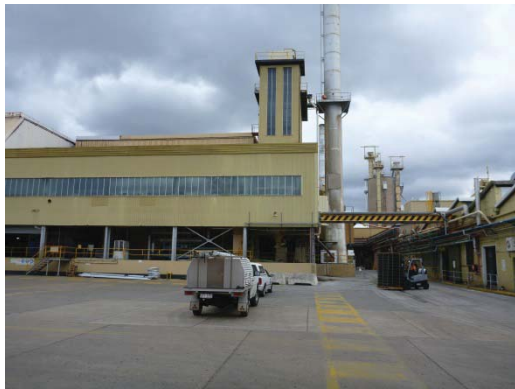
Photo 1 – Truck loading area

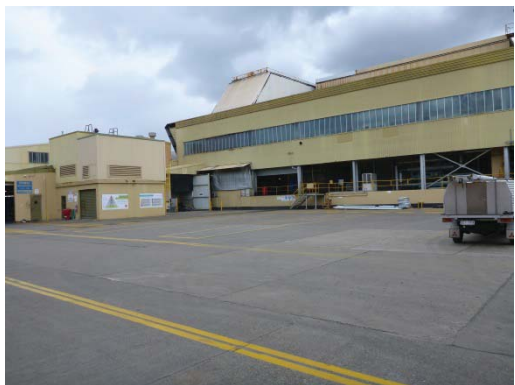
Photo 2 – Hardstand outside factory

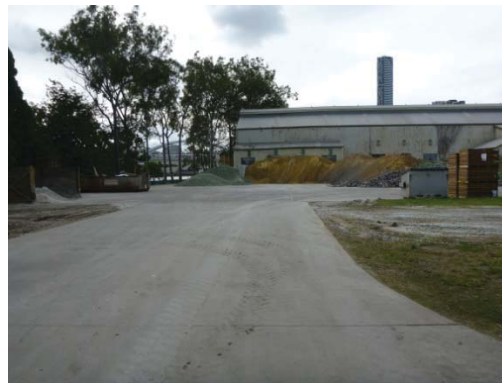
Photo 13 – Hardstand where glass shards were stored during previous inspection.

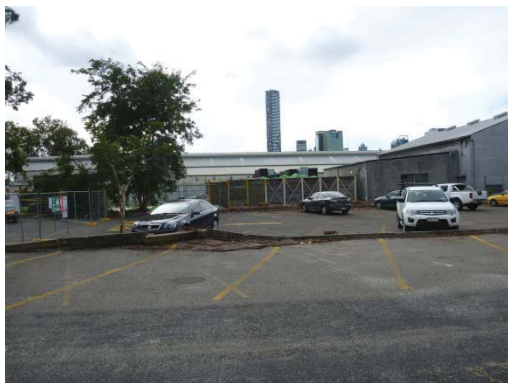
Photo 10 – Carpark where overflow glass material was stored during previous inspection

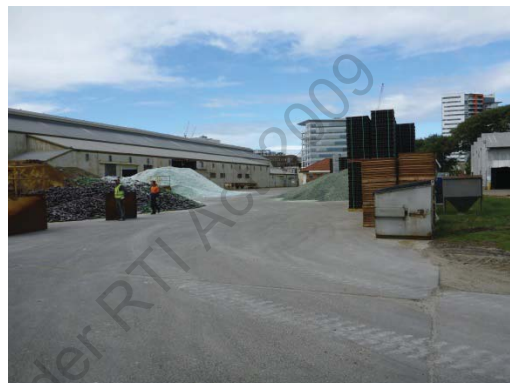
Photo 14 – Current stockpiles of glass for recycling.

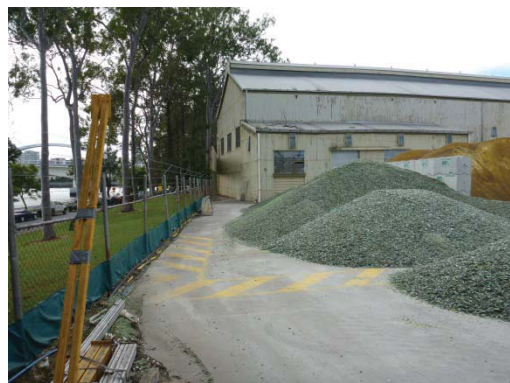
Photo 15 – Glass stockpiles the hardstand. Dust/glass particulate fence along site boundary.

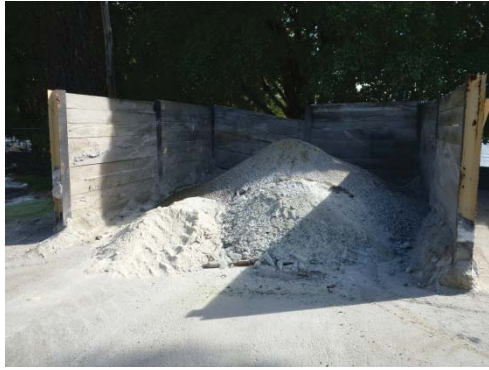
Photo 17 – Glass 'fines' dust

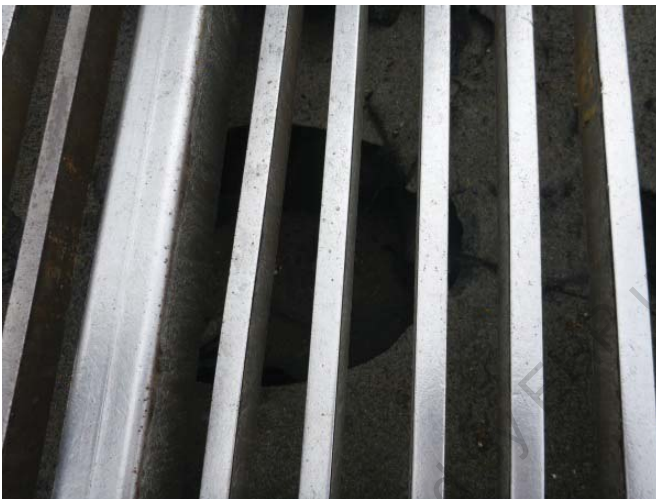
Photo 6 – Close up of stormwater drain

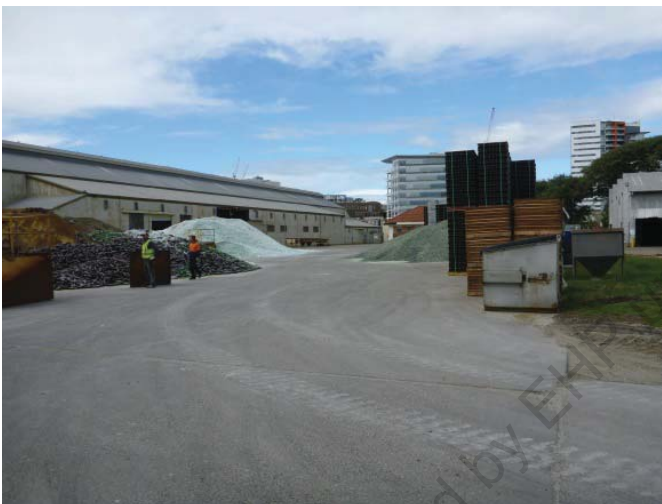
Photo 14 – Current stockpiles of glass for recycling.

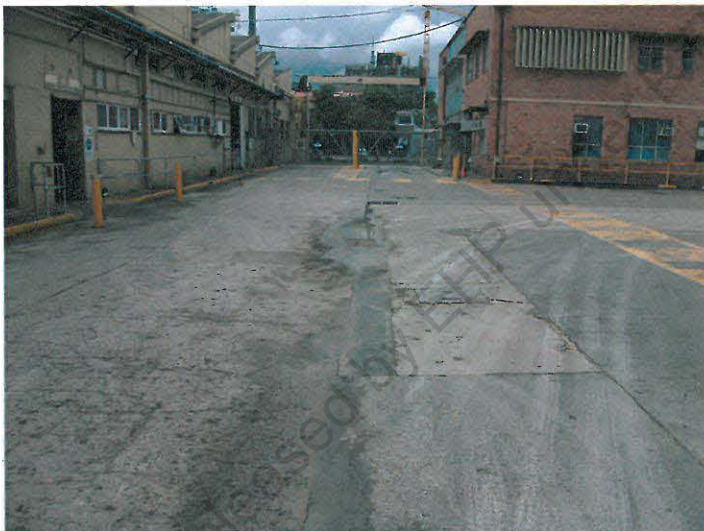
1. Outside the loading bay (diagonal to the mould shop), sediment laden water was observed leaving the bay and entering a stormwater drain (please refer to photo 1 and 2 in attachment 1). ACI staff informed officers that a Drain Warden was installed within the stormwater drain to contain oil and sediment run-off.

Furthermore the site appears to rely predominantly on water treatment systems such as Drain Wardens to manage the risk of contaminant releases to receiving waters (please refer to photo 1 and 2 in attachment 1). This management approach is confirmed in the Stormwater Management Plan and Stormwater Inspection documents supplied i.e. site sediment is marked for cleaning once in the drain, it is not addressed at the source.

**Photo 2.** Stormwater drain with 'drain warden', photo captured looking at the entry driveway near Montague Road/Brereton Street.

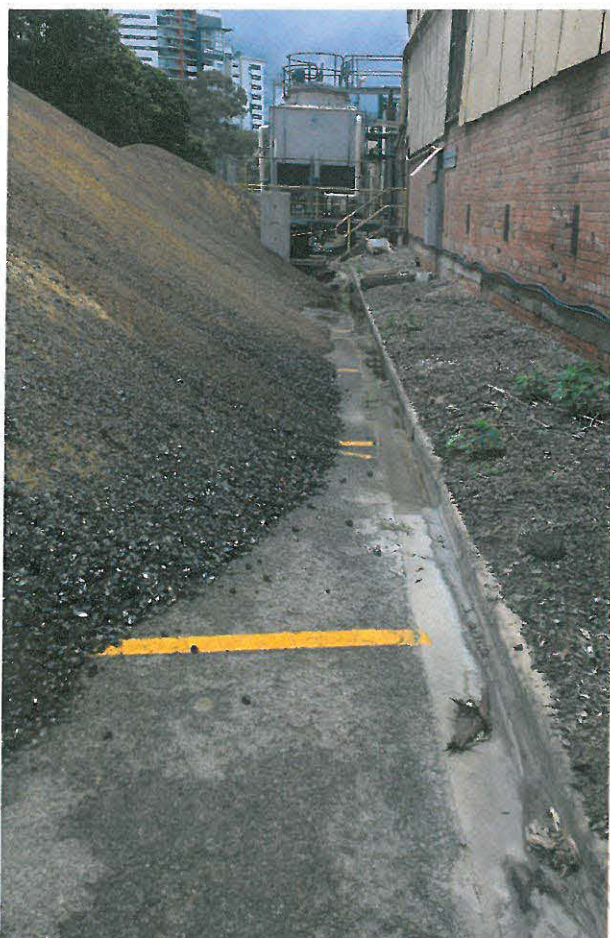
2. General housekeeping of the site (note previous compliance inspections by the department have indicated that housekeep was of a high-quality, unfortunately this was not the instance on 13<sup>th</sup> January 2015). Storage and stockpile management throughout the site was managed in haphazard manner, which appears to be exacerbated by surplus material following reduced production (please refer to photo 3 and 4 in attachment 1).

**Photo 3.** Surplus stockpile management of recycled glass.

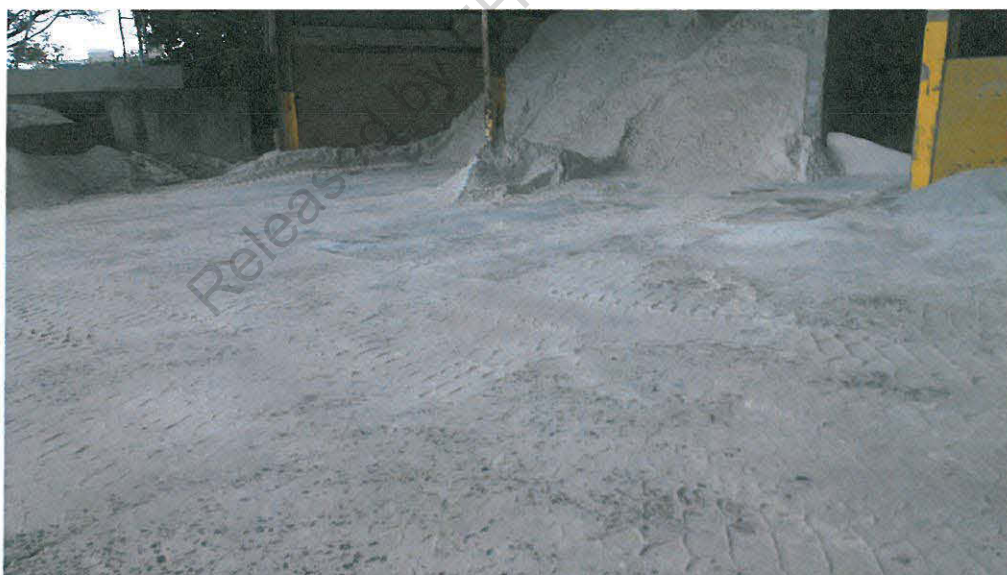
**Photo 4.** Stockpile management of raw material.
